# ASHREIGNEY METHODIST CHAPEL

HISTORIC BUILDING RECORDING

SOUTH WEST ARCHAEOLOGY LTD. REPORT NO. 181102

Draft issued: 6<sup>th</sup> November 2018  
Finalised: 2018

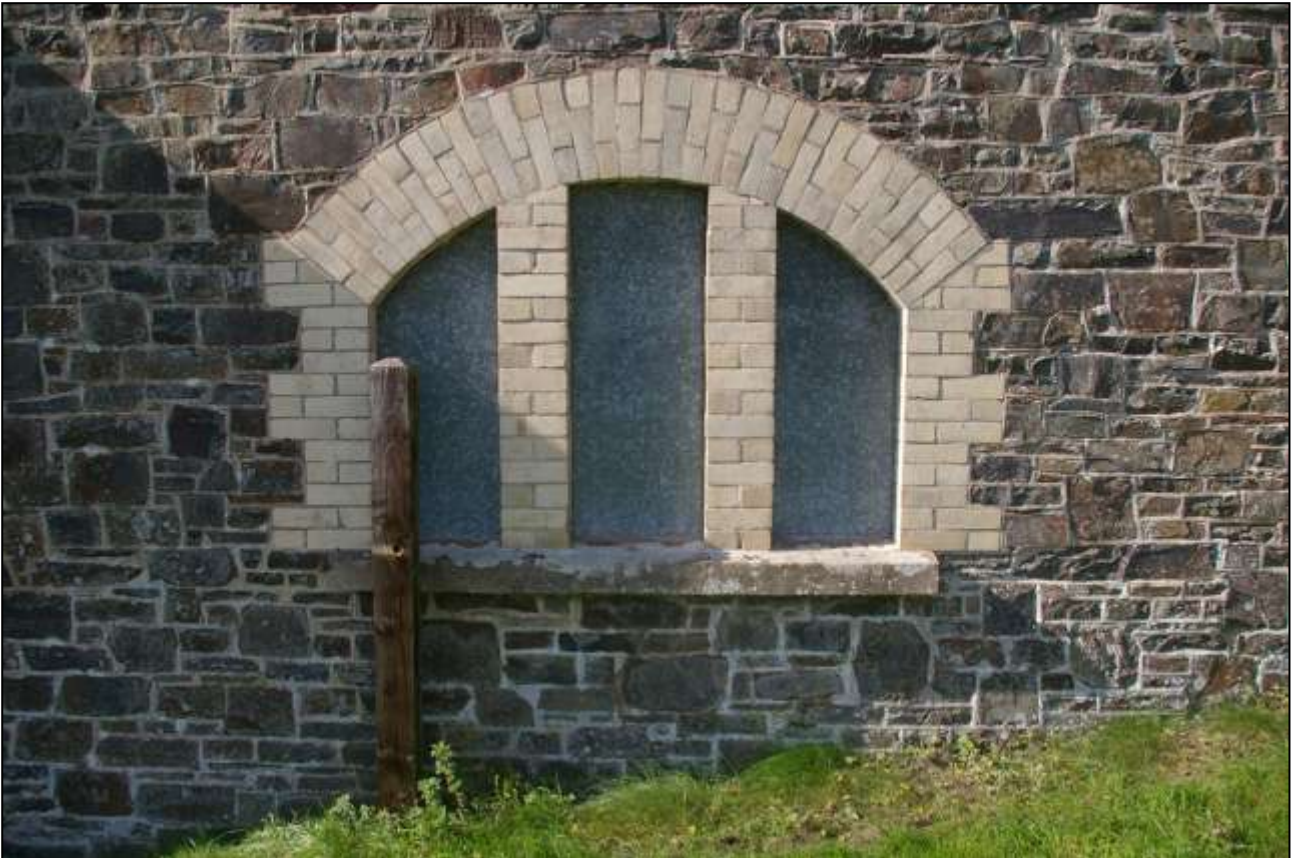
21. THE EAST TRIPARTITE WINDOW, LIGHTING THE CARRIAGE HOUSE, BLOCKED EXTERNALLY; FROM THE EAST.

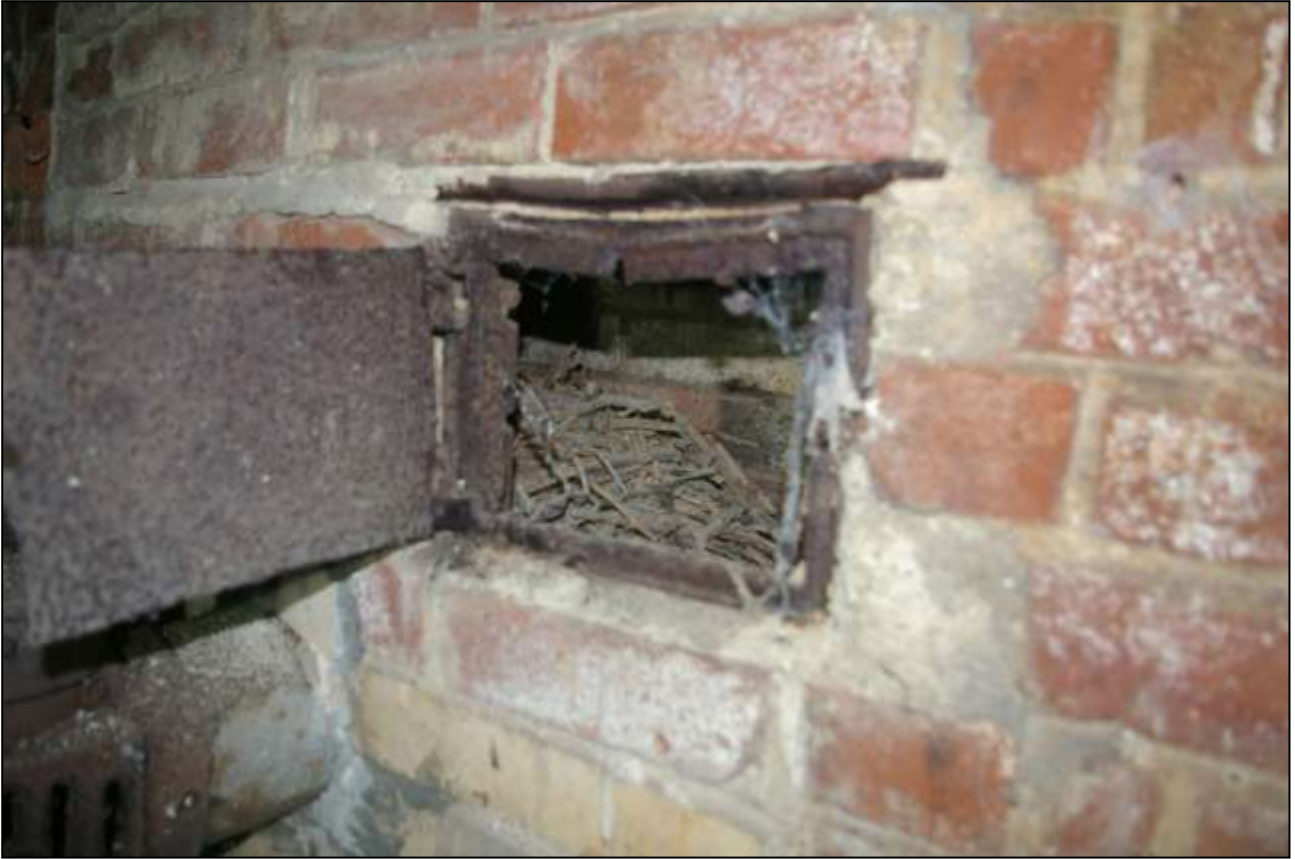
32. VIEW THROUGH THE HATCH SHOWING THE FLUE BLOCKED WITH JACKDAW NESTS; FROM THE NORTH-WEST.

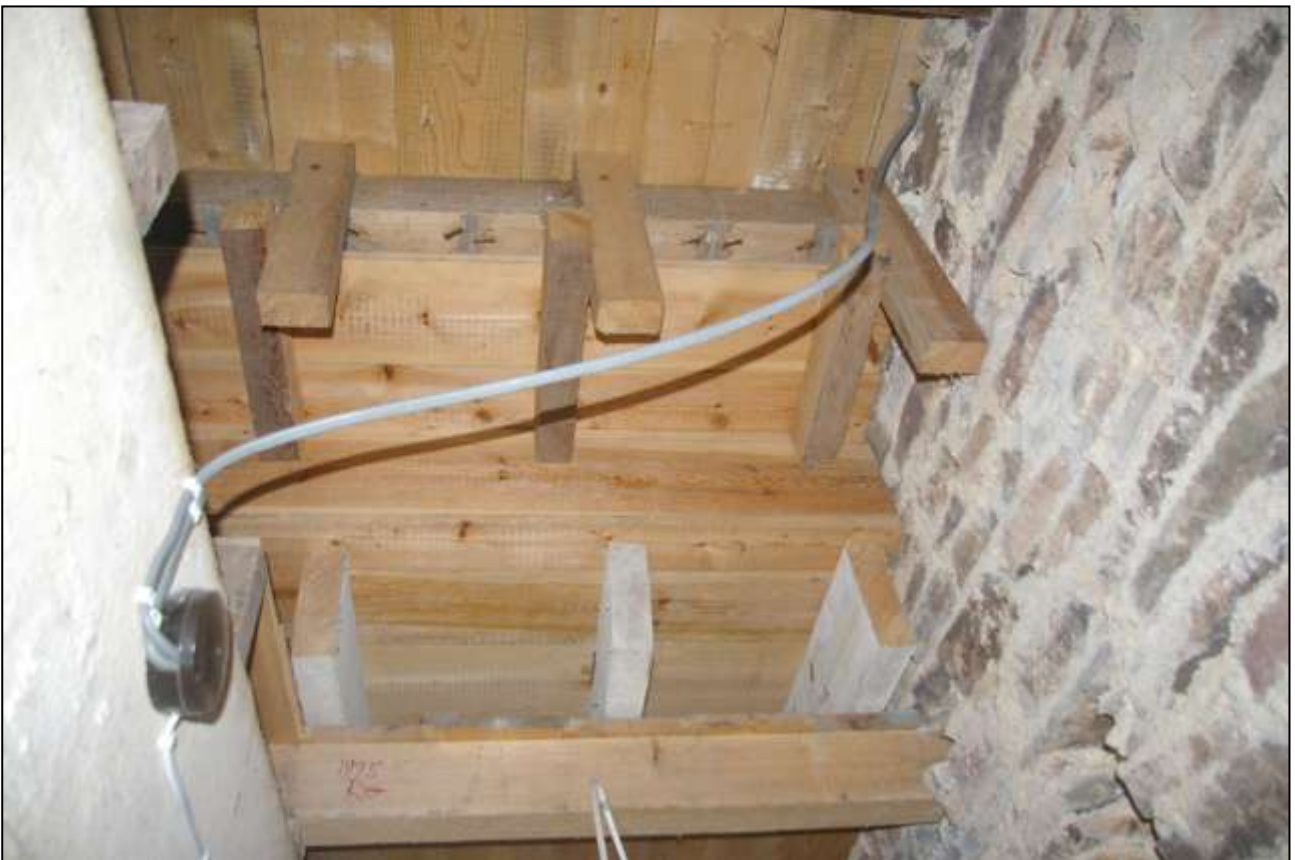
38. THE NEW WOODWORK UNDER THE FORMER ORGAN | THE UNDERCROFT, MARKED 1995; FROM THE WEST.

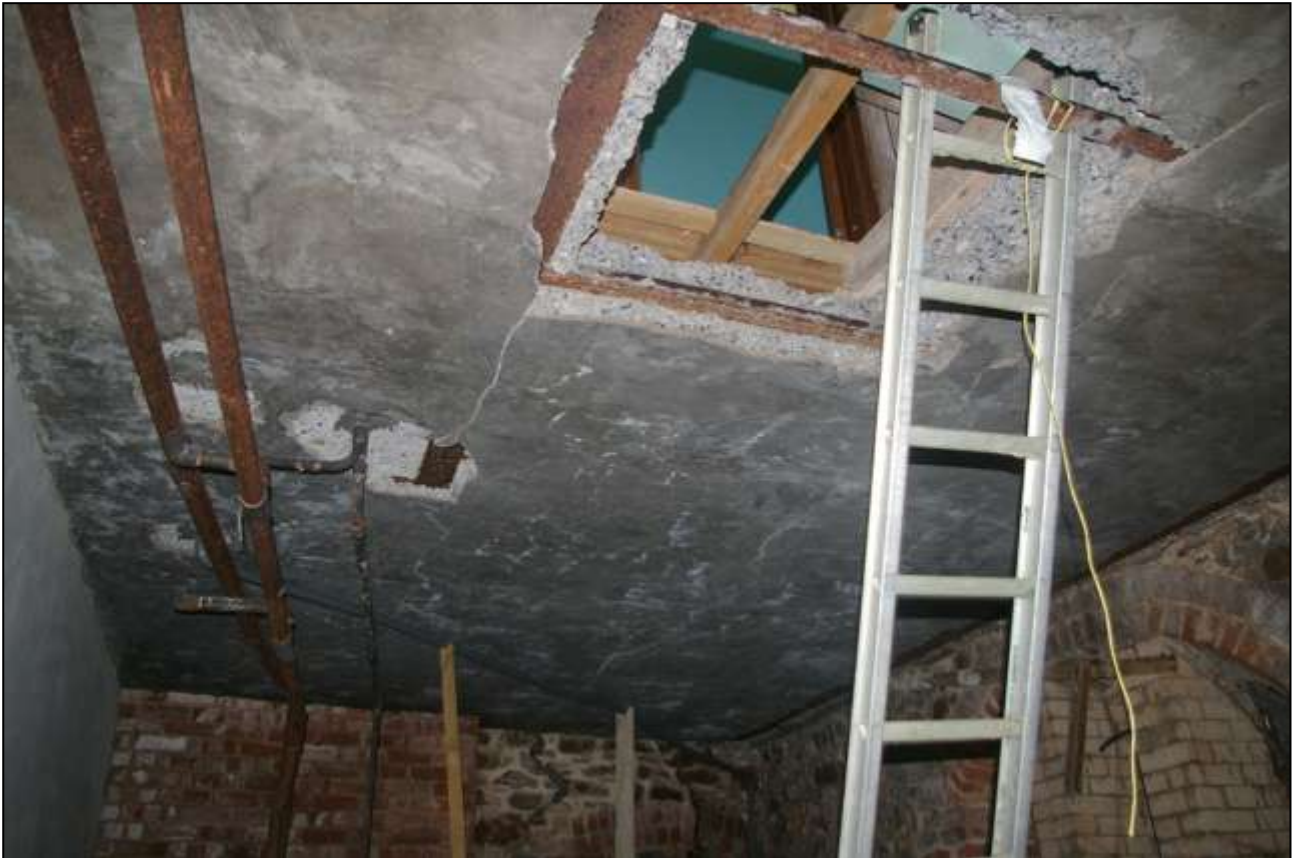
39. THE CONCRETE CEILING IN THE WESTERN END OF THE REAR CROSSWING, WHERE WOODEN JOISTS HAVE FAILED IN THE PAST, A LATER ALTERATION? FROM THE NORTH-EAST.

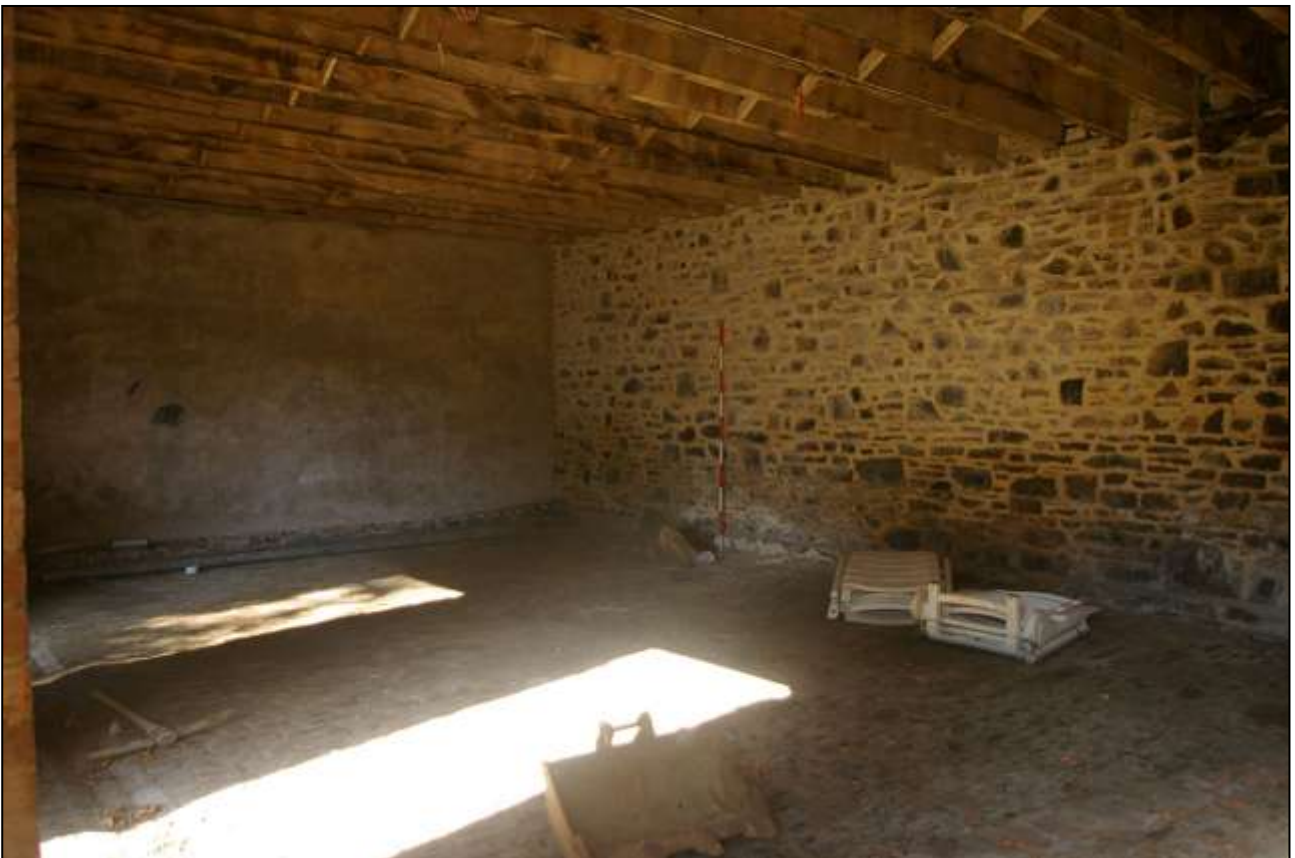
46. THE NORTH WALL OF THE CARRIAGE HOUSE AND THE INSERTED CONCRETE BLOCK PARTITION WALL; FROM THE SOUTH-EAST.

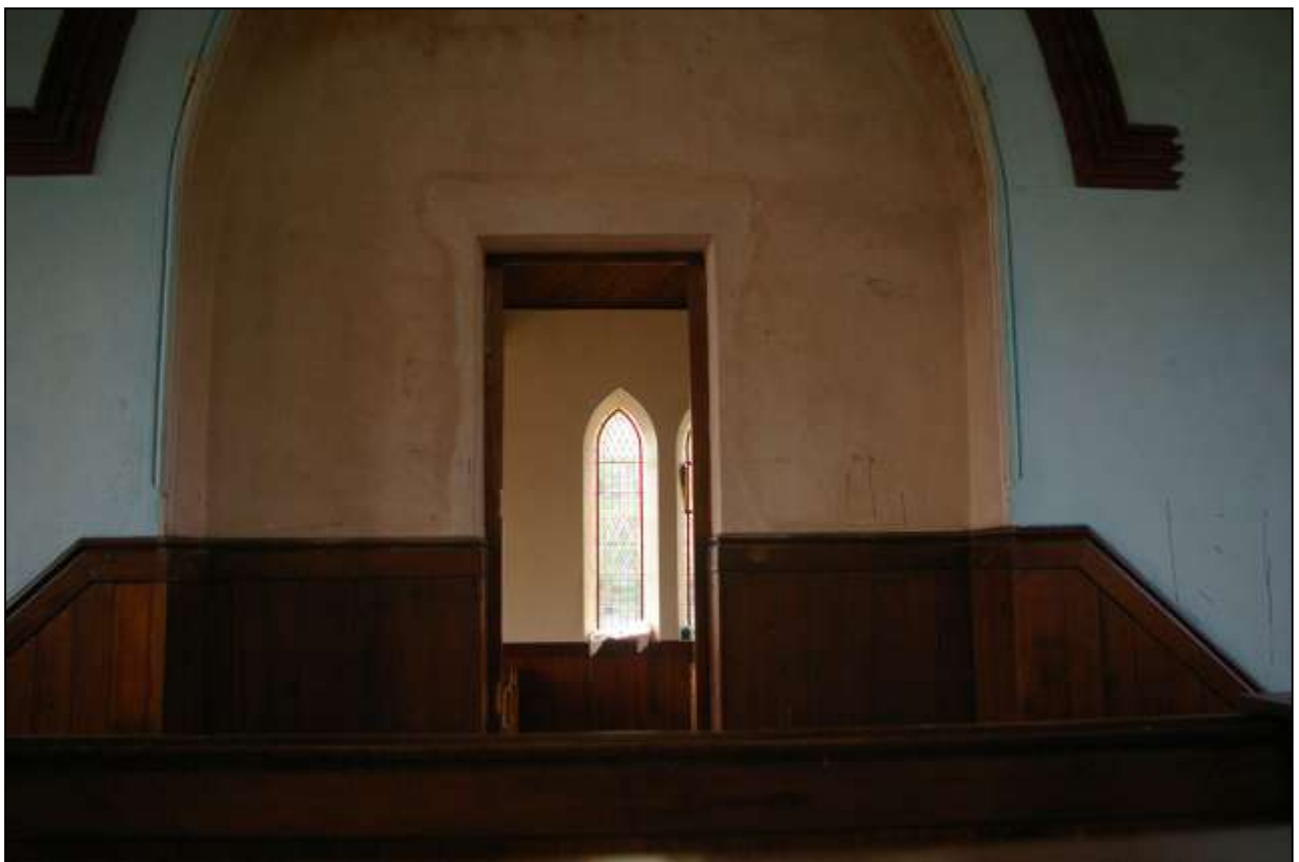
- An opening has been knocked in the recessed arched space behind the pulpit connecting through to the community hall.

71. THE MODERN FORCING OF AN OPENING TO THE BACK OF THE ALCOVE ABOVE THE PULPIT; FROM THE NORTH.

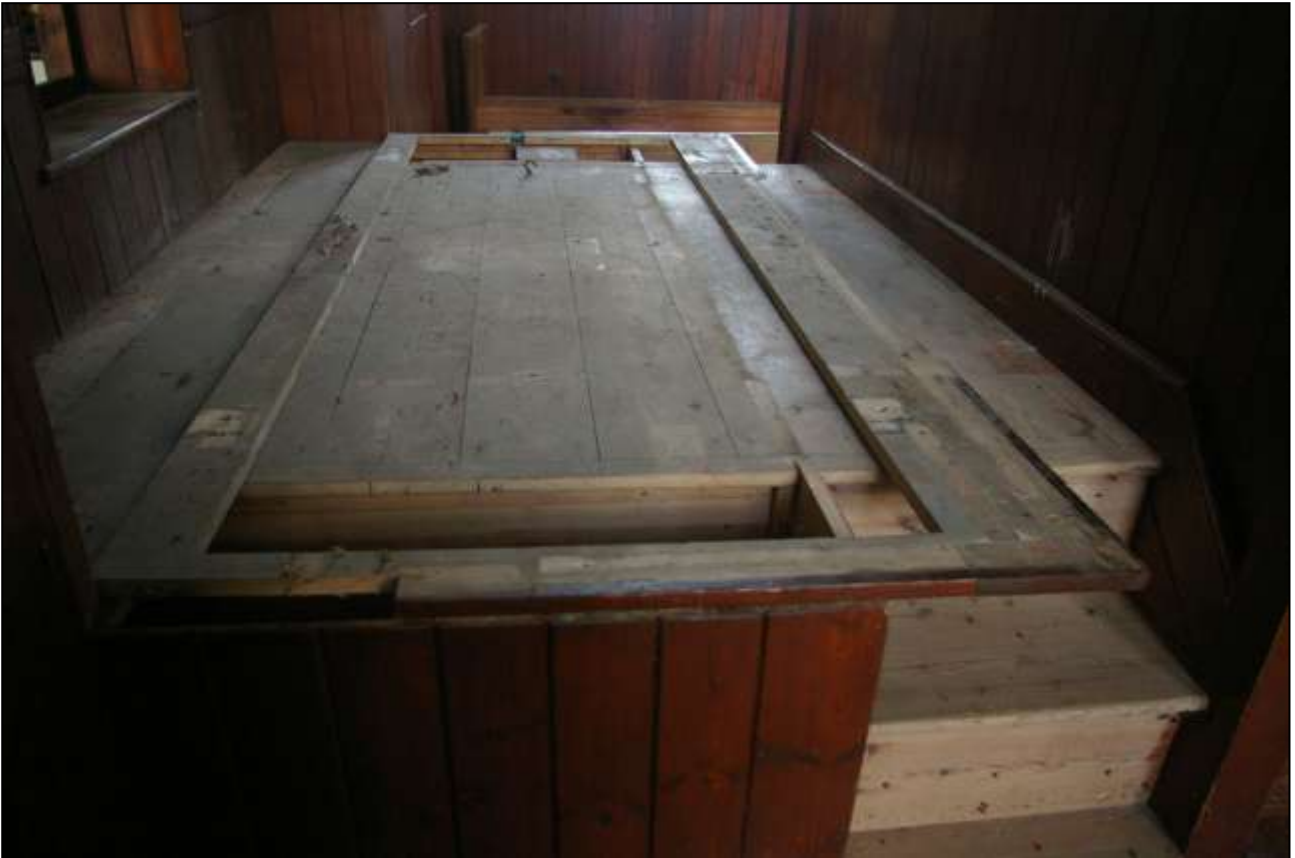
74. THE MODERN WOODWORK TO CARRY THE ORGAN, HIDDEN BEHIND RESET PANELLING, BEHIND THE PULPIT; FROM THE EAST.

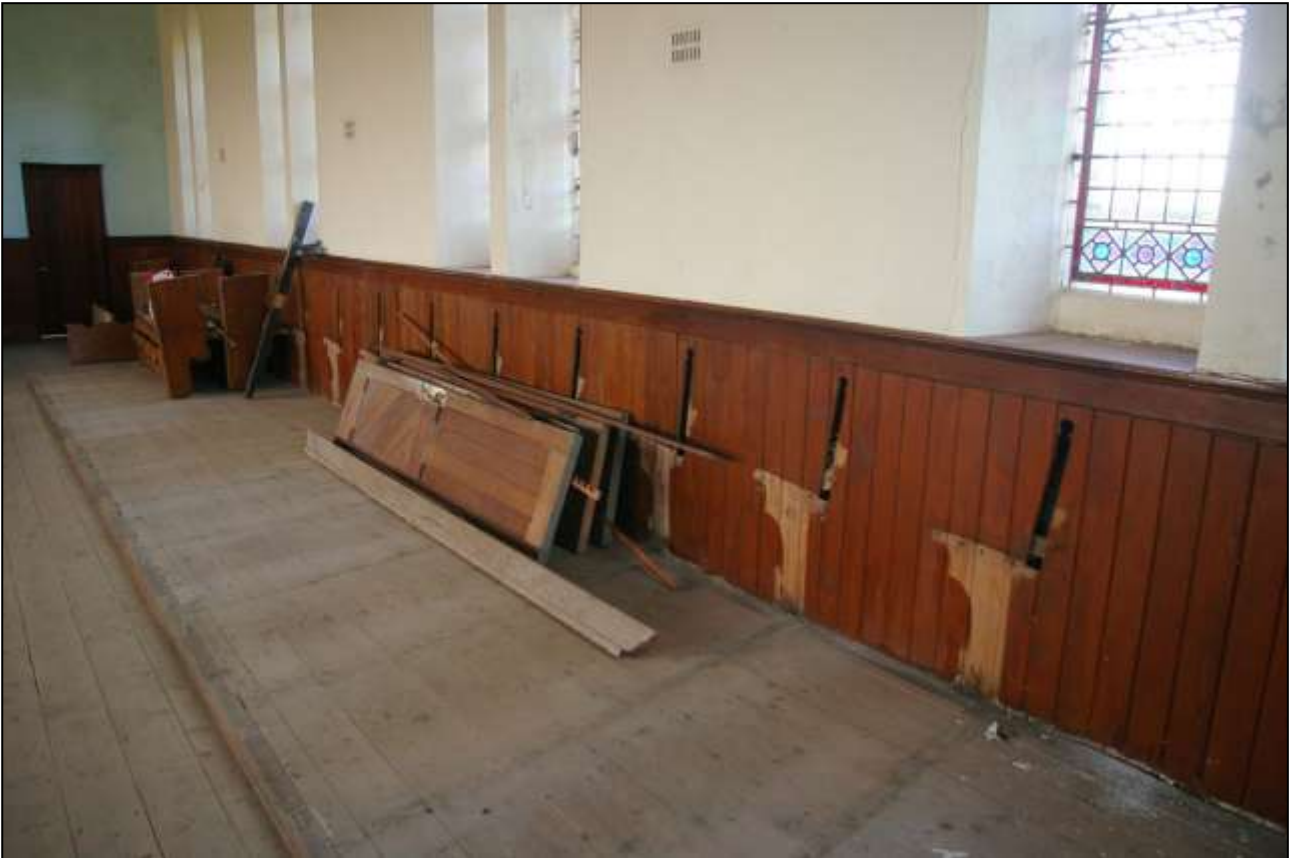
93. THE PANELLING TO THE WEST WALL, SHOWING THE SCARRING FROM THE REMOVED FITTED PEWS; FROM THE NORTH-NORTH-EAST.
