**BISH MILL  
BISHOP'S NYMPTON  
DEVON**

**HISTORIC BUILDING RECORDING**

**January 2017**

Project BNM256

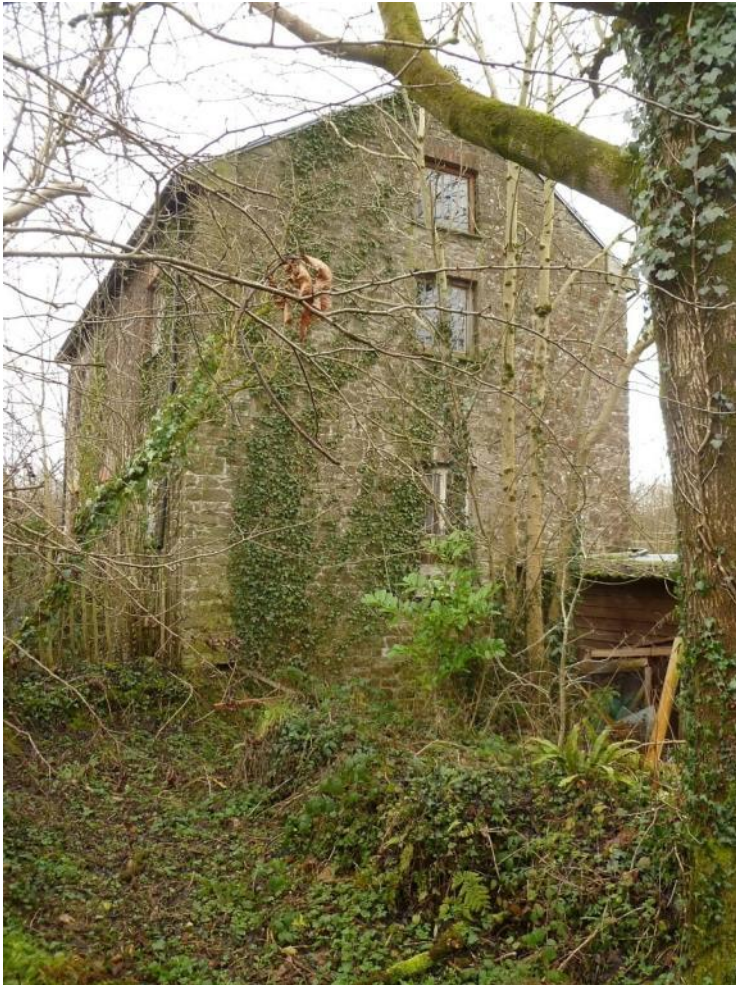
The east gable is the pit wall, with the external wheelpit at its base. There is some standing water and silt in the bottom of the wheelpit. The wheelshaft opening, which is just above ground floor level, has a stone lintel. A small opening about 1m below it acted as a drain to clear any water from the cog pit. There are two recesses, both about 22cm square, to the north of the shaft opening which may have served to position timbers across the pit, either to prop the waterwheel or to support a platform for working on it. At the north-east corner is a vertical recess in the masonry which is considered further below (see photograph).

East gable end with silted leat to left foreground

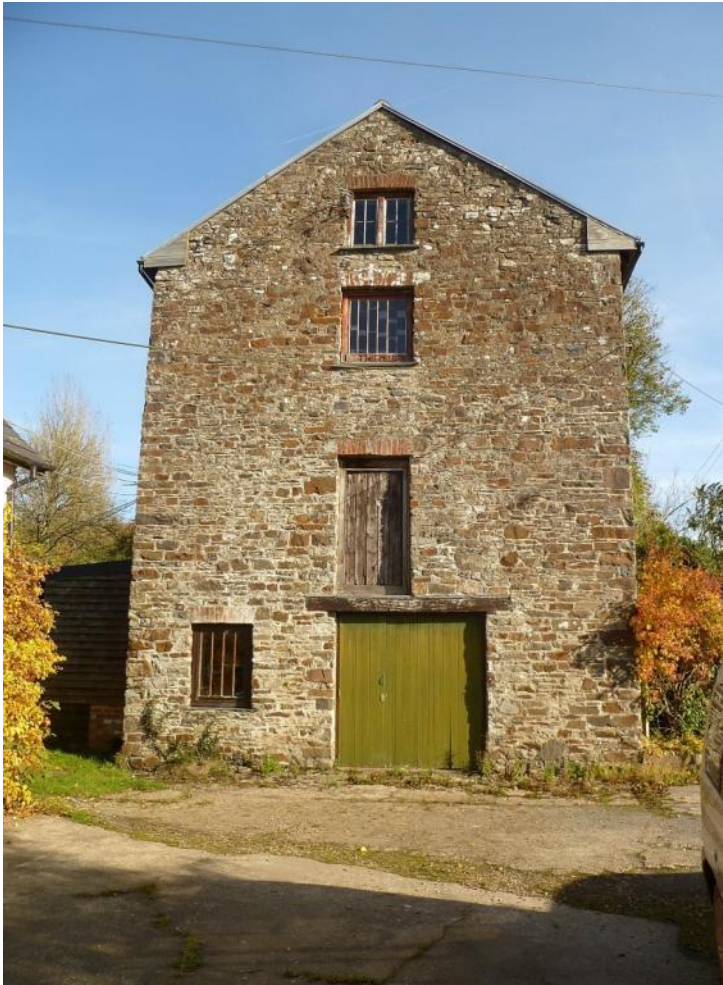
The west elevation has an enlarged doorway opening at ground floor level, with a squared timber lintel and three vertically-boarded door leaves. The north return of the doorway appears original, with quoins, while the south side has been rebuilt. From the symmetry of the elevation, it is suggested the original ground floor doorway was single leaf width. There are fragmentary remains of a cobbled surface immediately outside this doorway. A number

West gable end, from yard between mill and house

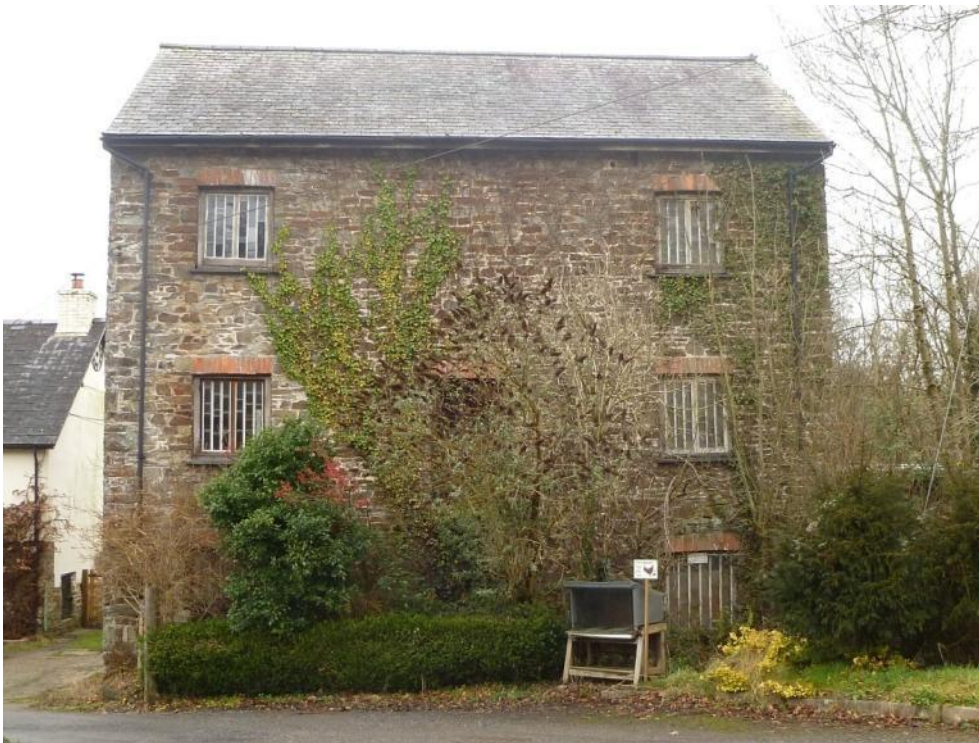
The south elevation is partly overgrown and inaccessible in places. The loading door at first floor level has two projecting oak timber cantilevers at floor level, presumably the remains of a platform which was used for unloading sacks of grain from the back of a cart or waggon.

South elevation. The first floor loading door is partially obscured.

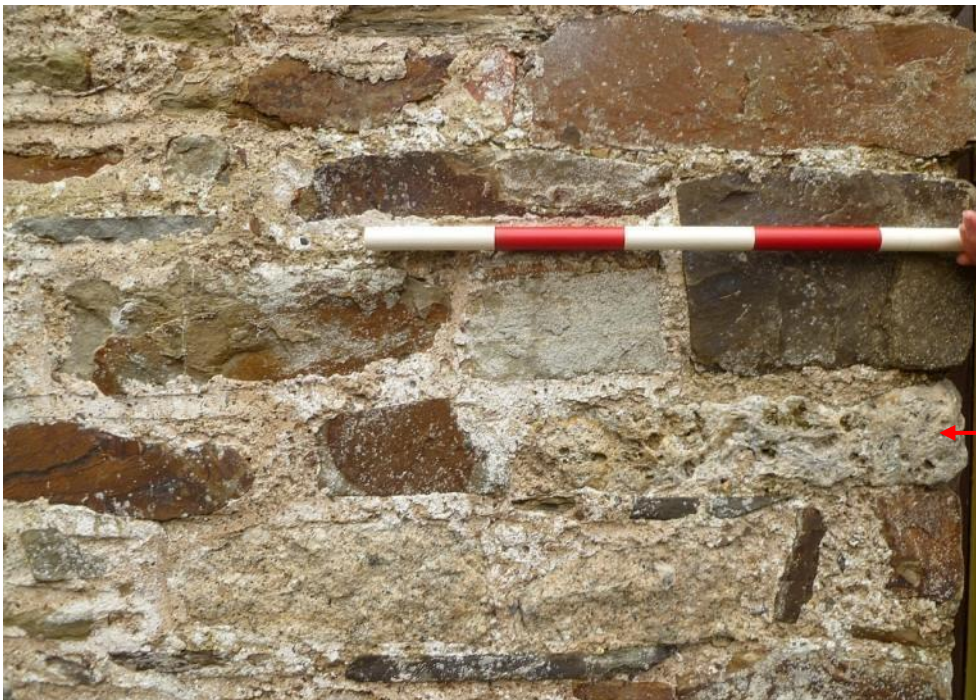
of millstone fragments have been built into the west gable wall on both sides of the ground and first floor doors. These are of French burr, granite and sandstone conglomerate (see photograph).

French burr millstone fragment built into west gable (half metre scale)

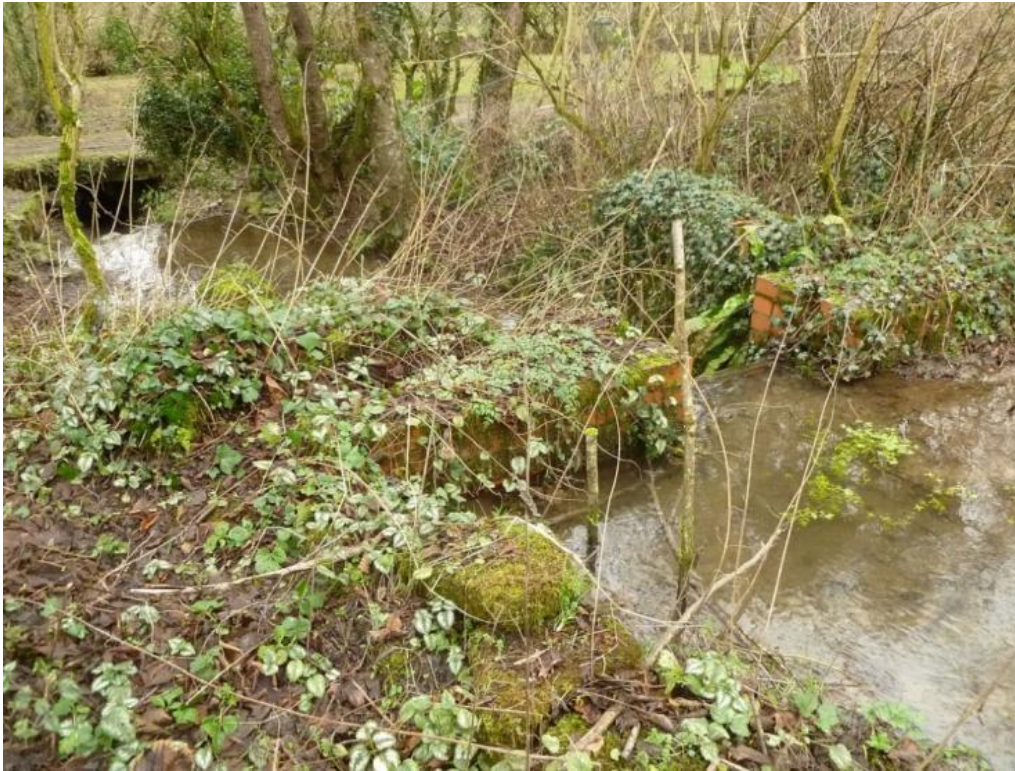
Leat diversion at spillway, with blocking to foreground

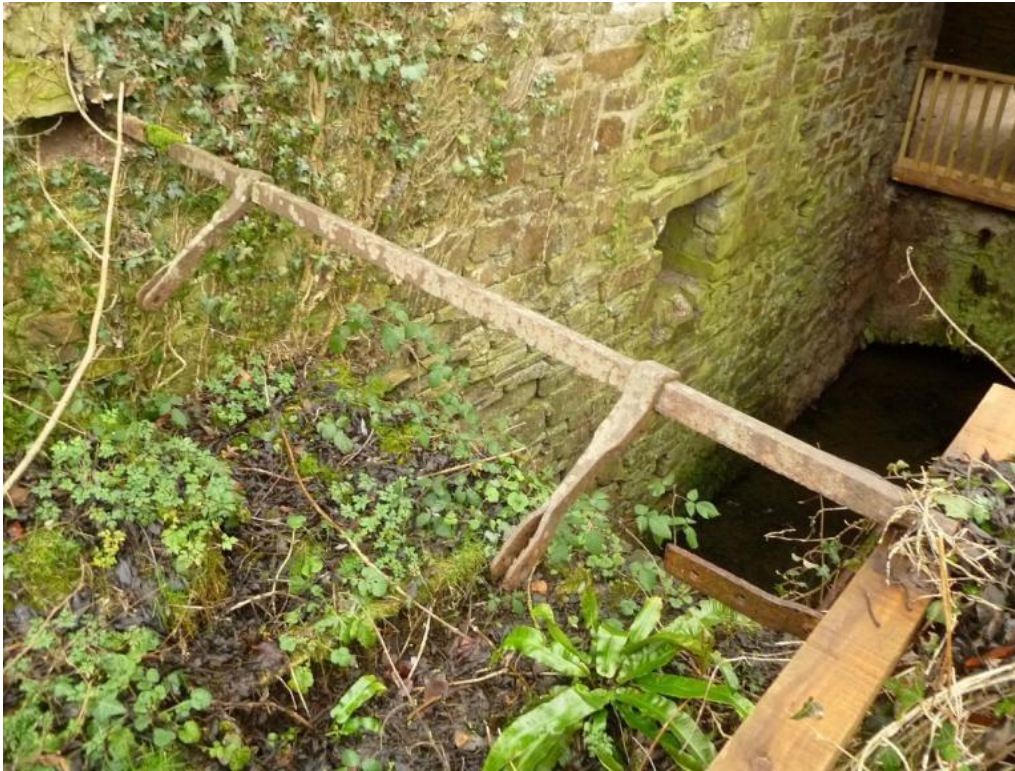
Looking down into wheelpit, with remains of penstock control

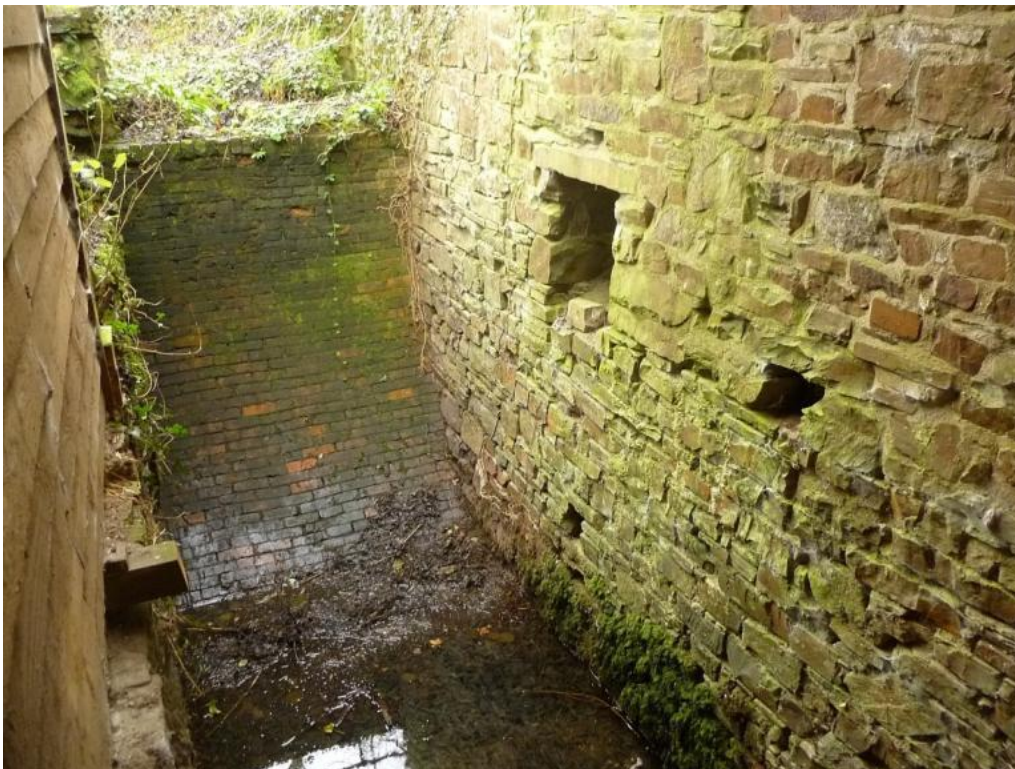
The external wheelpit along the east gable of the building would have contained a mid-high breast waterwheel of about 4.88m (16 feet) diameter by 1.82m (6 feet) maximum width. From approximate measurements taken of the level of the cill at the top of the curved brick breastwork at the south end of the wheelpit, the minimum head of water would have been about 3m (10 feet). The waterwheel was relatively powerful, capable of driving two or three pairs of millstones and ancillary machinery, including a hoist. The number of millstones working at any one time would depend on the water supply and what was being milled. Across the upstream end of the wheelpit is a square iron shaft with two arms projecting from it, the remains of the penstock control.

Wheelpit, showing curved brick breastwork at south end and wheelshaft opening

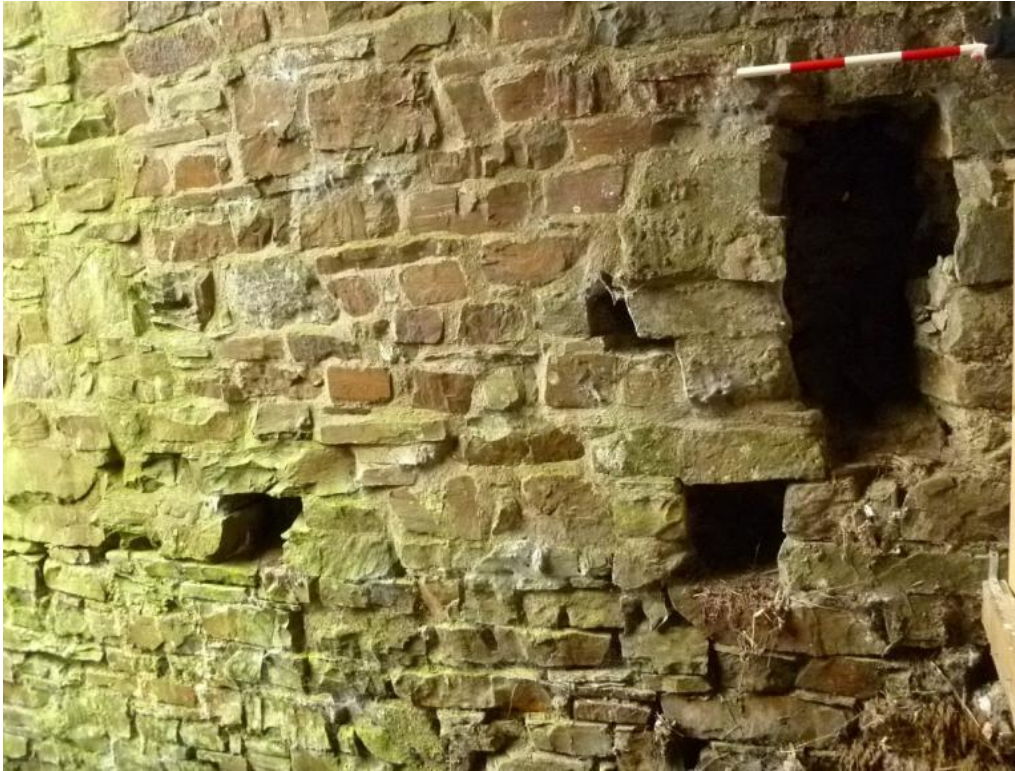
Recesses in pit (east gable) wall (half metre scale)

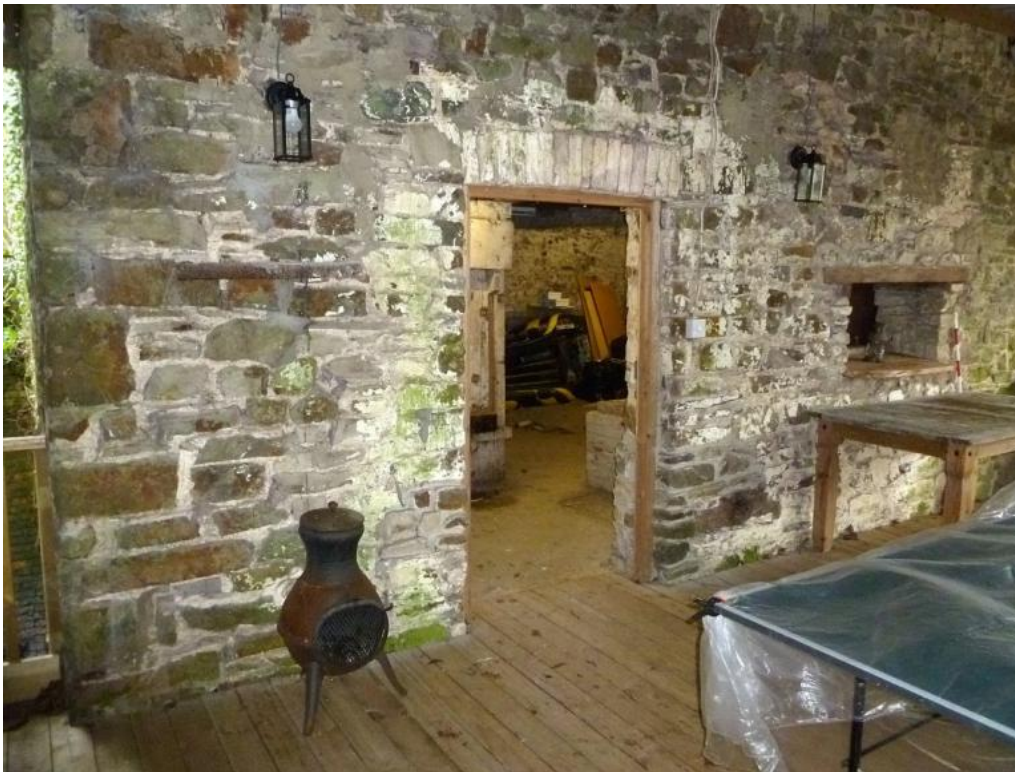
Doorway in north elevation into ground floor of mill, in former window opening

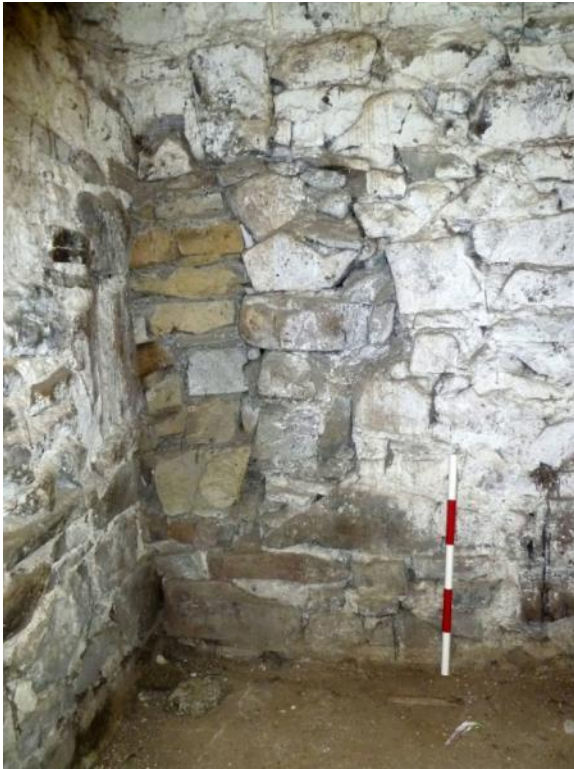
The inner face of the east gable wall has several interesting features. In the north-east corner is what appears to be a blocked partially circular opening. This is in about the same position as the exterior recess. Above the wheelshaft opening is an arc-shaped recess in the stonework, which would have allowed clearance around the horizontal spurwheel from which the drive to the millstones was taken from the vertical shaft (Figure 12). In the south-east corner is an angled timber, roughly squared and white-washed, with several holes bored in it, and a heavy metal forging, which formed the control handle by which the penstock (the sluice gate behind the waterwheel) was operated. The holes in the timber allowed the penstock to be opened and held in different positions, depending on the amount of water required to run the mill.

Blocked opening in north-east corner

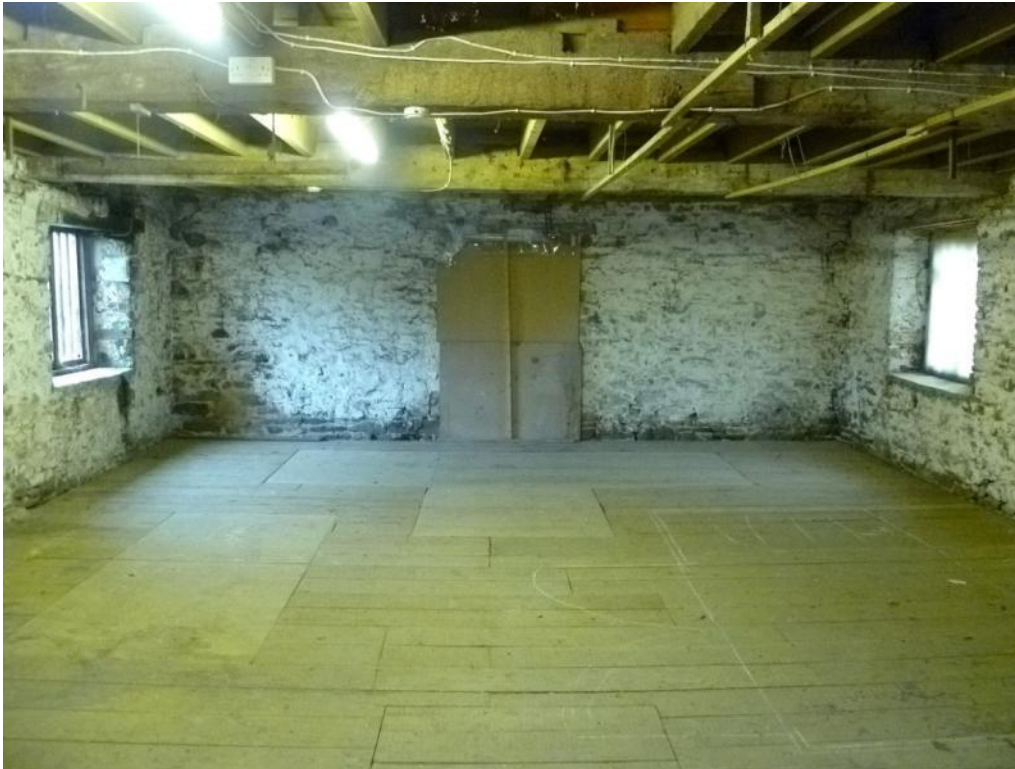
The remains of the hurst structure survive in the easternmost bay at ground floor level and the positions of the three pairs of millstones and the sack traps can be seen at first floor level, where plywood panels have been set in the floor. These and the positions of the vertical oak bridge posts are shown on the plans. The bridge posts are in pairs and, from the surviving evidence, would have supported cast-iron bridges, adjustable horizontal beams about 1.2m long, on which the foot bearings of the millstone drive spindles were located. There are horizontal iron tie rods between the feet of each pair of bridge posts close above floor level. The working positions of the millstones are indicated on the plan (Figure 5). The layout appears to have been a relatively conventional spurwheel underdrive arrangement, with the

First floor, looking east. Plywood panels indicate former millstone positions, a former opening over the brick plinth (left) and the sack traps (centre foreground)

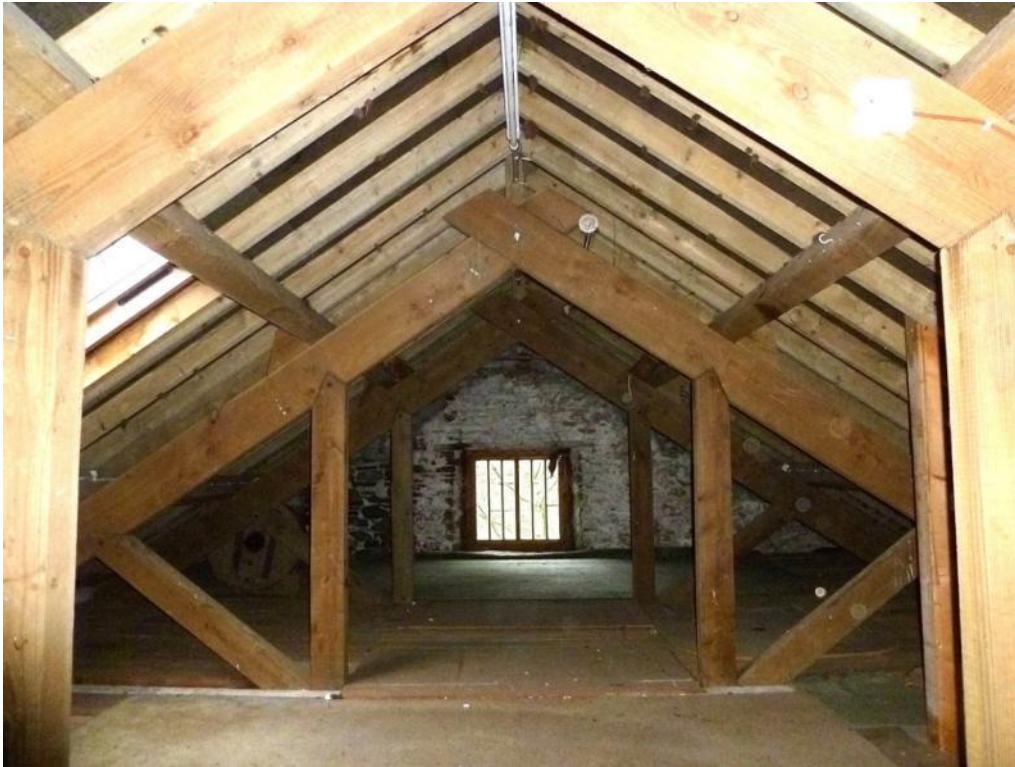
The roof structure has been completely renewed in good quality sawn softwood. It presumably replicates the original construction and has been neatly done, with a traditional appearance. The trusses are numbered I to III from west to east and there are other carpenter's assembly numbers on the west faces of all three trusses. The queen posts and struts are bolted to the principals. The principals are notched, lapped and bolted at their apexes and each has a vertical timber nailed to its east side to carry the vertical ridge board. The two rows of lapped purlins are located on cleats on the backs of the principals. The purlins support common rafters at about 40cm centres and the roof slopes are fully felted over the rafters. No details of any battening and slate fixing were visible. There is a single, modern opening roof-light in the north slope of bay 2.

Reconstructed roof, looking east

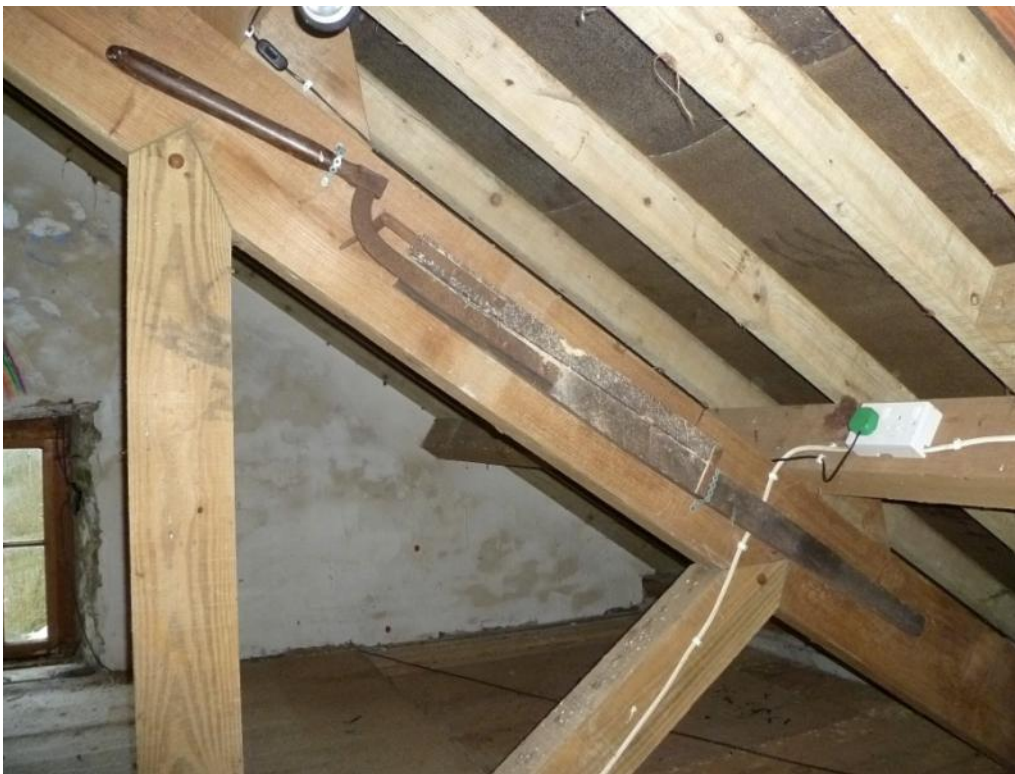
On the east side of the north principal of roof truss I a timber and iron hinged lever has been temporarily fixed, which may be a surviving element of the sack hoist control mechanism. At the east end of the loft is a displaced timber sack hoist drum with solid flanged timber drive pulley (see photographs). Because the roof has been renewed, the working position of the hoist is no longer evident and also all of the control rope and chain guide positions have been lost.

Hinged metal and timber lever fixed to principal of truss

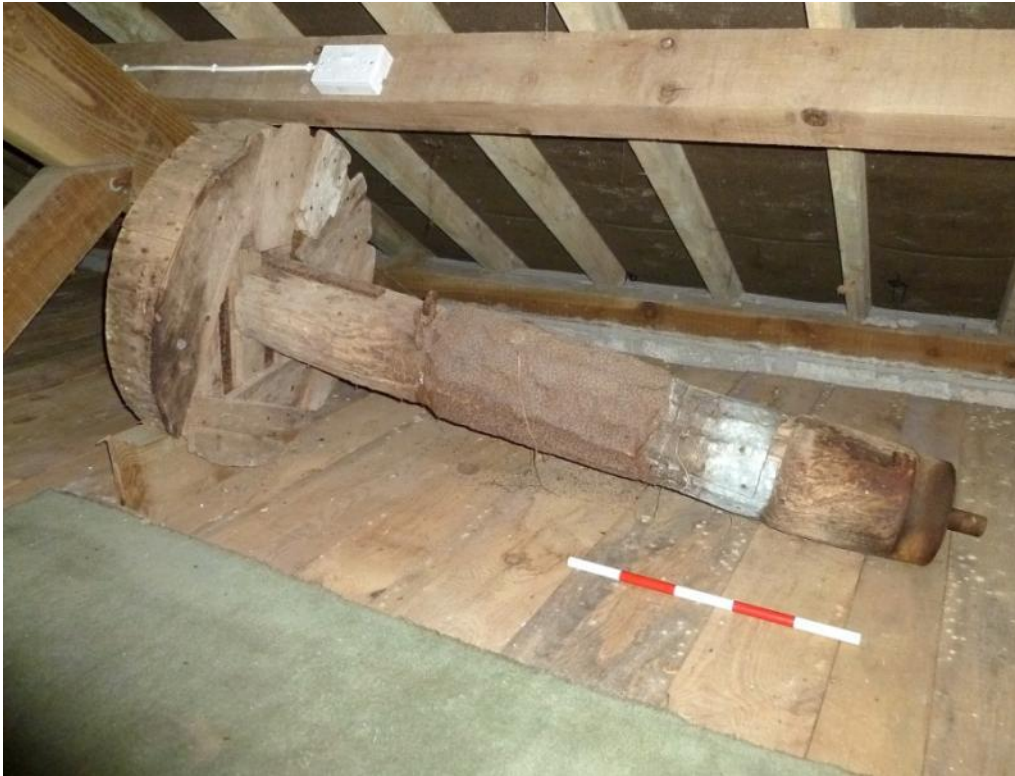
Former sack hoist chain bollard on loft floor (half metre scale)

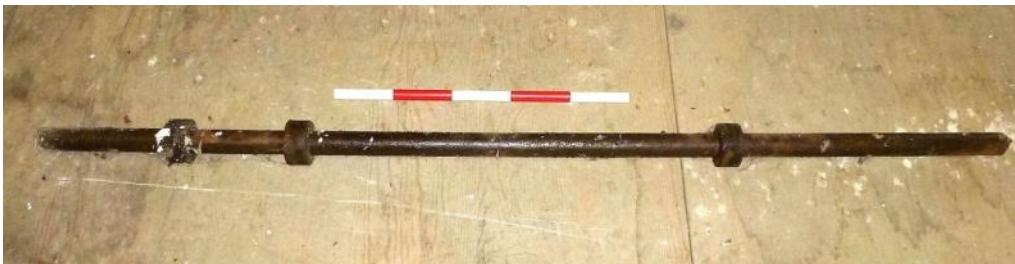
A short spindle or shaft from a grain cleaner or flour dresser survives, displaced at first floor level. It is 1.6m long, 3.8cm in diameter, with three circular collars (see photograph).

Drive spindle from grain cleaner or flour dresser (half metre scale)

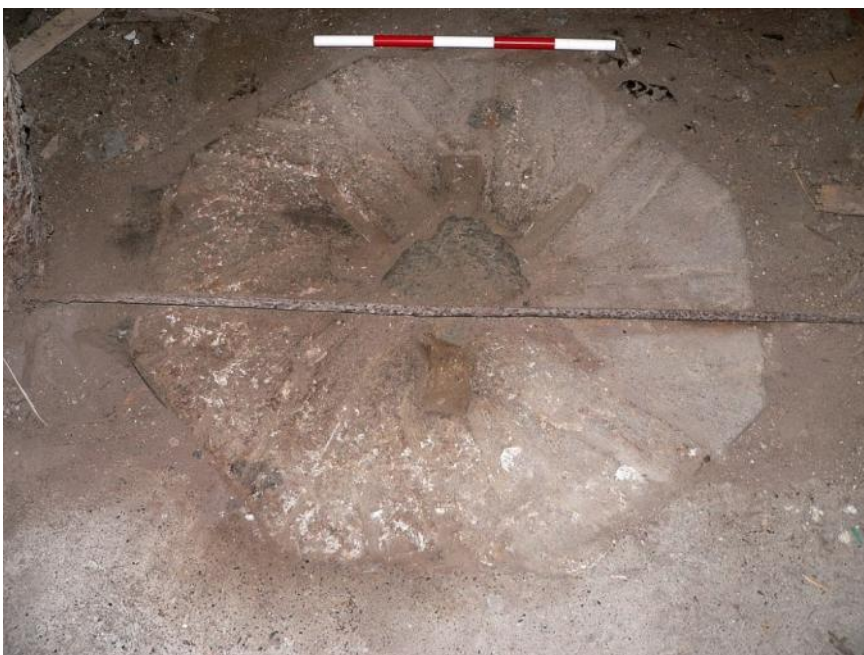
The ground floor is mass concrete, with an octagonal granite millstone and a stone slab set in under the hurst, the timber framework that supported the millstones and their drives. A concrete block pier has been inserted under the north end of the western cross beam. The principal cross beams are imported softwood, plainly converted, with some quality and import marks visible on some faces. The ends of the cross beams sit on timber pads built into the walls. The first floor joists (20 x 5.5cm) are partly notched over the tops of the cross beams. An additional cross beam spans north-south just inside the east gable (the pit wall), which forms the rear beam of the hurst. An oak beam that runs east-west between this timber and the next cross beam still carries a plummer block (plain bearing), which was the central bearing for the upright shaft.

Octagonal granite millstone set in ground floor below hurst
