**HIGHER PARK FARM**

**CREDITON**

DESK-BASED ASSESSMENT WITH HISTORIC BUILDING RECORDING

South West Archaeology Ltd. report no. 181115

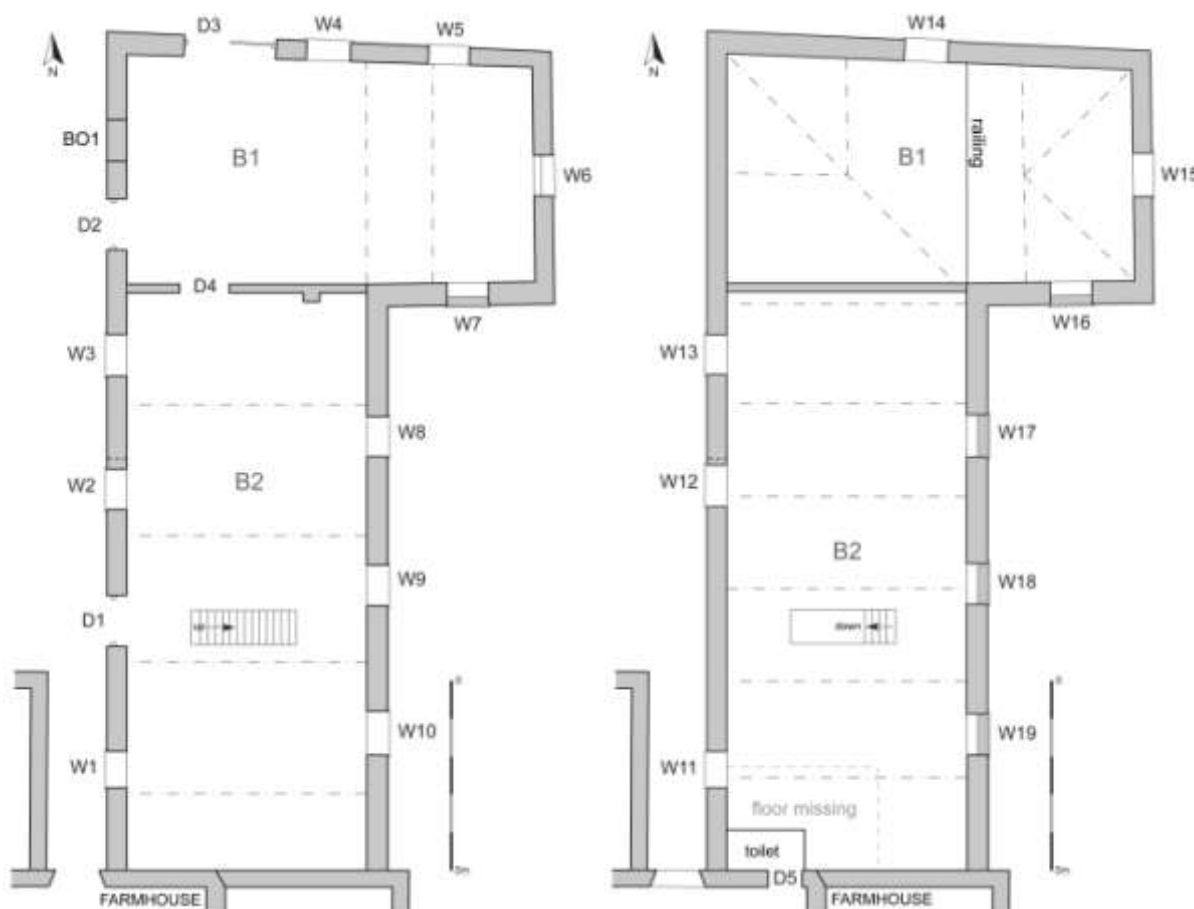
The Pound House part of the cob range lies to the north, contiguous with the Shippon to the south but separated by an internal brick wall. It is a two-storey rectangular building with walls of cob on a plinth of roughly-coursed slatestone blocks. The stonework of the plinth to the north-east side is noticeably better in terms of quality. The composition and texture of the cob would suggest either a lower building, or one with a steeper roof, as the walls appear to have been raised to two storeys. The north-west corner has been repaired in cob block, and part of the east wall in cob block and concrete block. The exterior is rendered with a spray-applied modern treatment, coloured light pink to mimic the colour of the local cob. The roof is hipped to the east and contiguous with that of the Shippon to the south; to the west and north the roof is covered with box-section plastic-coated steel sheets, to the east and south with ‘big six’ asbestos sheets. The roof is carried on a complex roof structure consisting of one mid 19<sup>th</sup> century king-post truss to the hip, and one long composite double king-post truss that stretches from corner to corner diagonally across the building. The latter – over extended – truss has been repaired with modern bolted tanalised timbers. All the ground-floor openings have thin oak lintels that rest on short oak pads.

FIGURE 12: GROUND- (LEFT) AND FIRST-FLOOR (RIGHT) PLANS OF THE POUND HOUSE (B1) AND SHIPPON (B2) (BASED ON SUPPLIED DRAWINGS).

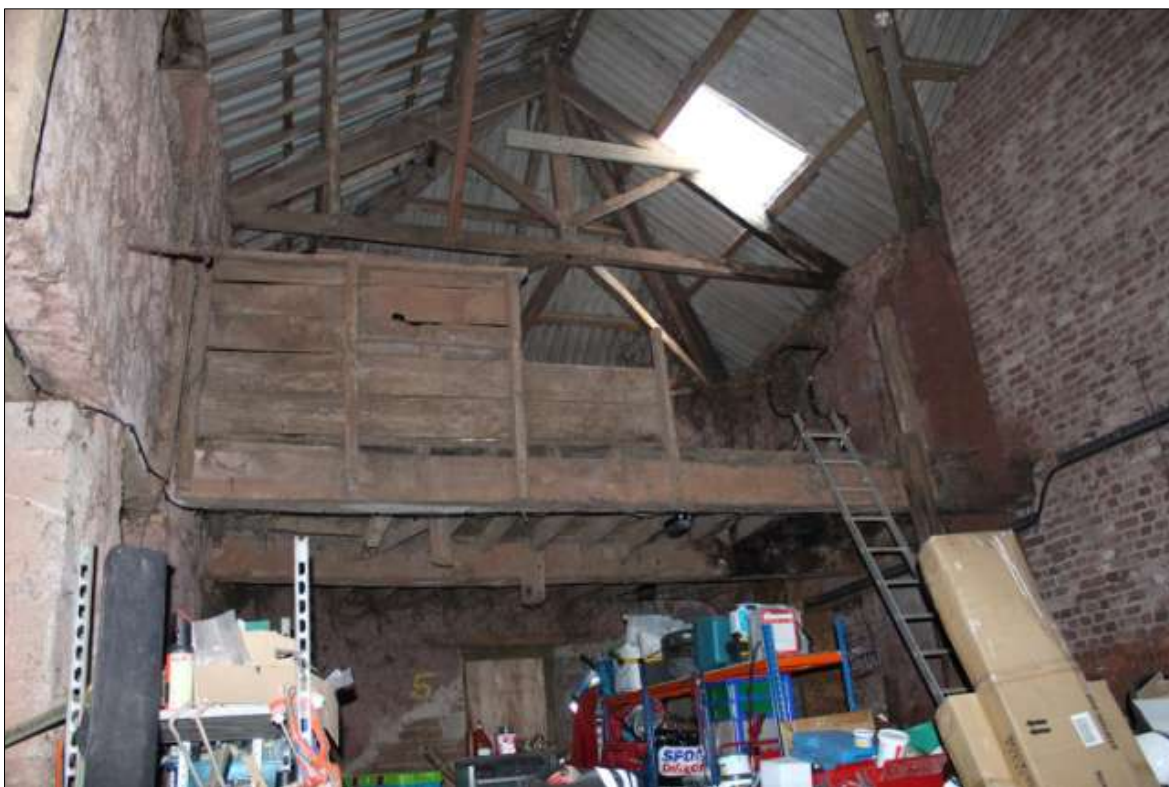
The interior of the Pound House has been heavily altered, stripped of most historical features, and was full of clutter when inspected. The cob of the walls is visible, as are the various repairs. The wall separating the Pound House from the Shippon rises up into the roofspace and is of pale pinkish-red brick laid, for the most part, in a header bond. It is pierced by a single ground-floor doorway (D4) with timber lintel. The internal floor level appears to have been lowered and replaced with modern concrete, and steps up irregularly to the Shippon; however, the reveals to D2 respect this lower level so the height of the floor may be genuine, and the *yard* may have been raised. The western part is open to the roof, but there are sockets in the north and south walls for beams and/or joists. The eastern part has a first floor carried on two heavy, transverse beams with deep but narrow joists. The floor is of even-width floorboards. There is a hatch to the north-west side, and the remnants of other timber fittings that would once have belonged to a mechanism. To the front and enclosing the loft, facing onto the void, is a rail-and-plank boarded screen that is spiked to the beam below.

FIGURE 14: THE INTERIOR OF THE POUND HOUSE, SHOWING THE GALLERY; VIEWED FROM THE WEST.

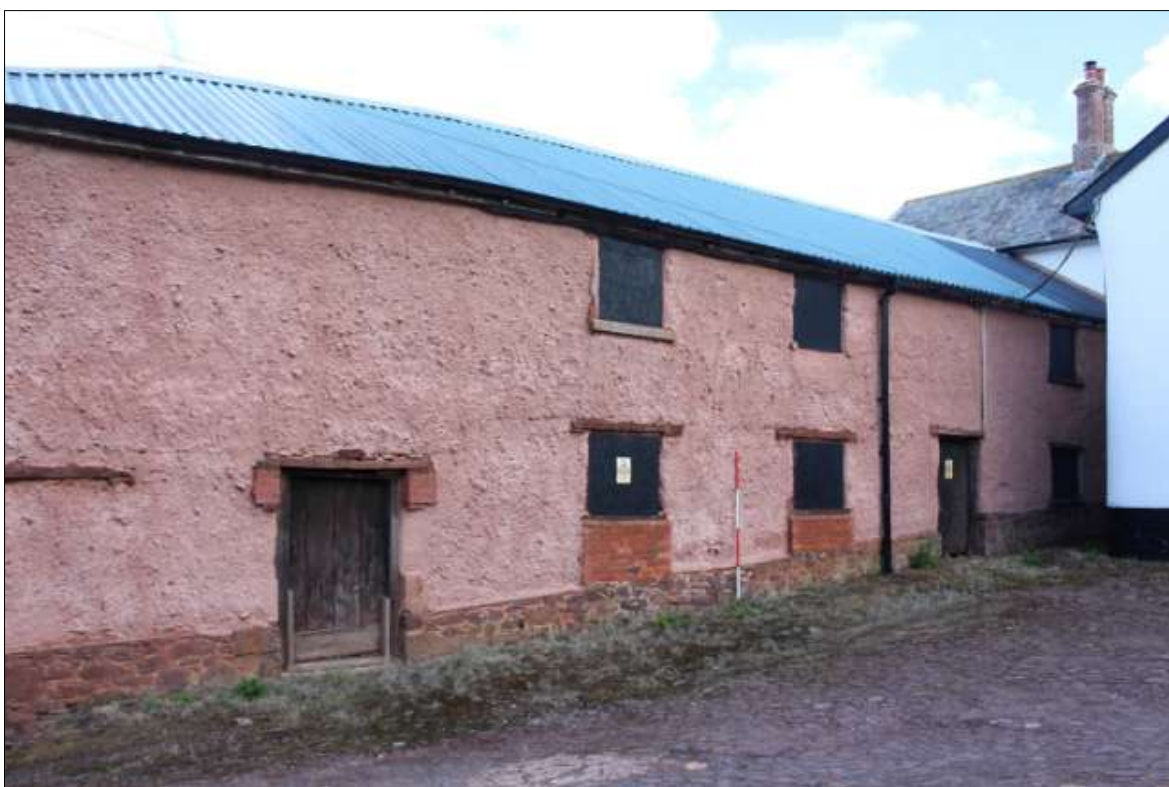
The west elevation faces on the yard behind the Farmhouse and is contiguous with the west elevation of the Pound House. There are seven openings in this elevation: a door and six windows, the windows forming a symmetrical 2/2/2 arrangement. The doorway (D1) has a narrow timber lintel with a chunky beaded doorframe; the door is a lightweight, even-width, plank door with an iron thumb latch. The frame matches D2 to the north; the door itself is a boarded door of rustic 19<sup>th</sup> century style. The stone reveals of the door are messy to the north, but some dressed stone has been used to the reveals. Most of the windows have been subject to repair: the walls below W2 and W3 have been rebuilt in red brick, the wall below W12 has been patched in cob, and W13 has a concrete sill. The three windows on the ground-floor all retain their 19<sup>th</sup> century pegged two-light timber frames. W3 has one shutter, of thin boards painted black, on small strap hinges with spearhead terminals. W2 has two shutters on simple strap hinges with spearhead terminals; both shutters are built of repurposed 17<sup>th</sup> century, narrow, raised and fielded panels. W1 is boarded and the opening is braced by mid 20<sup>th</sup> century timbers; laid horizontally within the opening is another shutter made from a section of 17<sup>th</sup> century panelling. On the first floor, W12 has lost its historic frame, but W11 and W13 retain their 19<sup>th</sup> century pegged two-light timber frames, bars and shutters; the shutters feature reused scratch-moulded 17<sup>th</sup> century timbers as ledging bars.

FIGURE 15: THE WEST ELEVATION OF THE SHIPPON, WITH POUND HOUSE TO THE LEFT; VIEWED FROM THE NORTH-EAST (SCALE 2M).

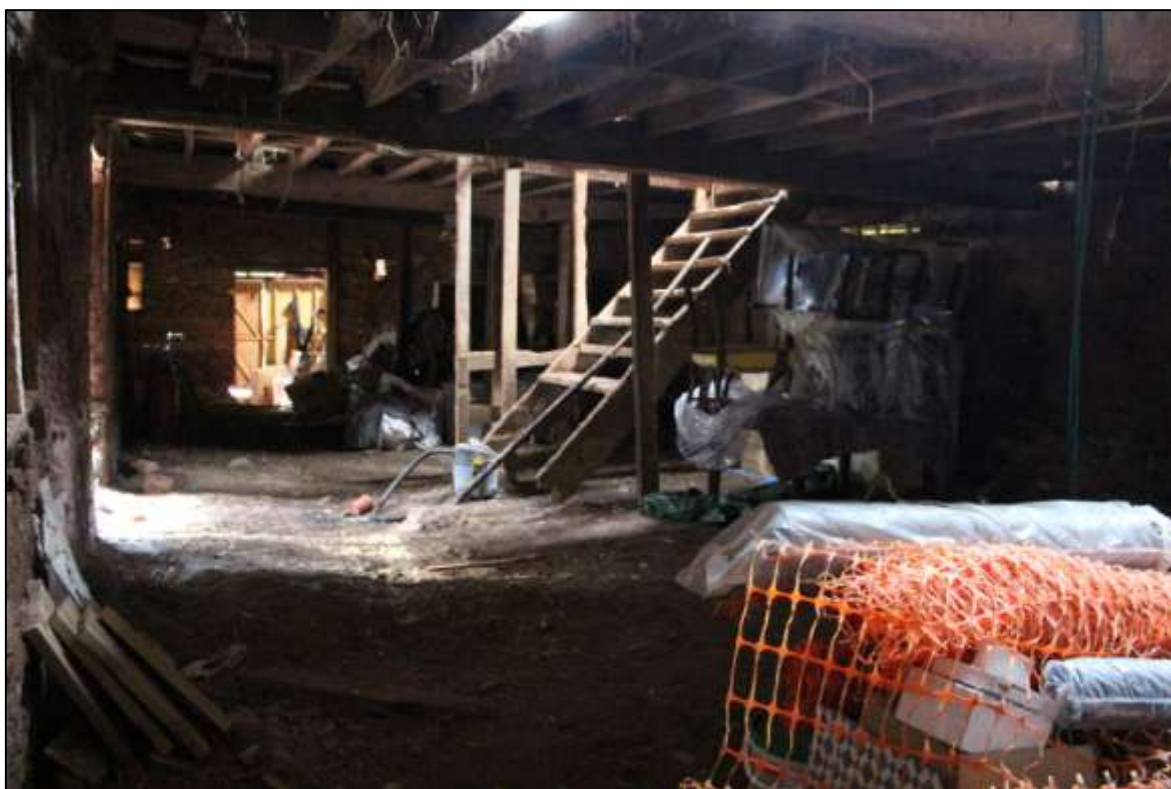
FIGURE 16: THE INTERIOR OF THE SHIPPON; VIEWED FROM THE SOUTH.

The interior of the Shippon is accessed via its west doorway (D1) or from the Pound House (D4). The interior was very cluttered during the inspection, but surviving cobbled floors were noted throughout the ground floor with a clear north-south drain to the western side. If the interior had once been sub-divided it was no longer apparent; however, the cobbled surface may retain that information – socket holes were observed to the north end. In the centre of the room, opposite D1, is a wide stair that provides access to the first floor. The stair has eight surviving treads with sockets for three more to the base, which have been lost/rotted out; the stairs are braced by several vertical timbers that may once have been boxed in.

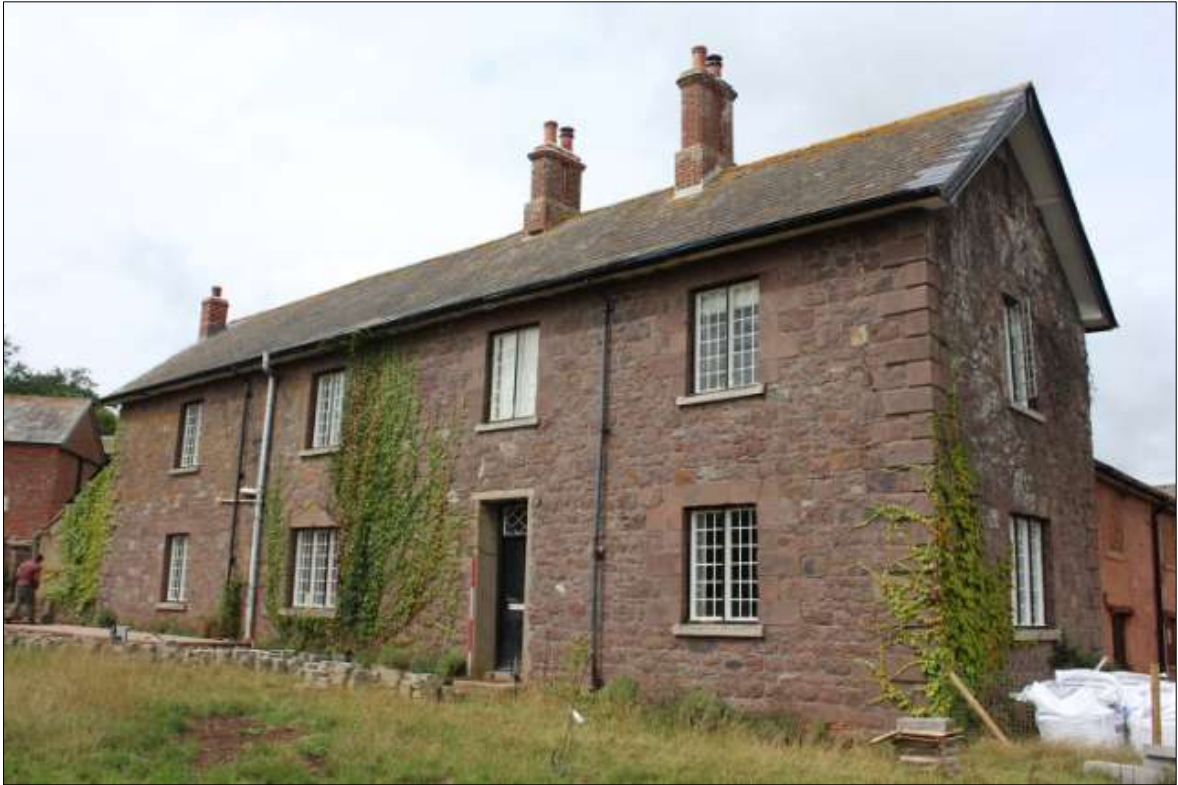
A brief but thorough examination of the farmhouse was undertaken in order to inform the interpretation of the farm buildings. This established, without a doubt, that this is *not* a very late three-room cross passage farmhouse, but a medieval former open hall with an early 17<sup>th</sup> century crosswing, extended to the east twice, once in the late 18<sup>th</sup> century and again in the 19<sup>th</sup> century. The south and east elevations were rebuilt, presumably in c.1852, to provide a uniform and near-symmetrical ashlar façade that conceals the complexity of the structure; at the same time the roof was raised and replaced with bolted kingpost trusses, as per B1-B7.

FIGURE 28: THE SOUTH ELEVATION OF THE FARMHOUSE; VIEWED FROM THE SOUTH-EAST (SCALE 2M).

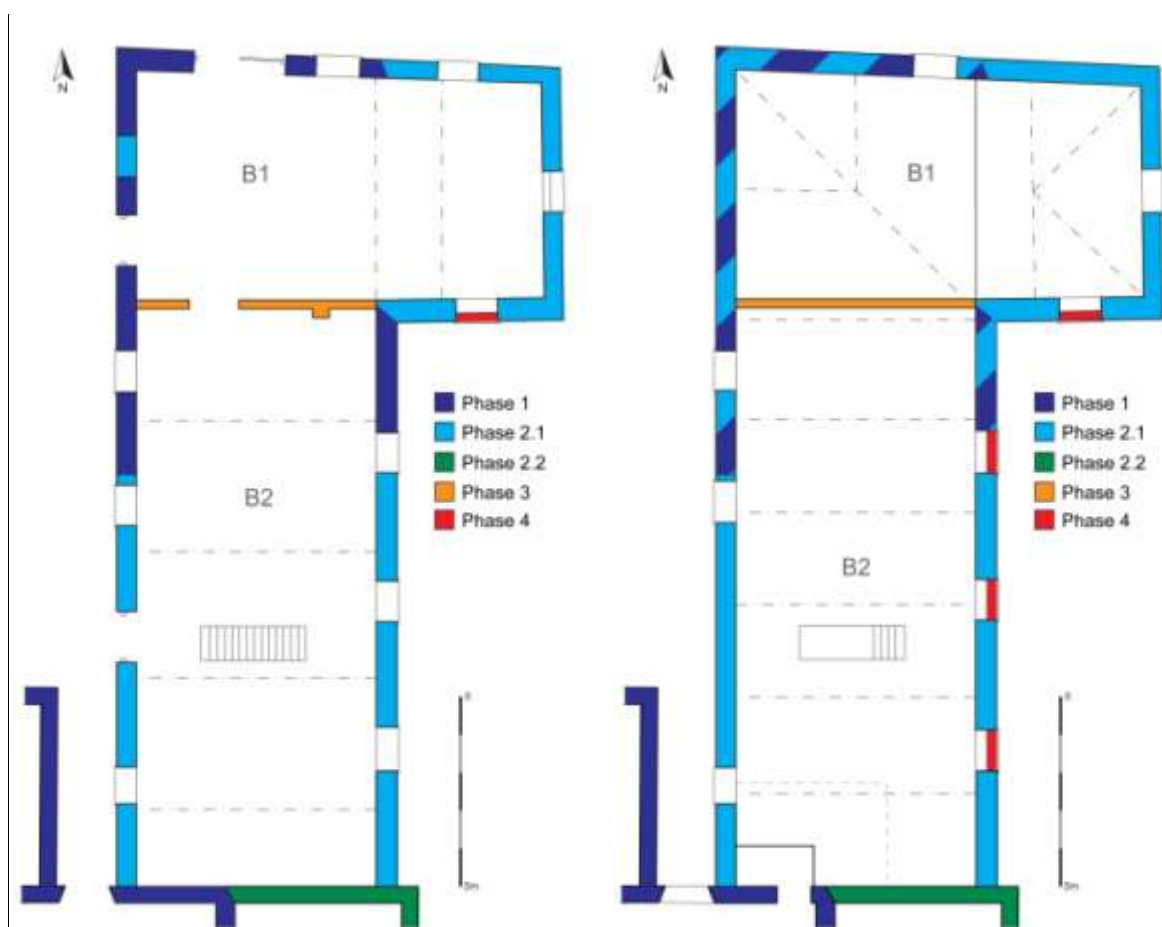
Historic maps showing the layout of the farmstead in 1808, 1837 and 1839; changes in the cob build and the relative height of D1. No other features or fittings predating 1839, with the exception of some reused elements in the Shippon and *ex-situ* doors in B5 and B6. All the roofs were replaced in Phase 2.

FIGURE 30: GROUND- (LEFT) AND FIRST-FLOOR (RIGHT) PHASED PLANS OF THE POUND HOUSE (B1) AND SHIPPON (B2) (BASED ON SUPPLIED DRAWINGS).

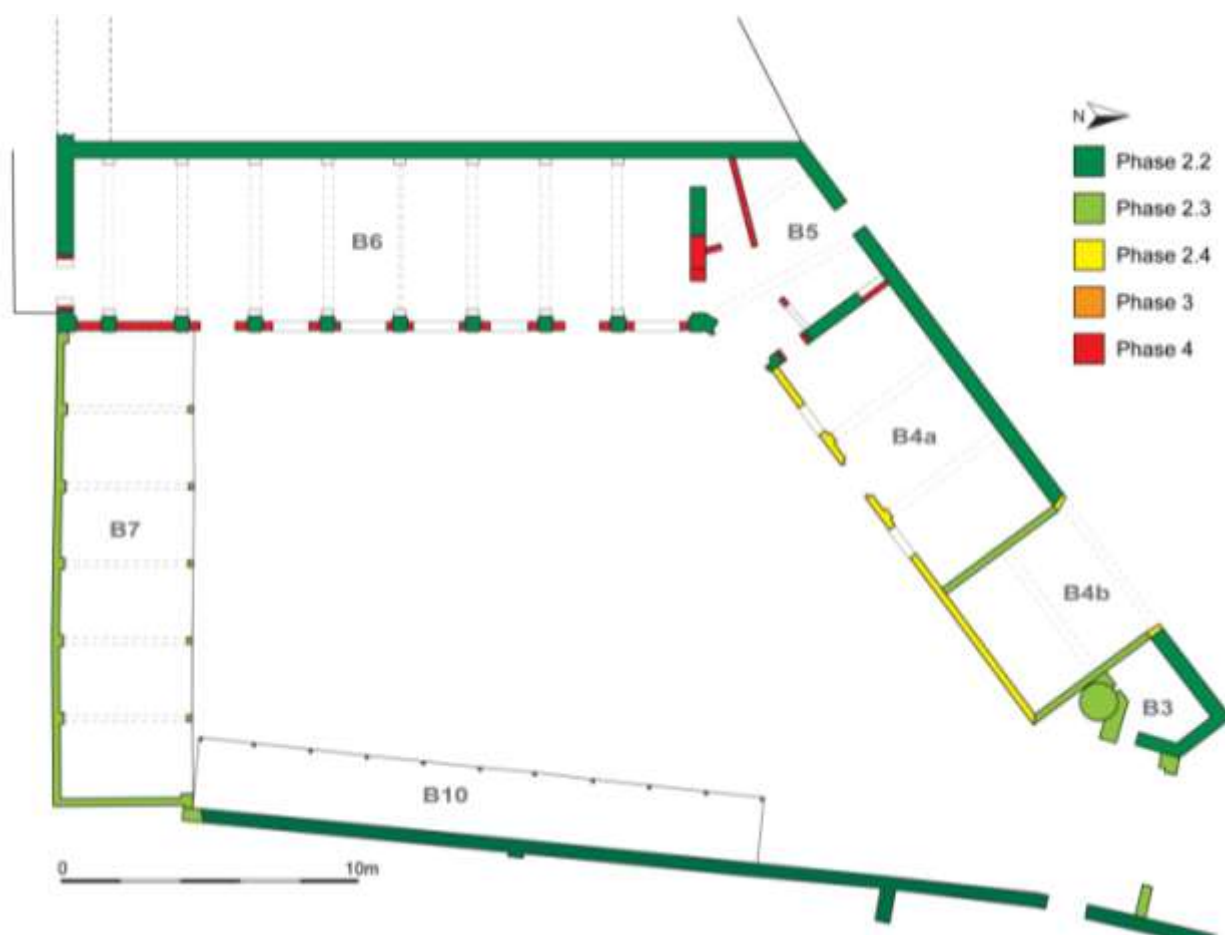
FIGURE 31: GROUND-FLOOR PHASING FOR THE BRICK BARNs (BASED ON SUPPLIED DRAWINGS).

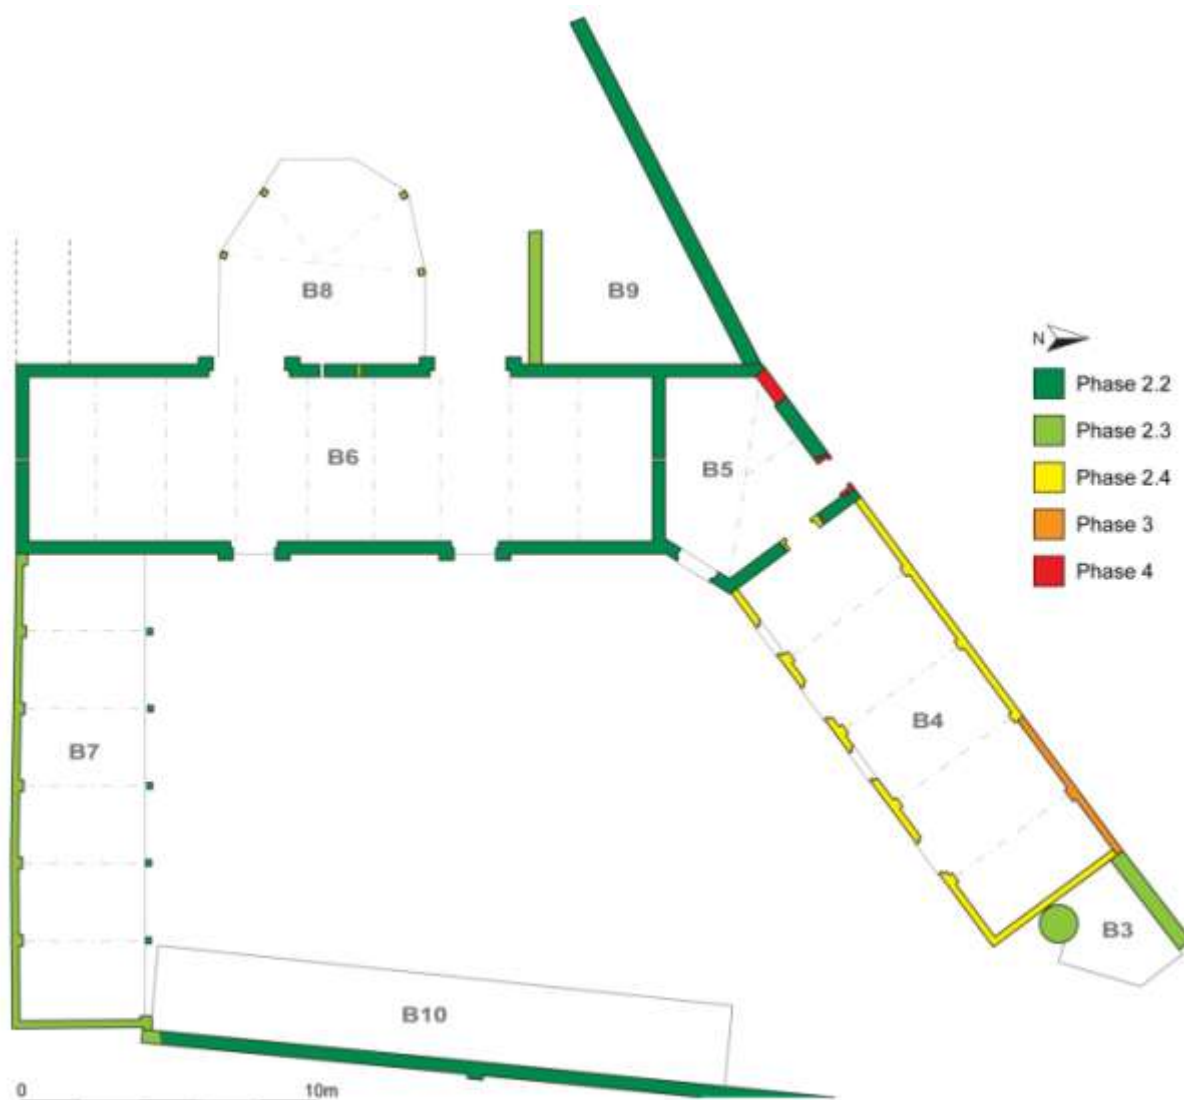
FIGURE 32: FIRST-FLOOR PHASING FOR THE BRICK BARNs (BASED ON SUPPLIED DRAWINGS).

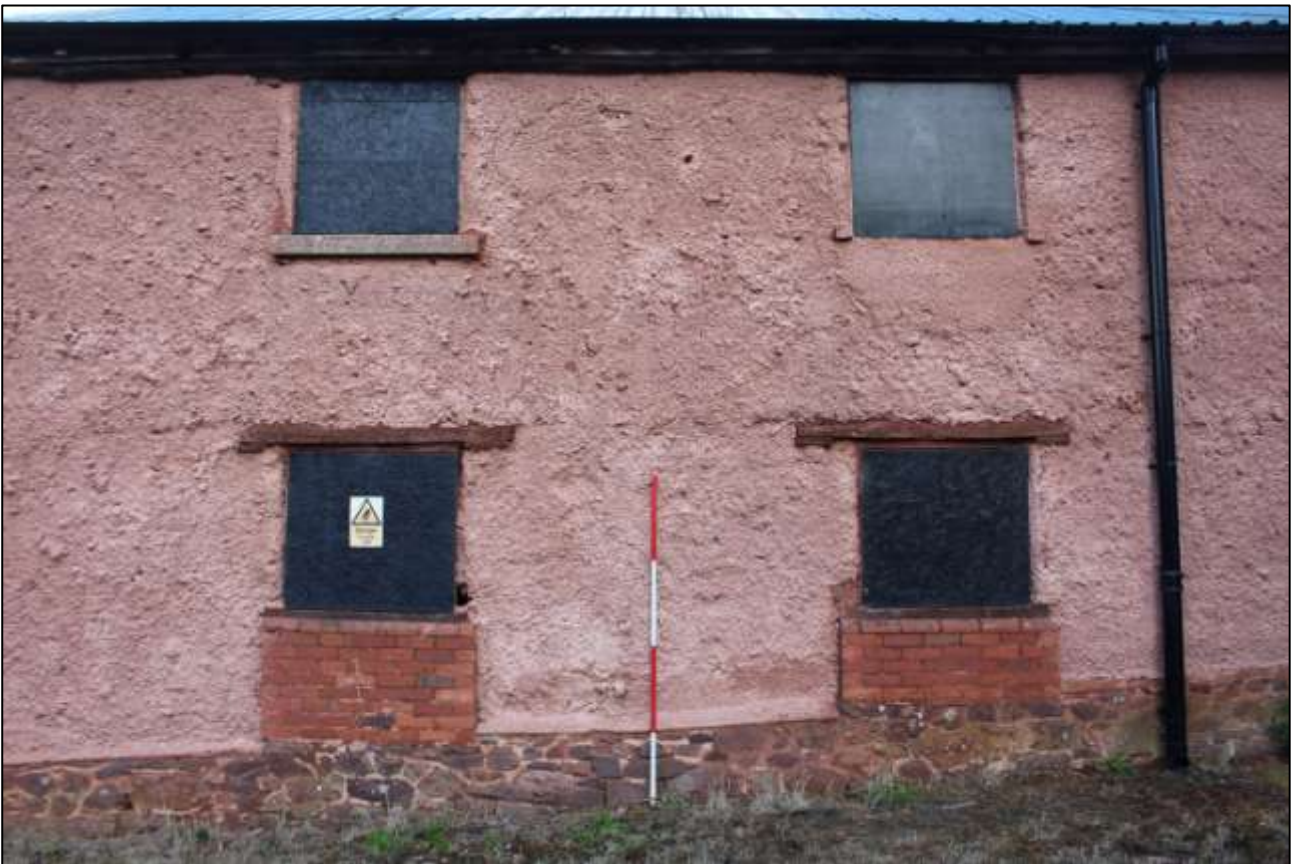
W3	GF window. Square window opening, boarded externally. Reused timber lintel on timber pads, timber sill. The wall below the sill has failed and been rebuilt in red brick. Surviving timber two-light frame, central mullion lost, sockets in the frame for iron bars. Two shutters on iron pintles and strap hinges with spearhead terminals, plain thin planks and ledging bars. One shutter is hung, the other is on the floor adjacent.
	W11	FF window. Square window opening, boarded externally. Timber lintel on timber pads. Slate sill. Surviving timber two-light frame, one iron bar to each light. Internal plank sill. Two shutters on iron pintles and strap hinges with spearhead terminals, a mix of plain thin planks and ledging bars, cobbled together.
	W12	FF window. Square window opening, boarded externally. Timber lintel on timber pads. Wall below the sill rebuilt in cob; projecting bricks to either side of opening. Crude modern frame of tanalised timber, sill rebuilt in cob block.

B2 EXTERIOR, WEST ELEVATION, SHOWING W2, W3, W12 AND W13; VIEWED FROM THE WEST (SCALE 2M).

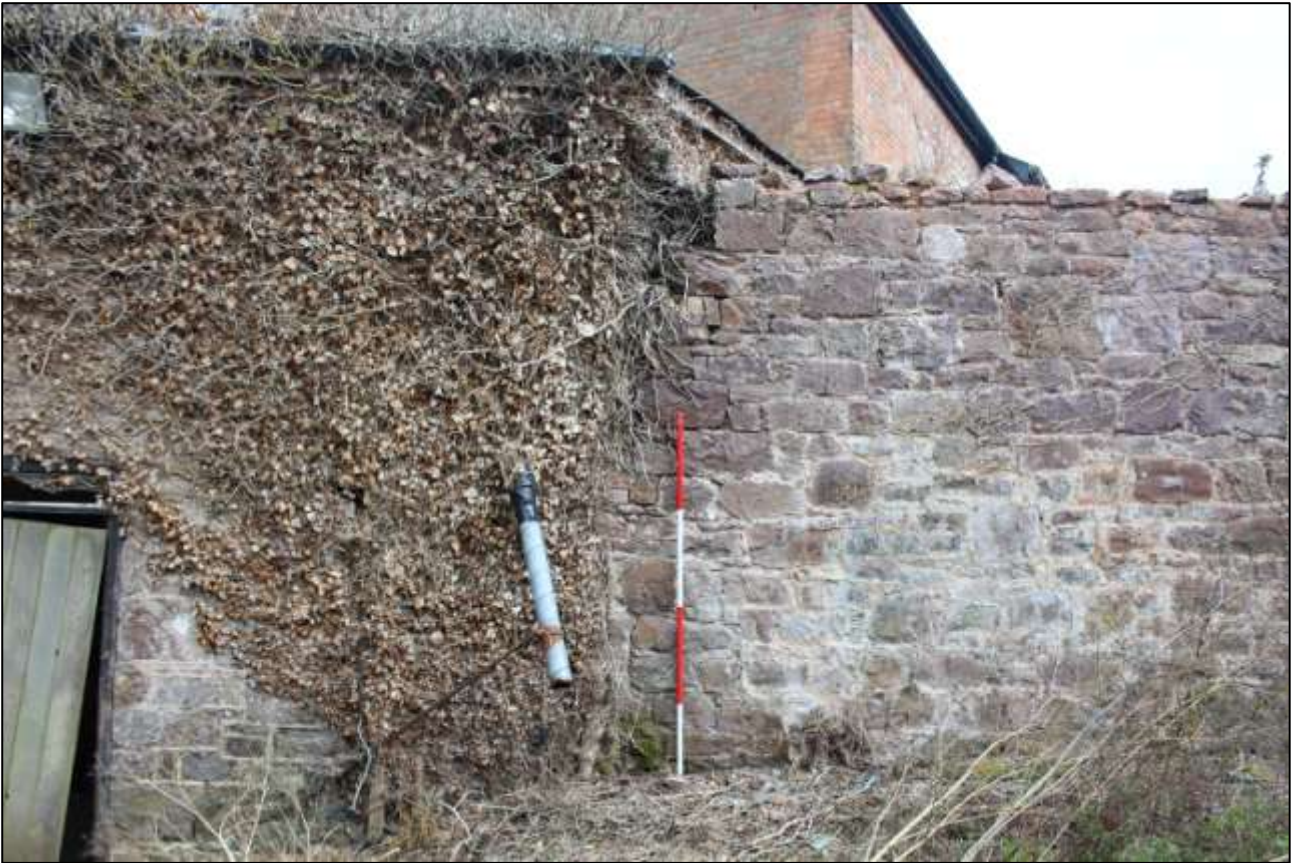
B5 EXTERIOR, NORTH-WEST WALL, SHOWING THE JOIN WITH THE STONE YARD WALL TO THE WEST; VIEWED FROM THE NORTH-WEST (SCALE 2M).

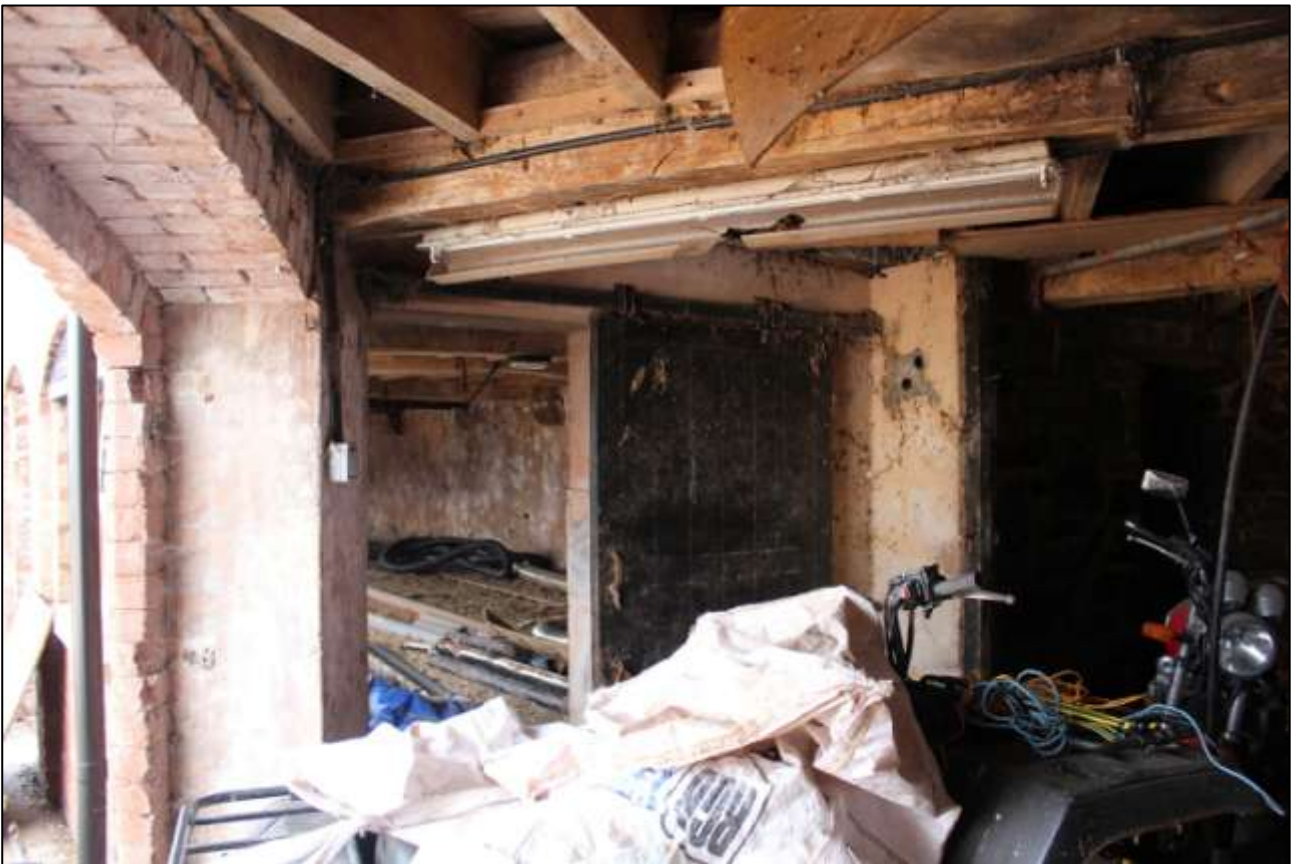
B5 GF INTERIOR, SHOWING THE FORCED DOORWAY TO B6; VIEWED FROM THE NORTH-EAST.

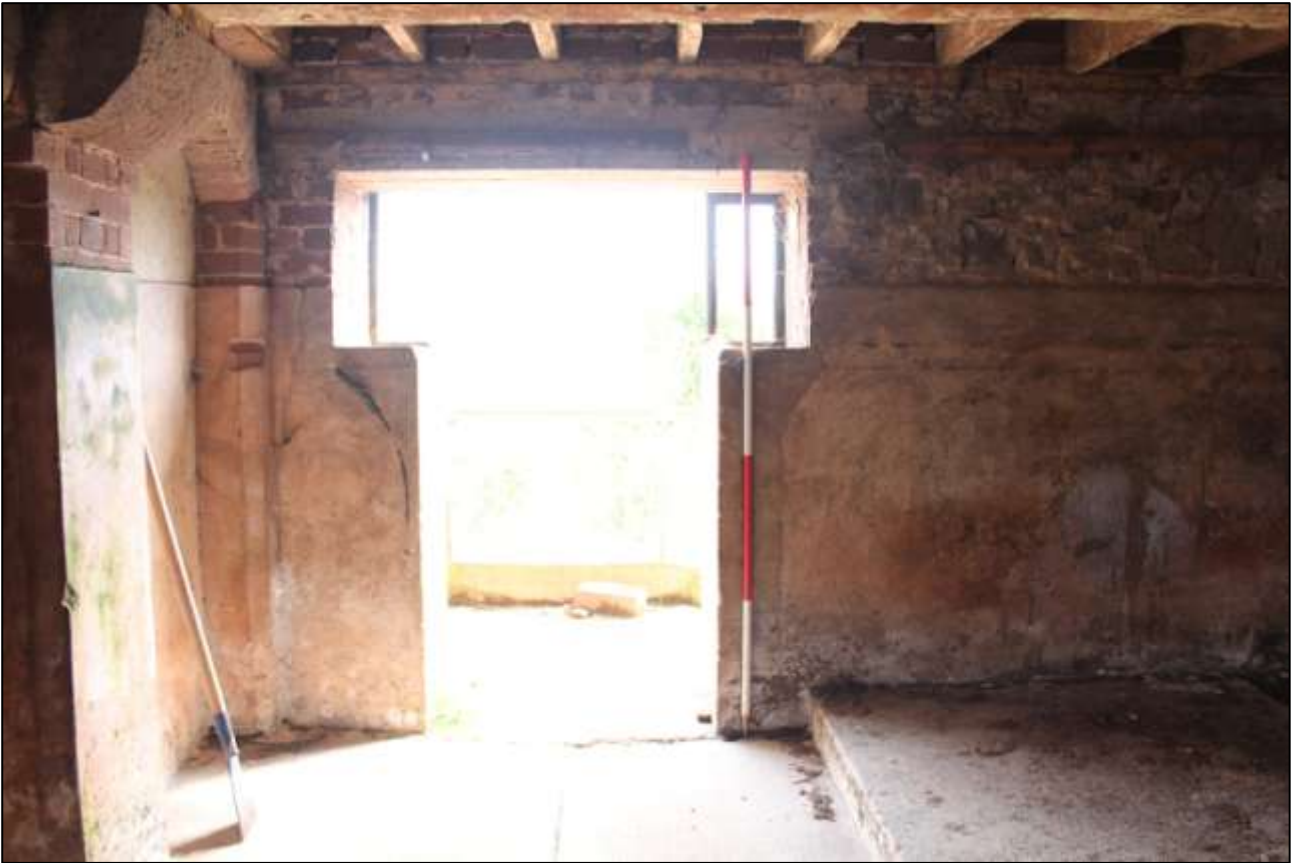
B6 GF INTERIOR, THE FORCED DOORWAY IN THE SOUTH WALL (SCALE 2M); VIEWED FROM THE NORTH.
