# MAYOR'S AVENUE TRAVIS PERKINS

Desk-Based Assessment & Historic Building Recording

South West Archaeology Ltd. report no. 181127

## Mayor's Avenue Travis Perkins, Dartmouth, South Hams, Devon Desk-Based Assessment & Historic Building Recording

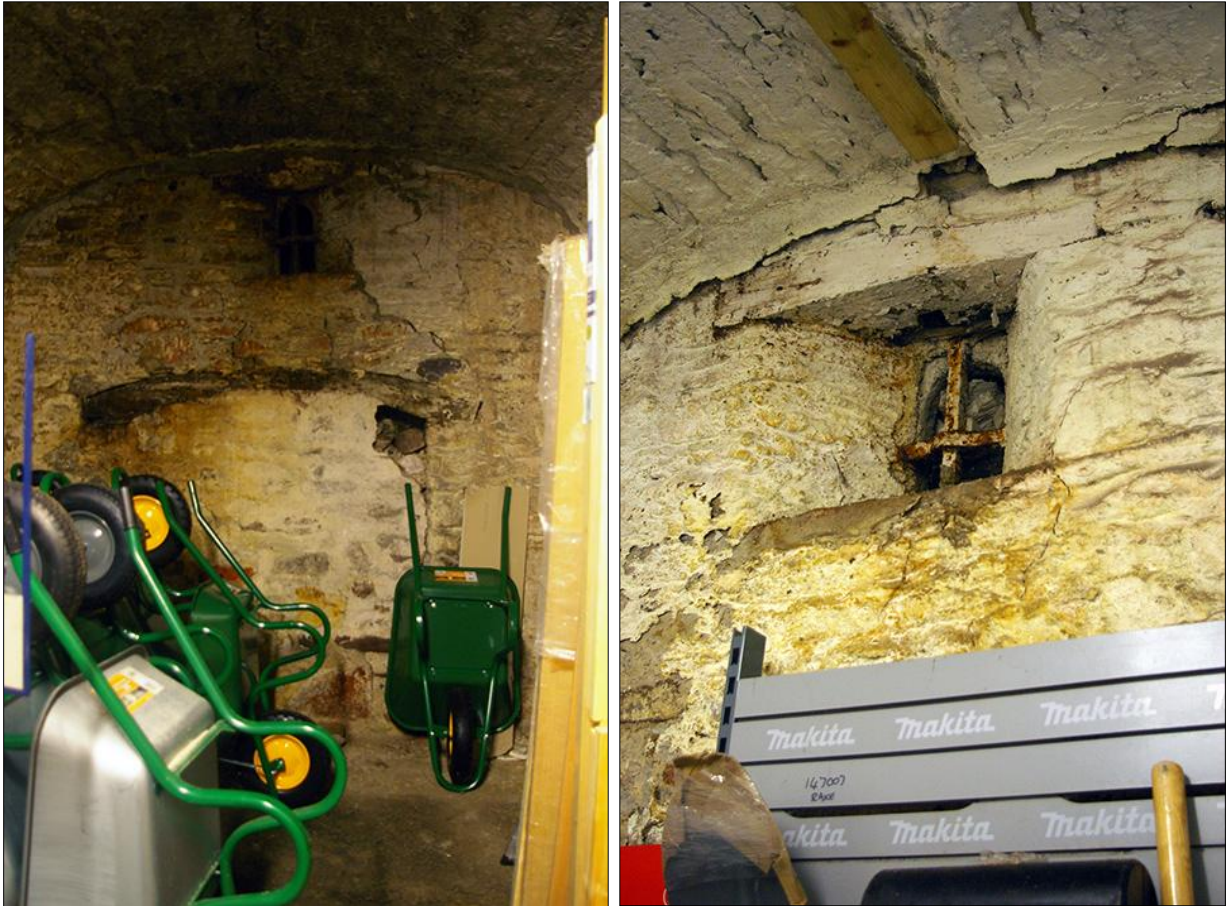
LEFT FIGURE 21: BO5 IN VAULT 5, WITH CURVING TIMBER LINTEL AND W5 ABOVE; VIEWED FROM THE EAST.  
RIGHT FIGURE 22: DETAIL OF W2 IN VAULT 2, WITH IRON FERRAMENTA; VIEWED FROM THE ENE.

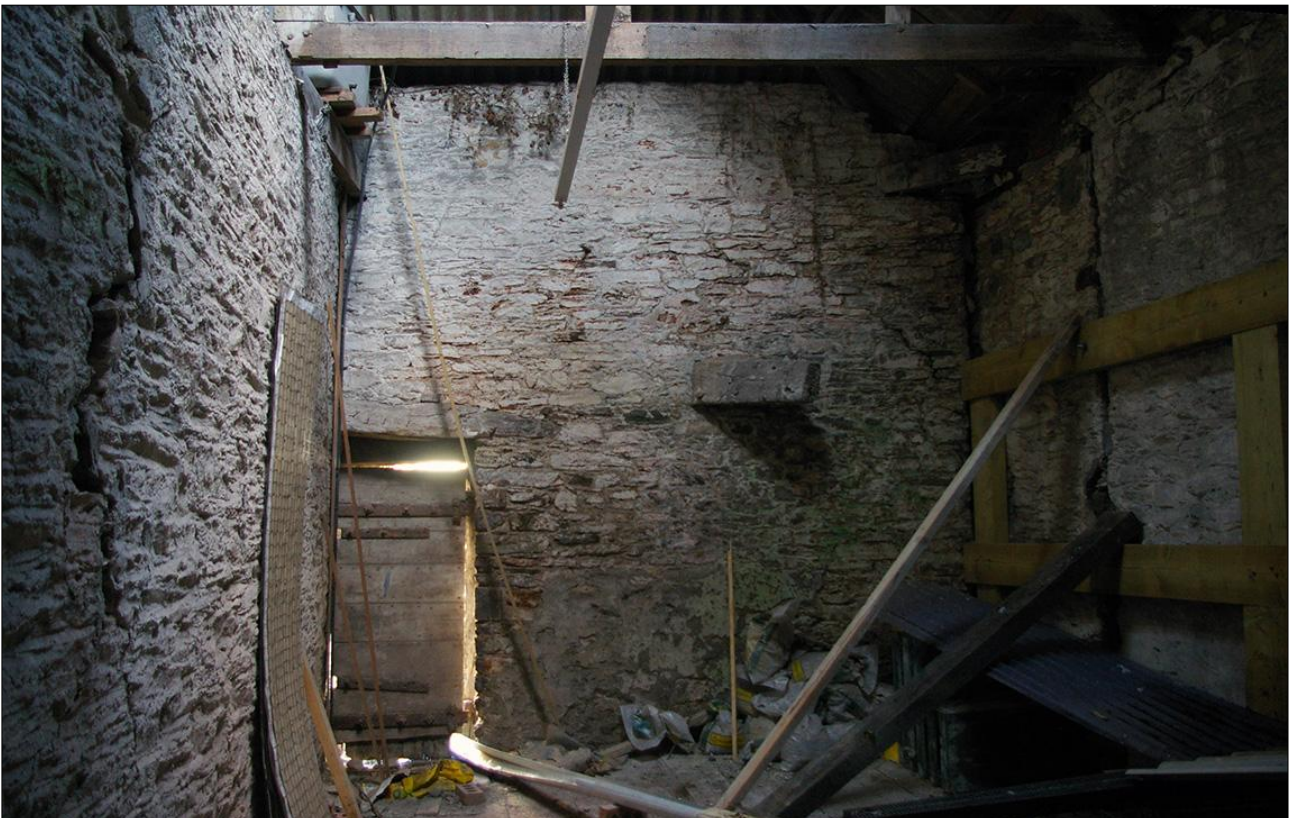
75. B1 FF R2, SHOWING D22 AND TRUNCATED DRAGON TIE (S11); VIEWED FROM THE SOUTH.

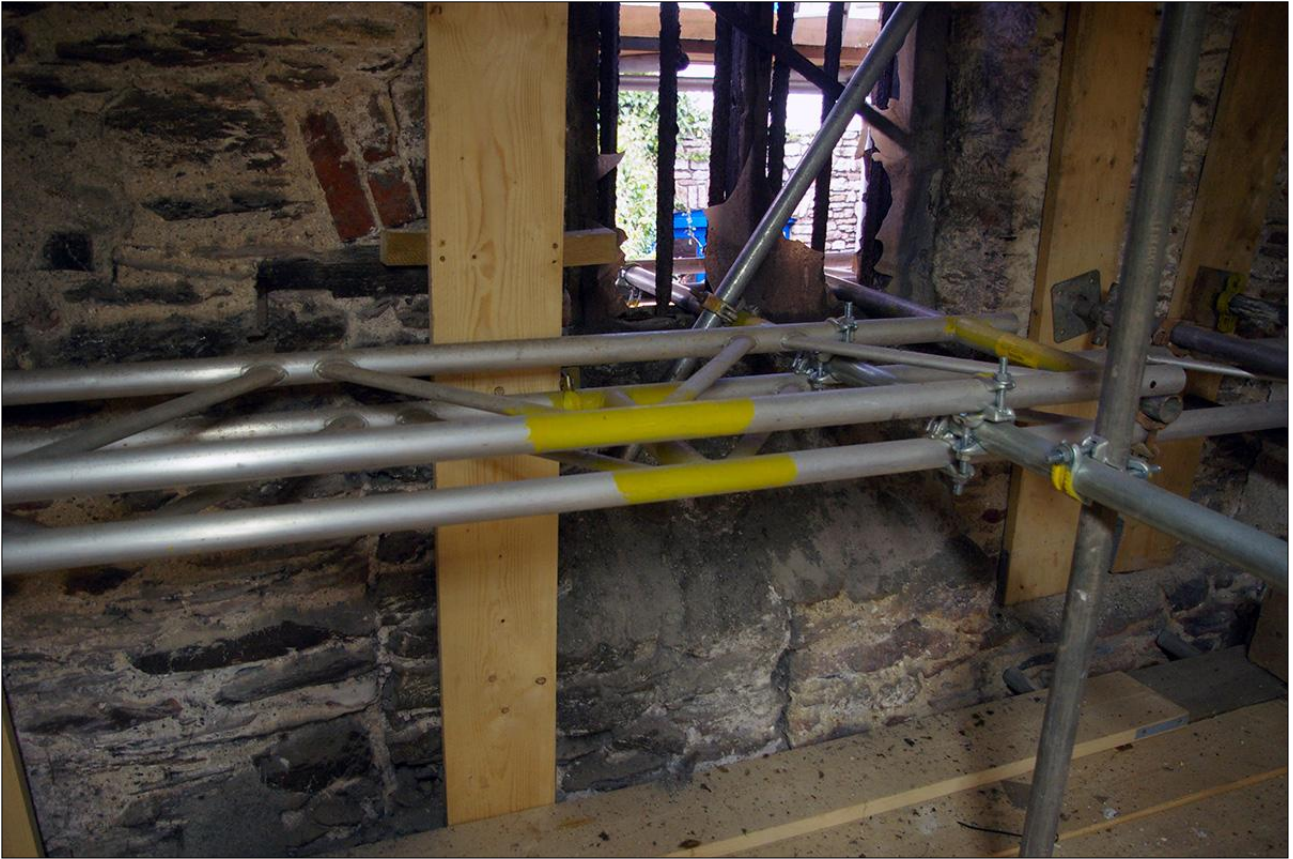
113. B2 FF INTERIOR, NORTH WALL, SHOWING W13 FORCED THROUGH THE BLOCKED FP2; VIEWED FROM THE SOUTH.
