**THE BICKFORD CENTRE  
23 SOUTH STREET  
GREAT TORRINGTON  
DEVON**

HISTORIC BUILDING RECORDING

South West Archaeology Ltd. report no. 181114

By E. Wapshott & N. Boyd  
Report Version: **DRAFT01**  
14<sup>th</sup> November 2018

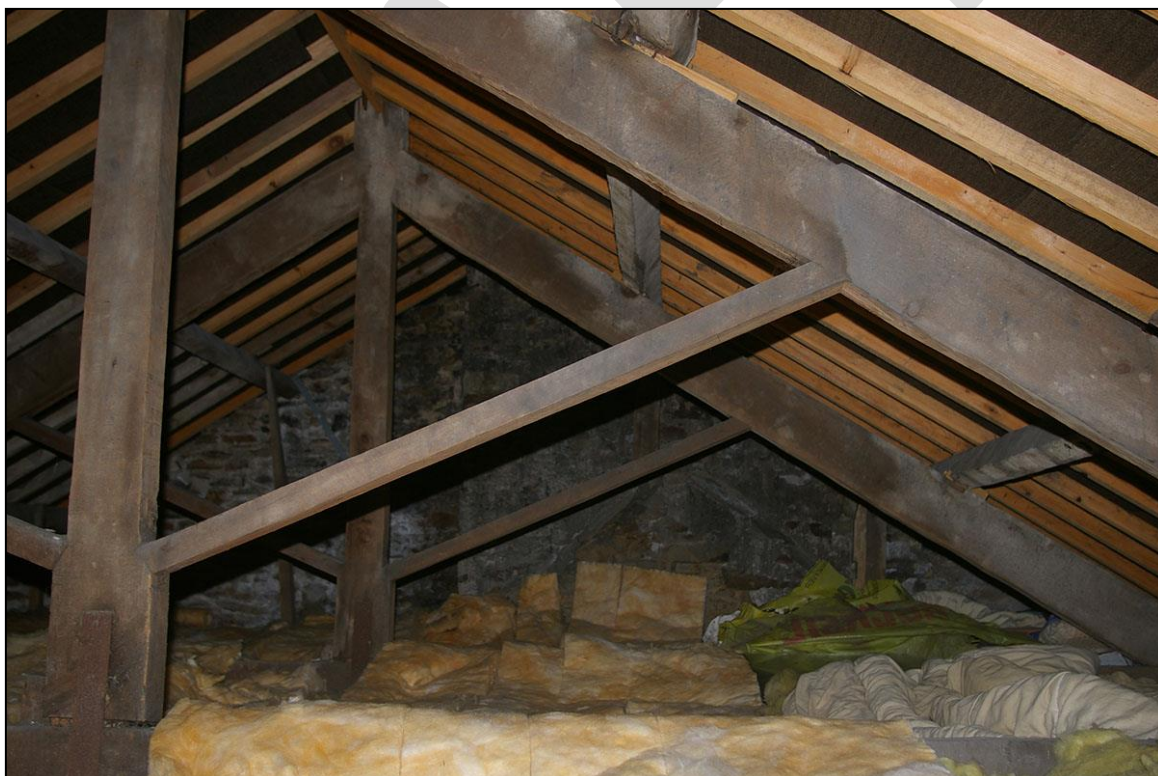
FIGURE 5: VIEW TO THE WEST PARTY WALL OF THE BUILDING, AND 19<sup>TH</sup> CENTURY KING POST TRUSSES OF BUILDING 1; FROM THE EAST.

The roof space over the front block is accessed via the hallway here, through a modern hatch. There are three large kingpost trusses, with pegged joints between the blades and kingpost at the ridge, but otherwise bolted, with additional later strap bracing. The struts are very lightweight and there are two purlins to each pitch, which loosely overlap, sitting directly on the backs of the blades. A narrow modern ridge has been cut into the historic king posts and modern rafters carry felt under the slates, the roof fairly recently overhauled. To the west end, in the roof space, there

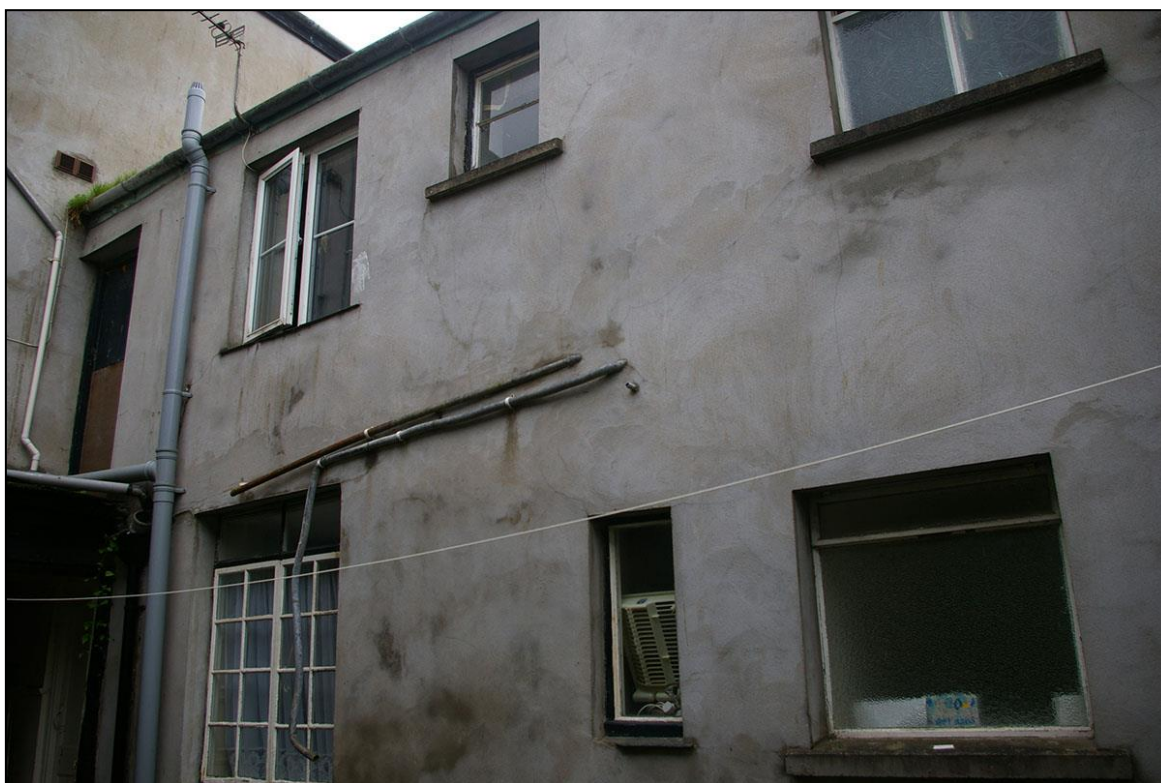
FIGURE 6: THE EAST ELEVATION OF BUILDING 2, SHOWING THE MODERN CHARACTER; FROM THE NORTH-EAST

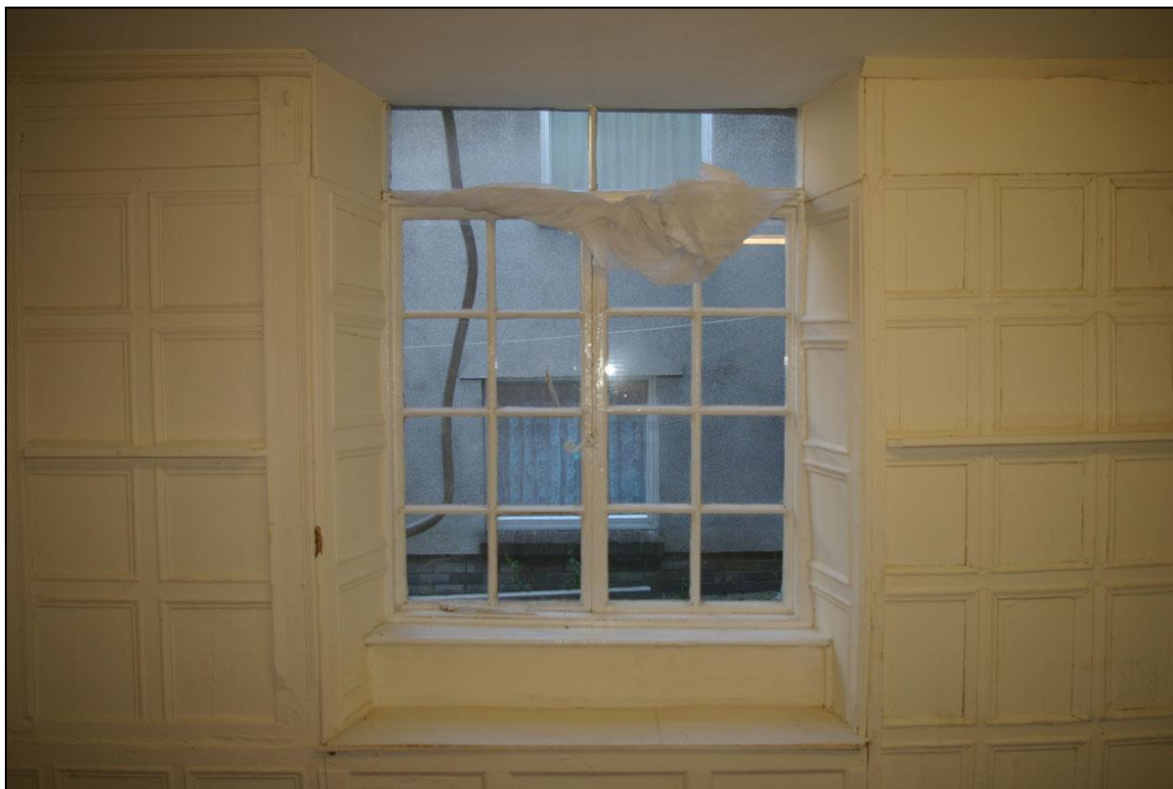
FIGURE 7: W13 IN ROOM 17, WITH RECYCLED AND RESET 18TH CENTURY PANELLED SECTIONS TO THE SIDES, SHUTTERS, CUT AND NAILED SHUT, AND EARLY 19TH CENTURY PANELLING FORMING A WINDOW SEAT; FROM THE WEST.

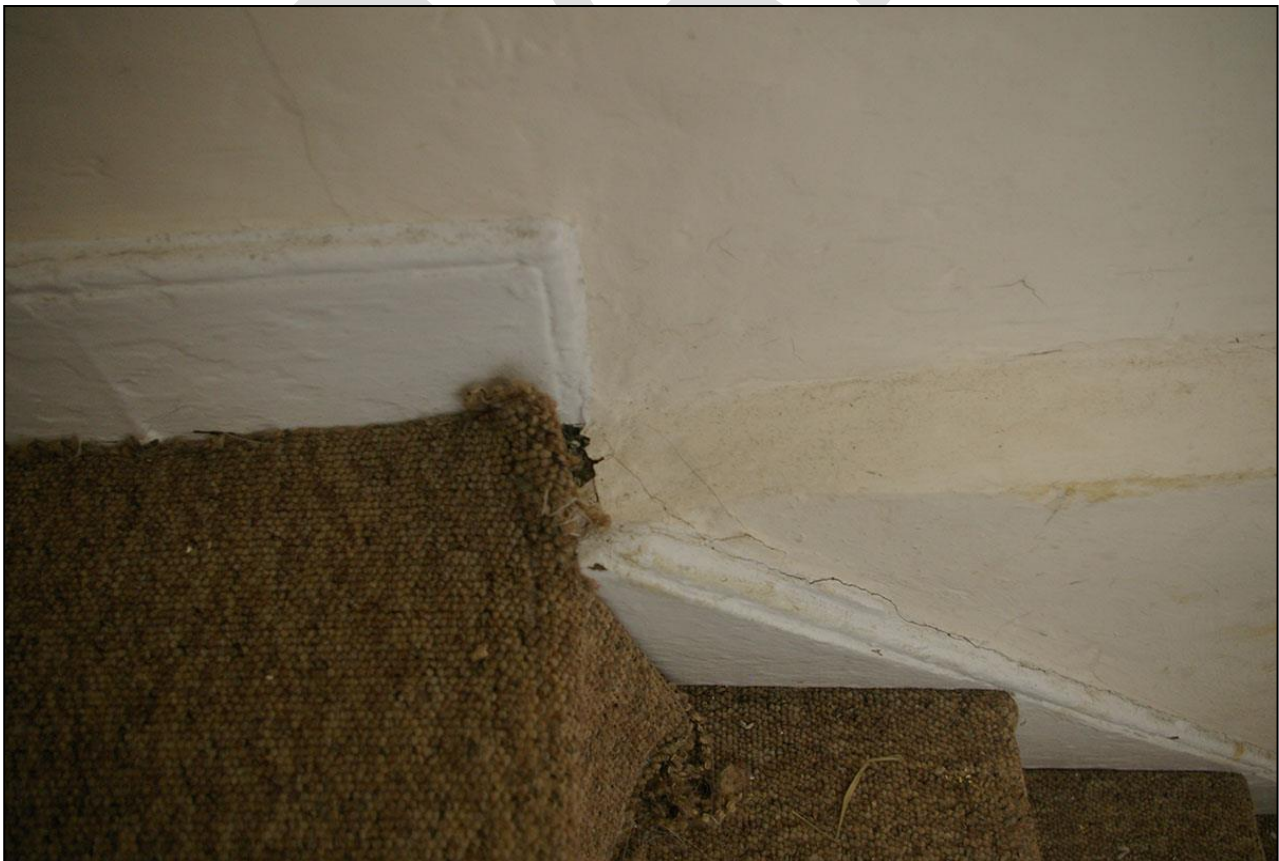
23. THE THICK SECTION OF GROUND FLOOR WALL, SHOWING A LEDGE DESIGNED FOR A FIRST FLOOR, SHOWING THIS STAIRCASE IS  
INSERTED INTO AN EARLIER SECTION OF BUILDING; FROM THE SOUTH-WEST.

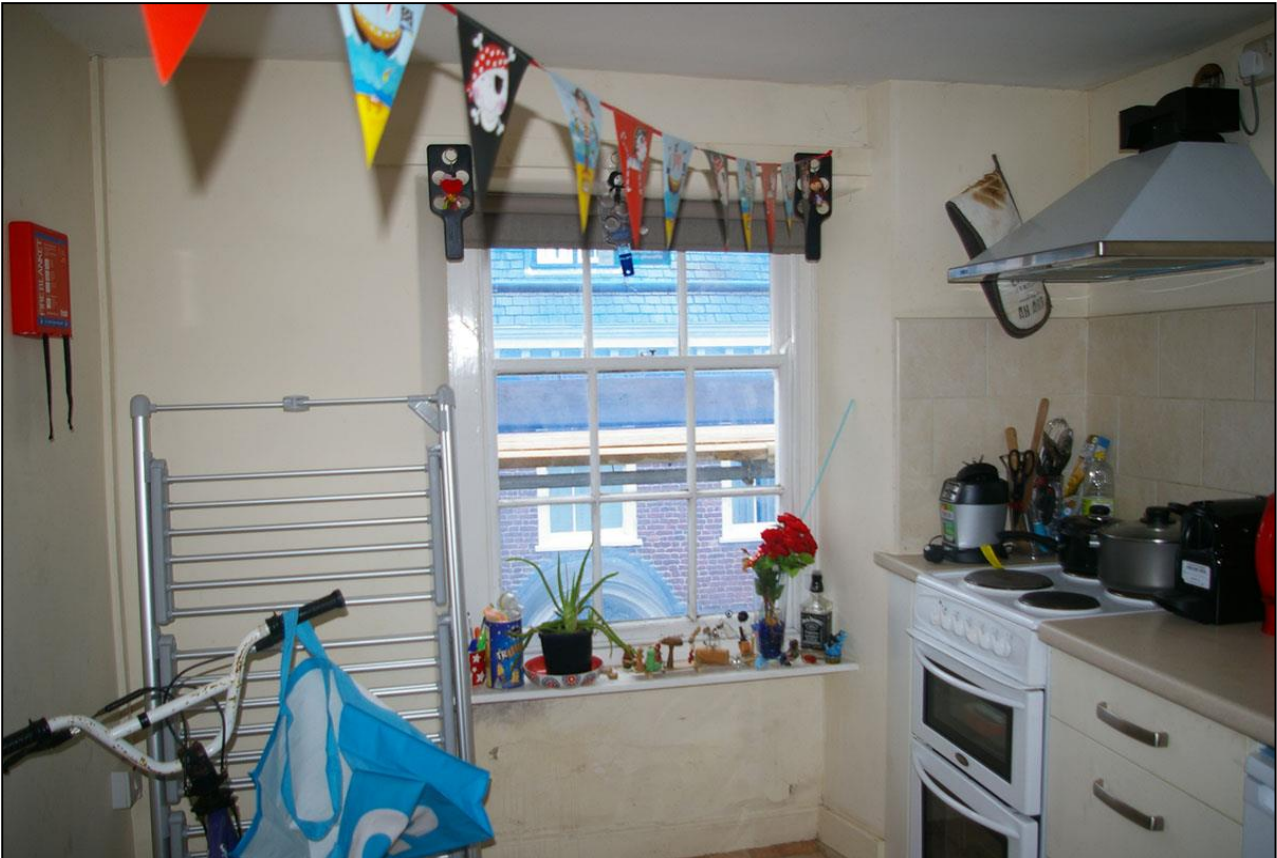
33. THE LATER HORNED SASH WINDOW WHICH LIGHTS THE KITCHEN, R14. ALSO SHOWING AN AWKWARD STEP IN THE WALL, THICKER TO THE WEST AND MAY SUGGEST INFILL BETWEEN BUILDINGS, FURTHER PHASING; FROM THE NORTH.

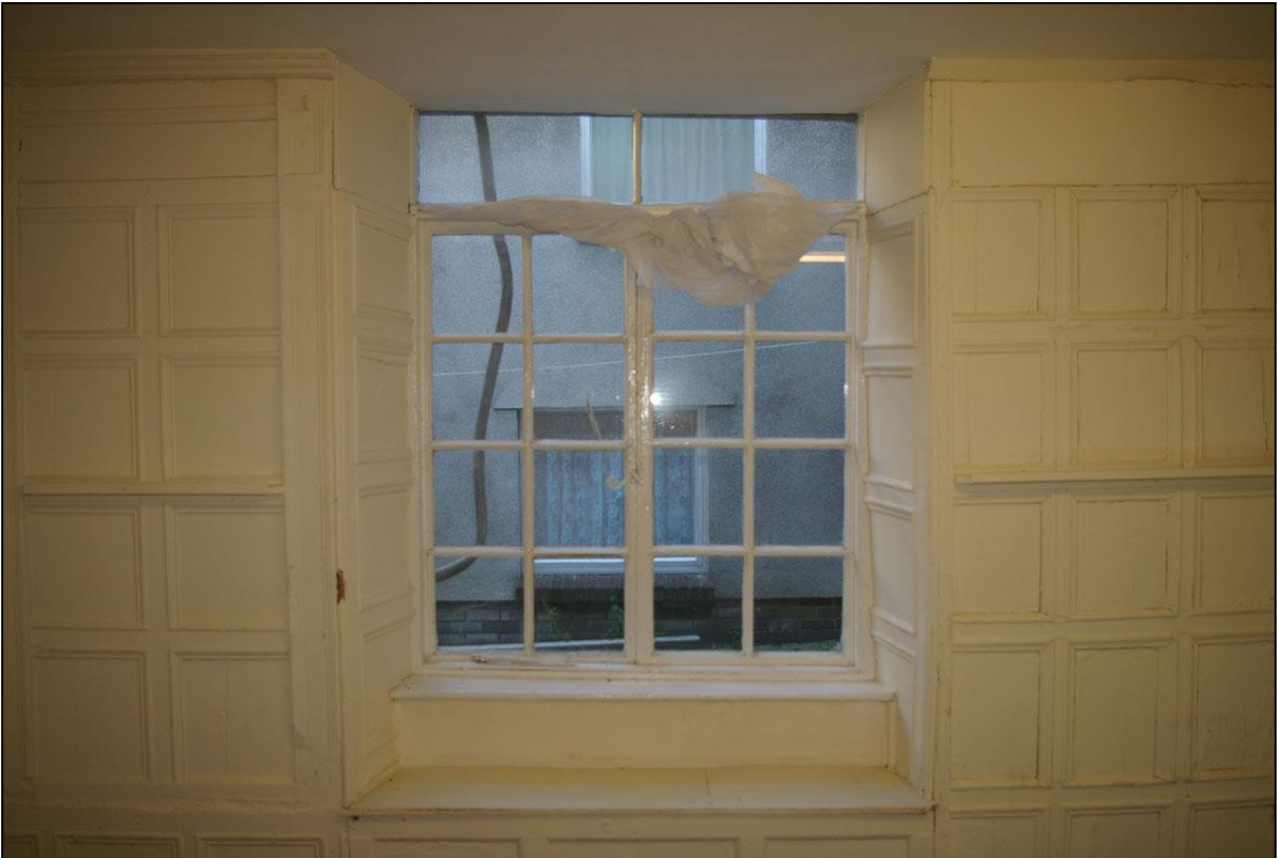
37. W13, WITH RECYCLED AND RESET 18<sup>TH</sup> CENTURY PANELLED SECTIONS TO THE SIDES, SHUTTERS, CUT AND NAILED SHUT AND WINDOW SEAT; FROM THE WEST.

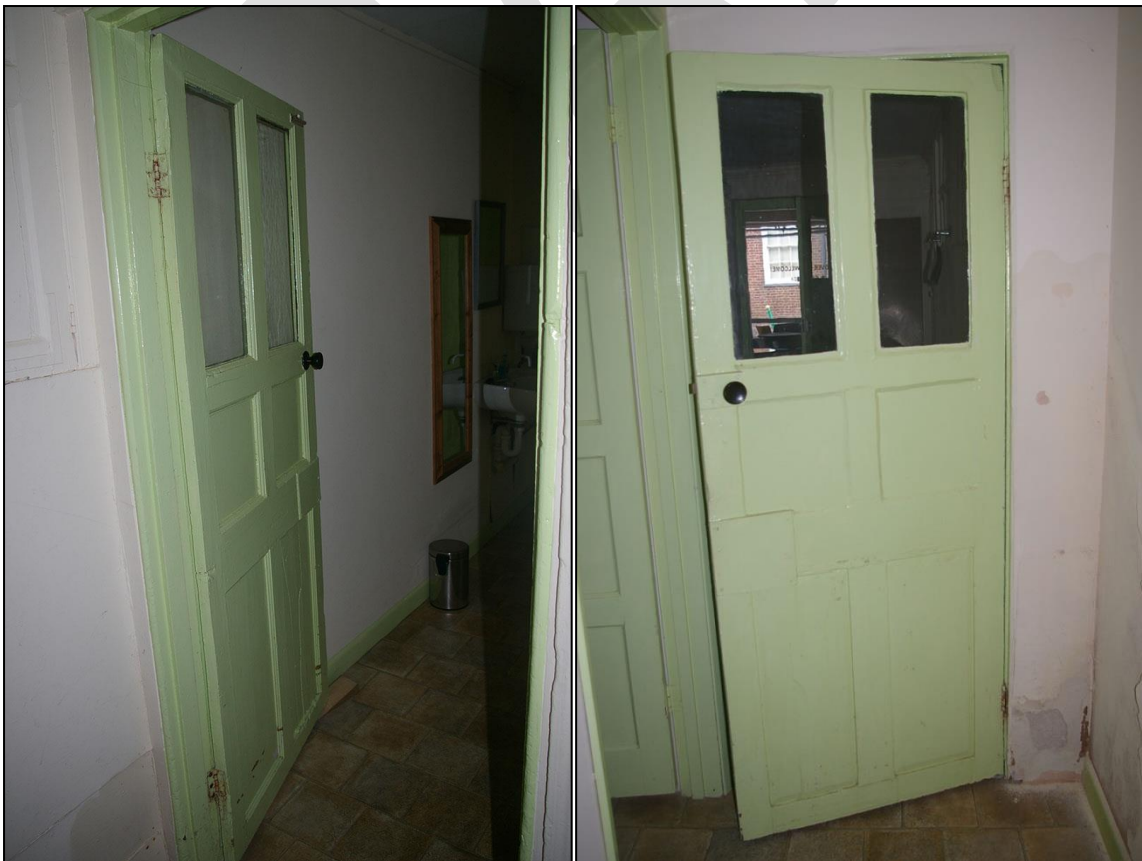
40. LEFT & RIGHT: D25, BETWEEN R17 AND R19, 18TH CENTURY STYLE DOOR WITH TWO GLASS PANES INSERTED; FROM THE SOUTH-EAST AND NORTH.

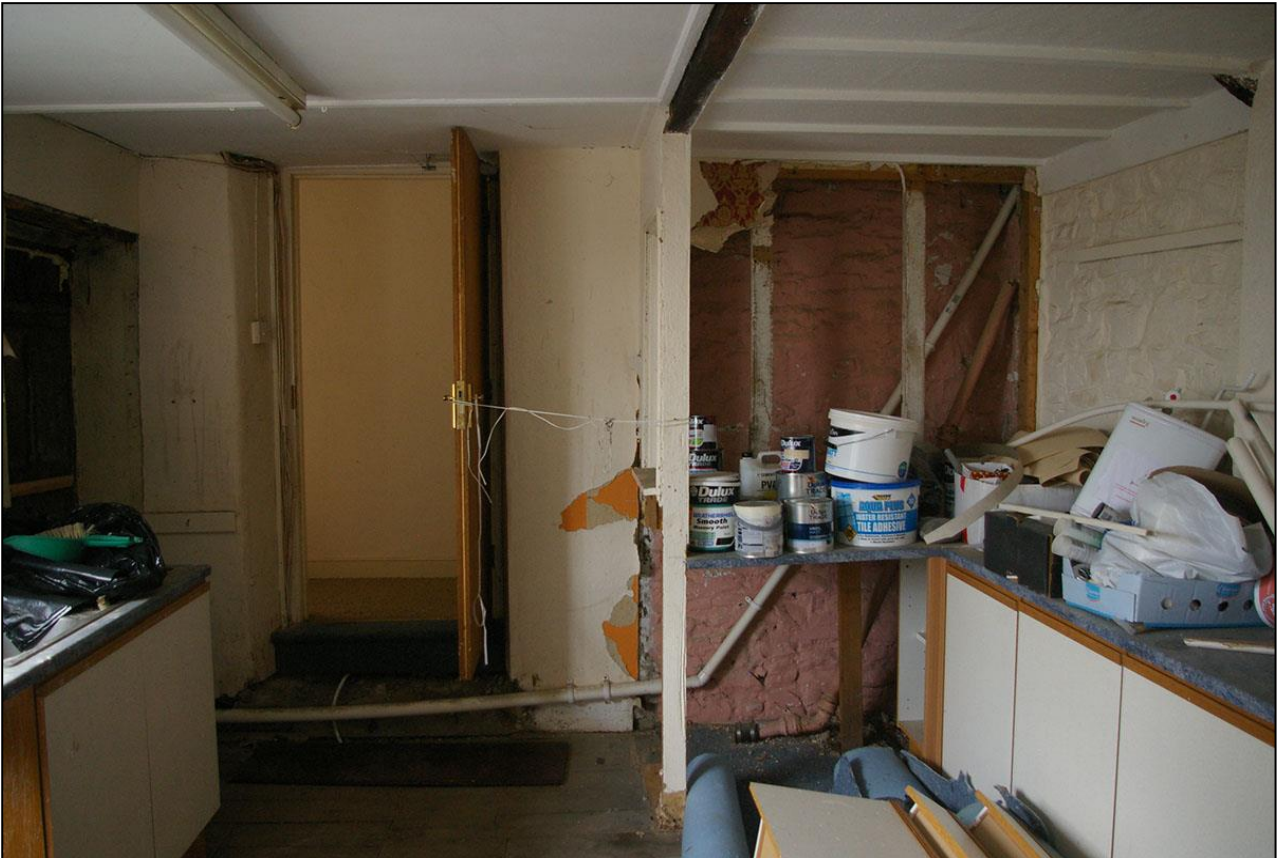
49. THE SOUTH PARTY WALL BETWEEN BUILDING 1 AND BUILDING 2, WITH FORCED DOOR, D29; FROM THE NORTH.

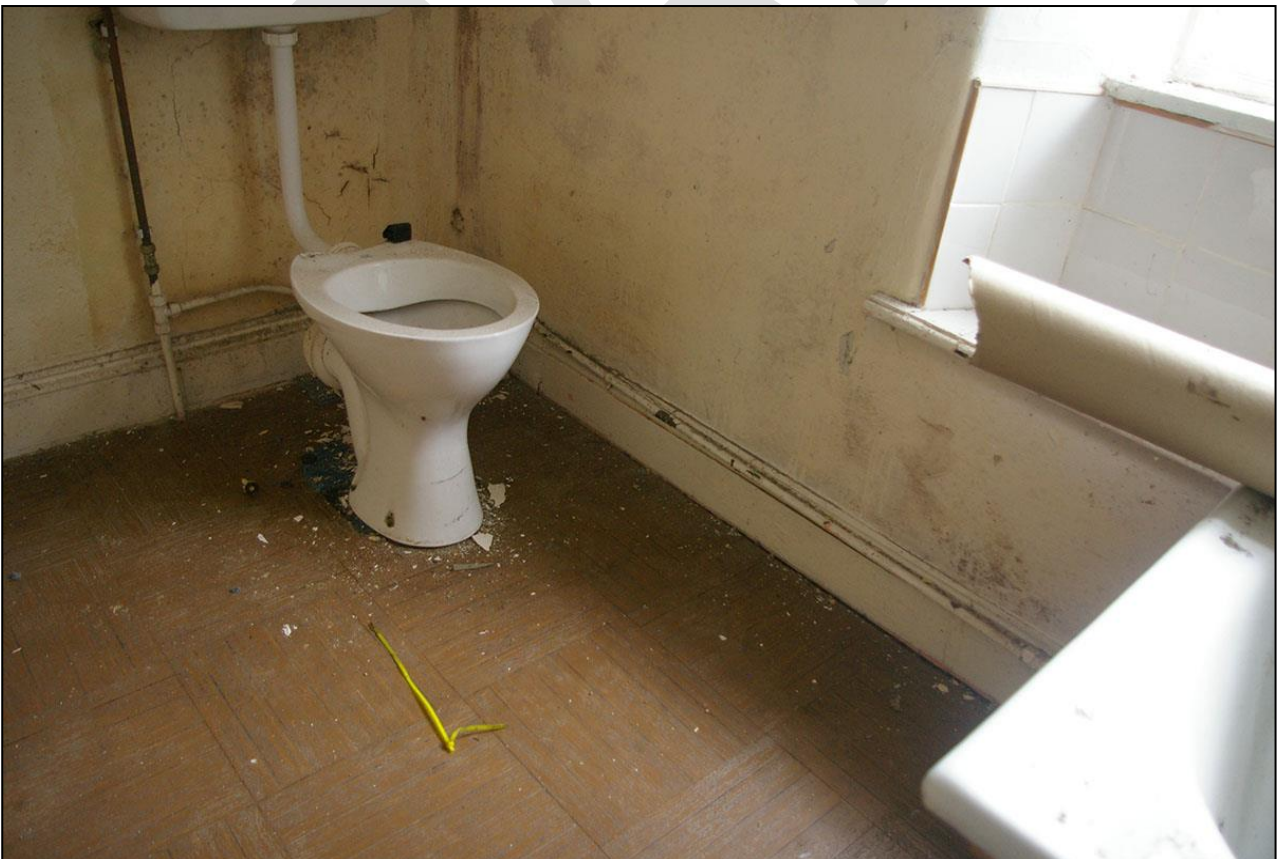
58. R20, THE BEADED SKIRTING RUNS BEHIND, AND IS CUT BY, THE MID-20<sup>TH</sup> CENTURY TOILET SUGGESTING IT MAY BE VICTORIAN OR EDWARDIAN; FROM THE SOUTH-WEST.

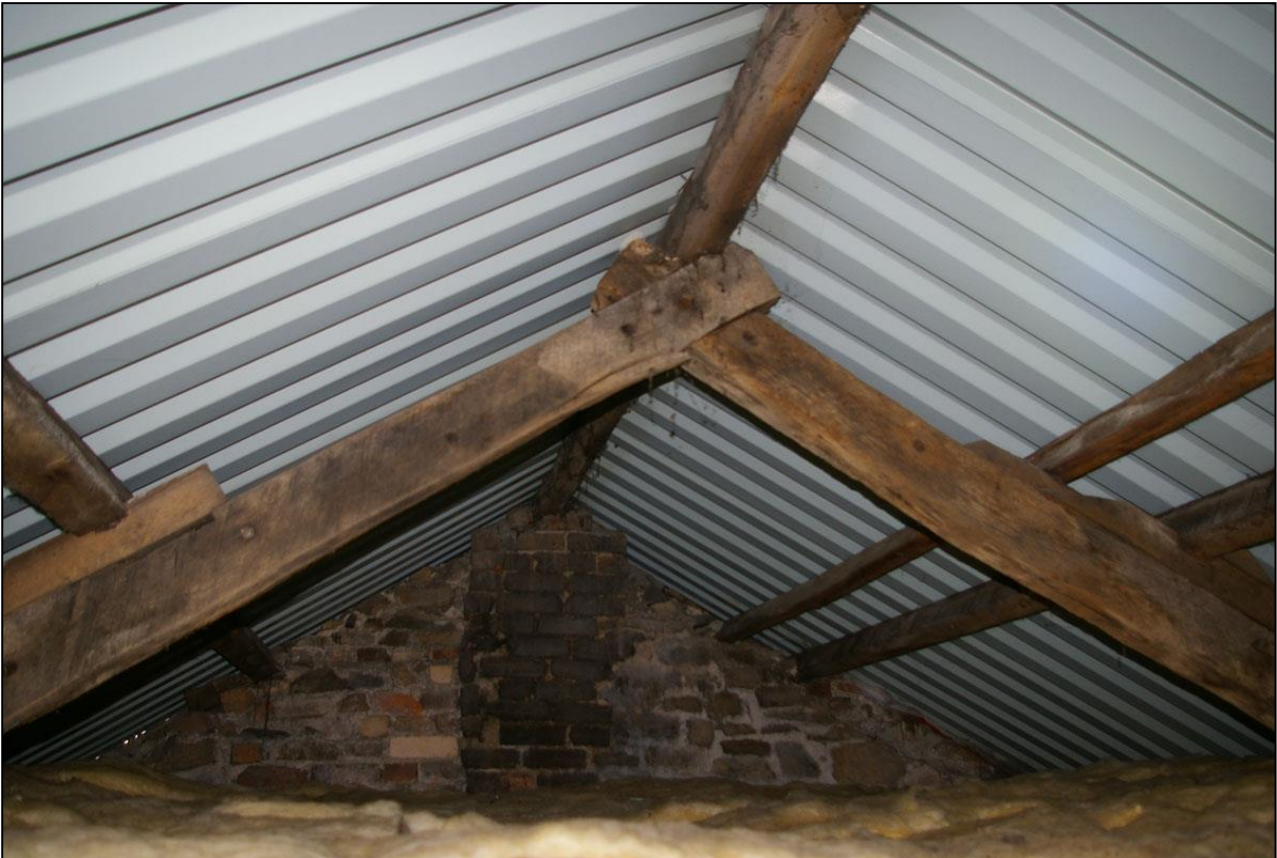
59. THE ROOF STRUCTURE OVER BUILDING 2, SHOWING REUSED BLADES IN THE TRUSSES AND PEGGED RIDGE, THE NORTHERNMOST TRUSS OF 3; FROM THE SOUTH-WEST.

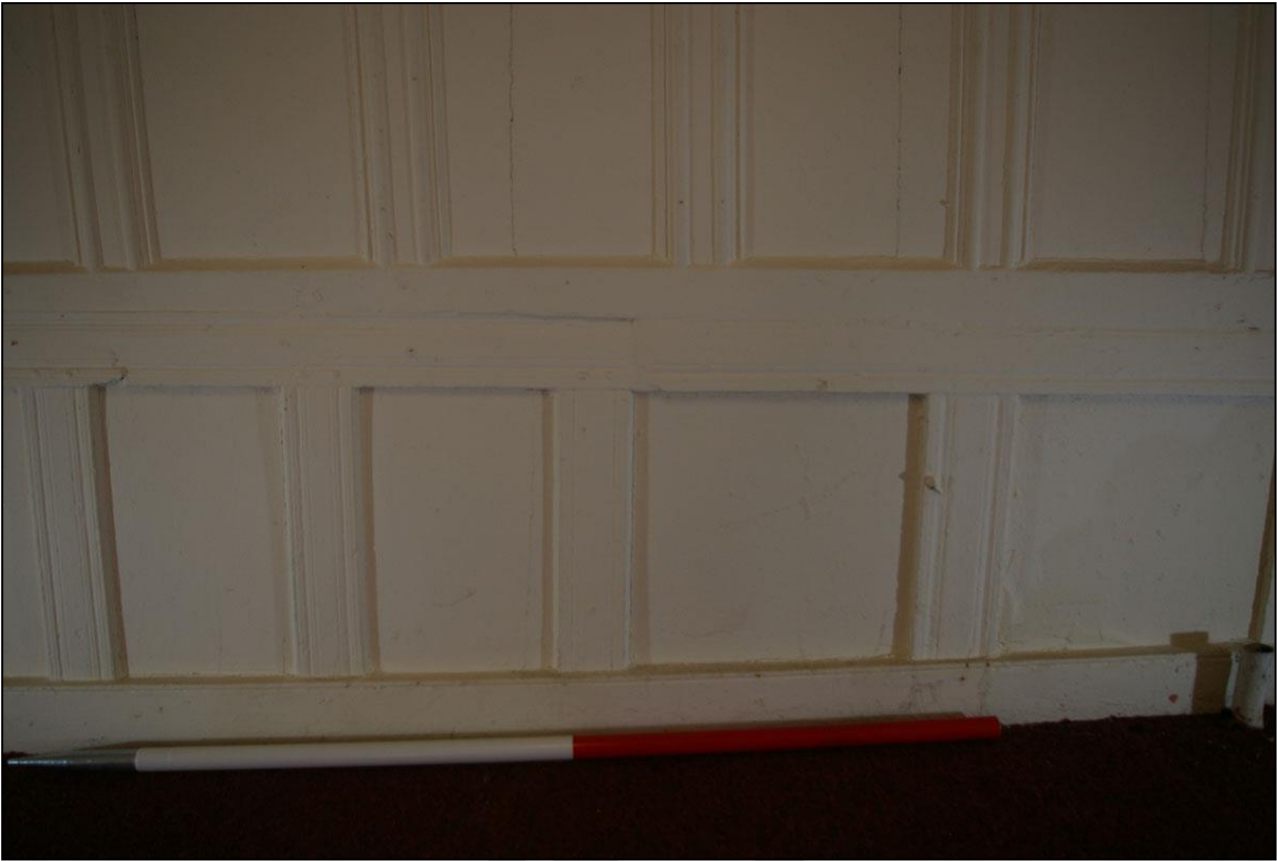
71. THE CUT AND DAMAGED SECTION OF PANELLING, WITH 1M SCALE; FROM THE SOUTH.

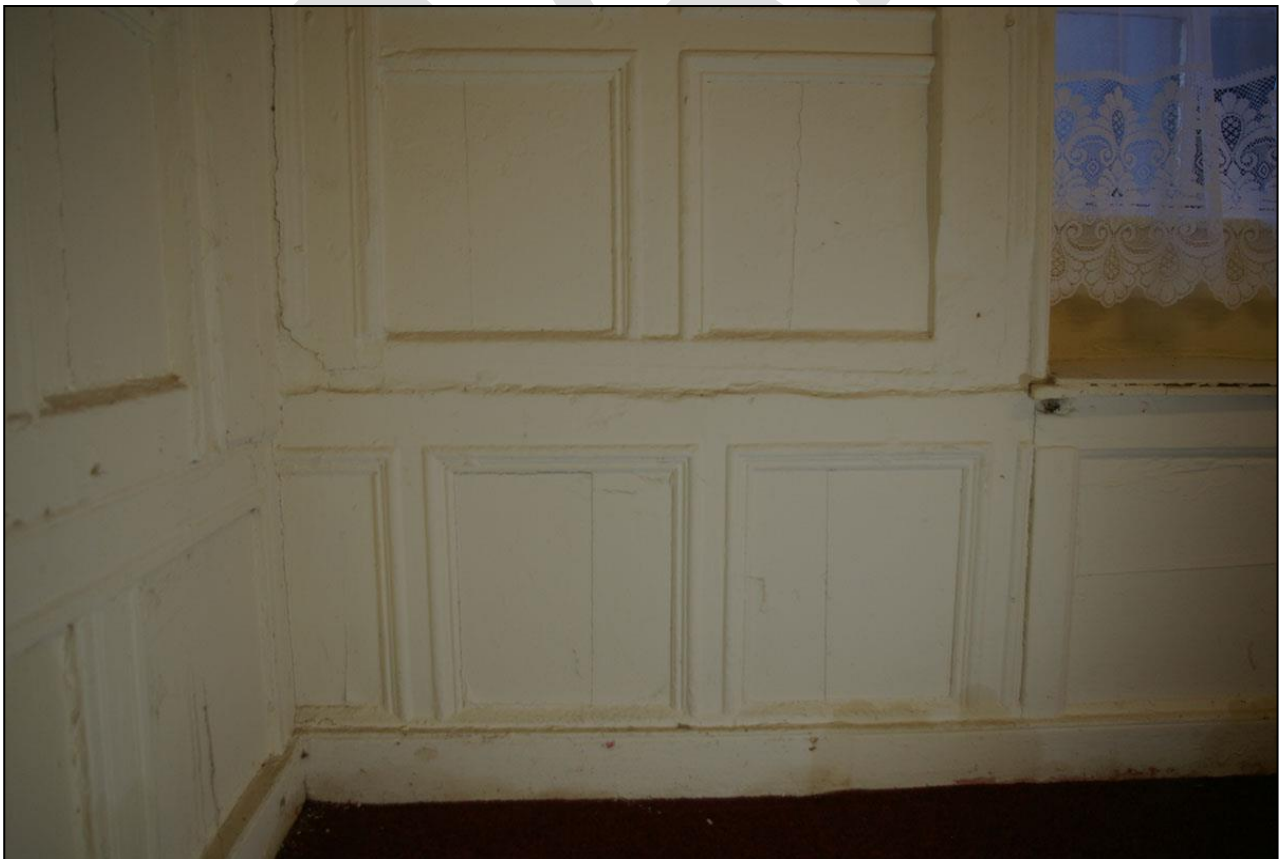
76. THE RAGGED JOINTS BETWEEN THE SECTIONS OF PANELLING ON THE EAST WALL; FROM THE WEST

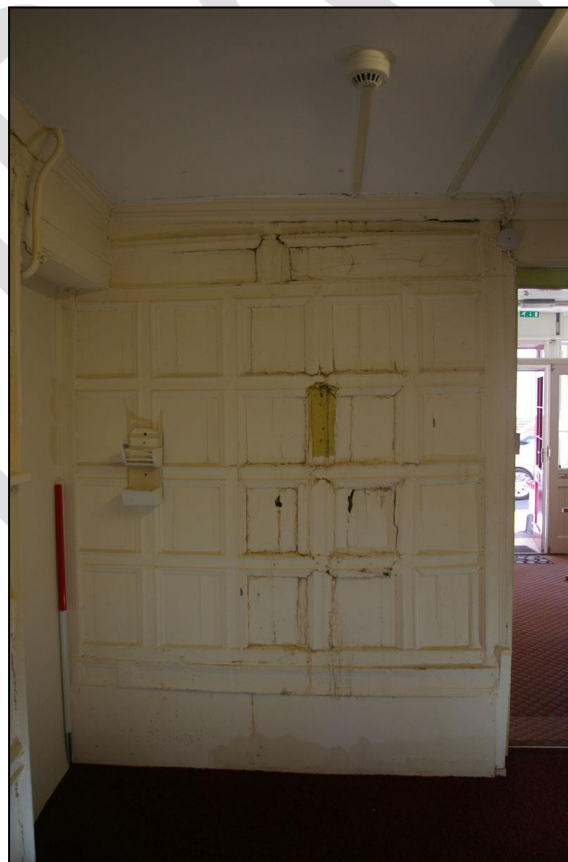
84. THE SOUTH WALL, EAST END, WITH 1M SCALE, D7 AND D24, SHOWING THE WATER DAMAGE TO THIS WALL; FROM THE NORTH.

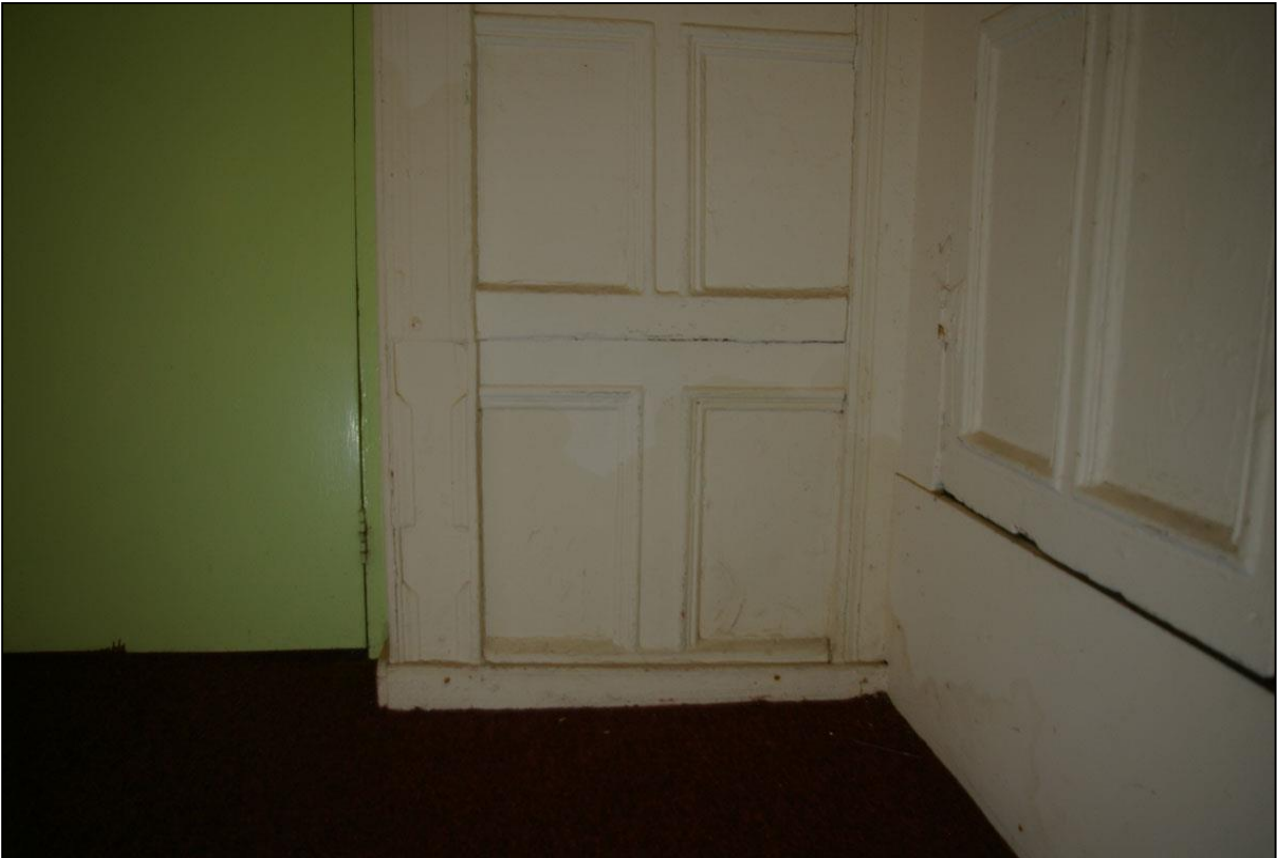
91. THE CUT AND RESET PANNELLING IN THE SOUTH-WEST CORNER; FROM THE NORTH.

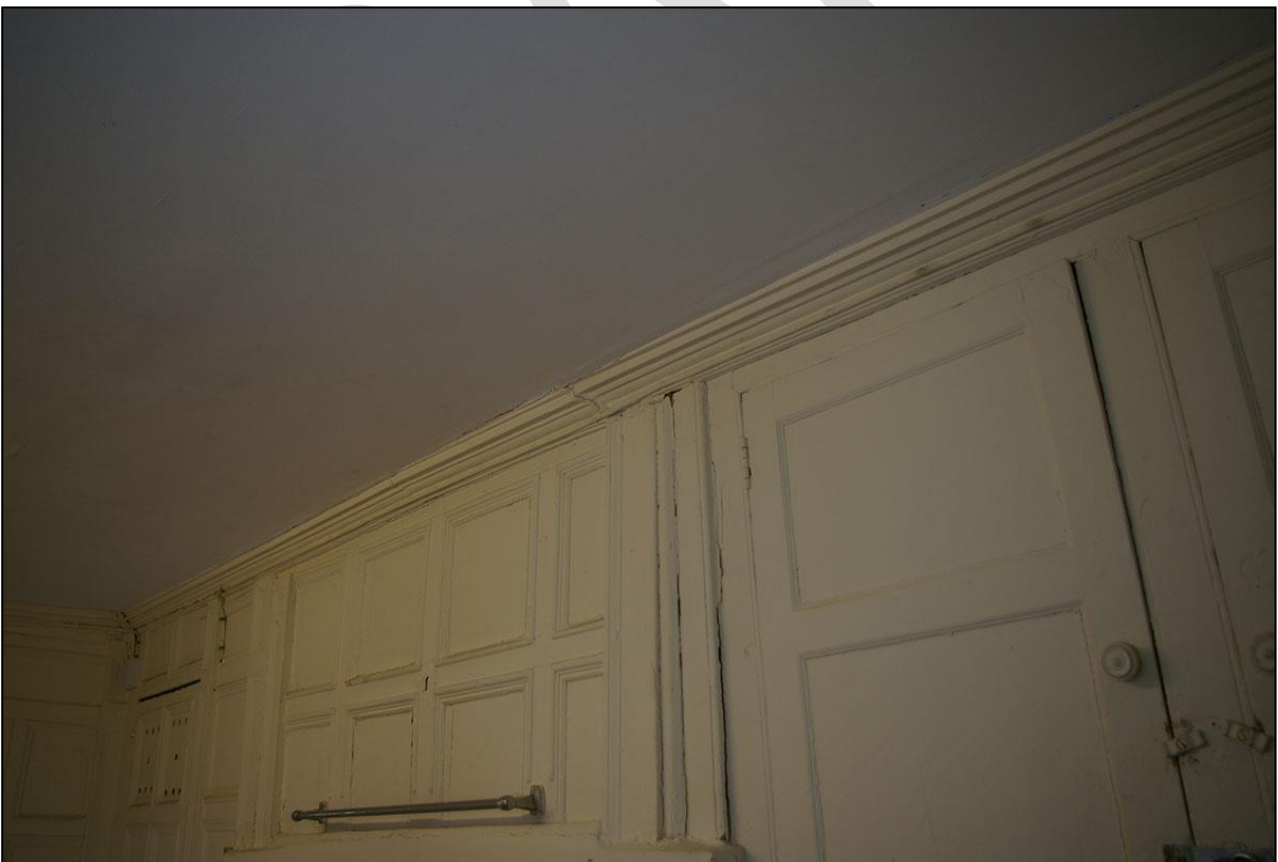
97. THE CUT AND RESET WOODEN CORNICE ALONG THE WEST WALL; FROM THE NORTH, NORTH-EAST

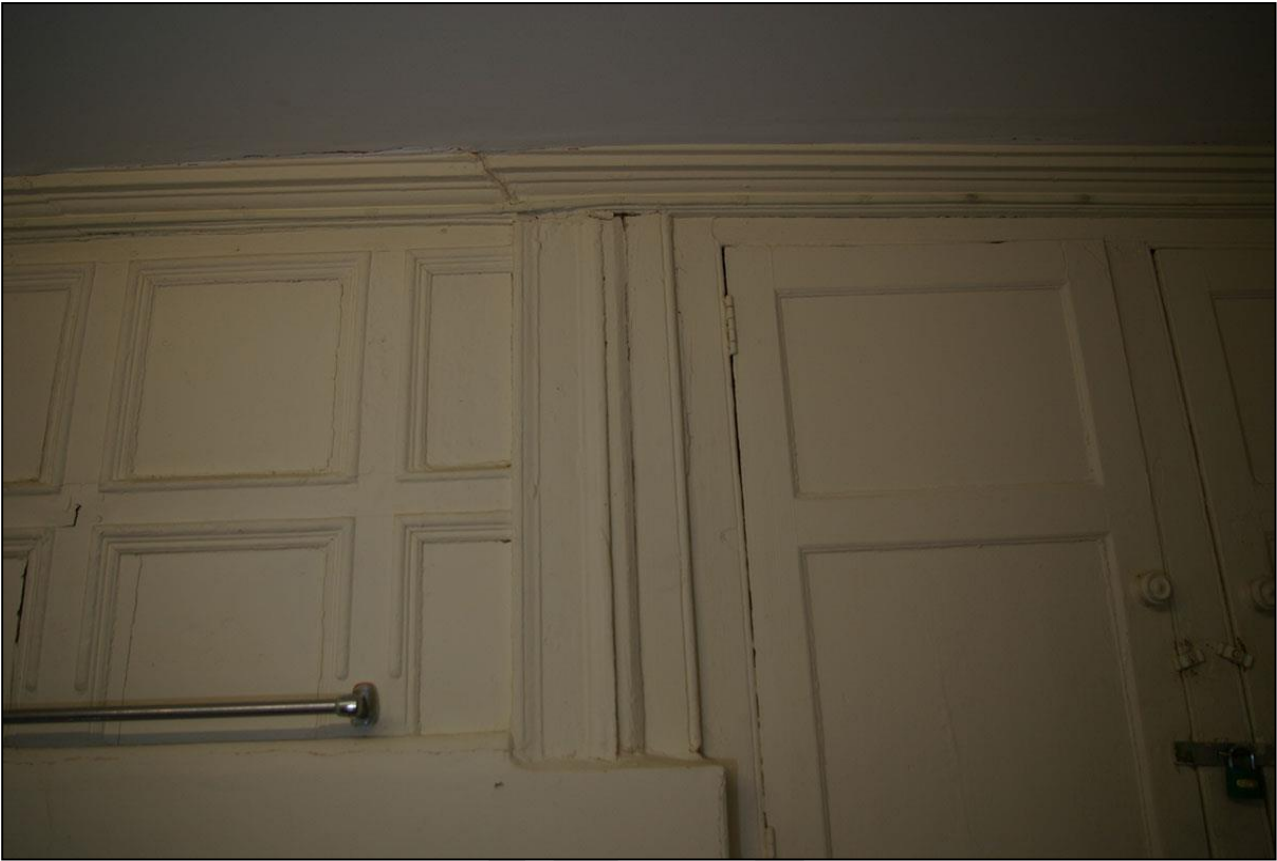
98. THE CUT AND RESET PILASTERS BETWEEN THE PANELLING AND CUPBOARD TO THE NORTH OF THE FIREPLACE; FROM THE EAST.
