Former stable at rear of 37 High Street, Dawlish

Level 2 Historic Building Recording

January 2019

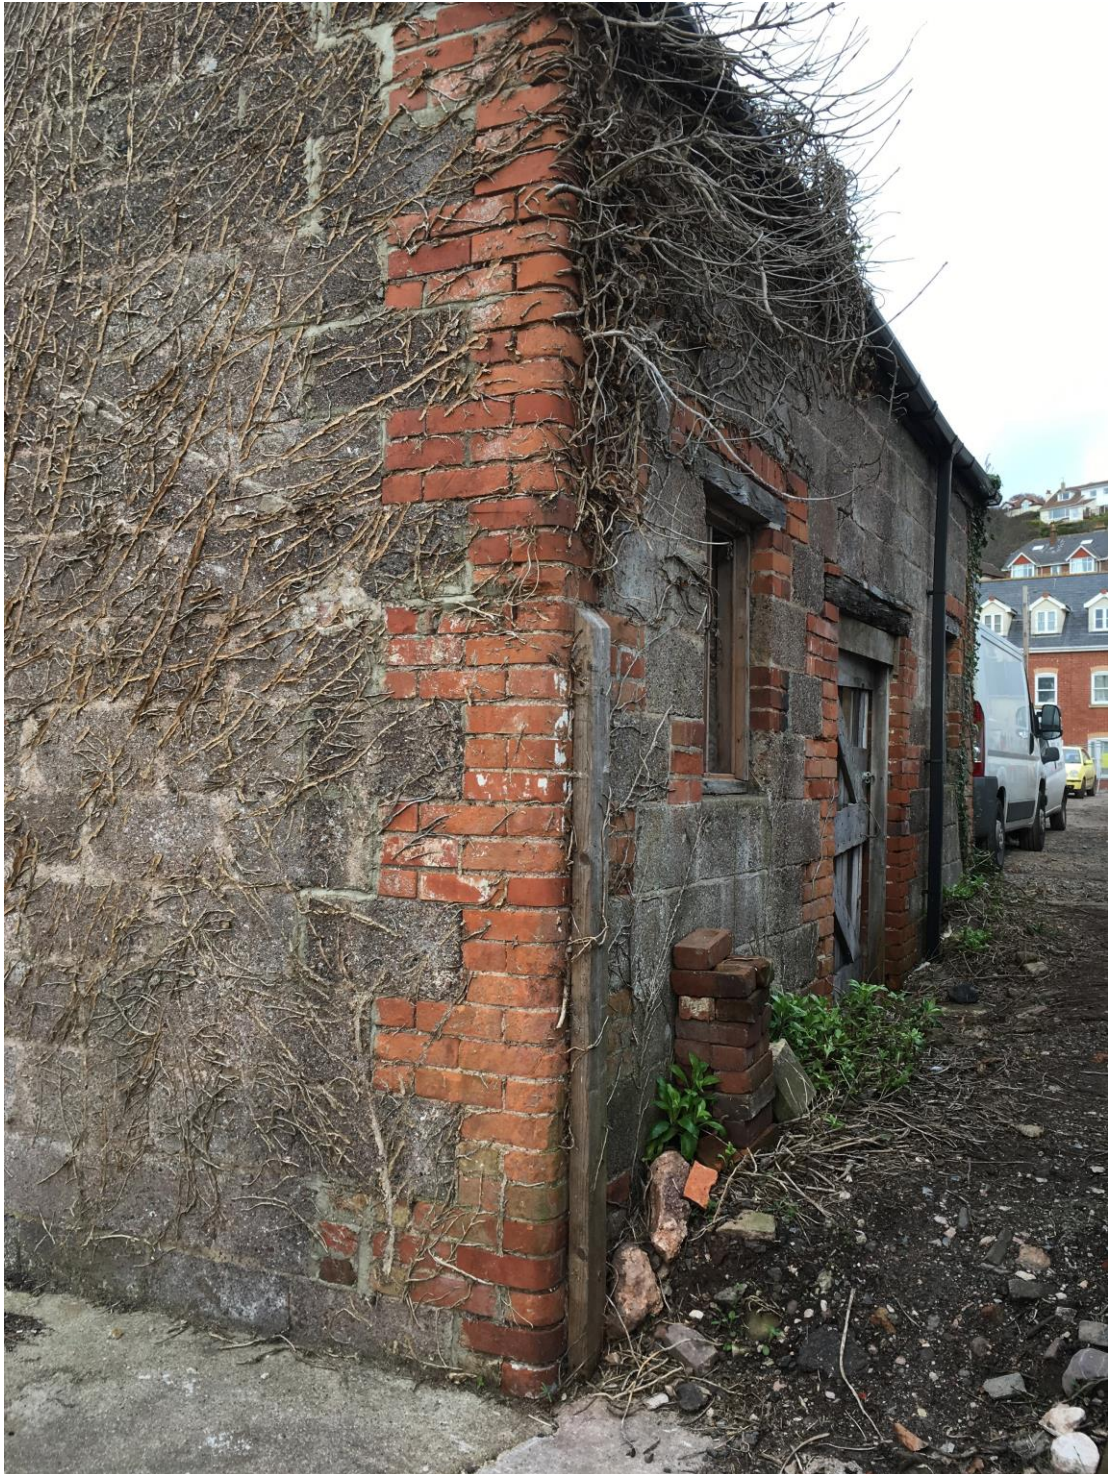
There are rudimentary dressings around the window and door openings in orange Wellington brick; those of the door jambs and quoins are bull-nosed. The rear wall is principally industrial brick laid to stretcher bond. The west elevation of the wall is rendered in what appears to be cement mortar.

Plate 4: South-eastern corner of the stable showing bull-nosed brick quoins

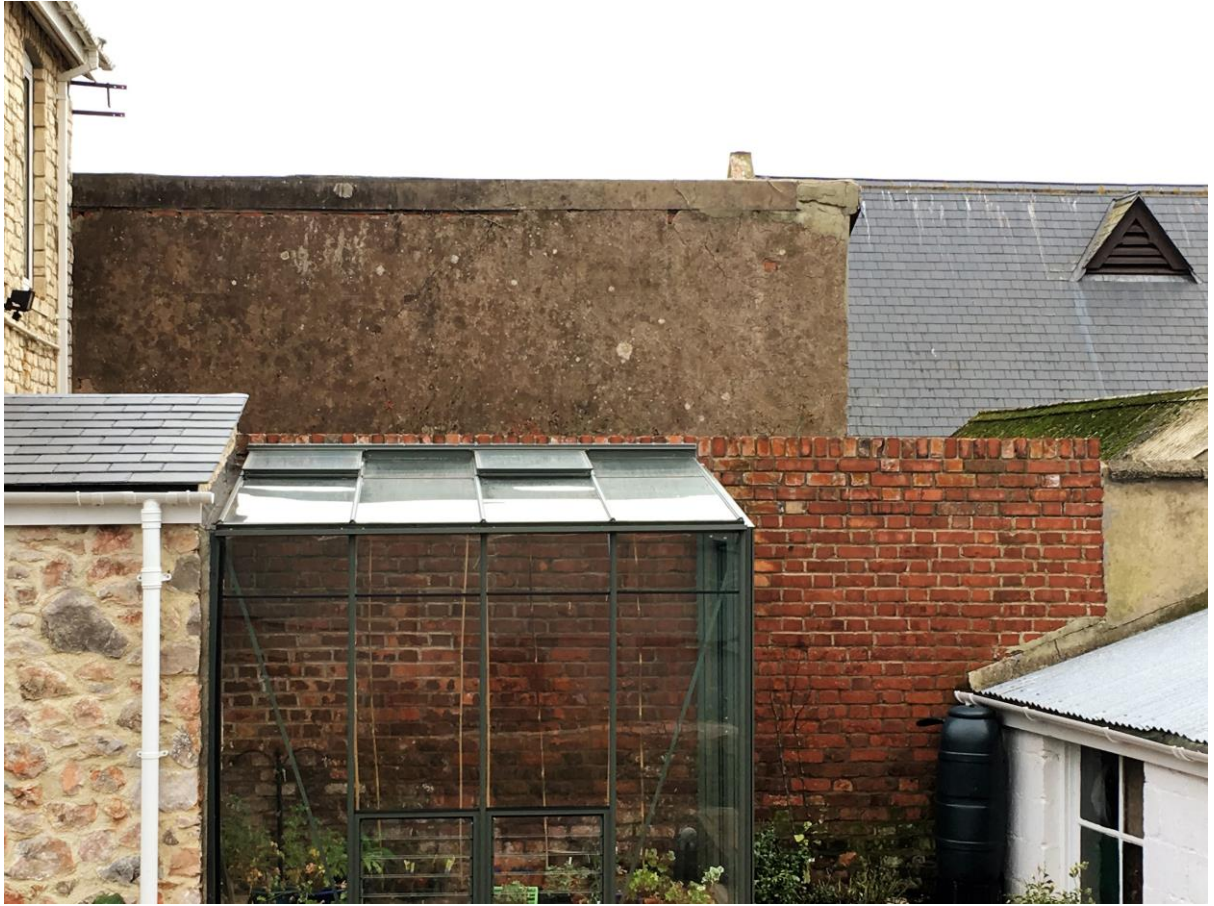
Plate 6: Rendered west elevation of stable visible above brick party wall

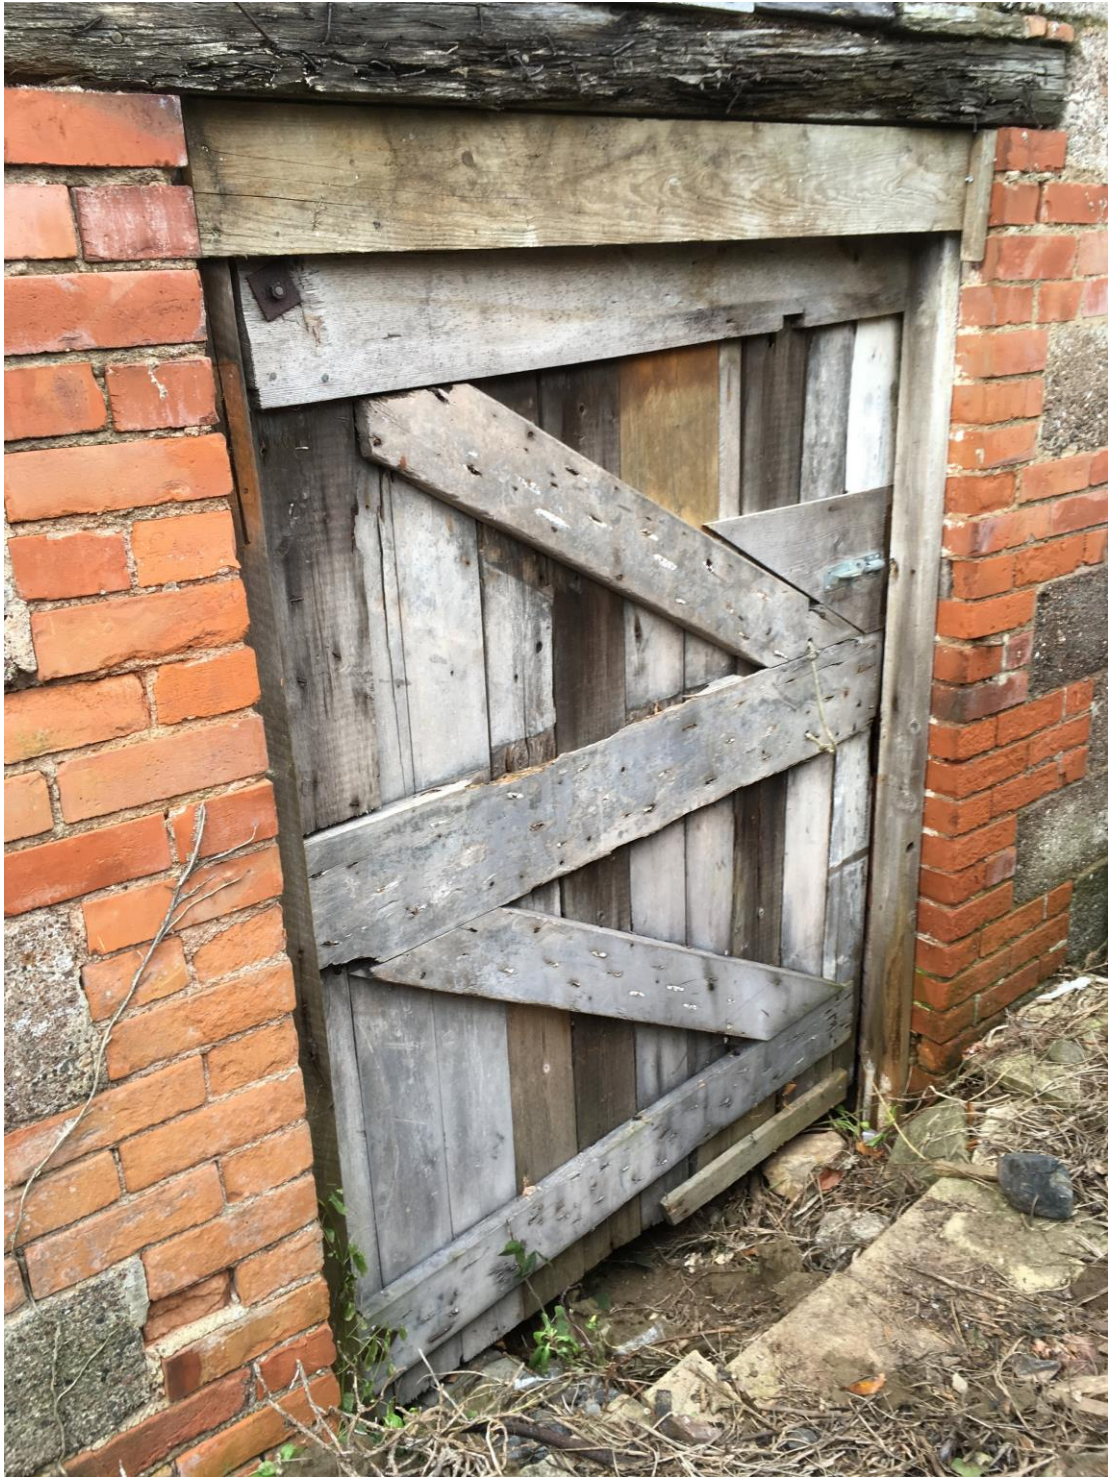
There is a simple ledged and braced plank door between the two lower windows hung on industrially made iron strap hinges.

Plate 7: Ledged and braced plank door on east wall

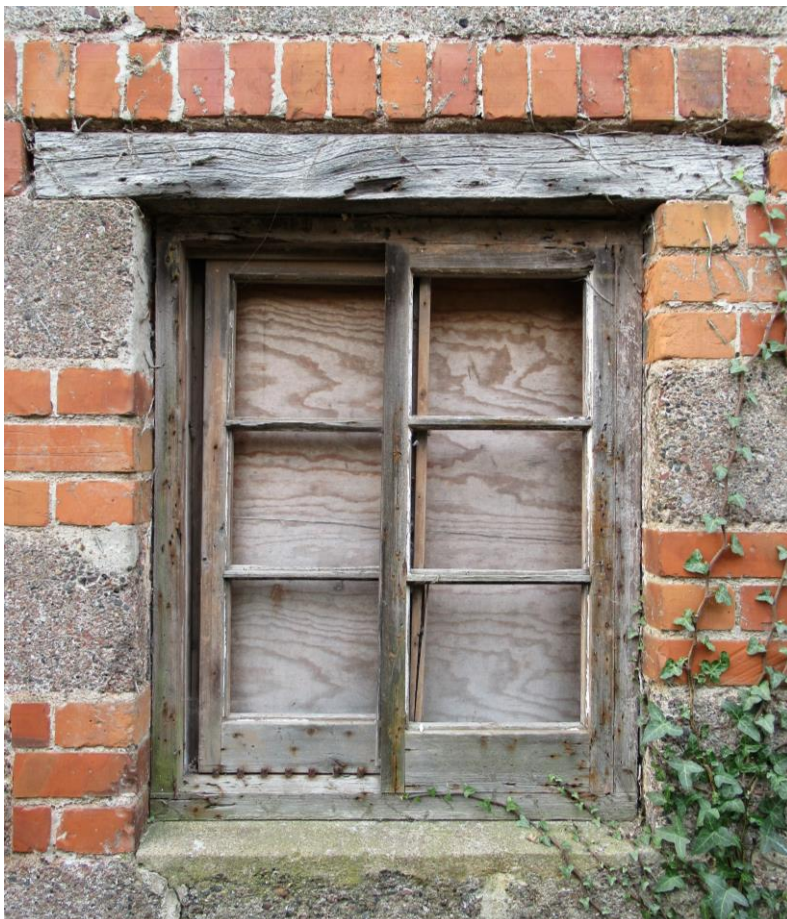
Two openings on the east elevation contain rudimentary softwood two-light Windows. These consist of two parts: a fixed outer sash and an inner sash that would have slid horizontally to open. A row of iron studs in the base of the frame kept the sliding sash in place. There is an iron-framed oculus window with glazing bars in the form of an X in the south elevation lighting the loft.

Plate 9: Timber sliding sash window in east wall with timber lintel and concrete sill. Both ground floor windows are now boarded up

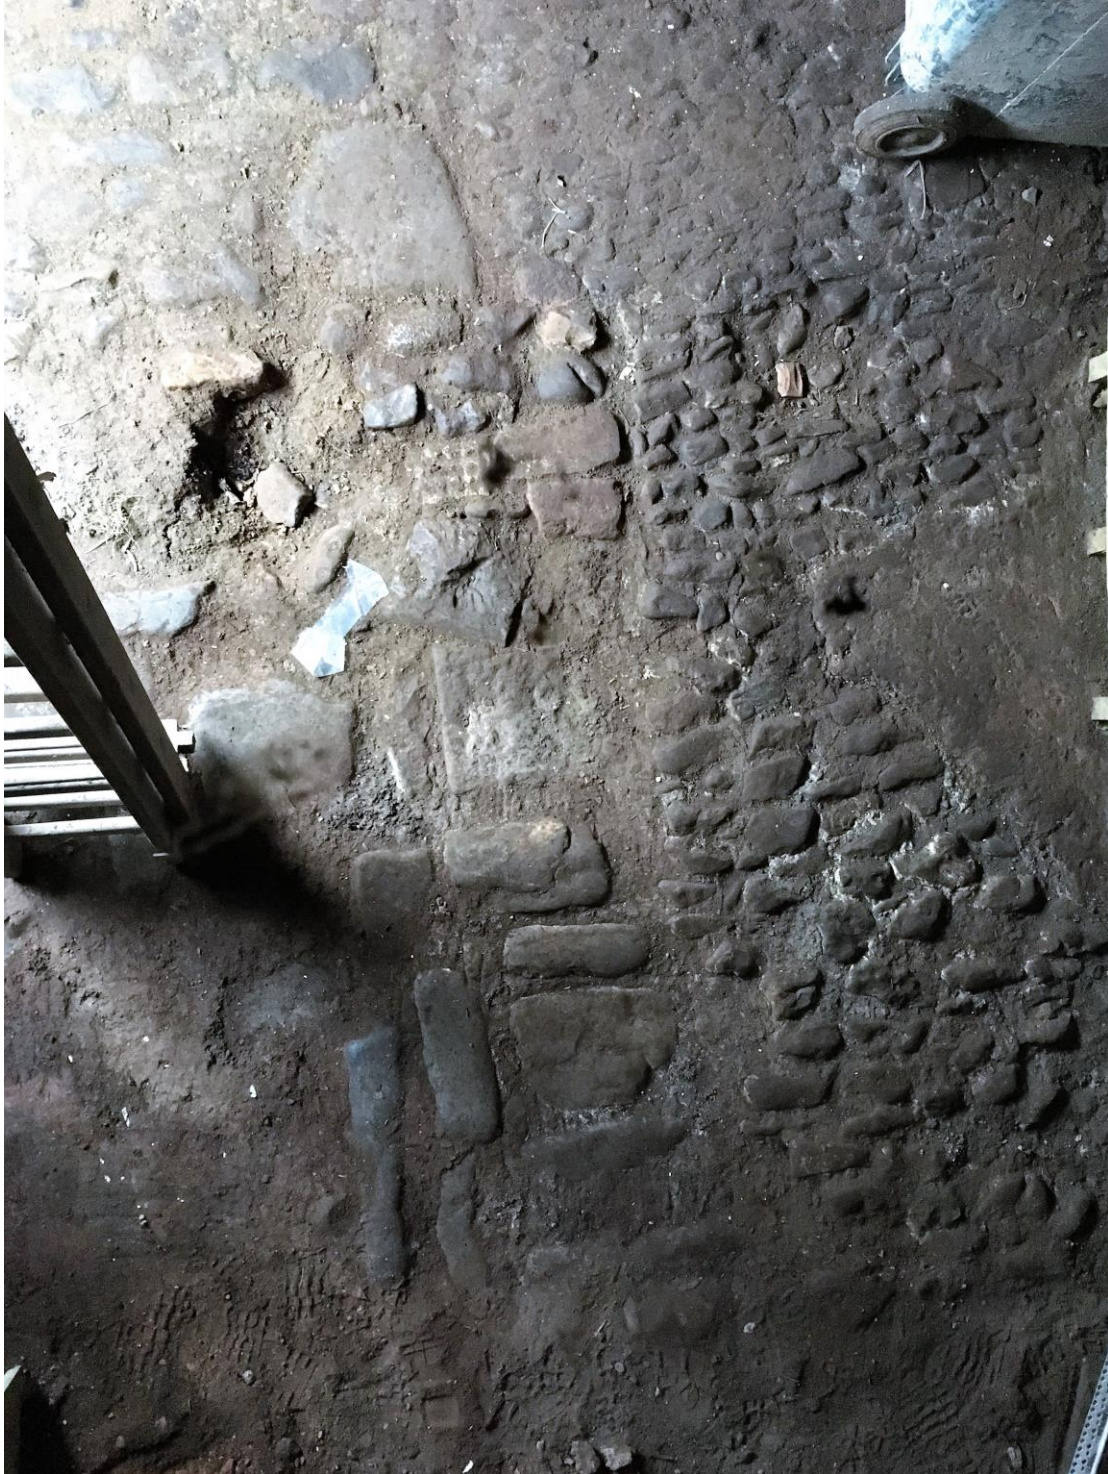
On the day of inspection, large areas of the floor were covered with rubble and sand. However, exposed areas show a predominantly cobbled floor, with some larger stones set in a haphazard pattern around the main door and ladder on the east wall. Although damaged in places, the cobbled floor supports the assumption of its use as stable.

Plate 12: Cobbled floor on ground floor and larger paving stones around doorway and ladder

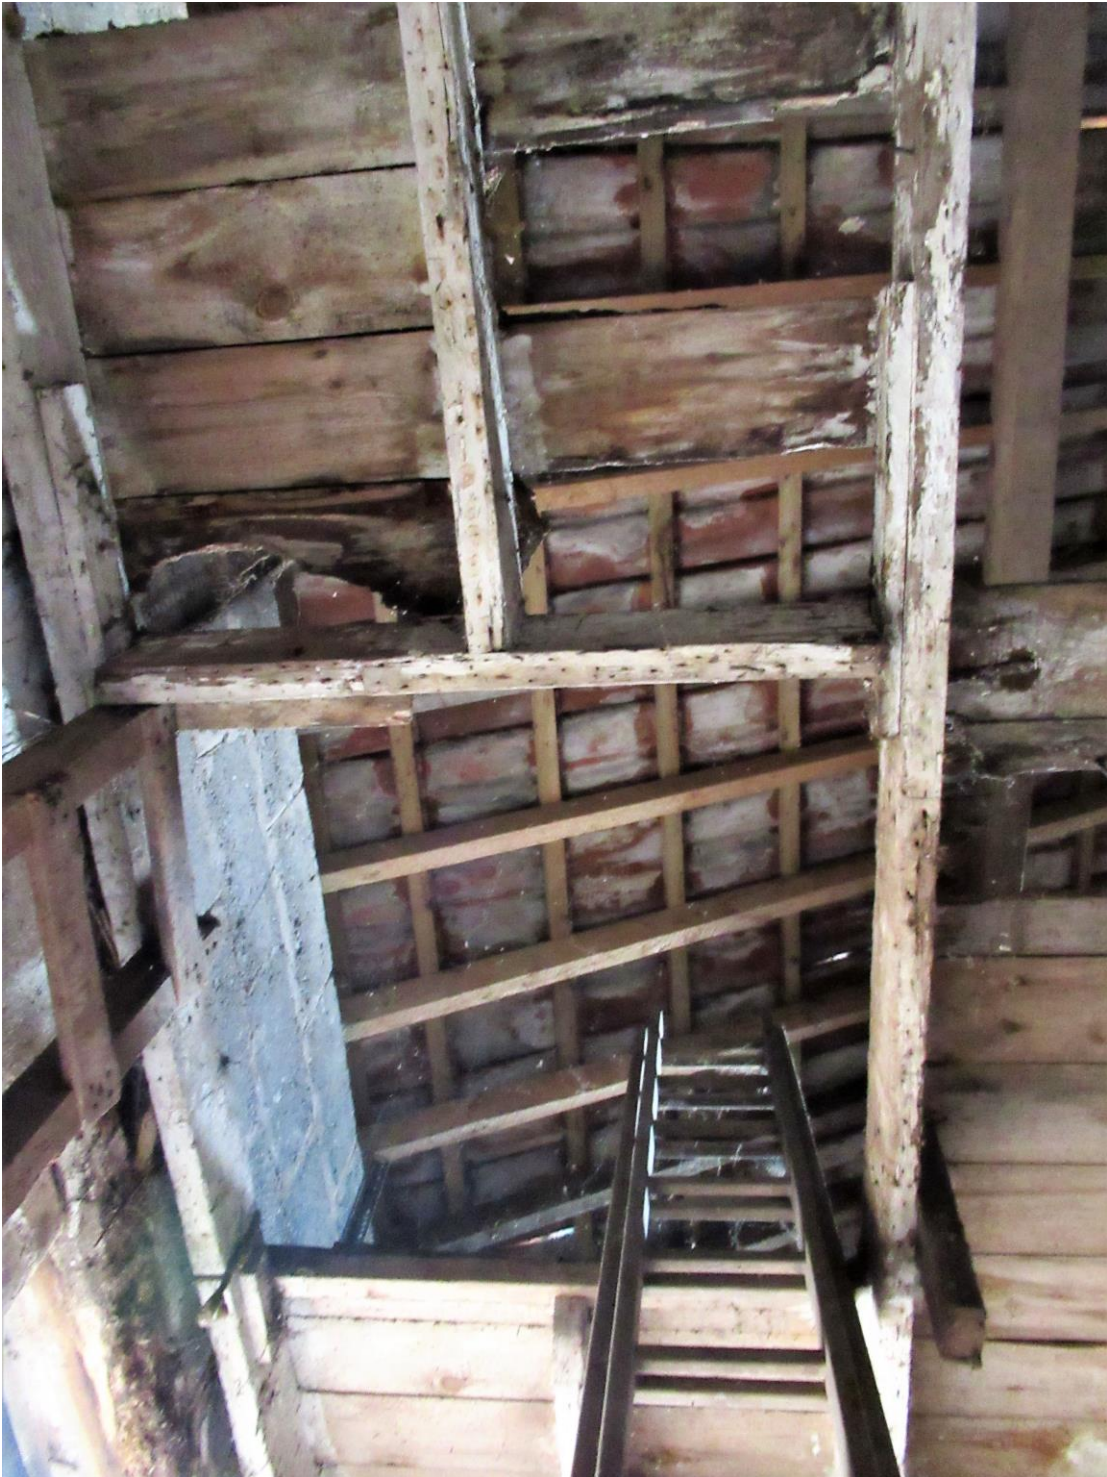
The underside of the floor structure above is exposed on the ground floor. However, the underside of the joists shows scarring from nails, suggesting that a covering was fixed to them at some point during the history of the building.

Plate 13: Underside of ceiling showing opening and underside of roof structure above

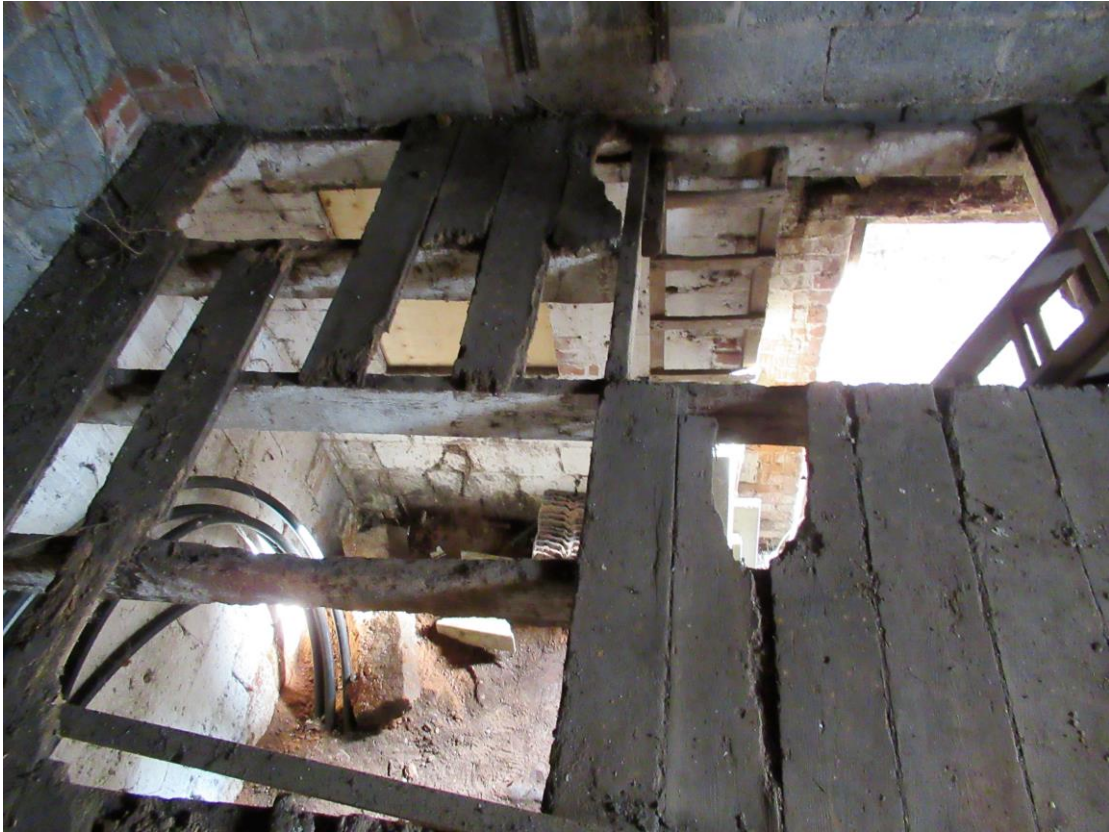
The floor to the loft is a simple softwood structure and access to the upper level is by a vertical ladder adjacent to the front wall. Joists span in both directions, with softwood floorboards fixed by nails above. Many of these have rotted or been damaged, leaving large voids in the floor surface.

Plate 14: First floor structure from above

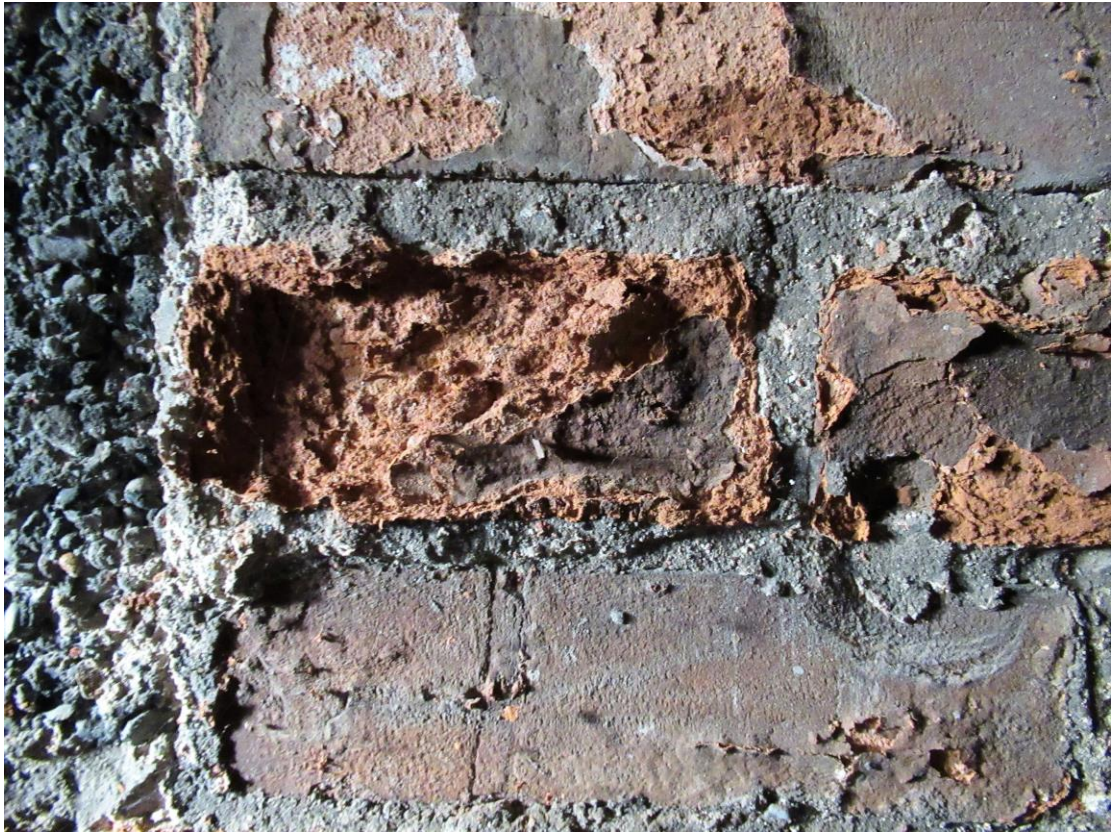
At first floor level, wall surfaces are exposed and bricks on the west wall show evidence of spalling. These are interspersed with concrete blocks, some of which are also damaged. Concrete blocks on the north, south and east walls remain intact.

Plate 18: Spalling of brick on west wall of first floor
