UPTON FARM, CLYST ST LAWRENCE, DEVON

Results of historic building recording

Planning references: East Devon District Council
08/2553/LBC and 08/2552/FUL

Document No: ACD54/2/0

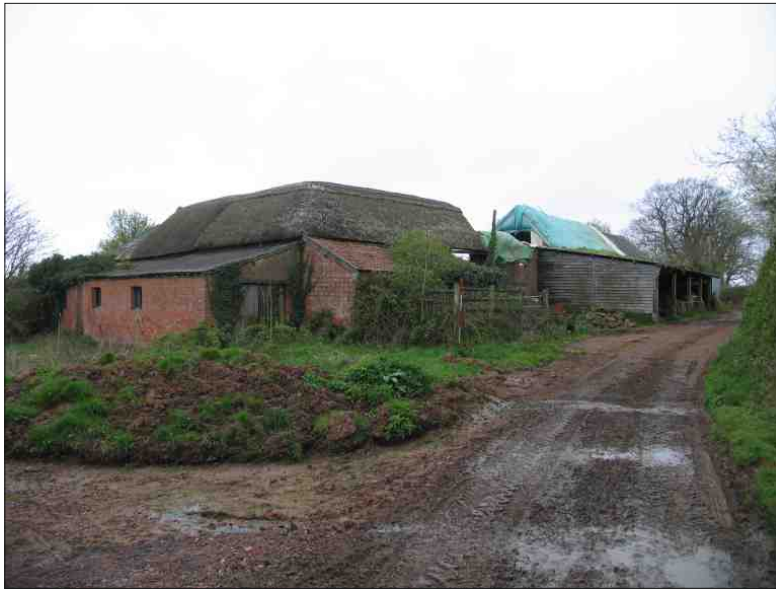
- 5.6** There is a further mid-late 19th-century structure attached to the north of the dairy (Plate 1). This is constructed of brick, with a sloping tiled roof and has a double width opening in the west elevation with timber cladding above. The roof is supported by closely-set principal rafters, which were in a poor condition causing a partial collapse of the roof.

Plate 1: The dairy with attached root store (centre and left) and threshing barn with attached lean-to beyond to the right, looking southwest (2m scale)

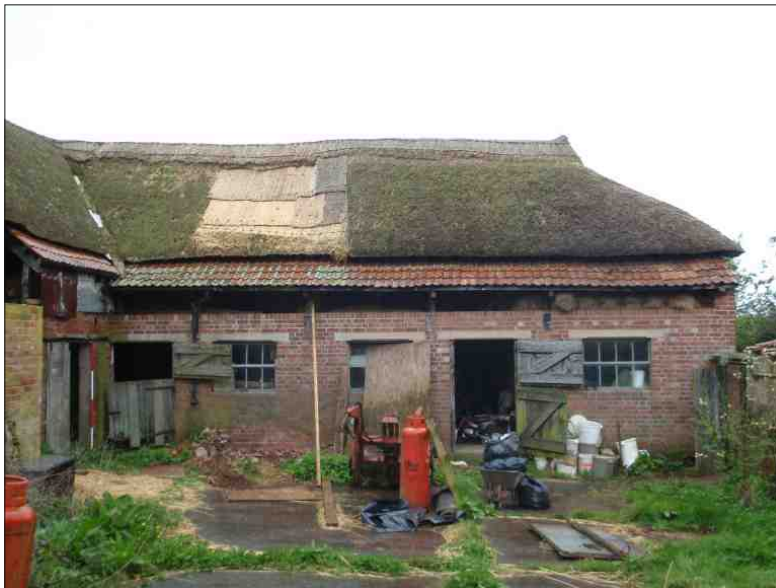
was enclosed in 1948 with bricks laid in English bond. In this frontage is a pair of stable doors and three eight-pane top-opening windows (Plates 1-3). The windows have bullnose brick cills, and all the openings have chamfered concrete lintels. The only other openings are in the east elevation where there is an inserted doorway into the mid-late 19th-century root house along with a series of inserted vents. The building has a hipped thatched roof, which on the west, yard elevation has been extended down and lowered at eaves level with Roman ceramic tiles, partially infilling an originally open first floor.

Plate 2: The dairy, looking east (2m scale)

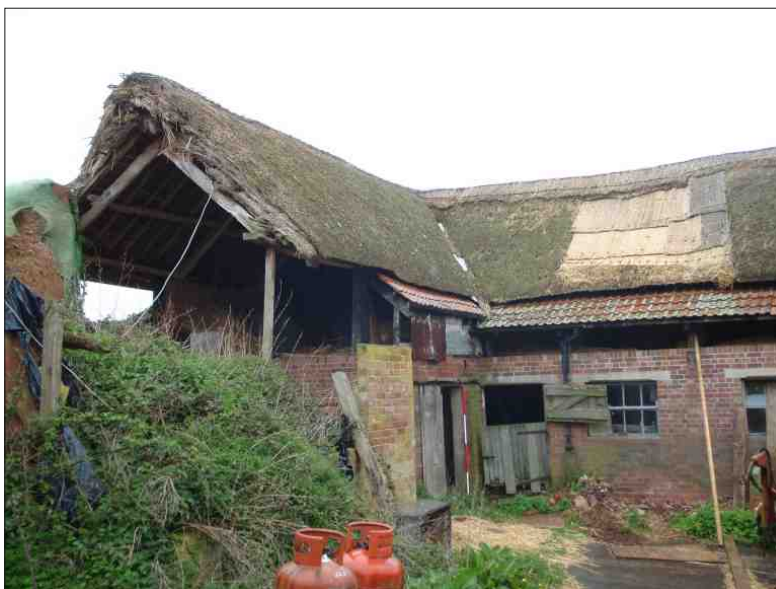
- 5.3** The 1948 refronting continues to the west forming the south and west wall of a rebuilt structure at the end of the north range (Plate 3). Here there are sliding doors in both the south and north elevations; the former again has a chamfered concrete lintel, whereas the latter has a plain thinner concrete lintel set into the earlier cob, along with additional brickwork. The thatched roof, with Roman tiles below, continues above this structure, and extends west over the covered passageway. Internally, there are suspended glass tanks and fittings formerly linked up to pipes connecting with the dairy to the east (Plate 6).

Plate 3: The dairy, looking northeast (2m scale)

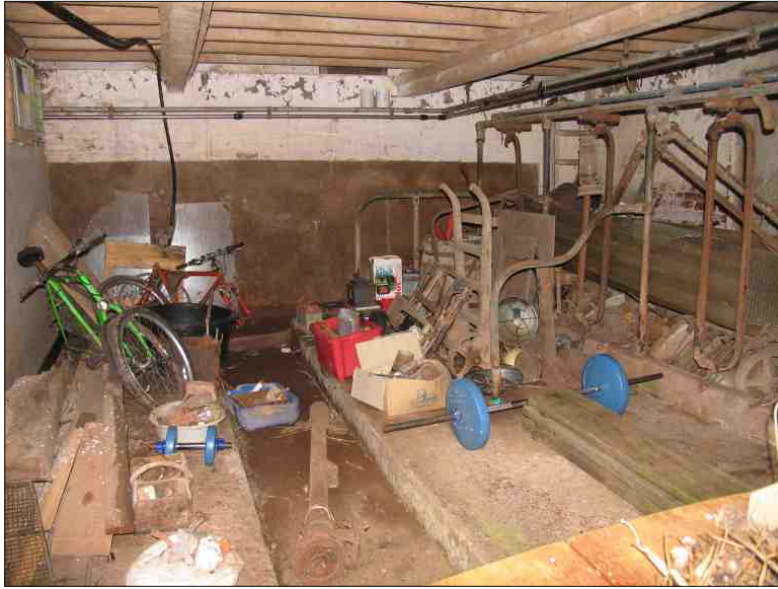
- 5.2** Internally the walls are rendered to a height of approximately 1.5m from the floor (Plates 4 and 5). The latter is concrete incorporating a drain towards the west side and feeding troughs to the east with a feeding passage beside the full length of the east wall. There are galvanised steel fittings for 14 cows. In the southeast corner is a vertical ladder to the loft above. The first floor is supported on replacement beams with slender joists between, supporting floor boards; these date to the 1940s.

Plate 4: Internal view of the dairy, looking northeast

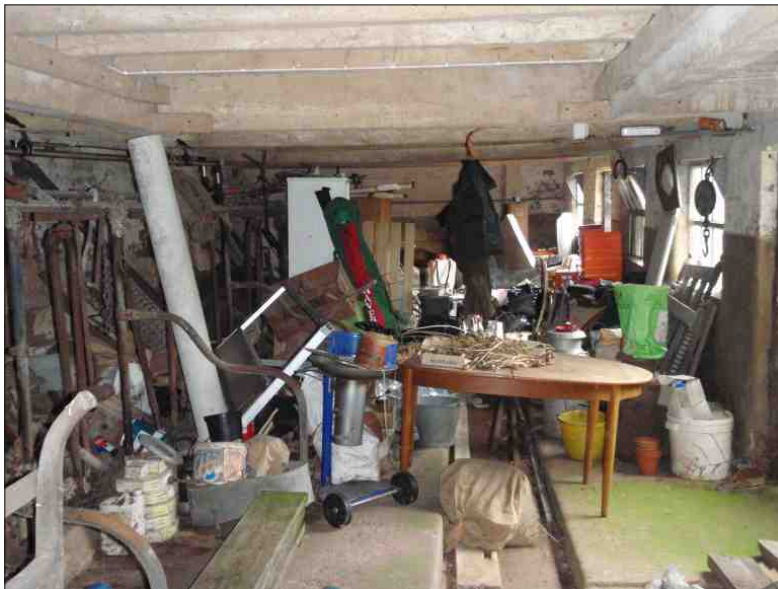
Plate 5: Internal view of the dairy, looking south

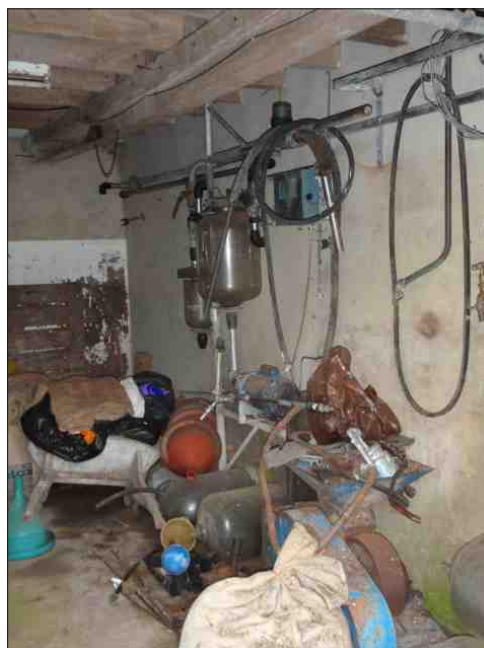
Plate 6: Fittings in the west structure of the dairy, looking northeast

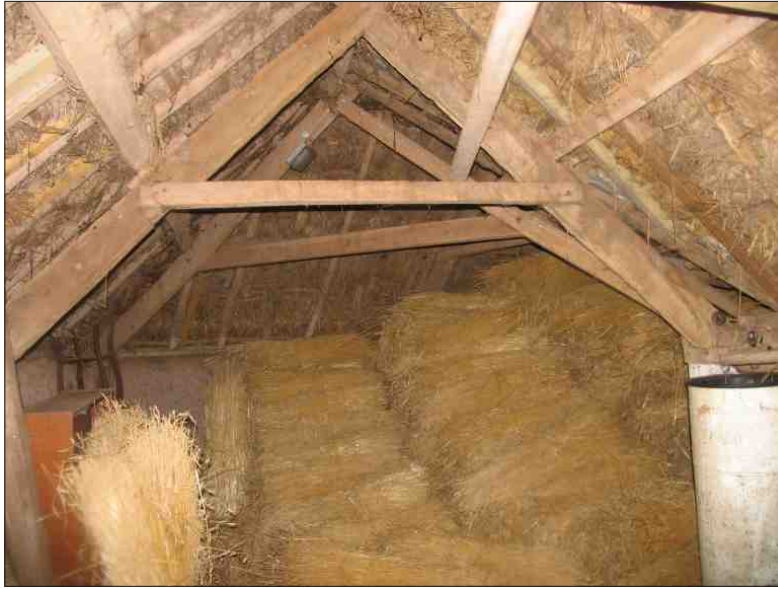
- 5.4** The roof structure over the dairy and room to the northwest is continuous, and is supported on A-frame trusses with lap-jointed apexes, and applied and lap-jointed collars all fixed using pegs and nails (Plates 7 and 8). The trusses are morticed onto the wall plates. There are single rows of slightly trenched purlins on each side. These support secondary rafters attached with pegs. They display a number of larger unused pegholes either indicating that they have been reused, or that the secondary rafters and attached battens (to which the thatch is attached) are historic replacements.

Plate 7: The roof over the dairy, looking south

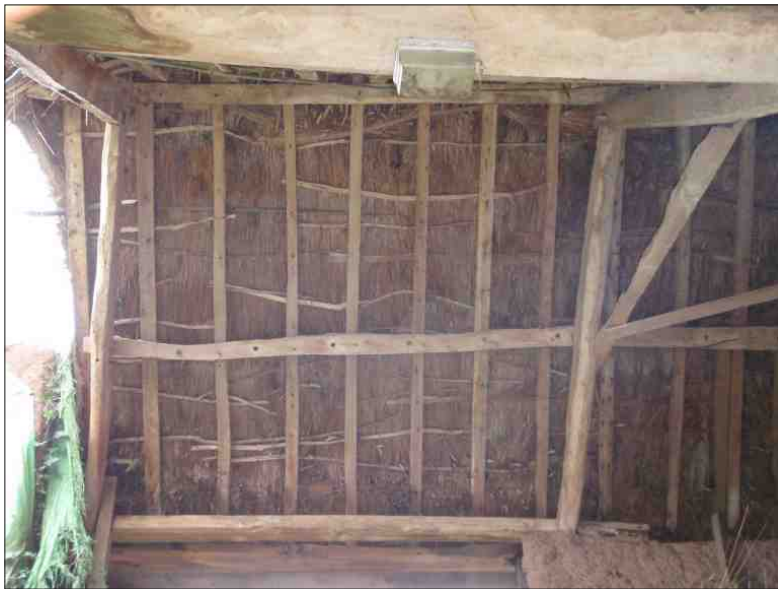
Plate 8: The roof over the dairy, looking north

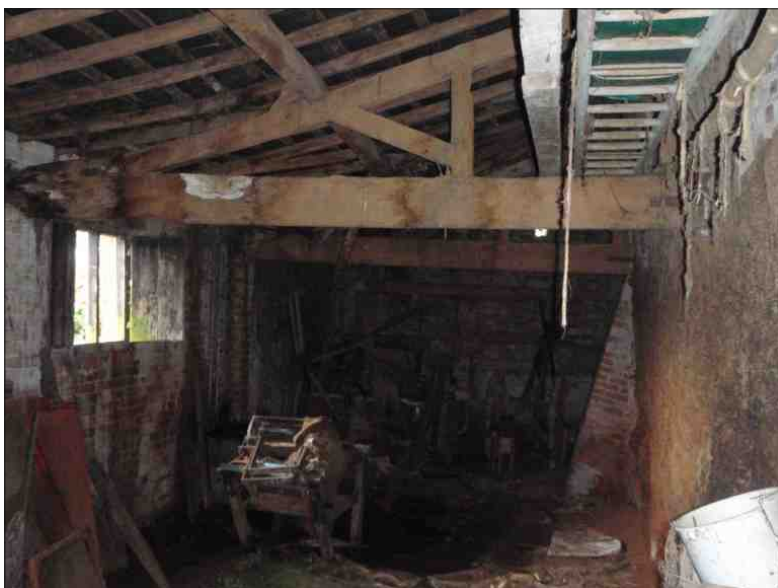
- 5.5** The root house is attached to the east side of the dairy, and is a mid-late 19th-century addition. It is single storeyed, and constructed of red bricks laid in Flemish bond under a sloping corrugated sheet roof. The north elevation incorporates wide double doors, and in the east elevation is a pair of shuttered window openings. All the openings have arched brick heads. Internally, the room has a trampled earth floor (Plate 9). The roof is supported on half trusses with tie beams, king posts and single struts. Back purlins are supported on cleats.

Plate 9: Internal view of the root house, looking south

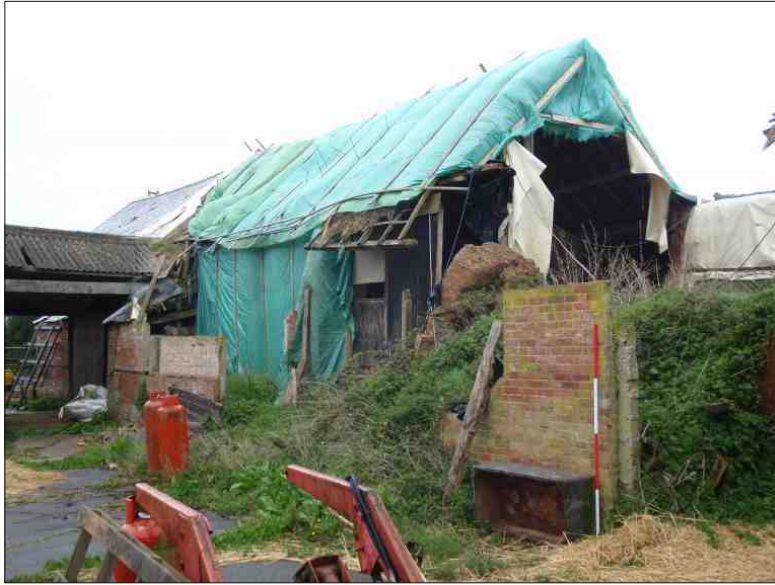
- 5.7** The barn forms the main part of the north range, and is constructed of cob with angular stone and straw inclusions (Plate 10). There is brick underpinning in the northeast corner up to a height of 1.9m with further underpinning of the south wall and the internal partition. The majority of the eastern third of the south wall, along with the east wall and roof structure over, has collapsed. This first section of wall formerly contained two windows. To the west there are opposing openings (in the north and south walls) central to the main threshing barn. In the southern opening the doors have a wooden

Plate 10: The threshing barn, looking northwest (2m scale)

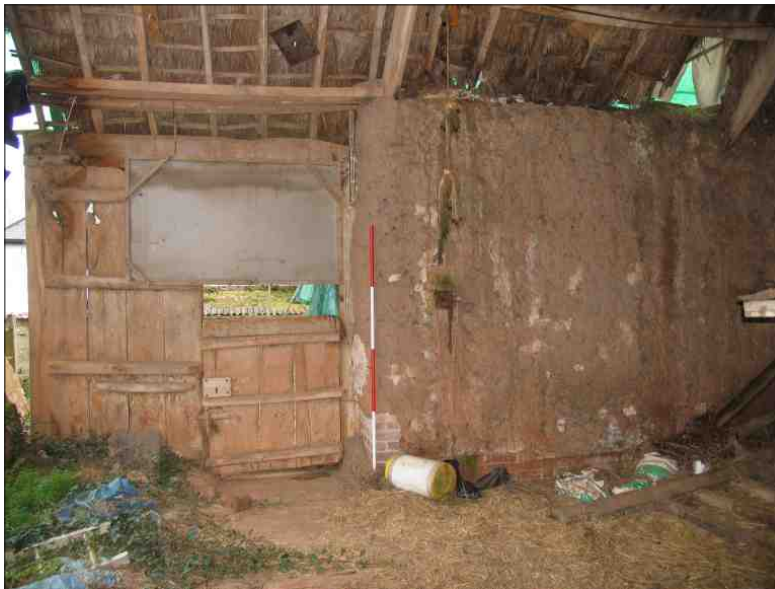
latch and lock case, with the west door cut in two; the upper part is now missing (Plate 11). The north opening is currently doorless. In the western section there are further single windows in the north and south elevations. At the west end is an integral former stable, with a doorway opening (minus the door) onto the yard, and a blocked opening in the west elevation (Plate 12). This has bullnose bricks in the cill and could therefore date to the later 19th century, and has been infilled using brick and cob. The partition wall between the stable and threshing barn is constructed of cob to the eaves level with the remains of a timber screen above. The north wall of the stable was rebuilt in the mid-late 19th century and incorporates a stable doorway along with an internal recess measuring 0.7m wide by 0.12m deep. The loft above the stable is accessed via a loading door in the north elevation of this masonry, and the floor is supported on a single beam and slender joists.

Plate 11: Double doors in the south elevation of the threshing barn, looking south (2m scale)

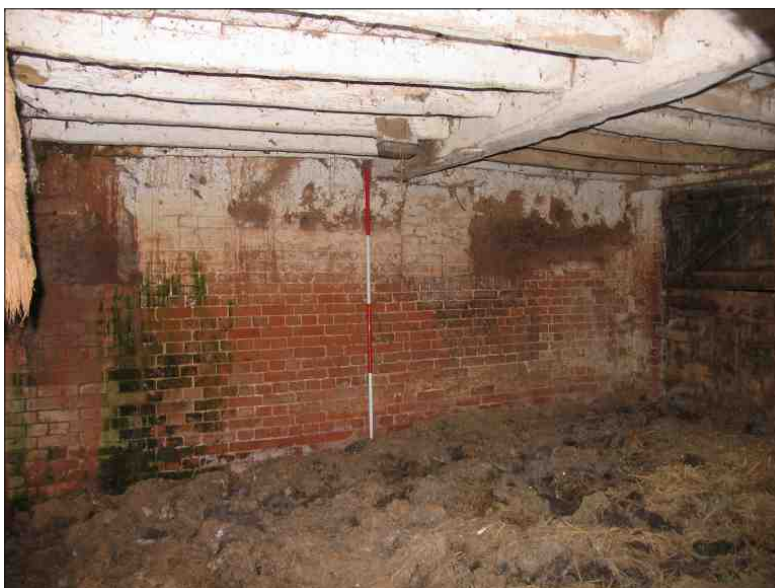
Plate 12: The stable within the threshing barn showing the blocked window in the west elevation, looking west (2m scale)

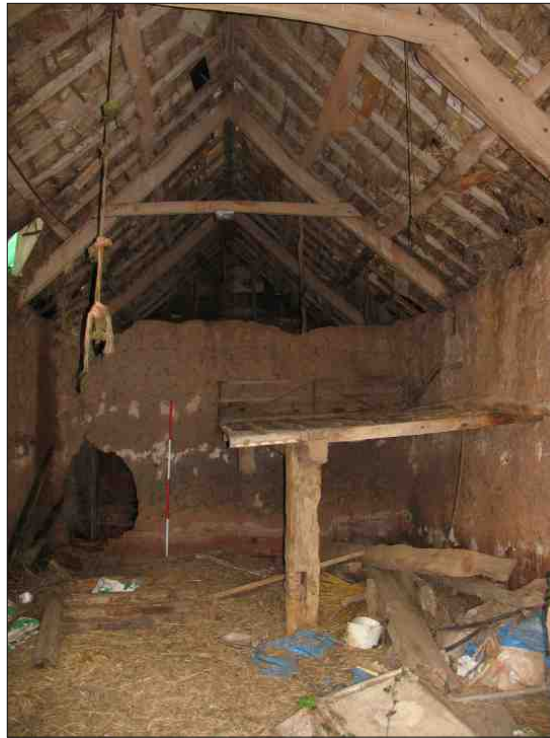
5.8 The floor in the east part of the barn is at a lower level than the central threshing floor but was covered with fallen thatch at the time of the site visit. In the main part of the threshing barn a small area of loft floor survives in the northwest corner (Plate 13). This has been inserted, and is supported on a reset post, possibly reused from the linhay in the 1940s. The roof is supported on nailed A-frame trusses, of which four survive, with applied collars. All the joints, including the lapped apexes, are nailed. They support pairs of back purlins on each side, with ridge pieces set angled between the overlapping ends of the rafters.

Plate 13: Partition wall to the stable and surviving loft floor in the threshing barn, looking west (2m scale)

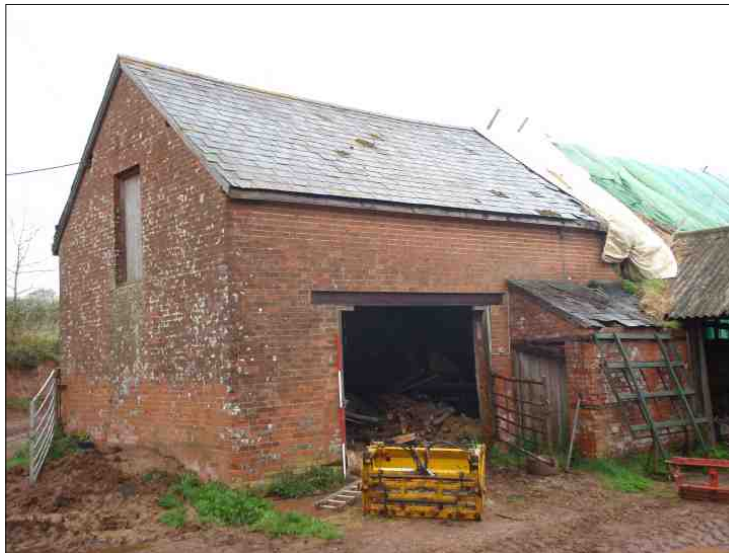
5.9 The barn has been extended on all three sides. The earliest addition is a two-storey stable with attached harness room to the west that dates the mid-late 19th century (Plate 14). It is constructed of brick laid in Flemish bond under a slate-covered roof. This has a wide doorway and a window in the south elevation and a pair of windows in the north elevation. The former has been widened to the west and is now open with the wall above supported on a rolled steel joist. In the west wall is a first-floor loading door with a head of bricks laid in a V-shape. The windows in the north elevation have the same design of head, and are fitted with wooden frames with top-opening casements. Internally the stable has a brick floor. Fittings comprise an iron gate partition along the east wall, and a metal trough against the west wall (Plate 15). There is also a ladder adjacent to the south door providing access to the first-floor loft. The first floor is supported on slender sawn closely-set joists with scissor bracing between. To the north of the threshing barn is a deep open-fronted mid-late 20th-century lean-to structure, with a corrugated sheet west side and weather boarded east side. The open front to the north has wooden posts laid onto concrete bases that support an asbestos sheet roof. To the south of the barn is a pair of mid-late 20th-century brick single storey calf houses. These have partially collapsed and/or been taken down following the collapse of the adjacent threshing barn. They had pitched roofs finished with a corrugated sheet covering.

Plate 14: The mid-late 19th-century stable, looking east (2m scale)

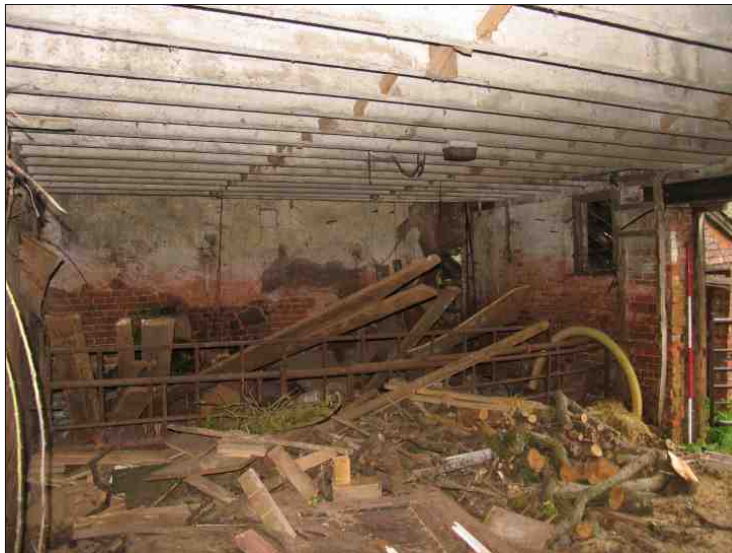
Plate 15: The mid-late 19th-century stable, looking northeast (2m scale)

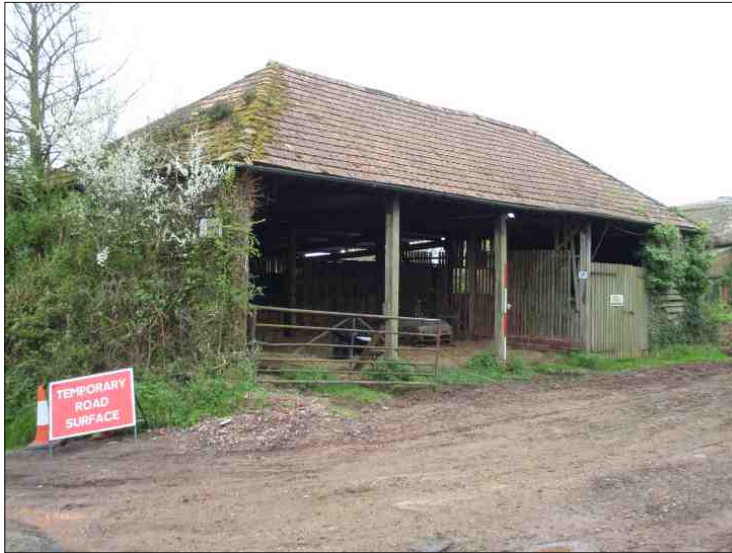
5.10 The shed is a five-bay structure, with the eastern three bays being open on the north side (Plate 16). The two parts of the building are divided by a replacement wooden partition constructed onto a low brick wall with bullnose brick capping. The roof is supported on timber posts. The other elevations are weather boarded laid onto a timber frame constructed on a low brick wall. There are double wooden doors in the enclosed section of the north elevation, and a further double door width, but now doorless, opening in the south elevation of this part of the building. It has a hipped tiled roof supported on king-post trusses with diagonal struts, and with the back purlins supported by cleats. There are additional metal straps holding the ends of the rafters and tie beams together and the king posts to the tie beams.

Plate 16: The wagon shed, looking southwest

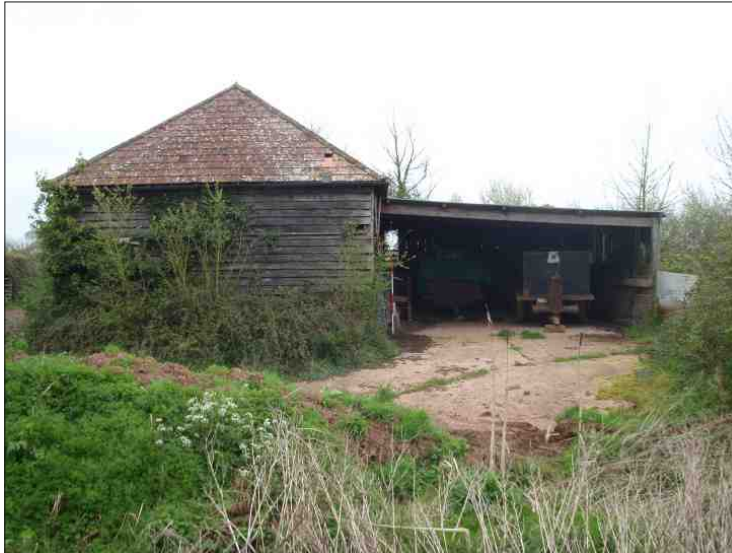
- 5.11** Attached to the south side is a late 20th-century lean-to structure that is open-fronted to the west (Plate 17). The other walls are constructed of concrete blocks with timber cladding above. It has a corrugated sheet roof.

Plate 17: The wagon shed and attached lean-to, looking northeast
