Cold East Cottages, Liverton, Devon.

**Heritage Appraisal.
Impact Assessment of proposed works.**

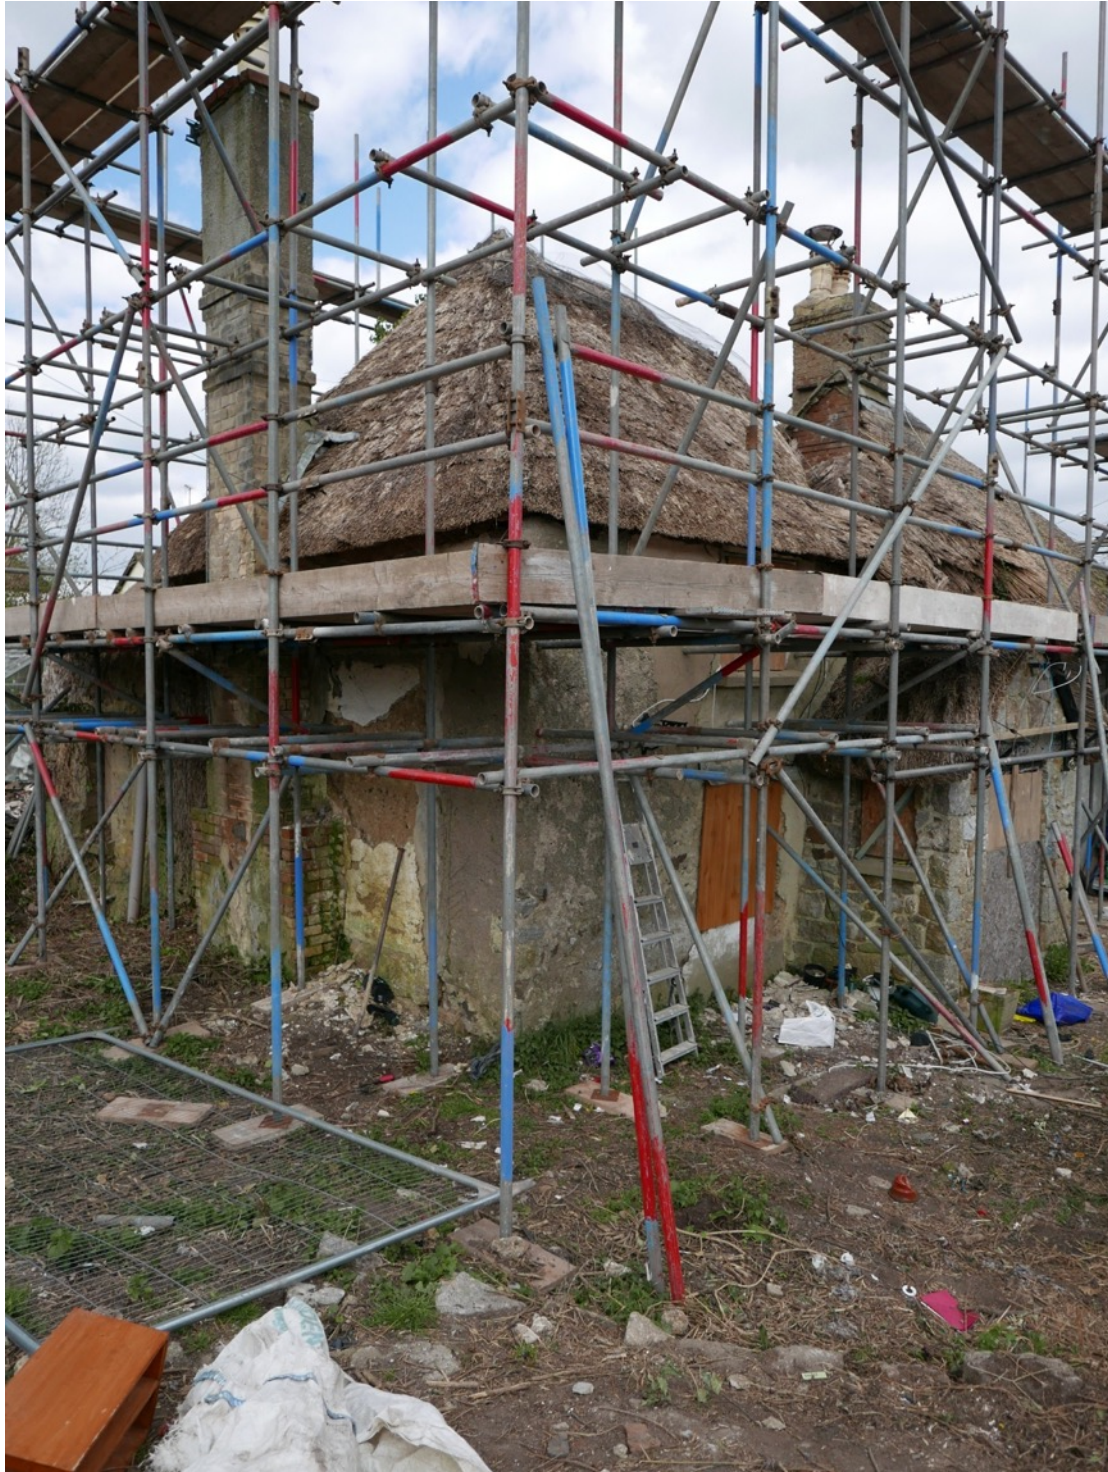
View of cottages from SW with Number 2 in the foreground (before collapse of remainder of south wall and roof).

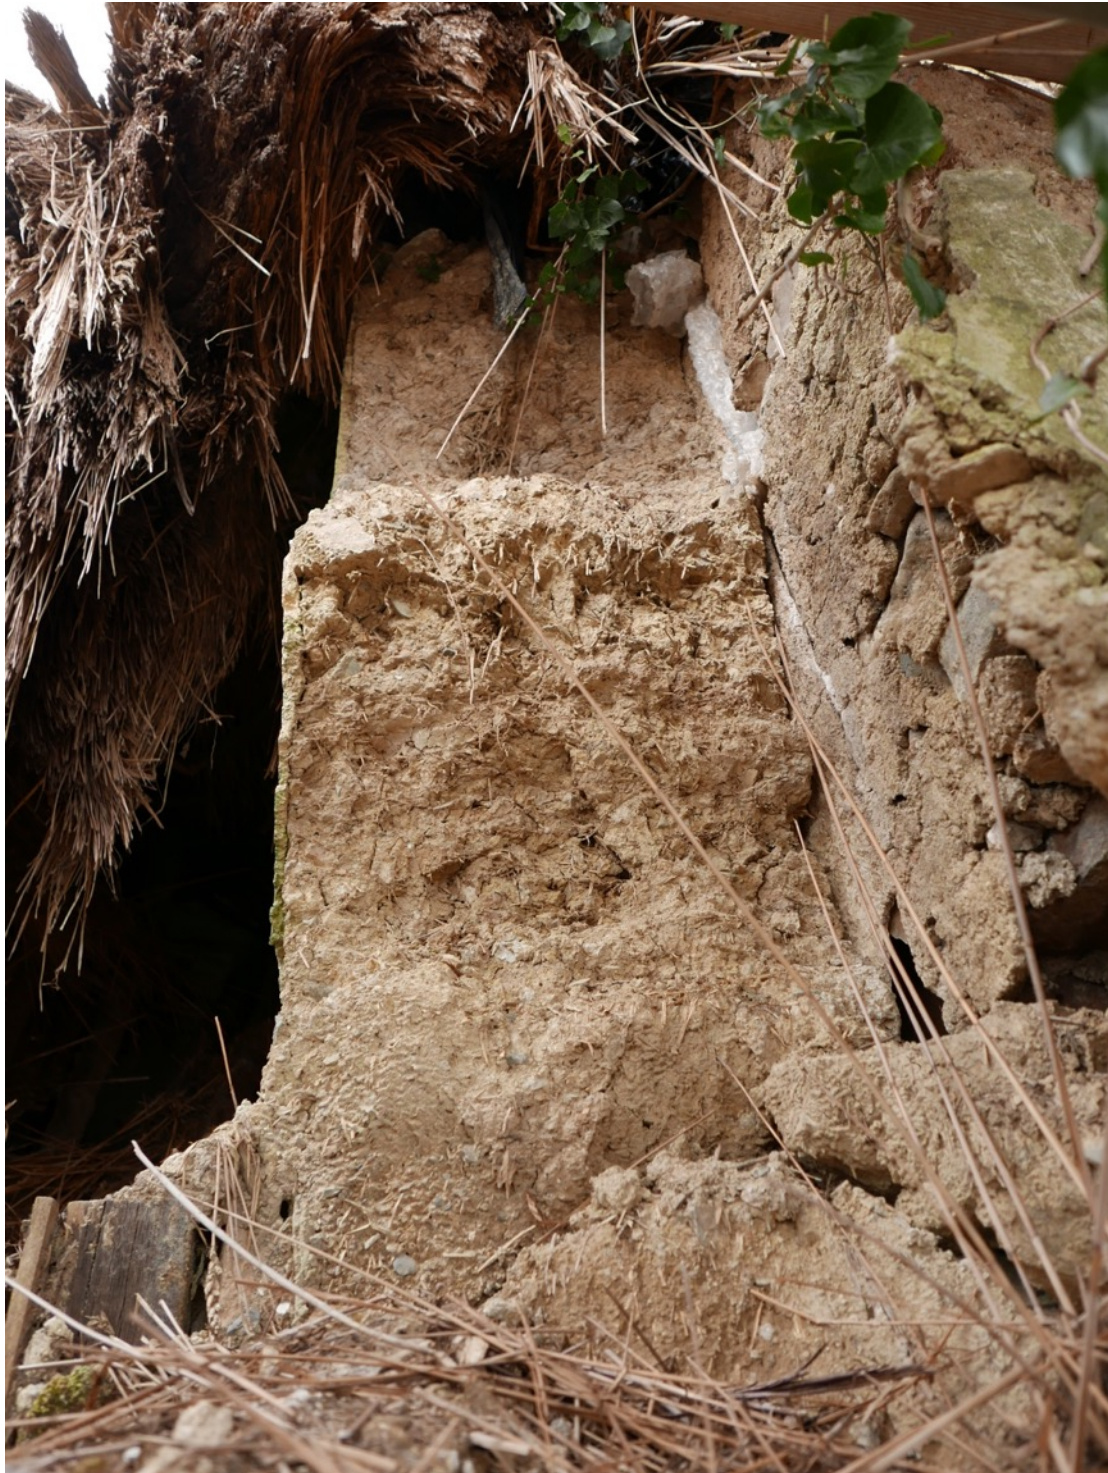
SE corner of cob wall of Number 2 in area of collapse showing how the predominantly stone rubble wall (right) of Number 1 abuts it.

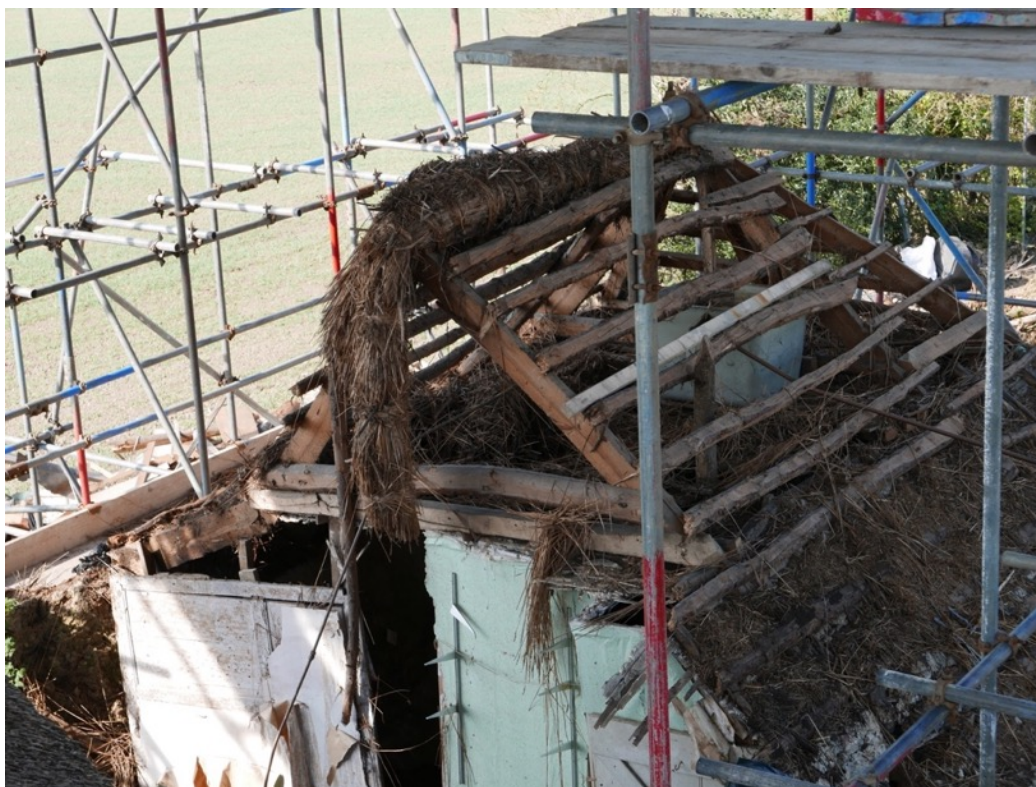
*View of the western part of the roof structure of Number 2 prior to its collapse and removal.
Thatch*

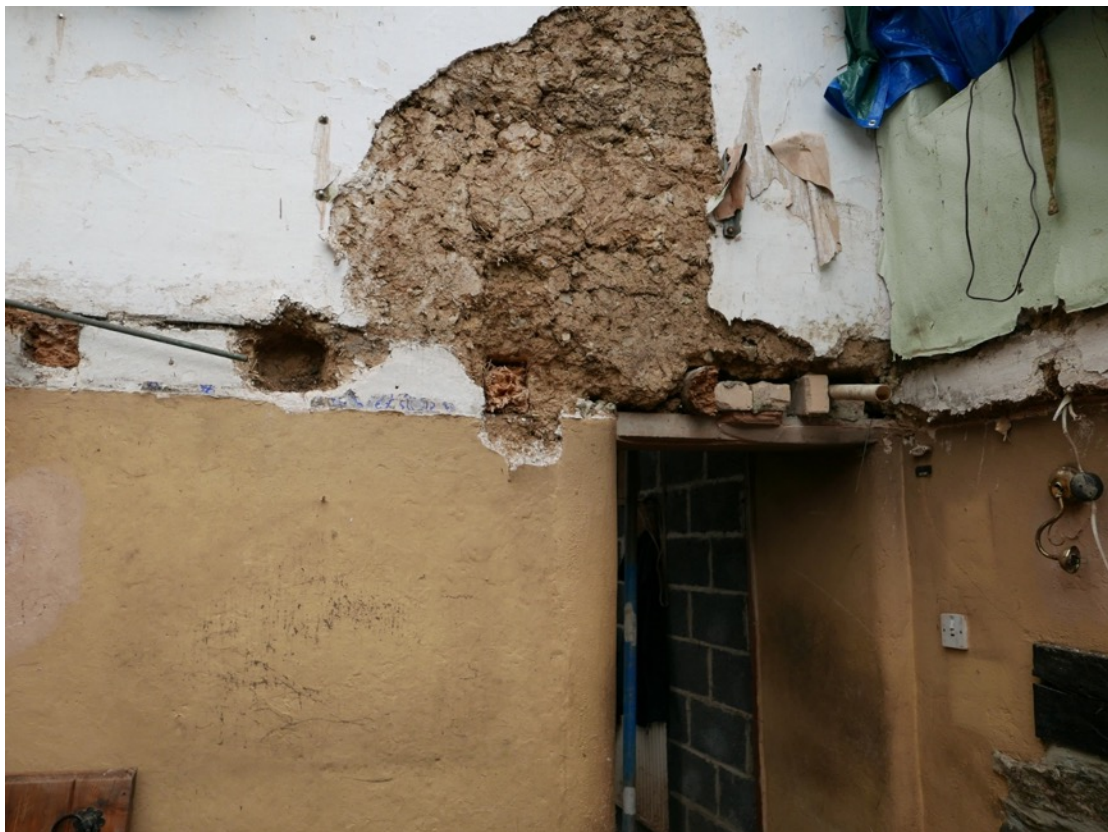
Floor joists are embedded directly into the walls; most had been replaced on Number 2, but the originals that survived were softwood similar to the roof timbers.

View of rotten joist ends, and sockets in north wall of Number 2

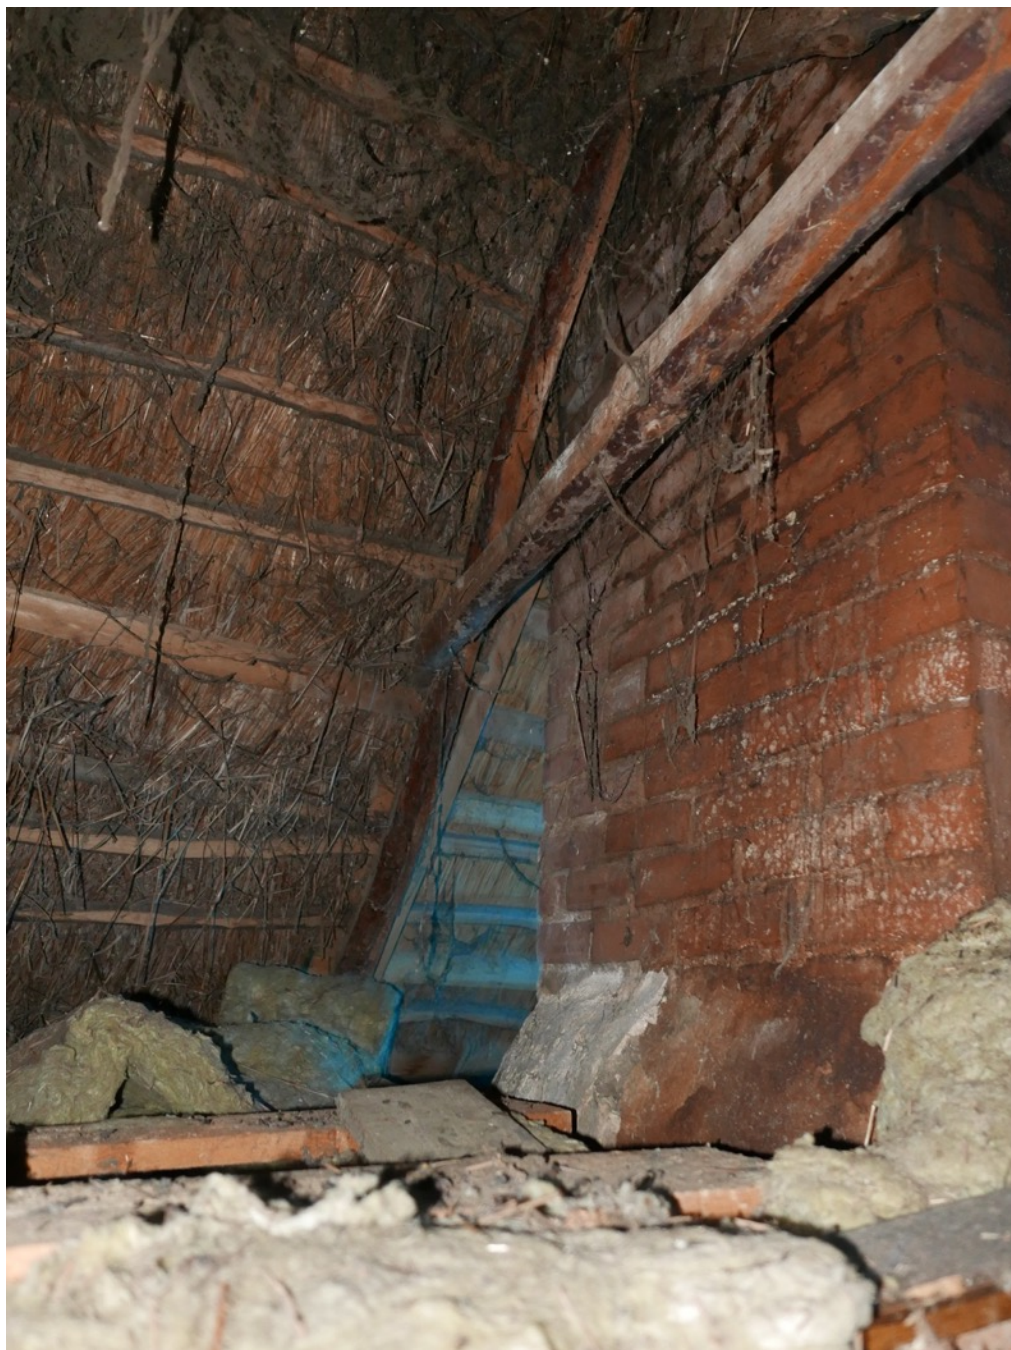
Chimney of Number 1 from within loft space.

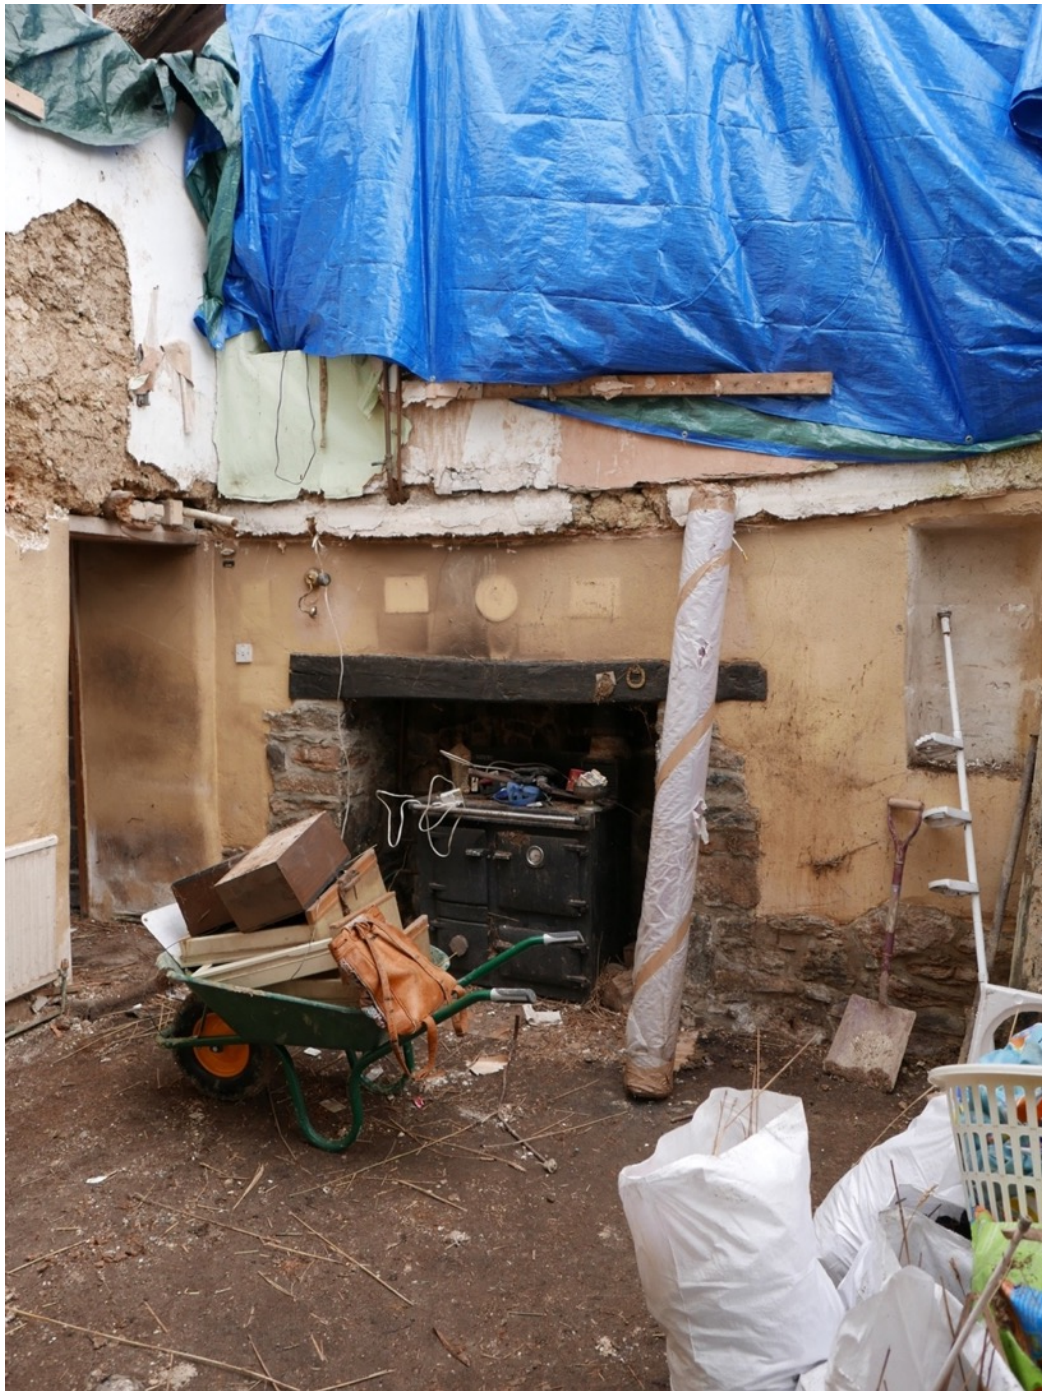
Number 2 has a simple fireplace containing a Rayburn in its east room. Again, there is a simple timber lintel and stone rubble jambs with no early features. A second fireplace in the west room is modern, formed of stone rubble.

Fireplace of Number 2 in party wall.

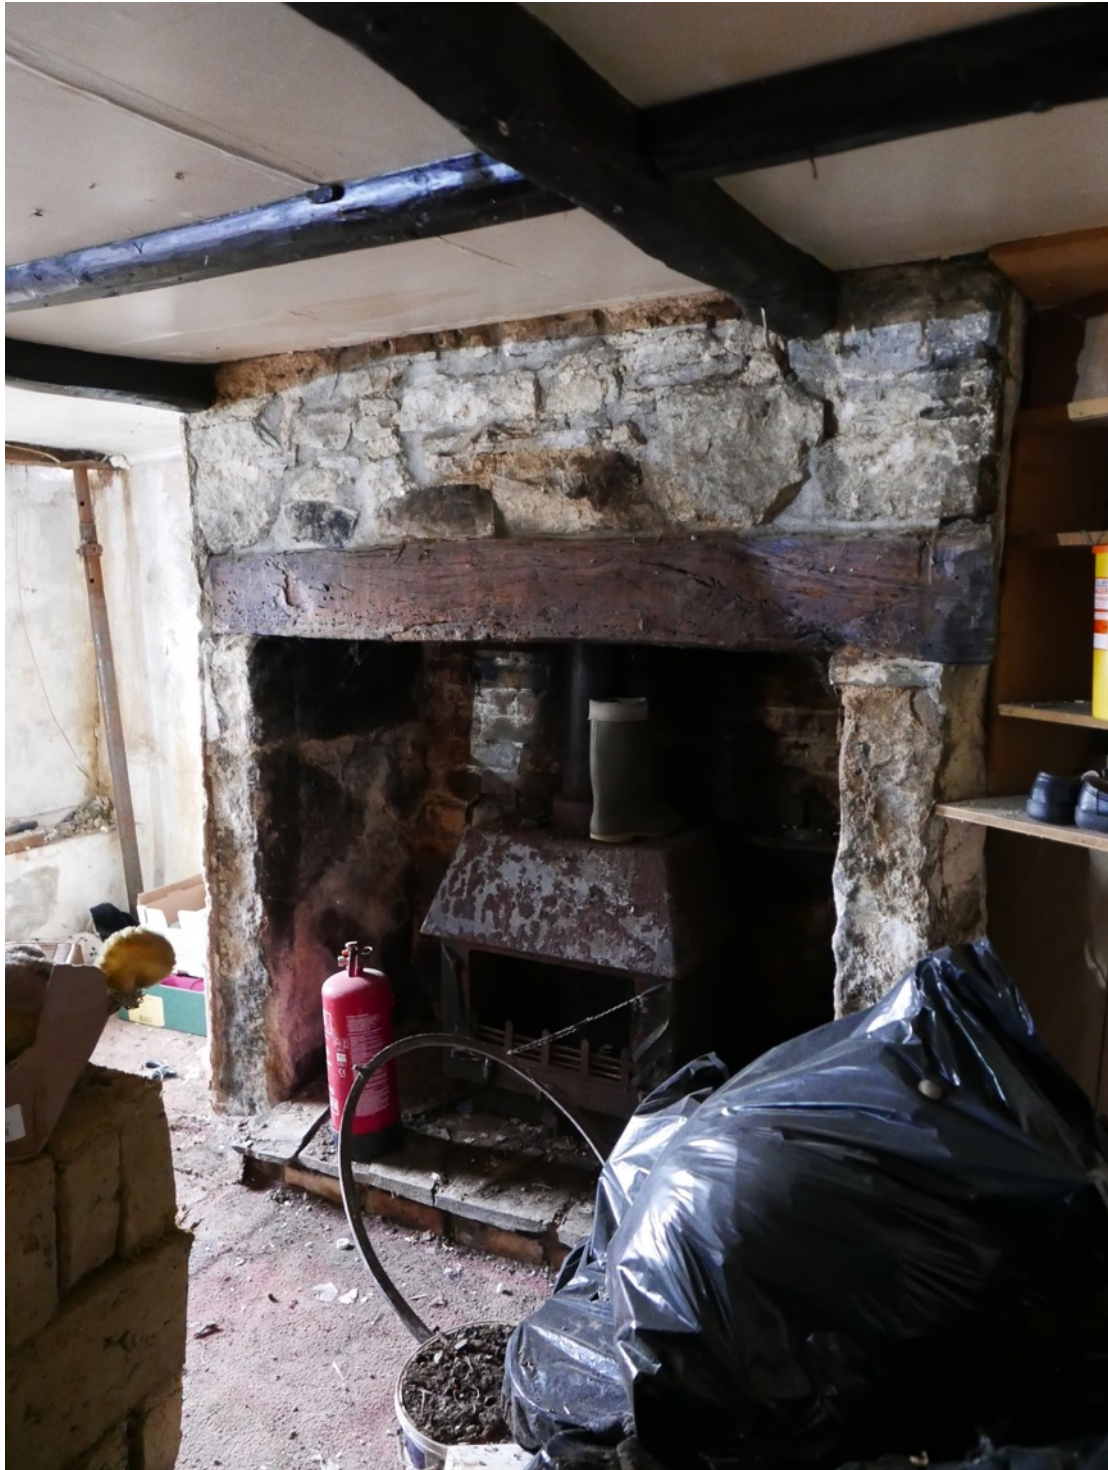
Fireplace of Number 1. Note fake beams and fibreboard on ceiling

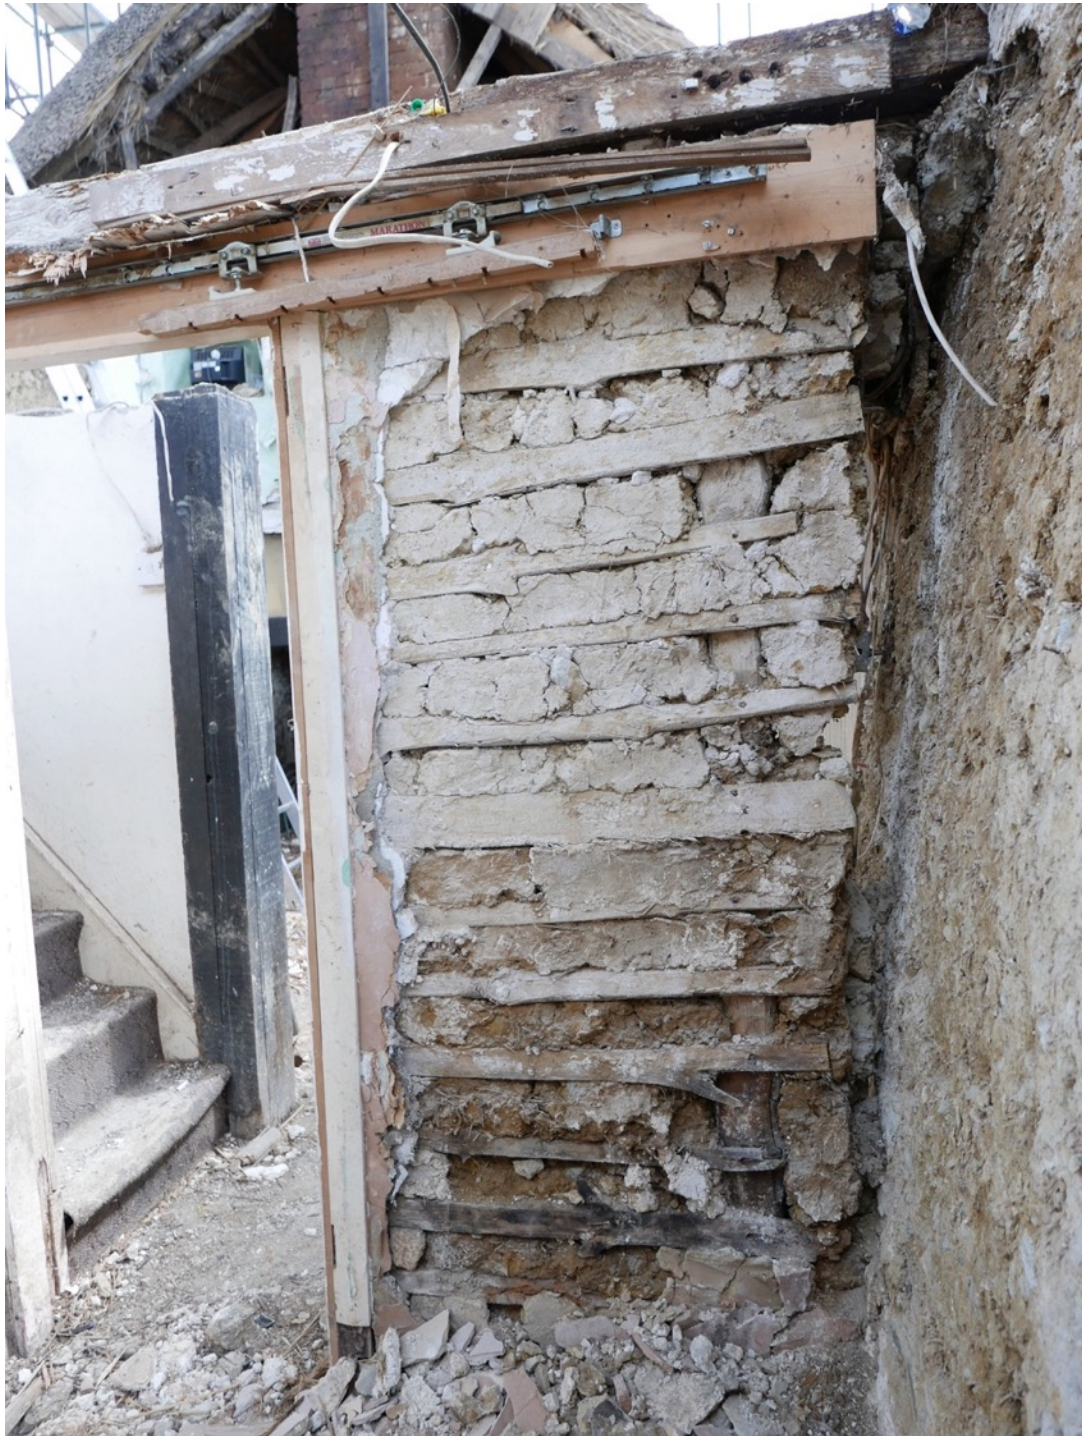
Lath and daub partition wall in Number 2.

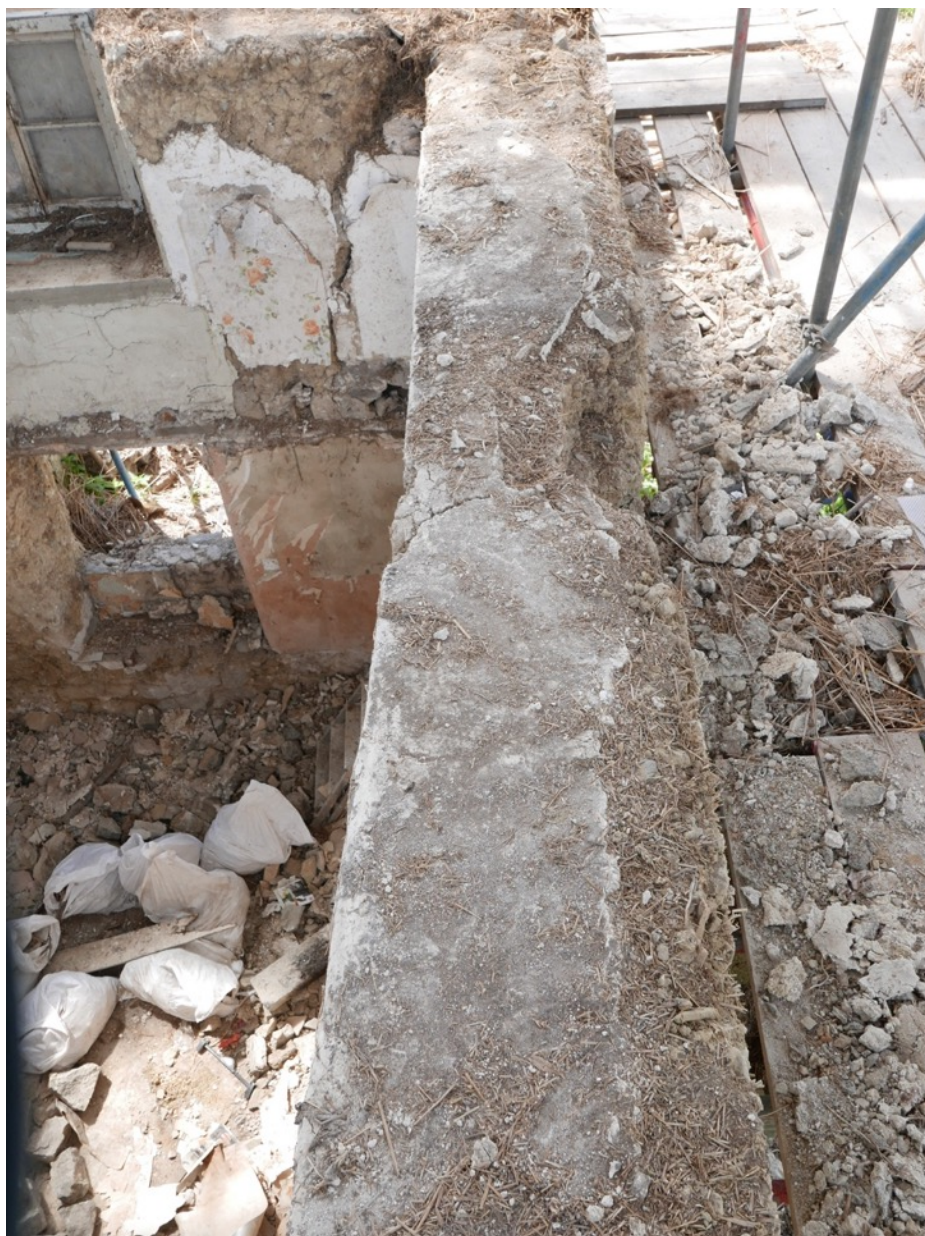
Wall top of Number 2 showing how internal plaster has been returned on to the head.

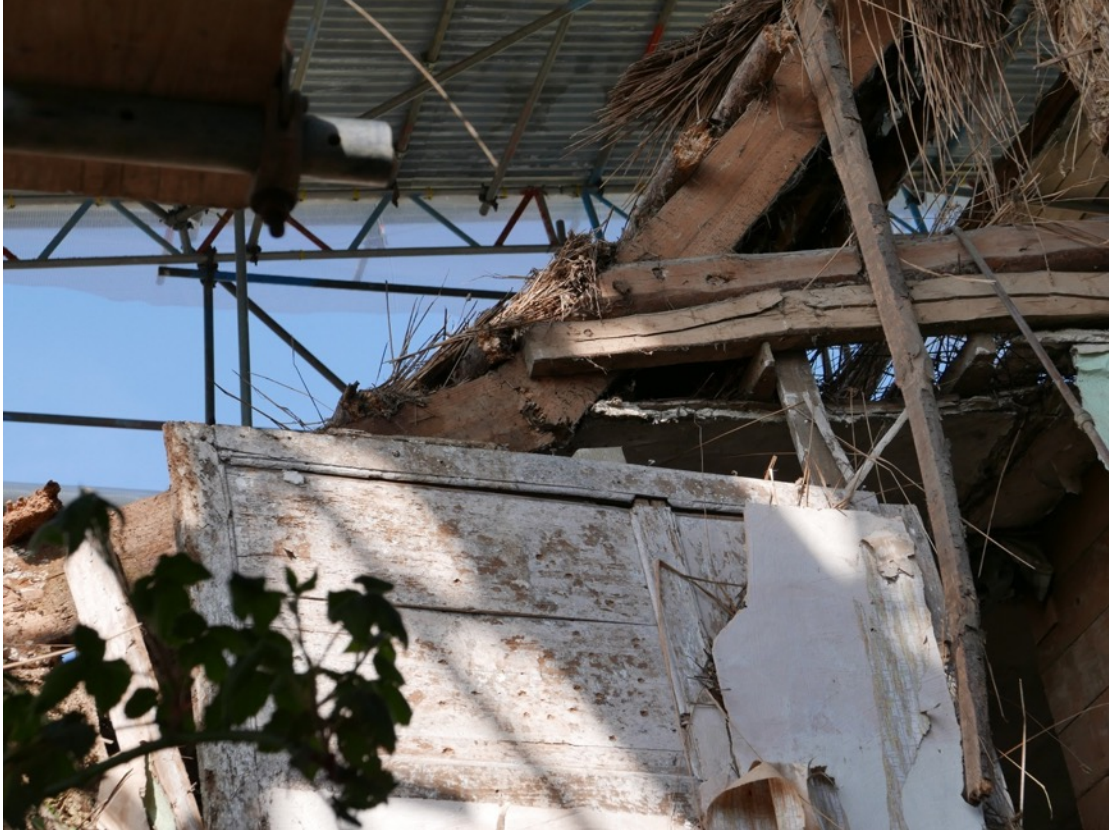
Although the cottages remained inhabited until 2019, they had been neglected and a number of factors contributed to the partial collapse of Number 2 in that year, including water ingress at the juncture between old and new thatch, presence of hard cement render preventing the cob wall of Number 2 from drying out, and the worm-eaten and rotten timbers that did little to hold the structure together.

Fractured principal rafter in roof of Number 2.

1. Reconstruction of south wall of Number 2 in cob block – as far as vertical crack in corner of west gable.
2. Reconstruction of timber roof structure of Number 2.
3. Re-thatching of Number 2.
4. Overcoating thatch of Number 1.
5. Removal of cement render and replacement with lime plaster.
6. Replacement of doors and windows.
7. Reinstatement of timber floor structure of Number 2.
8. Reinstatement of internal partitions and ceilings of Number 2 in lath and lime plaster.
9. Introduction of new, standing seam zinc roof on outshot and rear wing.
10. Removal of east wall of rear wing to create usable entrance porch.
