The Linhay, Sandridge Barton, Stoke Gabriel.

Level 2 Historic Building Recording

NW Conservation Report No.	210101
Site Name:	The Linhay, Sandridge Barton, Stoke Gabriel
Post Code	TQ9 6RL
District:	South Hams
County:	Devon
Grid ref:	SX 86180 56519
Date:	January 2021
Planning Consent reference:	2979/20/LBC
OASIS ID:	nwconser1-413947
Prepared by:	Nils White and Sophie Mcilwaine

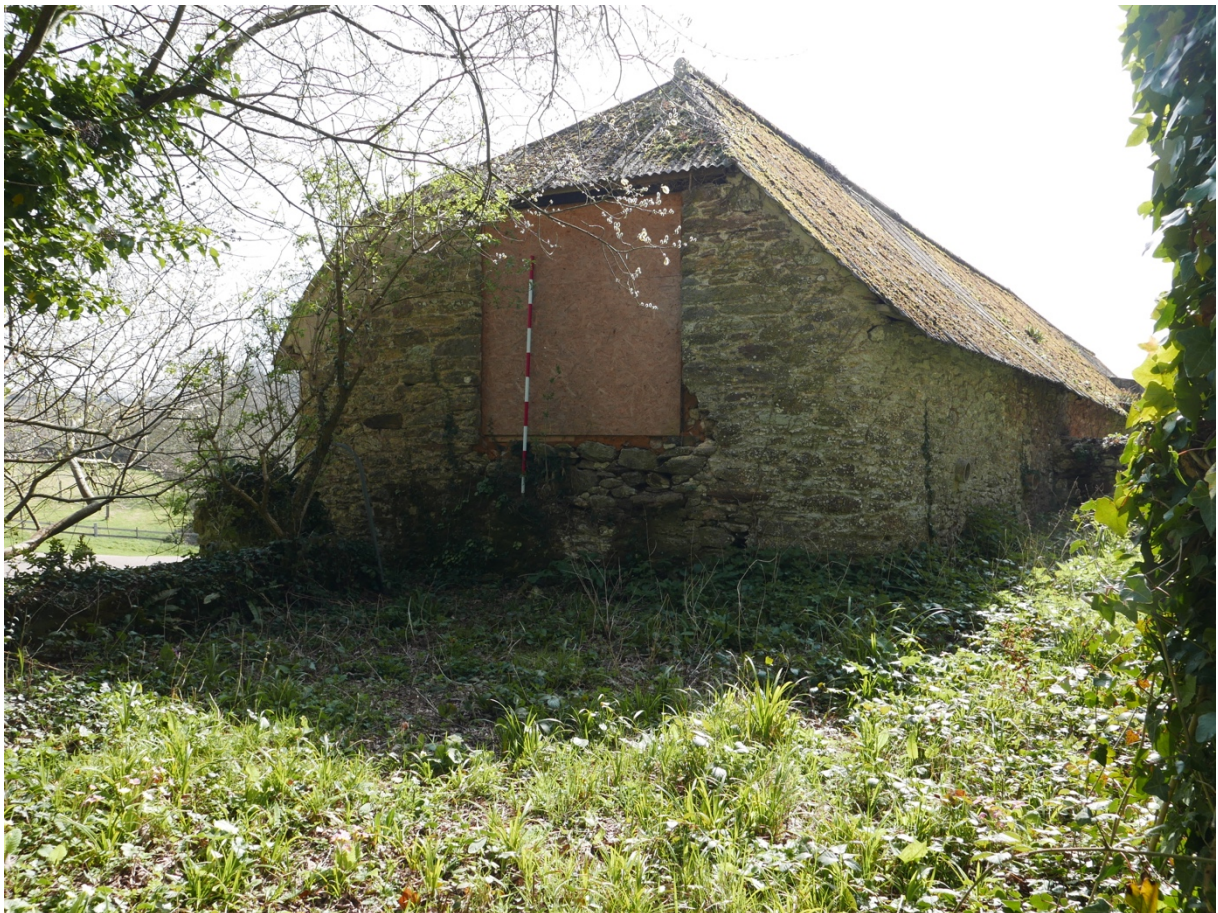
Plate 2. Sandridge Barton Linhay. North elevation.

The north elevation is built of rubblestone, with a half-hipped roof and a pitching door at upper floor level (Plate 2). The east corner is a continuation of the round pillar at the far end of the east elevation, and the west corner forms a shallower curve. Steep stone steps run alongside the wall from the yard at the north west corner, following the slope of the land (Plate 3). These appear contemporary with the original structure. A modern metal balustrade is held at the lower end by a hand-forged iron ring (Plate 4), which matches another on the east elevation.

A large opening at first floor height provided access to the hayloft. This has a modern timber lintel at eaves height; stonework at sill level has been damaged, and polyurethane foam inserted here and along the jambs. The opening is now boarded with OSB. A large projecting slate in the wall below presumably acted as a step to access the opening.

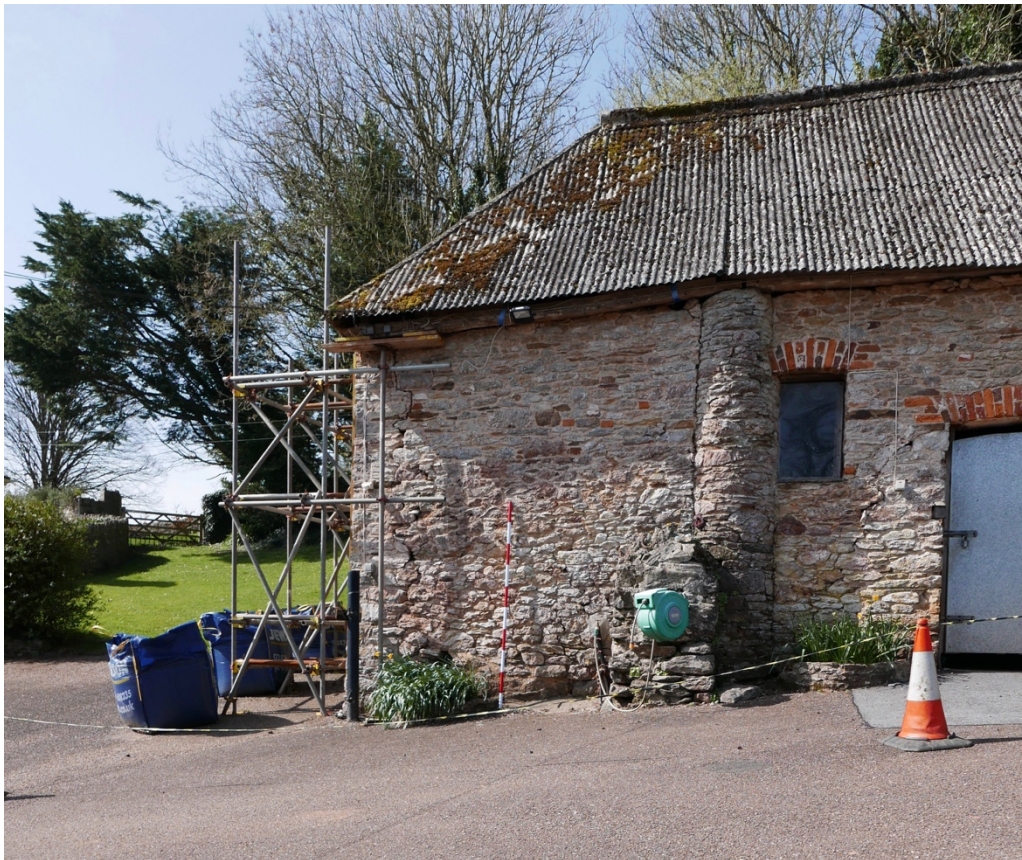
Plate 7. East elevation, Bay 1.

Unlike the rounded corresponding north east pillar, the south east corner forms a 90-degree angle (Plate 7). There is a small section of original stonework at the far south end which presumably formed a pier. The joint between this and the Phase 2 infill stonework is evident as an uneven crack in the stonework running approximately vertically for the full height of the wall. Some red bricks are present in the top third of the infill section of wall. A stone projection at the northern end of this bay appears to have been part of a gatepost. It is not tied in to the stonework from either phase.

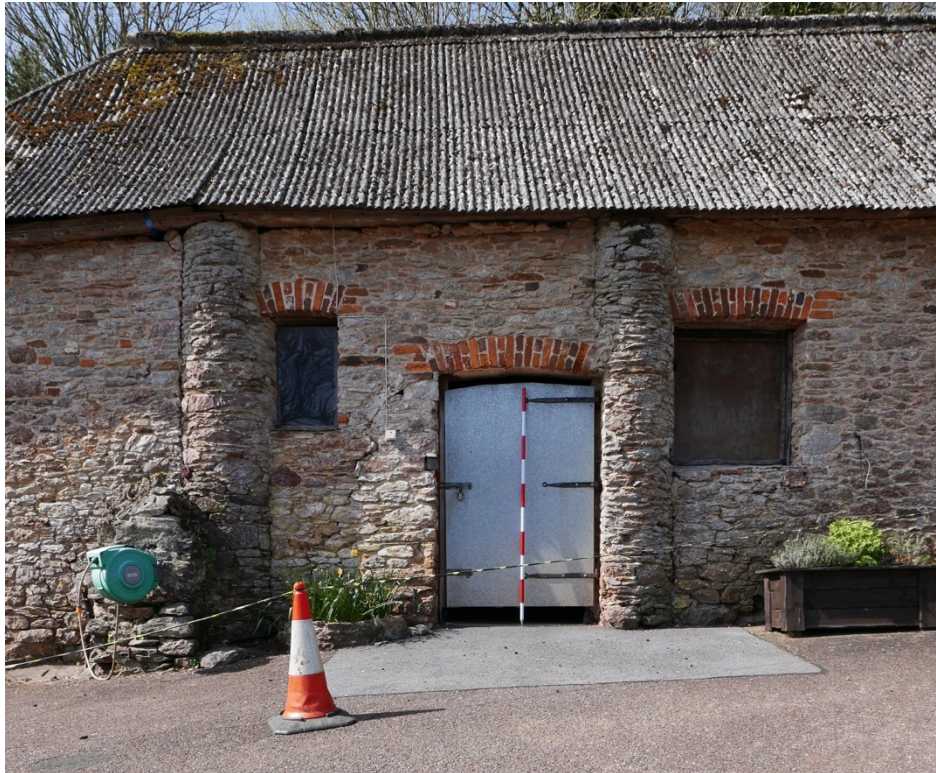
Plate 8. East elevation, Bay 2.

The second bay from the south (Plate 8) contains a doorway and a high window opening. Together with the window in the next bay, these create a roughly symmetrical arrangement commonly seen in 19th century stables. The wide doorway cuts slightly in to the pier at the northern end of the bay forming a rebate. The Phase 2 door has been replaced with a modern metal door, but hand-forged iron strap hinges remain (Plate 9). Flat arches of soft red brick form the external lintels of both the door and the window, with timber lintels behind. The bricks appear to be 18th or early 19th century in date. The window has a fixed softwood frame with modern acrylic glazing and slate sill.

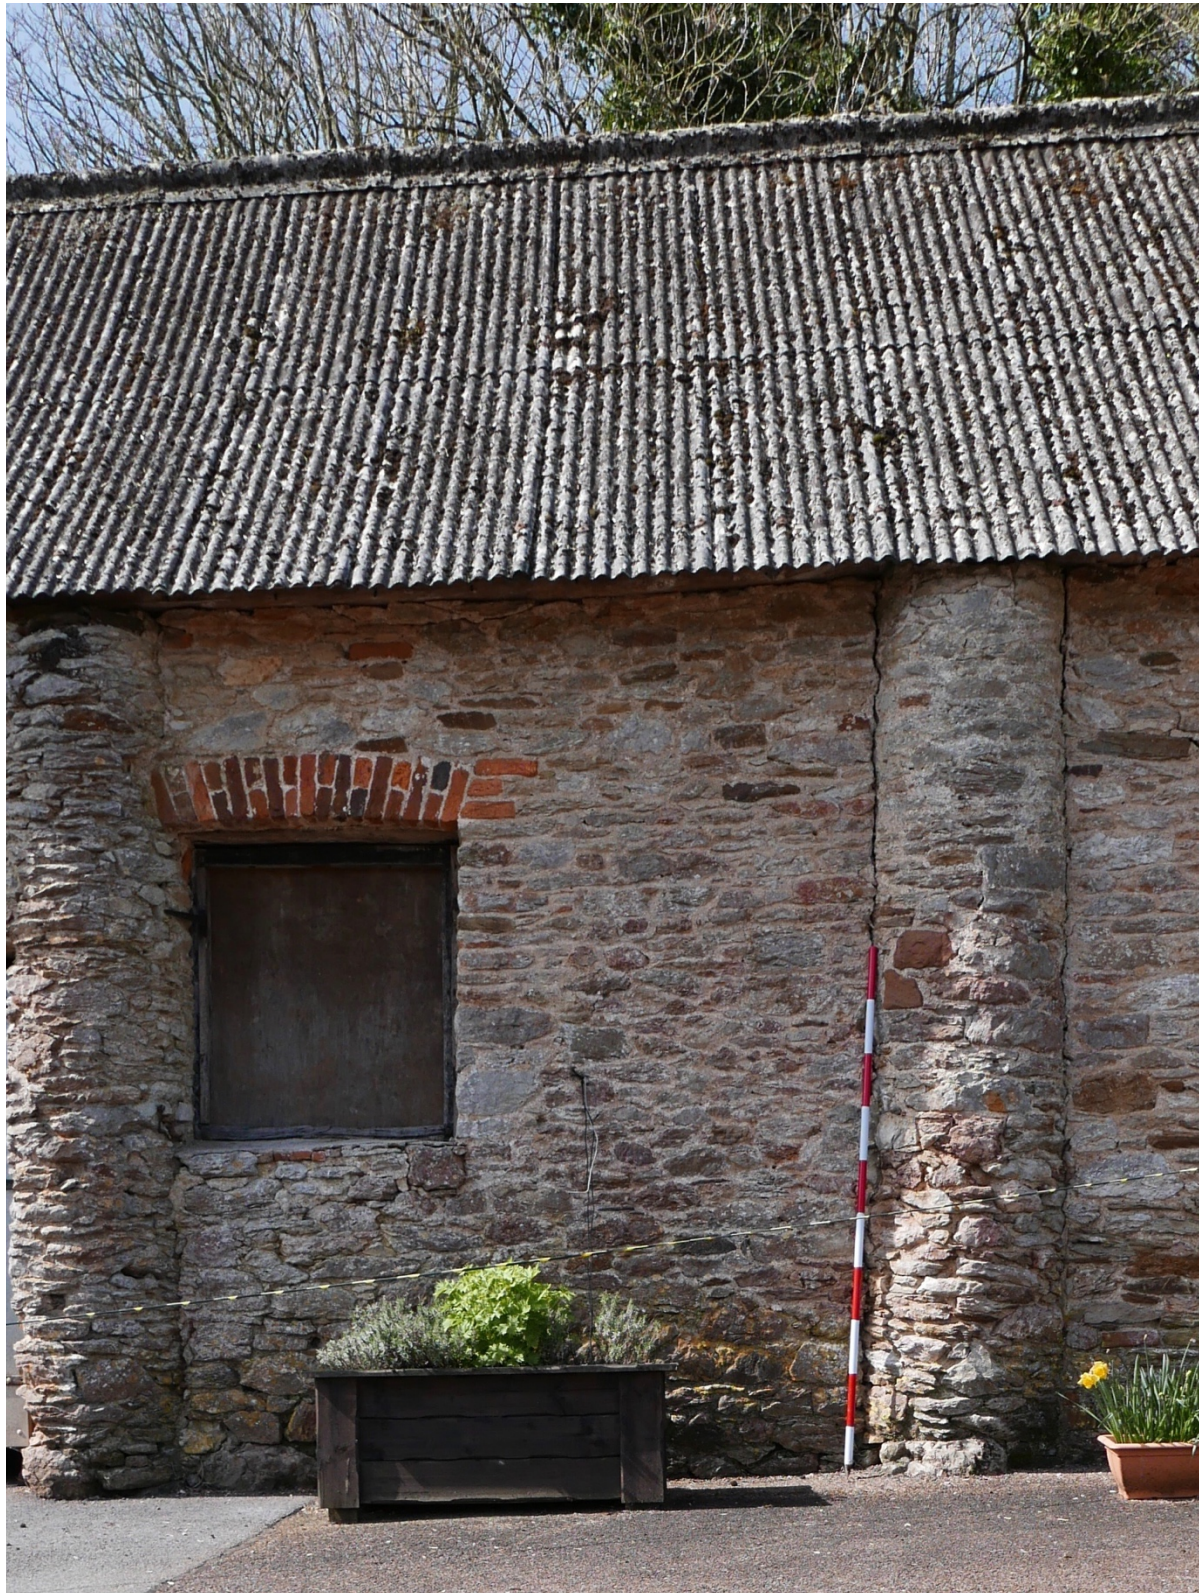
Plate 10. East elevation, Bay 3.

Bay 3 (Plate 10) has a slightly larger window opening with a similar red brick arch, although the sill has been infilled with cement (Plate 11). The timber frame appears to be original to Phase 2. It contains a mortice in the centre of the top and bottom rails (suggesting two lights divided by a mullion), remains of metal stanchions on either side of this, and a pintle suggesting the presence of shutters (Plate 12). There are wooden pegs at the corners. A later inserted timber on the left side contains an industrial strap hinge. The window is boarded up. A small iron ring is set into a patch of concrete mortar at the joint between the infill stonework and the pier to the north.

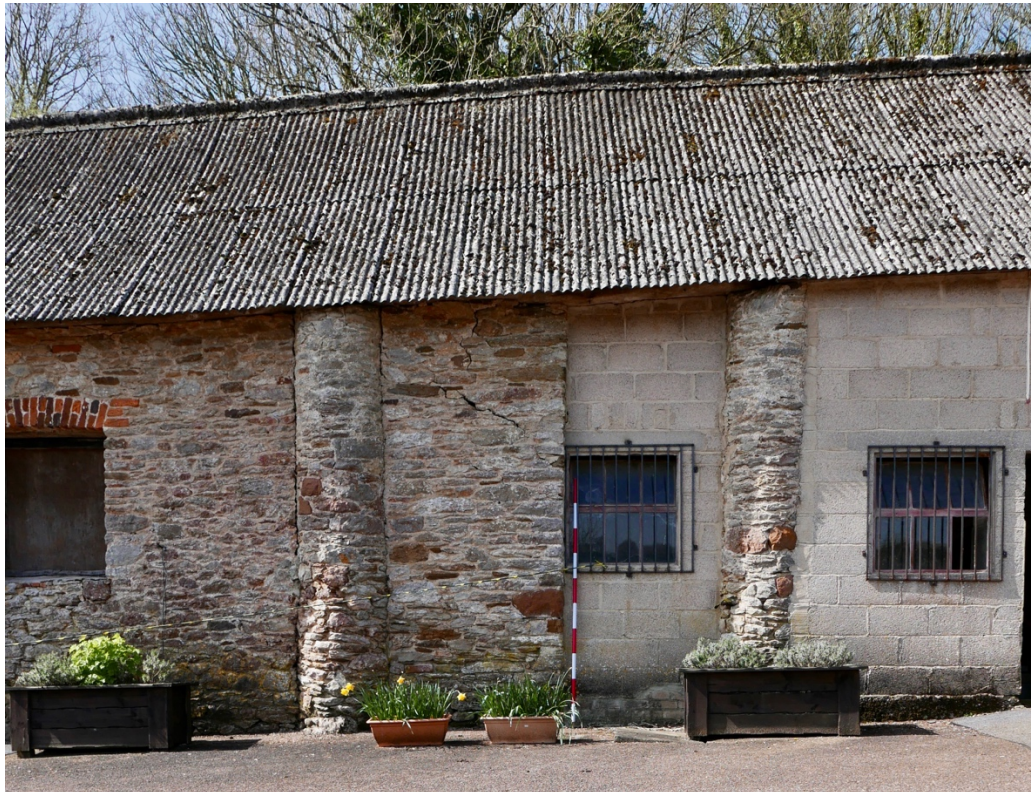
Plate 13. East elevation, Bay 4.

In Bay 4 (Plate 13), the Phase 2 stonework extends halfway along the bay, its end corresponding with the location of the internal dividing wall. The infill beyond this to the north is set back slightly and made of dense concrete blocks with cement mortar (Phase 3). There are two to three courses of red brick at the base of the wall, which extend to meet the concrete slab of the higher internal floor level to the north. There is a six-light galvanised steel window with a concrete lintel. The top three lights form a bottom-hung, inward-opening casement and the lower three lights are fixed. An external grille of vertical iron bars is bolted to the surrounding concrete. A hand-forged iron ring (matching that supporting the handrail of the stair along the north elevation) is set in the mortar of the Phase 1 stonework of the pier to the north of this bay.

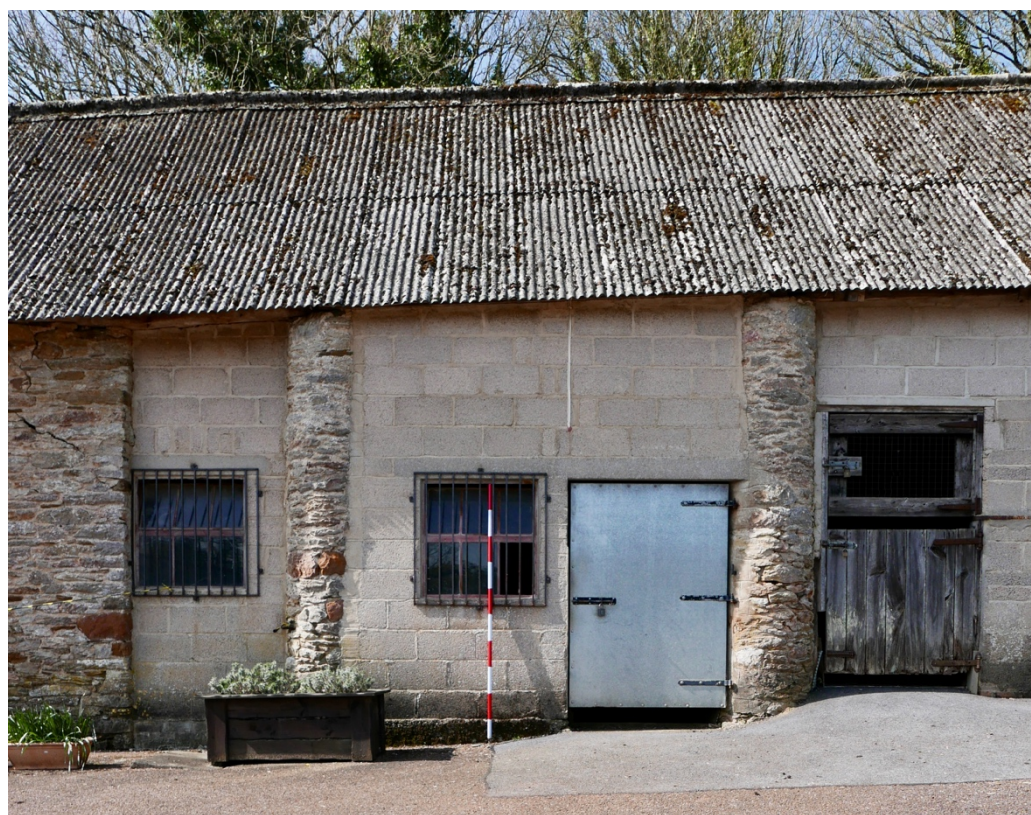
Plate 14. East elevation, Bay 5.

In Bay 5 (Plate 14), the concrete block infill is set further forward than that of the two bays either side. It contains a wide doorway with a concrete lintel and mid-20th century industrial hinges now fixed to a replacement metal door. A six-light metal window to the left is identical to that in Bay 4, but has a glazing pane missing.

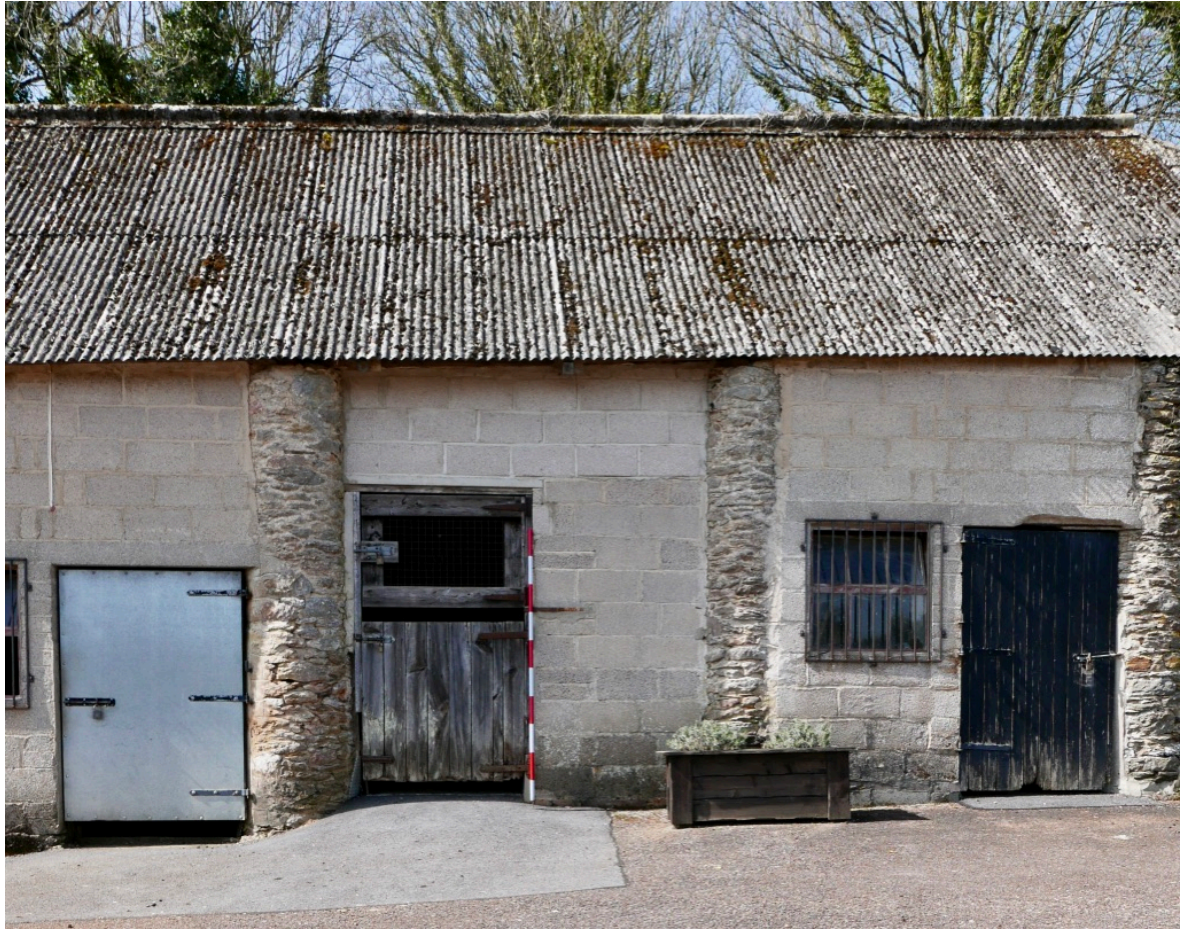
Plate 15. East elevation, Bay 6.

The wall of Bay 6 (Plate 15) is also built of concrete blocks. The top three courses appear to have been replaced later, as the blocks have a more uniform appearance and there is a distinct horizontal joint with the masonry below. A stable door at the south end of the bay appears to have been inserted into the blockwork, as the blocks are irregularly cut back and some parts are patched up with cement. There is a concrete lintel and a timber door frame, with an iron tie into the blockwork at the north (hinge) side. The lower leaf is a wooden plank door, and the upper leaf has a central metal grille. Both hinges are 20th-century industrial metal strap hinges, though the lower hinges are slightly more elaborately moulded. There is a small iron hook inserted into the concrete mortar joining the infill and the pier to the north. A single course of red bricks is just visible at the base of the wall.

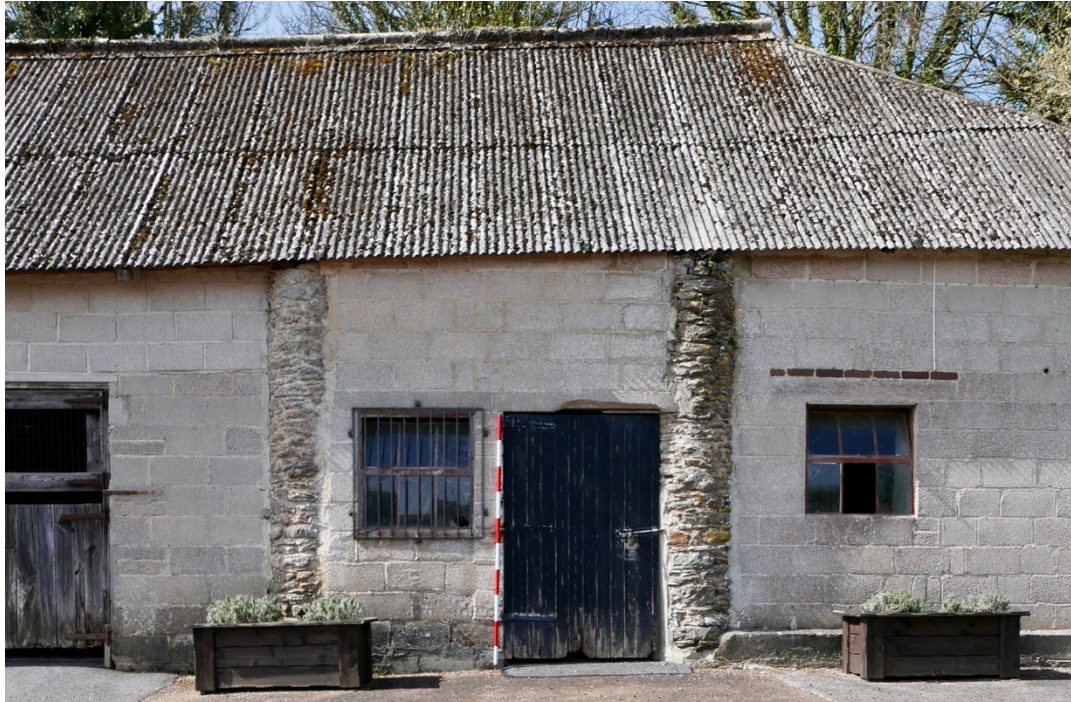
Plate 16. East elevation, Bay 7.

Bay 7 (Plate 16) is built of concrete blockwork, with a wide doorway and a metal window identical to those in Bays 4 and 5. The door is a mid-20th century vertical plank door with industrial metal strap hinges, and appears to be contemporary with the surrounding blockwork. The concrete lintel has been damaged, exposing the iron reinforcement bars.

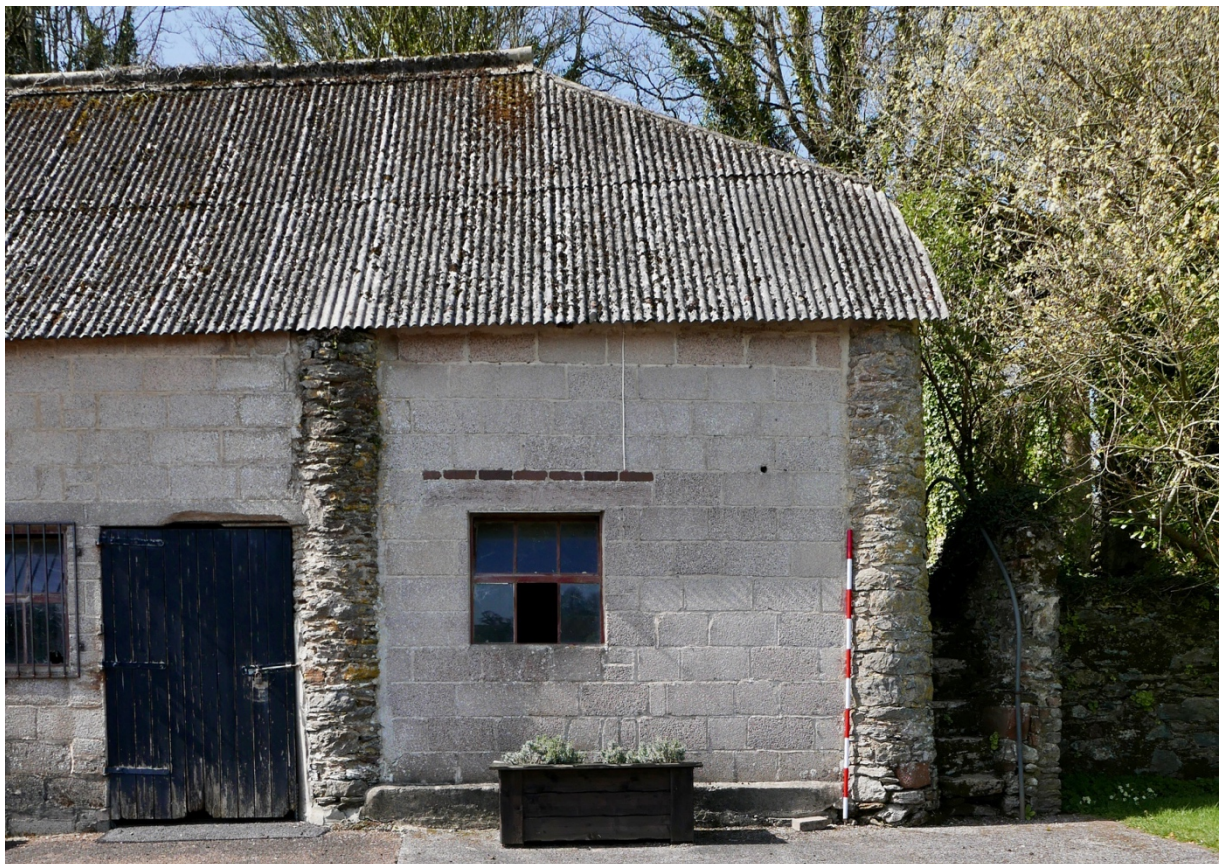
Plate 17. East elevation, Bay 8 and steps.

Bay 8 (Plate 17) is also built of Phase 3 blockwork and contains another 6-light metal window, with the central lower pane missing. There is a deep concrete lintel above, topped by a single

course of red bricks. The concrete ground slab projects slightly beyond the wall, forming a plinth.

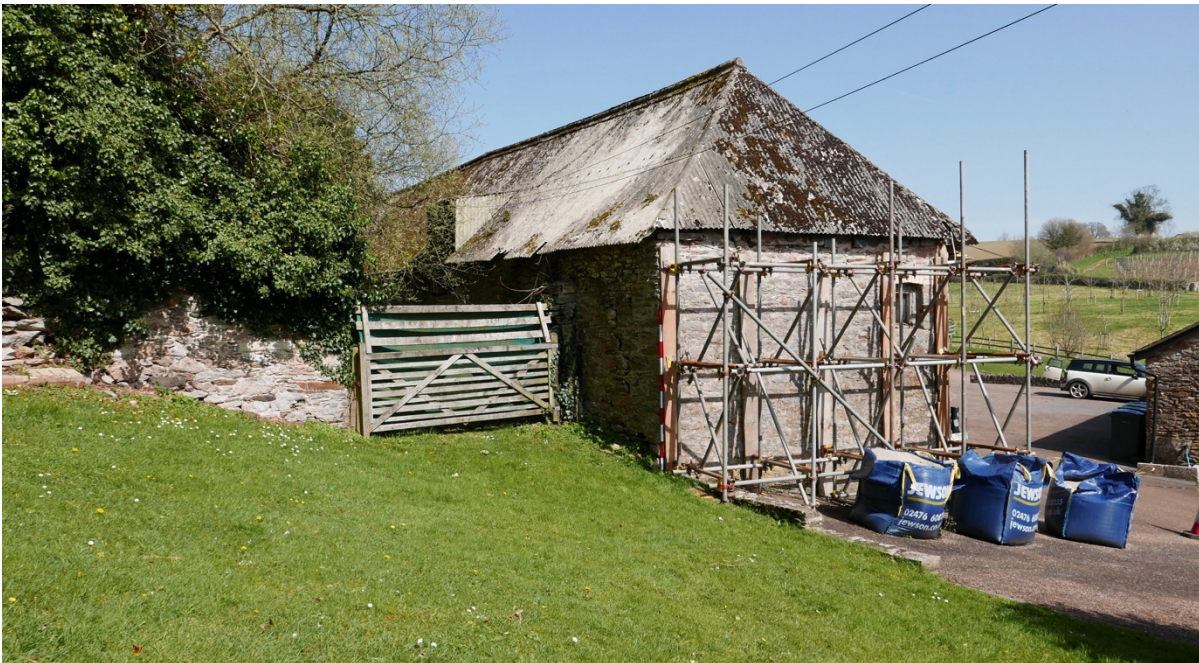
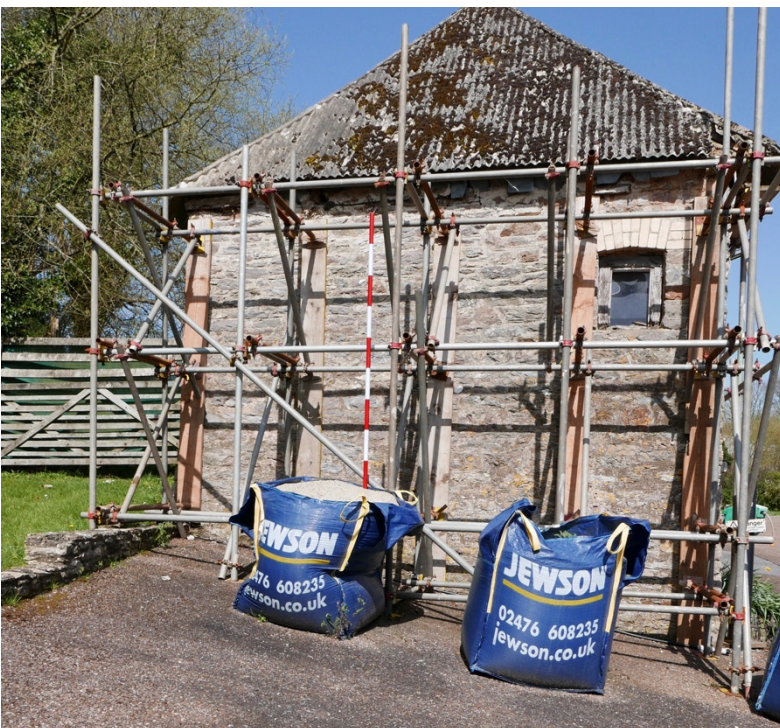
The South elevation (Plates 18,19) is built of local random rubblestone. The stonework is assumed to belong to Phase 1, with additional cement pointing added later.

A small window in the top right corner of the wall has a fixed timber frame held together with iron pins. Its lintel is a flat arch made of modern buff-coloured bricks. The end of a broad, flat timber beam projects from the stonework at high level, surrounded by earth and cement mortar. It does not appear to correspond with any of the internal beams so may be part of an earlier floor structure. A line of roofing slates of various shapes hangs from beneath the eaves, some of which are damaged or missing (Plate 20): presumably a later addition to compensate for the insufficient eaves depth and minimise further water ingress from driving rain.

Plate 18. South elevation viewed from SW.

Plate 19. South elevation.

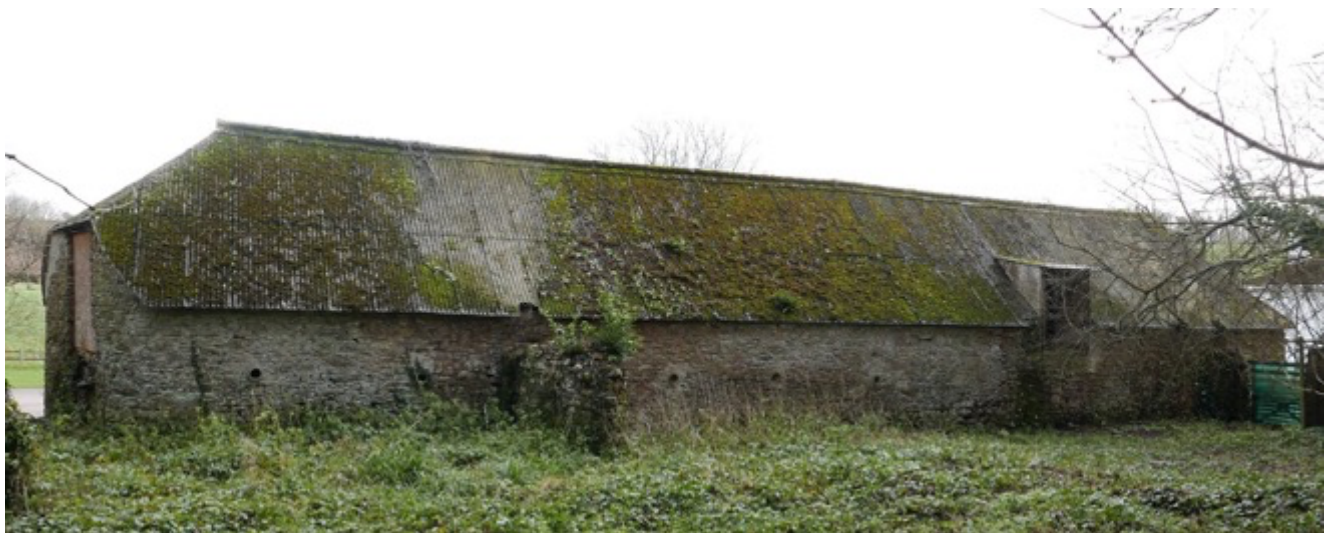
Plate 21. West elevation.

The west elevation (Plate 21) is built of local random rubblestone with mainly earth mortar (Phase 1), some of which has eroded at lower levels. Earthenware drain pipes have been inserted at regular horizontal intervals along the northern half of the elevation (Plate 22); Peter Child attributes a mid-20th century date to these, describing them as ‘very characteristic of such conversions carried out in this period of MAFF-inspired agricultural improvement.’⁹ A slightly curved stone wall projects from the elevation at the northern end. Its rounded end contains part of an iron hinge, so may have formed part of a gated enclosure within the former yard. It is not tied in to the stonework so is assumed to belong to a later phase.

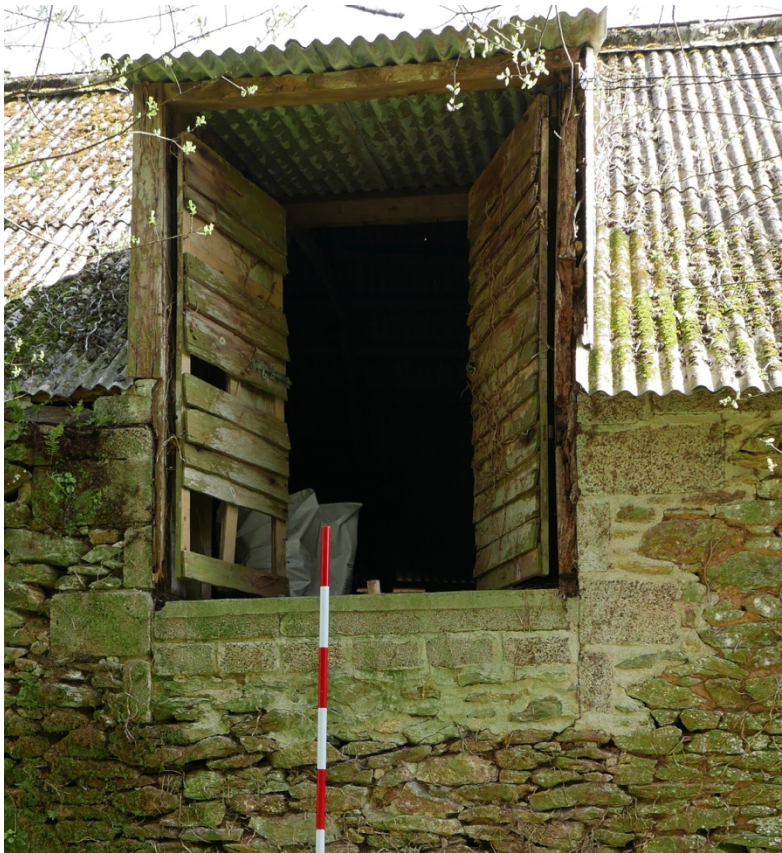
Plate 23. Pitching door, west elevation.

A large opening at first floor level allowed additional access to the hayloft towards the south end of the elevation (Plate 23). This contains a damaged wood frame and a double door set of two timber horizontal plank doors. The opening itself appears to have been inserted or altered in a later phase, as there are two courses of concrete blocks below the concrete sill, and cement pointing surrounding modern concrete block quoins.

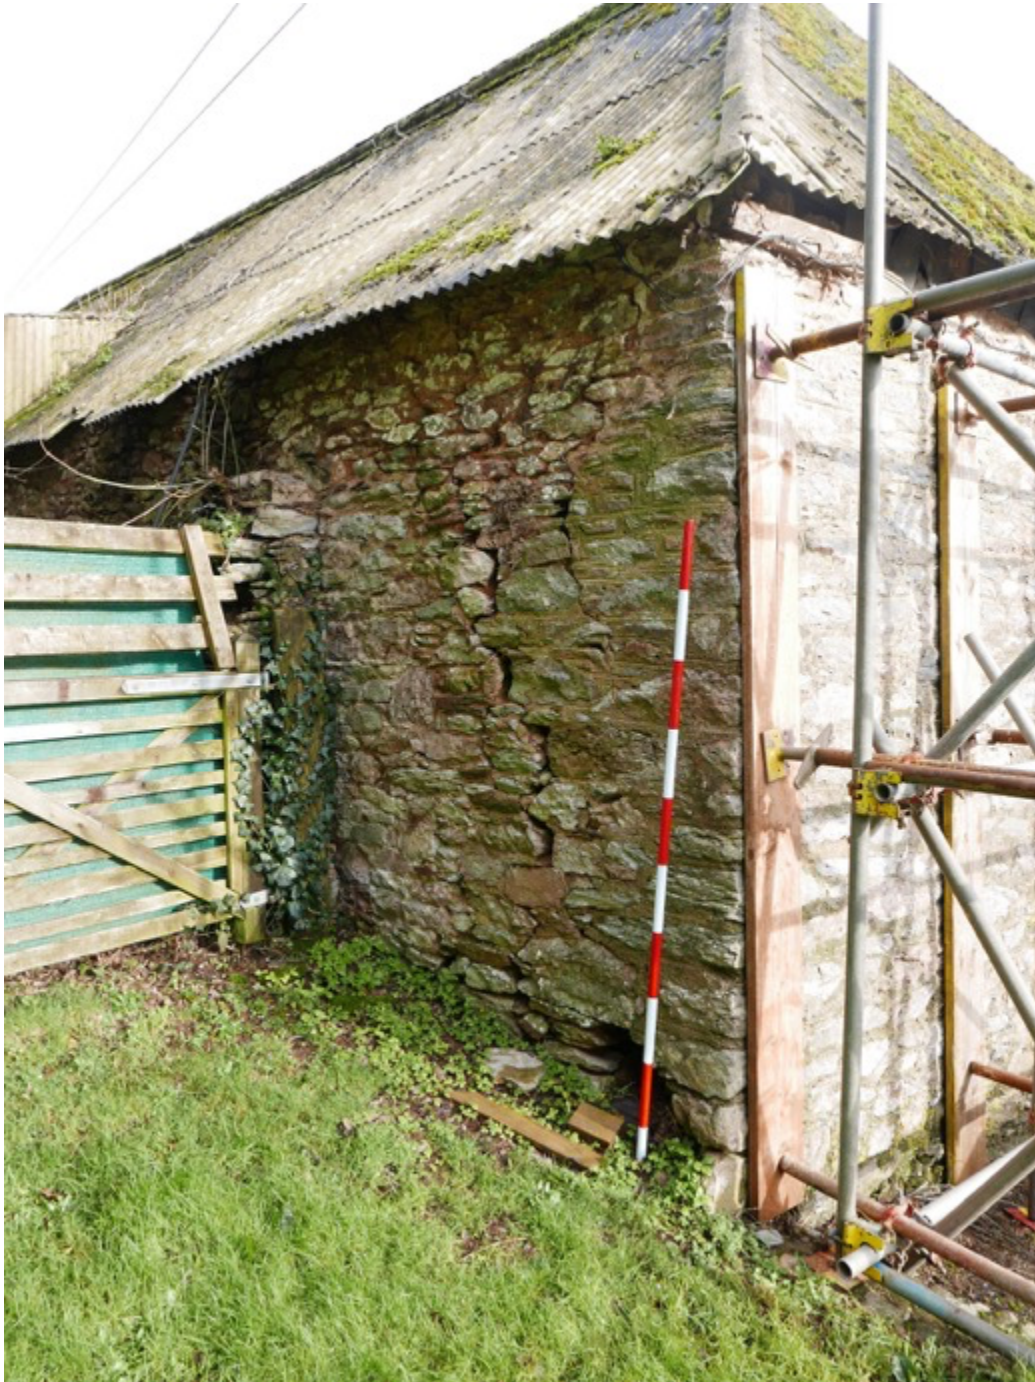
At the south end of the elevation, a rubblestone gatepost appears to be tied in to the Phase 1 stonework. Its rebate and iron hinge correspond to those of the gate pier opposite, part of the wall extending to the west. A crack in the stonework at the south end, similar to that on the east elevation, is likely to have been exacerbated by the use of cement pointing on the south elevation (Plate 24).

Plate 24. Interior. SW corner showing cracking due to cement pointing.

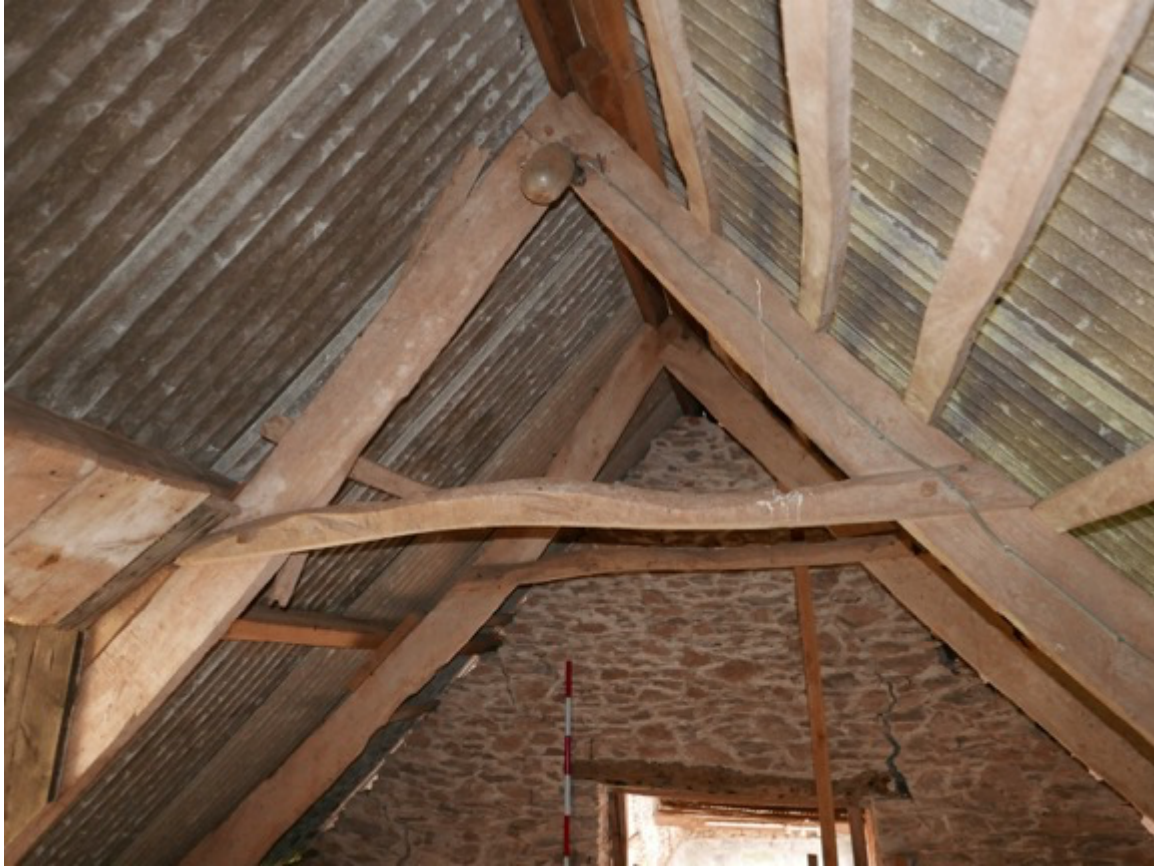
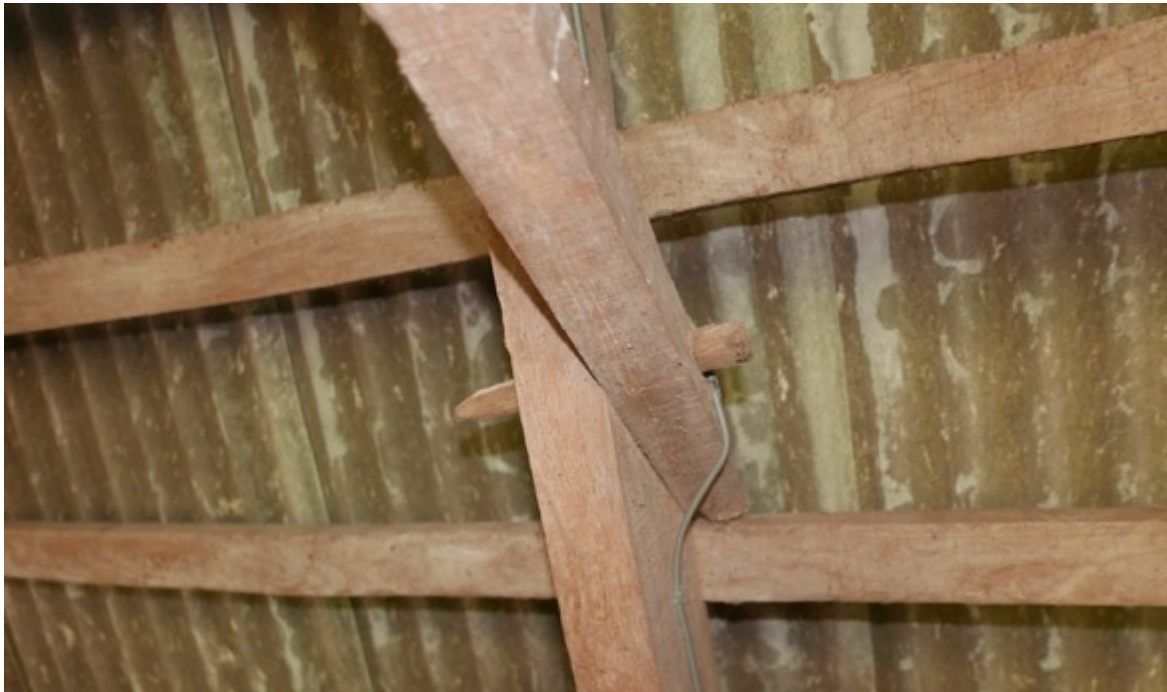
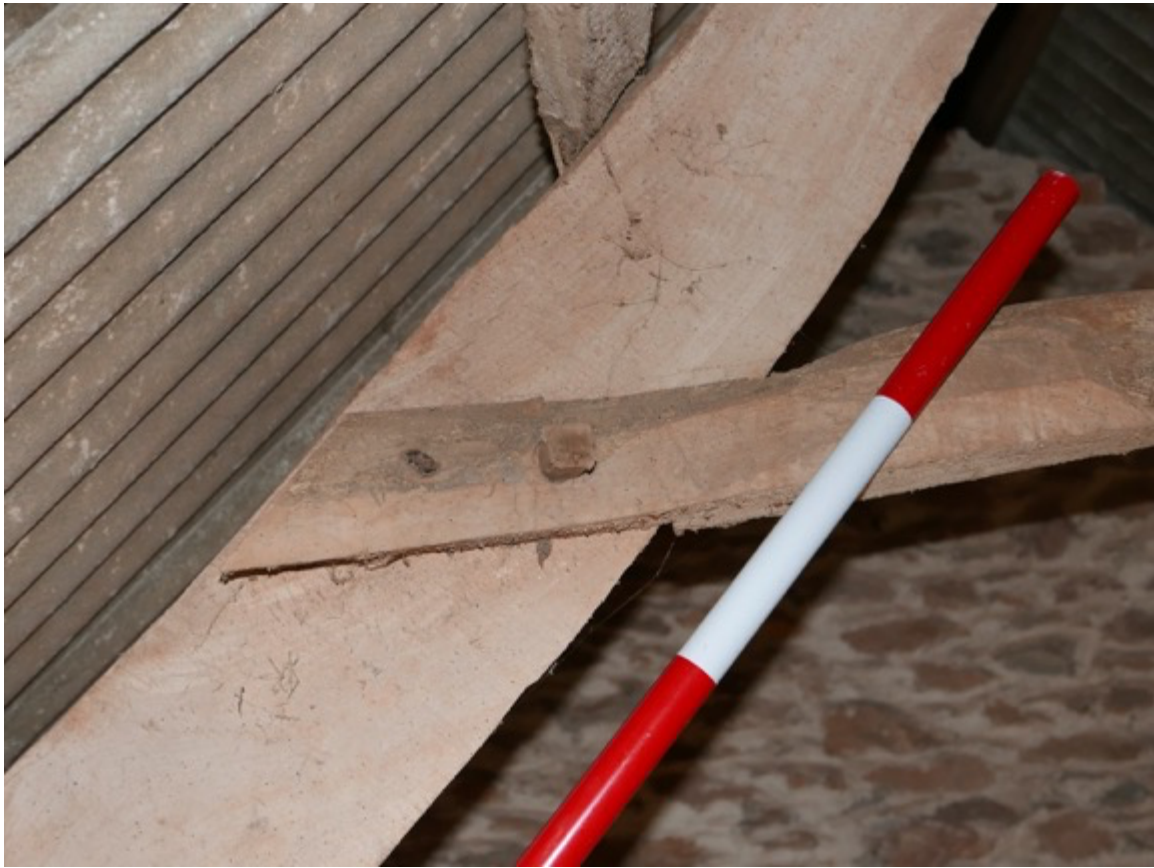
The original thatched roof has been replaced with corrugated sheeting, but all of the original trusses remain (Plates 37-39). Their size and spacing have been analysed by Peter Child:

[The original roof trusses] measure 20 by 6.5cms (8" by 2¼") in section and have high, light collars, face-pegged with single pegs. Their apexes are morticed and tenoned together and secured by two pegs. The trusses are set closely (157 cms [5'2"] centres) and are connected not by purlins but by large (4.0 by 9.0 cms [1.5" by 3.5"]) battens set 25cms (10") apart. This is typical of roofs found in some parts of Devon which were designed specifically for thatch where, because there was no need for secondary rafters to support slating battens, purlins were omitted in favour

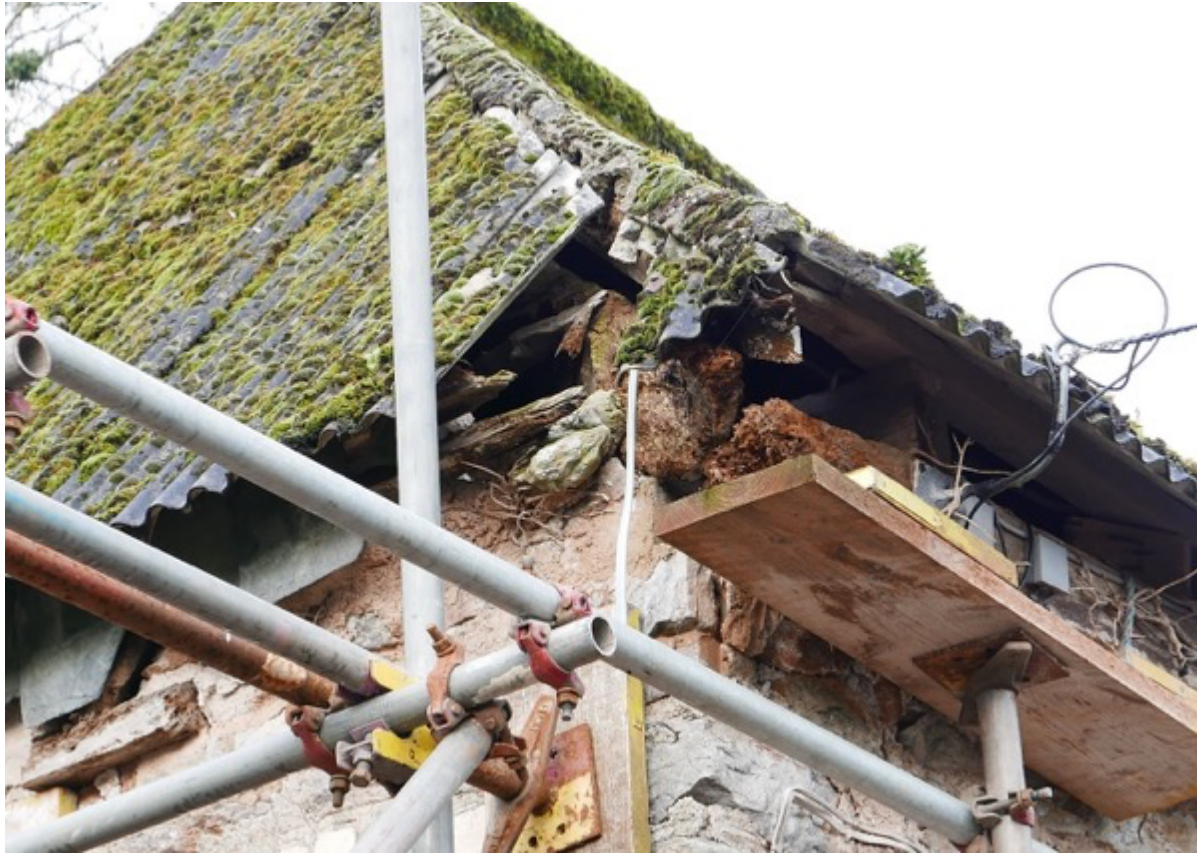
Plate 43. South east corner eaves damage.

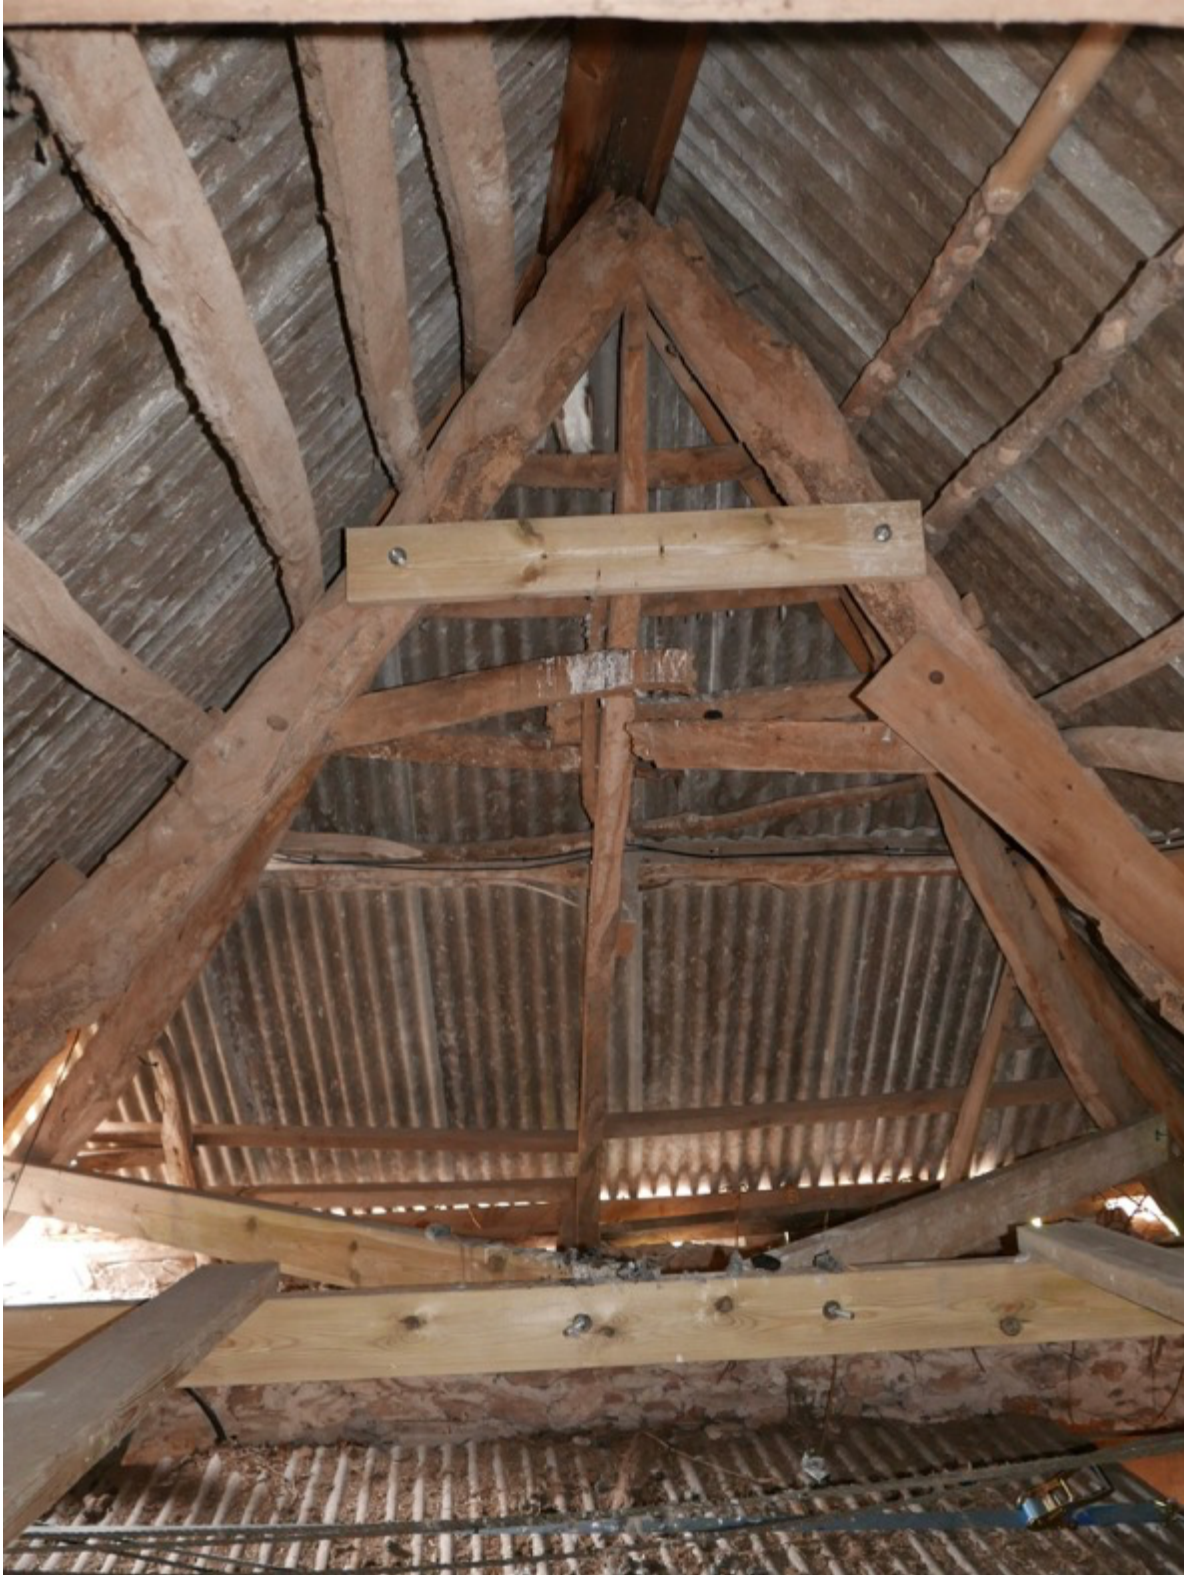
The trusses are supported on the west side by the stonework, and on the east by a timber wall plate resting on top of the wall. Bays 4, 5, 7 and 8 retain their original wall plates, which are significantly deflected due to the point load of the intermediate trusses (Plate 40). The remaining wall plates appear newer, but nevertheless show evidence of damage and deflection, particularly externally (Plates 41-43). Some of the trusses contain a notch at the apex to accommodate a later diagonal ridge beam; however, on others, the beam rests on one side of the principal rafter. Several of the principal rafters are fractured and have been reinforced with additional timbers. The hip principal rafter and many of the original thatching battens remain; though these have also been supplemented with newer, mechanically-sawn timbers to support the corrugated roof structure (Plate 44).

Plate 44. Interior. Roof - South end hipped roof structure (spot the barn owls).
