The Linhay, Sandridge Barton, Stoke Gabriel.

Level 2 Historic Building Recording

NW Conservation Report No.	210101
Site Name:	The Linhay, Sandridge Barton, Stoke Gabriel
Post Code	TQ9 6RL
District:	South Hams
County:	Devon
Grid ref:	SX 86180 56519
Date:	January 2021
Planning Consent reference:	2979/20/LBC
OASIS ID:	nwconser1-413947
Prepared by:	Nils White and Sophie Mcilwaine

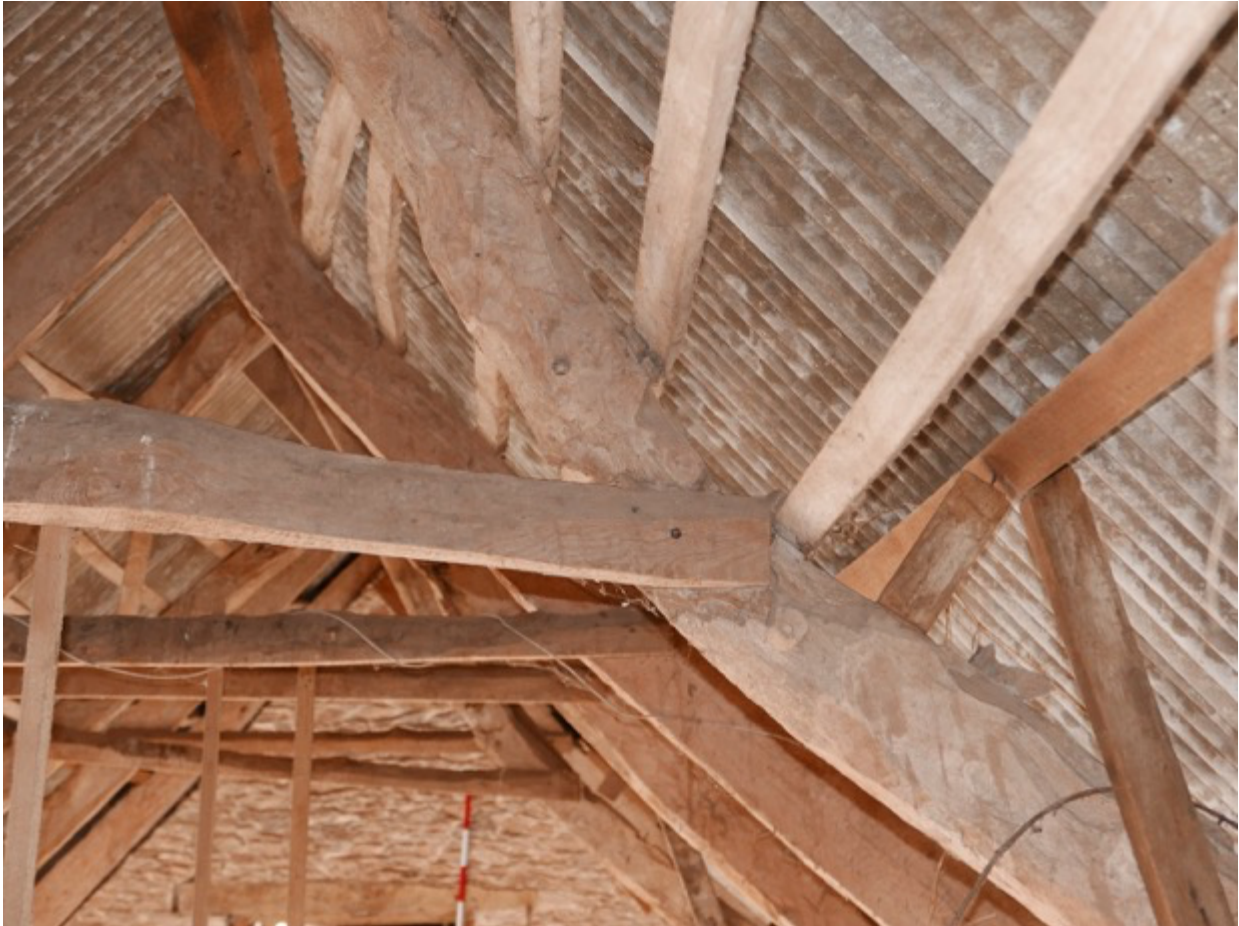
The trusses in the southern part of the linhay mostly retain their original pegged collars, which are high, cranked and undersized. Collars to the north of the dividing wall have been replaced with slightly deeper timbers. In some cases, the trusses have been further reinforced with modern tie beams and crown struts, connected by longitudinal binders along the centre of the tie beam (Plate 45). The truss directly above the dividing wall contains peg holes, so must have originally contained a collar: evidence that this was originally a continuous space and that the cross wall is a later addition.

Plate 45. Interior. Roof south end roof timber details showing replacement collar and original peg hole above.
