The Barn
at
Whelmstone Barton
Colebrooke
Devon 1996

**The Barn at
Whelmstone Barton
Colebrooke
Devon**

Report K468

Grade II listed building

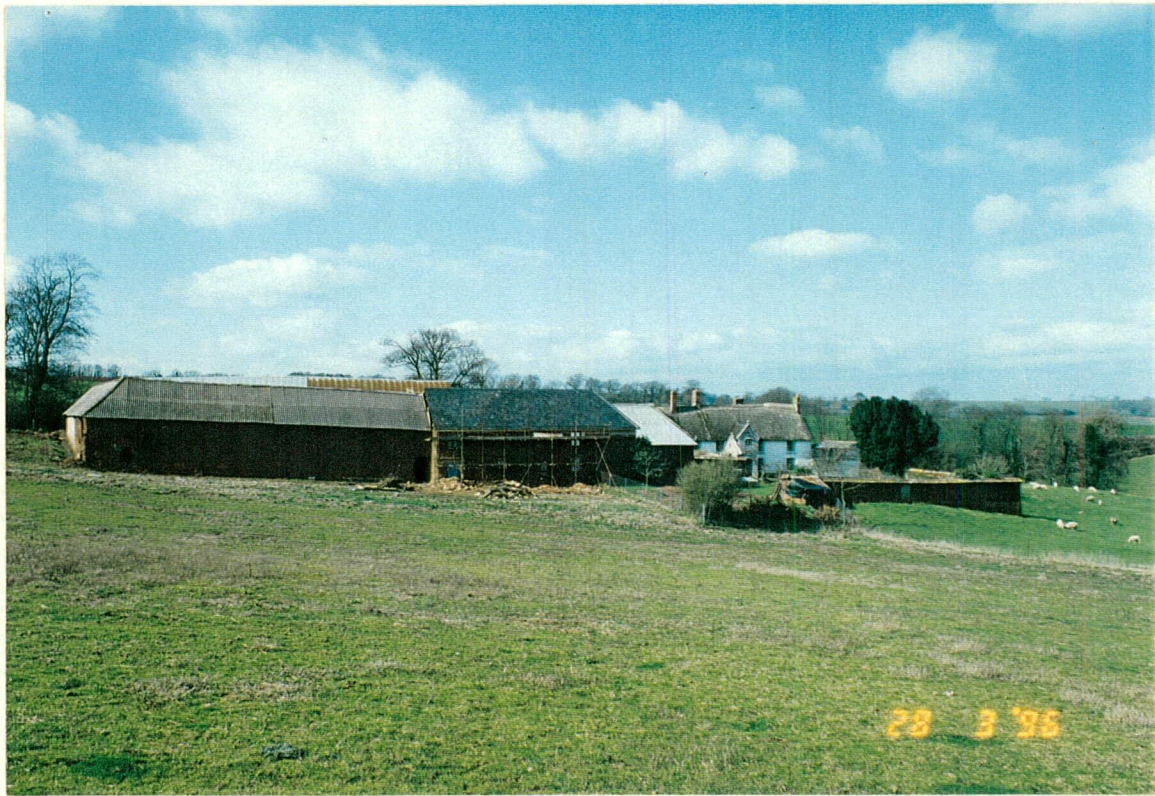
Plate 1 The steading from the southeast. The barn is on the far side of the yard beyond the 19th century linhay and cider house (with scaffolding) and only the top of its roof can be seen.

The farmbuildings lie a short distance to southwest beyond a late 19th century weatherboarded shed. The barn is the longest and the largest of the group. It is built down the gradual slope on a southwest-northeast axis (Plates 3 & 4). It has a 2-bay cob-walled shed on the northeast end which was originally open-fronted onto the yard to the southeast. In fact the ground also falls away to the southeast and this yard is a little lower than the floor of the barn which forms its northwest side. The long southeast side is made up of a cider house flanked by open-fronted cattle linhays, all facing northwest onto the yard. Formerly the cider house was thought to be older than the linhays but the map evidence appears to suggest that the whole range was built as one at some time between 1846-1889, the dates of the two earliest maps of the steading. There is a 3-bay linhay to

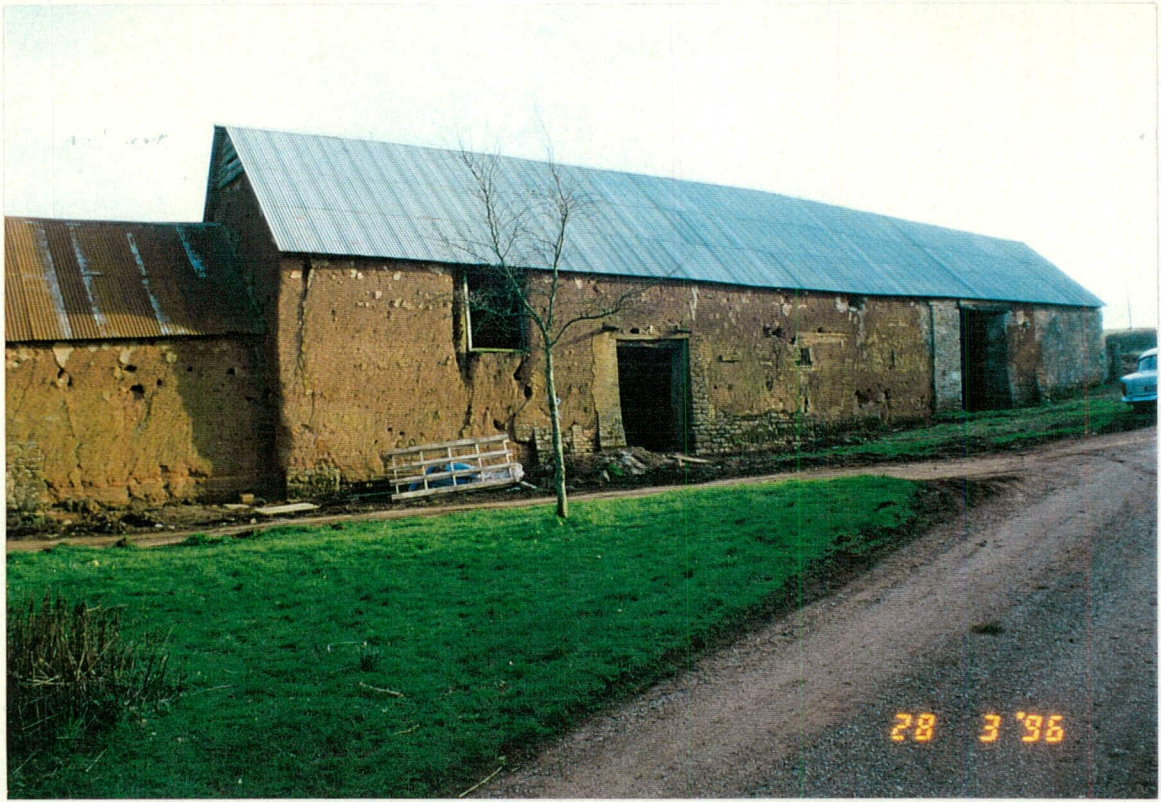
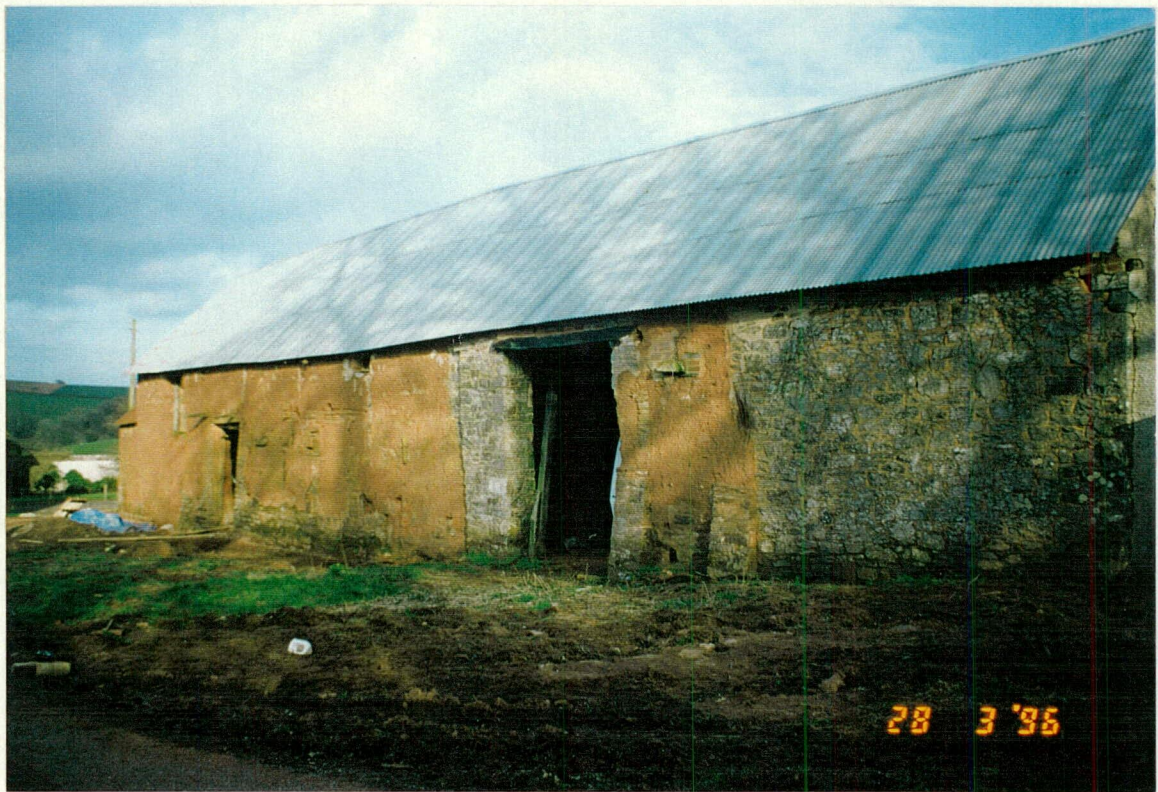
Plates 3 & 4 The northwest front of the barn from the north and west.

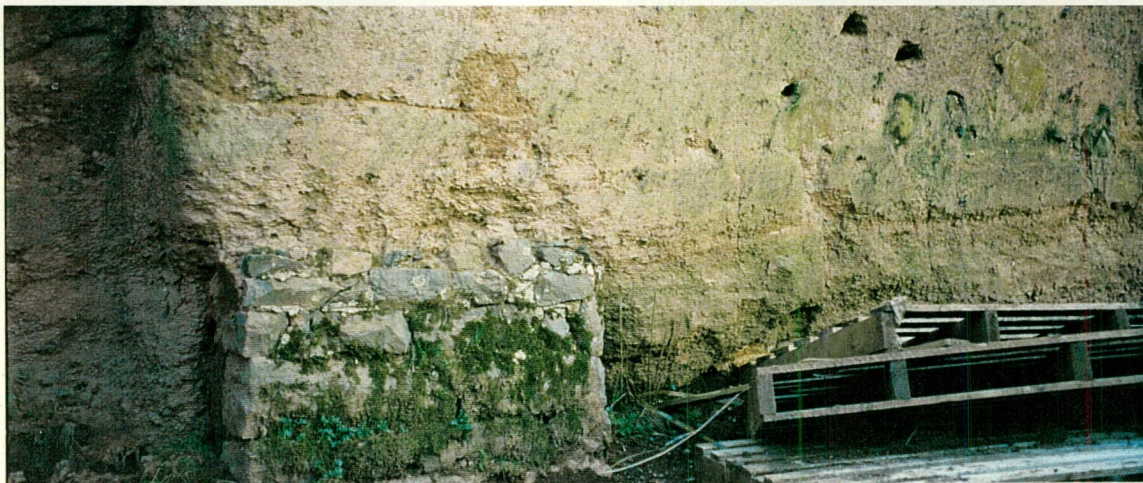
Plate 5 The northeast end where the break between the cob and the natural bedrock has been picked out.

Neither phase of cob in the barn has any footings, except where they have been inserted later. Instead the cob sits on upstands of the sandstone bedrock which is exactly the same colour as the cob (Plate 5). This varies in height from 300mm to just over 1m. It is highly improbable that the barn was built like this. Presumably the ground level was somewhat higher when the barn was built, and indeed when it was extended. Also it was apparently terraced a little into the natural slope on the northwest side and southwest end. It seems that the former ground level has since been degraded which happens quite often to walls where the adjacent area of the farmyard is unsurfaced and has been used as a stockyard. This process can leave upstands of natural bedrock. It would seem that the cob walls of both major historic phases were built directly onto a platform of natural bedrock.

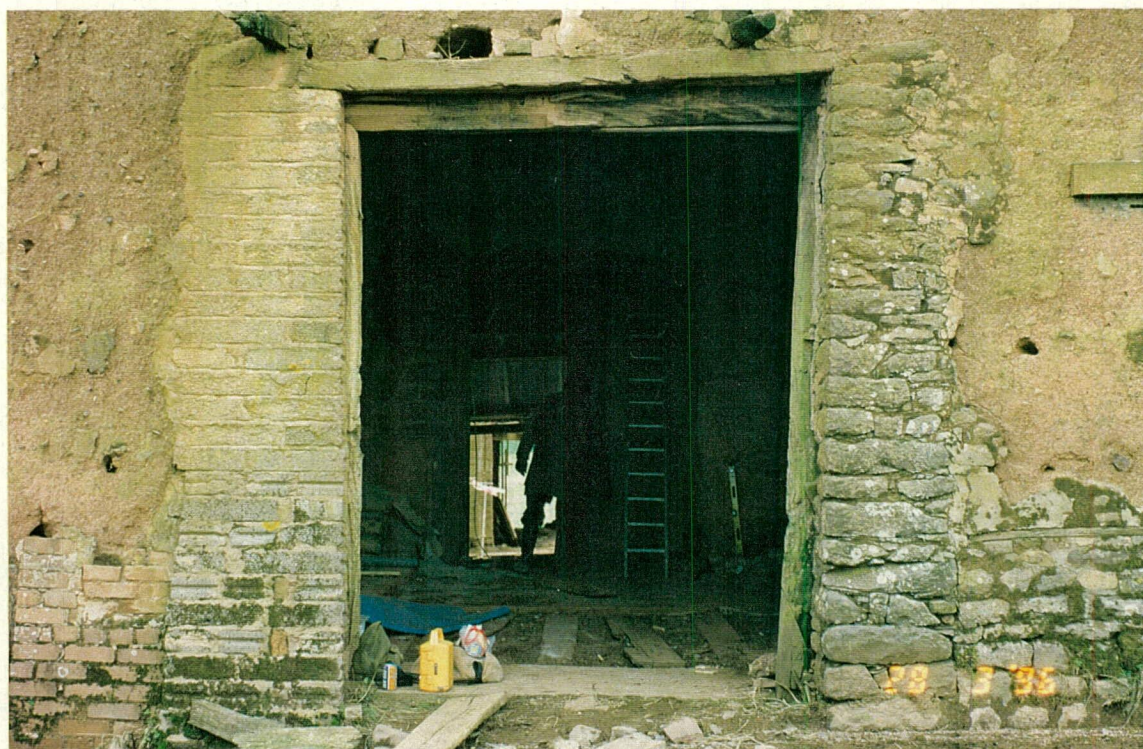
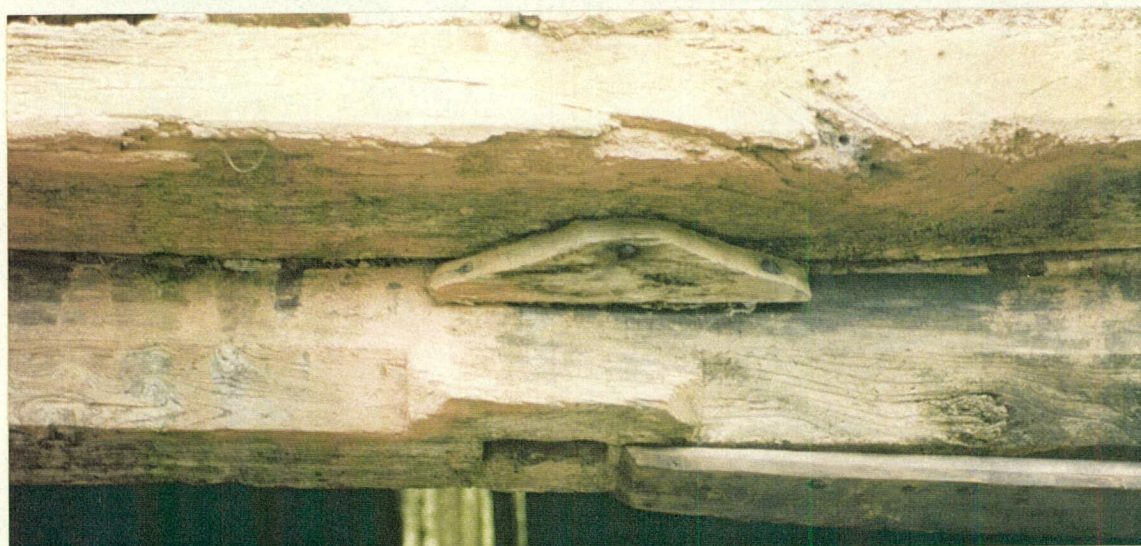
Plates 6 & 7 The northeast midstrey doorway and detail of the doorframe headbeam.

Both of the doorways to the northeast threshing floors contain the remains of very early, if not original, oak doorframes. Both are evidently identical but the southeastern one remains substantially intact (Drawing K468/2, and Plate 7 shows northwest one). Built of oak the frames had external chamfers with carpenters' mortises on the corners where the upright jambs meet the headbeam (pegged mortise-and-tenon joints). In the centre of the headbeam the chamfer is step stopped each side of a short length which is square in section. The soffit here contains a slot for an upright post, a removable stay against which the double doors could be secured shut. The northwest doorway has no doors and those of the southeast doorway date from the late 19th century or even the early 20th century.

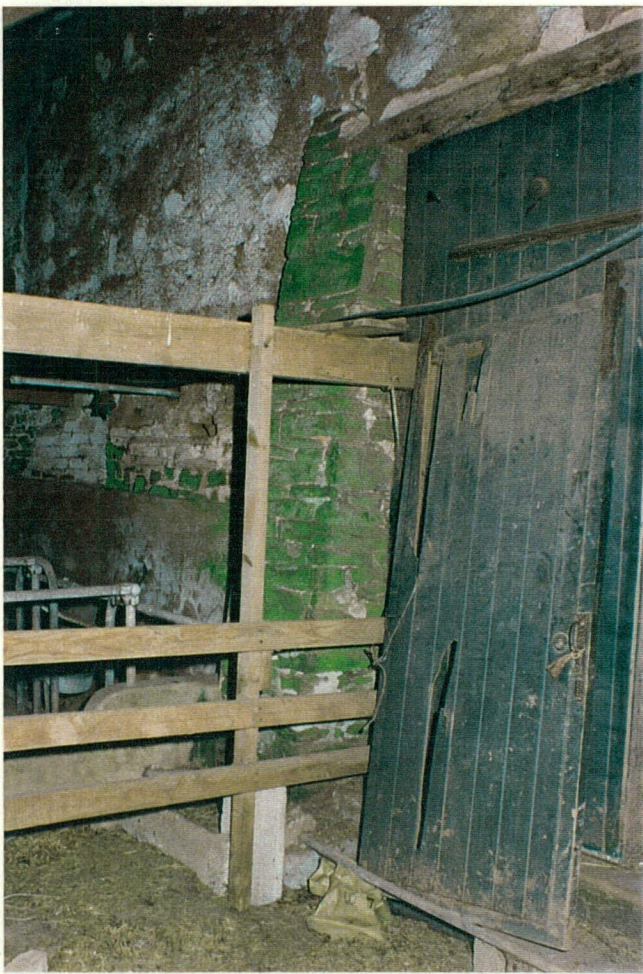
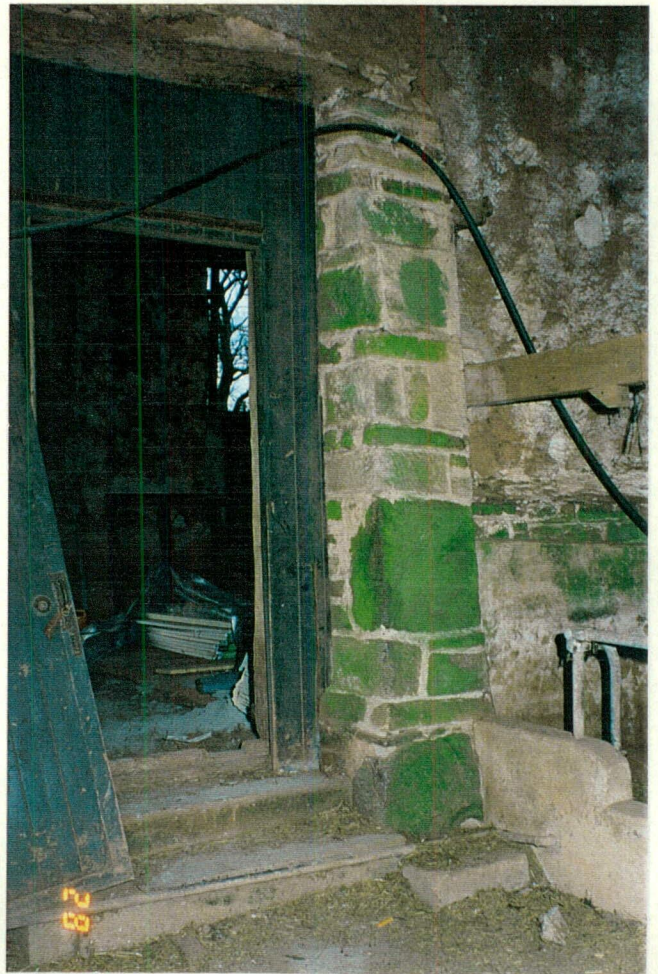
Plates 8 & 9 The flanking buttresses either side of the northeast midstrey doorway.

The southeast doorway is relatively fine as if it was the show side as it would have been seen from the front courtyard of the house. Here the doorway is flanked by two tall raking buttresses rising from ground level to support the plain oak lintel. Because these buttresses are so tall and their slope so slight that they give the impression of being flanking pilaster buttresses, which commonly flank the midstrey (threshing floor) doorways of many of the old barns in Devon. Both are built of stone but they are very different. The right (northeast) one is an original, the other a replacement. The right one is noticeably more vertical, more pilaster-like, and is built of coursed volcanic ashlar and squared local mudstone with a neat chamfered plinth (Plate 9). It is also set at a slight angle, canting outwards as it were. This may have been a device for encouraging a good through-draft across the threshing floor. The inserted left (southwest) buttress is plain and built of roughly squared blocks of local mudstone brought to rough courses (Plate 8). Both buttresses are bonded in a red clay mortar containing flecks of lime, but the mortar of the original buttress is grittier and paler in colour. It was pointed up in pure lime mortar. The clayier bonding of the replacement buttress is much more like the bonding of the inserted footings nearby.

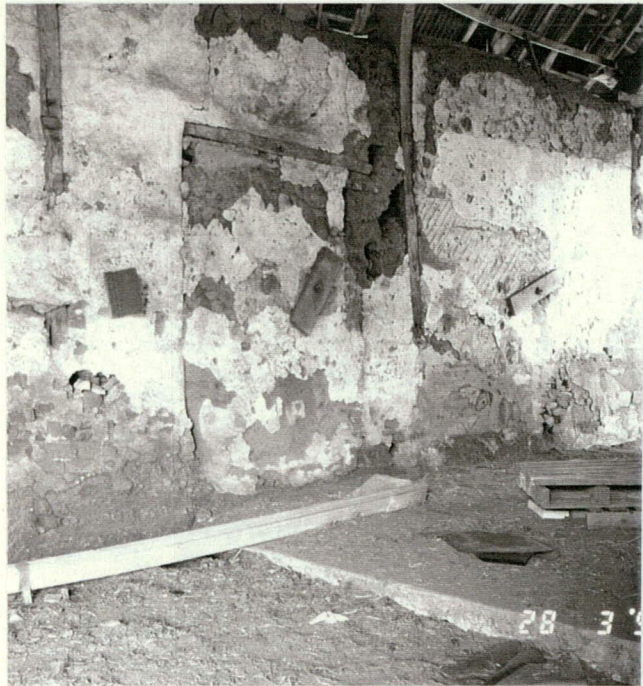
Plate 10 The blocked central doorway.

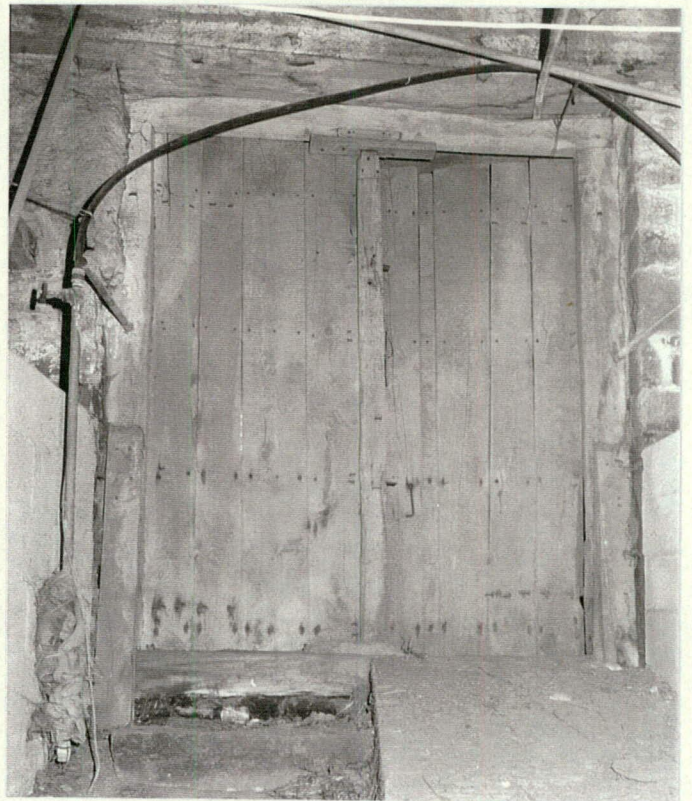
Plate 11 The southwest midstrey doorway in the extension.

The new cob walls, like the old ones, are red cob built directly off the natural bedrock which now stands as low upstands. The original surviving parts of all three doorways shows that they were simple cob-lined openings with plain oak lintels; all that is except the northeast side of the doorway on the southeast side. This one was built in a stone rubble bonded in a buff-coloured earth mortar containing flecks of white lime. The masonry is neatly presented to the exterior (Plate 11). The masonry here is bonding the new work into the older cob at the junction between the two. This doorway also contains what seems to be its original doorframe since it is set into the cob of the southwest side. It is a sturdy oak frame with two pegs to each of the mortise-and-tenon joints as the posts join the head. The head is chamfered with runout stops each side. There is still a central closing stay or strut but it is now fixed top and bottom to replacement timbers which hide or have destroyed the original arrangement. The sides were chamfered but any stops have worn away. The double doors could possibly be contemporary – they are plain plank-and-ledge affairs hung on wrought-iron strap hinges. The opposite doorway was altered in the late 19th century and the man-door, close by, has been blocked up leaving only its northeast side and the slot for its removed lintel.

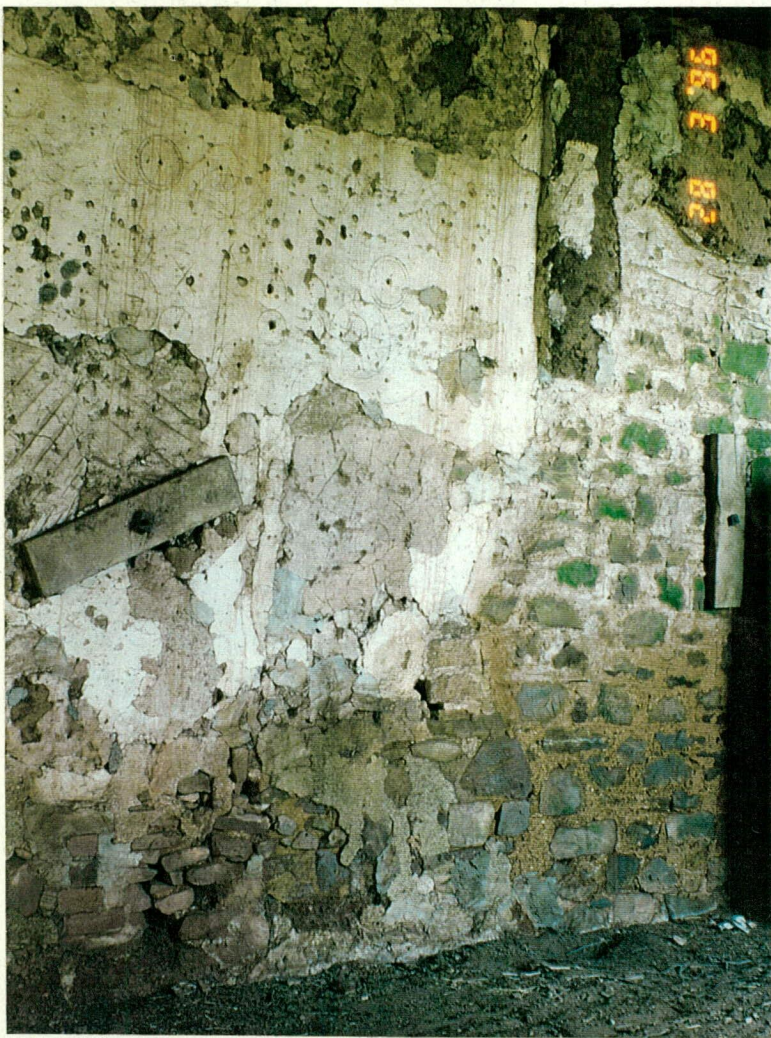
Plate 12 The stub of the original southwest end wall shows on the southeast side.

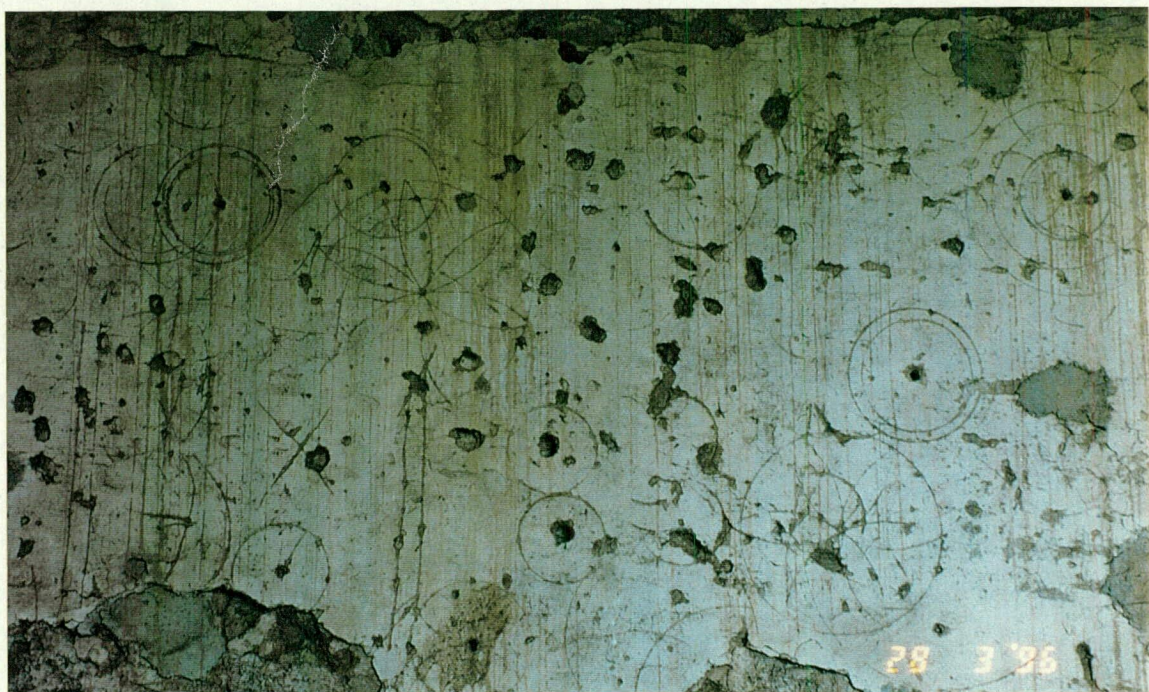
Plate 14 Detail of inscribed charms or sigils on the plaster of bay 6, southeast side.

The older plaster is packed with geometric incisions mostly representing multiple circles or hexafoil sigils (six-petal motifs) which were believed to be magical marks or talismans put there to protect the farm produce (Plate 14). Such symbols, particularly the six-petal motifs, are found throughout Devon dating from the medieval period into the 19th century. They are often associated with barns or found in plank-and-muntin screens in houses. Their significance has only recently been recognised due to the work of Timothy Easton in Suffolk, who is working on a taxonomy of the marks he has found in Suffolk. He has not yet published his findings but has sent Keystone Historic Buildings Consultants a long letter summarising his conclusions in relation to examples formerly noted by Keystone Historic Buildings Consultants.

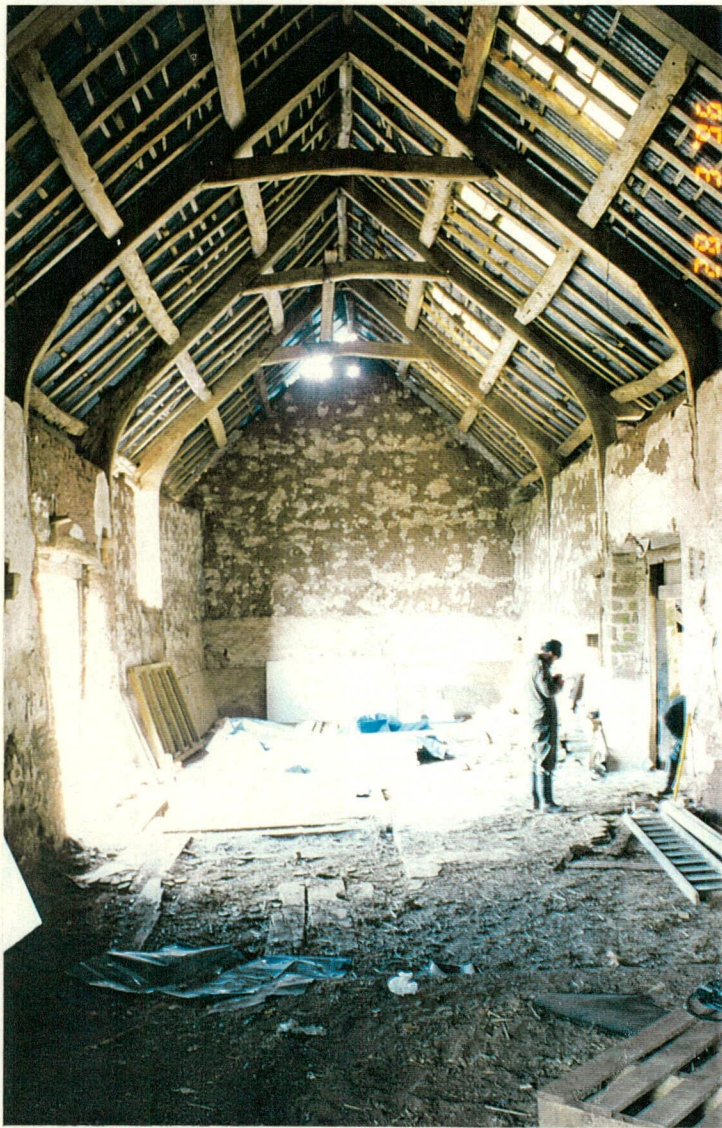
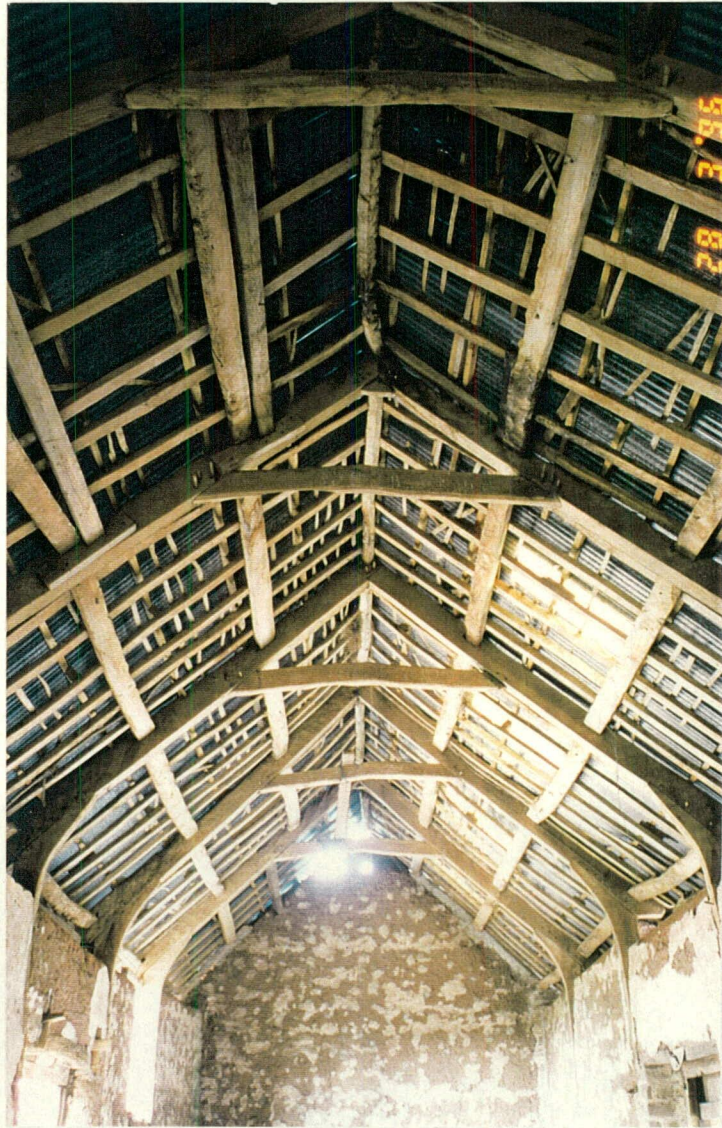
Plates 15 & 16 The old roof from the southwest.

The five trusses are side-pegged jointed crucks. Their general form and construction is of the type standard throughout most of Devon, particularly mid and east Devon, and much of Somerset from the late 15th century through to the mid 17th century, but details of the construction put the roof into a smaller sub-category which can be dated stylistically to a tighter date-range.

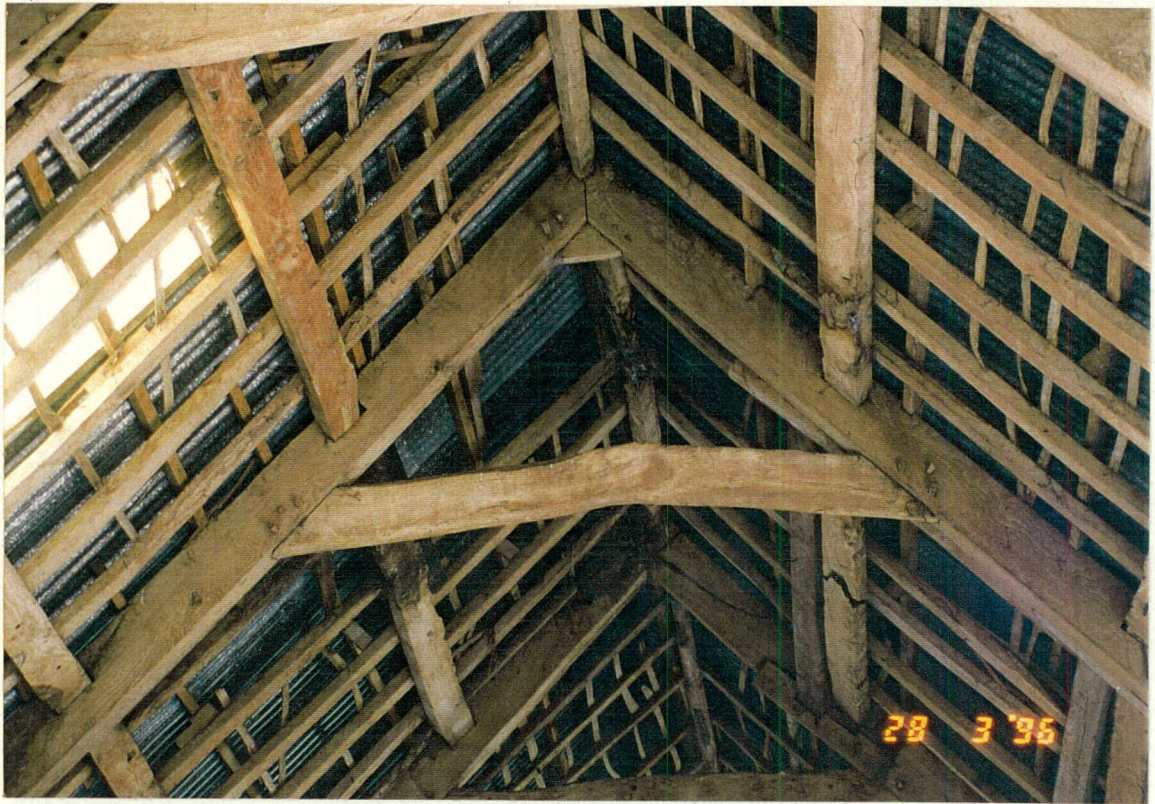
Plate 18 The yoke apex joint of truss 4.

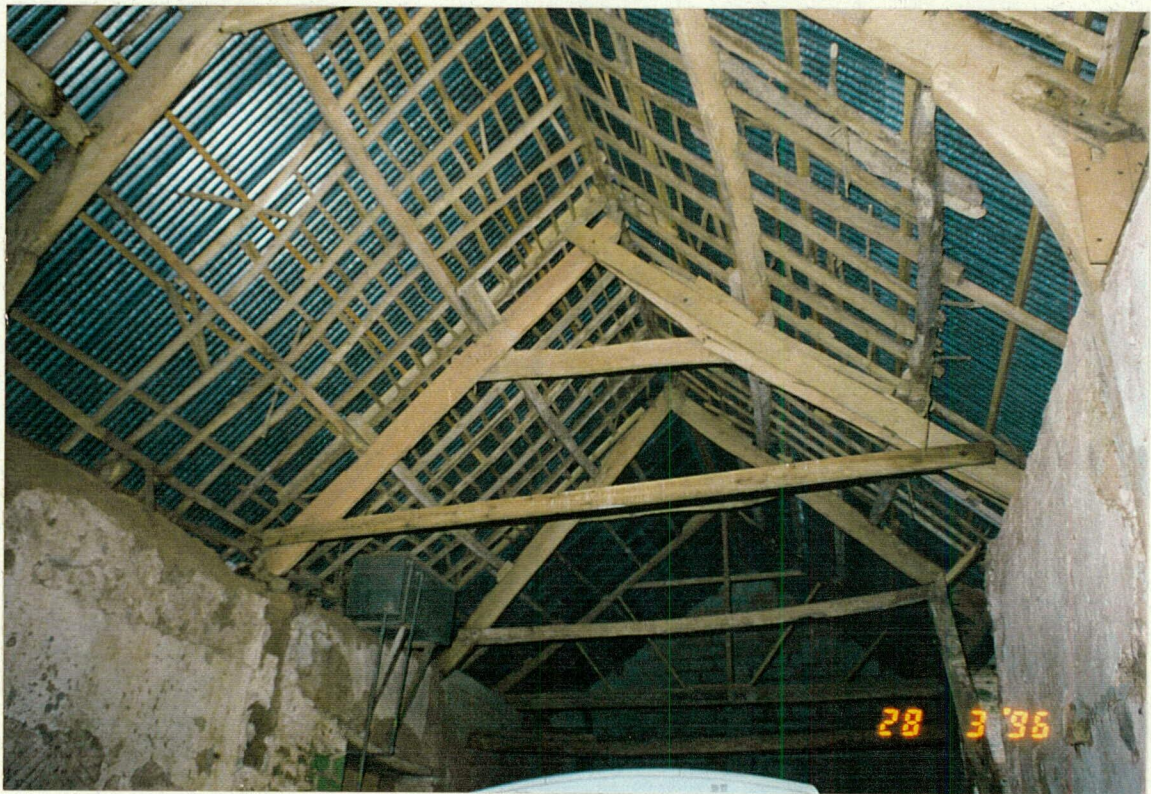
Plate 19 The roof over the southwest extension.

The roof structure over the extension is of 3 bays on 3 trusses (Plate 19). The southwest end truss is certainly a late 19th century replacement but the other two may be originals. However they are pretty rough-and-ready in terms of carpentry. They are A-frame trusses with upper and lower collars lap-jointed and spiked to the principals. The principals sit on spreader plates lid along the wall tops and are notched, halved and spiked together to form X apexes. The purlins simply rest on the backs of the principals.
