# Countess Wear Bridge, Exeter, Devon

An Archaeological Programme of Works: Desk-Based Assessment and Historic Building Recording

March 2013

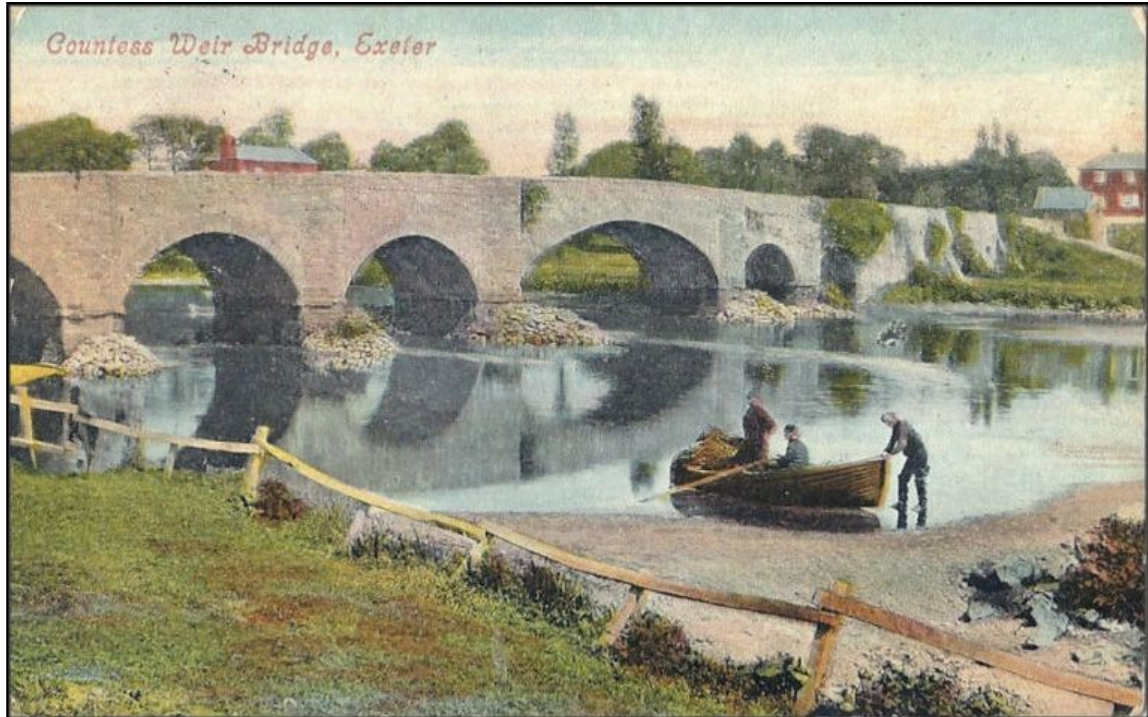
- 3.6 Two watercolour postcards dated to the early 1900's (Plate 2) and to 1904 (Plate 3) depict the downstream (south-east) elevation prior to the extension of this side of the bridge in the 1930's. The triangular cutwaters rose to the top of the parapet and the supporting tapered buttresses supporting the bridge on the eastern bank are also visible. Piles of pebbles or stones obscure the lower courses of the cutwaters. Almost the entire width of the bridge span across the River Exe is shown on the postcards, including the three western segmental arches, the wider central elliptical arch and the two eastern segmental arches.

Plate 2. Postcard dated to the early 1900's (DHC/64/16)

Plate 3. Postcard dated 1904 (DHC/64/16)

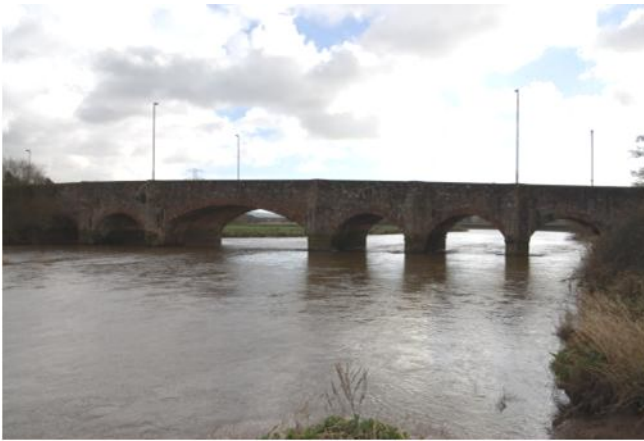
Plate 4. Upstream elevation (looking SE)

- 5.2 Recording of the upstream elevation (**Plate 4**) was mostly conducted from the south-western bank, the north-eastern bank being only partly accessible due to dense undergrowth and housing occupying the top of the bank. The modern road carries three lanes of traffic and two flanking pedestrian walkways (**Plates 5 & 6**). The downstream elevation relates to the widening of the carriageway between 1935 and 1938 and replicates the upstream elevation in form, dimensions and architectural style (**Plate 7**).

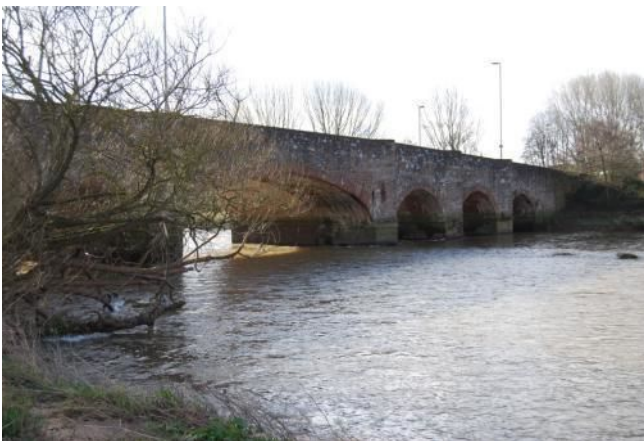
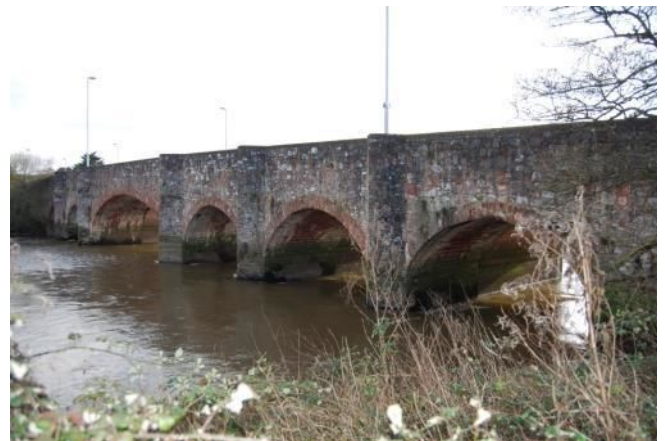
- 5.4 The eastern and western ends of the upstream elevation were obscured by dense undergrowth (**Plates 8 & 9**). Consequently the survey was restricted to observations of the main span across the River Exe with very limited observations at either end.

Plate 8. Upstream elevation (looking SW)

Plate 9. Upstream elevation (looking E)

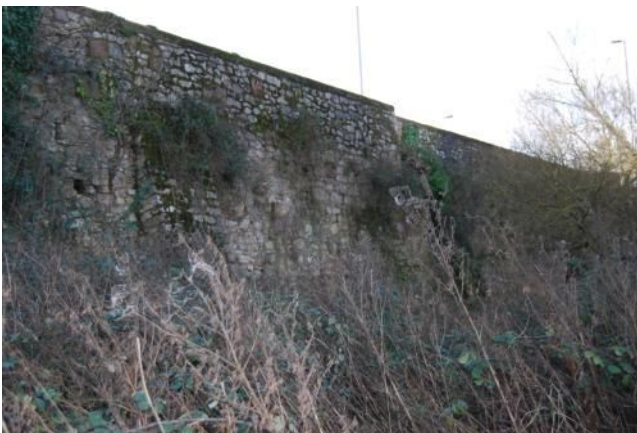
Plate 14. Buttresses at eastern end of upstream elevation (looking S)

- 5.8 One original supporting buttress at the western end of the elevation and three at the eastern end (**Plate 14**) could not be accessed due to dense undergrowth but the upper parts were seen to be constructed of light-coloured ashlar and rubble. Photographs supplied by the client following vegetation clearance show the buttresses in more detail, the slope of the buttresses continuing at the same angle to the ground (**Plate 26**).

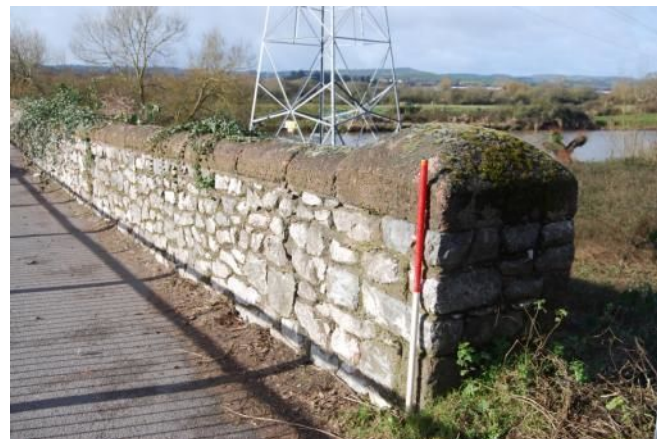
Plate 15. West side of entranceway, upstream parapet (looking W)

- 5.9 To the east of the easternmost buttress was a small entrance from which the riverbank was accessed although there is no formal path (**Plate 15**). The parapet continues north-eastwards on the other side of the entrance.

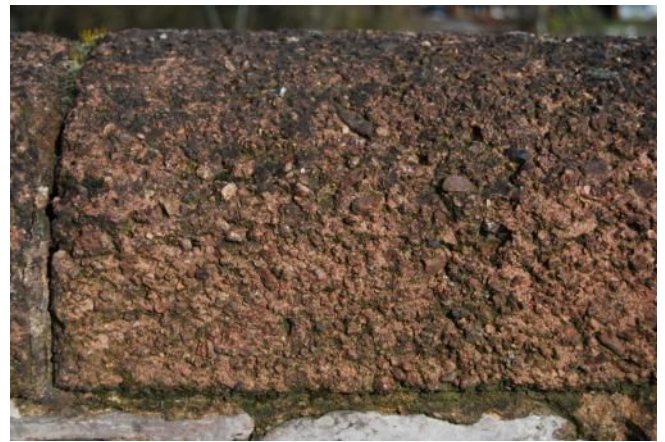
Plate 19. Red cement coping, upstream parapet (looking NW)

- 5.10 The inside of the parapet adjacent to the pedestrian walkway is of the same construction as the exterior, faced with random rubble comprising limestone, red sandstone and the occasional red granite (**Plates 16 & 17**). Widening of the parapet (**Plate 17**) may relate in part to the rectangular widened area shown on the 1840 tithe. In the centre of the upstream parapet is a backing stone for a plaque (**Plate 18**) which is no longer present; this presumably memorialised the remodelling of the bridge in 1935-38. The parapet is capped with red cement with red sandstone inclusions, chamfered on both sides (**Plate 19**); the coping is deteriorating and starting to flake.

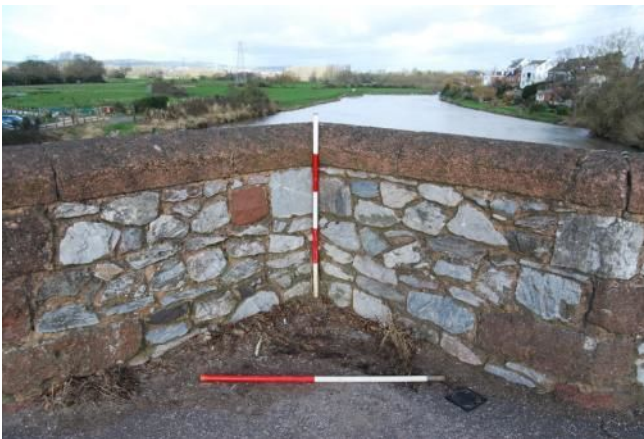
Plate 20. Refuge, upstream parapet (looking NW)

- 5.11 The parapet refuges are faced with the same material as used for the parapets (**Plate 20**) with red sandstone for the quoins (**Plate 22**), identical to the refuges on the downstream parapet (**Plate 21**). The south-western end of the upstream parapet curves out slightly (**Plate 23**) which is not evident from the modern architects plan.

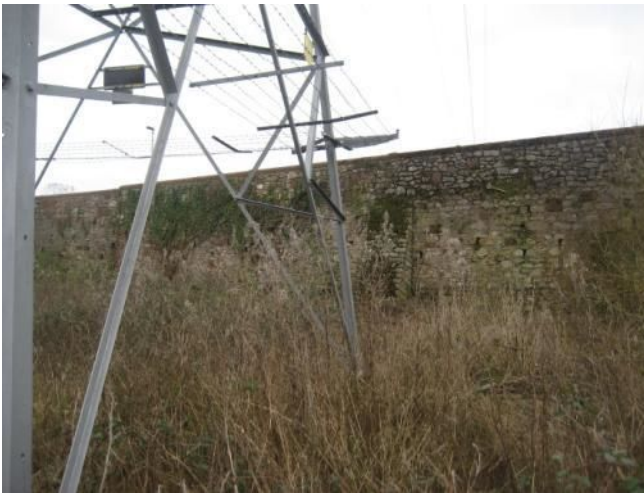
- 5.12 Photographs provided by Ms Jackson show numerous rectangular voids in the stonework of the north-west elevation (**Plates 24 & 25**). These voids are original features and are staggered along the centre of the elevation at either end of the bridge suggesting they are associated with drainage.

Plate 24. Eastern end of upstream elevation (looking SE)

Plate 25. Voids in upstream elevation (looking SE)
