**Historic Building Recording
at
Veryards, 4 Fore Street
Cullompton, Devon
in 2017**

**by
Stuart Blaylock**

August 2018

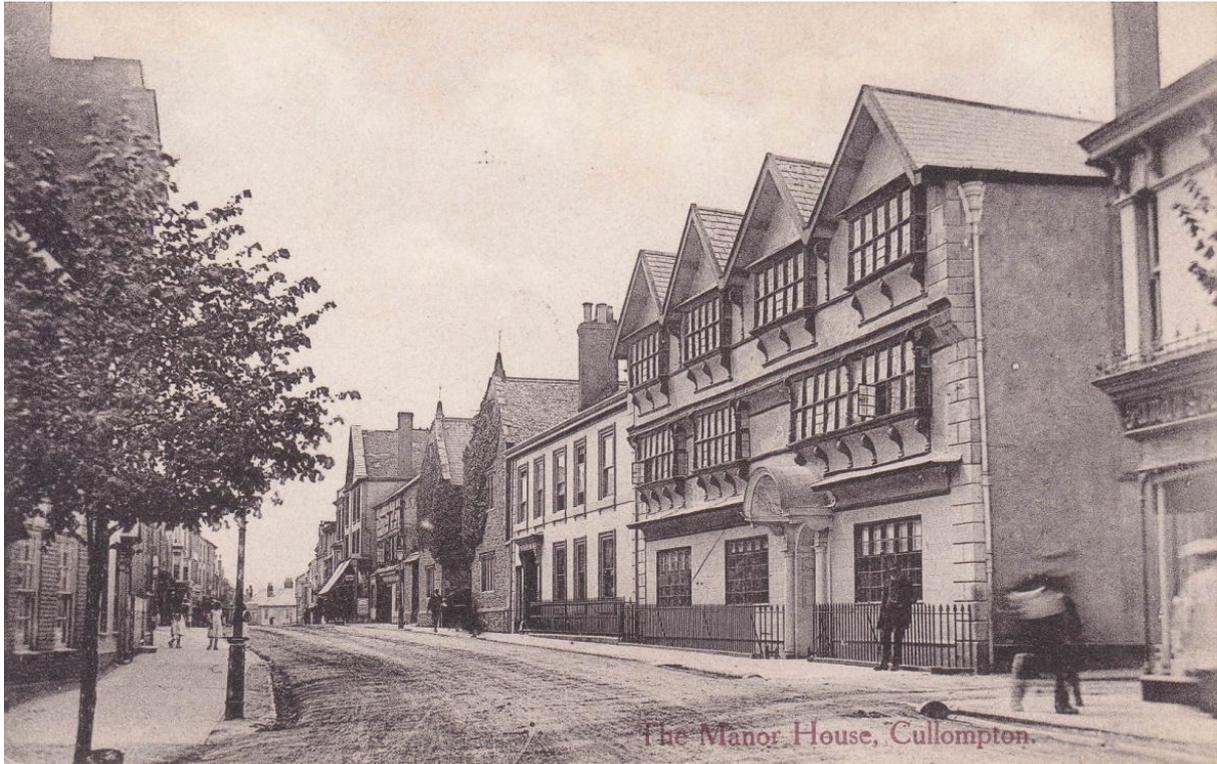
Fig. 10 Undated postcard view of Nos 2-8 Fore Street, Cullompton, showing the facade of No. 4 without the oriel window; perhaps c.1910 (author's collection).

The main alterations of note seem to have been the addition of the oriel to the front elevation (dated to the mid.-20th century by photographic evidence: compare Figs 10–11 with the 1950s photograph illustrated in Blaylock 2016, fig. 9); repairs to chimneys, perhaps in the mid.-20th century (Figs 48–49) and the major alterations associated with the annexation of Veryards into use as part of the hotel in the 1980s. These saw major structural alterations: principally the construction of new bar facilities in a large new extension to the rear; but also the creation of integral bathrooms to bedrooms (with associated new partitioning and windows, and the like); the cutting of a doorway to provide internal access between Nos 2 and 4; and the removal of garden walls, and associated amalgamation of the two tenement plots, much of this large area, alas, being devoted to car parking rather than any more amenable use. There was also a good deal of refenestration at this phase, it seems (Sue Warren, personal communication). These alterations did not all take place at once, since the building functioned as part of the hotel for a number of years after its acquisition by Mr and Mrs Peters in 1983, before the extension was contemplated c.1989 (the present author recalls drinking in the small back bar formerly in this position when first living in Cullompton in 1987).

The dentilled cornice was typically 55mm wide by 75 mm high by 50mm deep, with dentils spaced at approximately 40mm intervals, occasionally 41 or 42mm. This sat on a moulding 60mm deep, with a 40mm projection. All these details were in timber (the cornice, eaves and moulding beneath, and so were not disturbed. The cornice continued above the bay/oriel window, although obscured by the flashings associated with it. We know from pictorial sources that the oriel was an addition of the early–mid. 20th century (above and Figs 10, 11).

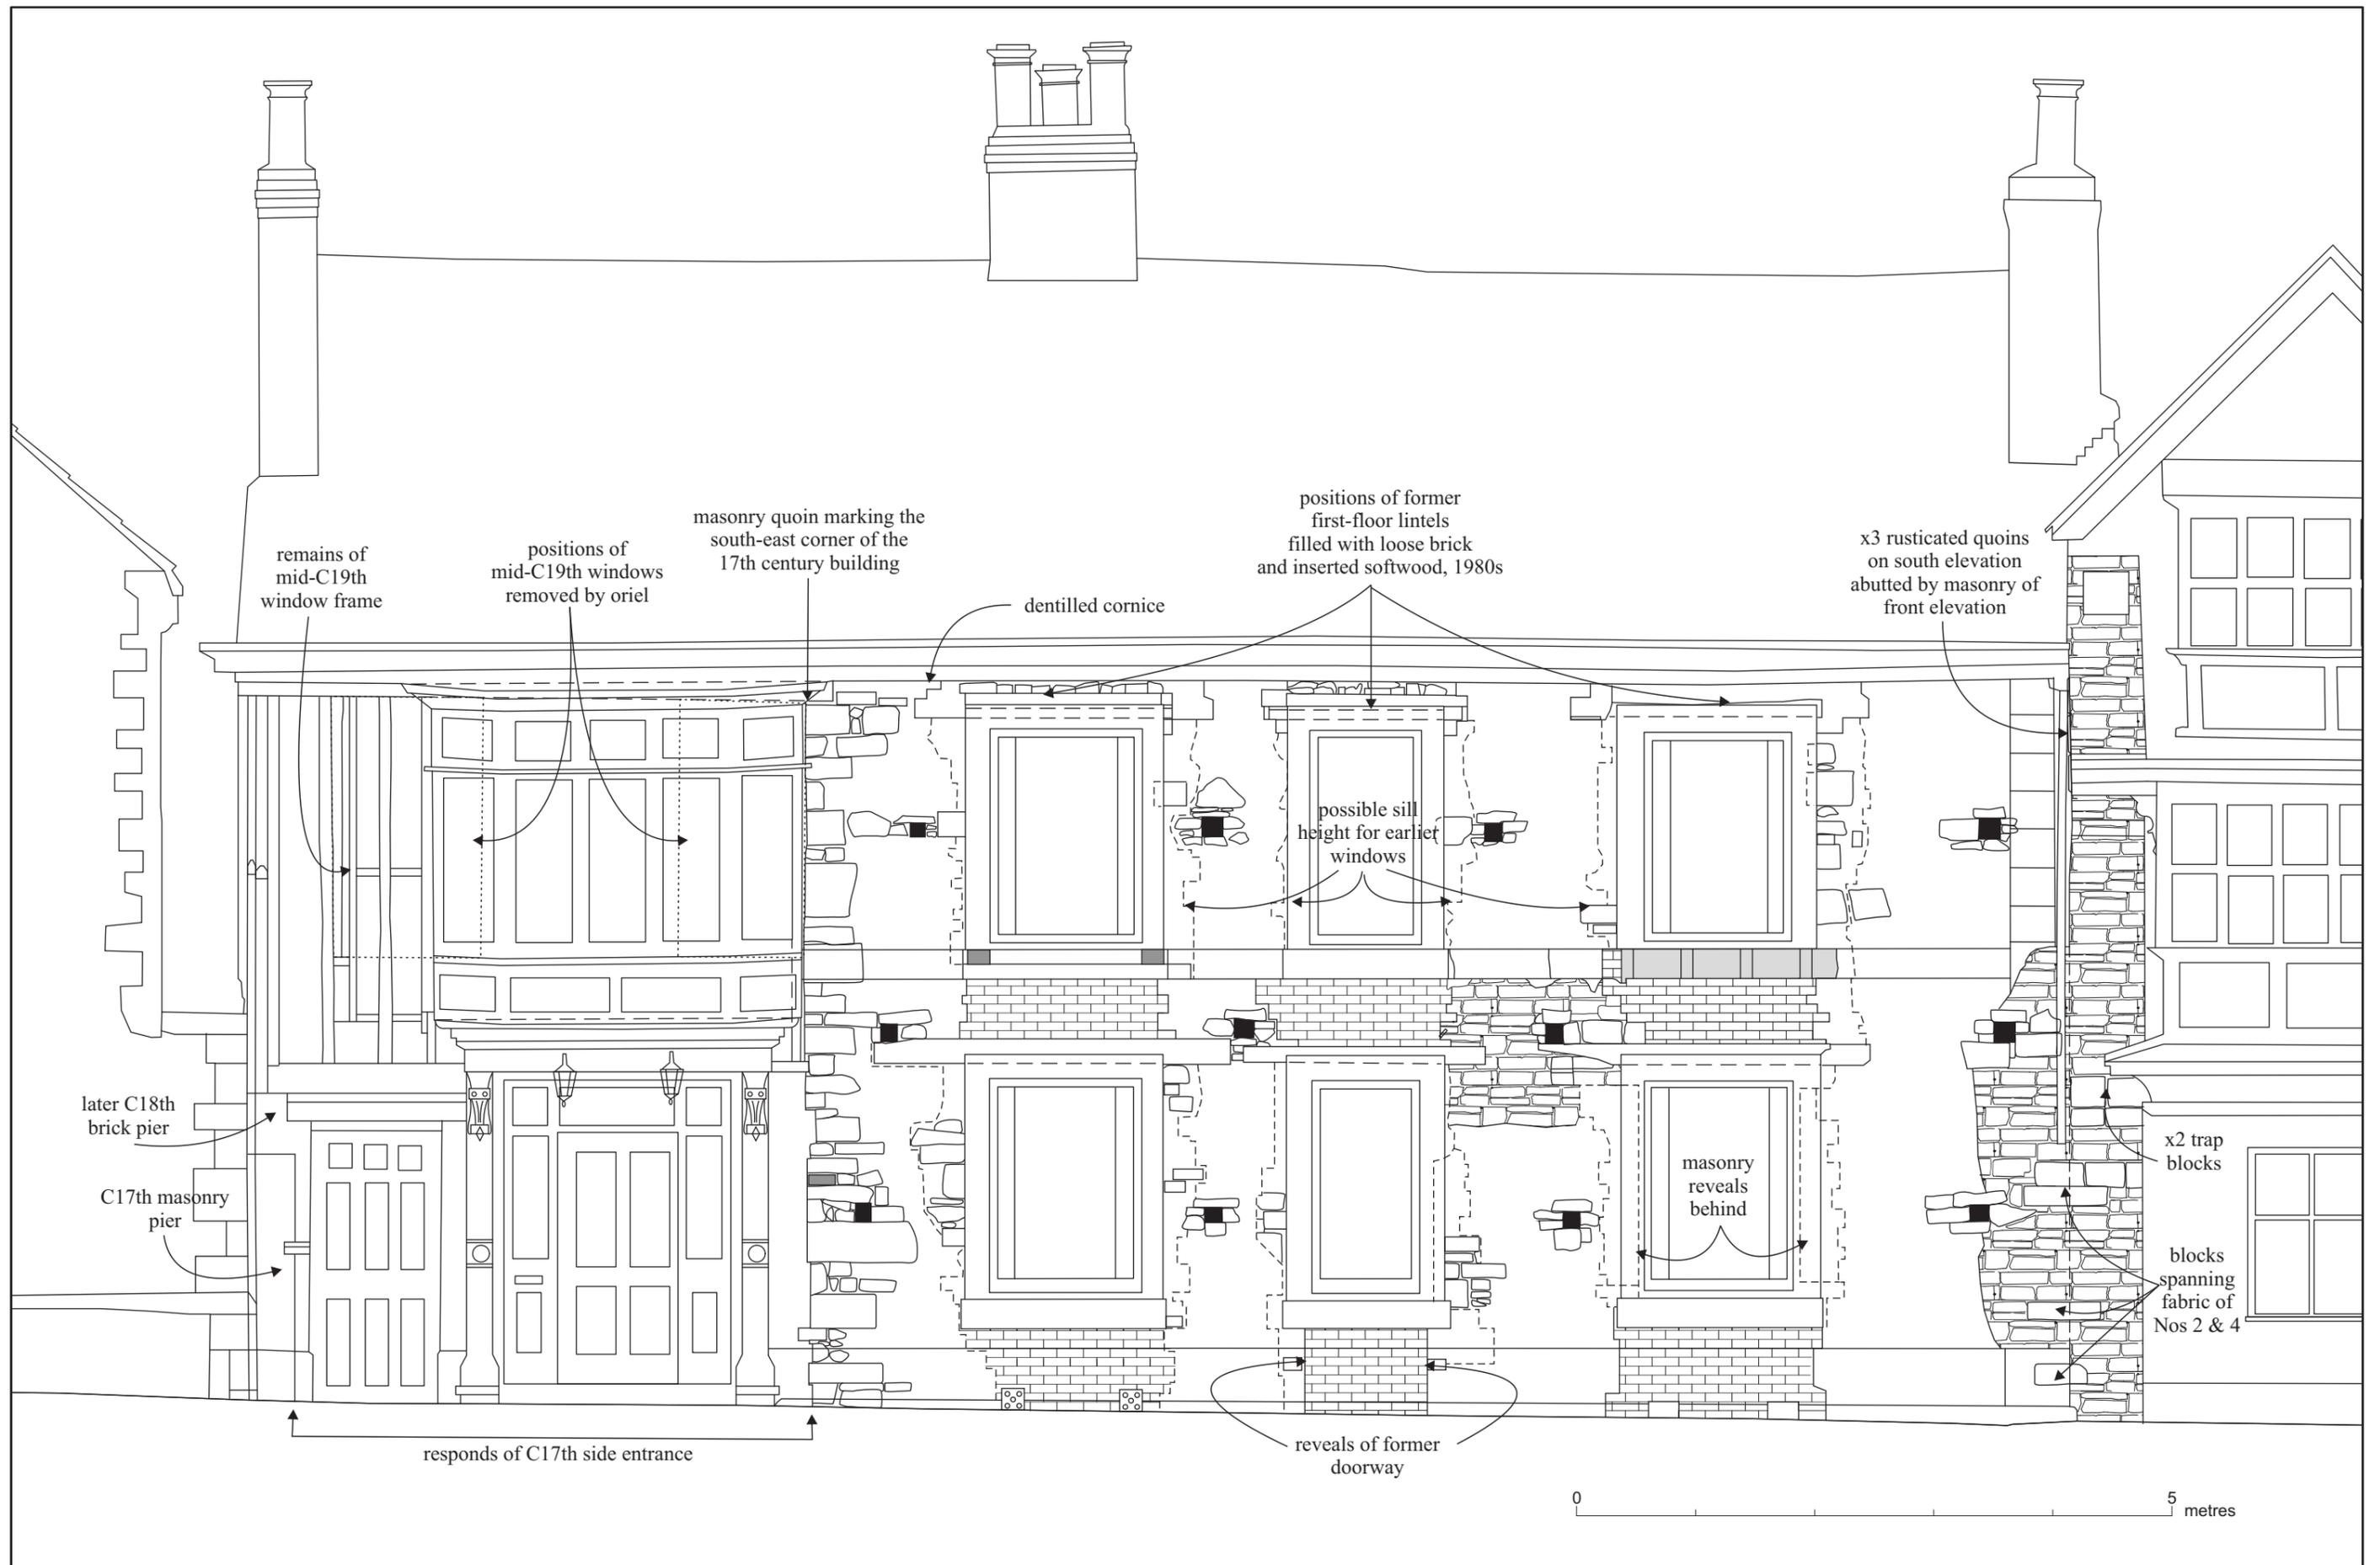
Fig. 12 Fore Street (east) elevation, annotated with observations (based on Barry Honeysett drawing no. 14179/45 with additions, with kind permission).

Surviving original 17th century fabric in this elevation consisted of four 'piers' of masonry between the intrusions caused by the insertion of the later windows which were visible cut into the rubble masonry (Figs 12, 15) and whose filling contained some brick, which the original masonry did not. The rubble masonry contained three tiers of putlog holes (representing the positions of beams for the support of scaffolding during original construction) at vertical intervals of 1.6–1.7m (Fig. 12). The top row of was approximately 1.30m beneath the cornice, invariably filled with brick. The presence of putlog holes established beyond doubt that the fabric between the window must be of 17th century date. The top tier of putlogs was pretty clear. Further close examination of the fabric succeeded in detecting putlogs lower down in two further tiers approximately at first-floor level and mid-way on the ground-floor (Fig. 12).

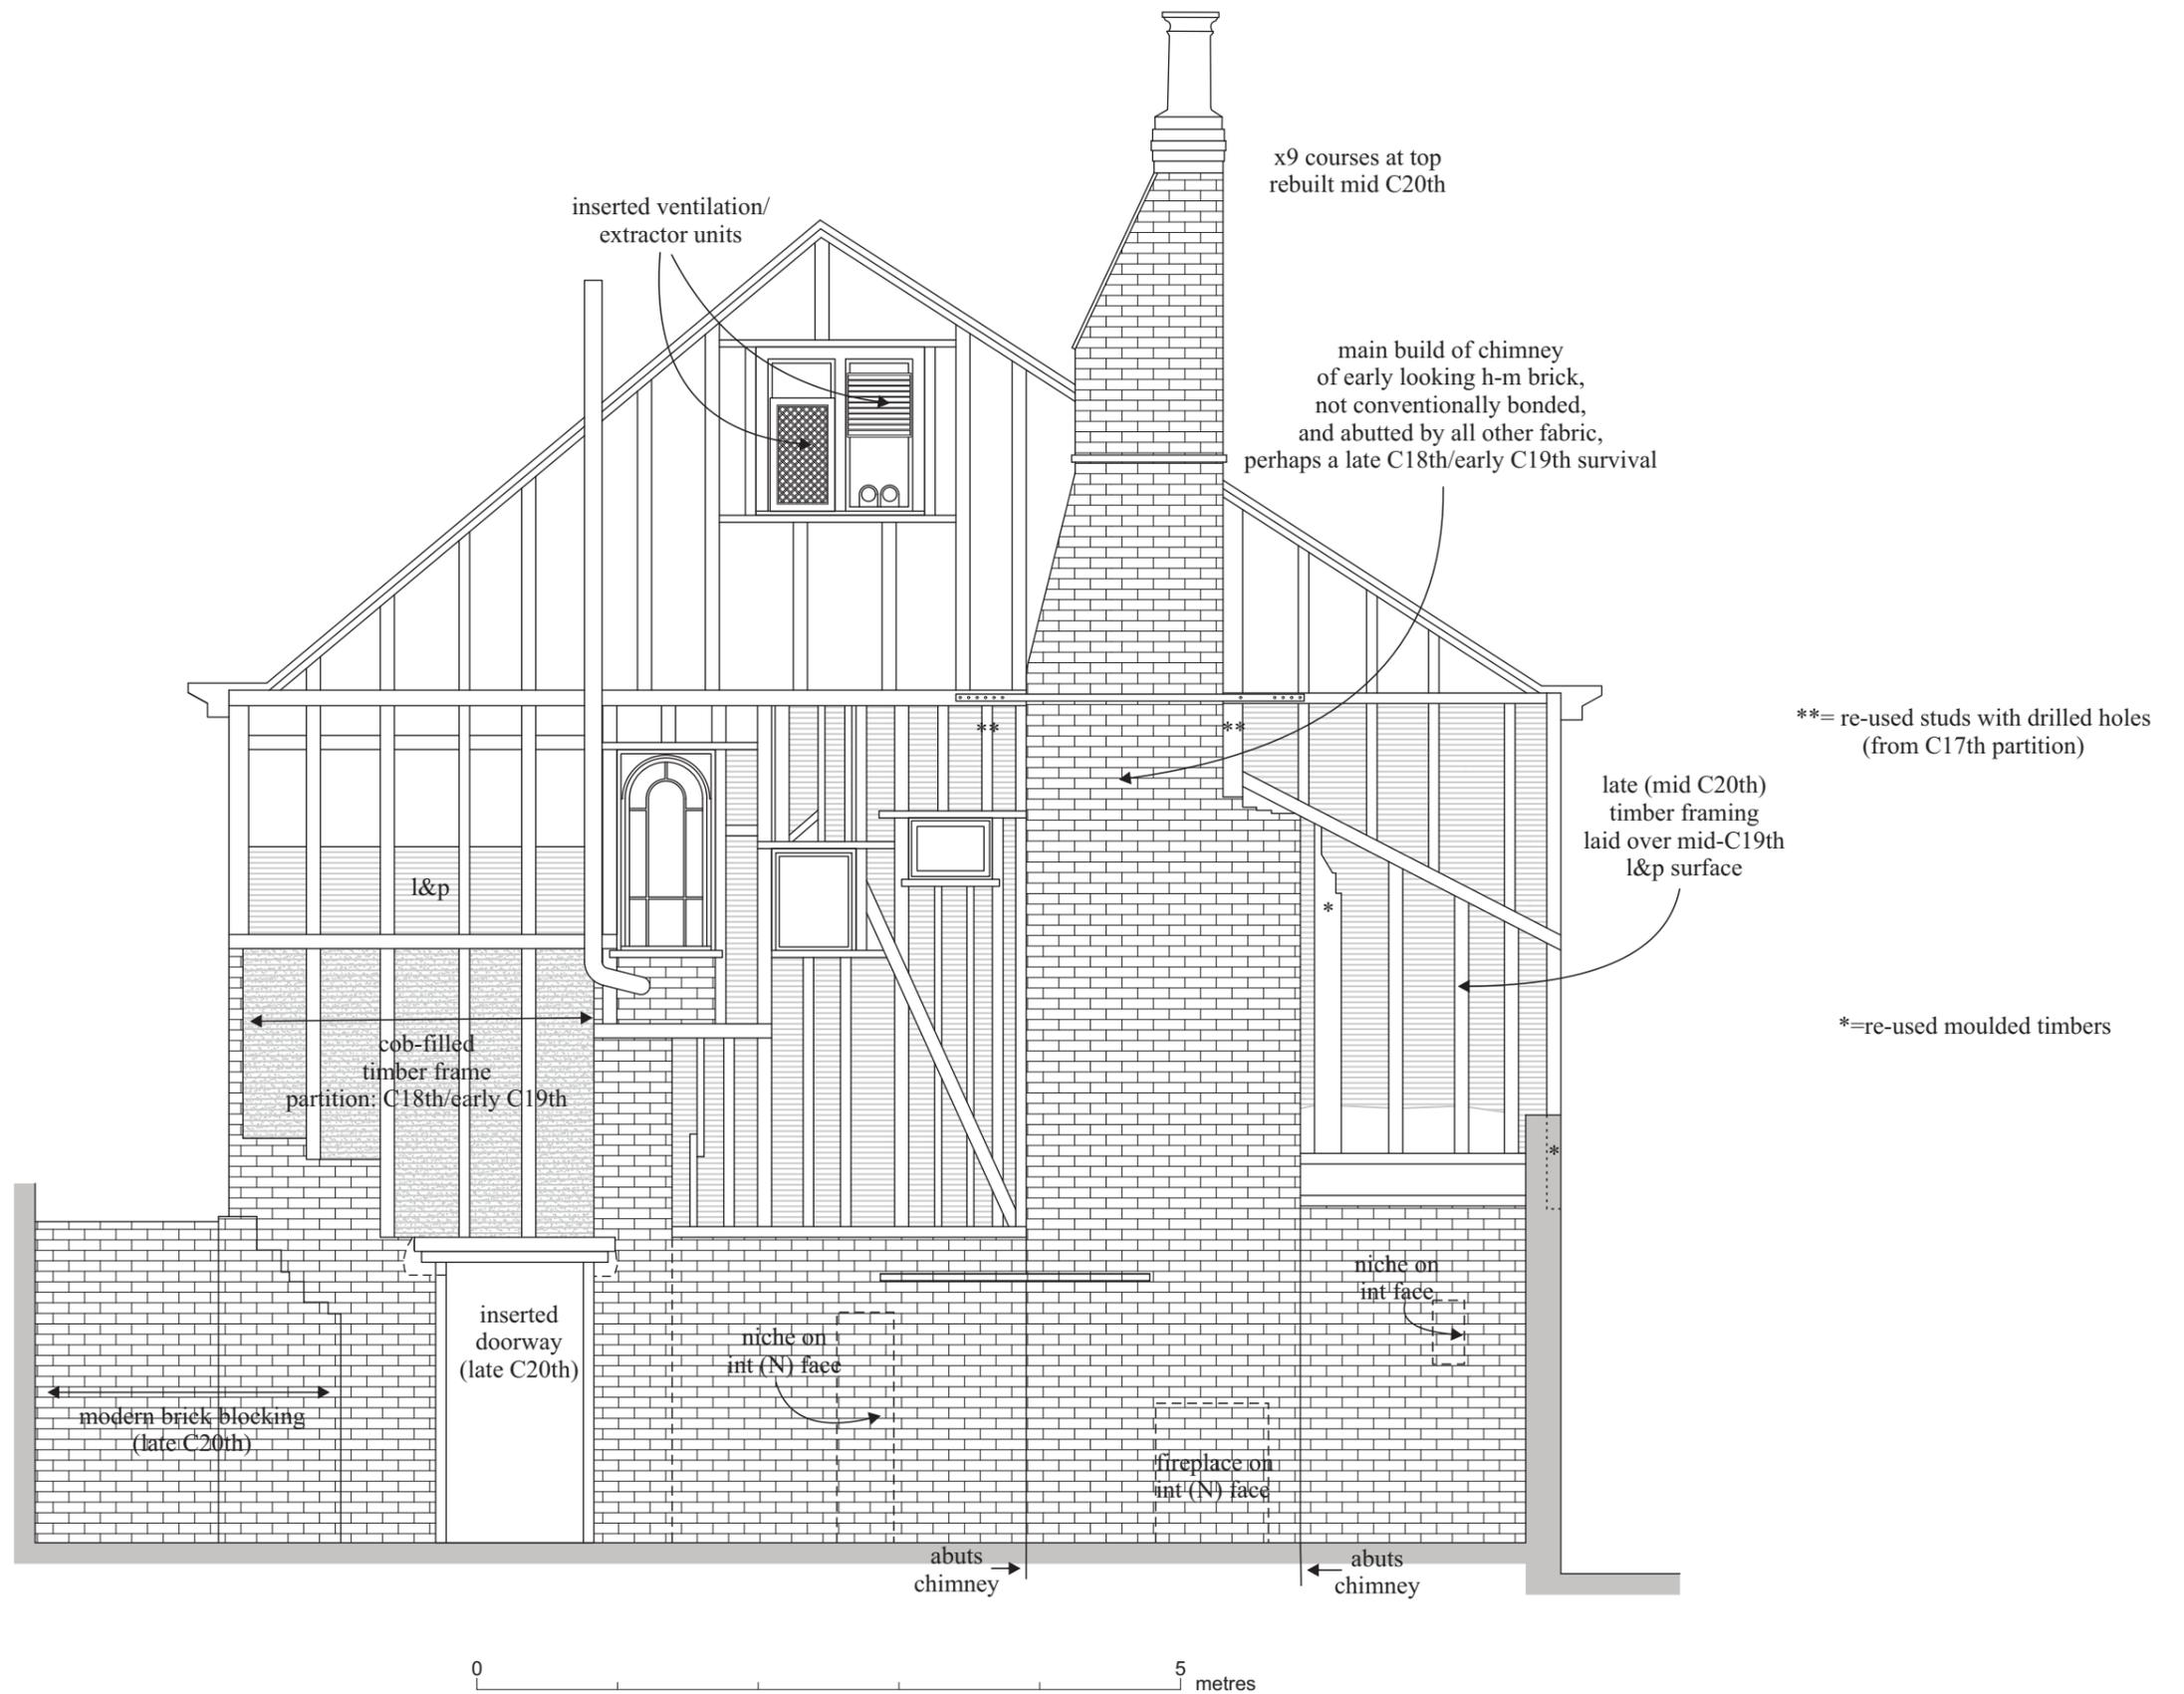
Fig. 13 Side (south) elevation, annotated with observations (based on Barry Honeysett drawing no. 14179/48 with additions, with kind permission).

Access to the south elevation was difficult, possible only from the extremely narrow gap between the standing walls of Veryards to the north and The Walronds to the south (Figs 34–36). In places this was as little as 250–300mm, or a single scaffolding plank's width, and conditions were very inclement (smelly from accumulated guano, slippery when wet, and prone to assault by live pigeons). The restricted access meant that only very oblique and/or close-to photography was possible, and this meant that the photographic record of this part of the work is considerably less than ideal (Figs 34–35). In consequence the recording of this elevation was more than usually reliant on drawings (Figs 13; 16).

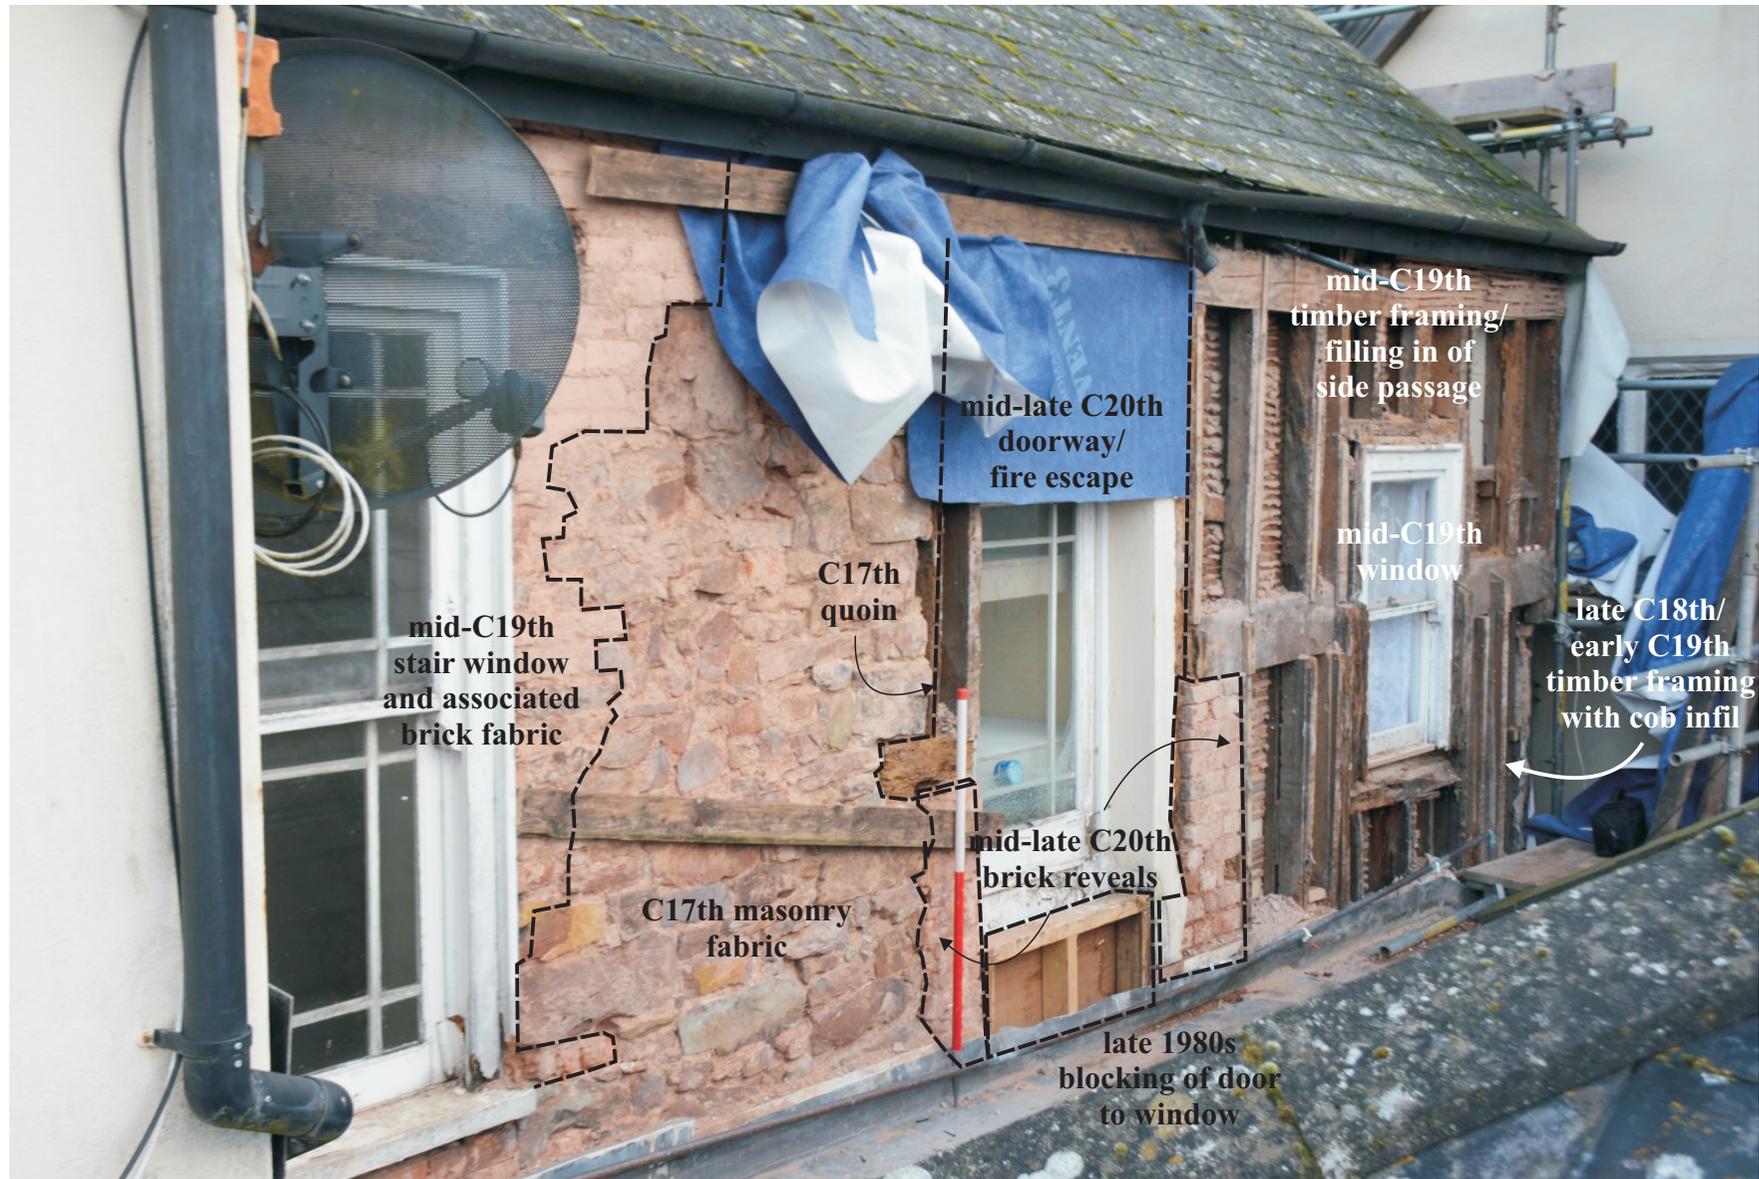
Fig. 14 Rear (west) elevation, photograph annotated with observations and phasing (photo ref: SRB 7502).

The timber framing was a hotch potch of different phases, containing large (230 x 140mm/9 x 5½") timbers at the top and in the middle (Fig. 40), with nailed-on studding forming the basic frame, and with lath and plaster cladding on both internal and external surfaces. Below was an area of 20th-century brick repair. This had an integral sash window (to the south) with plate glass and horned sashes (Fig. 39): therefore of mid.-19th century date. To the north was a more modern opening, perhaps occupying the position of an earlier window, but now a door in its present incarnation, although blocked by the construction of the western extension to Veryards of c.1989. This looks like a mid.- or late-20th century fire escape, predating the addition of the rear bar of Veryards in the late 1980s, and with its lower half obscured and blocked in with timber framing at that time (the lead flashing of the 1989 guttering runs against this: Figs 14; 39).

The doorway was faced with modern brick below (Fig. 14). This probably related to the first fitting out of the hotel in 1983, after the acquisition of No. 4, and the extension of the hotel into this building. N.B. that the brick rose to the full height of the door on the south reveal, but only the lower half of the north reveal was of brick, hence the suggestion that there might have been a window in this position before. Although it was sealed and painted over, the door remained in position. It too had the stuck-on marginal panes/moulded glazing bars noted for the stair window to the north.

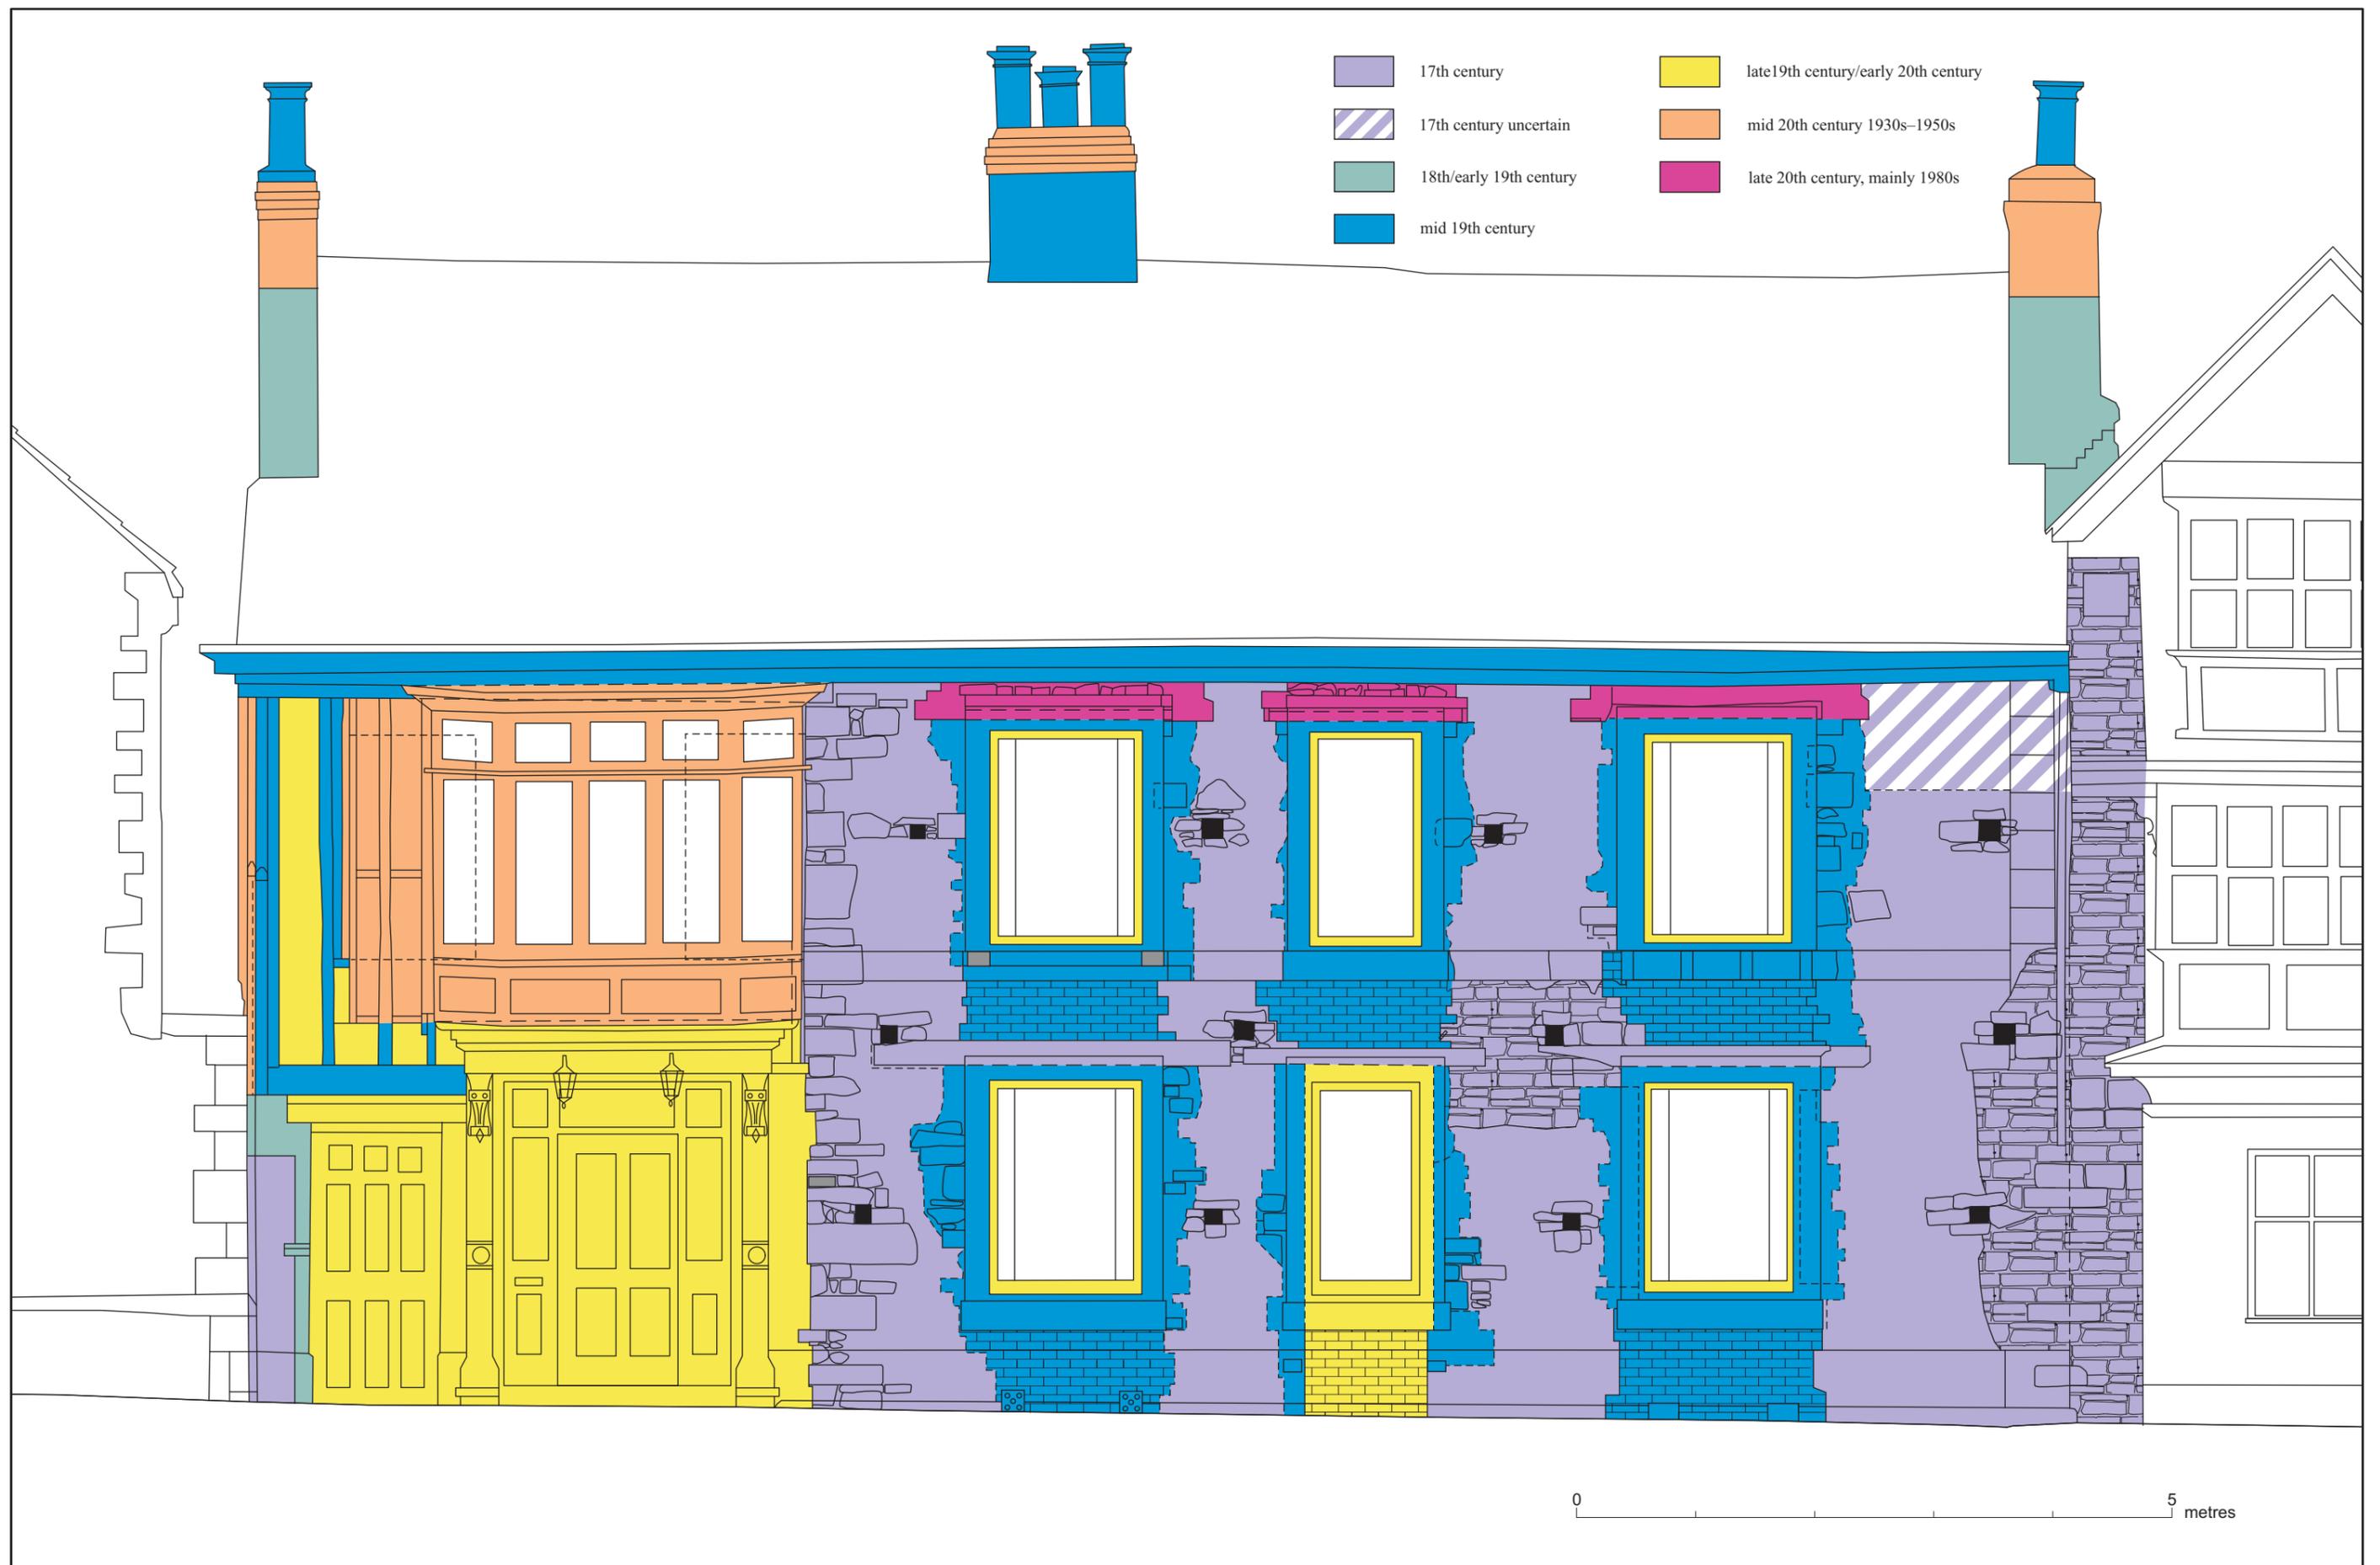
Fig. 15 Fore Street (east) elevation, coloured up with phasing of observations (based on Barry Honeysett drawing no. 14179/45, with additions).

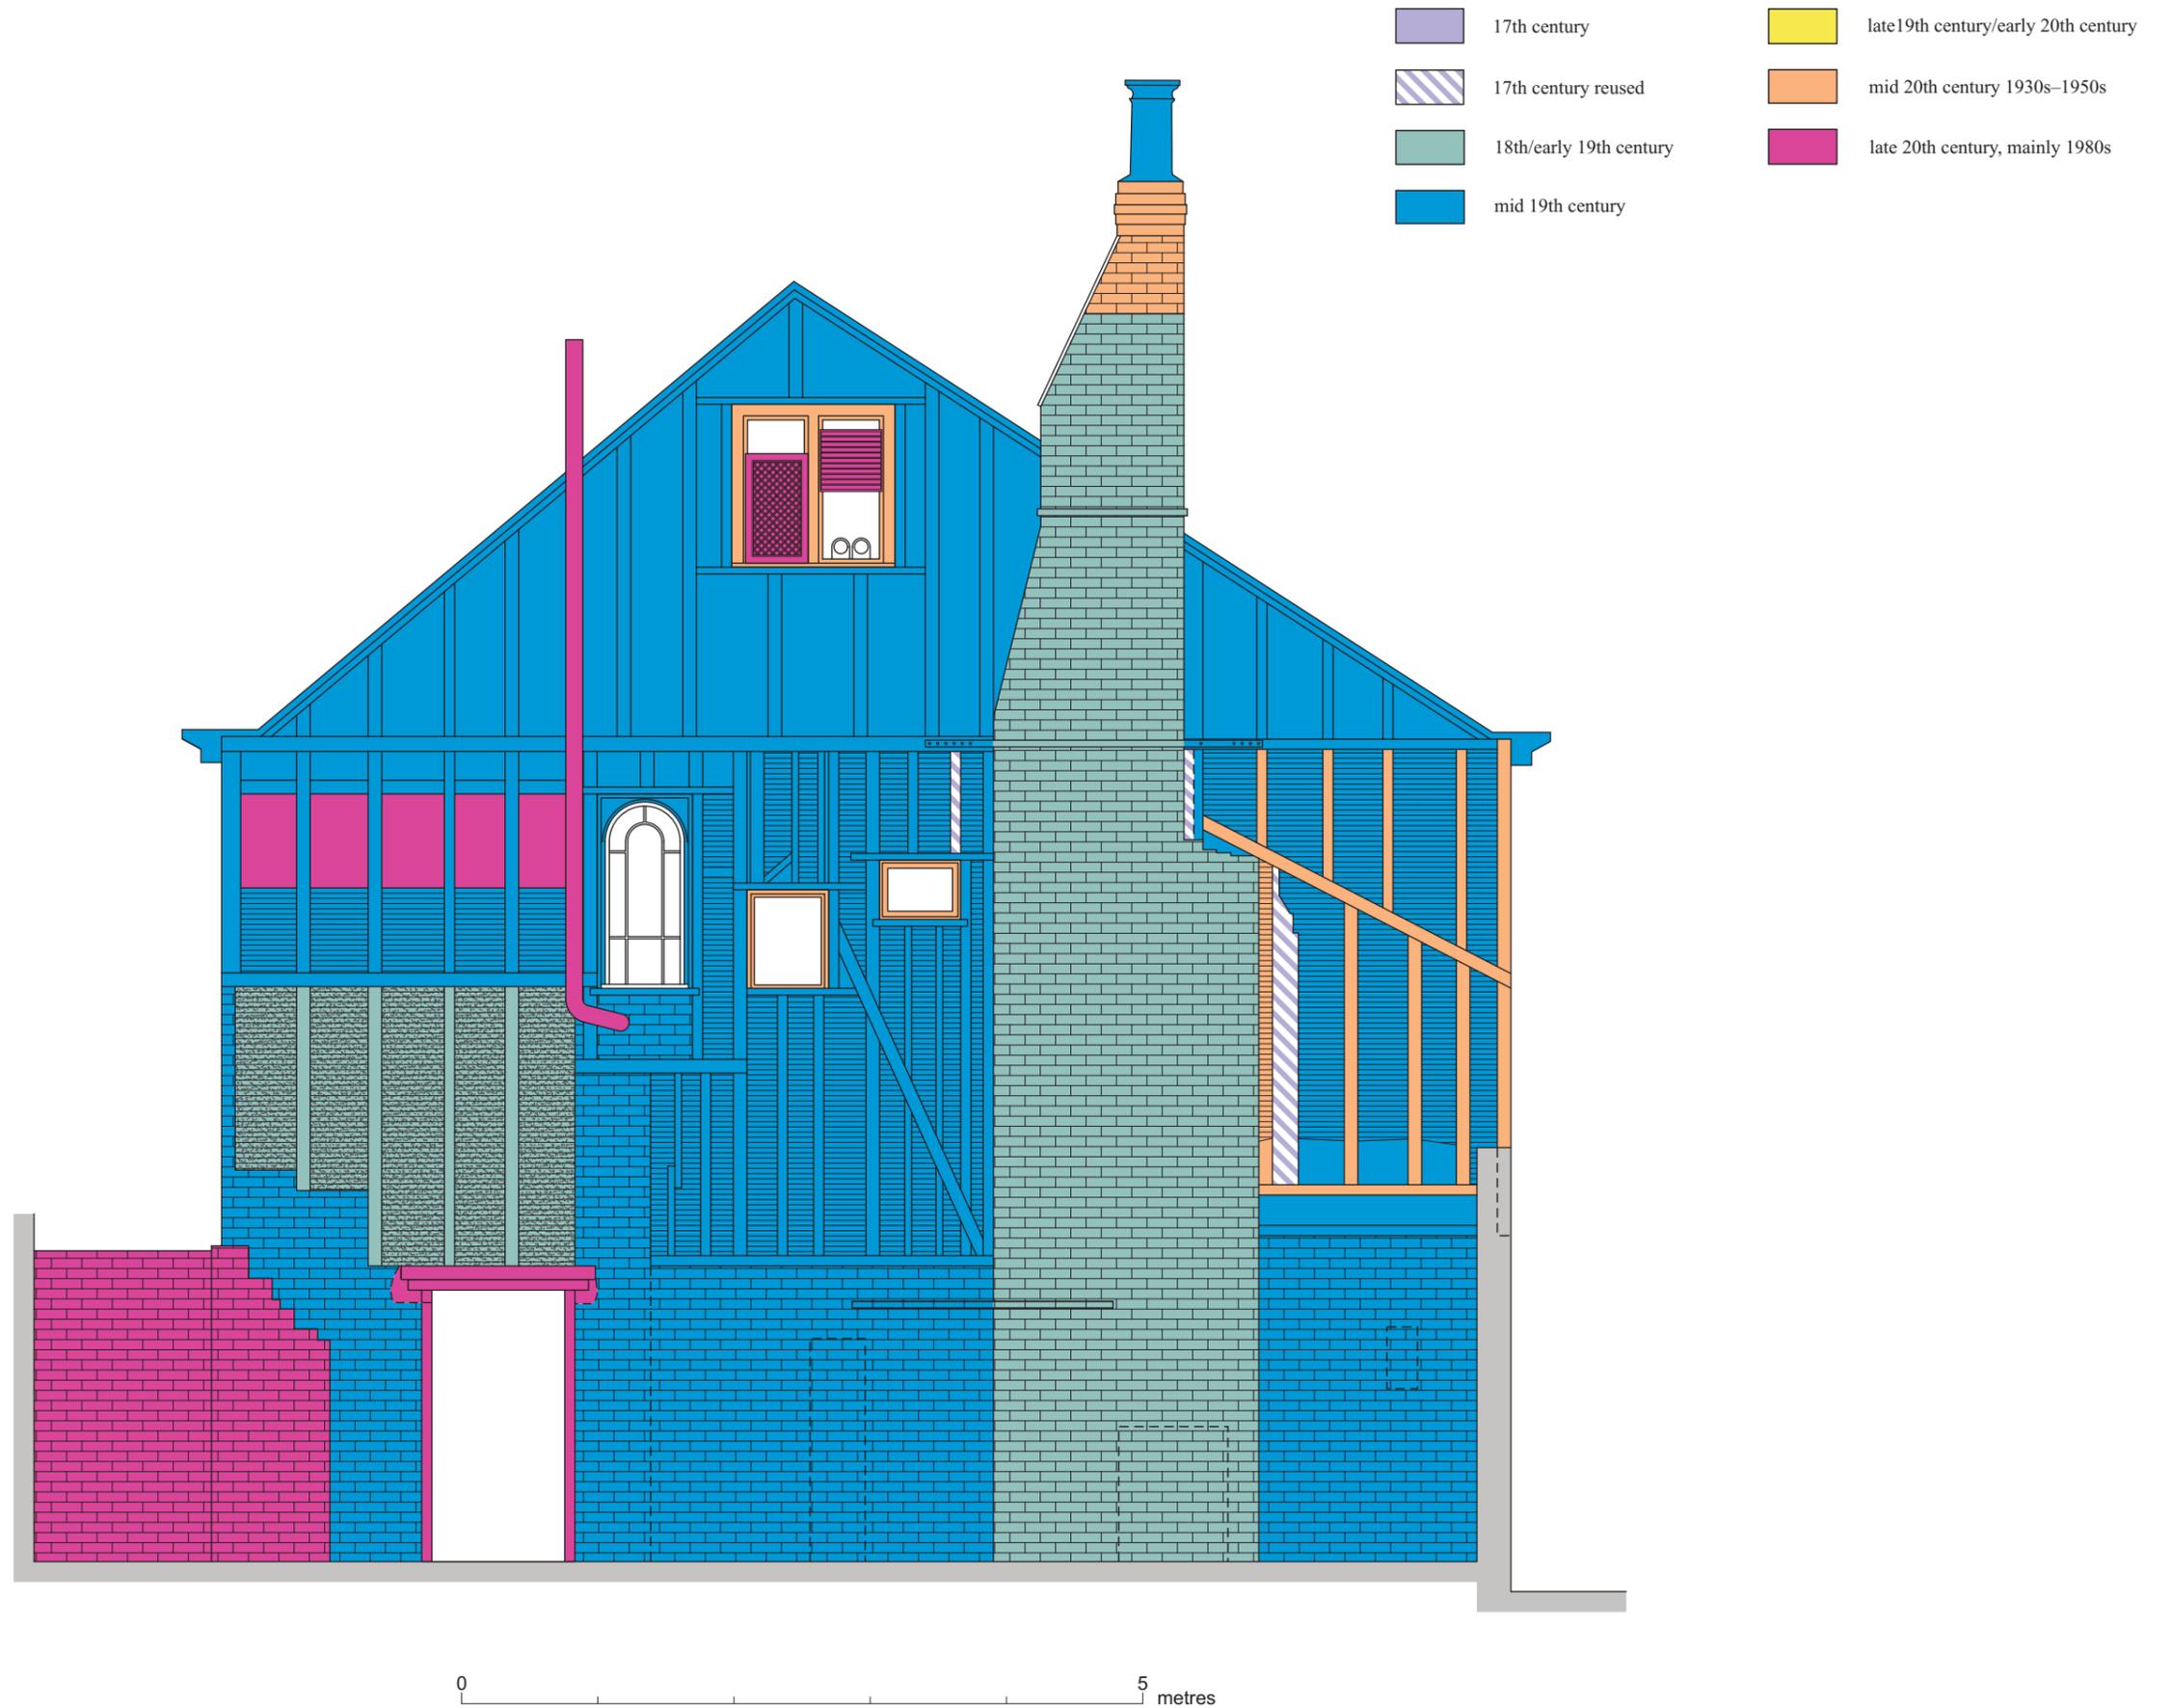
Fig. 16 Side (south) elevation, coloured up with phasing of observations (based on Barry Honeysett drawing no. 14179/48, with additions).

The windows seemed to be integral to the main run of framing, and help to date it. The tall round-headed light with large panes and marginal lights ought to be mid.-19th century in date, so therefore contributes to the dating of the whole assemblage. Occasional later repairs were noted, notably an area of later 20th century plasterboard repair to the interior of Room 10 (south-west corner); the insertion of the doorway (presumably to permit access once the western end of the drang was blocked by the extended brick wall (above); etc. (Fig. 16).

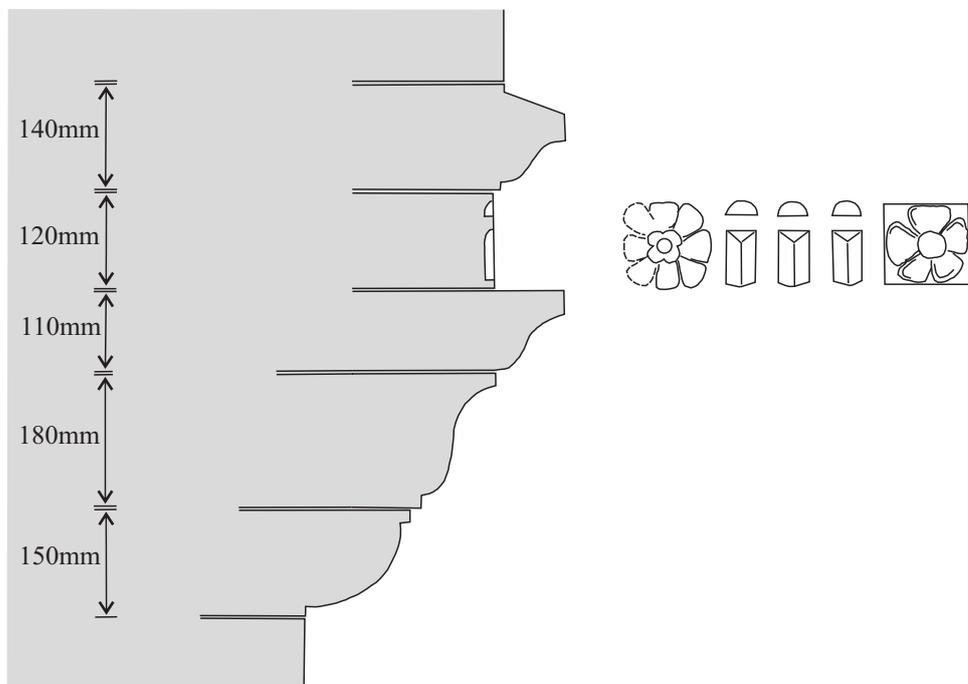
Fig. 17 Scale drawing of the corbel mouldings of the south wall of No. 2 Fore Street, The Manor House Hotel, with detail of the frieze ornament. Scale 1:10.

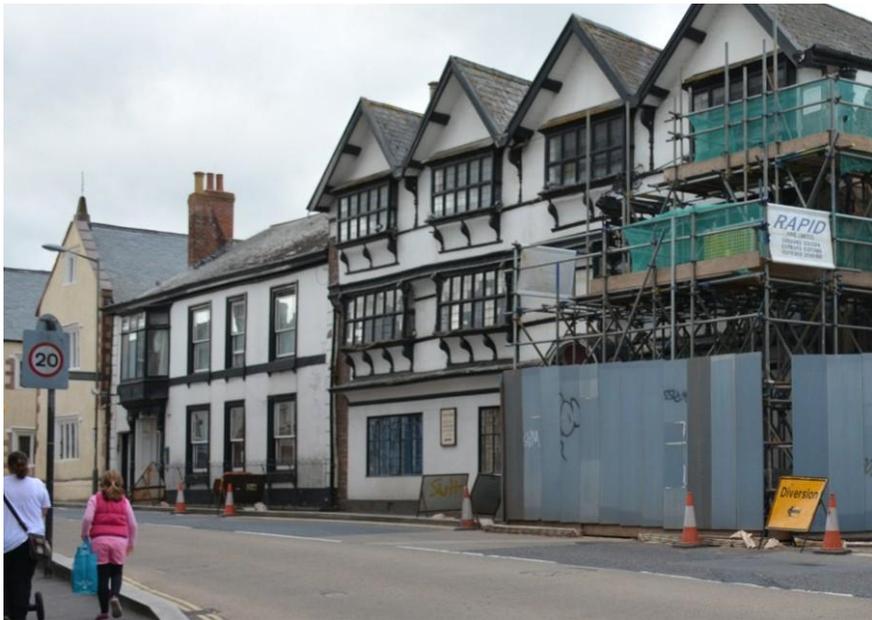
Fig. 18 Nos 2 and 4 Fore Street in August 2015, with works in progress on the Manor House Hotel, showing Veryards pre-works (photo ref: 2115).

The plinth at ground level (Figs 18; 20) was *c.*500mm high and projected 20mm or so from the wall face. The ground floor windows had projecting sills supported on brackets individually 200mm high. These had stooling for the timber window frames, not well articulated on the drawings and not easy to photograph behind the railings.

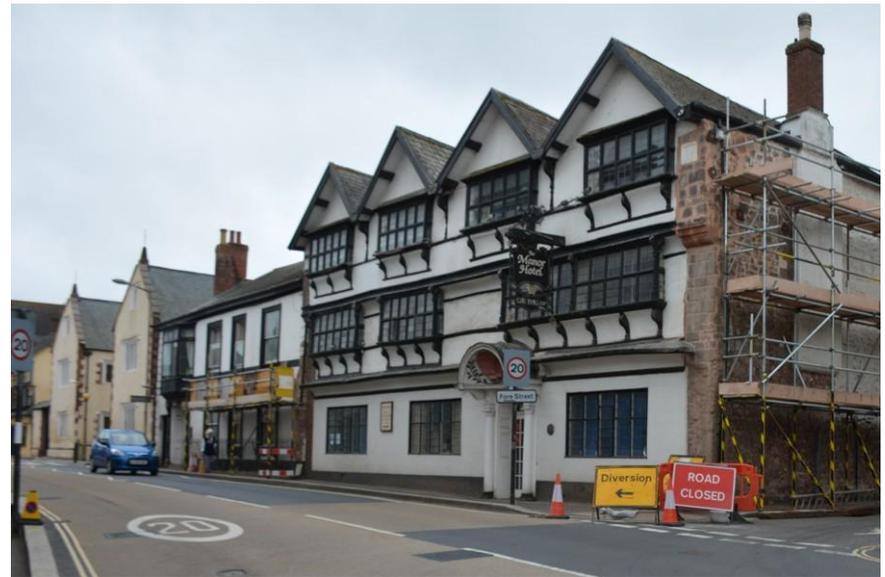
Fig. 19 The same view in November 2015, with works coming to an end on the Manor House and an inspection scaffold erected on No. 4 (photo ref: 8239).

An inspection scaffold was erected in autumn 2015, while work was still in progress on the north wall (Fig. 19). At this time selected areas of rendering were removed towards the north end of the main (street) elevation.

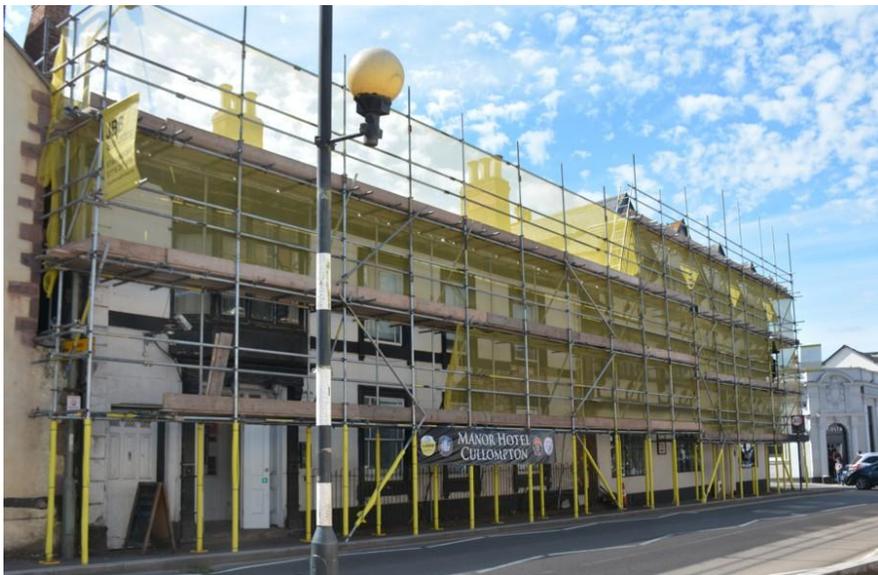
Fig. 20 Fore Street frontage fully scaffolded in July 2017, before commencement of works (photo ref: 5411).

- 5409–12 General view of the building when first fully scaffolded, July 2017, looking north-west.
- 5413 Same, detail of south end of street elevation, looking west.
- 5414–21 Same, general views looking south-west.

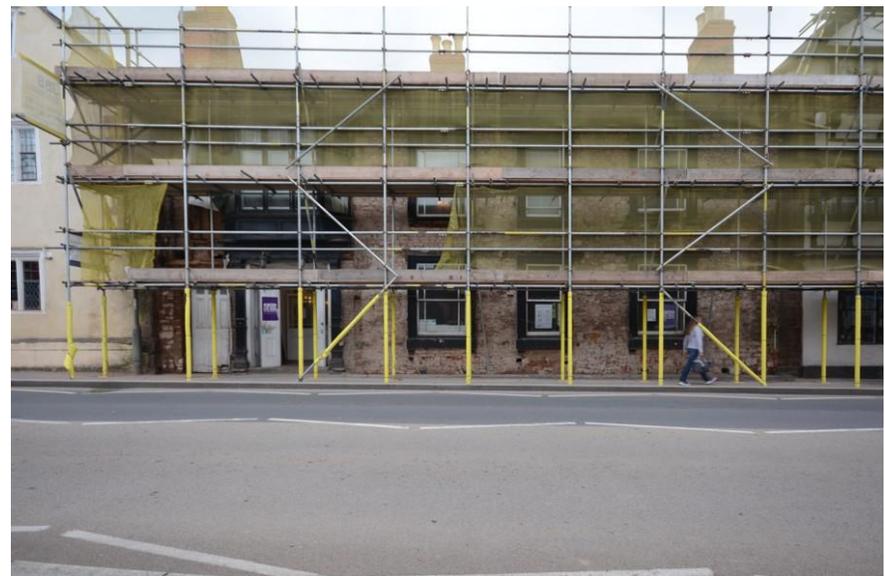
Fig. 21 Fore Street frontage with rendering removed in October 2017 (photo ref: 7072).
