**Historic Building Recording
at
Veryards, 4 Fore Street
Cullompton, Devon
in 2017**

**by
Stuart Blaylock**

August 2018

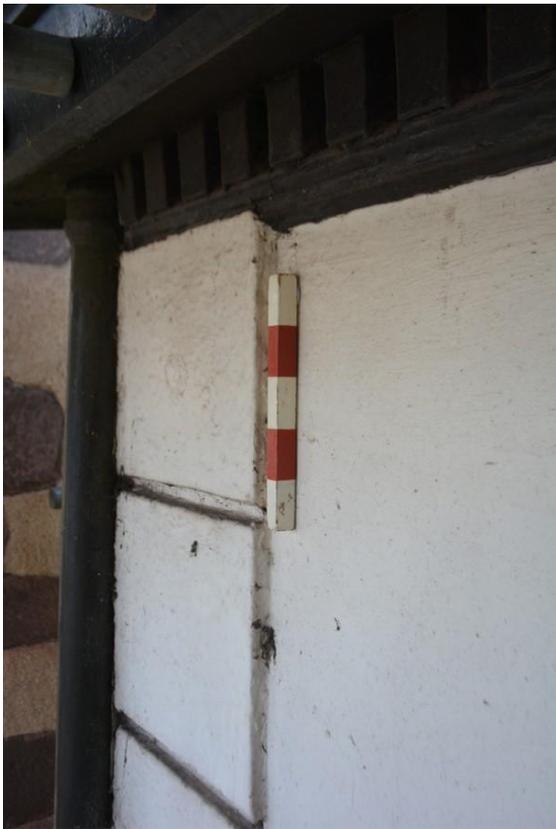
Fig. 22 Southern quoin, detail of rusticated quoins and cornice at wall top (photo ref: 6872).

The rusticated quoins (Figs 12; 22–23) were 360mm wide, 285mm high and had a minimum projection of *c.*18–20mm; the gap between them was *c.*30mm. By the time individual 'blocks' have been gummed up with paint they measured more like 370 x 300mm. The quoins began 120mm short of the visual corner of the building in order to allow space for a rain water down-pipe. At the top/second floor level the gap with the jettied-out wall of No. 2 was 150mm. The plat band (Fig. 24) was 240mm deep, projected from the wall face by *c.*20mm; and stepped out another 50mm beneath the first-floor window sills. The brackets beneath the first floor windows were 160mm wide and 160–170mm high, with a maximum projection of *c.*50mm (Fig. 24).

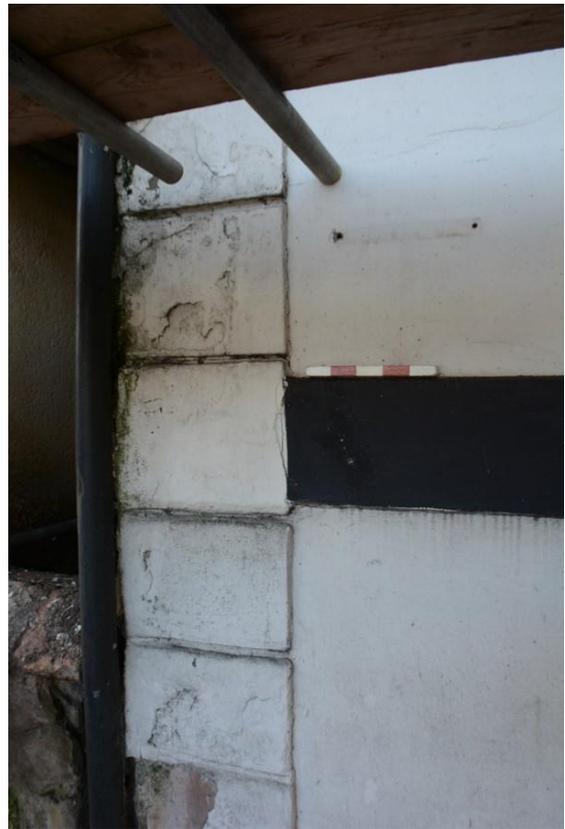
Fig. 23 Southern quoin, detail of rusticated quoins and plat band, looking south west (photo ref: 6908).

The rusticated quoins at the south end of the facade, as those at the north end, were 300mm high, 360mm wide, and projected 20mm(+/-) from the plane of the wall. They stopped short of the true corner of the building by 120mm in order to leave room for the rain-water pipe (Fig. 23).

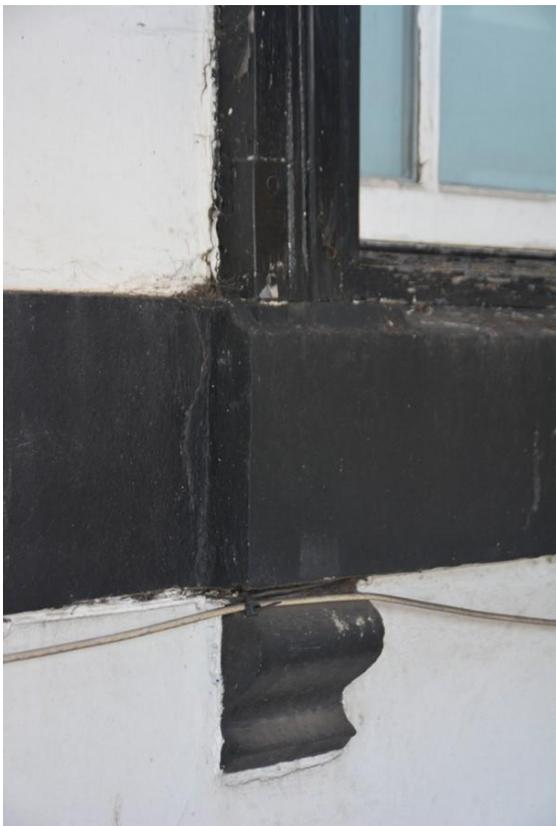
Fig. 24 Detail of plat band stepping out beneath windows and bracket beneath (photo ref: 6916).

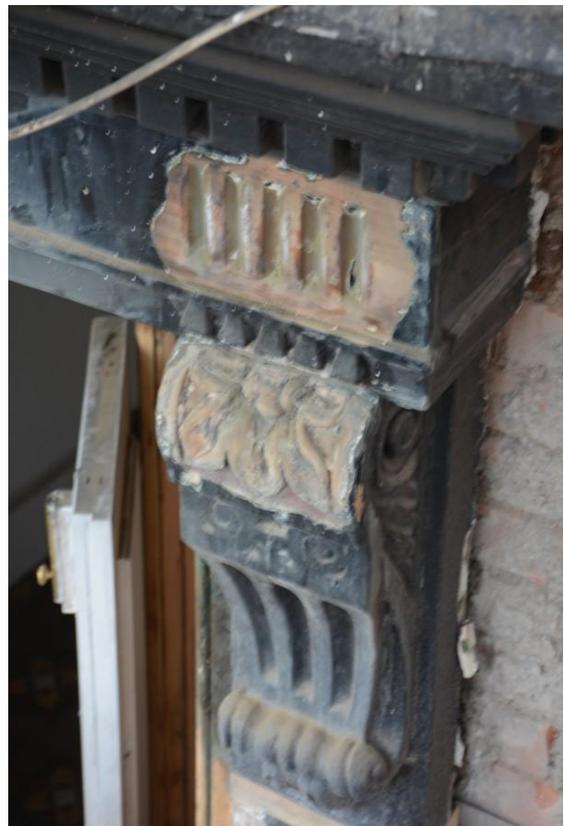
Fig. 25 Detail of console bracket of late 19th century doorway to the side passage, partially stripped, showing the clarity of detail beneath layers of paint (photo ref: 7528).

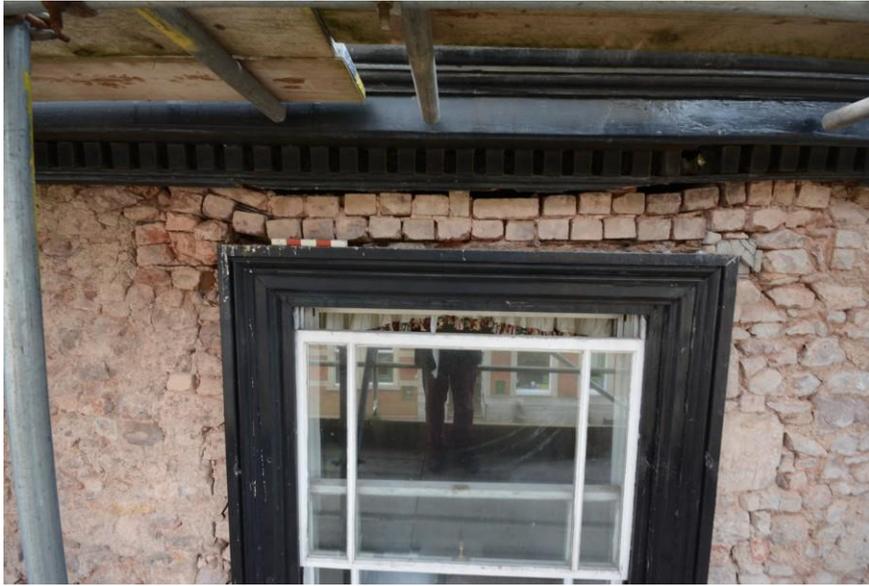
Fig. 26 Northern first floor window, showing improvised 1980s brick repair of decayed lintel (photo ref: 6997).

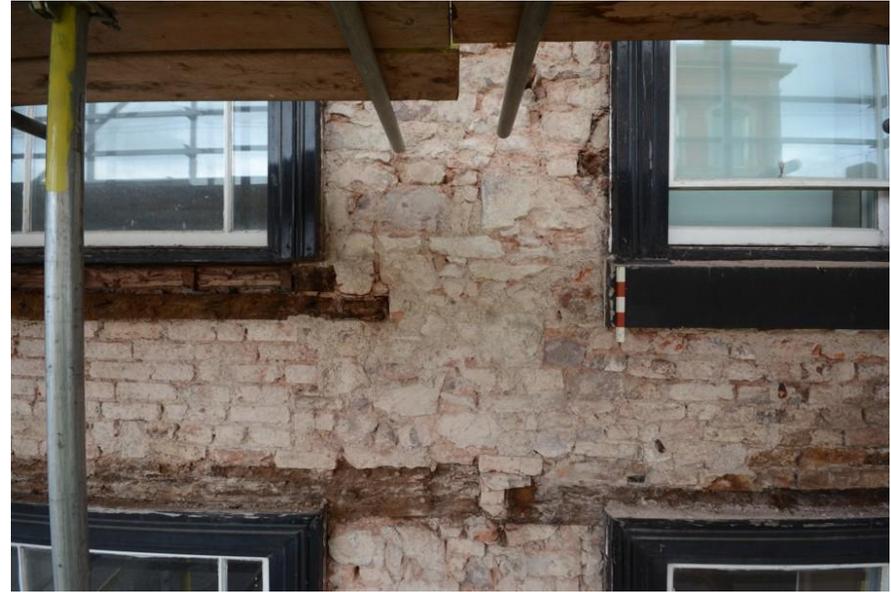
Fig. 27 Southern and central first-floor windows, showing brick aprons beneath and original lintels to ground-floor windows below (photo ref: 7028).

and timber sills (decayed in places). Largely decayed timber lintels were seated in undisturbed masonry either side of the present ground-floor windows (Fig. 27), suggesting that these may have been original 17th century lintels and that the surviving window embrasures represented the positions of earlier openings in some way.

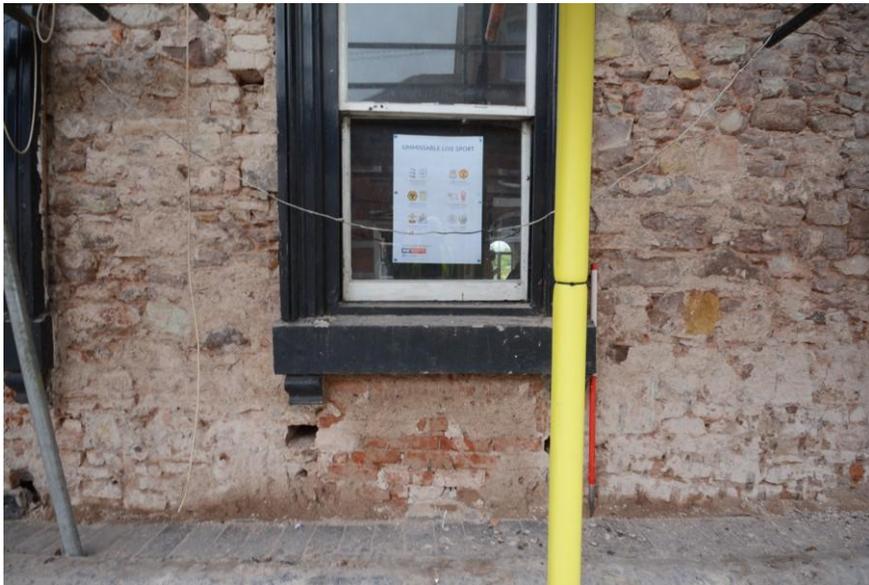
Fig. 28 Central ground-floor window, with blocking of earlier doorway beneath (photo ref: 7064).

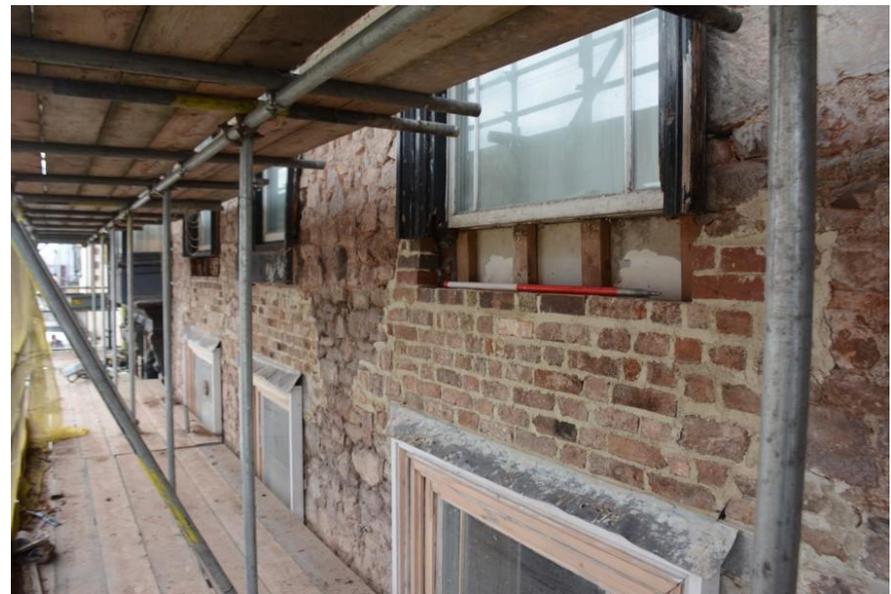
Fig. 29 Oblique view along first floor at window sill level, showing repairs in progress after inserted of new concrete lintels (photo ref: 7522).

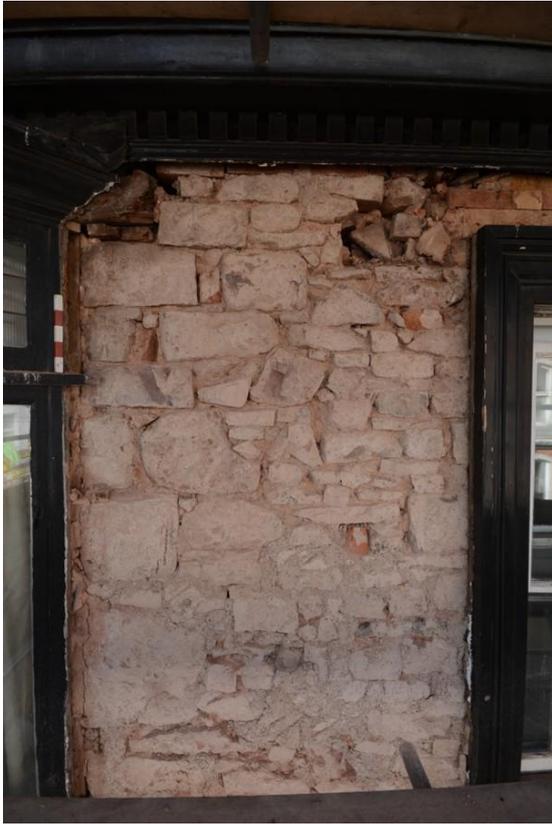
Fig. 30 Masonry walling north of the oriel window, showing the SE quoin of the 17th century building, upper stage (photo ref: 6984).

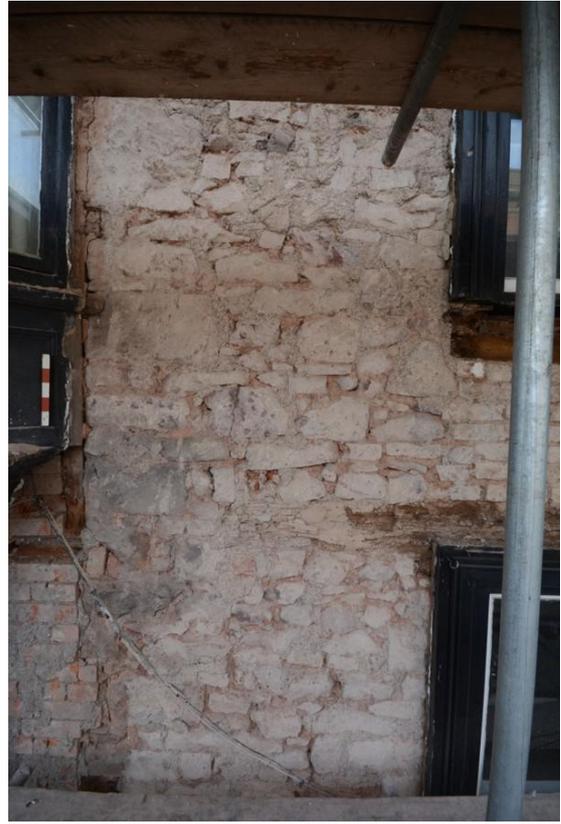
Fig. 31 Masonry quoin, middle stage, showing the base of the oriel and top of the ground-floor doorway (photo ref: 7019).

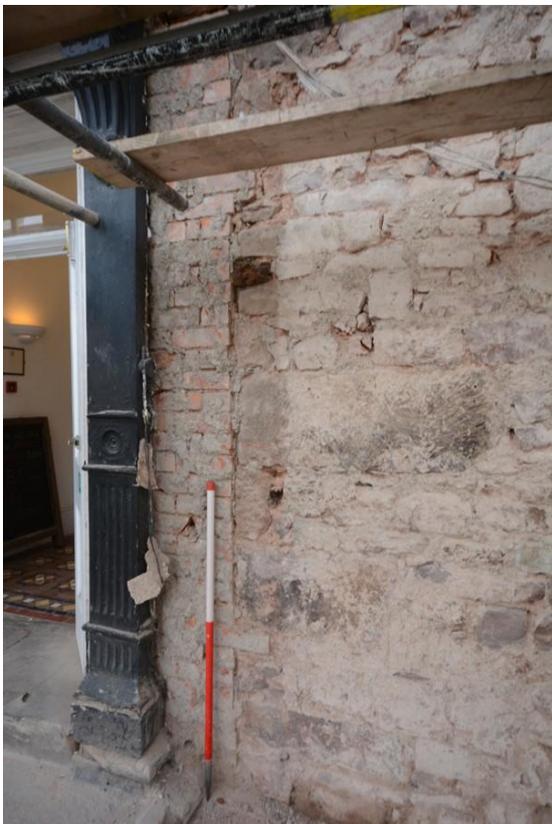
Fig. 32 Masonry quoin, ground floor stage, showing also brick north pier of late 19th century doorway (photo ref: 7055).

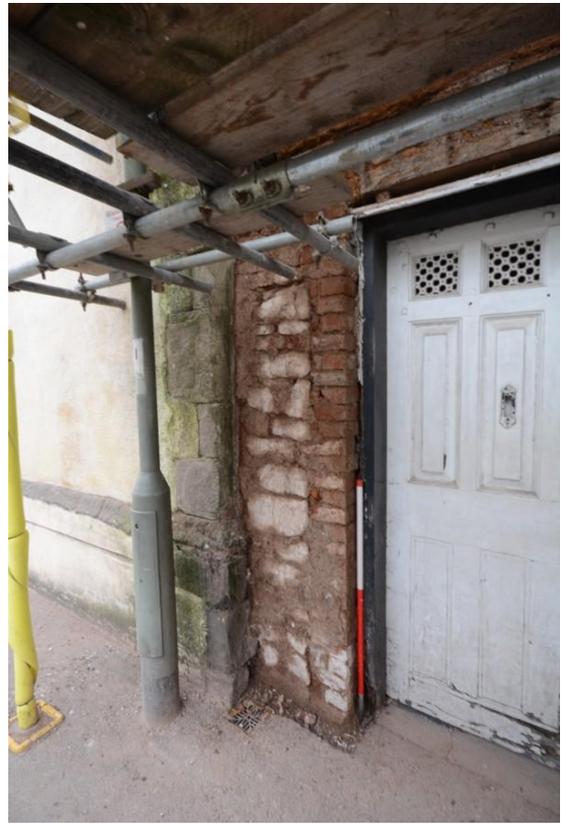
Fig. 33 Masonry pier on the south side of the original side entrance, abutting the quoin of The Walronds, looking south west (photo ref: 7051).

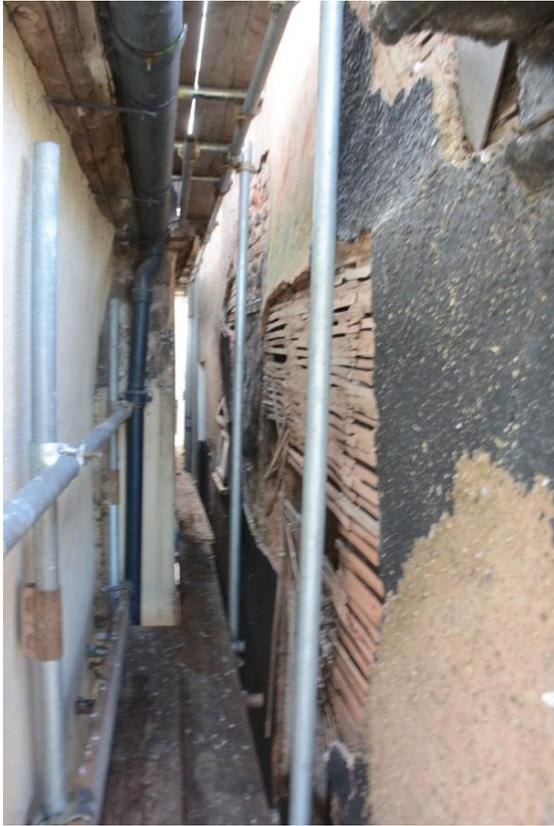
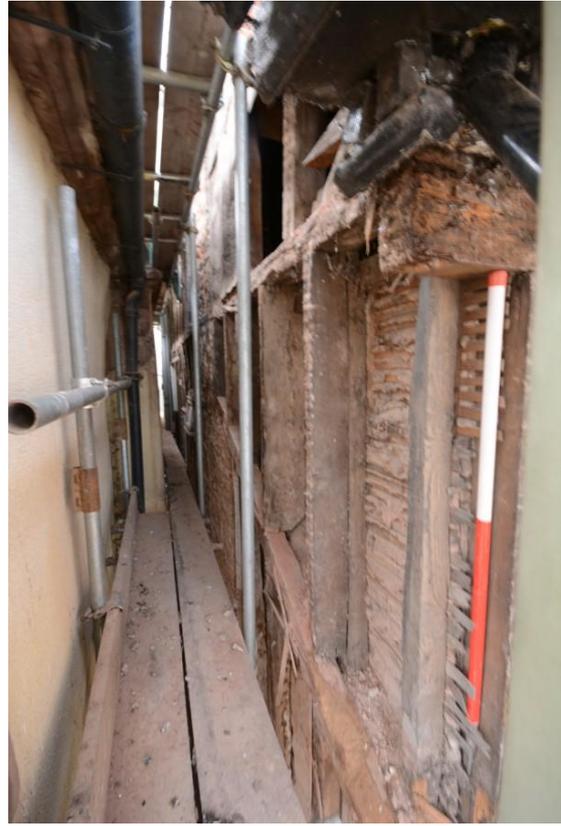
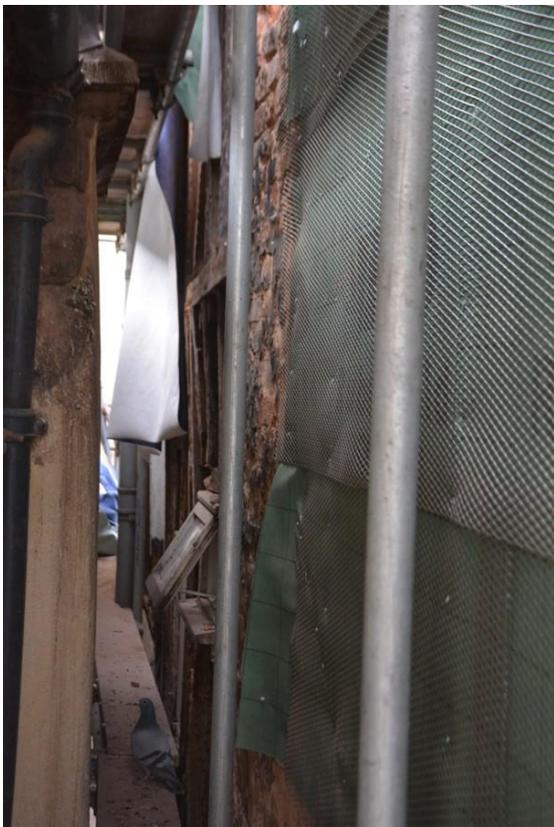
Fig. 34 South elevation, oblique view looking west along the wall in the narrow gap between Veryards (left) and The Walronds (right), showing condition before stripping in September 2017 (photo ref: 6868).

Fig. 35 The same, once lath and plaster had been removed in October 2017 (photo ref: 6979).

Fig. 36 Same, during repair in December 2017 (photo ref: 7545).

Access to the south elevation was difficult, possible only from the extremely narrow gap between the standing walls of Veryards to the north and The Walronds to the south (Figs 34–36). In places this was as little as 250–300mm, or a single scaffolding plank's width, and conditions were very inclement (smelly from accumulated guano, slippery when wet, and prone to assault by live pigeons). The restricted access meant that only very oblique and/or close-to photography was possible, and this meant that the photographic record of this part of the work is considerably less than ideal (Figs 34–35). In consequence the recording of this elevation was more than usually reliant on drawings (Figs 13; 16).

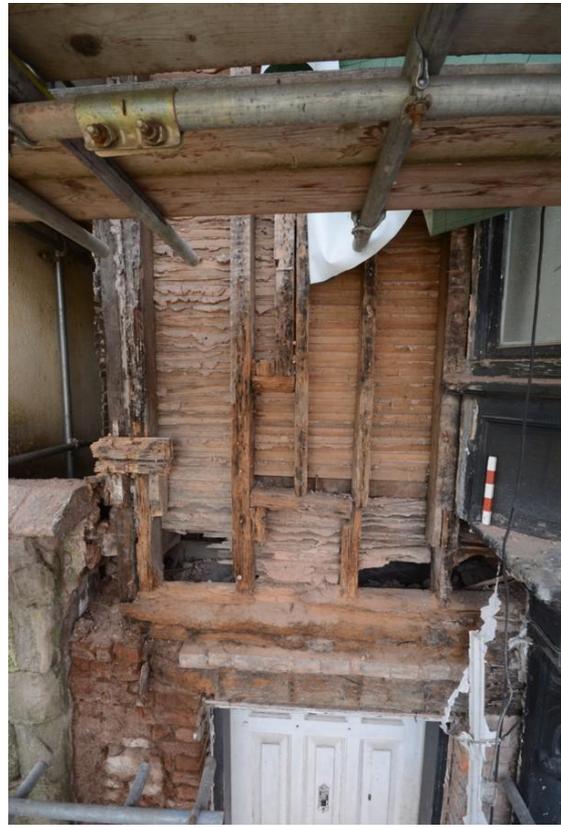
Fig. 37 South end of the south elevation, between the corner and the oriel window, showing original mid.-19th century framing (left) and blocking of a first-floor window (centre), note two phases of lath and plaster (photo ref: 7016).

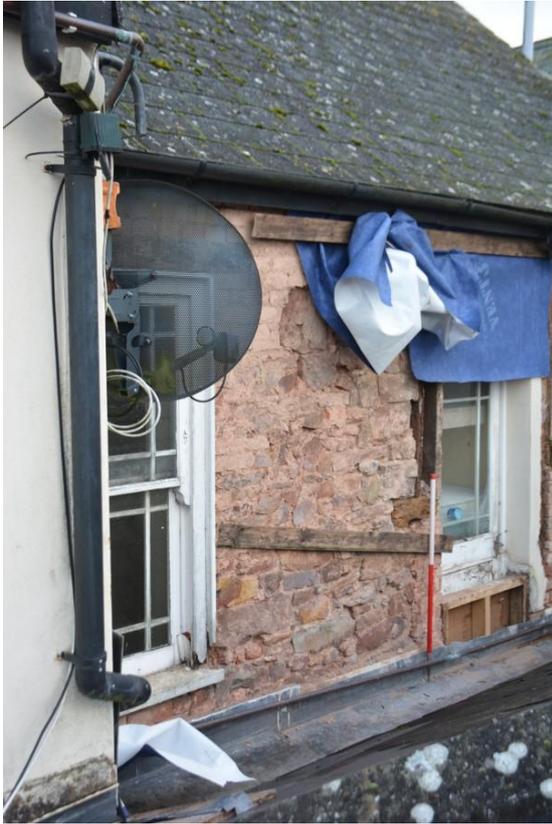
Fig. 38 Rear (west) elevation, showing rubble masonry fabric with south-west quoin (in line with the scale), and brick filling around the window (left) (photo ref: 7495).

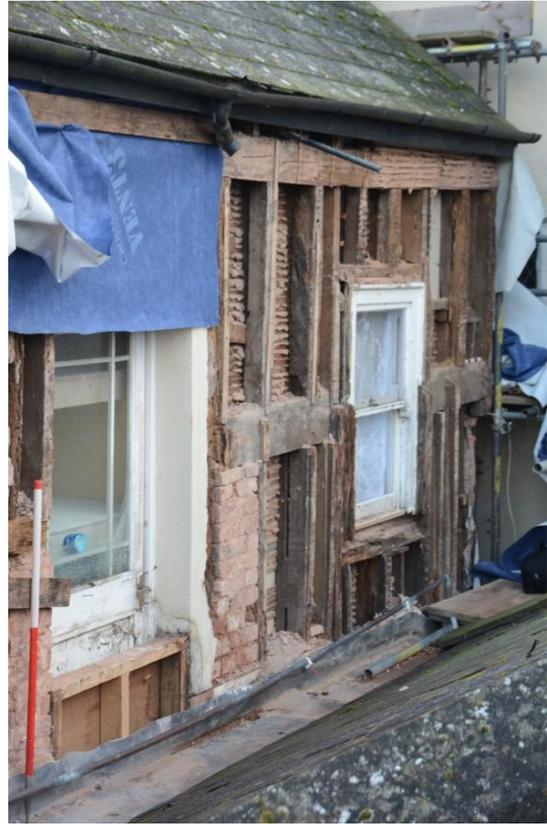
Fig. 39 Rear (west) elevation, showing mid-19th century timber framing (right) and inserted late 20th century door/window (left) (photo ref: 7501, cropped).

The timber framing was a hotch potch of different phases, containing large (230 x 140mm/9 x 5½") timbers at the top and in the middle (Fig. 40), with nailed-on studding forming the basic frame, and with lath and plaster cladding on both internal and external surfaces. Below was an area of 20th-century brick repair. This had an integral sash window (to the south) with plate glass and horned sashes (Fig. 39): therefore of mid.-19th century date. To the north was a more modern opening, perhaps occupying the position of an earlier window, but now a door in its present incarnation, although blocked by the construction of the western extension to Veryards of c.1989. This looks like a mid.- or late-20th century fire escape, predating the addition of the rear bar of Veryards in the late 1980s, and with its lower half obscured and blocked in with timber framing at that time (the lead flashing of the 1989 guttering runs against this: Figs 14; 39).

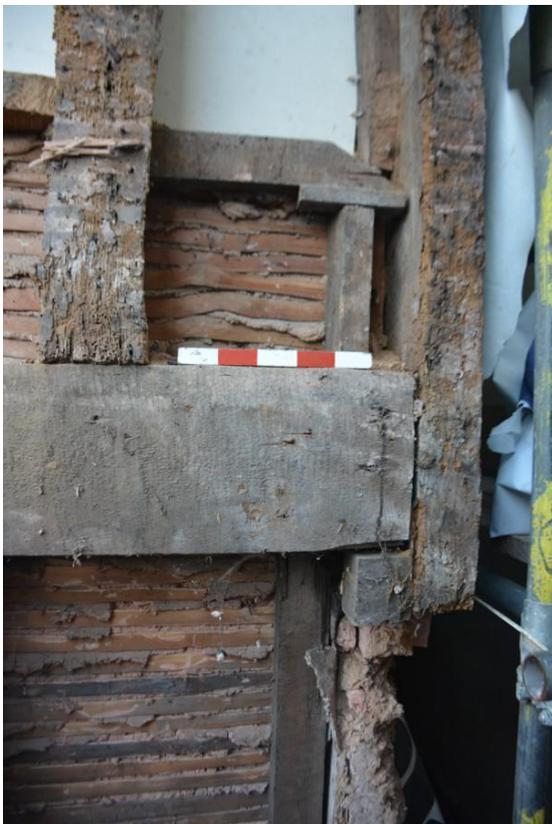
Fig. 40 Rear elevation, detail of timber framing, looking east (photo ref: 7489).

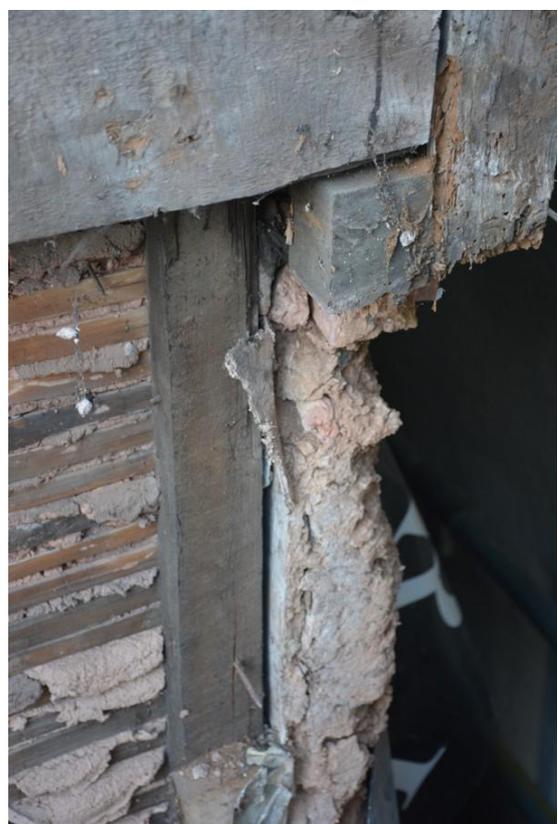
Fig. 41 Rear elevation, detail of cob filled partition of south wall, seen here in section in the west, looking south east, note plaster on inside face (photo ref: 7486).

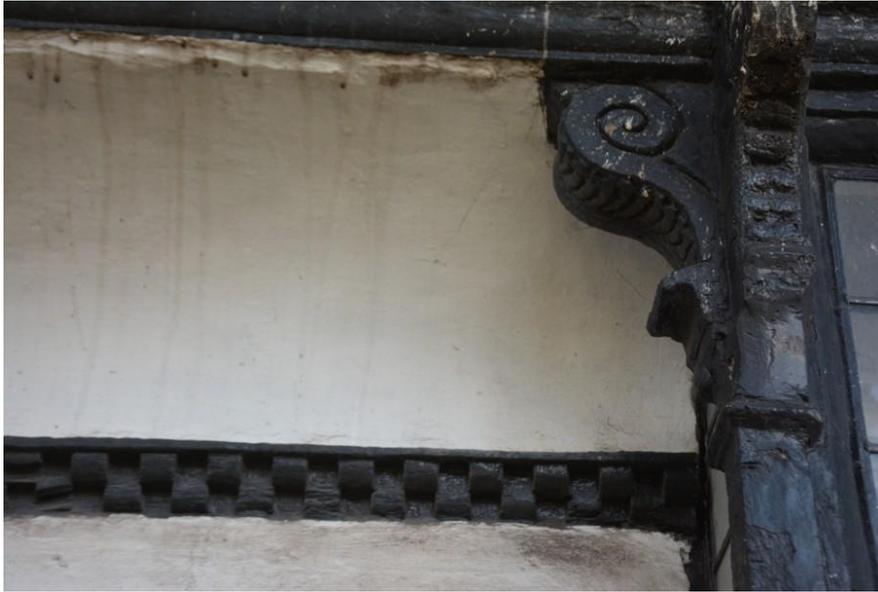
Fig. 42 Details of the Manor House Hotel facade, showing billet ornament and scroll brackets in Bay xx (photo ref: 6920).

The top brackets of the first/southern first-floor window are both damaged and are missing the front part of their scrolled sections, and are in need of repair. Everywhere the carved detail is very gummed up with paint (Fig. 42) and would probably show up very nicely if it was stripped down and repainted or oiled (or limed as No. 8 Fore Street was to good effect, some years since).

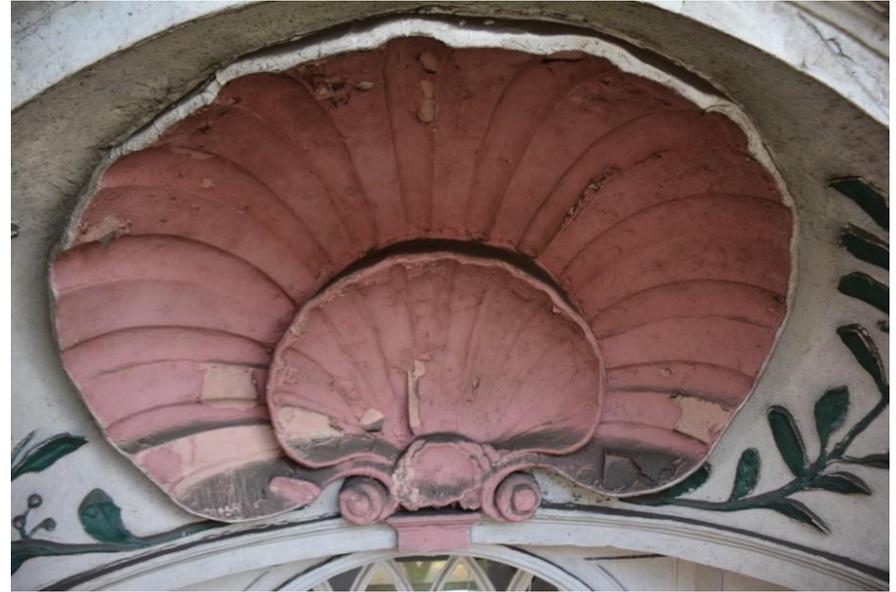
Fig. 43 Early 18th century shell hood over the front door, detail before restoration (photo ref: 6922).

Chris Flint was working on conserving the shell hood over the main doorway of the Hotel (Fig. 43) in October 2017. He subsequently also made repairs to the timber frame above the hood, and removed the lead covering to expose the extrados of the timber work (August 2018 onwards). This revealed the positions of some of the studs of the timber frame of the front wall of the building (photograph refs: SRB/2715–21, 8.viii.18). He also carried out many of the repairs and refurbishments to the windows, doorframes and other timberwork on the street elevation of No. 4.

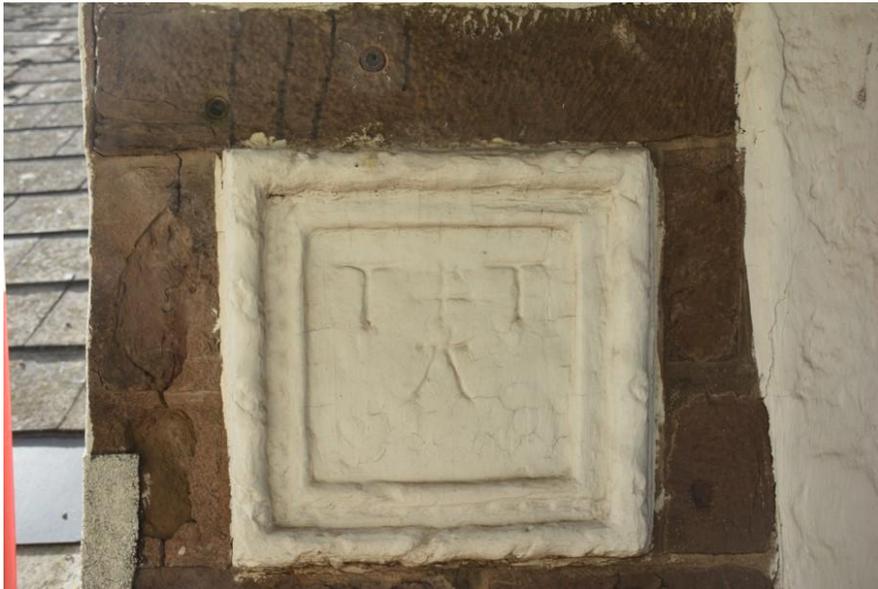
Fig. 44 Inscribed plaque at the top of the south wall, with the triad of initials for Thomas Trock and (presumably) his wife (photo ref: 6814).

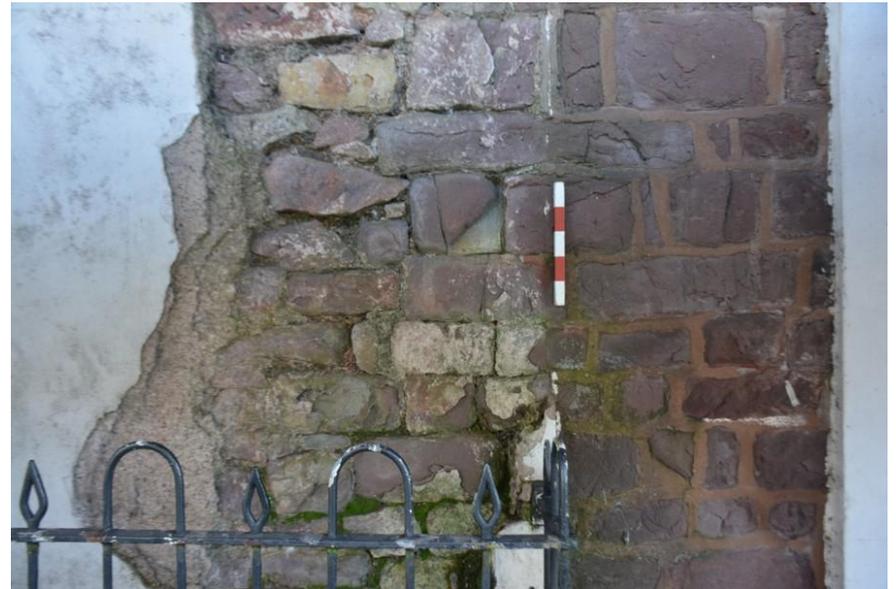
Fig. 45 Masonry at the junction of Nos 2 and 4 Fore Street, showing blocks running across the line of the junction (photo ref: 6969).

Where some of the rendering had been removed previously the fabric could be seen as coarse cement-based render, pale brown to buff in colour with frequent fine, medium and coarse grit, up to 5mm in diameter (Fig. 45). This was probably two-coat work, at least 55mm in total thickness, with a 3–5mm surface skim of neat cement on its exterior surface. In turn, this had been painted up with multiple layers of proprietary paint. At the north corner, where the quoin projects it is as much as 60mm with a flat fillet, 110–120mm wide until the beginning of the rusticated quoin (and the plinth below) begins. This is 600mm south of the equivalent rendered edge of the ground floor of No. 2 Fore Street, the Manor House Hotel. This is an important dimension, and one that was in danger of being lost in the stripping and re-rendering process (this also emphasises the artificiality of the division between the two buildings, in the sense that the fabric is continuous behind the rendering and indivisible in any clear straight join).

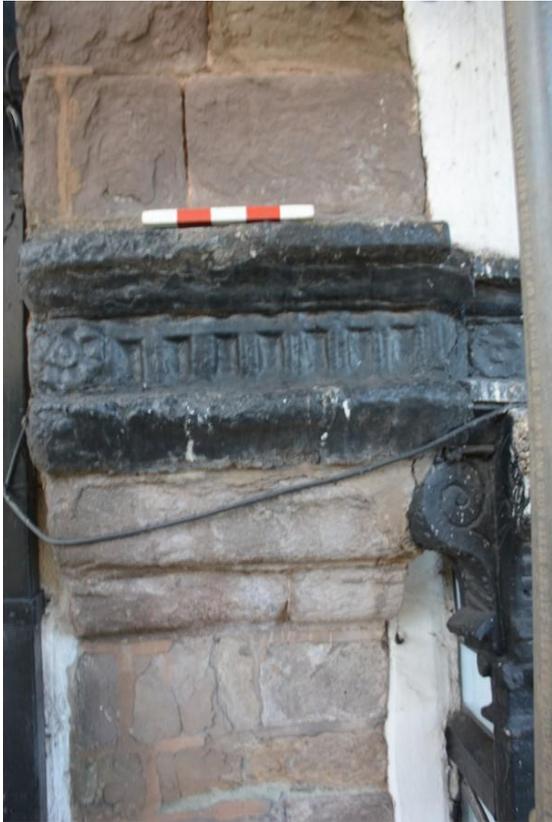
Fig. 46 South wall of Manor House, showing corbelled stage (photo ref: 6842).

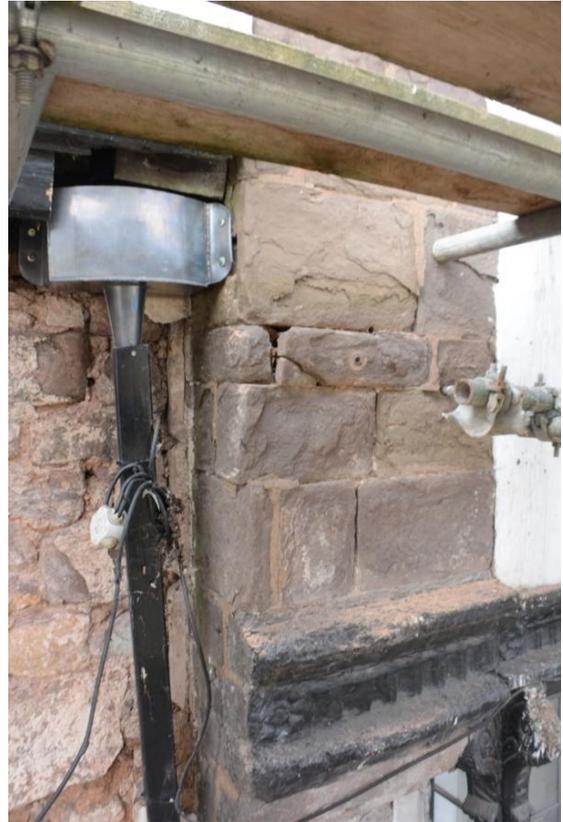
Fig. 47 South wall showing plaster rusticated quoins in section against the south face and abutted by the masonry of No. 4 (left) (photo ref: 7533).

On the south-facing wall of No. 2 Fore Street, the Manor House Hotel, the remains of three rusticated quoins made up in mortar survived at the top of the wall; these were abutted by the fabric of the east wall of No. 4 Fore Street and are therefore stratigraphically earlier than the fabric of No. 4 (Figs 12; 47; sketch in author's notes of 10.x.17). In turn, the quoins were also abutted/concealed by the rendering of No. 4, removed in October 2017. In total they survived for 950mm below the eaves. They must be interpreted to indicate that there was a stage when the south wall of No. 2/the Hotel stood above the front wall of No. 4, even if only temporarily. This does not fit well with the position observed lower down, that the blocks span the transition/position of a straight join between the south end wall of No. 2 and the street elevation of No. 4 (unless these have been pieced in later, which seems unlikely). It is possible that the front wall of No. 4 had been heightened at some point, perhaps by a similar margin of 950mm or so, but no sign could be detected in the exposed fabric that this was so and the significance of this observation remains uncertain as a result.

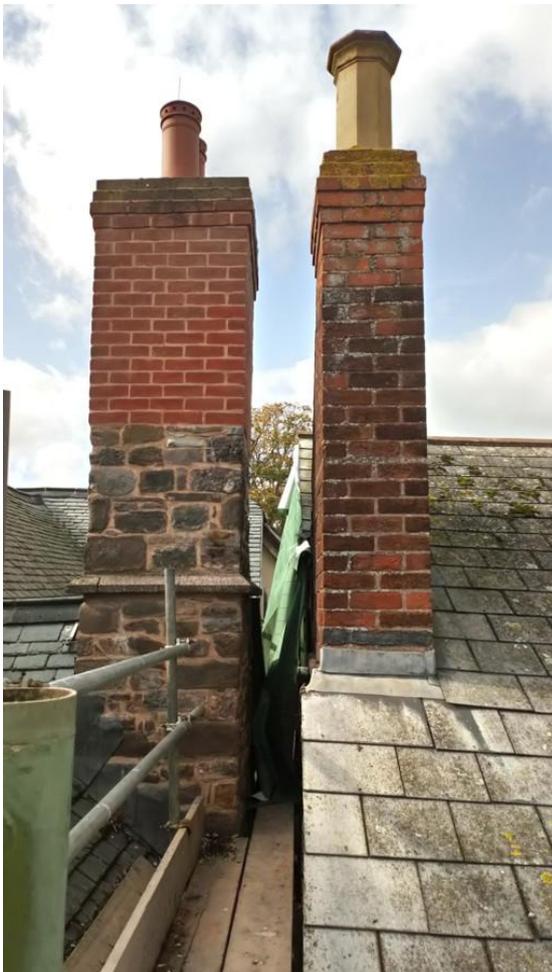
Fig. 48 Chimney of south gable, note brick repair of upper nine courses, with chimney of The Walronds to the south (photo ref: 0064).

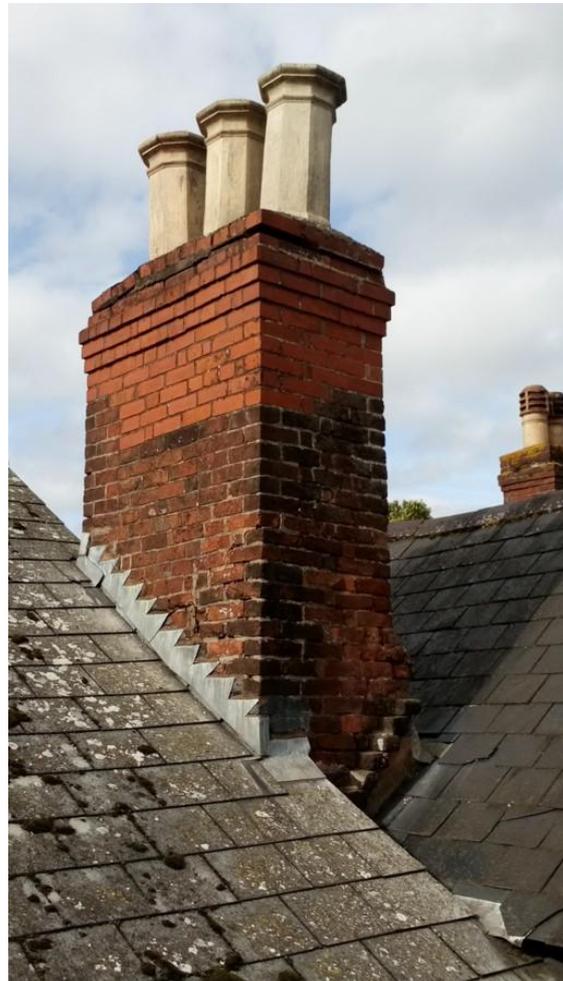
Fig. 49 Chimney of north gable, showing top eleven course rebuilt (photo ref: 0062).
