Historic Environment Record

Parish Alphington	National Grid Reference SX 9181 9008	Number (Leave blank)	
Subject Observations during external alterations and repairs to No. 87 Church Road, Alphington.	Measurements See attached location and floor plans		
Description <i>History, field notes and other information. (Please use a separate form for ea</i> No. 87 is a grade II listed building that, according to the short 1952 list description, is thought to date to the C18. Listed Building Consent (ECC 06/0642/07) was granted for refurbishment/replacement of windows and replacement of former shop front with windows; the front elevation was also subsequently re-rendered as part of the works. No stripping of render however was undertaken on the side or rear elevations, nor any removal of finishes within the interior of the building. One visit was made on 22 May 2007, after the render had been removed and the windows replaced, but before re-rendering. This revealed a complex structural sequence, including perhaps some potential pre 18C fabric. A rapid record was made, including a sketch outline elevation drawing, and a series of photographs. Description (nos refer to the different builds th

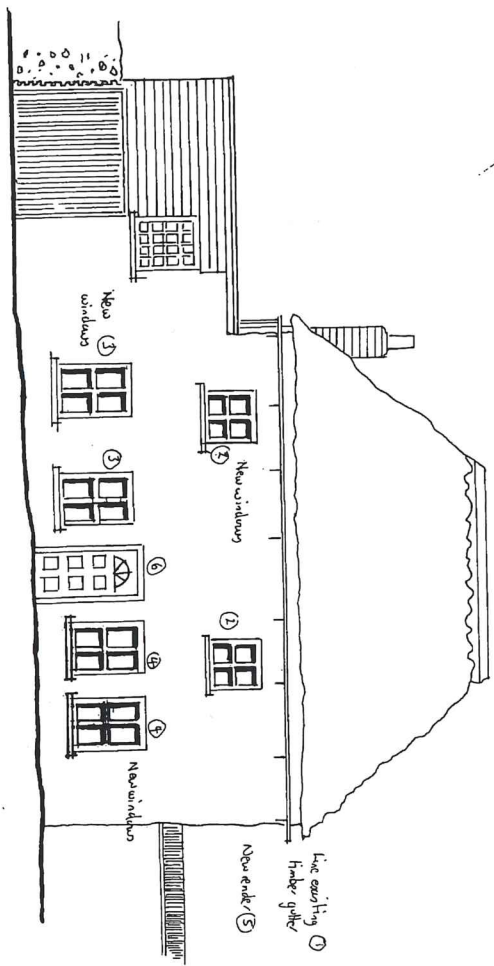
PROPOSED FRONT ELEVATION

NOTES:
 ① Line existing timber gutter with single layer Seralu® or similar membrane

② Take out existing windows and renew with timber casement windows which match existing style with additional horizontal bars/guying as ③ below.

③ Remove shop front windows and door and replace with timber sliding sash windows. Lippell between windows will insulate sashwork and render finish glazing to be timber like clear double glazing.

④ Take out existing timber windows and replace with new timber sliding sash windows to match ③ above

⑤ Hack off all the render to the front elevation and soffit on return. Renew with lime mortar render on stainless steel expanded metal lathing. Lay new insulation between any existing timber stud external walls.

⑥ Renew front door to match existing including new stone threshold

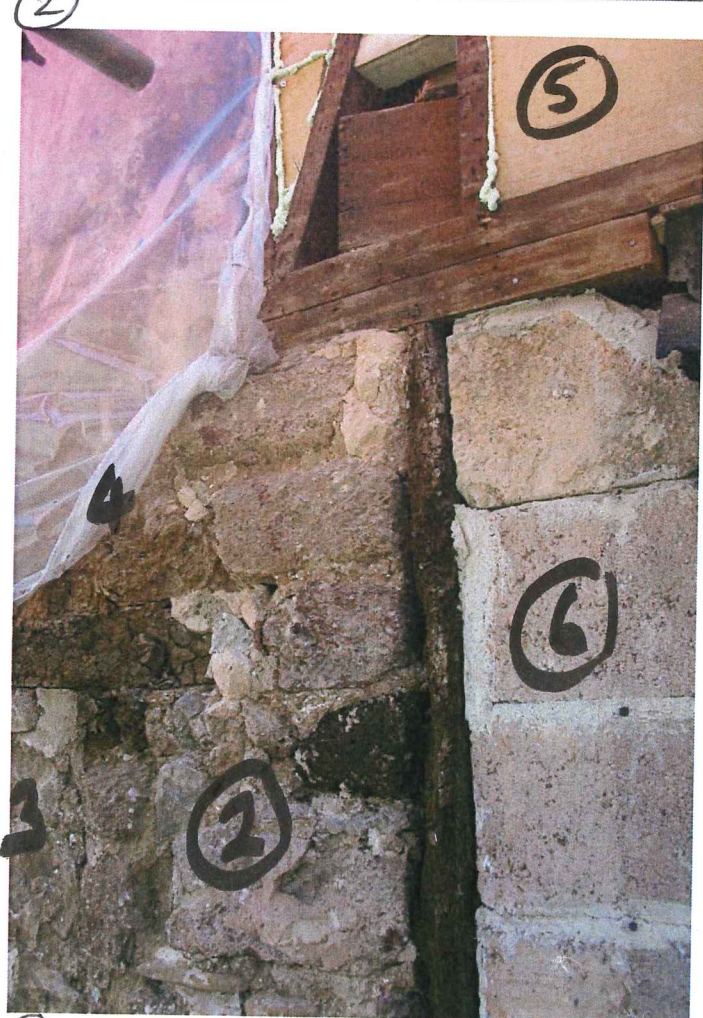
④

6. (photo 4) Concrete breeze block infill of former shopfront.

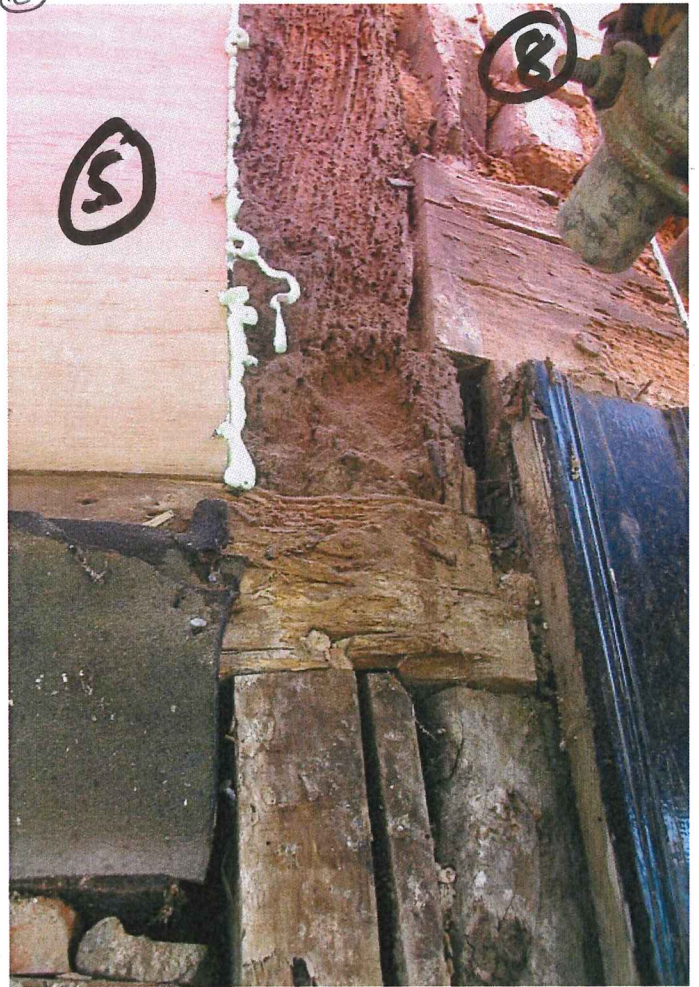
9. (photos 8 - 12) Wide opening, infilled with timber studwork and windows, with lathes infill. Probably an infilled former shopfront. R/H end butts up against stone pier (10). Opening appears to have been heightened slightly in the past, probably when the original wide opening was blocked and the present door and windows inserted, possibly to accommodate the higher door frame. This is indicated by an earlier, lower, notch in the earlier adj beam and upright at the top north corner of this opening, below the current top of the door frame (see photo 8), and by the uppermost course (10a) of the stone pier (10) at the south end consisting of different, thinner, stones from those making up the rest of the pier below – suggesting pier was heightened slightly to support the beam spanning the top of this opening. Studwork (8) above sits directly on this beam, suggesting it was contemporary or slightly later in date than the heightening of the wide opening below.

13. (photo 8) Thick, old ?oak upright; earliest in sequence of fabric at first floor level; on change of angle between N & S buildings, and may represent end of timber wall/partition subdividing the two. Timber upright below it appears later in date, but may have replaced equivalent timber to 13. Sits on substantial beam that supports first floor studwork (5) above, but which at some point to north has been replaced by later softwood timbers. Much of studwork 5 may be later than this supporting beam, the southern end of which has been notched to take a possible predecessor of beam 14.

14. (photo 8) Thick timber beam supporting studwork 8 above and forming top of wide opening below. Has either been raised slightly when door and windows (9) below installed within wider opening, or has replaced an earlier beam at a lower level.

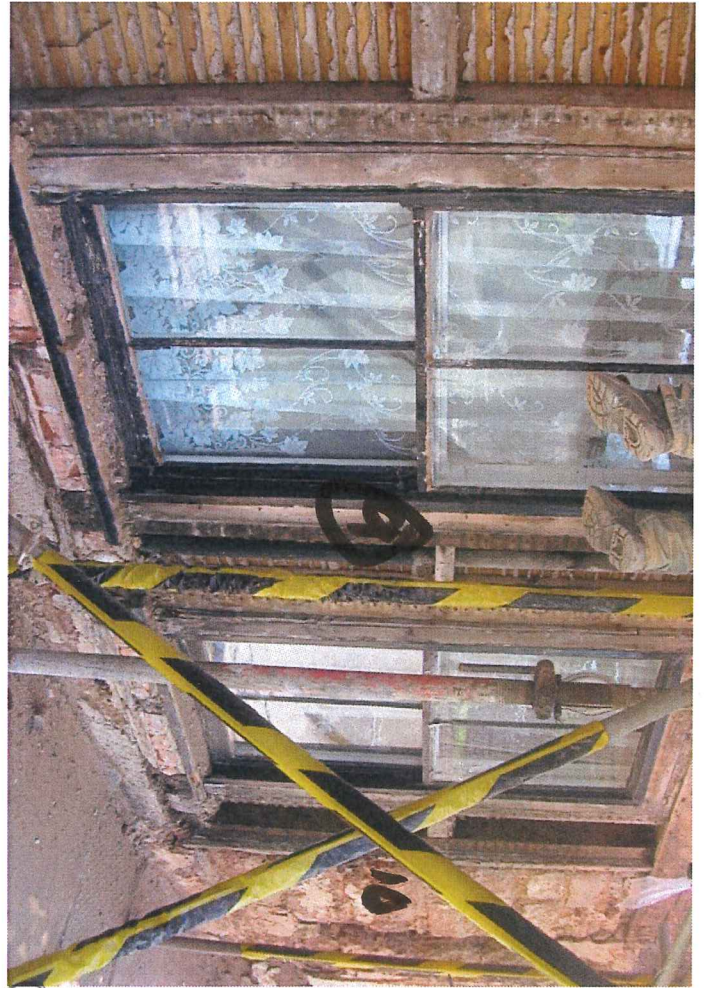
10

7. (photo 9) Brickwork forming southern edge of former shopfront.

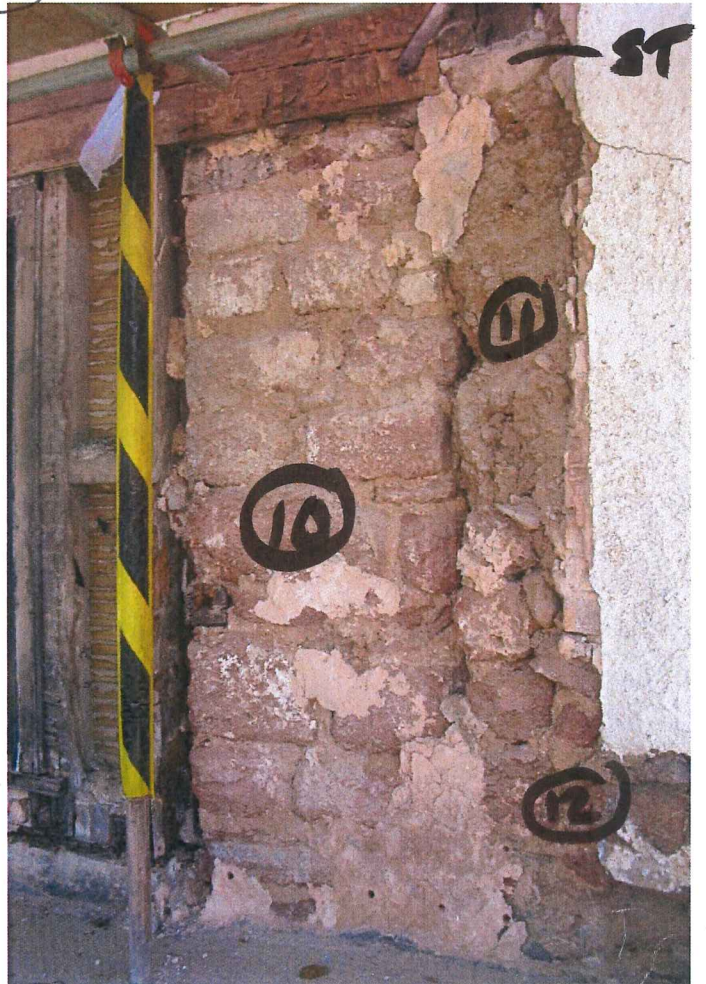
12

10. (photos 11, 12, 13) Stone pier of squared conglomerate blocks; good edges to each side; north edge includes fixing timber for opening to north. Topmost course (10a) of different stone; probably represents later heightening (see above). Cob walling (11) and probably stone walling below (12) butt up against south edge of 10, though relationship with latter obscured by render at base. Has larger, more regular blocks and coursing than is evident in other early stonework (2) at north end of north building.

11. (photo 12) Cob walling; render obscures southward extent; so not clear if it forms boundary wall to south (but is likely as the latter is rendered and has a tile capping/hat).

12. (photo 12) Rubble stone walling, forming footing for cob walling (11) above, though height at exposed north end greater than would be expected for a footing; so may in part represent an earlier wall, or just handy stones being used with the cob.

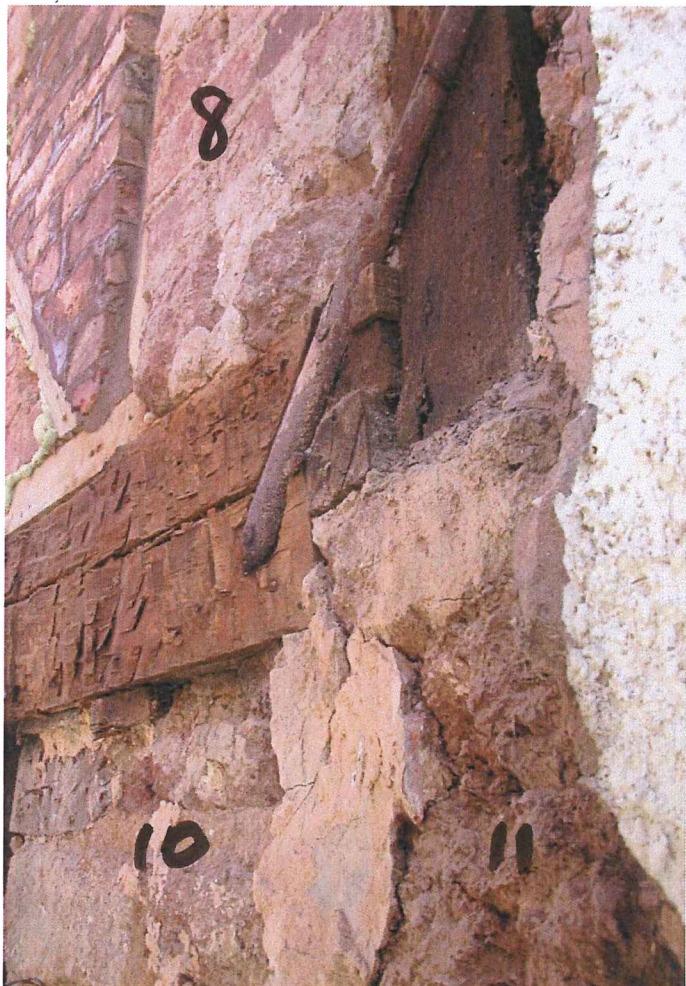
8. (photos 13 – 17) First floor, S. Building. Timber studwork with brick infill (except for a small area of stonework at bottom S corner); studwork apparently older than 5. Sits on large timber beam that spans whole frontage of this building, north end of which has been scarfed into older ?oak upright (13) that extends to eaves level. Single window opening.
