**AN HISTORIC BUILDING RECORD OF  
A FORMER THRESHING BARN  
NEAR ILTON FARM,  
MALBOROUGH,  
SOUTH DEVON**

- On 17 October 2012 Trent & Peak Archaeology carried out an historic building survey on a former threshing barn near Ilton Farm, Malborough, South Devon.

- The former threshing barn is located between Ilton Farm and Ilton Castle Farm in a rural setting area rich in medieval earthworks. It is centred at Ordnance Survey Grid Reference SX 7241 4024. The building is not listed but lies within the Scheduled Ancient Monument 1019947 *Medieval settlement, site of quadrangular castle and relict garden between Ilton Farm and Ilton Castle Farm*.

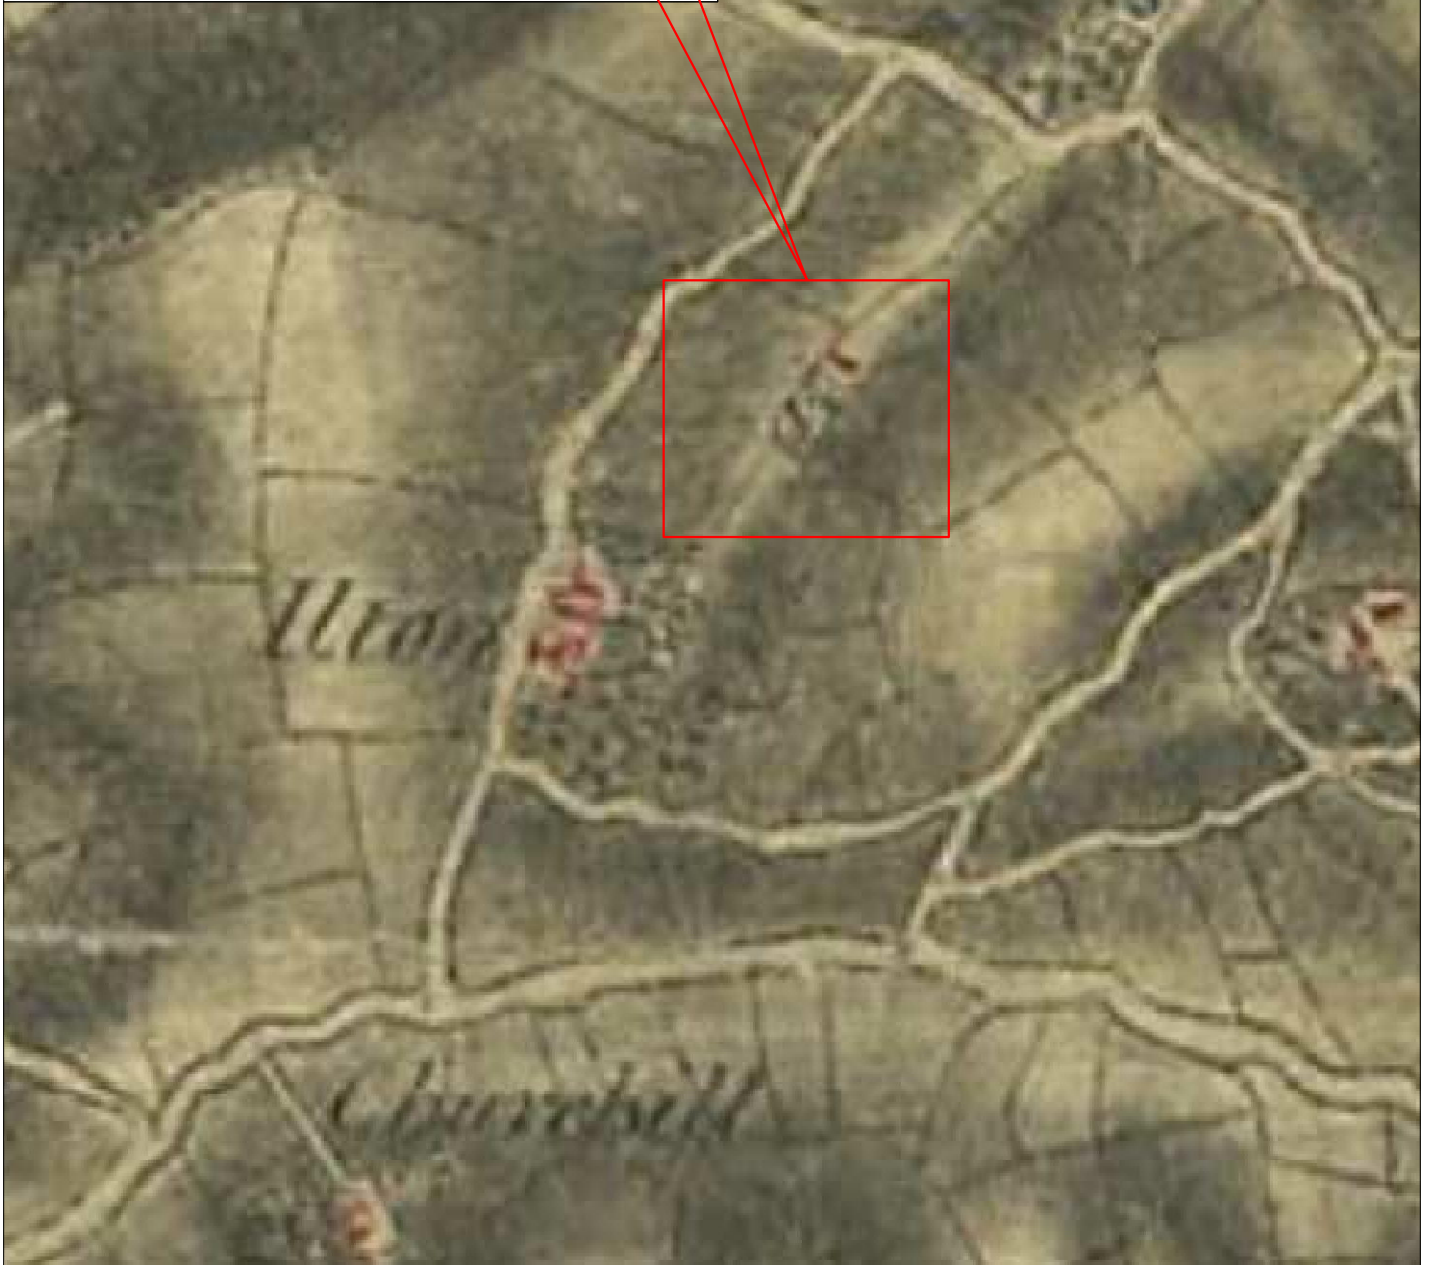
IMS Ilton, Devon  
 Figure 4 Extract from 1885 First Edition Ordnance Survey 25 inch scale map  
 Scale at A4 1:2,500

The barn is present on the 1885 First Edition Ordnance Survey 1:25 inch scale map (Figure 4). The main threshing barn is present, together with the shippon at the northwest end of the building. An entrance is indicated in the southwest elevation, which corresponds to where the large doorway is currently located. Extending down the northeast side of the barn are a number of small add-ons. The buildings to the southwest have by this time disappeared.

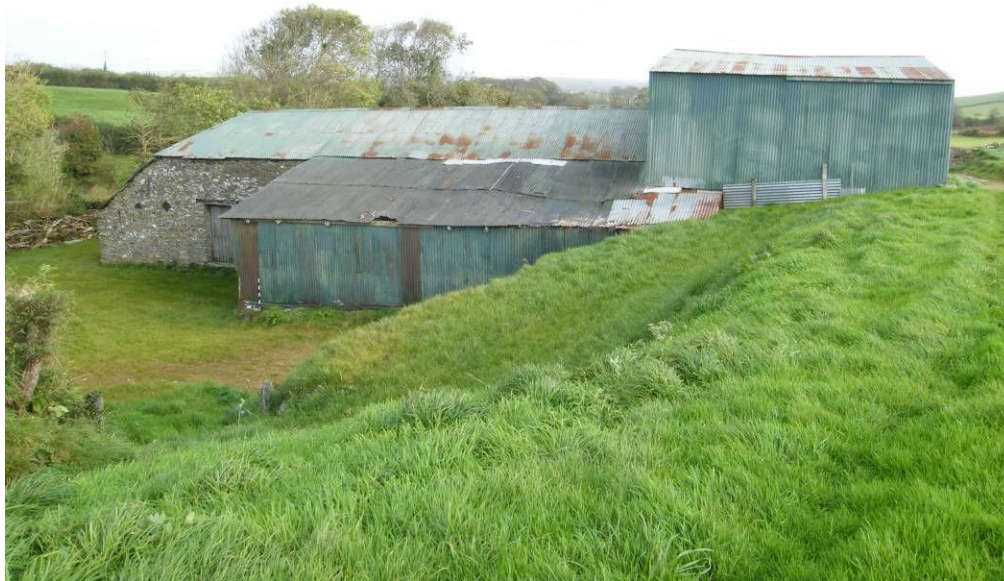
**Plate 1:** General view of the barn, viewed looking north northeast

The former threshing barn is a single storey stone and cob building which is orientated northwest to southeast (Plate 1). It is terraced into the slope which runs behind the building. The earliest part of the building is the central portion which has nine modern trusses, one by the northwest wall, forming ten bays. The roof is covered by corrugated metal. There is a short northwest extension which comprises three modern trusses forming four bays. It too has a corrugated metal roof. Modern sheds constructed of timber posts encased in corrugated metal have been added to the southwest, northeast and southeast elevations.

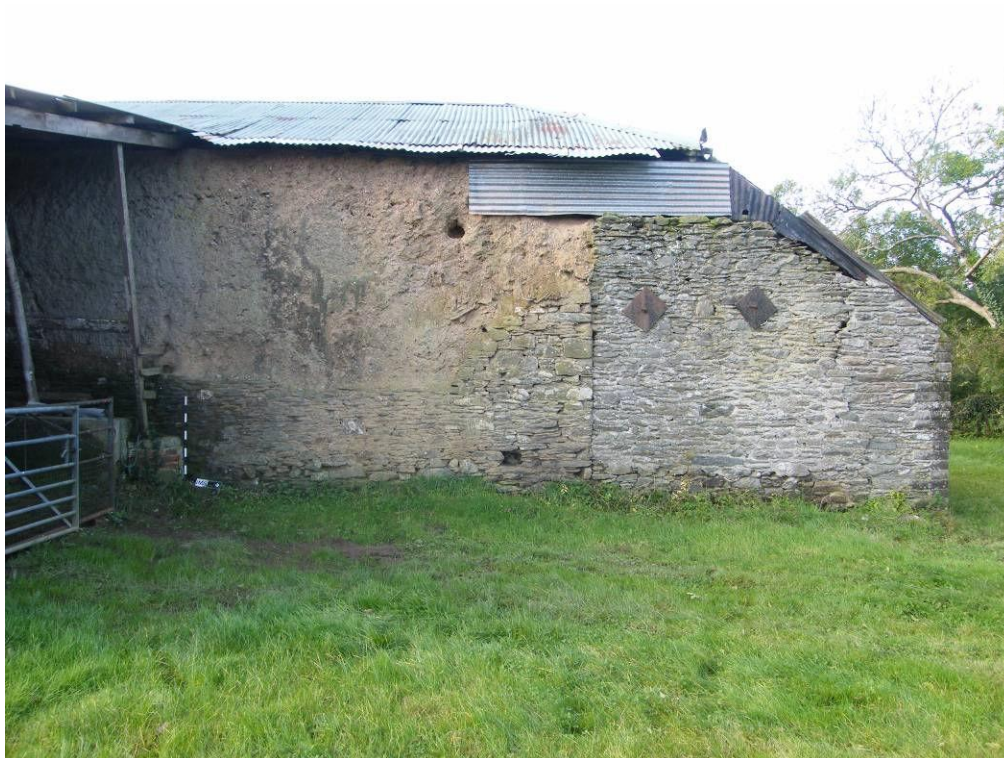
**Plate 2:** Northeast elevation of the threshing barn and shippon, viewed looking southwest

The northeast elevation of the threshing barn was constructed of a cob wall resting on a high stone plinth, with a single central winnowing doorway (Plate 2). Adjacent stonework and reused softwood lintel indicate that it has been modified, or is a later insertion. Mangers associated with the modern shed extend along the wall to the southeast. A building join shows that the northeast wall of the northwest extension is later than that of the threshing barn (Plate 3).

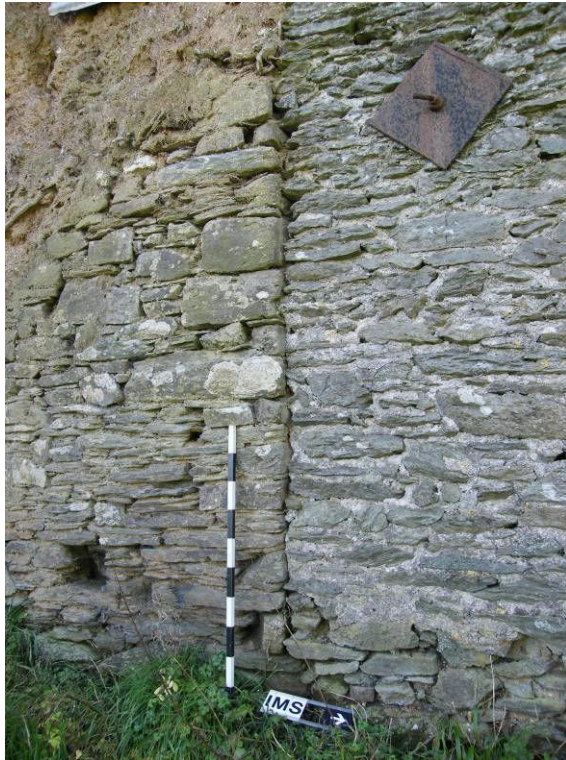
**Plate 3:** Building joint between the threshing barn and shippon on the northeast elevation, viewed looking southwest

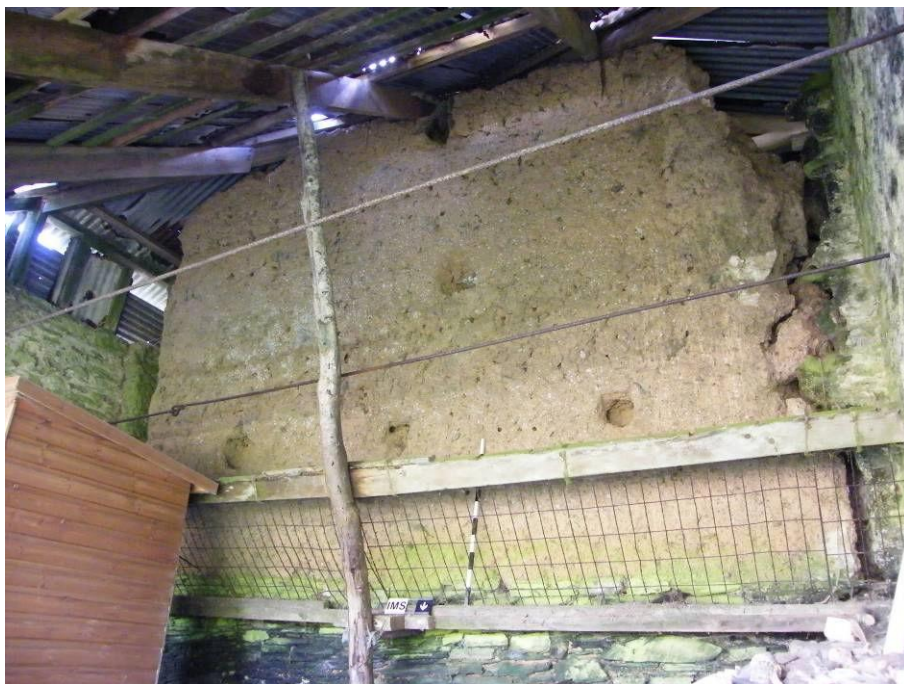
**Plate 4:** The northwest back wall of the shippon containing holes for a ridge and ceiling beams, viewed looking southeast.

The cob wall at the north end of the threshing barn was used as the back wall of the northwest extension. Holes in this wall for a ridge and three floor beams indicate that the barn had an adjoining two story shippin, used for animal shelter with feed and bedding stored above, extending to the northwest. There had been no access from inside the threshing barn as no doorways were present in the cob wall (Plate 4). The remains of stone mangers were present at the back of the building.

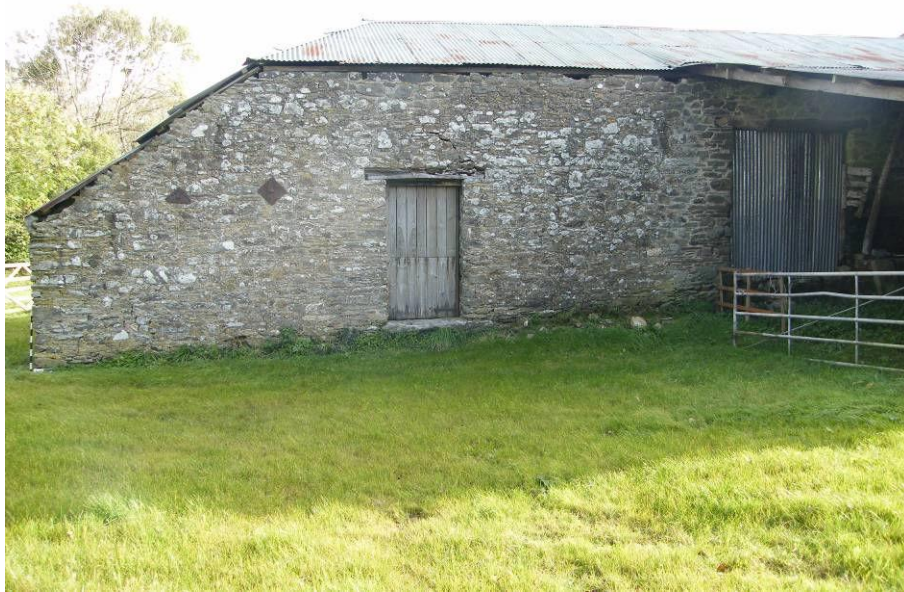
**Plate 5:** Southwest elevation of the threshing barn and shippon, viewed looking northeast

The southwest elevation of the threshing barn was predominantly stone built, probably due to this elevation being exposed to the prevailing wind. Here there was no building join present between the threshing barn and the northwest shippin (Plate 5). Two doorways are present, the smaller of the two appearing original. The stonework around the larger cart door suggests that alterations have been undertaken (Plate 6). To the southeast of the larger door the walling is cob on a stone plinth, (as on the northeast elevation), with a window opening set within the cob walling. A stone wall extending to the southwest from the corner of the building is likely to be a boundary wall both retaining the bank and protecting the entrance from the weather. (Plate 7) The

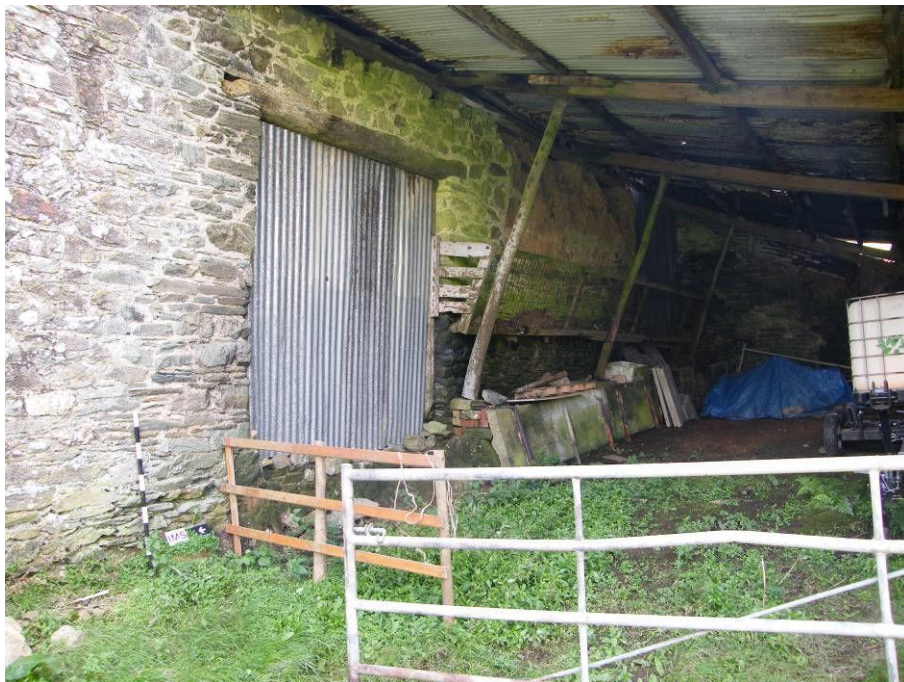
**Plate 6:** Cart door in the southwest elevation, viewed looking southeast

presence of two holes above the large door suggests the presence of a former projecting canopy or porch.

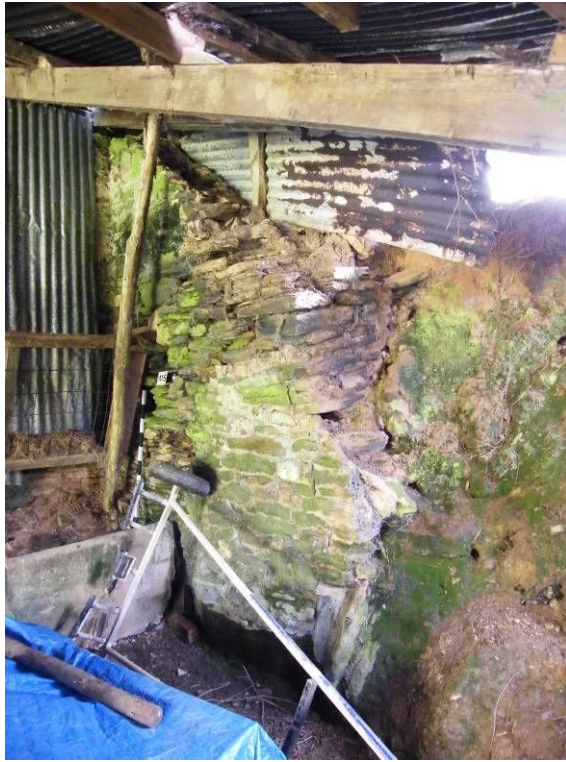
**Plate 7:** Stone wall extending southwest from the southwest corner of the threshing barn

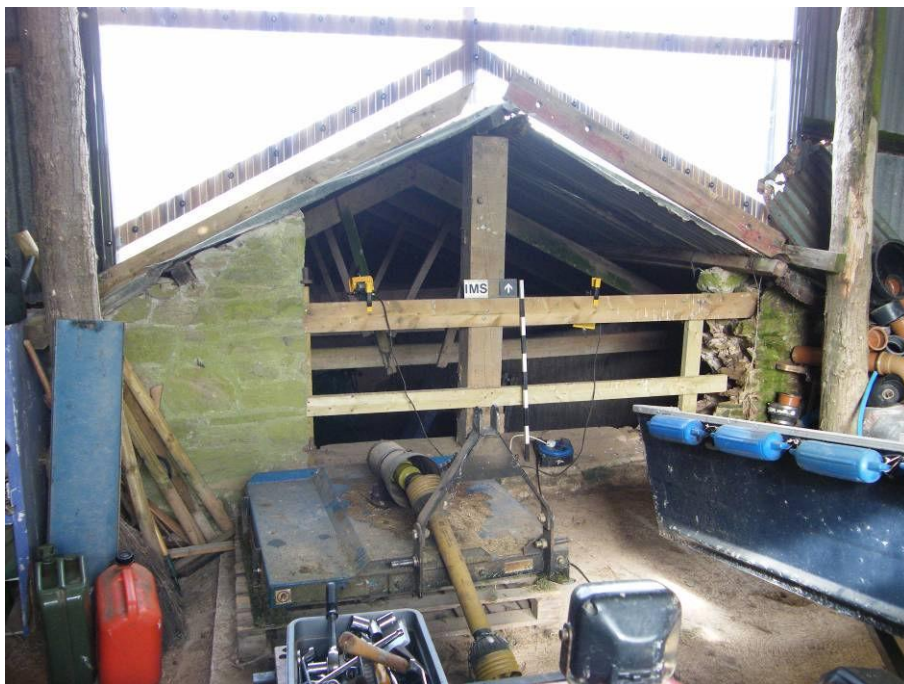
**Plate 8:** Southeast elevation of the threshing barn from the interior of the modern workshop

Much of the original southeast elevation had been altered by later building works and obscured by the erection of the modern shed currently used as a workshop (Plate 8). The original loading bay door is likely to have been located here.

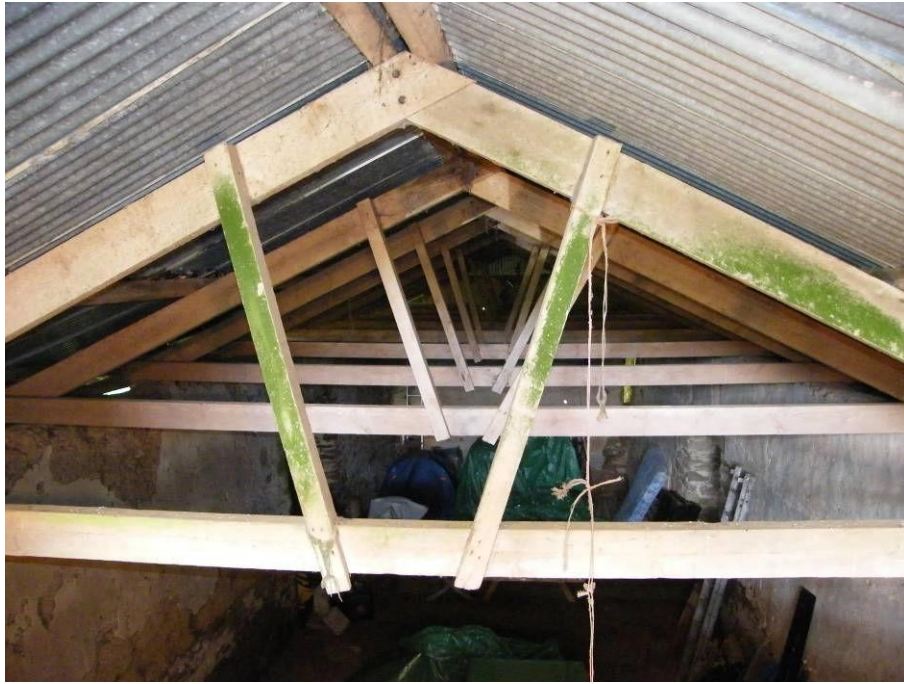
**Plate 9:** General view of the roof, viewed looking northwest

Internally, the threshing barn has nine trusses, one against the northwest end, forming ten bays. The trusses comprise two principal rafters, tie beam and two struts. The tiebeams rest directly upon the walls (Plate 9). All the timbers present within the roof are machine sawn softwood of modern date. The internal walls were whitewashed. No evidence was present to suggest the barn ever had an upper floor. The cobbled threshing floor is placed slightly off centre towards the northwest end of the building. The floor to the southeast is level with the threshing floor and is of concrete and the one to the northwest lower by 0.45m. The large partially blocked opening in the back southeast wall is probably the original loading doorway (Plate 10). All the lintels within the building are reused timbers with the exception of the one over the small door in the southeast elevation.

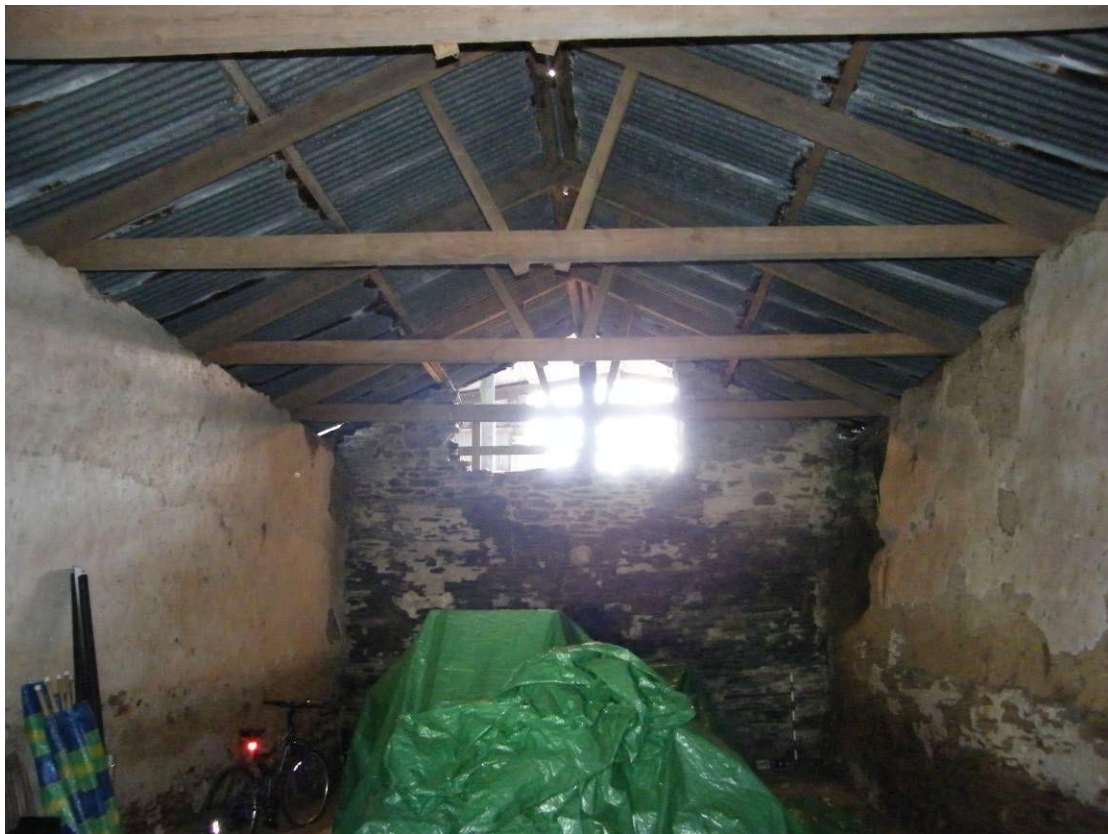
**Plate 10:** General view of the barns interior, viewed looking southeast
