LEW MILL, NORTHLEW DEVON

**ARCHAEOLOGICAL APPRAISAL
and HISTORIC BUILDING RECORDING**

January 2012

Project No. 179/2009

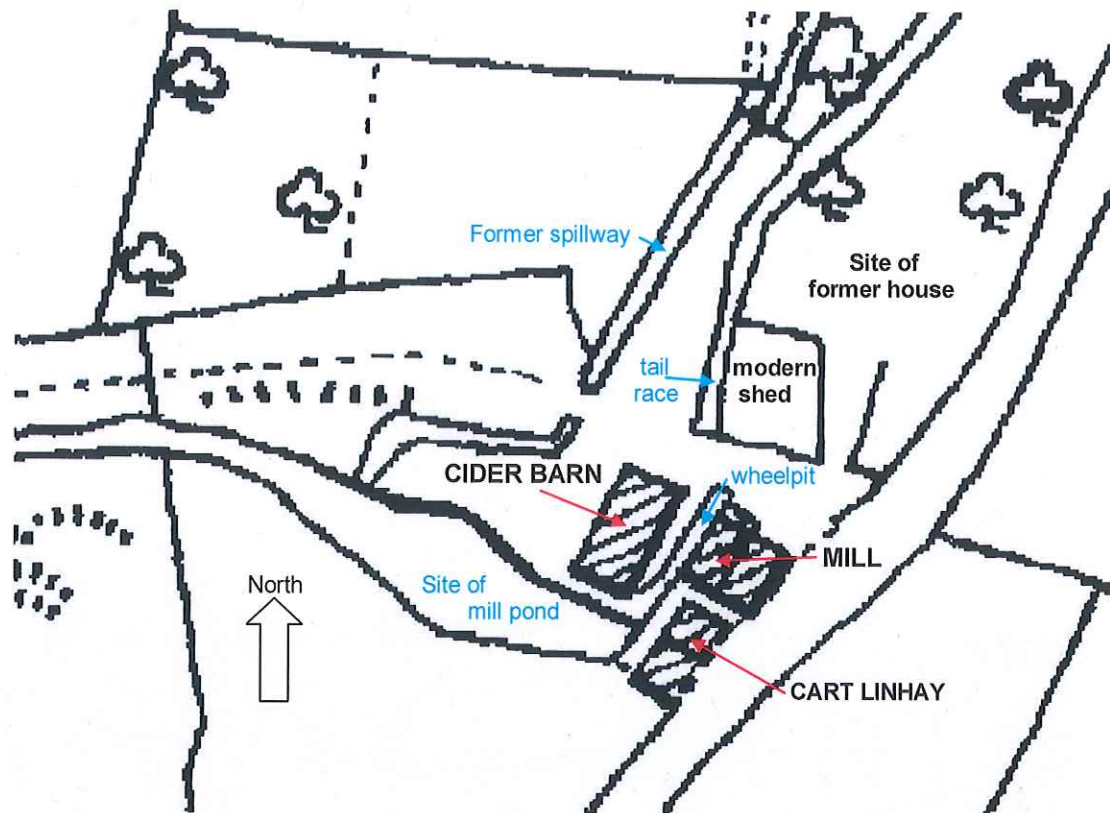
Figure 3: Lew Mill. Site plan showing principal buildings and features

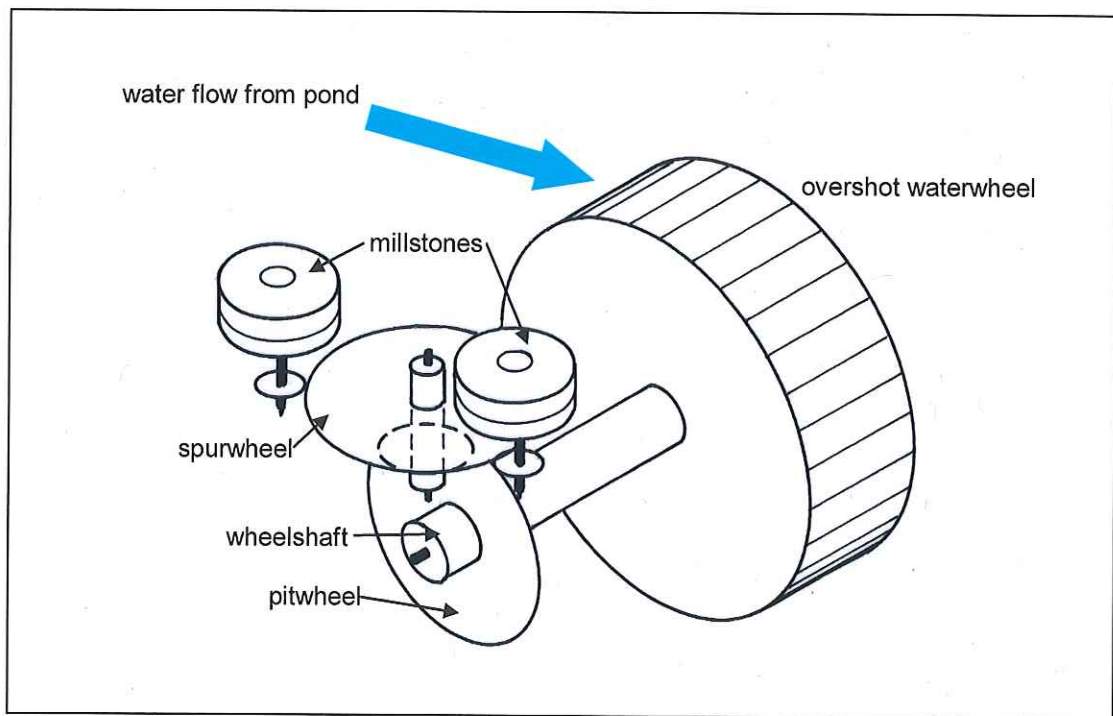
Figure 9: Lew Mill. Diagrammatic reconstruction of final phase of mill machinery at south end

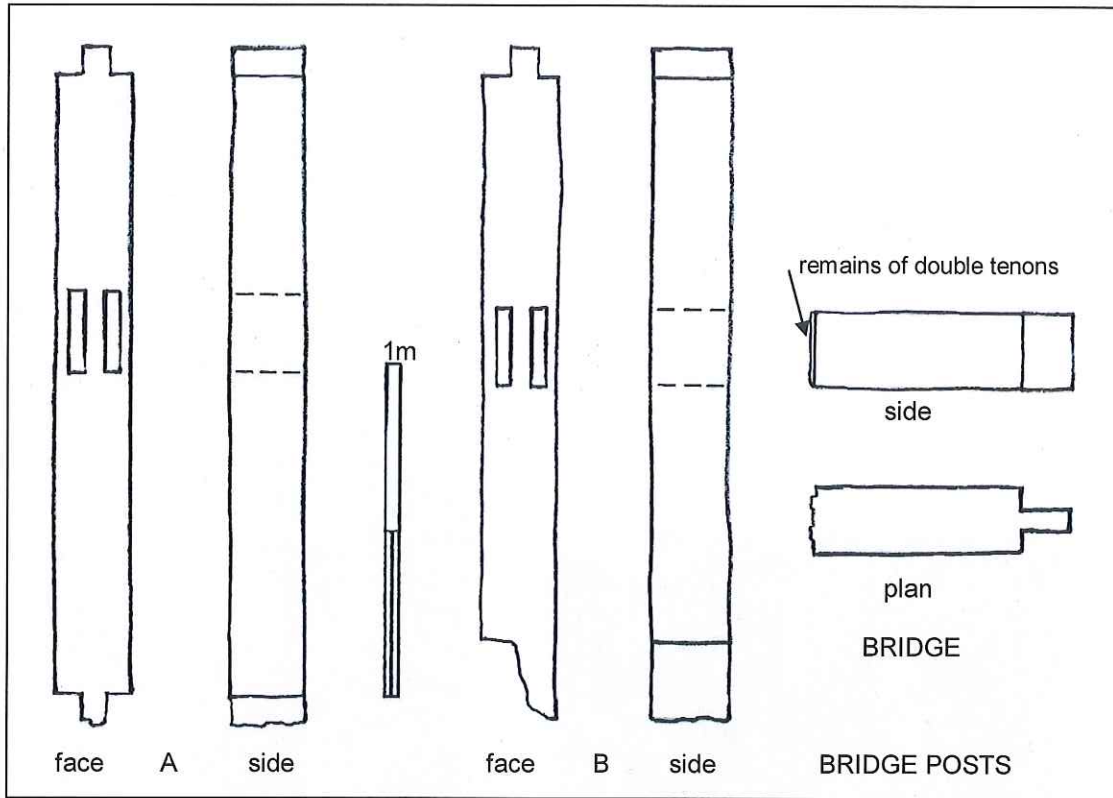
Figure 12: Lew Mill. Bridging timbers from hurst, recovered from wheelpit fill

Also found in the debris cleared from the waterwheel pit were three decayed structural timbers from the hurst, the timber frame that supported the millstones and their drive. These timbers comprise two bridge posts and a bridge tree (Figure 12), all probably of oak. Both bridge posts have double mortises, indicating that they were rear posts, formerly located against the pit or back wall of the mill. The bridge tree, which spanned between the rear and front bridge posts and carried the foot (bottom) bearing of the millstone drive spindle, has the remains of a pair of tenons at one end and a long, single tenon at the other.

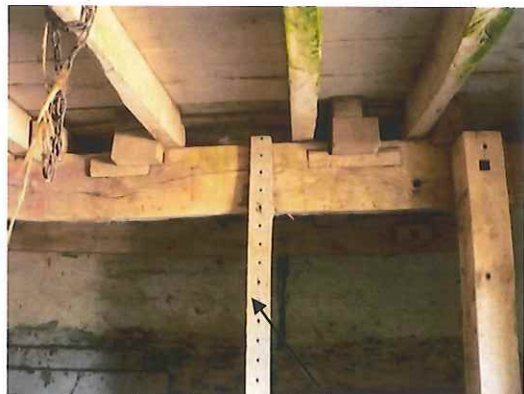
Hurst, north end. Possible tenter beam reused

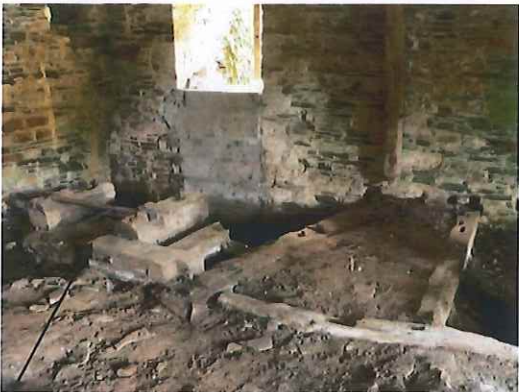
Bearing block and south cog pit

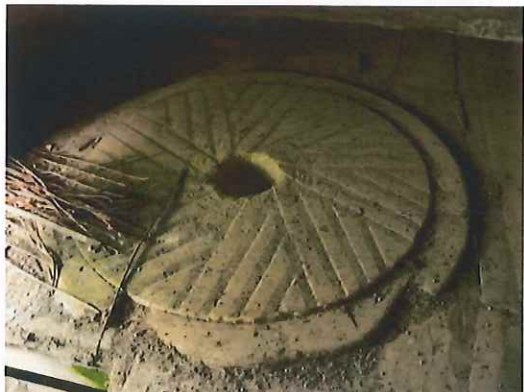
Conglomerate millstone, 1st floor

At first floor level a millstone (a bedstone) 1.22m in diameter survives *in situ* towards the north end of the hurst, supported on timber beams which form part of the first floor. This stone is visually identified as being of Old Red Sandstone conglomerate. Its source was probably the Wye valley, from where considerable numbers of millstones were imported into the south-west peninsula in the post-medieval and early modern periods. Two other millstone positions are indicated by the timber skirtings that surrounded and located them, one *in situ* at the south end of the first floor, the other now displaced. The working position for the latter is not certain, although it was most likely in the position shown on the plan, Figure 8. The millstone position at the south end is offset rather than being in

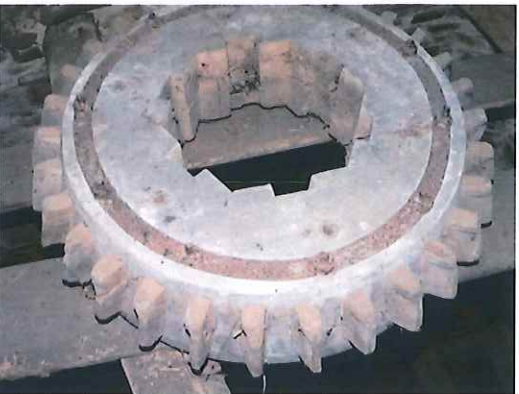
Timber bevel gear (in animal house)

On the first floor beams in the animal house is a displaced timber bevel gear, made to fit a hexagonal timber shaft. It carries approximately 30 inserted timber cogs with a maximum pitch of 83mm (3¼in), suggesting a relatively early 19th century date for its construction (Stoyel 1997, 13). This centre of this gear indicates that it was mounted on a hexagonal-section timber shaft 30cm across the flats. This gear does not appear to be part of the last working machinery of the mill.

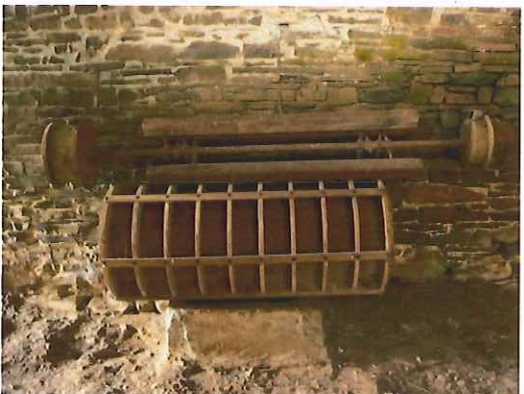
Cylinder and shaft of corn cleaner

At ground floor level in the mill is a displaced cylindrical screen from corn cleaner, along with central spindle and beaters, the remains of a typical 19th century machine which would have usually been located at first floor level and used for cleaning grain prior to milling. The cylinder is 1.1m in length and 34cm internal diameter, with 10 timber ribs.

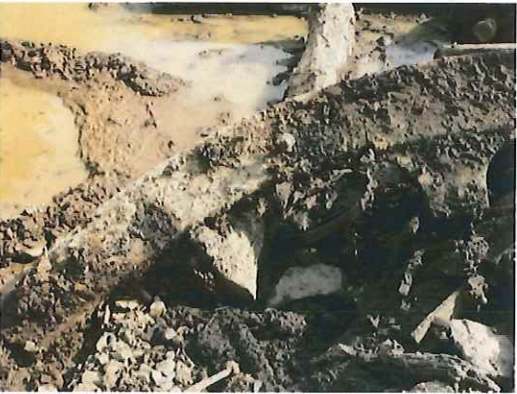
Cast-iron shroud section of waterwheel

The last waterwheel (south) appears to have been overshot, fed at the top via a timber launder. It was of timber and iron construction, mounted on a timber shaft. At both ends of the shaft position (one inside the mill, the other on the west side of the wheelpit) is a shaped granite block with a curved recess, to allow for the rotation of the shaft, and iron plates on which the shaft bearing pedestals were located. Part of the outer end of the timber shaft was found in the wheelpit fill. It was about 1.37m long and 0.45m in diameter over the outer ring at its end. An iron cross-tail gudgeon which formed the end bearing was still in place, held in by three gudgeon rings. The cross-tail gudgeon from the inner end of the shaft also survives on site. Three cast-iron shroud sections [the curved sections that form the circumference of the wheel and carry the buckets] were also found in the wheelpit fill. Two are from the inside face of the wheel and one from the outside. These sections are 20.5cm deep, with integrally cast flanges that located the ends of the timber bucket boards. From measurements taken of these components the waterwheel was about 3.8m (12ft 9in) overall diameter by 1.22m wide, with 42 timber buckets, each formed of three boards ('elbow shaped'). The wheel had two sets of six timber arms, 15 x 7.5cm in section, part of one being found in the wheelpit fill. There was an annular ring gear attached to the outer (west) set of arms from which a drive was taken to the apple mill (Figure 8 and photographs). This gear comprised a chunky timber ring made in sections with arc-shaped cast-iron toothed segments bolted onto its inner circumference. There appear to have been 13 gear sections each with 13 teeth, giving it a working diameter of about 3.05m (10ft).

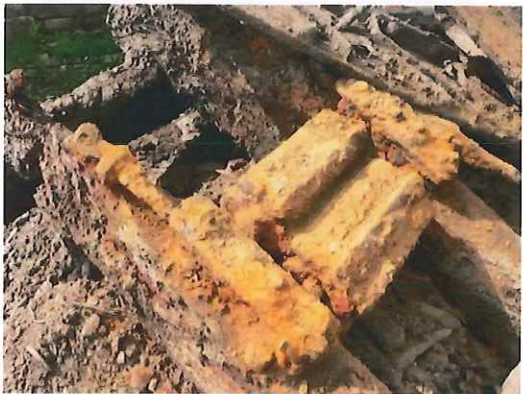
Remains of apple mill

Also recovered from the debris filling the wheelpit was the remains of an apple mill – some substantial timbers with two coarsely-toothed iron rollers which performed the primary breaking up of the apples – and a square section iron shaft with the remains of two timber belt wheels or pulleys mounted on it. The shaft and pulleys may have been part of the drive to the apple mill (see photographs).

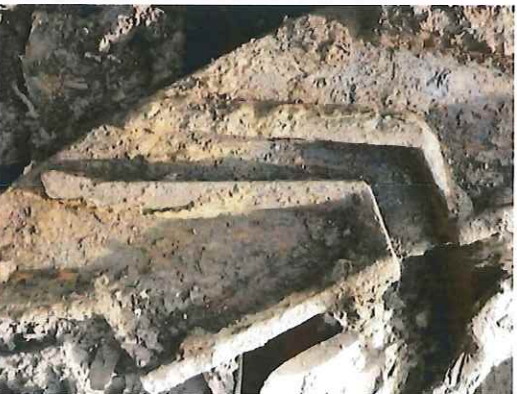
Detail of shroud, showing bucket flanges

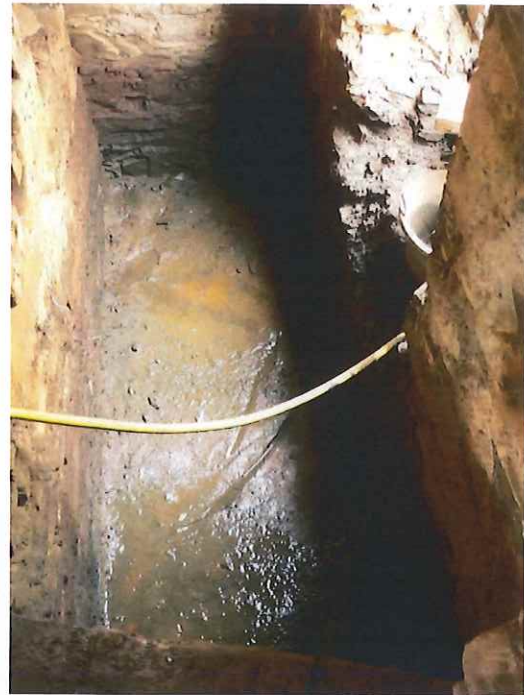
Internal cog pit after clearance

to have drained into the cogpit. It is rectangular in cross section and capped with concrete. The wall in the south-west corner, above the cog pit, has been rebuilt. The cog pit is stone-lined, the inner face at its south end being partly built into the south wall of the mill. There is a skewed granite beam across the north end of the pit, with evidence of a bearing having been fixed to its upper face. The wall that this bears on and which forms the north end of the present cog pit has been inserted, the east wall of the pit running northwards beyond it.

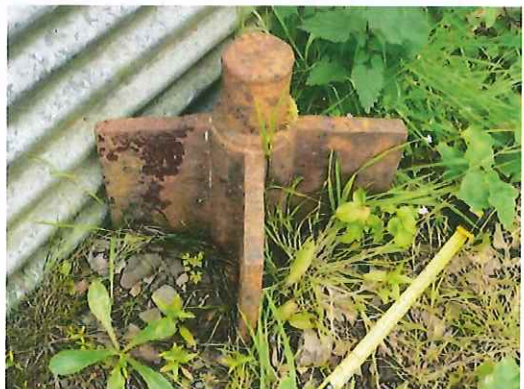
Cross-tail gudgeon from inner end of wheelshaft
