Route 39 Academy, Steart Farm Bucks Cross, Bideford, Devon

Historic Building Record

Ref: 115060.02
January 2017

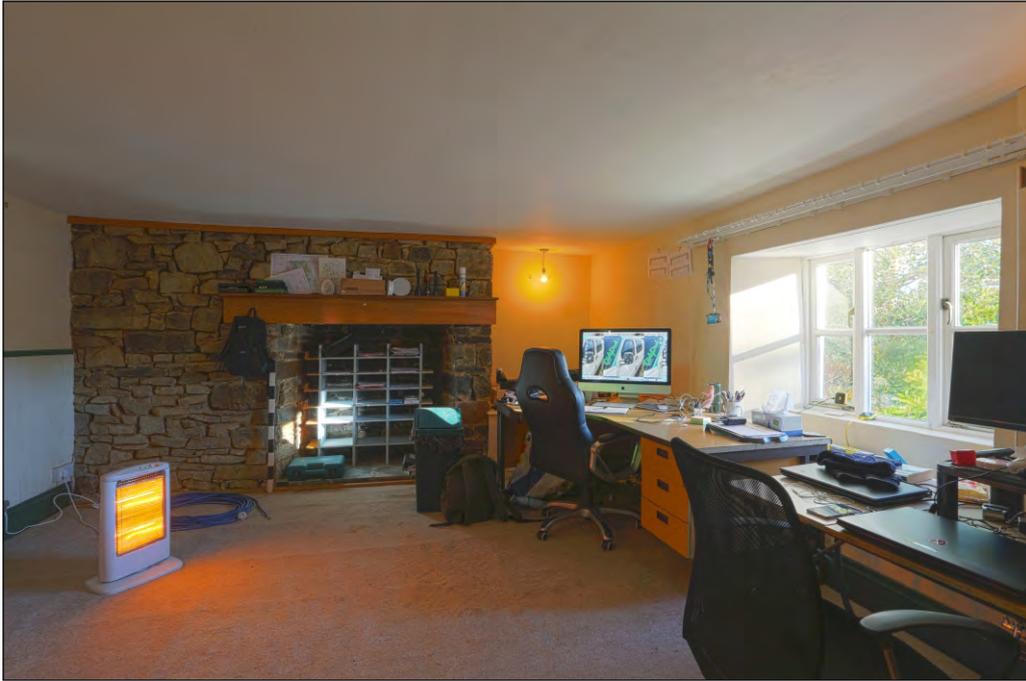
Plate 13: Steart Farmhouse room G3 general view of room showing single splayed window opening

- 4.2.18 The room is lit by a single splayed window opening in the south wall, which is fitted with a modern replacement timber framed casement window (**Plate 13**). Wainscoting to the north wall is considered to be of modern date, as the boards appear to be of regular softwood tongue and groove.

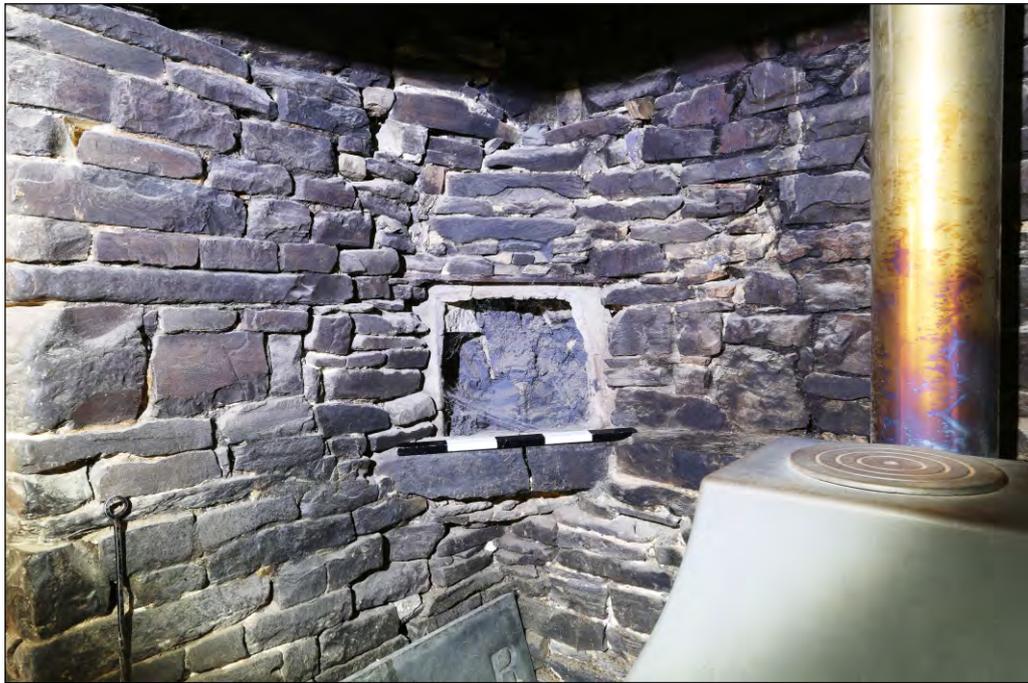
Plate 16: Steart Farmhouse room G4 remains of south cloam oven

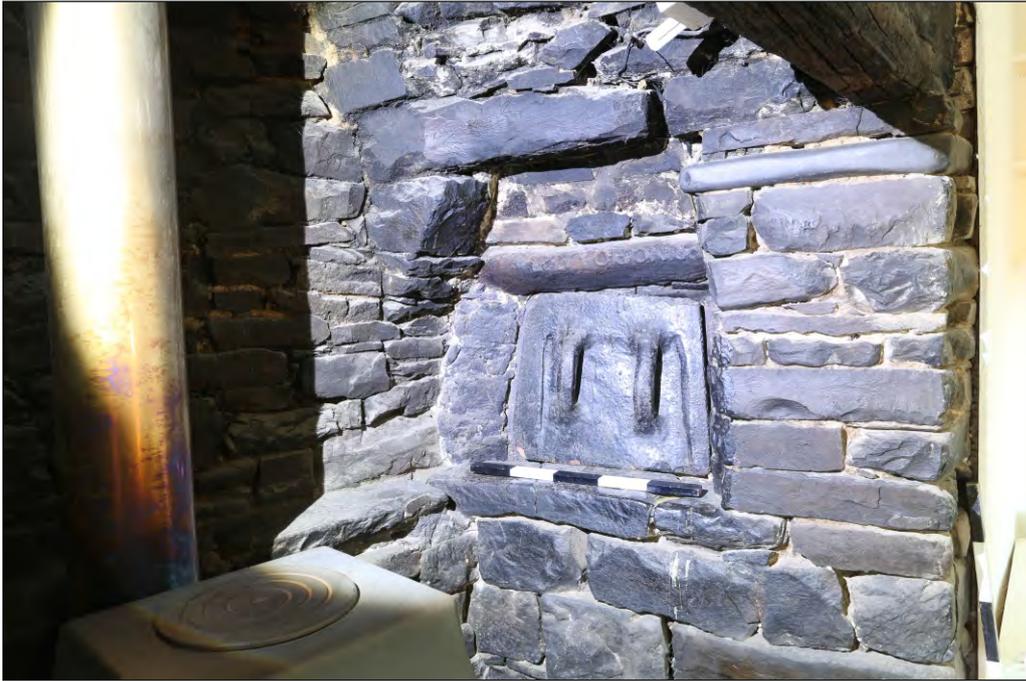
Plate 17: Steart Farmhouse room G4 north cloam oven with cast iron door in-situ

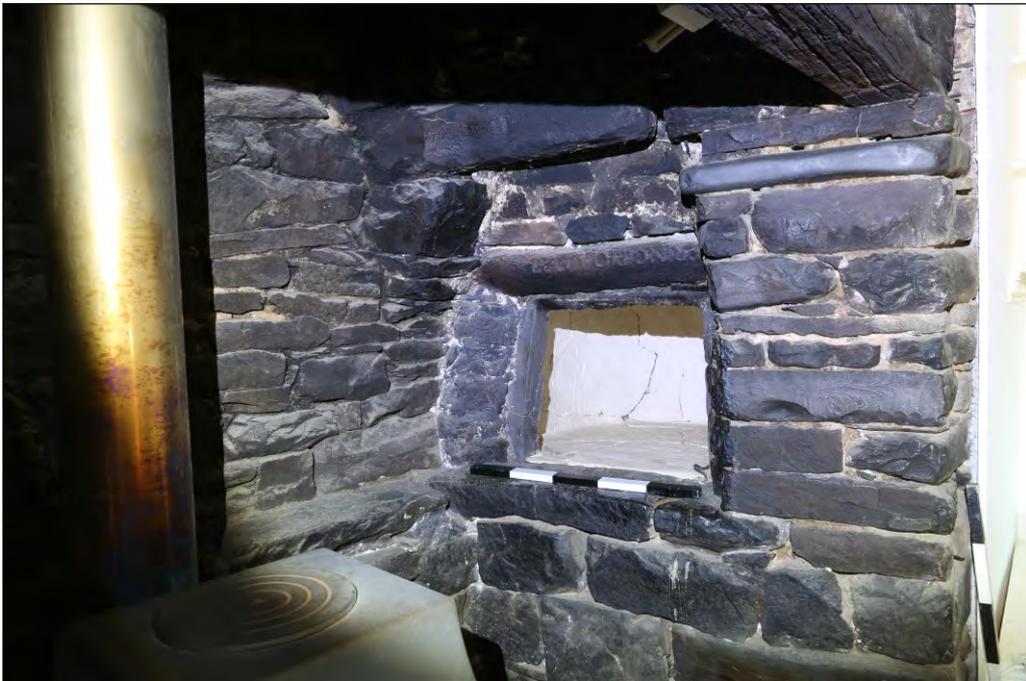
Plate 18: Steart Farmhouse room G4 north cloam oven with cast iron door removed

- 4.2.24 The north cloam oven appears to be constructed into the stone walling of the chimney rather than being a later insert with a larger stone opening formed by corbelled stonework surround. There is also a large stone lintel above the main opening. An original cast iron door to the cloam oven still survives. This feature has been simply cast in a trapezoidal profile with two crude projection handles also formed in the same casting. It appears to fit the north cloam opening well suggesting that it is contemporary rather than a later replacement (**Plate 17**). With the removal of the oven door, the interior could be viewed. The rounded and domed oven has been lined with possibly fire clay but did not appear to have been used in recent years (**Plate 18**).

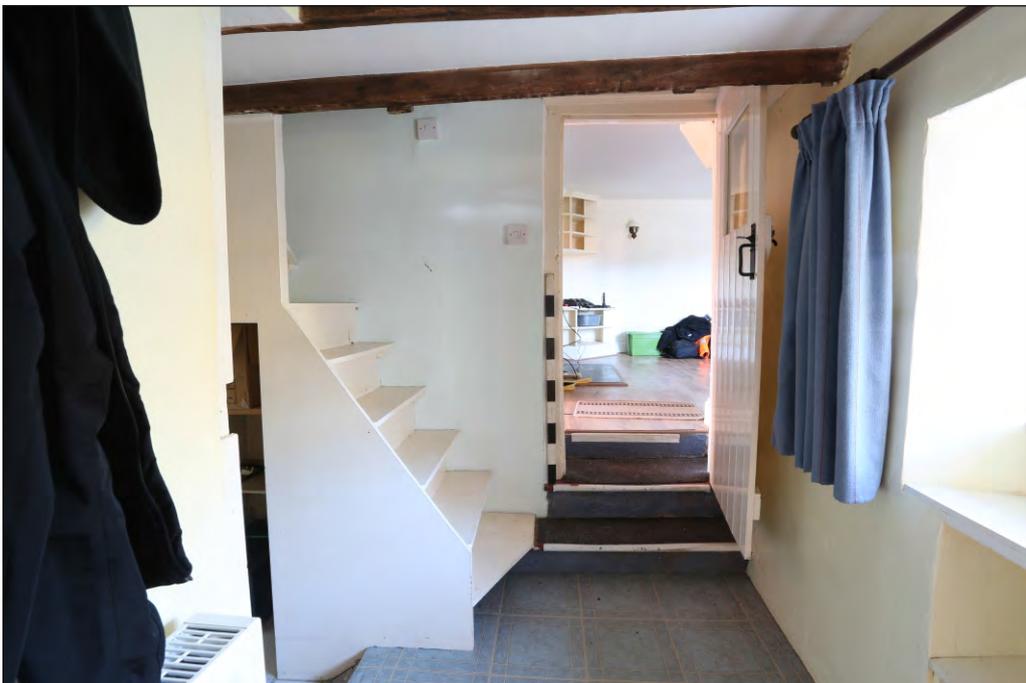
Plate 24: Steart Farmhouse low door and floor level change between east-west range and south-west wing

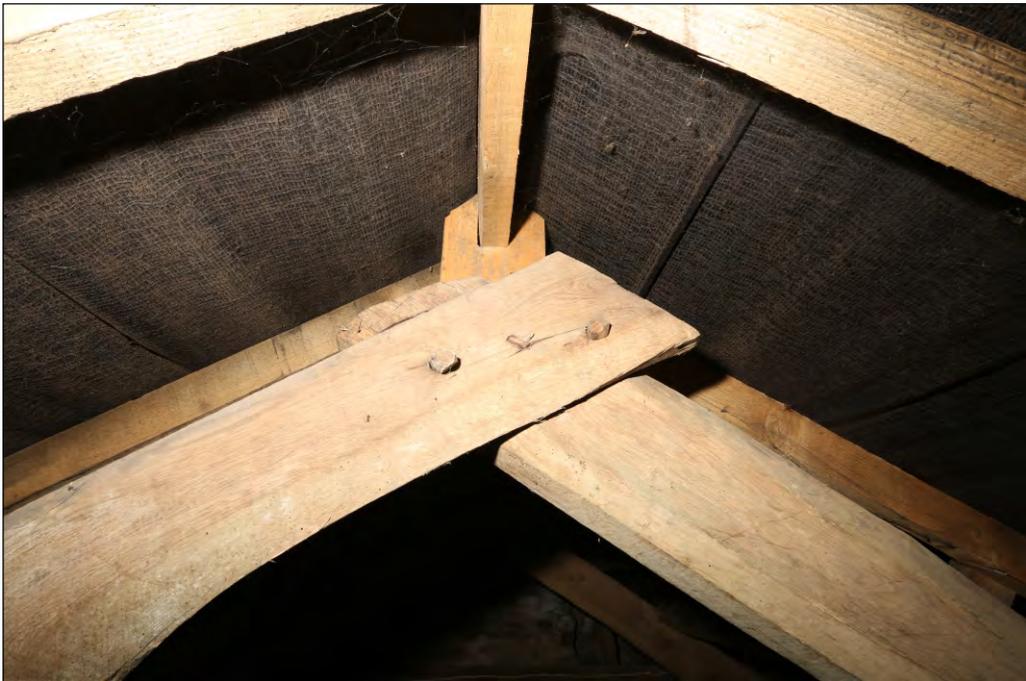
Plate 36: Steart Farmhouse typical roof truss apex joint

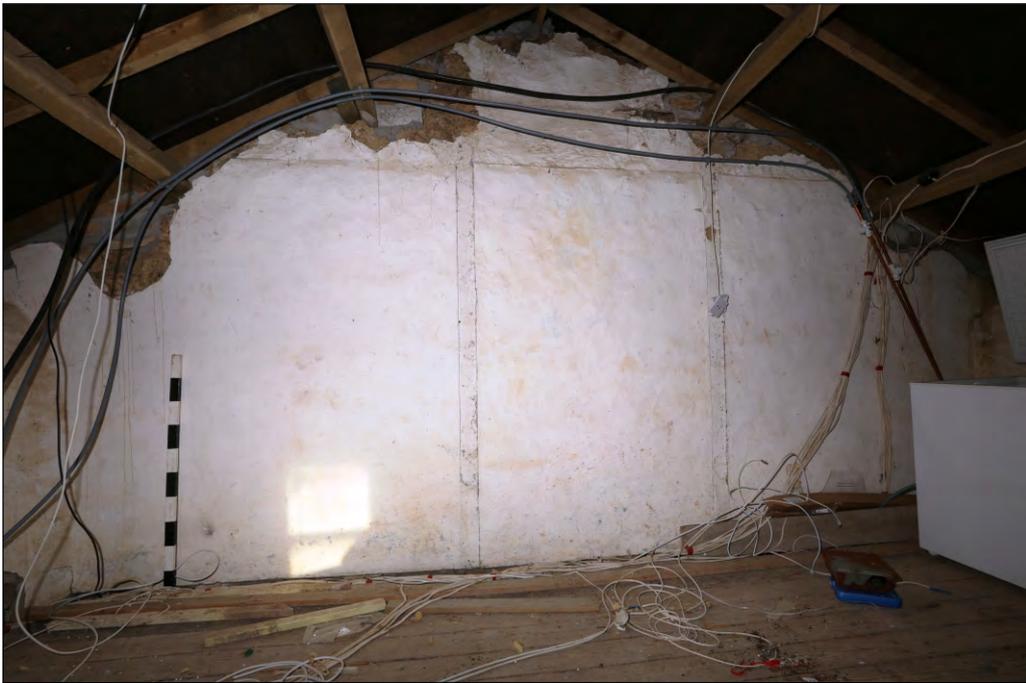
Plate 40: Steart Farmhouse south-west wing first floor room F6 north cob dividing wall and timber studs

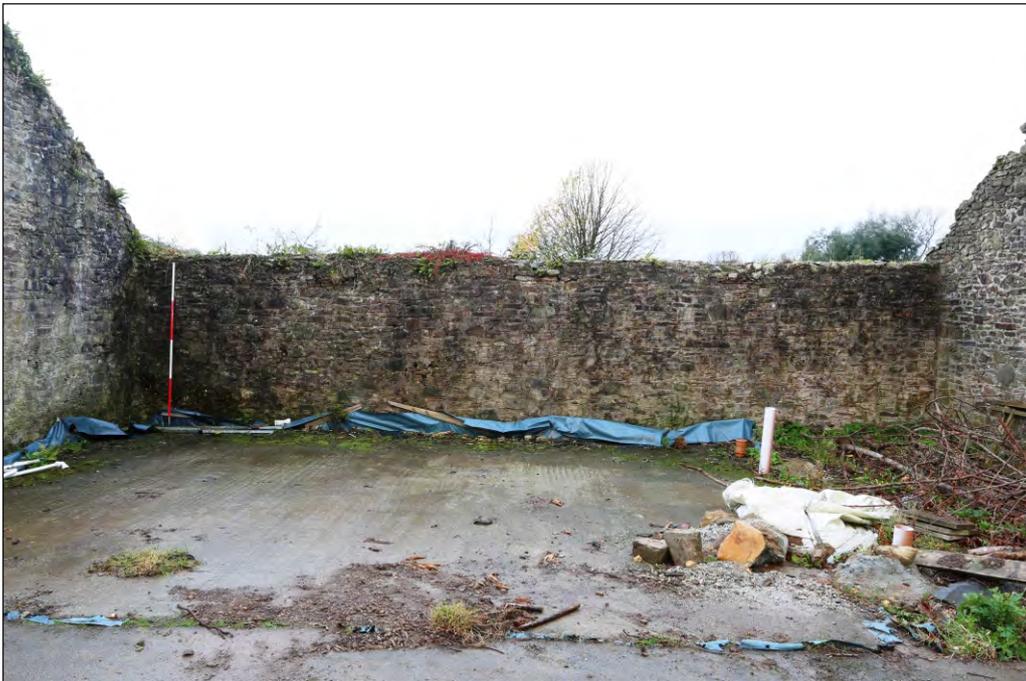
Plate 42: Open fronted cart shed Building 3, interior view of west wall showing timber roof truss pads set in wall fabric

- 4.3.4 It is thought that there would have been four internal bays. The roof trusses are missing but short lengths of timbers are still to be seen in the inside face of the west wall marking their positions (**Figure 8, Plate 42**). The present floor surface is concrete and clearly modern.

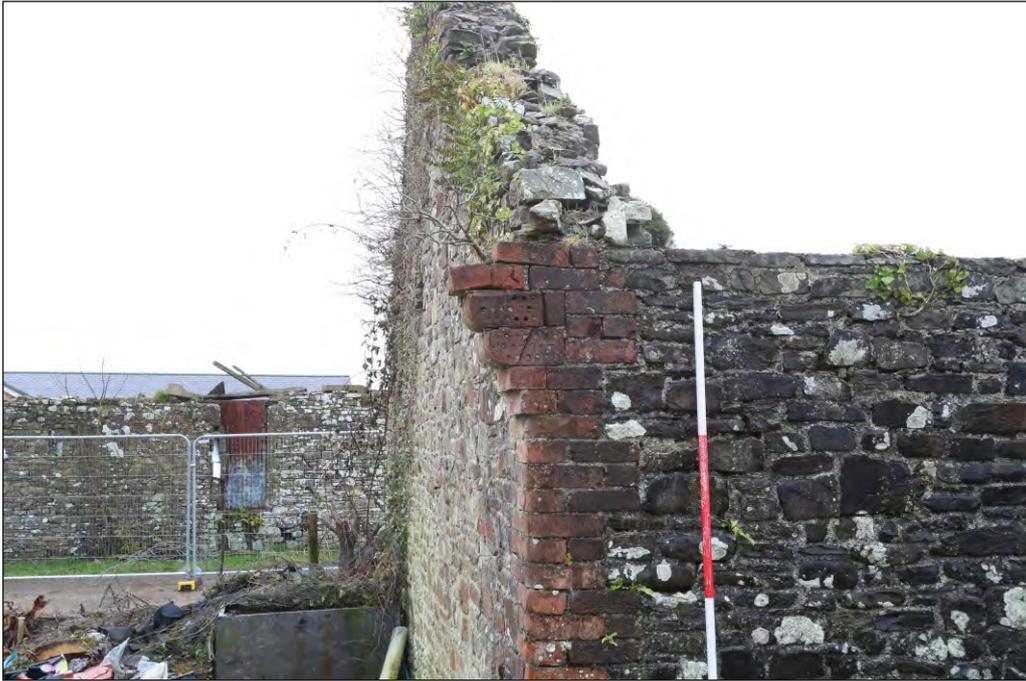
Plate 43: Open fronted cart shed Building 3, detail of characteristic corbel detail in brick

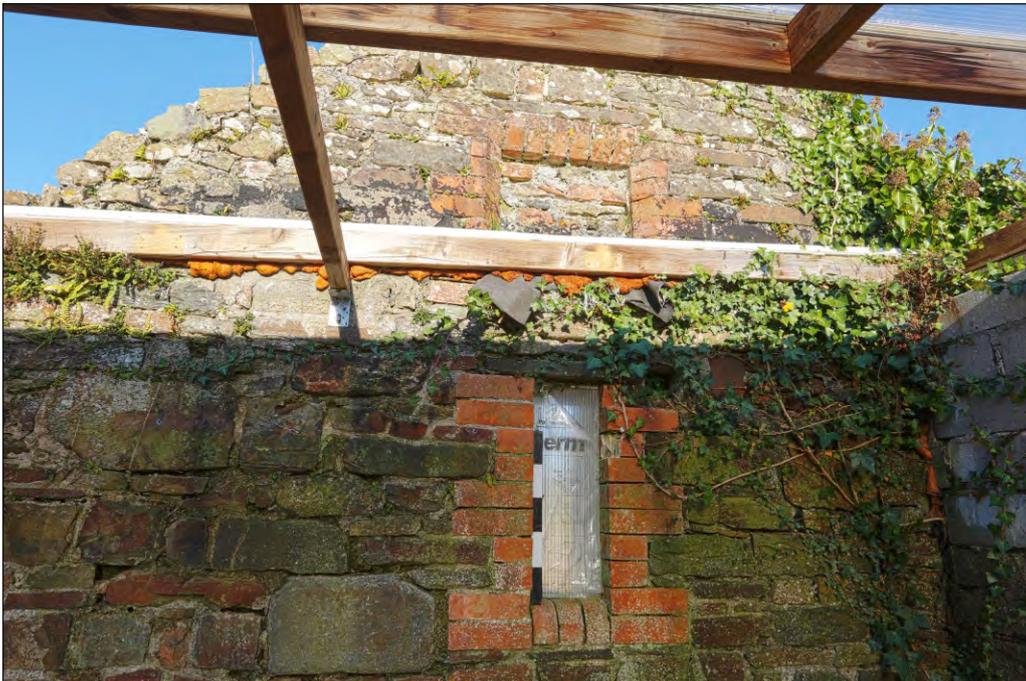
Plate 44: Open fronted cart shed Building 3, south gable wall showing window and commemorative plaque recess

- 4.2.29 The two recesses may have once had a commemorative Mark Rolle's plaque in each. Both buildings are considered to be of Rolle's work and the surviving example is the only one found at the farm.

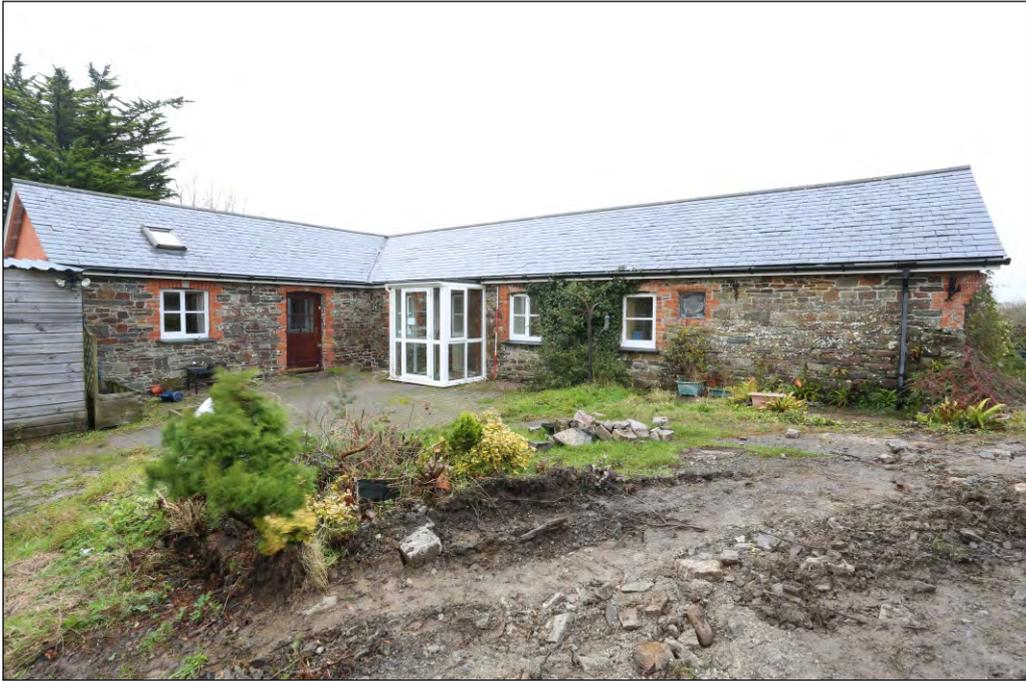
Plate 45: Former farm range building 4, east-west and north-south ranges viewed from south-west

- Exterior
- 4.4.4 The south and west facing elevations face inward to the open-sided yard (**Figures 10 and 11, Plate 45**). The south elevation of the east-west range has a single window and door opening (**Plate 46**). Each of these openings has characteristic red brick dressings of Rolle's work. The window exhibits block quoining with a cambered arch of soldier bricks with stone keystone. The window sill is slate with a modern replacement wooden framed casement window. The door has similar red brick dressings and the door head has a similar keystone.

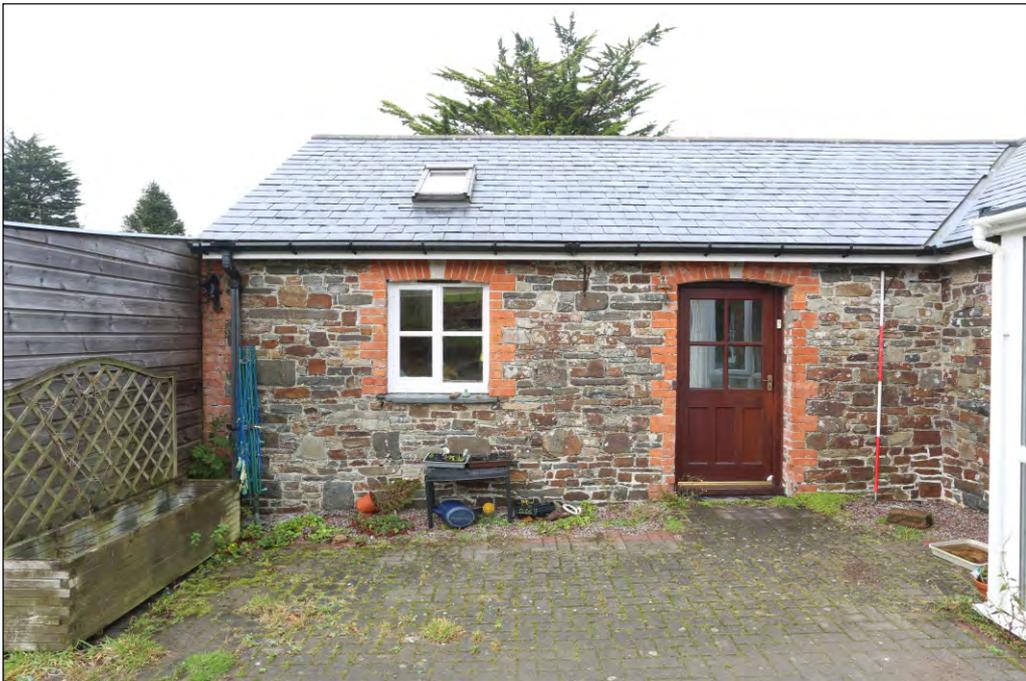
Plate 46: Former farm range building 4, south elevation of east-west range

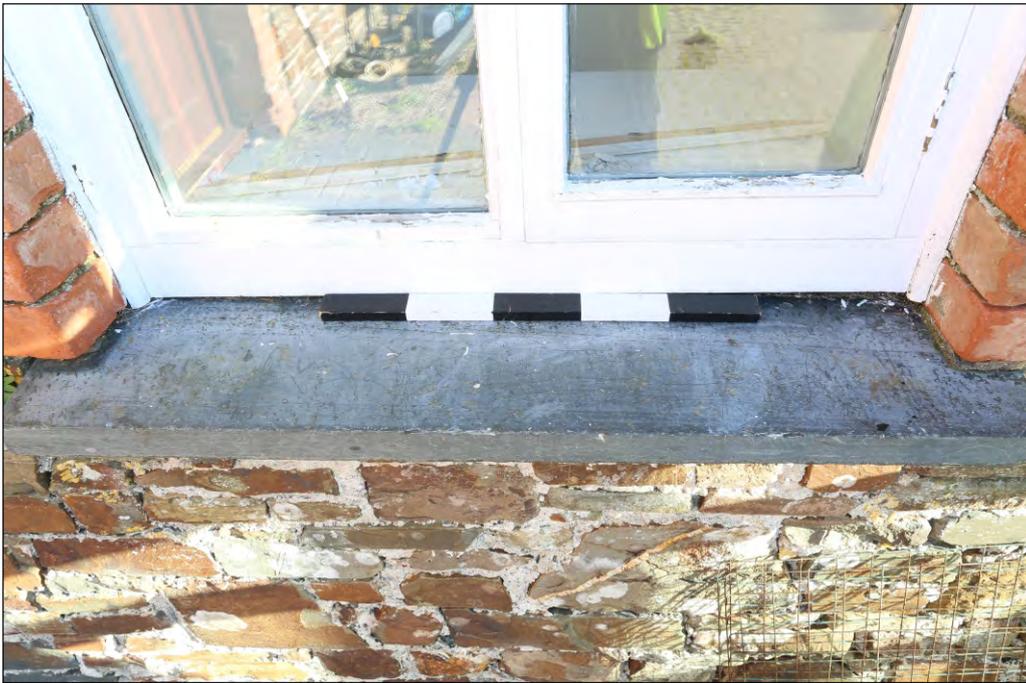
Plate 48: Former farm range building 4, detail of apotropaic marks on window sill

- 4.4.8 The two small windows flanking the west facing door entrance similarly share red brick dressings (**Figure 11**). The north window has a slate window sill that exhibits possible apotropaic marks. Among what appears to be general scratches and signs of wear on the surface of the slate window sill, are several faint daisy wheel patterns inscribed into the upper surface (**Figure 11, Plate 48**). Such 'witch' marks are thought to have been used to protect a building from evil spirits, witches or their animal familiars (Hall 2005). Fear of witches was at its height in the 17th century and the placement of apotropaic marks was crucial in providing protection against these perceived threats. Generally placed around doors, windows and fireplaces as these were seen as danger points, through which evil spirits could enter a building. The marks can be many designs, although the daisy wheel is more common. Whether these particular marks are original to the farm or come from a re-used sill is uncertain. However, the superstition and tradition has continued down the years with many 19th and 20th century examples found.

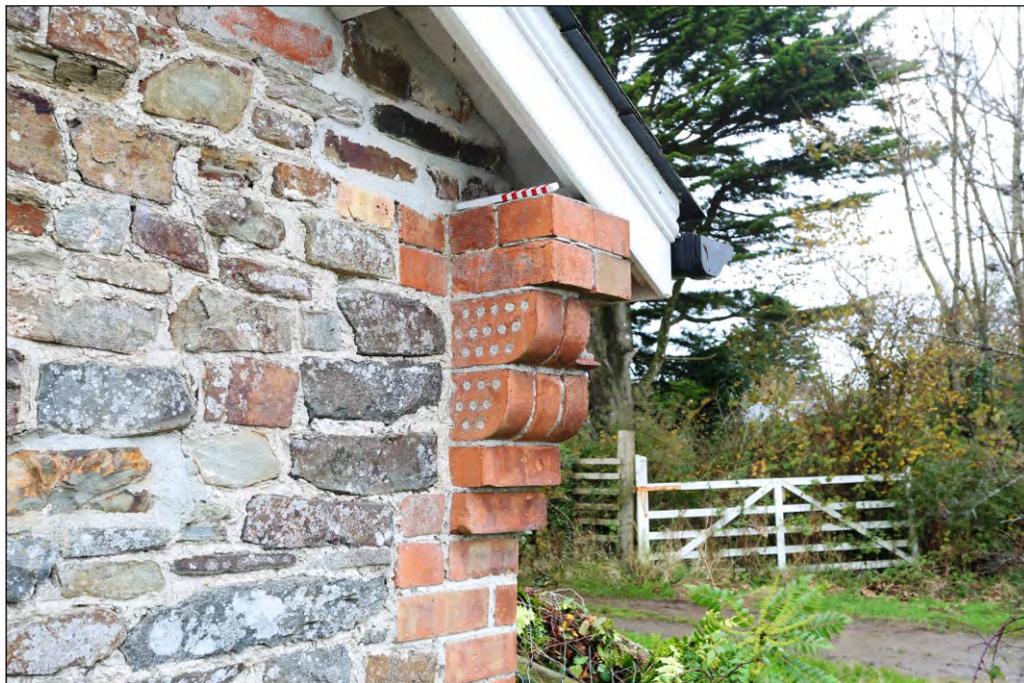
Plate 52: Former farm range building 4 good surviving example of Rolle's brick corbel

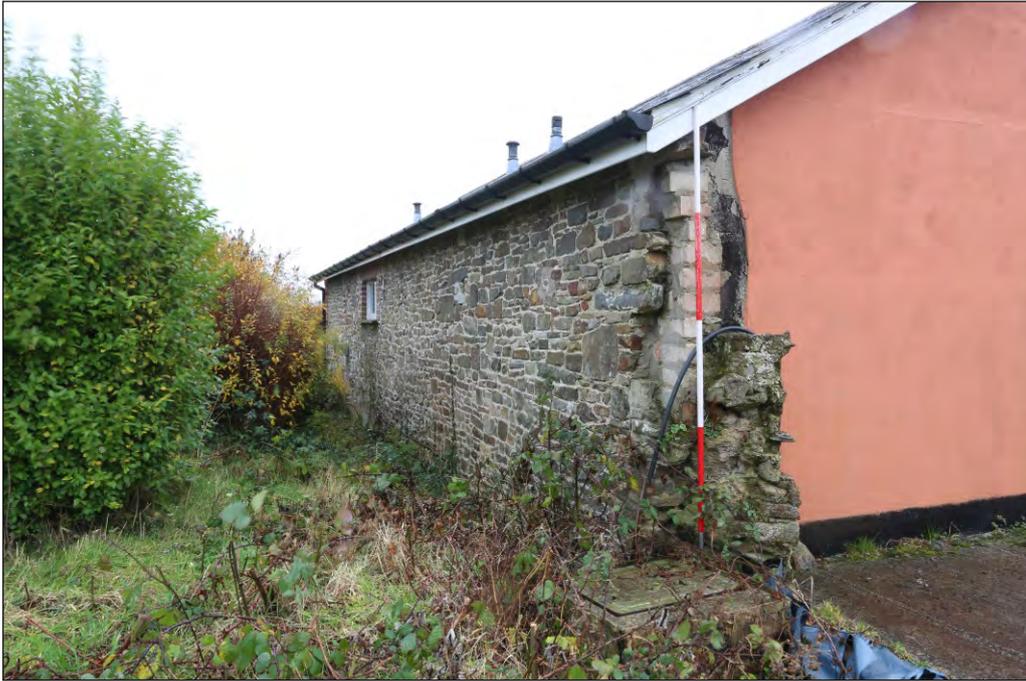
Plate 53: Former farm range building 4 oblique view of north elevation

- 4.4.13 The north elevation of the east-west range remained generally plain (**Figure 10, Plate 53**). The 1997 building drawings, supplied by the Client, indicate that originally, the elevation had air-brick openings and a single high-level window. The presence of such features strongly suggest that the building was used as a Shippon. The air-brick provided ventilation and the window, located at high level, allowed some natural light and was positioned as to not be damaged by moving cattle. The air-bricks have been removed and blocked with stone walling and the existing window is a modern replacement.

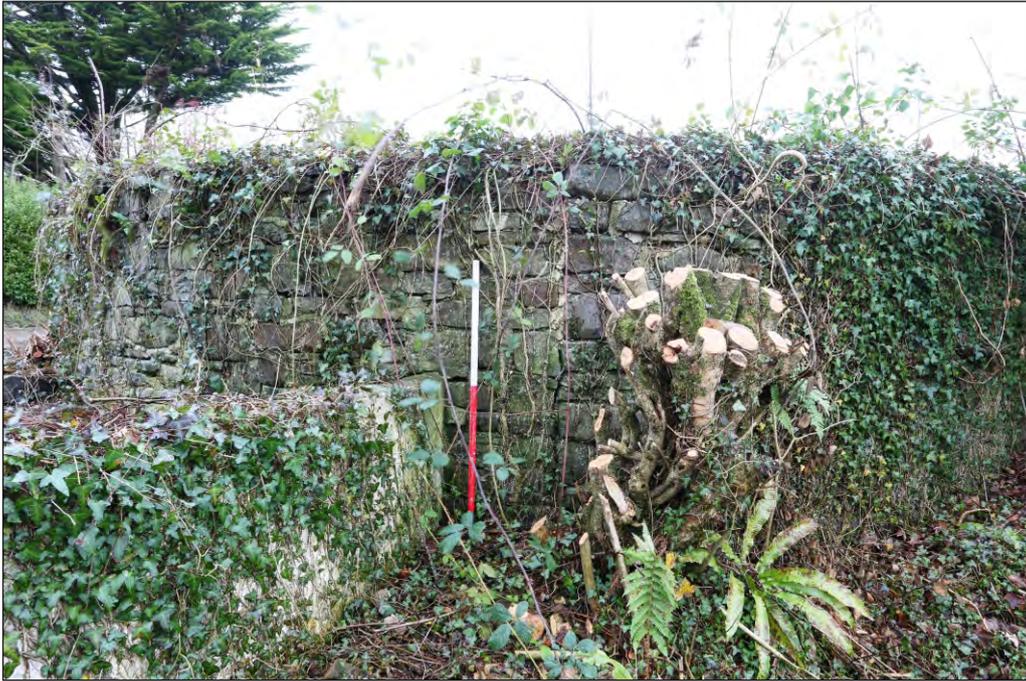
Plate 61: Former farm range building 8 evidence of blocked door entrance to horse-gin house

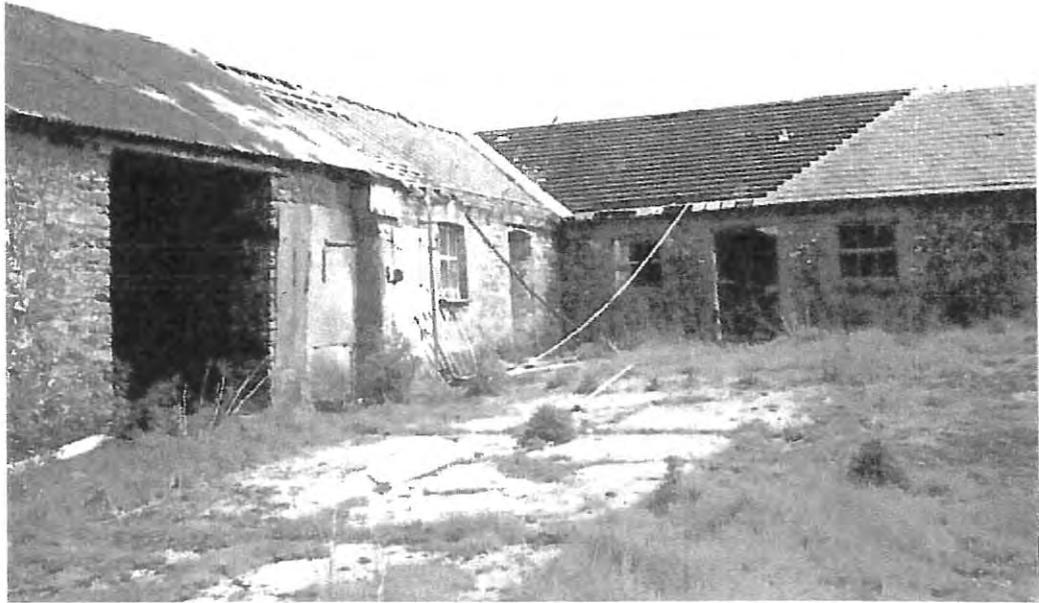
Figure 41. 1995 photograph. Inner angle of Buildings 04 and 08 creating the NE corner of the yard, building 04 shows Rolle brickwork, building 08 does not.

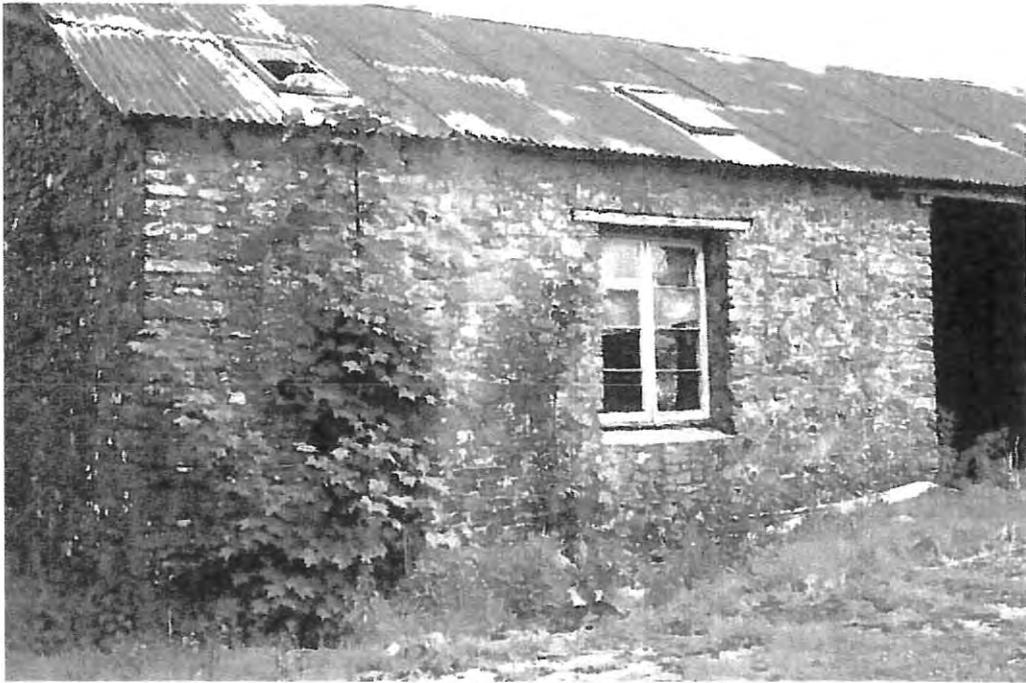
Figure 42. 1995 photograph. West end of the south elevation of building 08, no characteristic Rolle brickwork, this end of the building is believed to have C17 origins as discussed below.

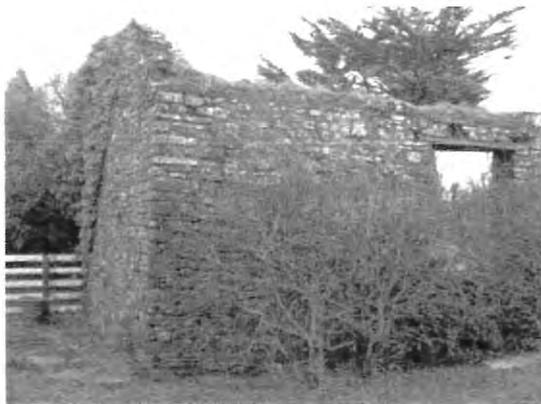
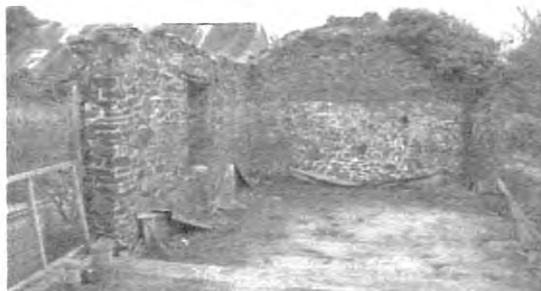
Figure 42a. Exterior and interior of the west end of building 08. (Interior from RPS plate 16, Appendix 12). The damp proof membrane (blue plastic sheet) beneath a concrete floor indicates that work to convert/repair the building have commenced but have never been finished

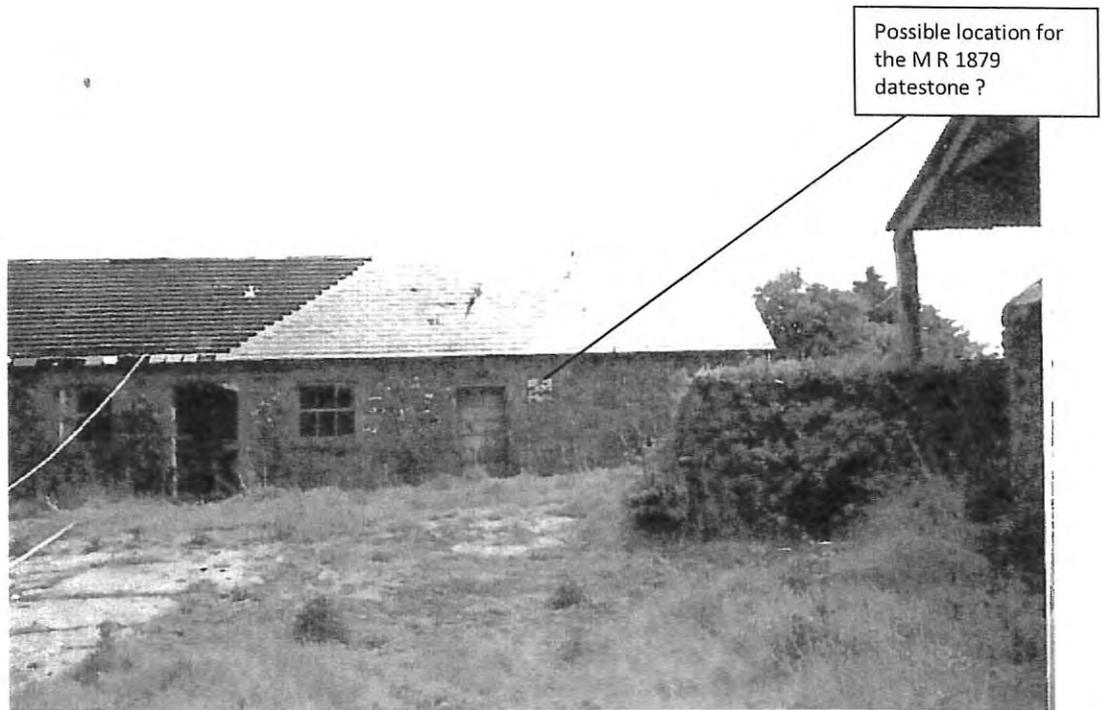
Figure 45. 1995 photograph, west elevation of building 04 showing characteristic Rolle brickwork detailing – the brick dressed square may where the datestone that is held within the farmhouse was originally located?
