EAST HOLME, NEWTON ST. CYRES, DEVON

HISTORIC BUILDING RECORDING AND ARCHAEOLOGICAL WATCHING BRIEF

STEWART BROWN ASSOCIATES
NOVEMBER 2011

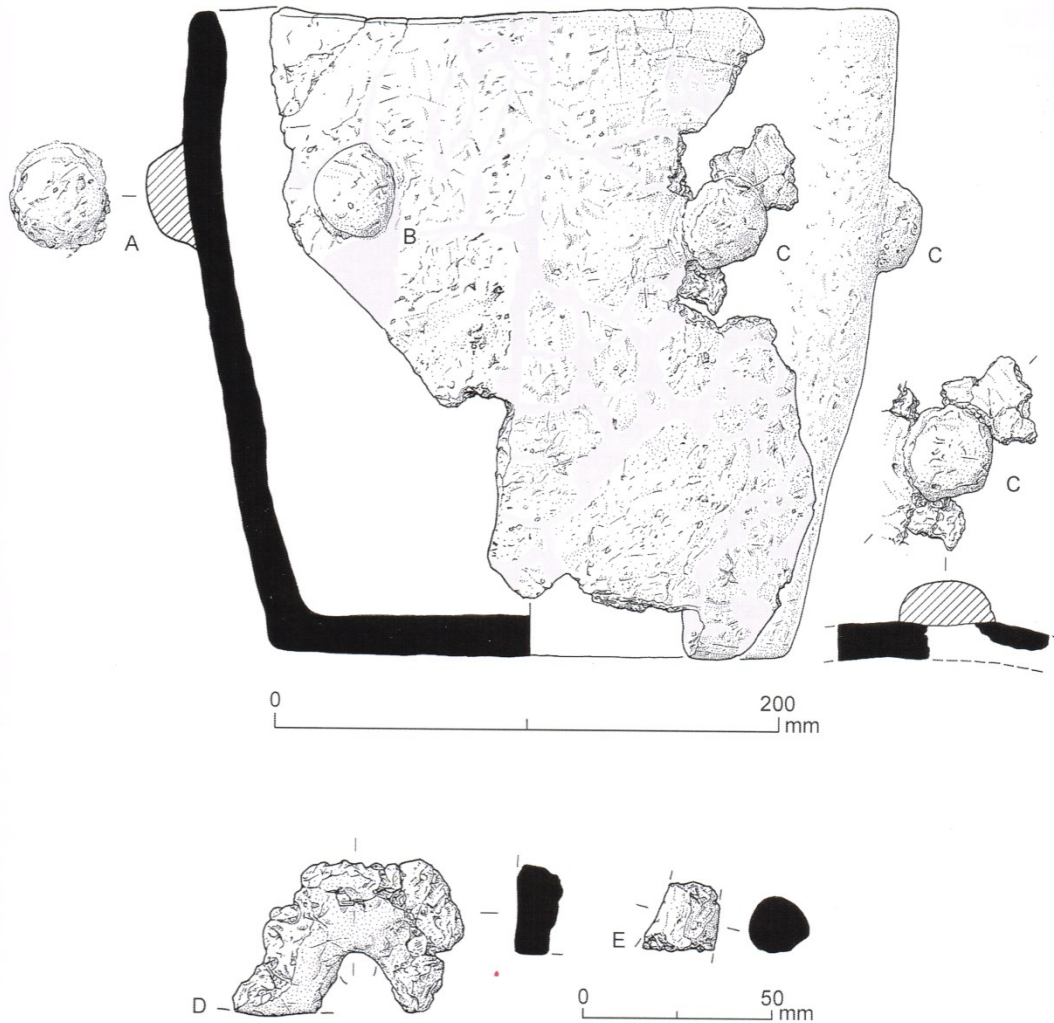
Fig. 2. The vessel: grey indicates areas of surfaces now infilled after consolidation. Scale 1:3 (drawing by Jane Read).

The remains of the vessel were found as three sherd groups, which appeared to represent three large sherds when buried, and some smaller fragments. The pieces within each of the large sherd groups had become somewhat displaced, probably through root action and the disruption caused by the removal of the tree which had occupied pit No. 8. The base, which was largely complete, was buried bottom downwards at the base of the pit. The other two original large sherds were from the side of the vessel, from the rim to the base, and both had 'lugs' or bosses attached. Both were laid outer side down. The lower sherd had one surviving boss A (Fig. 2) and lay with its rim top facing north. The upper sherd with two surviving bosses B and C was laid partly overlying the lower, with its rim at about 120 degrees to it. Sherd D with part of a perforation and the cylindrical fragment E were found close to boss C. The two large sherds join: that with boss A joins to the left of that with bosses B and C and is drawn so that lug A appears both in section and in side view (Fig. 2).

Small sherd D with part of a perforation 14 mm across was found near boss C but did not join any surviving sherd: it had split down its centre so that the outer surface did not survive. A smooth edge, shown at the bottom on Fig. 2, is likely to represent part of a coil edge rather than of a rim. Small sherd E, found close to D, appeared to have been part of a rounded cylinder some 20 mm in diameter.

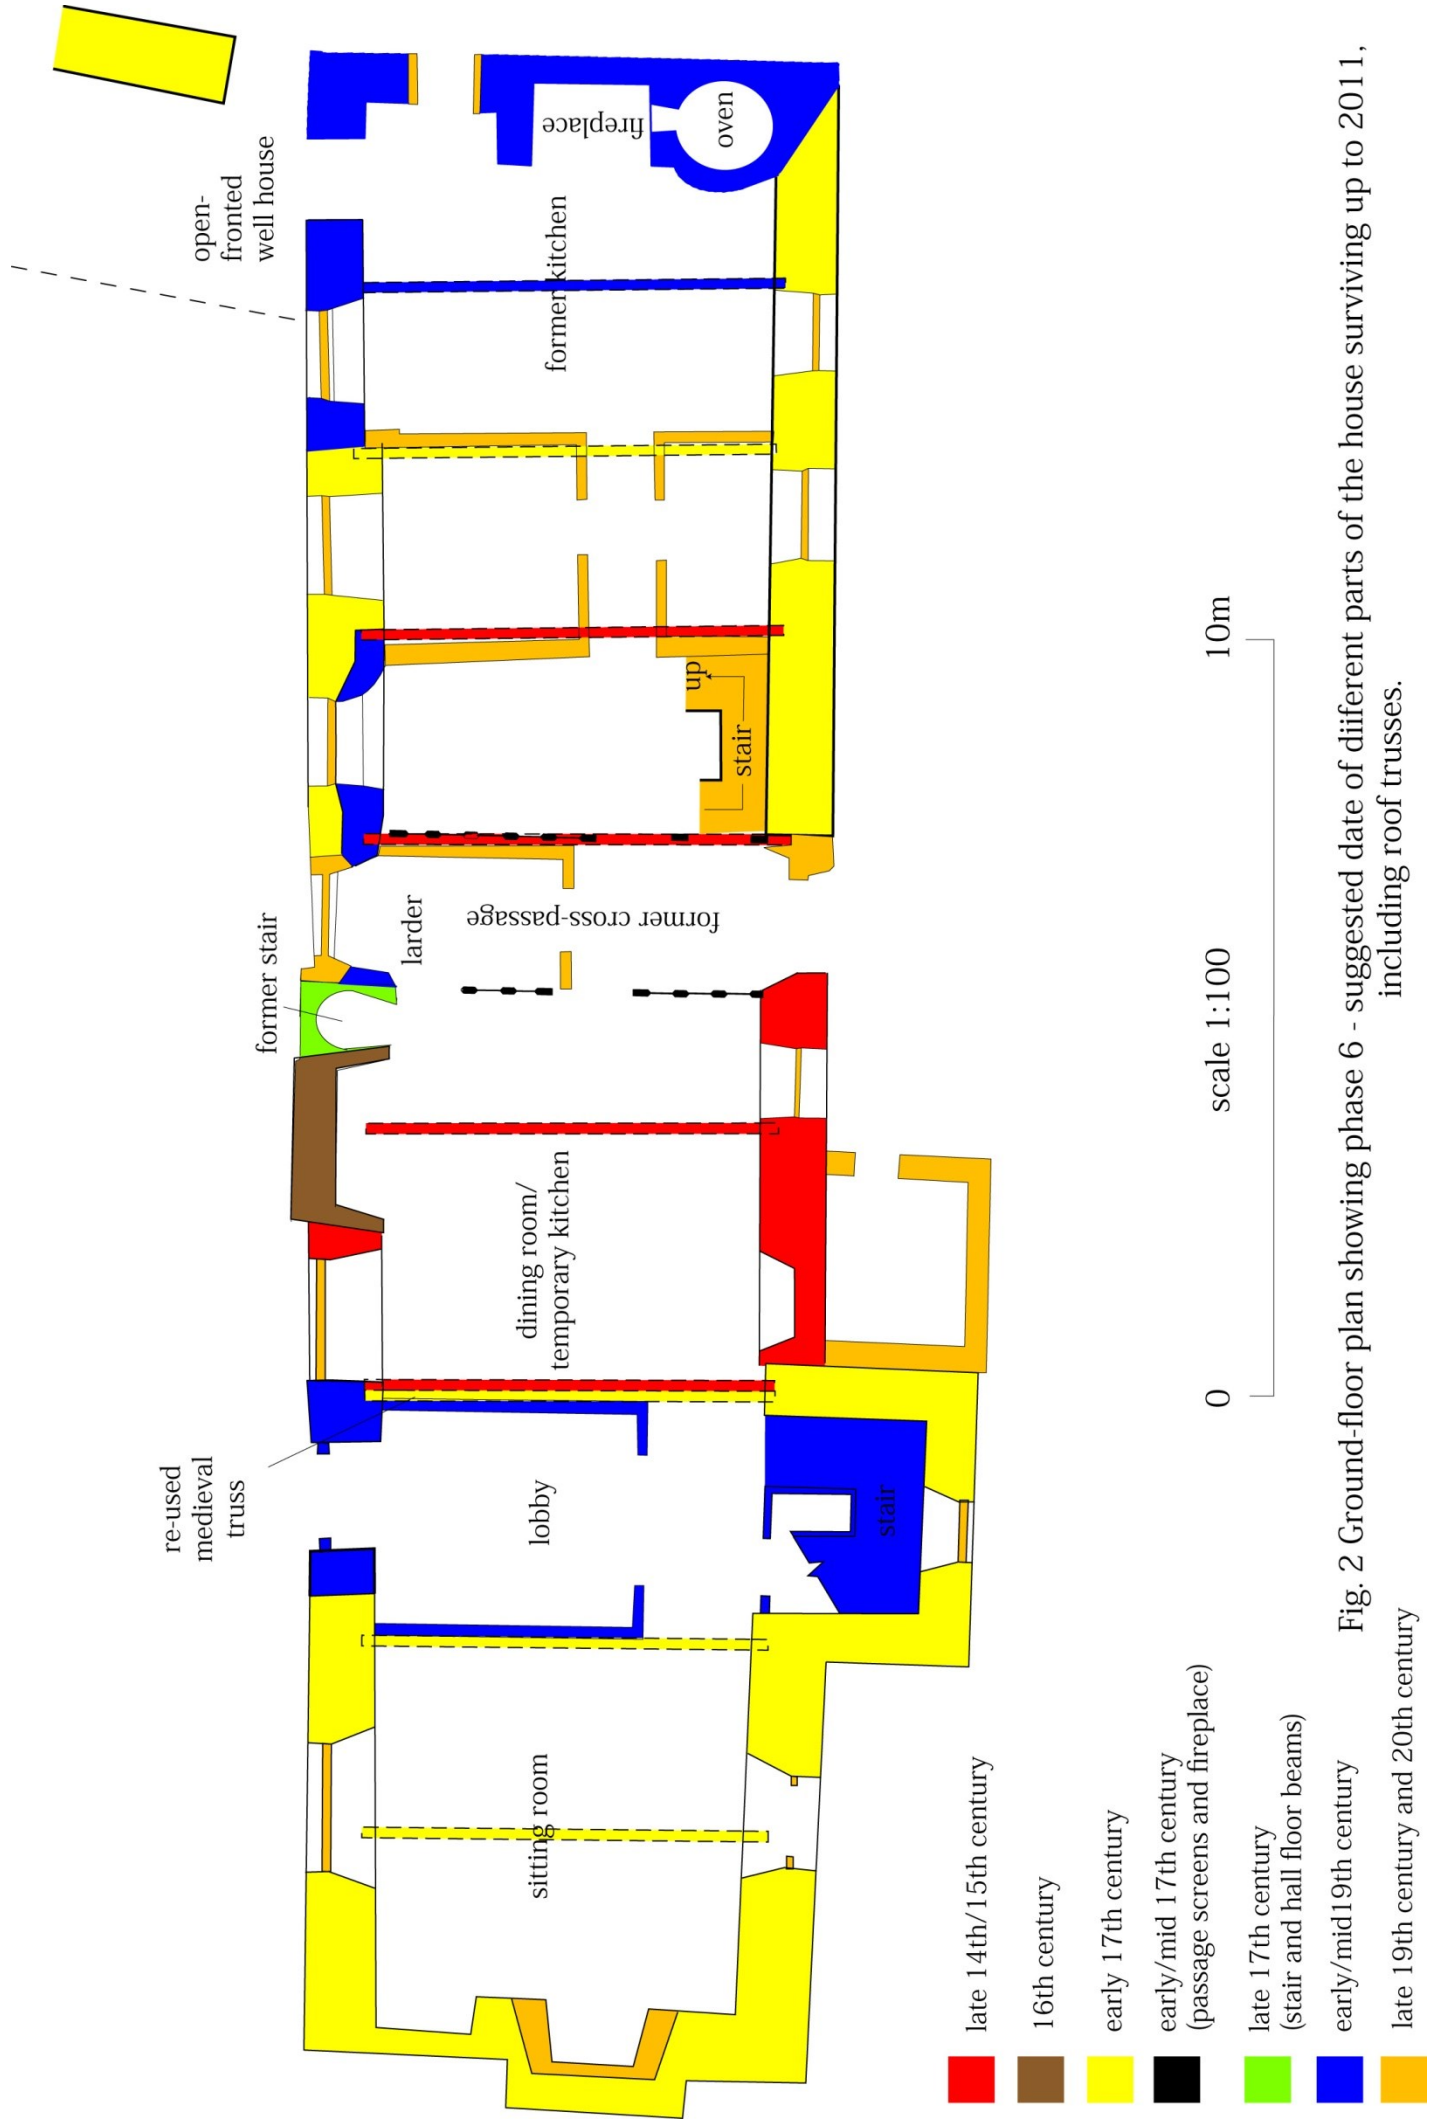
Fig. 2 Ground-floor plan showing phase 6 - suggested date of different parts of the house surviving up to 2011, including roof trusses.

Later modifications to the house are minor, assuming that the 19th-century brick kitchen fireplace at the east end replaced an earlier 17th-century one sited in the same position and of about the same size. Suggested dates for different parts of the house surviving up to 2011 are shown in Fig. 2.

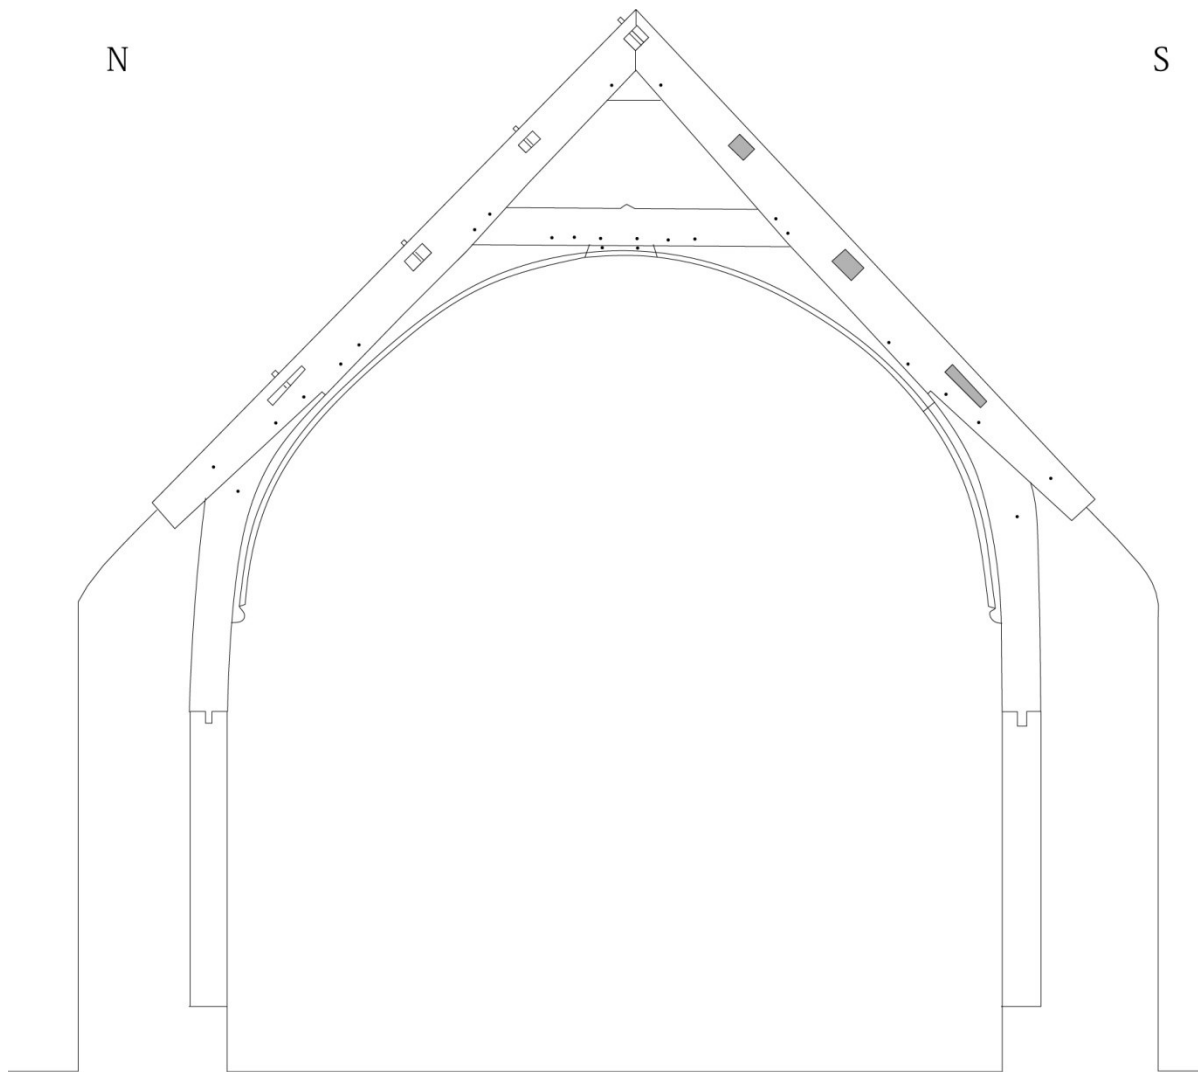
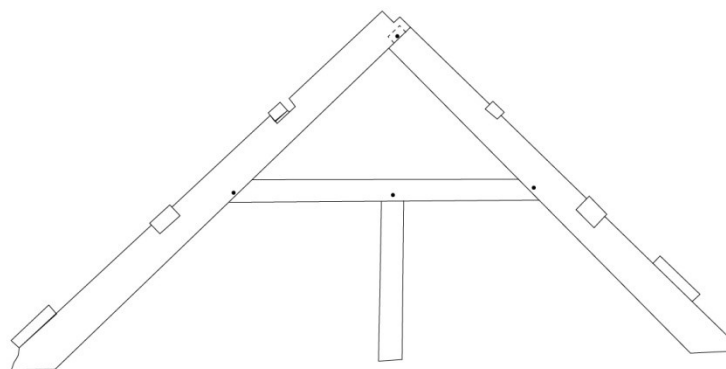
Fig. 3 a) elevation of jointed-cruck truss above former kitchen (after Keystone 2008);
 b) elevation of closed A-frame truss supporting the east end of the medieval roof.

The jointed cruck trusses have a mortise and tenon joint at the elbow with a long tenon on top of the curving head of the cruck post and a corresponding mortise cut into the underside of the principal rafter which extends to the apex (Fig. 3a; Plate 3). The cruck truss appears not to

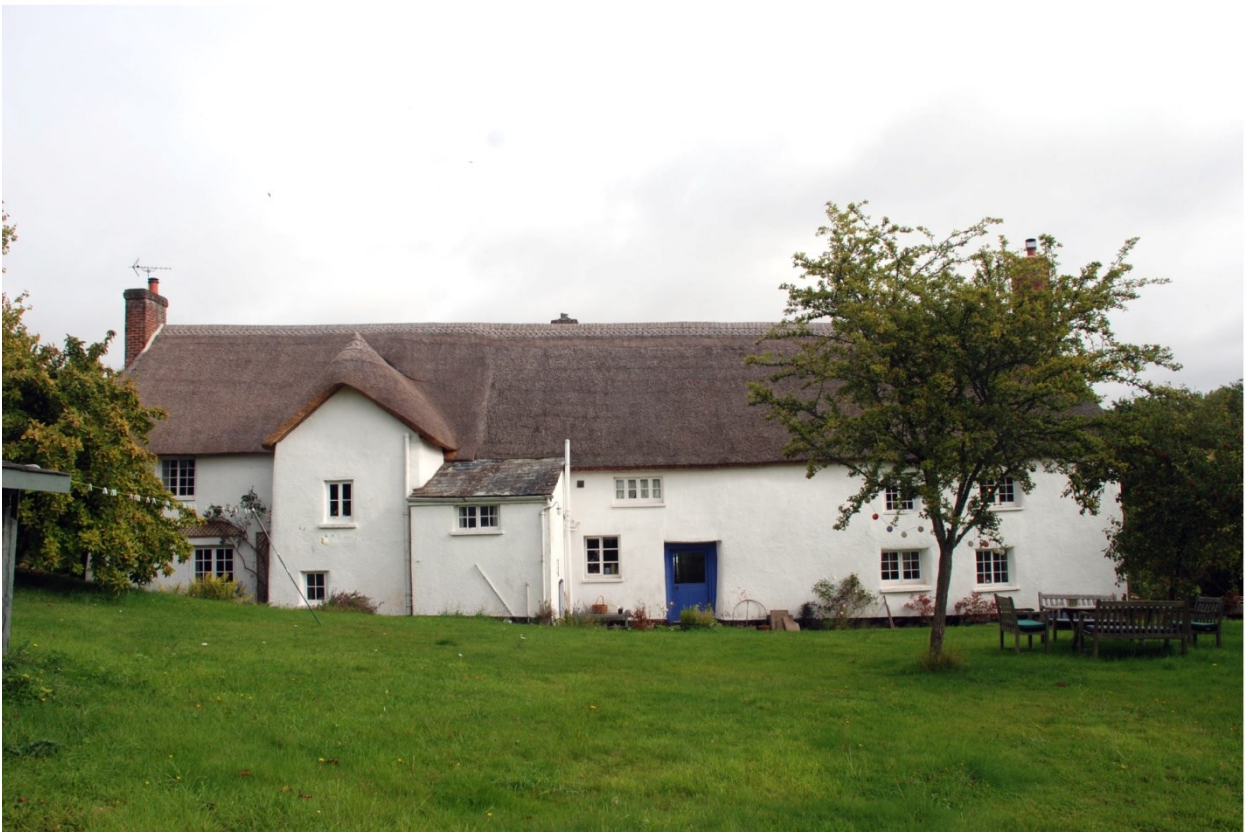
Plate 2 The rear elevation of the house, looking north.

The standing structure (Plates 1 and 2) retains elements from six different building phases dating from the late medieval period to the late 20th century (Fig. 1, Phases 1-5; Fig 2, Phase 6).

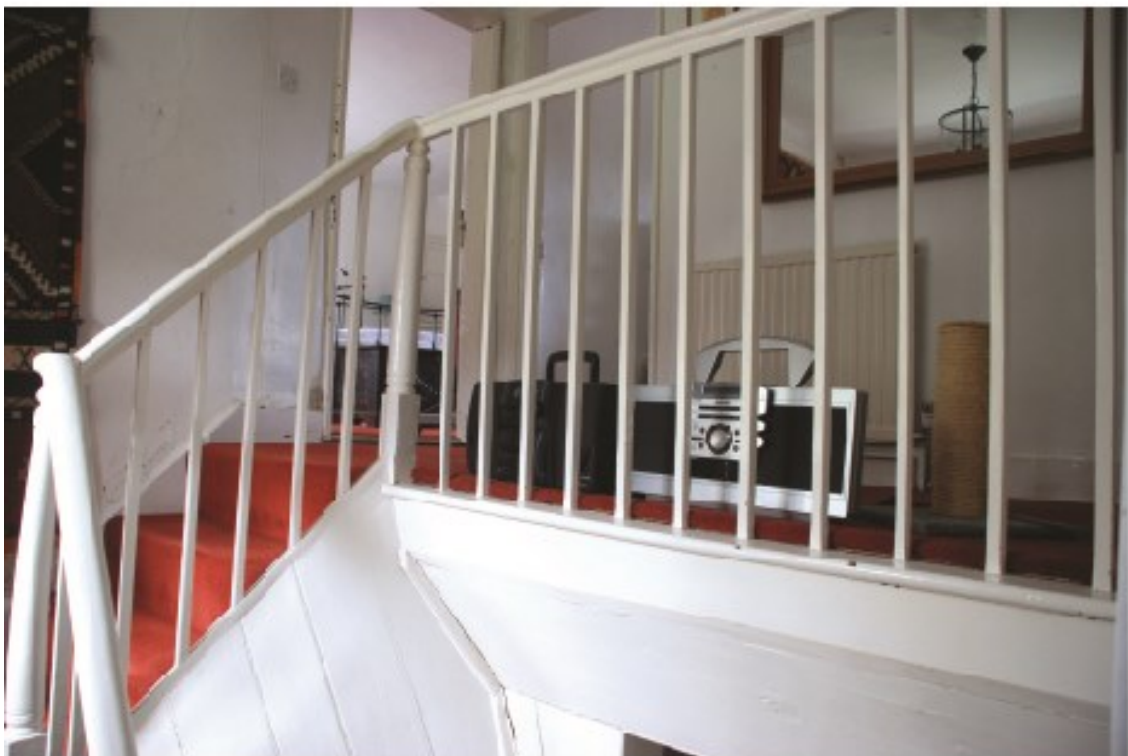
Plate 26 The 19th-century stair associated with the present entrance and lobby of the upper, east end of the house, looking southwest.

A number of alterations date from the early or mid 19th century (Fig. 1, phase 5). The main entrance and lobby in the upper, western end were refurbished and a new wooden stair inserted (Plates 26). The kitchen at the east end was largely rebuilt. Its north and east walls were rebuilt above foundation level with brick and cob. The north wall was rebuilt narrower than it had been before with a new window and doorway. The fireplace was rebuilt largely in brick, with a side oven for baking. The wooden lintel from the previous earlier kitchen fireplace was re-used (Phase 3, above). At first-floor level a new cast-iron fireplace with brick hearth was inserted into the north wall (Plate 27). The easternmost truss of the roof was replaced at this time with the present, crude A-frame truss made up of barely trimmed timbers (Plate 28). The truss has lap-jointed collar and apex with diagonal ridge and back purlins, fixed with pegs and large nails.
