Archaeological desk-based assessment and Historic building appraisal at Troake's Farm, Clayhidon, Devon

Report No. 20-11

December 2020

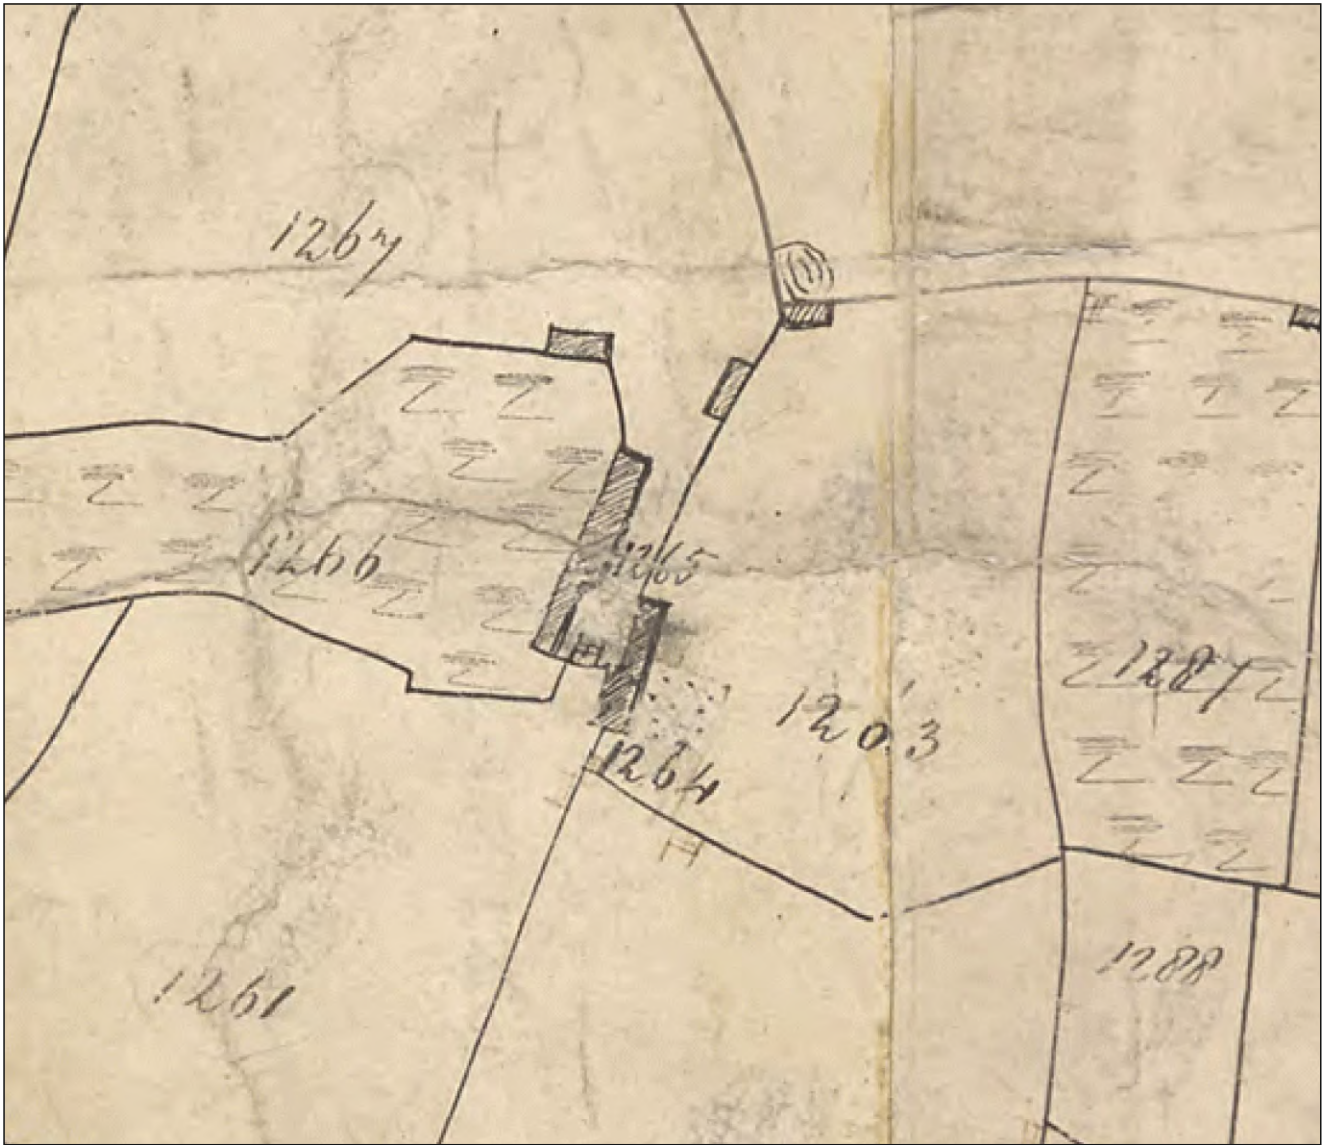
Fig. 2 Detail from the 1838 Clayhidon parish tithe map.

The tithe survey of Clayhidon parish in 1838 (Fig. 2) showed that the buildings and most of the land was now owned by the Reverend John Clarke, Gale retaining the garden, War Mead, Gatchels Mead, Croft and Eastern Close. The map clearly shows the rectangular house on the eastern side of a long farmyard. A small garden, presumably a vegetable garden is shown at the rear of the property. On the western edge of the farmyard a long rectangular range of buildings, presumably agricultural outbuildings including the current threshing barn, are shown, with three smaller buildings to the north. John Hartnell was still occupying Troake's in the 1851 census.¹⁷ He was described as a widower aged 71, a farmer of 41 acres with 5 agricultural labourers, and living with his son William aged 26, daughter-in-law aged 28, and grandson Henry aged 5. Also in the household were William Broomfield, John's grandson aged 13, Daniel and Ruth Manning, visitors, possibly father and daughter and two agricultural servants.

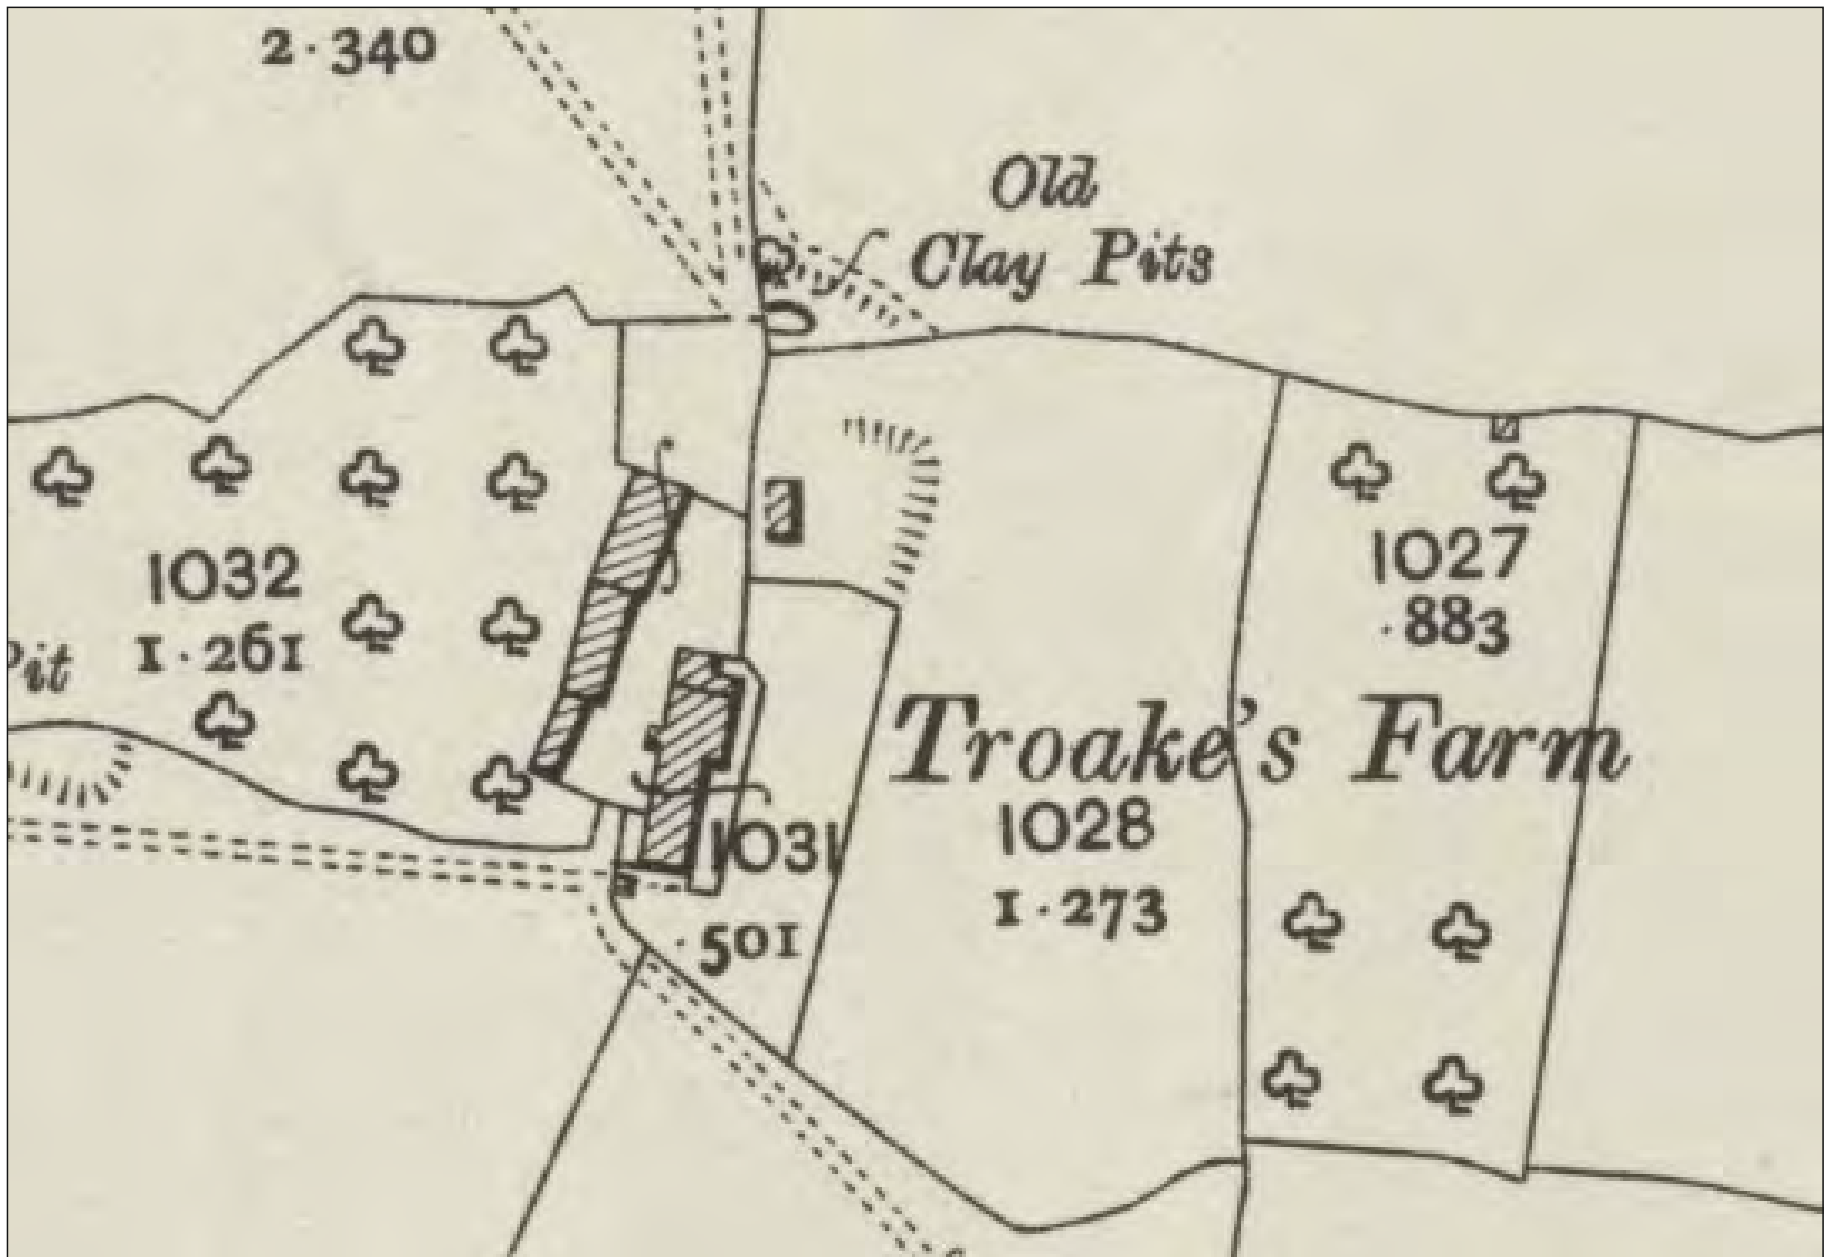
Fig. 4 Detail from the 1905 2nd edition Ordnance Survey Map Devonshire Sheet XLVII.8.

The property remained remarkably unaltered throughout the early 20th century, as is evidenced by the 1905 Ordnance Survey map (Fig. 4), although by 1911²² George, a farmer, and Margaret White were living at Troake's with George's mother, Maria, and Harry Trickey, a farm servant aged 13. The house was listed with six rooms, not counting the scullery, landing, lobby, closet or bathroom. The couple had no children and the Whites stayed at Troake's until at least 1939 when George White, farmer appears in the Kelly's Directory for Devon. By this time he would have been in his 50s and they may have stayed on until he retired.

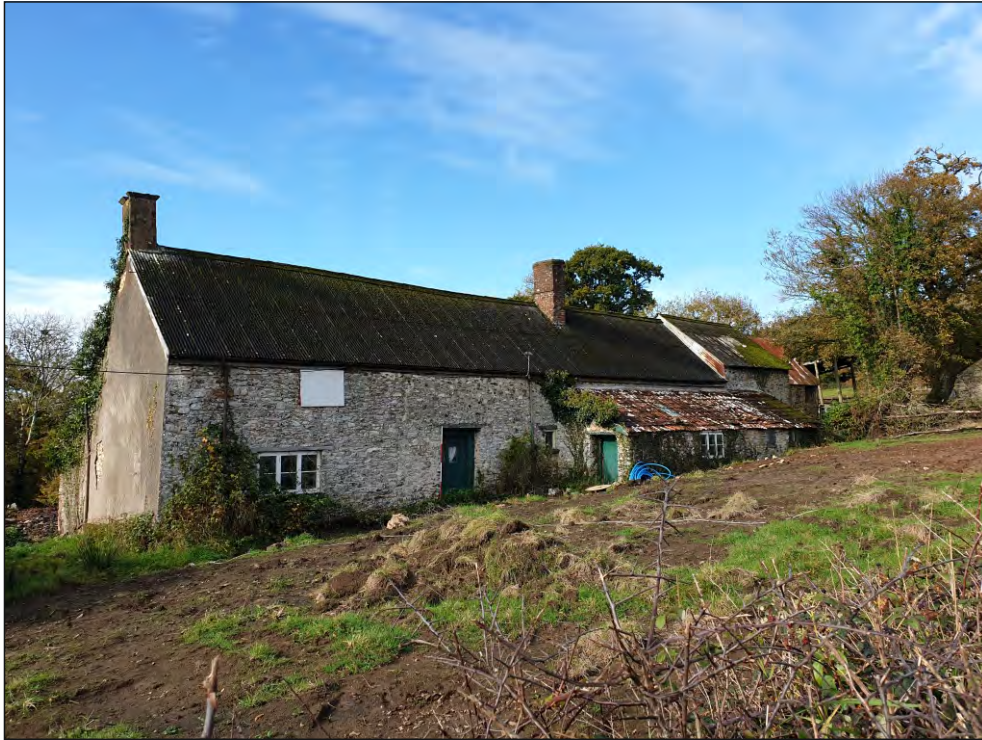
Pl. 1 General view of former main elevation showing Ham stone chimney, position of cross-passage and position of later outshut. 2m scale. Looking northwest

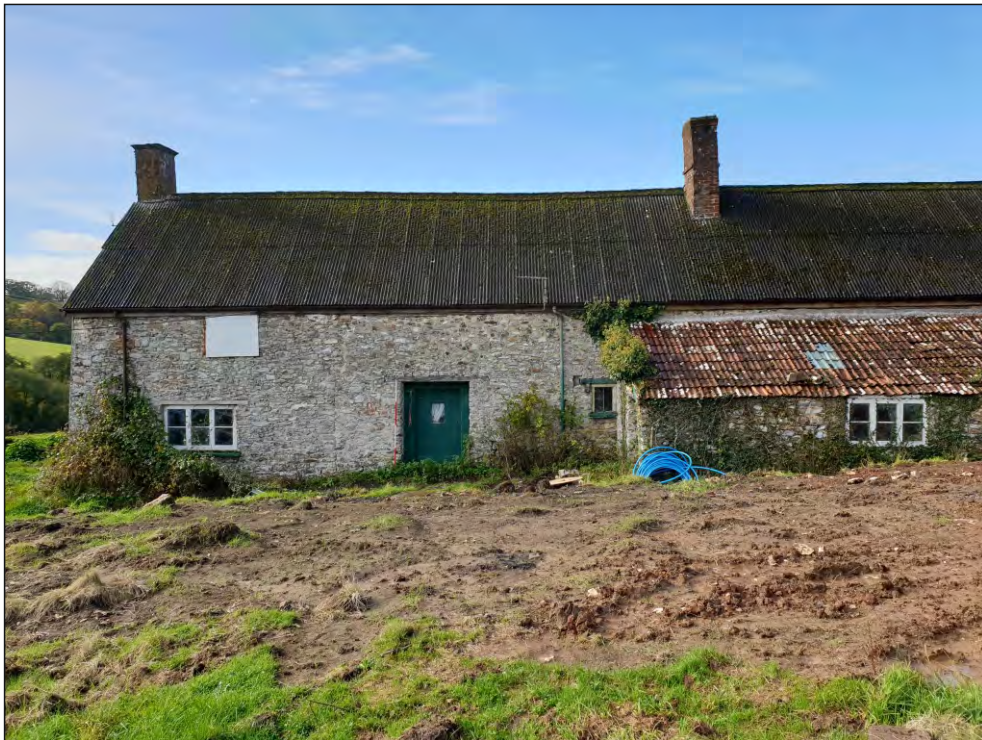
Pl. 2 Close-up of south end showing ground- and first floor fenestration, position of cross-passage with 17th century doorway and the 19th century outshut extension. 2m scale. Looking west.

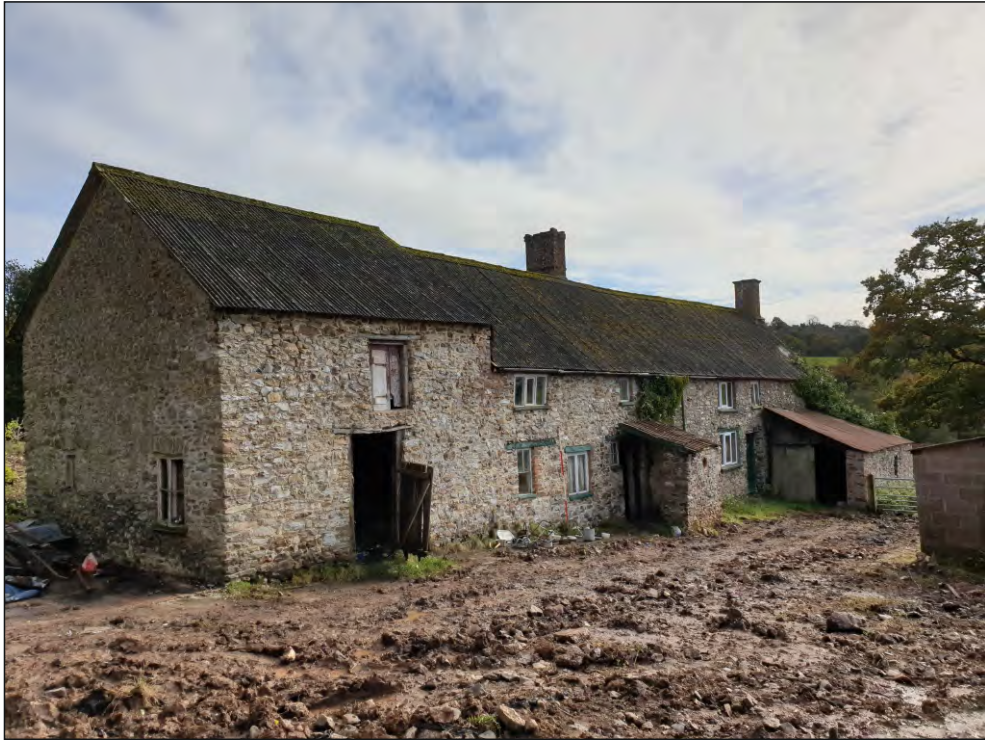
Pl. 3 General view of the farmyard elevation showing the barn at the northern end of the main range. 2m scale. Looking southeast.

The west elevation of the main building presents a simple two-storey elevation onto the farmyard with irregular fenestration of various periods (Pls. 3-4). This has latterly provided the main entrance into the farmhouse with two doors located at either end of the elevation. The southern doorway (Pl. 5) is the original western doorway of the cross passage and features a replacement doorframe with simple moulding. The northern half of the house is entered through a later doorway (Pl. 6), probably inserted in the 18th century when this part of the house was extensively reconfigured. While the majority of the windows lighting the ground- and first floor are 20th century in date the three-light window lighting the northern bedroom (F05) would have formerly contained metal casements and is likely to date to the late 17th or early 18th century.

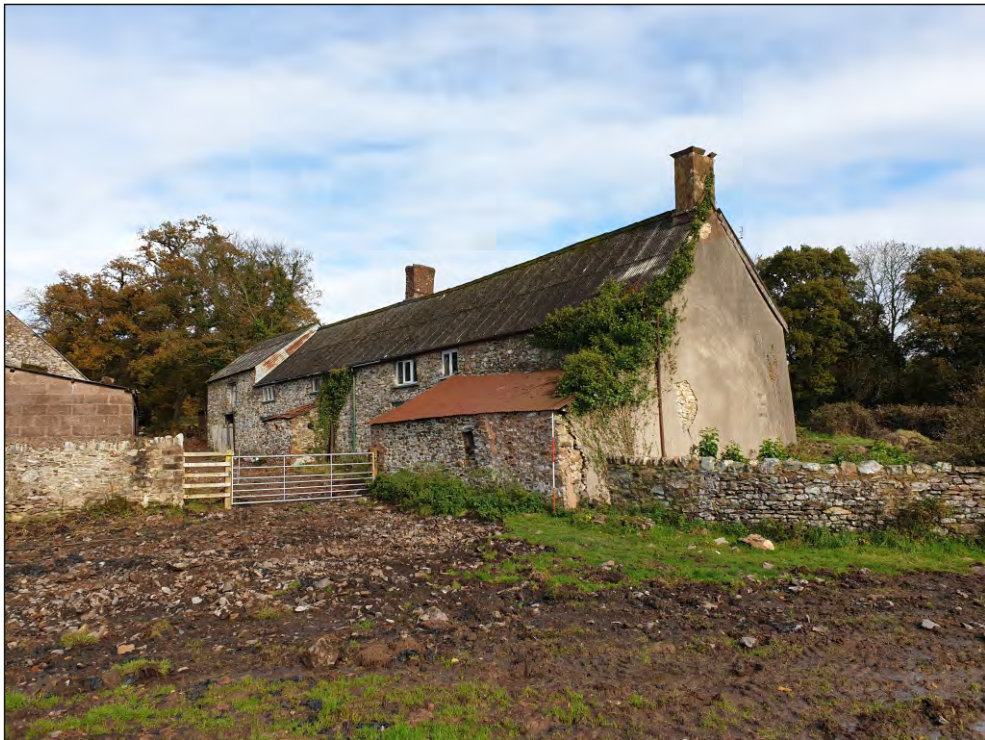
Pl. 4 General view of the farmyard elevation showing the Ham stone chimney at the southern end of the main range. 2m scale. Looking northeast.

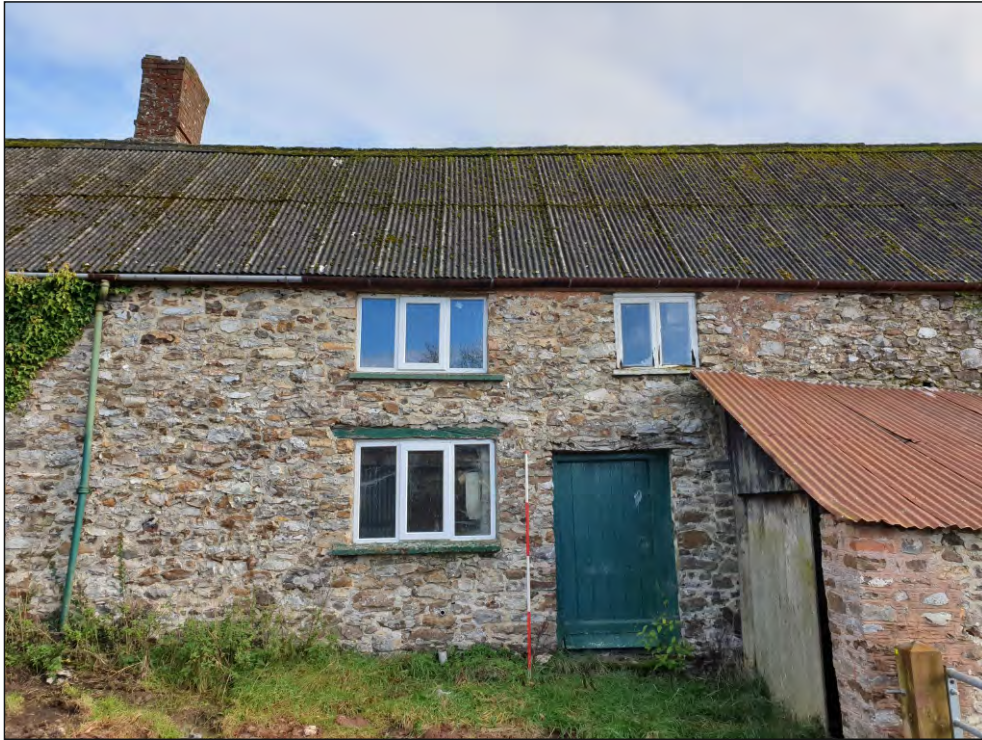
Pl. 5 Close-up of south end showing ground- and first-floor fenestration and position of cross-passage with 17th century doorway. 2m scale. Looking east.

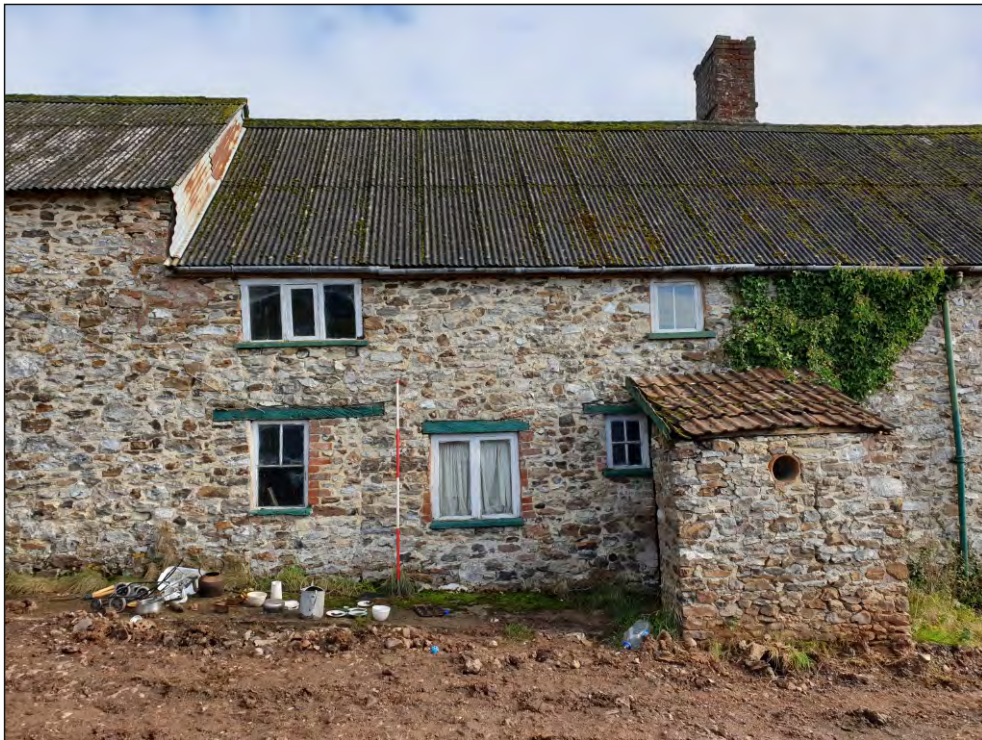
Pl. 6 General view of north end showing ground- and first-floor fenestration and blocked doorway. 2m scale. Looking east.

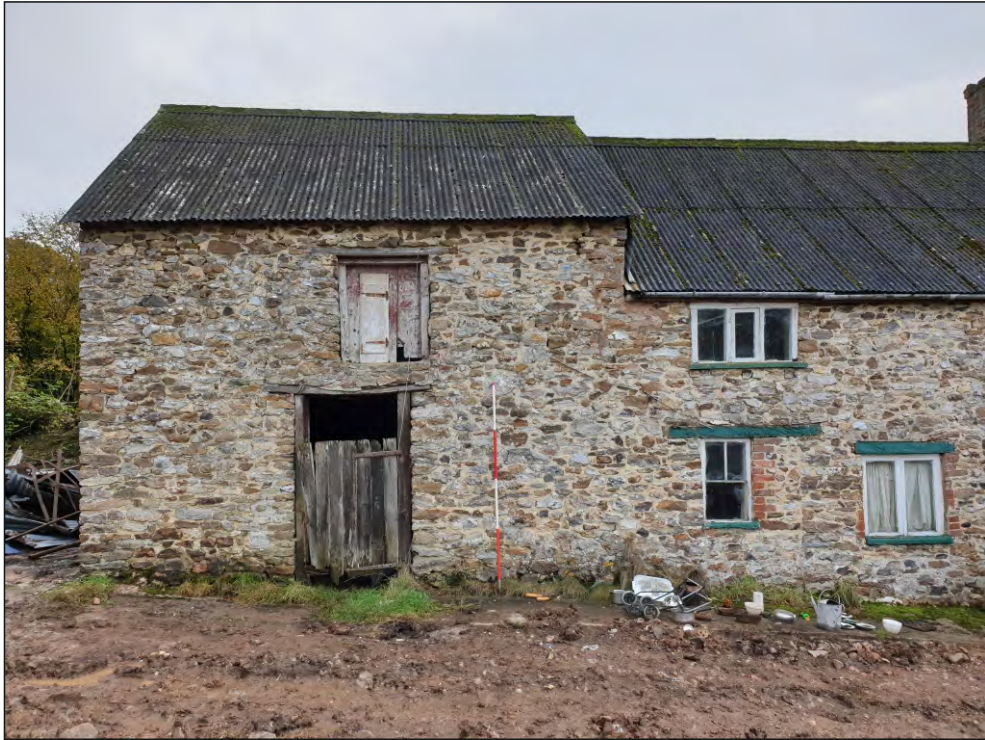
Pl. 7 Close-up of barn at northern end of main range. 2m scale. Looking east.

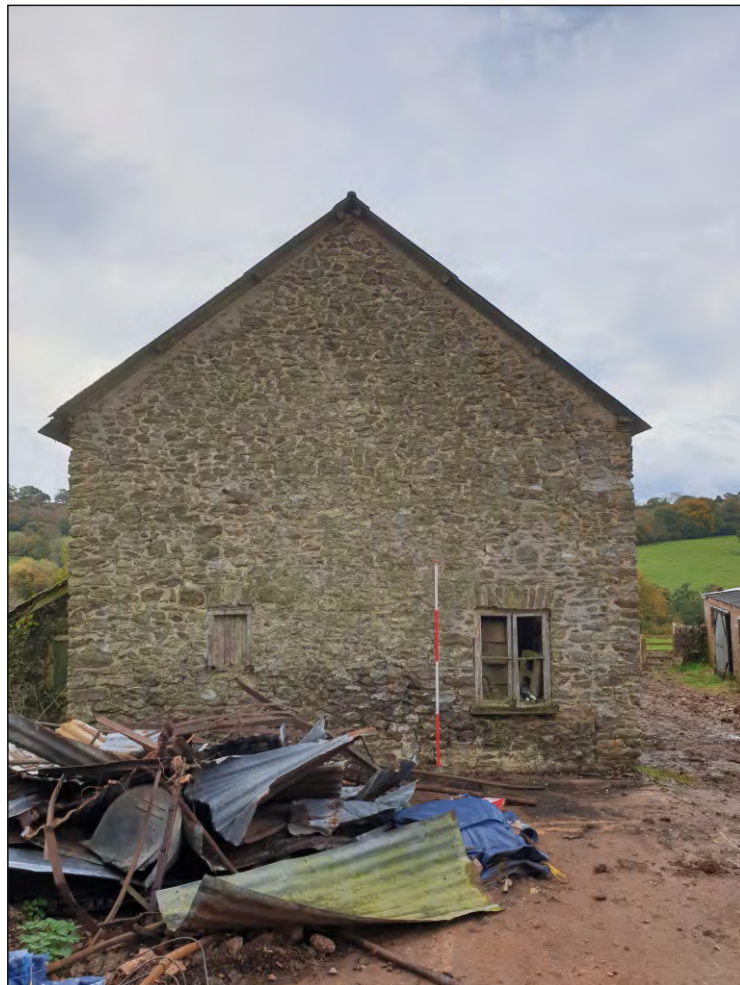
Pl. 8 Close-up of north elevation of barn showing blocked doorway. 2m scale. Looking south.

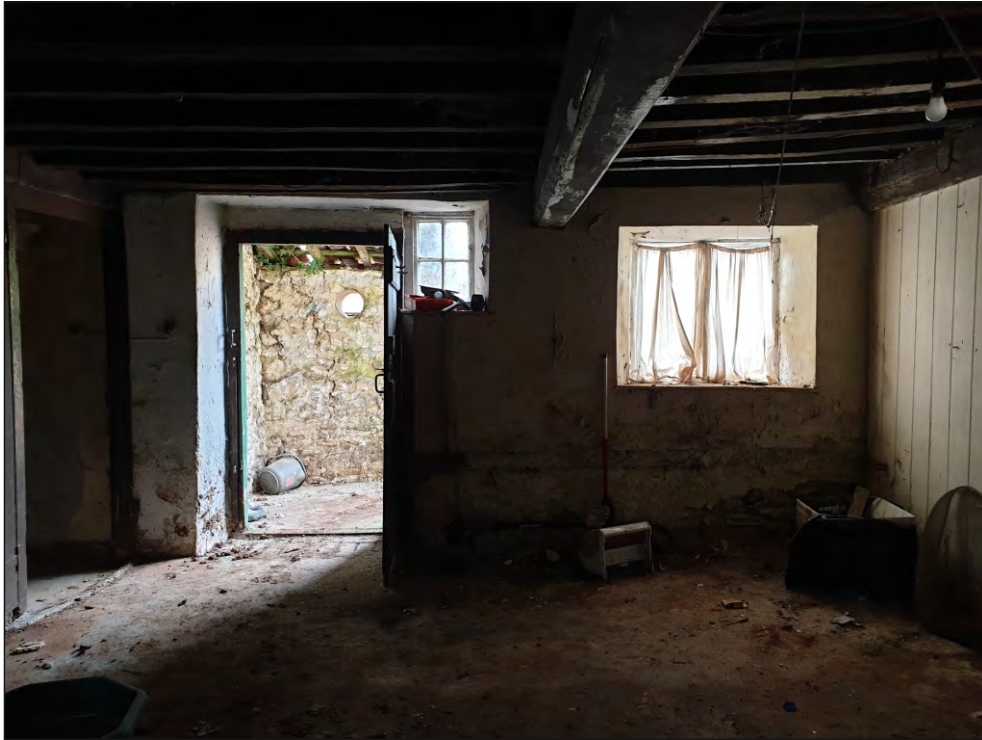
Pl. 9 General view of west elevation in G02 showing 18th century doorway and window arrangement with original joists resting on top of, rather than within the replacement beam. 1m scale. Looking west.

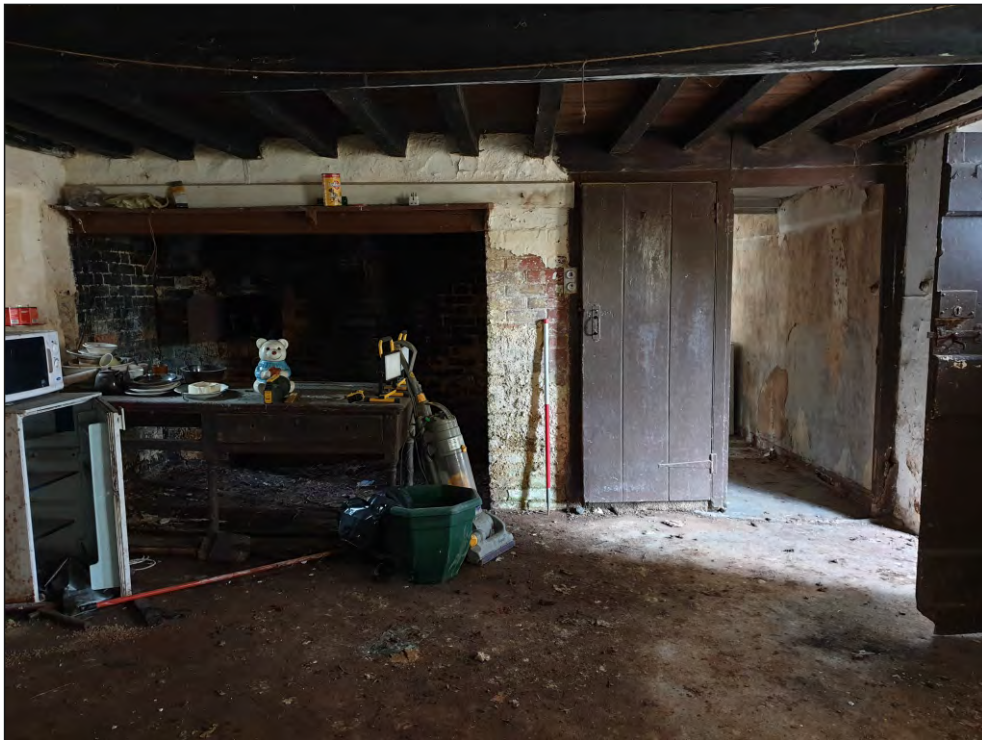
Pl. 10 General view of south elevation in G02 showing arrangement of 19th century kitchen fireplace and bread-oven, staircase and corridor leading to G04. 1m scale. Looking south.

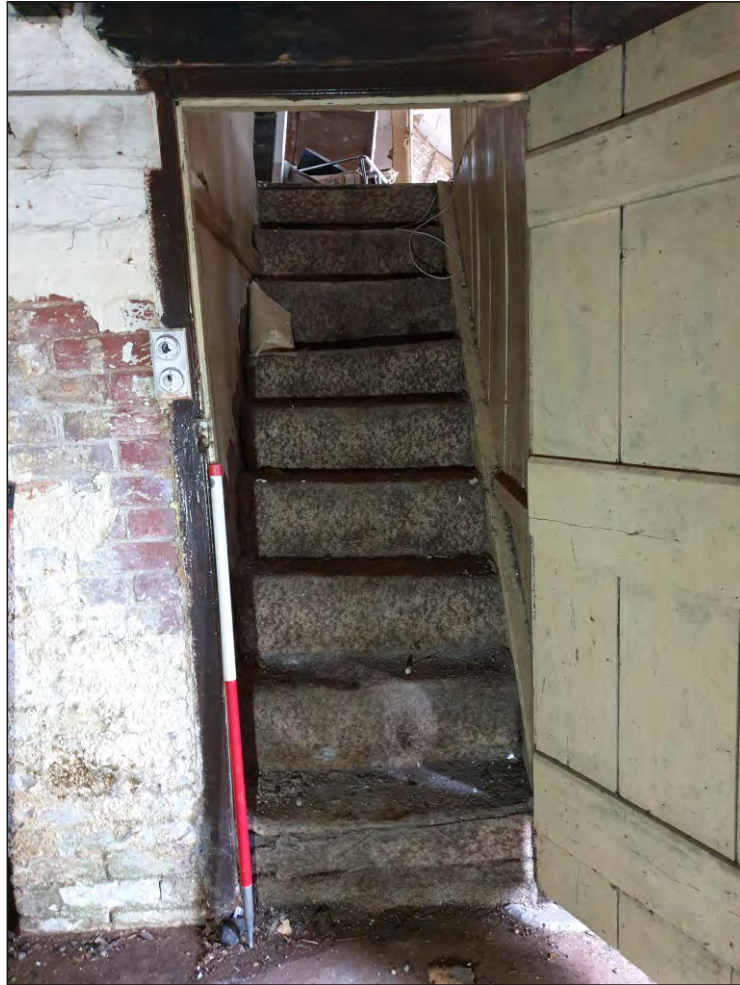
Pl. 11 Close-up of staircase leading to F03. 1m scale. Looking south.

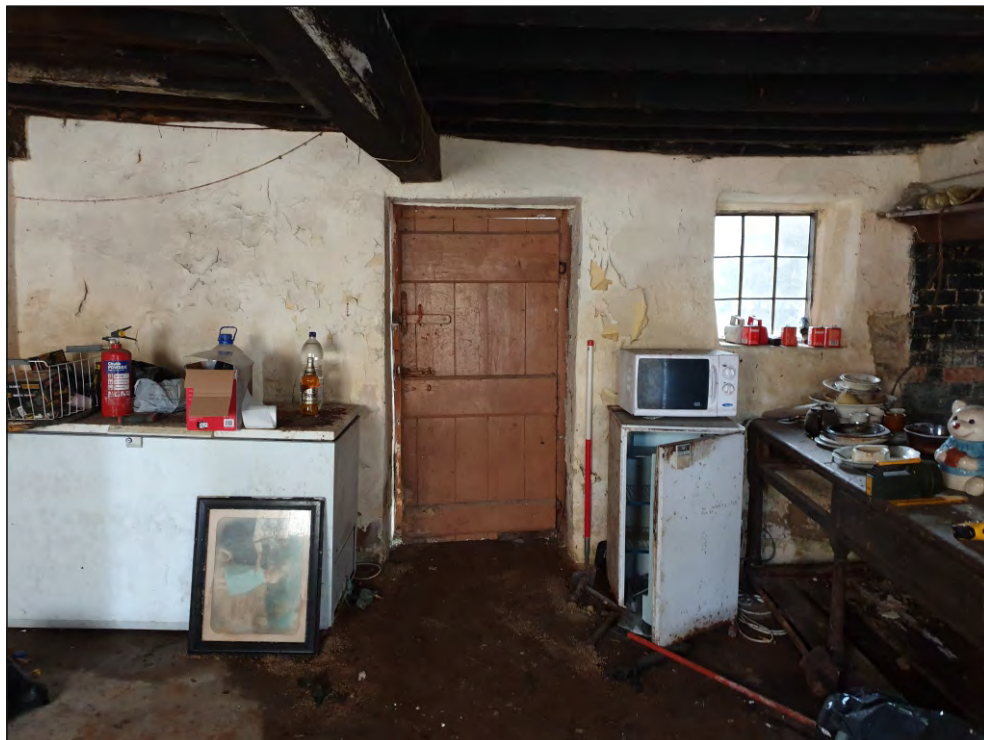
Pl. 12 General view of east elevation in G02 showing plank door and window with leaded lights giving onto 19th century outshut extension G07. 1m scale. Looking east.

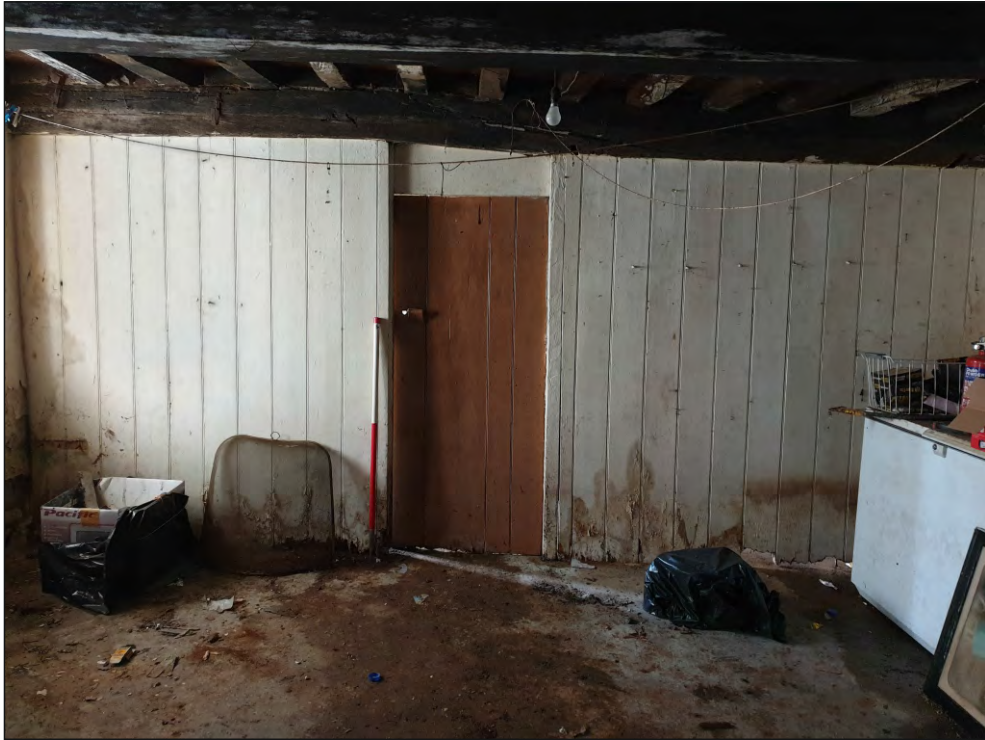
Pl. 13 General view of north elevation in G02 showing 19th century partition and doorway with original 17th century beam above. 1m scale. Looking north.

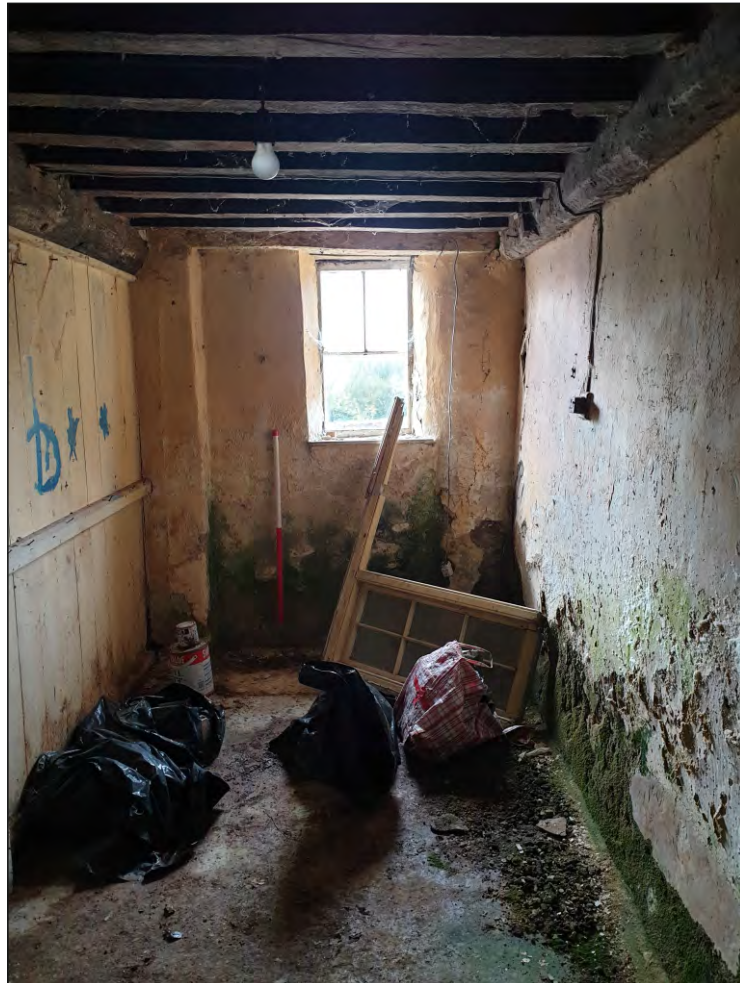
Pl. 14 General view of former corridor G03 showing blocked doorway. 1m scale. Looking west.

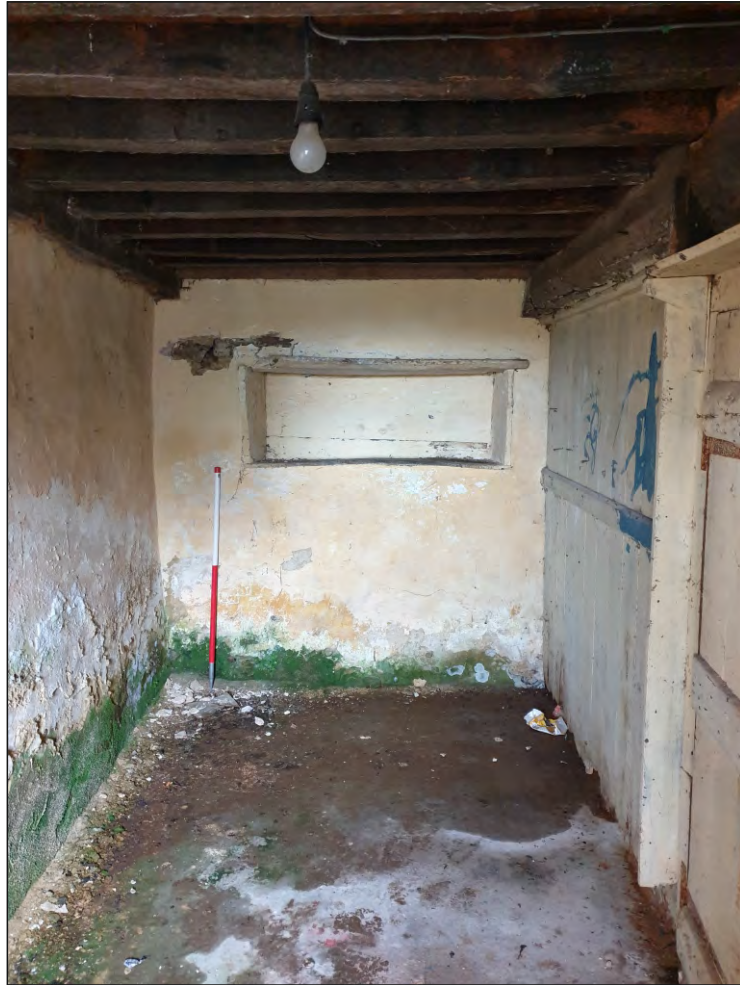
Pl. 15 General view of former corridor G03 showing position of partially blocked doorway re-using remains of former screen. 1m scale. Looking east.

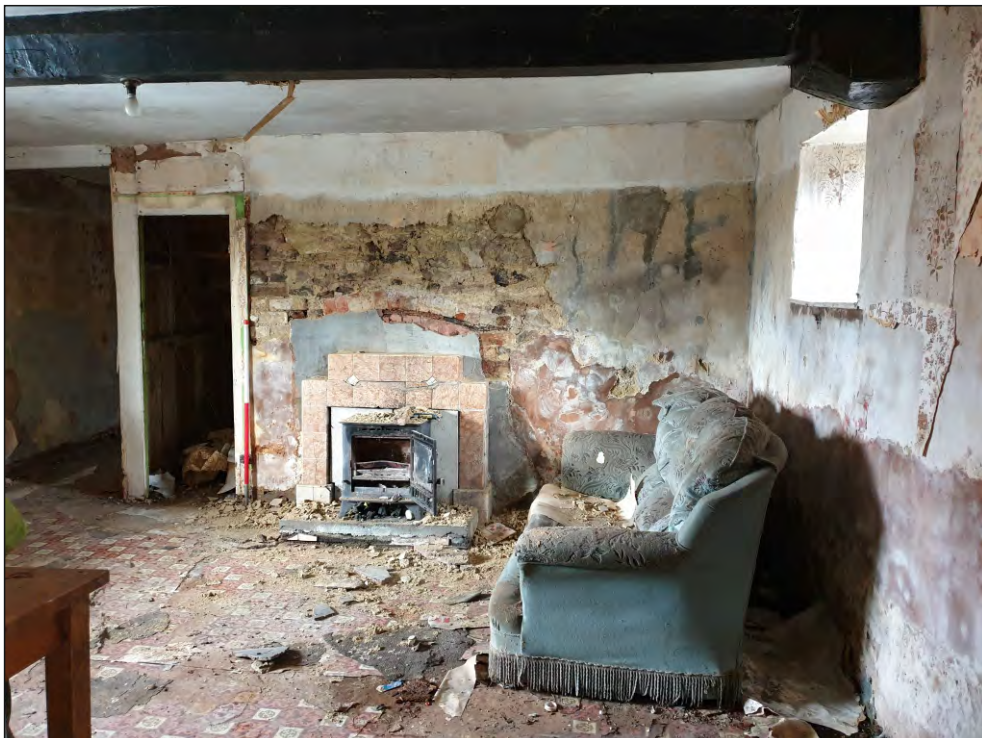
Pl. 16 General view of north elevation in G04 showing inserted fireplace with later 19th century rebuilding and modern infilling. 1m scale. Looking north.

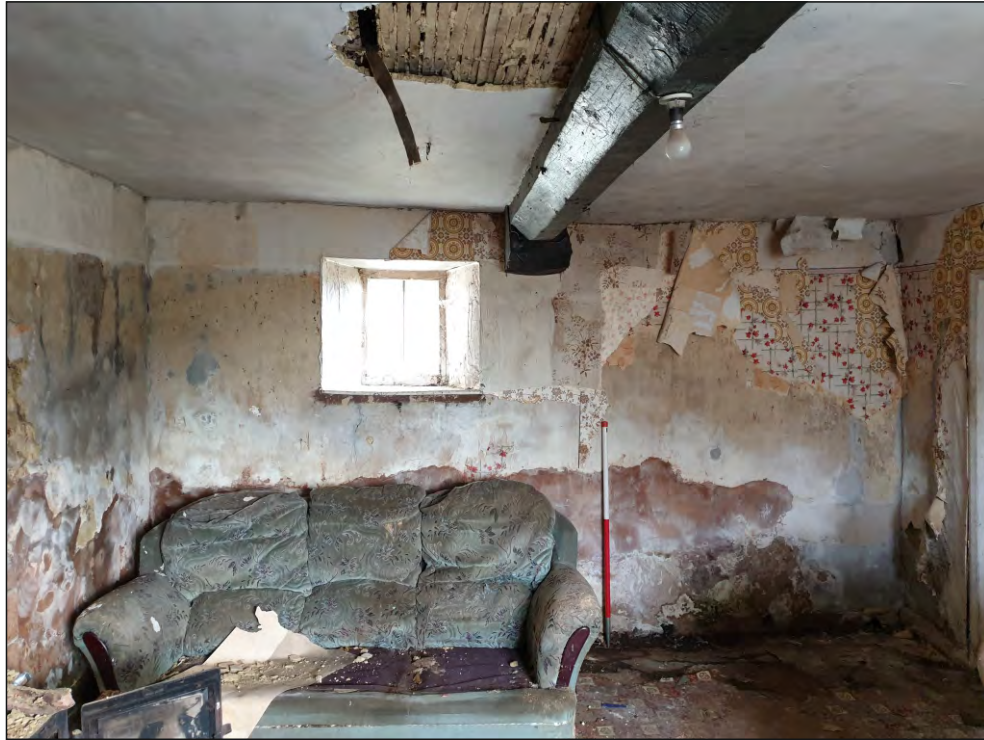
Pl. 17 General view of east elevation in G03 showing reduced wall width with the 17th century beam resting on a projecting bracket. 1m scale. Looking east.

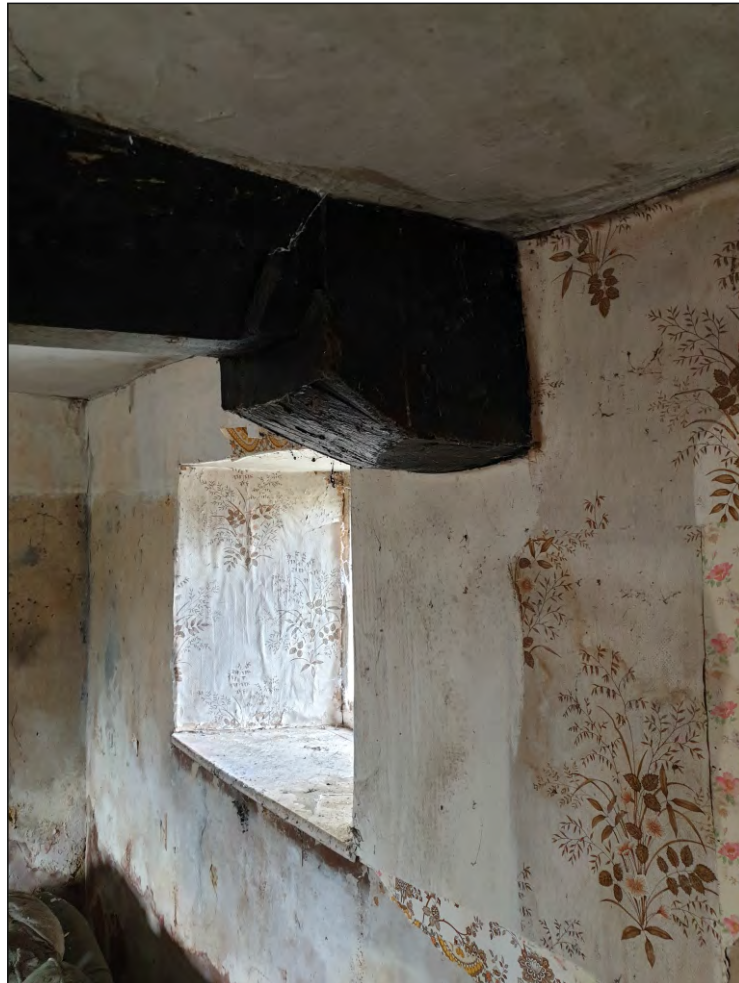
Pl. 18 Close-up showing the projecting bracket supporting the 17th century beam. Looking northeast.

stopping short of the moulding suggests that both walls have been rebuilt, thereby exposing more of the original beam and necessitating the additional support of the bracket. A vertical break visible in the east wall of the house externally may betray evidence of a phased replacement of an original thick-walled cob structure with stone walling. This refacing or recasing of the house may have been part of its 18th- or 19th-century remodelling and is likely to be contemporary with the conversion of the former kitchen into a parlour and the extensive alterations taking place at the northern end of the house; however, such rebuilding might also be undertaken sporadically, over a very long period, in response to failures of parts of the original cob walling due to subsidence or water damage.

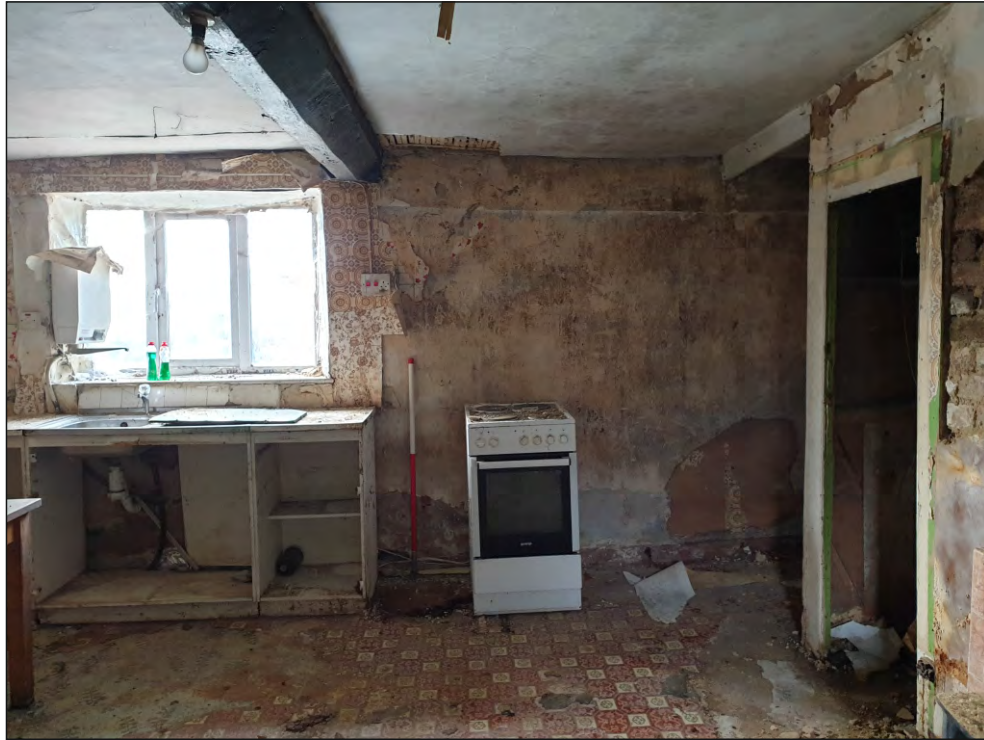
Pl. 19 General view of west elevation in G04 showing modern uPVC window and 17th century beam. 1m scale. Looking west.

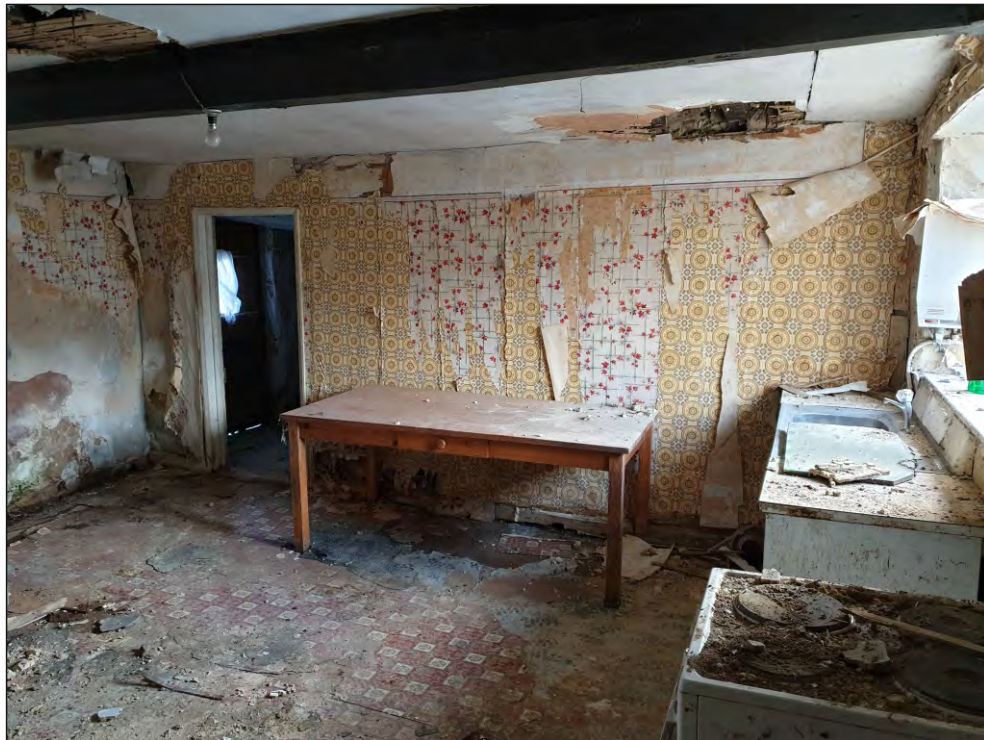
Pl. 20 General view of south elevation in G04 showing 19th century doorway. The beam above the cob-and-stud partition has seemingly been removed with the ceiling joists simply resting on top of the partition. Looking south.

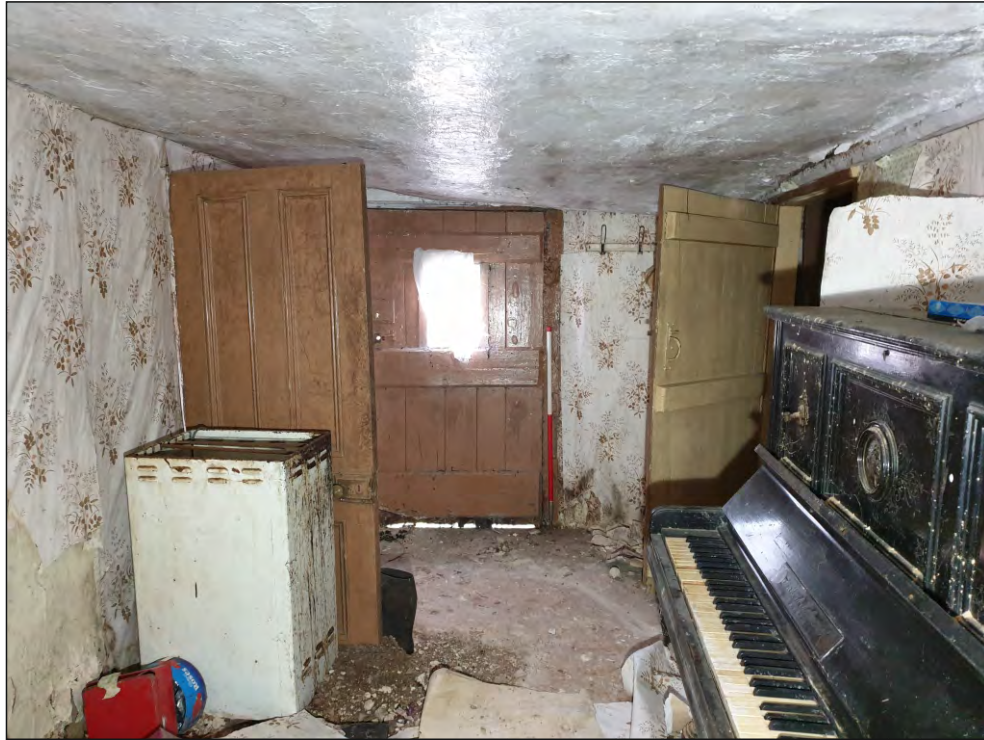
Pl. 21 General view of former cross-passage G05 defined by cob-and-stud partitions with 19th century doorways leading to G04 and G06 respectively. The additional width on the south side suggests the position of a former stair. 1m scale. Looking east.

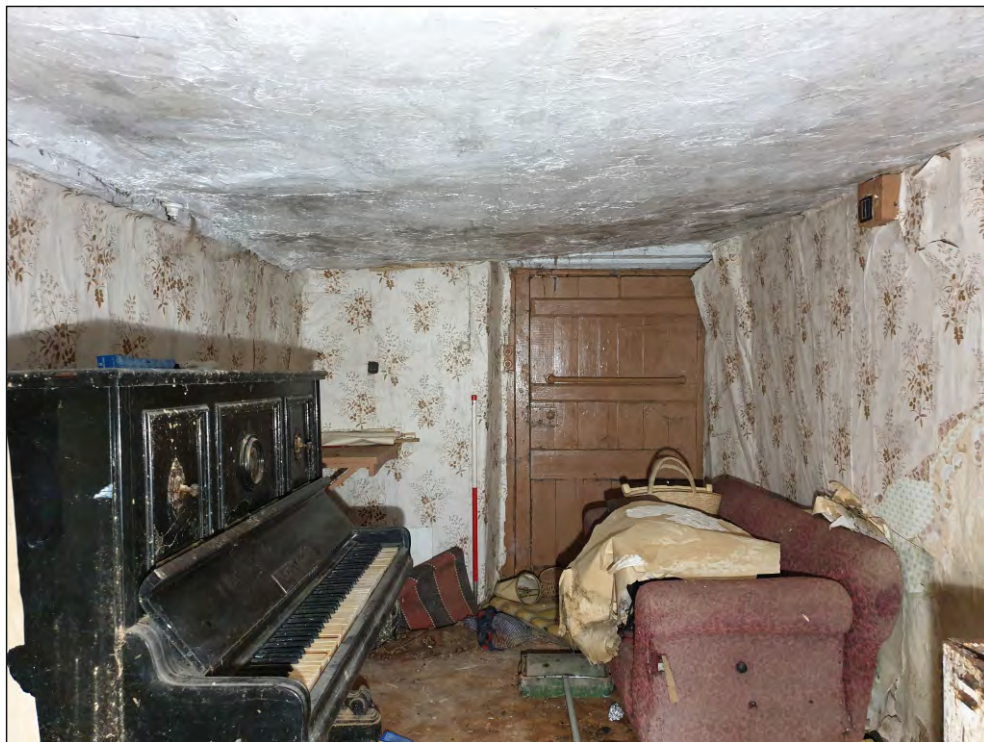
Pl. 22 General view of former cross-passage G05 defined by cob-and-stud partitions. The additional width on the south side suggests the position of a former stair. 1m scale. Looking west.

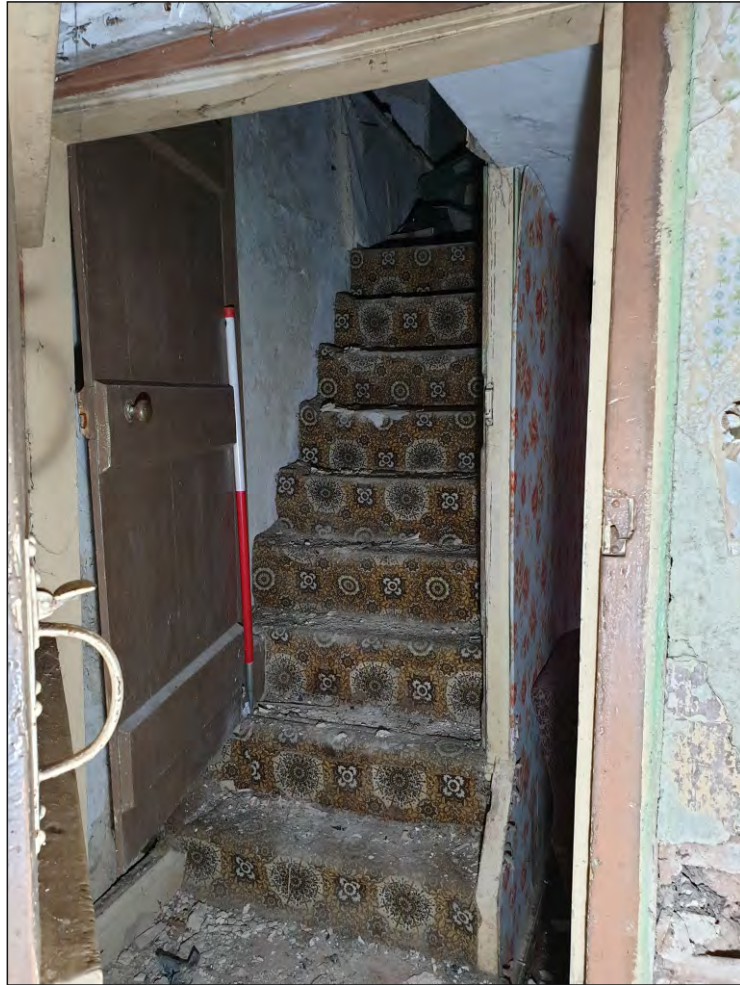
Pl. 23 Close-up of stair within G06 leading to F01. 1m scale. Looking southeast.
