Archaeological desk-based assessment and Historic building appraisal at Troake's Farm, Clayhidon, Devon

Report No. 20-11

December 2020

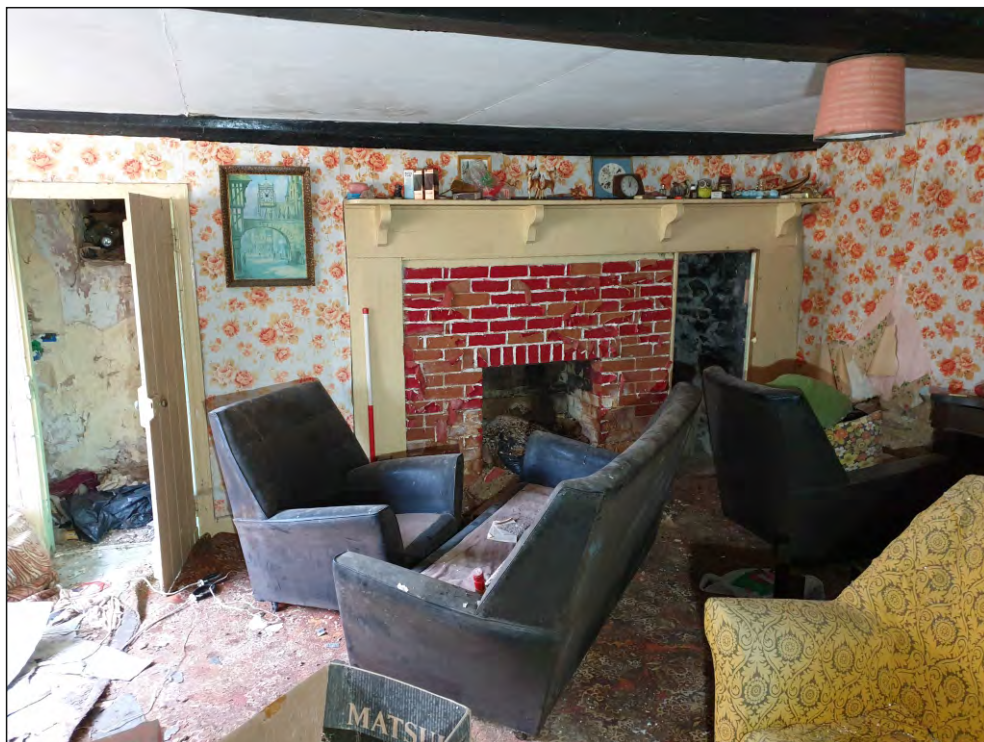
Pl. 24 General view of south elevation in G06 showing modern fireplace. This was formerly the kitchen and subsequently the parlour fireplace and occupied most of the gable elevation while the small cupboard to the left is the possible position of a former staircase. 1m scale. Looking south.

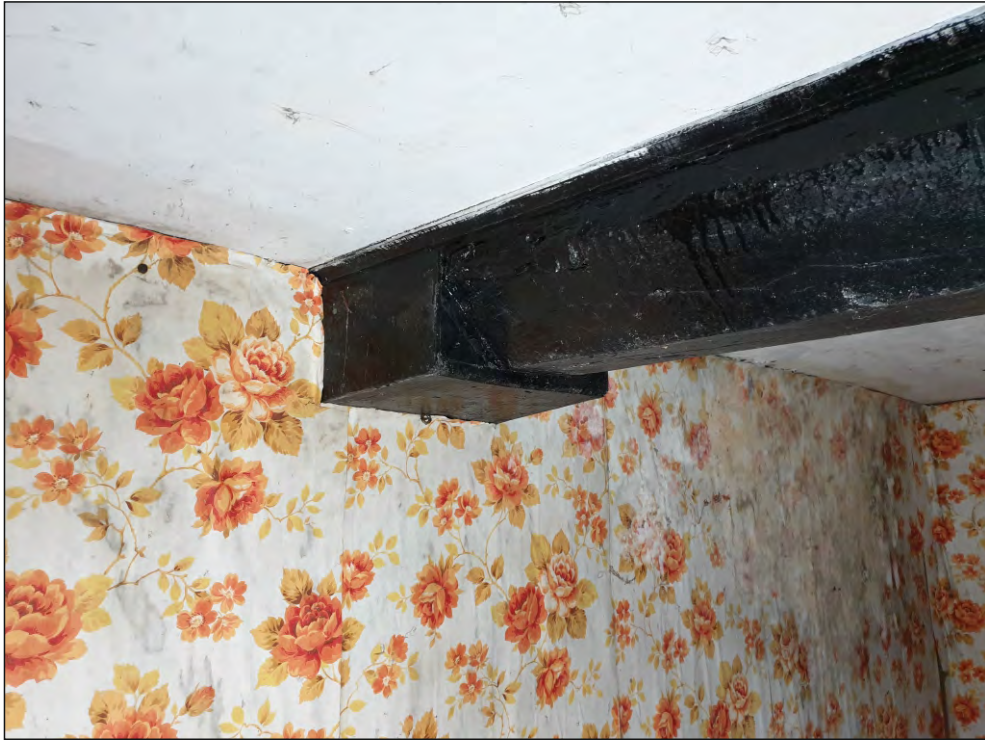
Pl. 25 Close-up showing the projecting bracket supporting the west end of the 17th century beam in G06. Looking northwest.

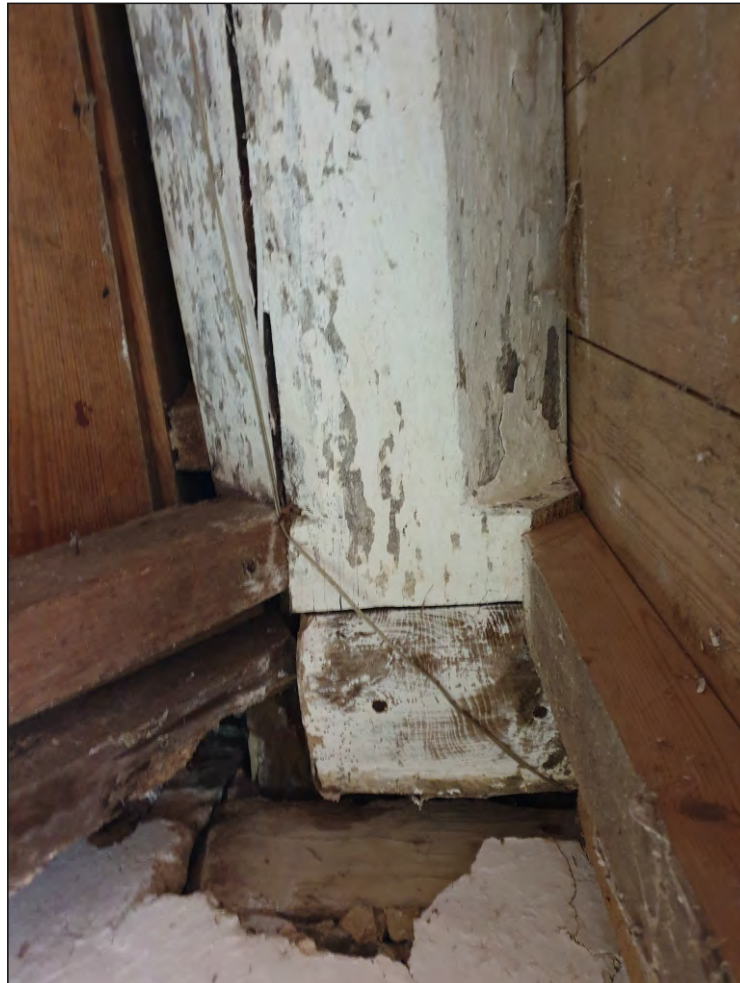
Pl. 26 Close-up showing the projecting bracket supporting the east end of the 17th century beam in G06. Looking east.

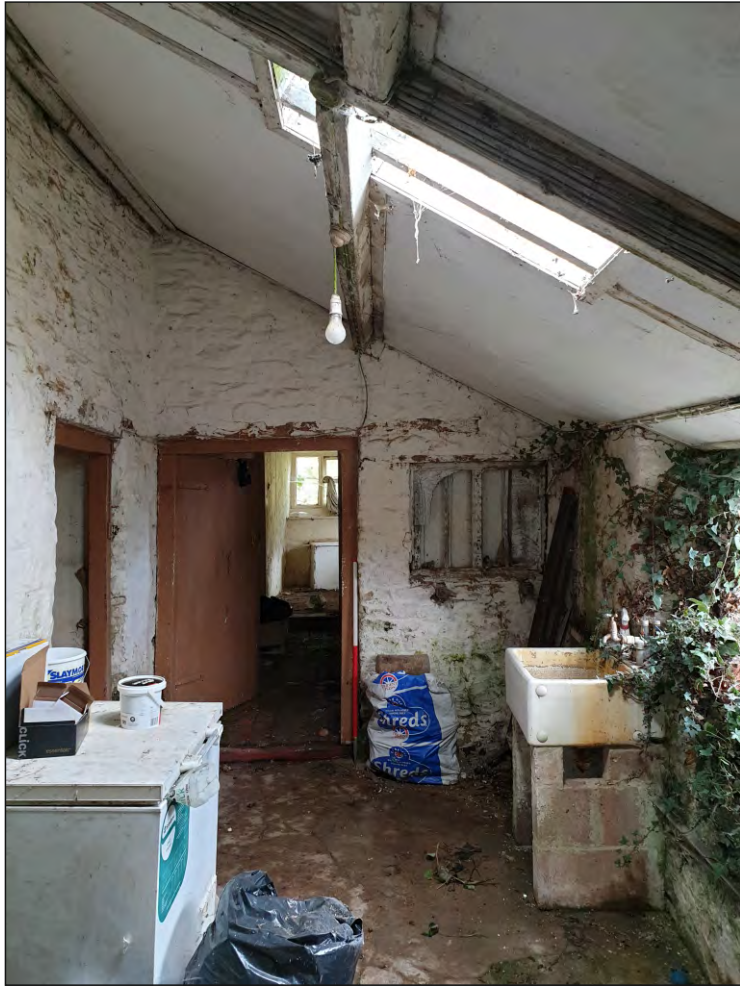
Pl. 27 General view of outshut showing plank doors leading to G02 and G08 respectively and vent window. 1m scale. Looking north.

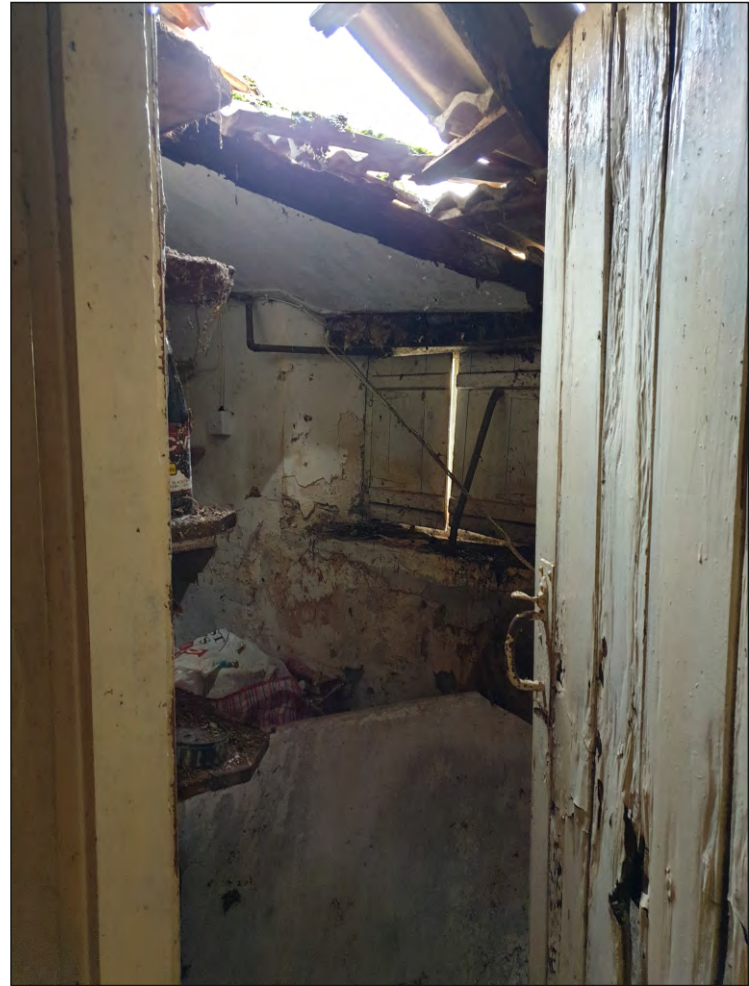
Pl. 28 General view of east elevation of G09 showing shutters of vent window. Looking northeast.

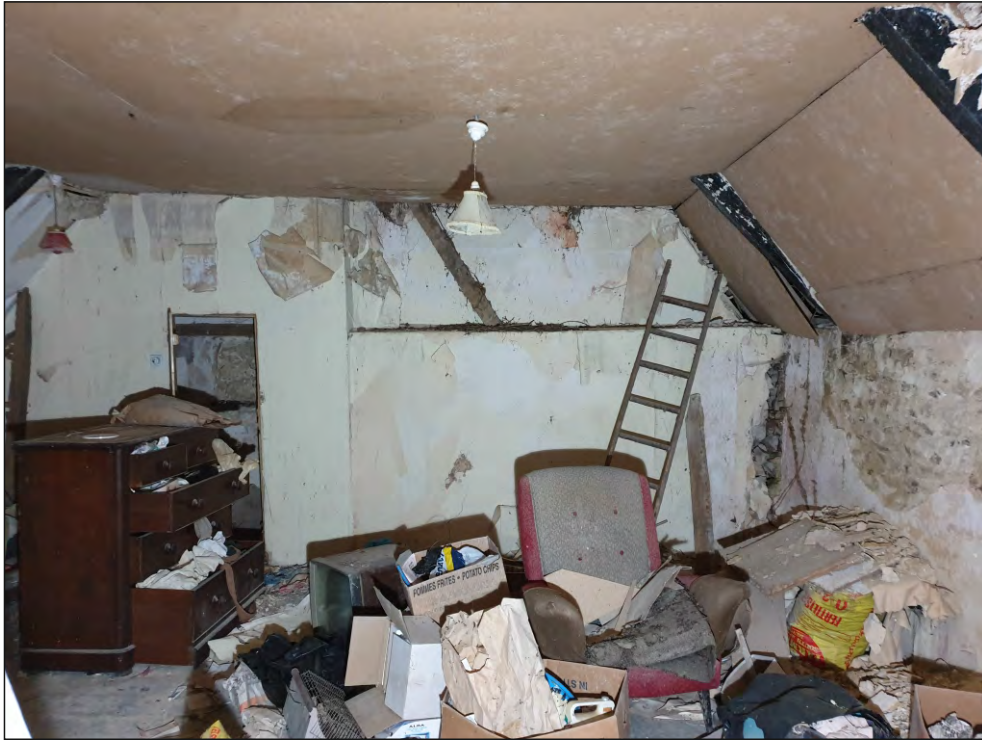
Pl. 29 General view of south elevation in F01 showing chimney stack with the cupboard to the left with its blocked window the possible position of a former staircase. The roof over the southern end has been replaced in the 19th century. Looking south.

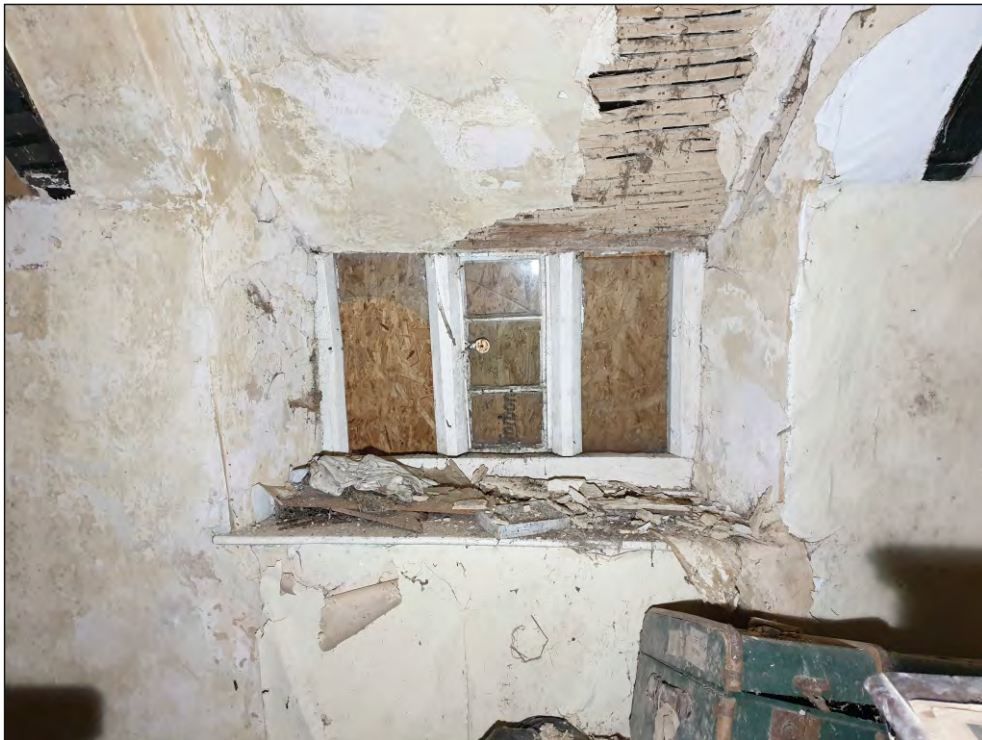
Pl. 30 Close-up of original early 17th century window in east elevation in F01. Looking east.

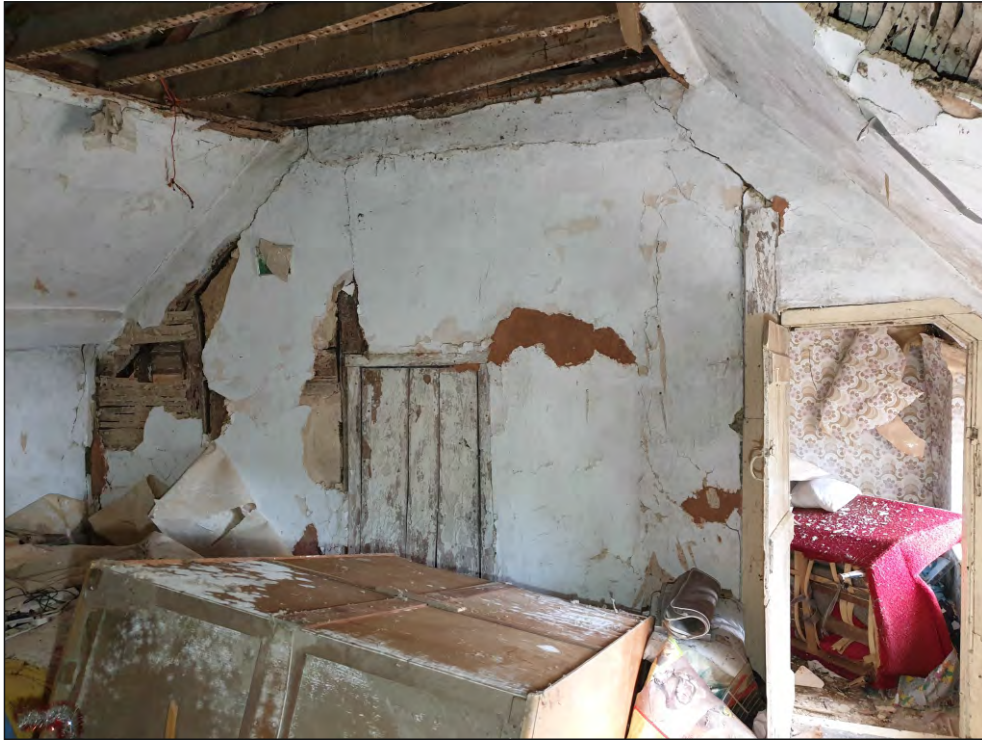
Pl. 31 General view of south elevation in F03 showing original 17th century low doorway in the centre of the cob-and-stud partition with later 19th century doorway inserted to the right. Looking south.

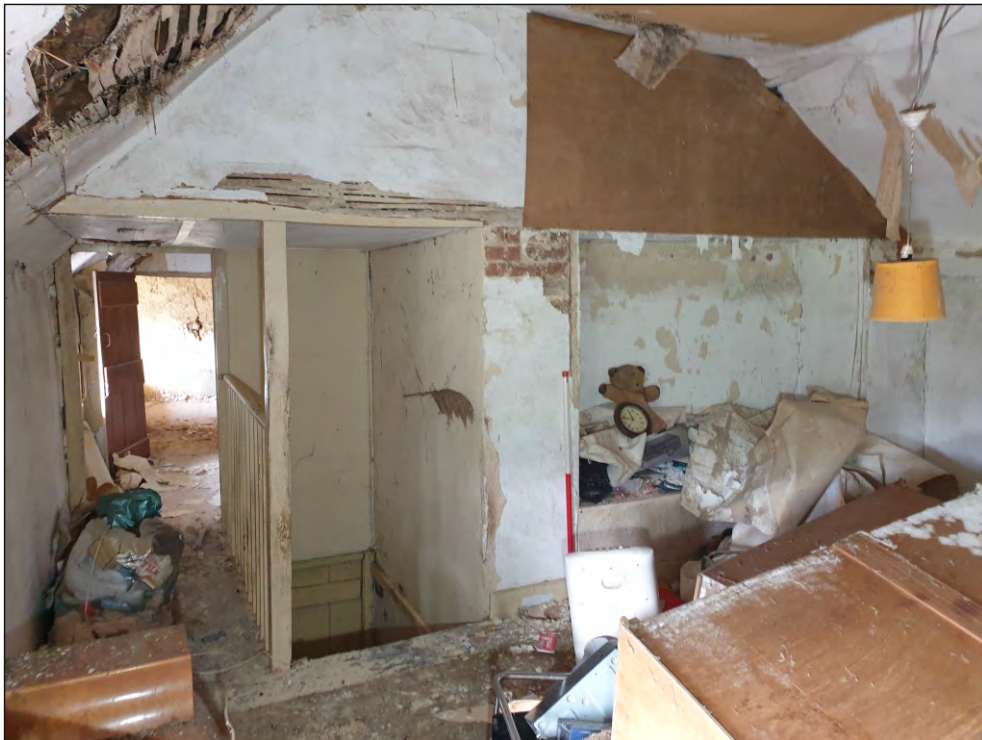
Pl. 32 General view of north elevation in F03 showing inserted chimney stack and stair, with corridor leading to F04 and F05. Looking north.

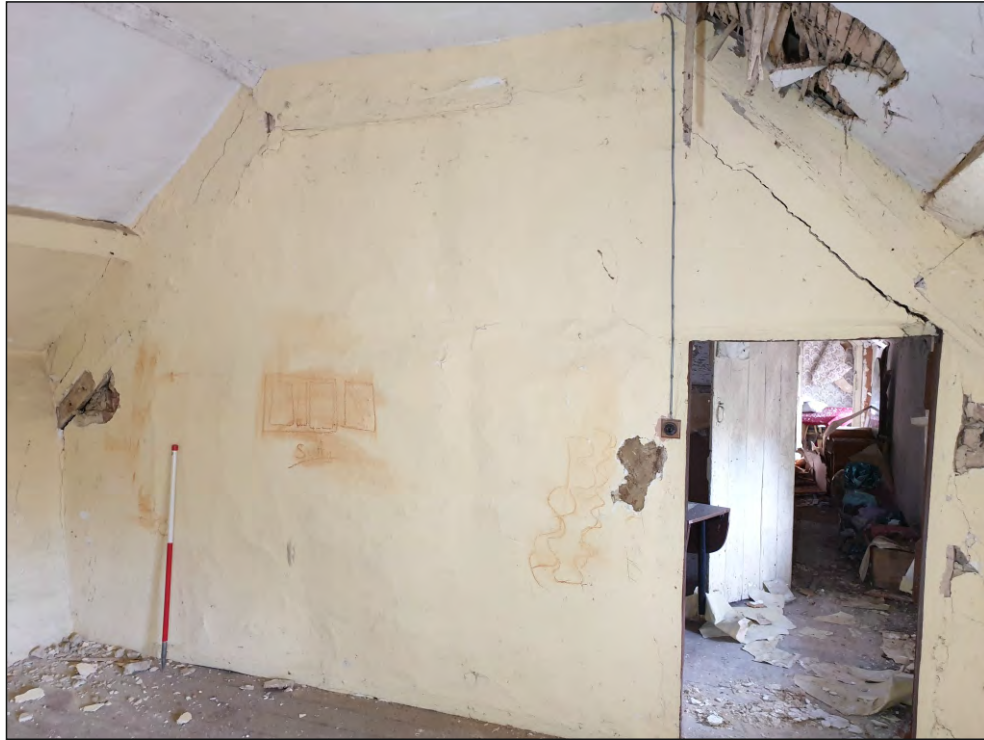
Pl. 33 General view of south elevation in F05 showing the cob-and-stud partition with later doorway. 1m scale. Looking south.

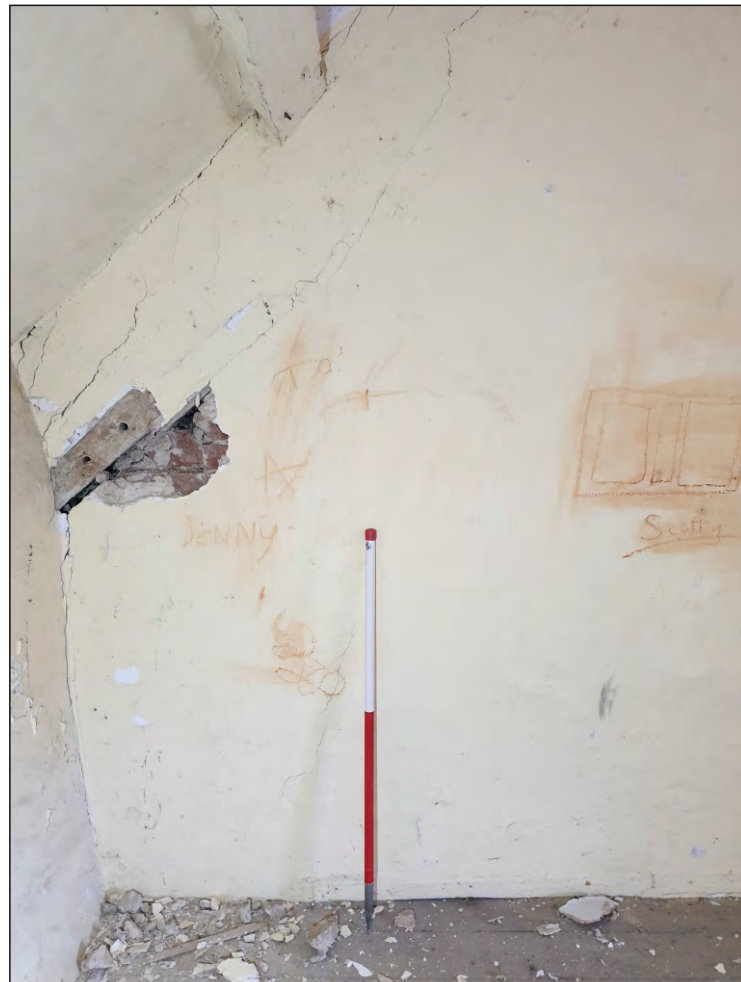
Pl. 34 Close-up showing the remains of the late medieval jointed-cruck truss re-used in the 17th century roof structure and first-floor cob-and-stud partition. 1m scale. Looking south.

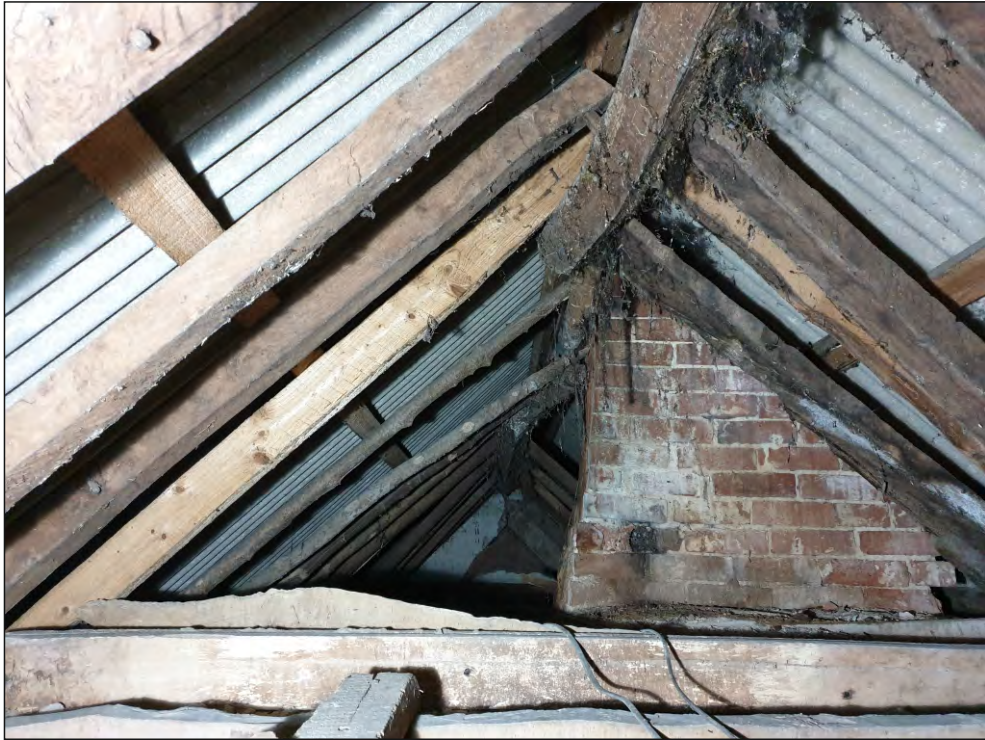
Pl. 35 General view of roof structure showing original section above F03, F04 and F05 truncated by insertion of chimney stack. Looking north.

The roof structure of the main range is visible through the partially collapsed 19th century ceiling in F03. Access to the roof area was difficult and a detailed inspection could not be made due to the dangerous condition of the ceiling and the uncertain condition of the joists, as well as the probable presence of bats. The following description is based on inspection from a position within the centre of room F03.

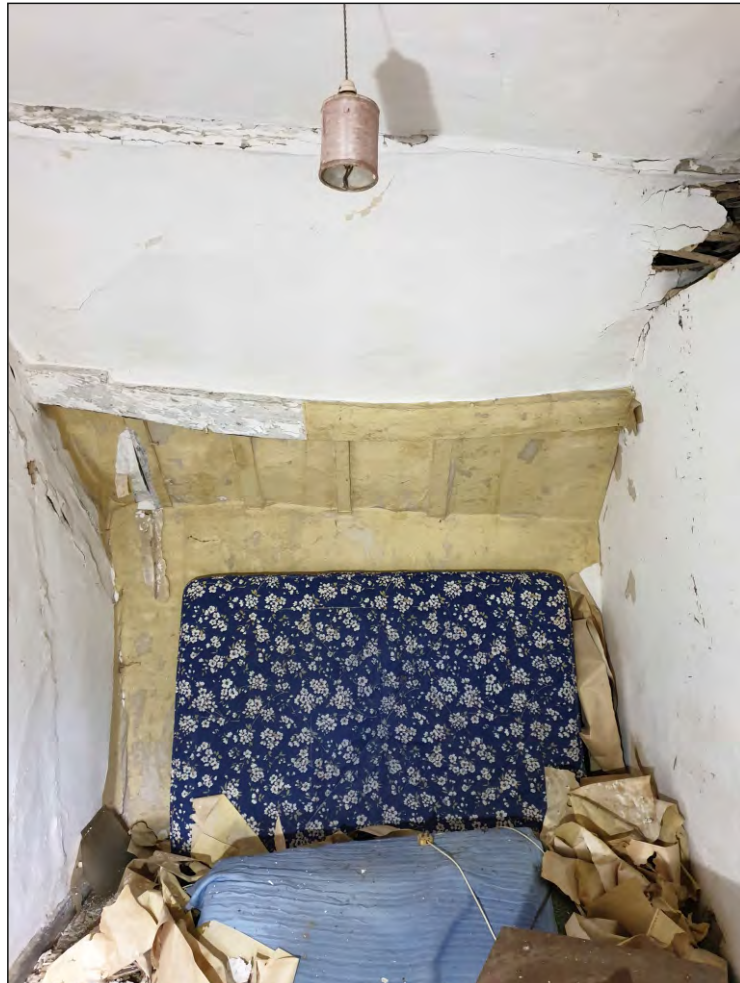
Pl. 36 General view of lower purlin with rafters in F04. Looking east.

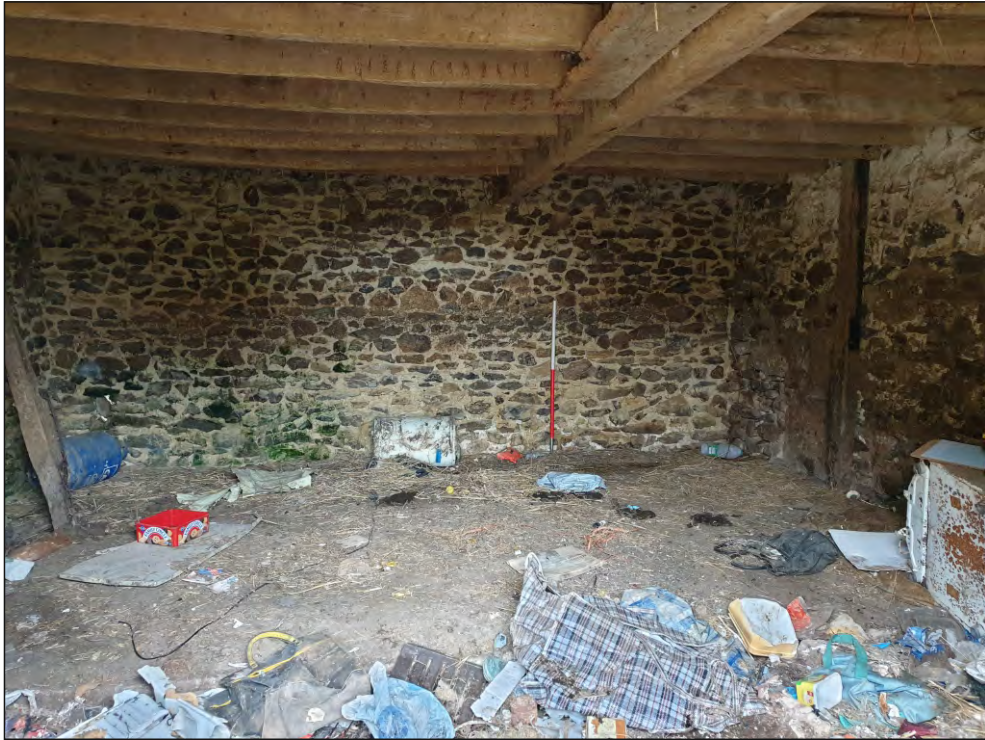
Pl. 37 General view of G01 showing first-floor beam with narrow chamfer. 1m scale. Looking east.

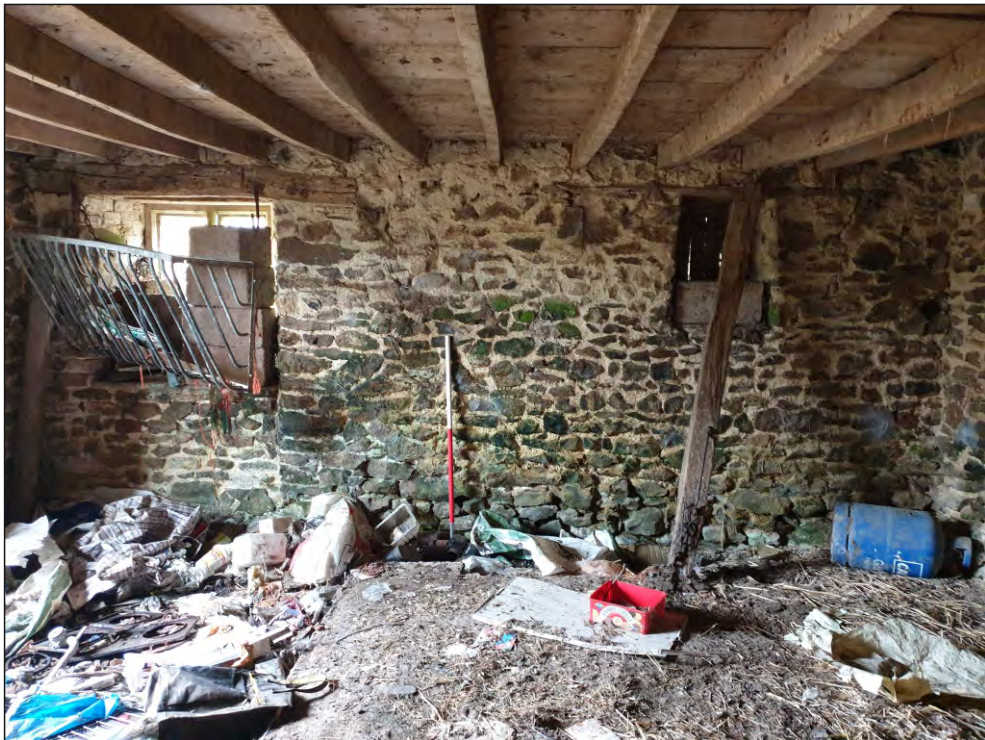
Pl. 38 General view of north elevation in G01 showing earlier door arrangement and narrow first-floor joists. 1m scale. Looking north.

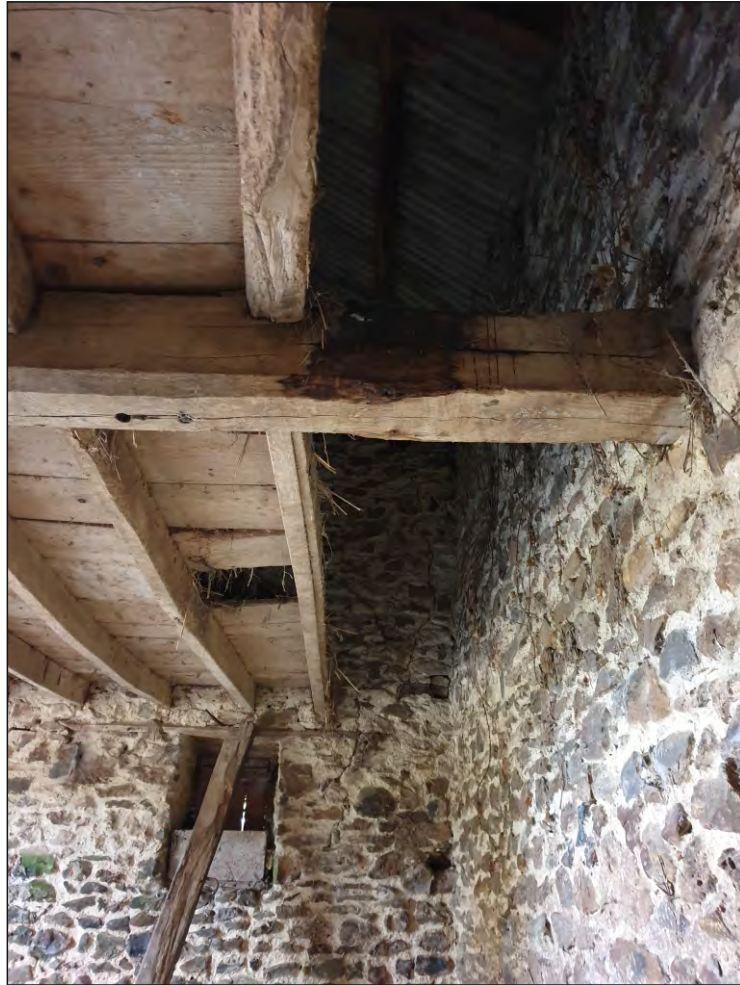
Pl. 39 Close-up of first-floor structure in G01 showing feeding void. Looking north.

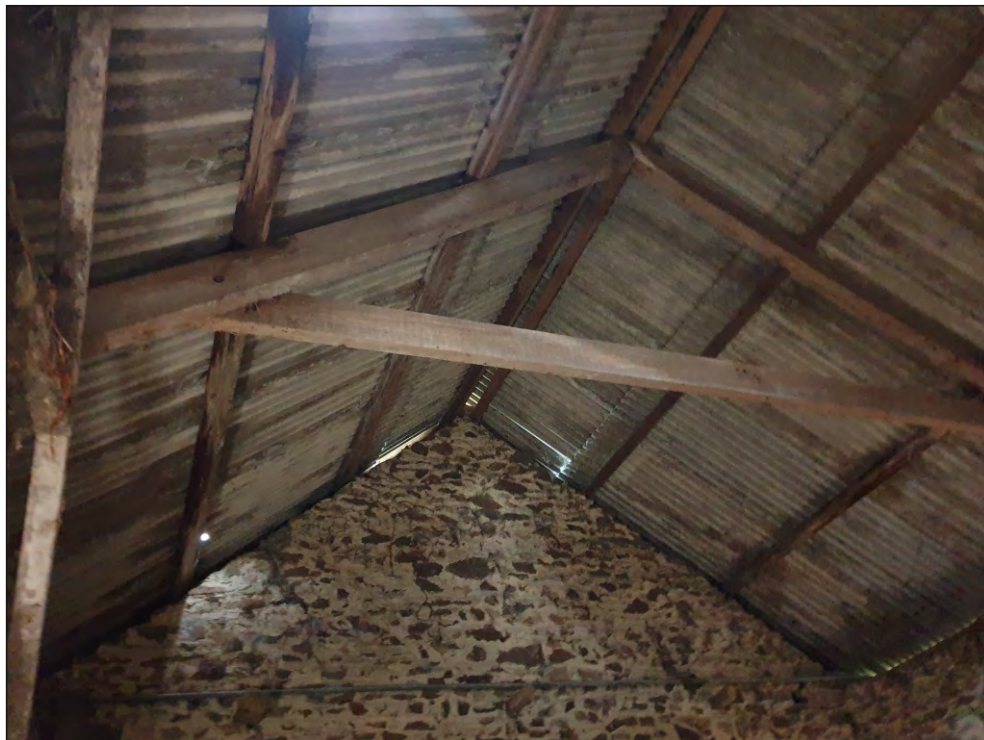
Pl. 40 General view of roof structure showing late 19th or early 20th century A-frame with applied collar. Looking north.

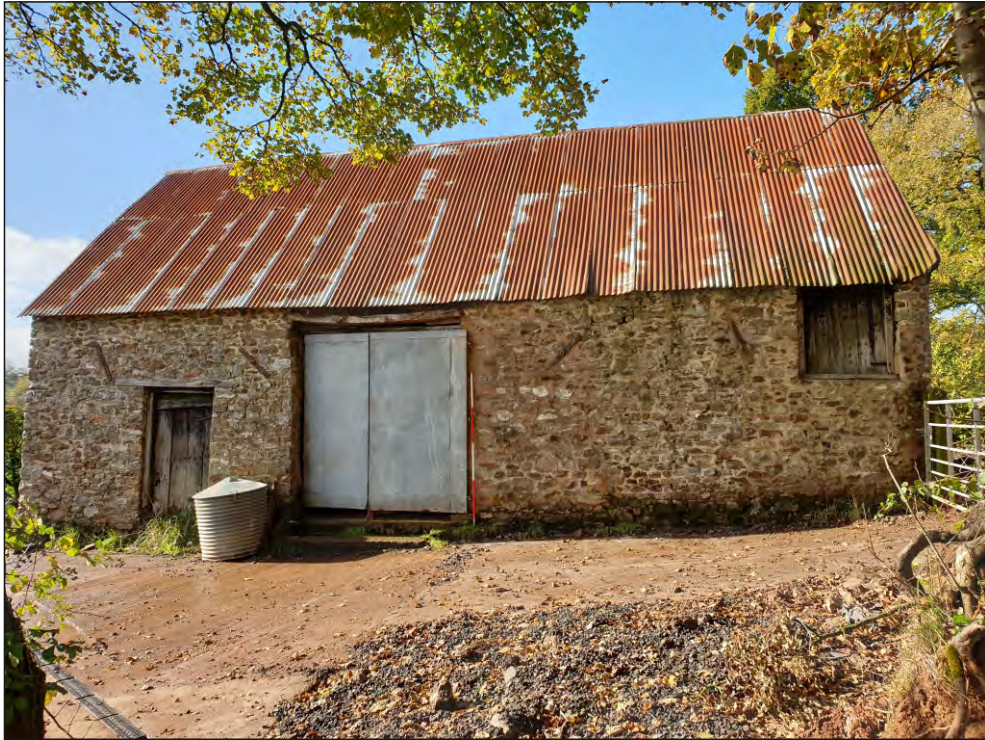
Pl. 41 General view of east elevation of former threshing barn. 2m scale.
Looking west.

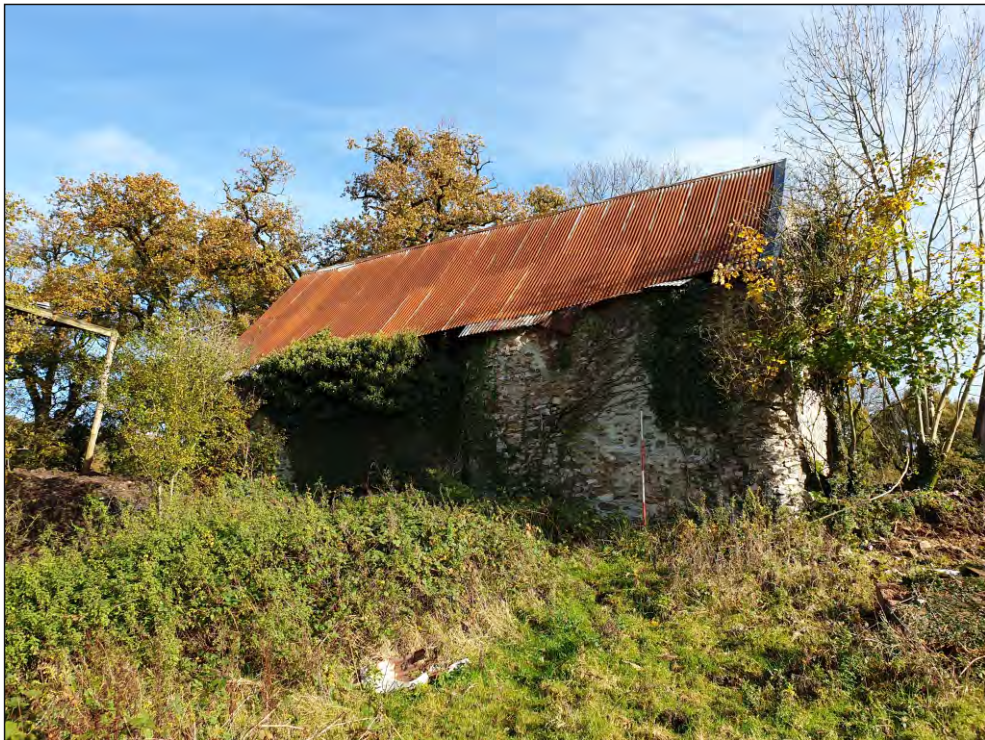
Pl. 42 General view west elevation of former threshing barn. 2m scale.
Looking east.

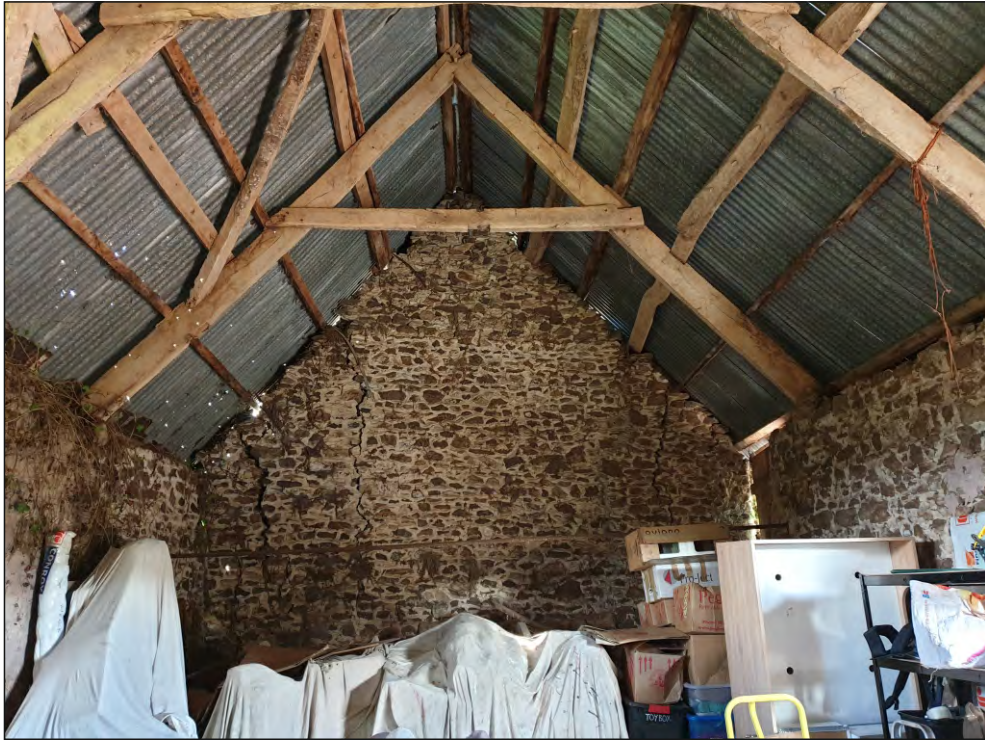
Pl. 43 General view of north elevation of former threshing barn showing roof construction. Looking north.

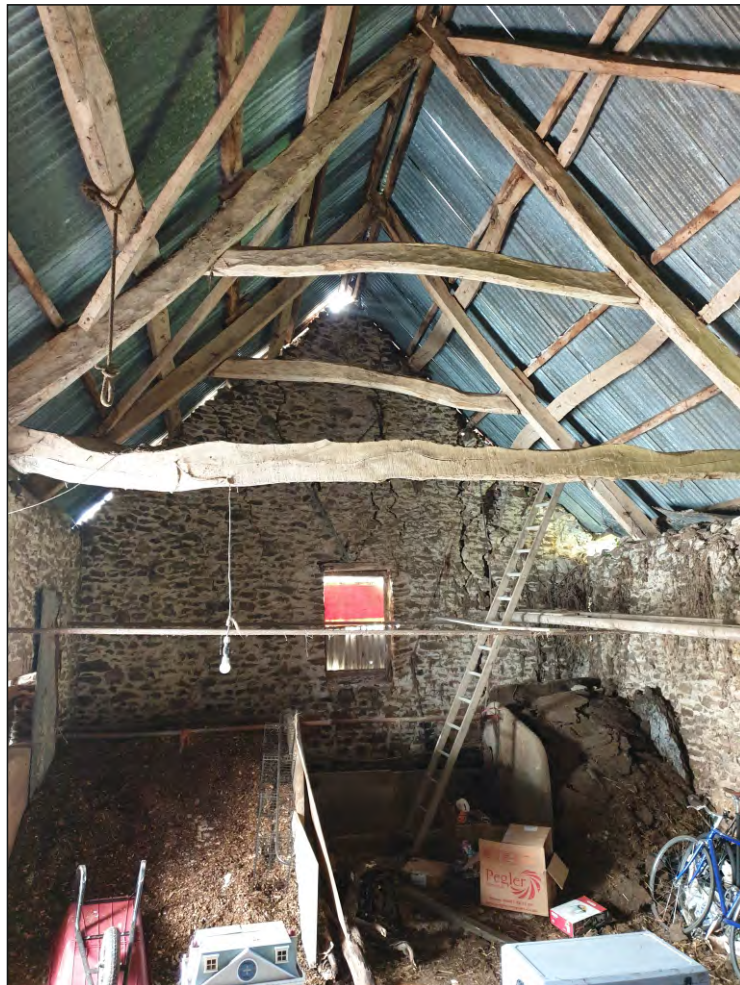
Pl. 44 General view of south elevation of former threshing barn showing roof construction. Looking south.

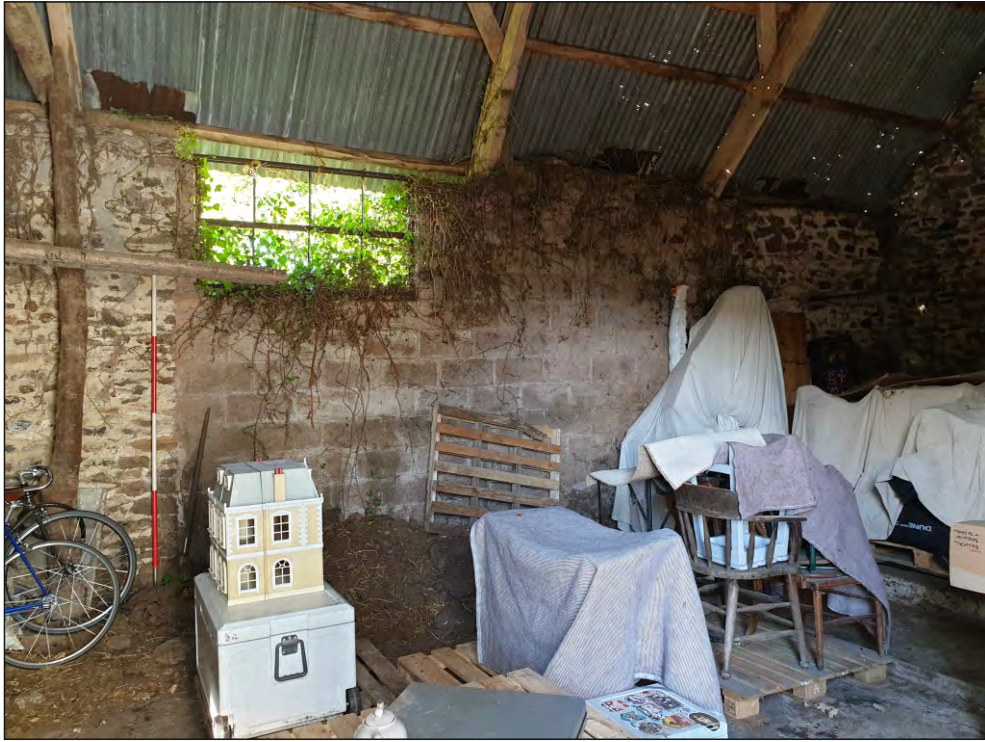
Pl. 45 General view of former west doorway. 2m scale. Looking west.
