**ARCHAEOLOGICAL RECORDING  
AT BERRY HEAD, BRIXHAM, DEVON  
MAY TO OCTOBER 2009**

prepared for the  
Torbay Coast and Countryside Trust

**Exeter Archaeology**

**Report No. 10.73**

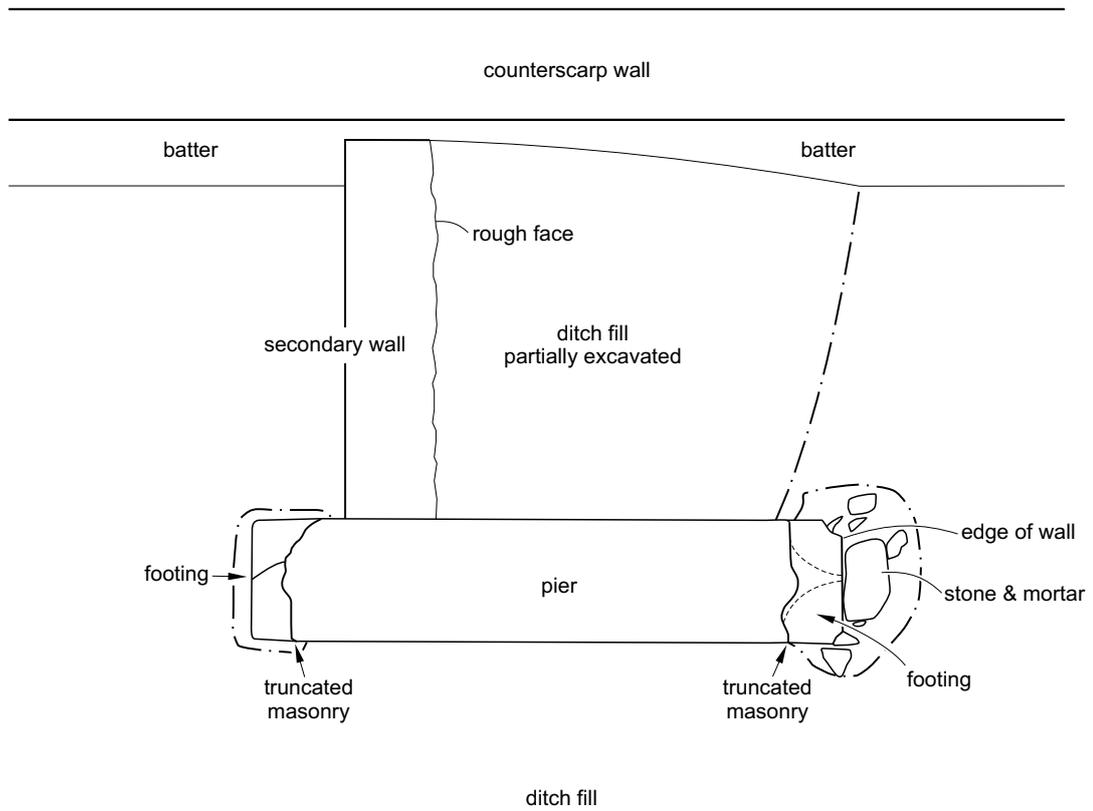
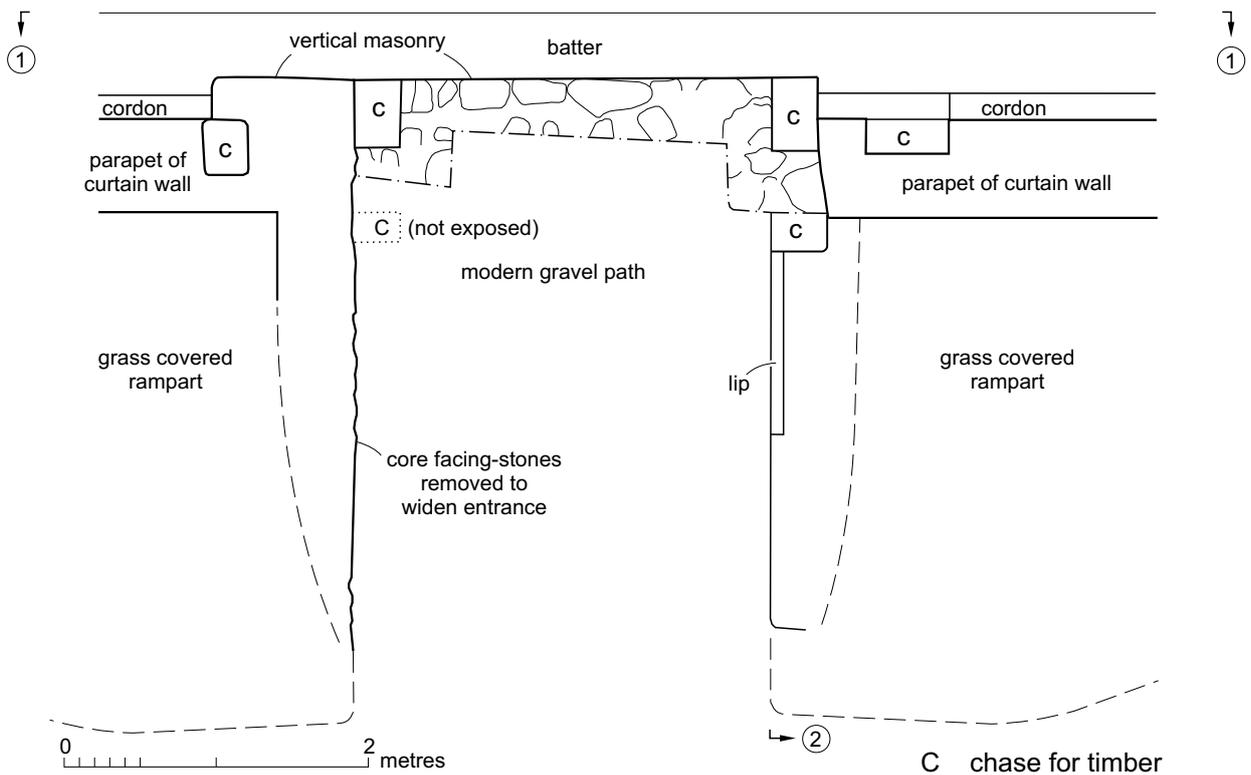
Fig. 3 Fort 1: plan of the entrance.

# Fort 1: entrance Plan

The entrance to the fort is defined by the remains of two retaining walls holding back the rampart. Both retaining walls have been disturbed, probably when the drawbridge was removed, and the western wall has been cut back to provide a wider, vehicular access into the fort. Consequently, some of the features described below do not survive on the west side of the entrance (see Fig. 3).

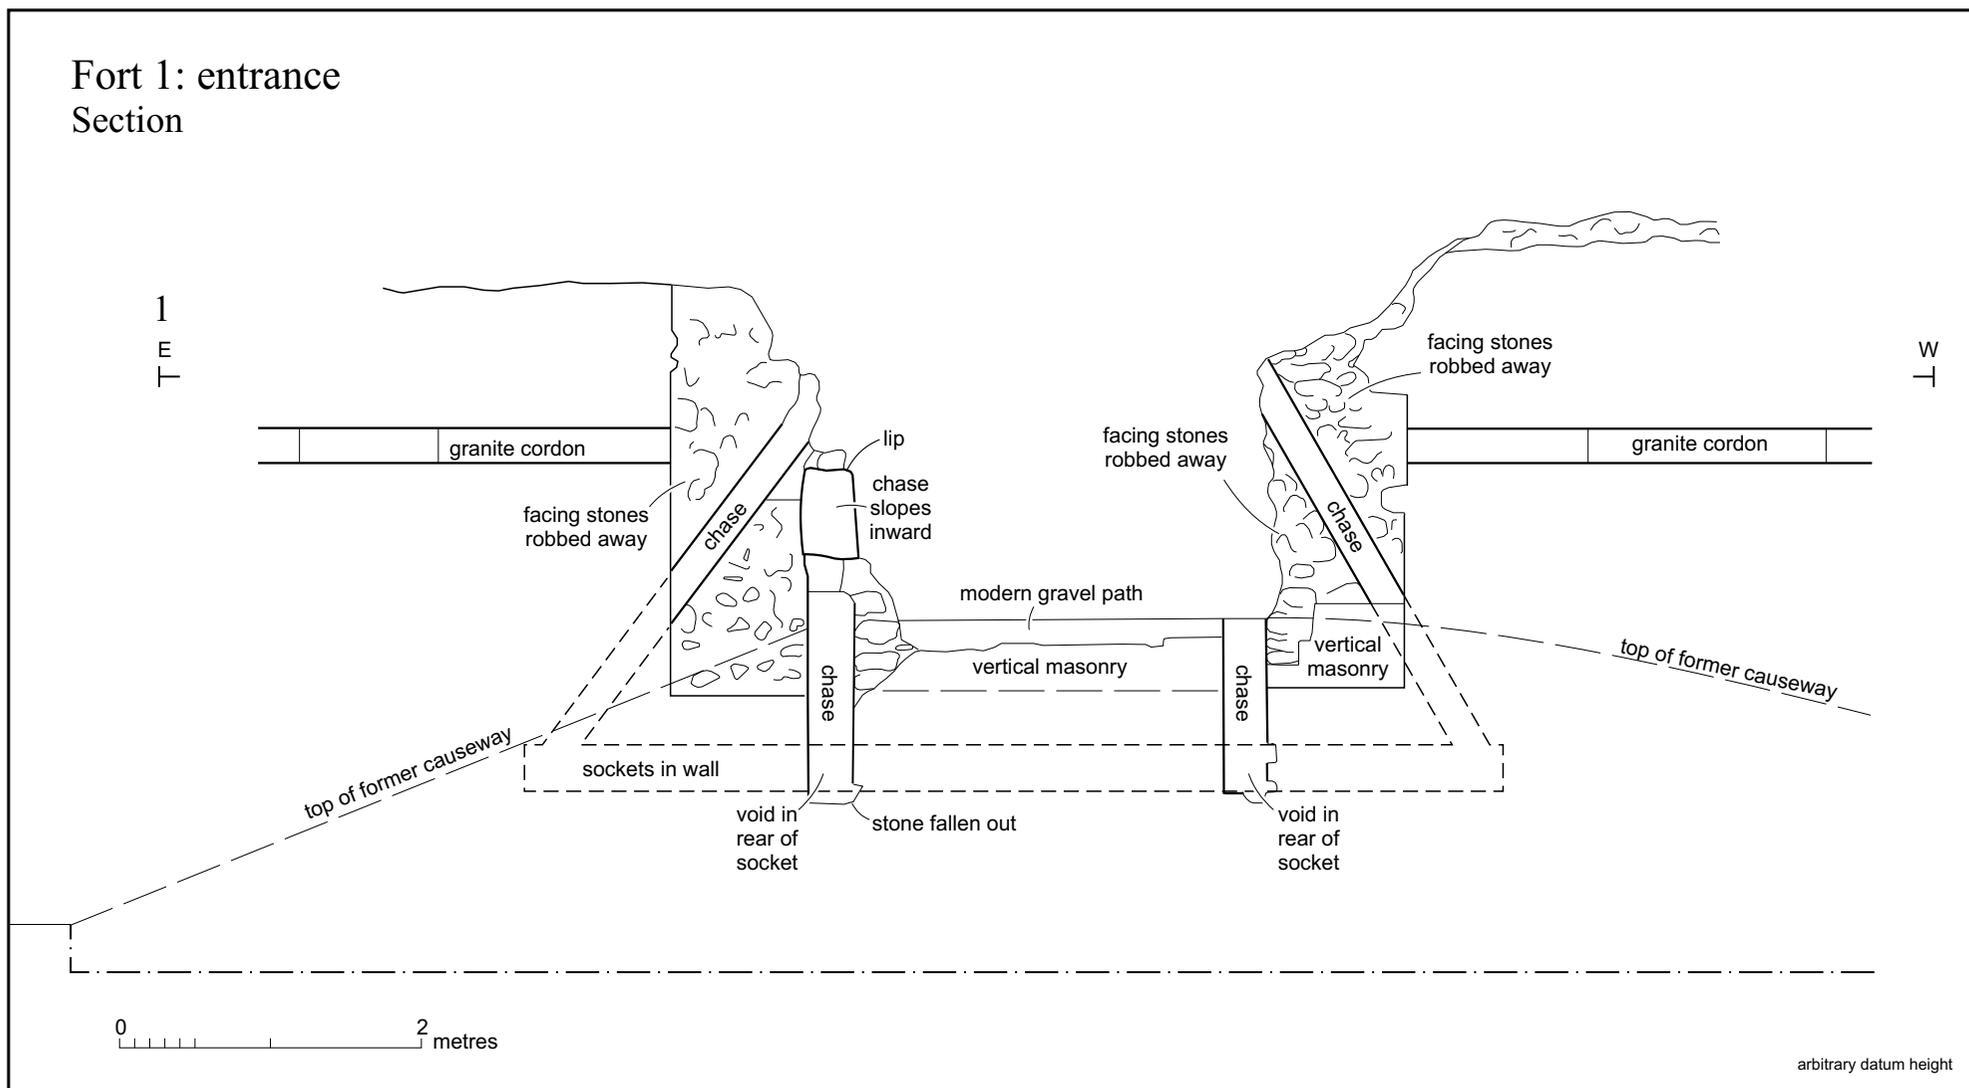
Fig. 4 Fort 1: section of the curtain wall at the entrance.

# Fort 1: entrance Section

The removal of the causeway exposed structural features relating to the entrance of the fort, some of which were previously visible and had been recorded in 1990. The curtain wall is constructed of limestone, is battered inwards towards the interior of the fort, and finishes at a round granite cordon. Above the cordon are the remains of a vertical parapet wall. There are no embrasures within the parapet wall on this side of the fort.

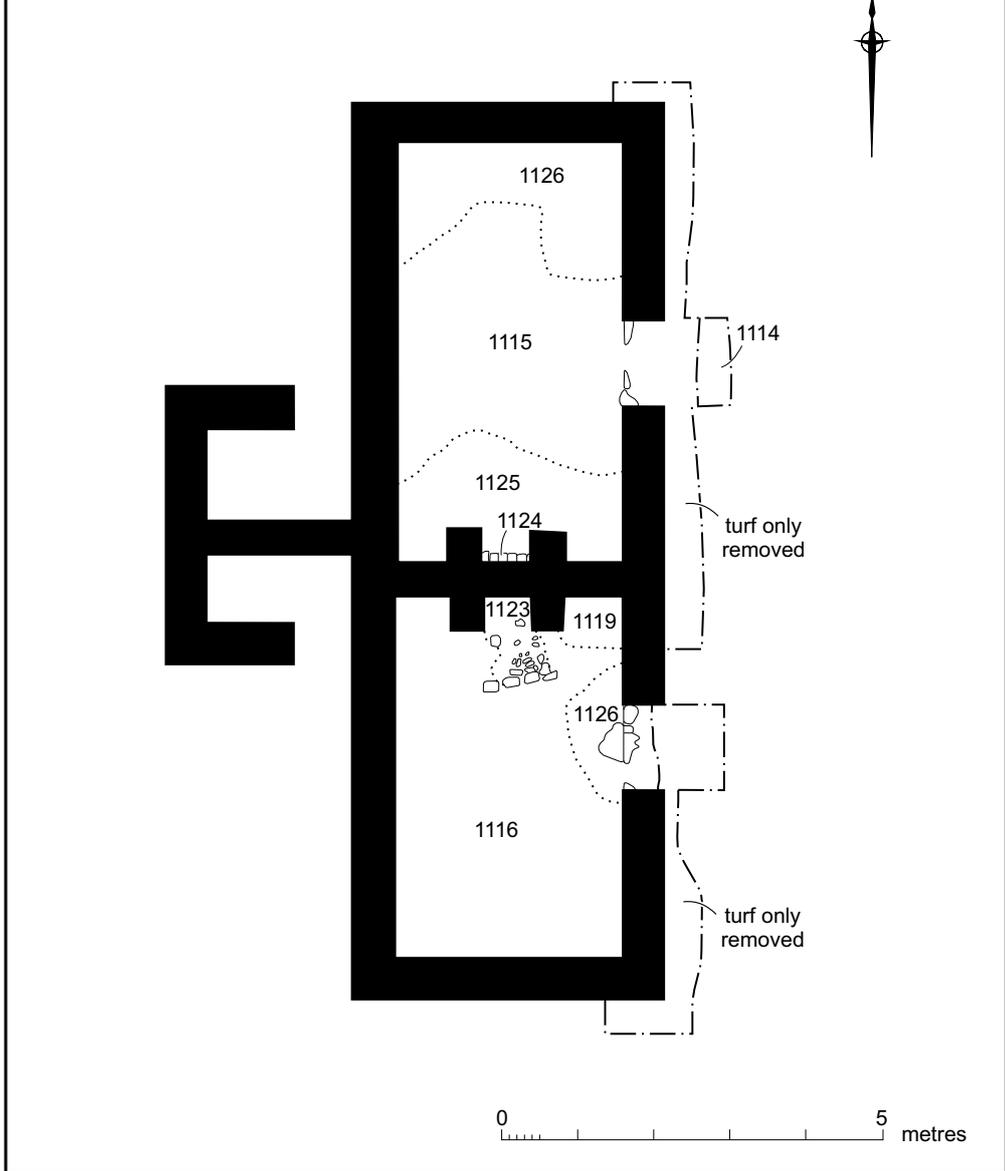
Fig. 6 Fort 1: the guardhouse.

Fort 1: guardhouse  
Plan

The guardhouse comprises two front rooms with two small toilets at the rear. The interior of the front rooms was excavated to the original floor level (although no floors actually survived), entailing the removal of turf (1114) and most of the collapsed rubble deposits (1115 and 1116 below). Limited removal of turf outside the building to expose the masonry and provide level access to the interior was also carried out.

Removal of turf exposed near-central entrances into both rooms and integral fireplaces in the central dividing wall, none of which was visible prior to the excavations. In the south room the remains of a hard slightly gravelly white lime mortar hearth, lined with limestone and brick survived (1123). To the south of the fireplace an area of light red-brown friable silty clay was exposed (1119), possibly representing a make-up layer for the former floor surface.

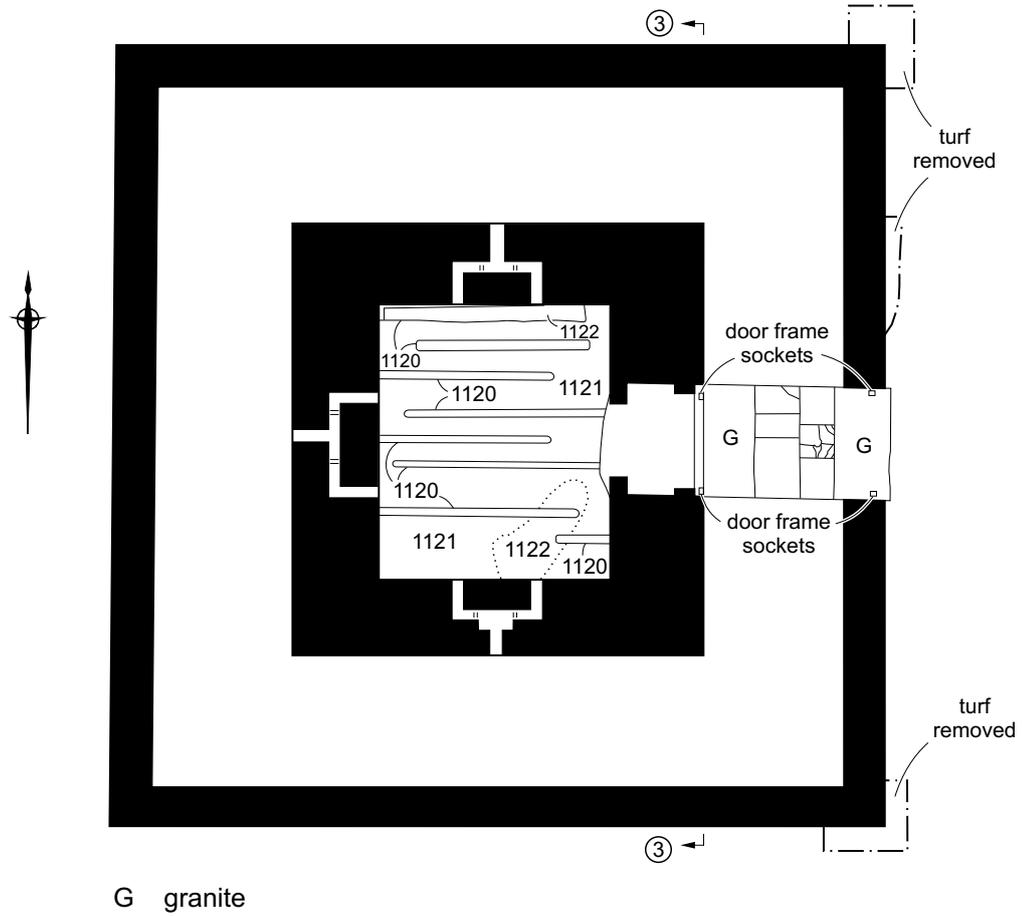
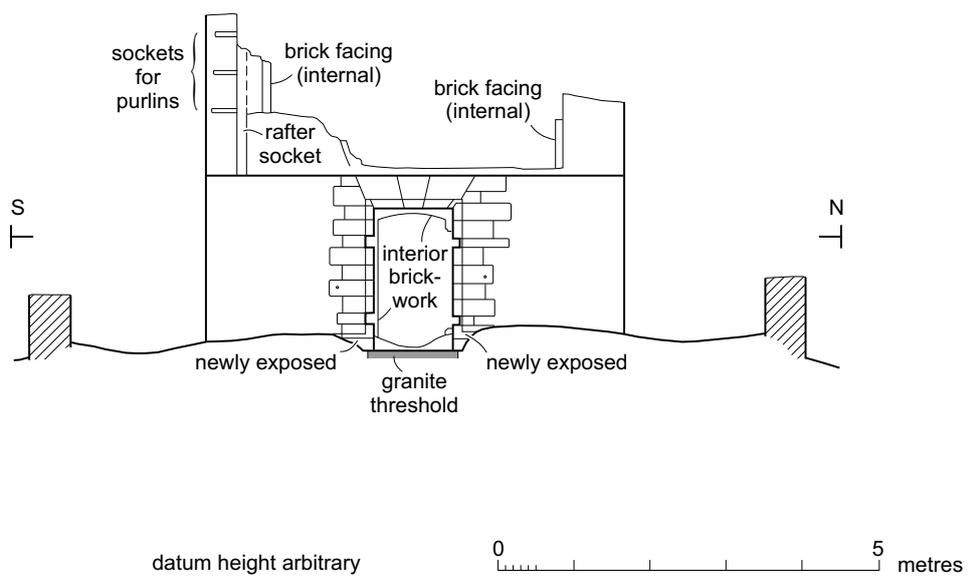
Fig. 7 Fort 1: the magazine.

Fort 1: magazine  
Plan

Section 3

The debris (1117 and 1118) inside the magazine was cleared to the level of the original floor. Turf was removed along the pathway between the magazine and its outer enclosure wall, with further turf and vegetation cleared to expose the enclosure wall.

Inside the magazine two make-up layers were found. The lowest, a friable-soft mid-brown sandy silty clay with occasional blue slate fragments (1122), was only exposed where the upper layer (1120) had been previously removed. The upper make-up layer comprised a distinctive soft orange-red clayey-silty sand containing occasional limestone fragments and rare lime mortar fragments (1121). Into this deposit a series of eight east-west aligned joist sockets (1120) had been excavated, two of which still contained fragments of very-decayed wood. This must indicate that the building had wooden floorboards, probably laid at a slightly higher level than the entrance, which would be a sensible safety measure in a building containing explosives (i.e. the step up acted as a barrier to soldiers entering the magazine).

Outside the magazine the stone path to the building was uncovered, and this surface had been laid with two slabs of granite, each with sockets for removed door frames, separated by two rows of smaller slates. The presence of a door at the entrance to the building was already known from the evidence on the standing building, but the evidence for an outer door is a new discovery. This does however seem logical in that it presents an outer barrier to the magazine complex.

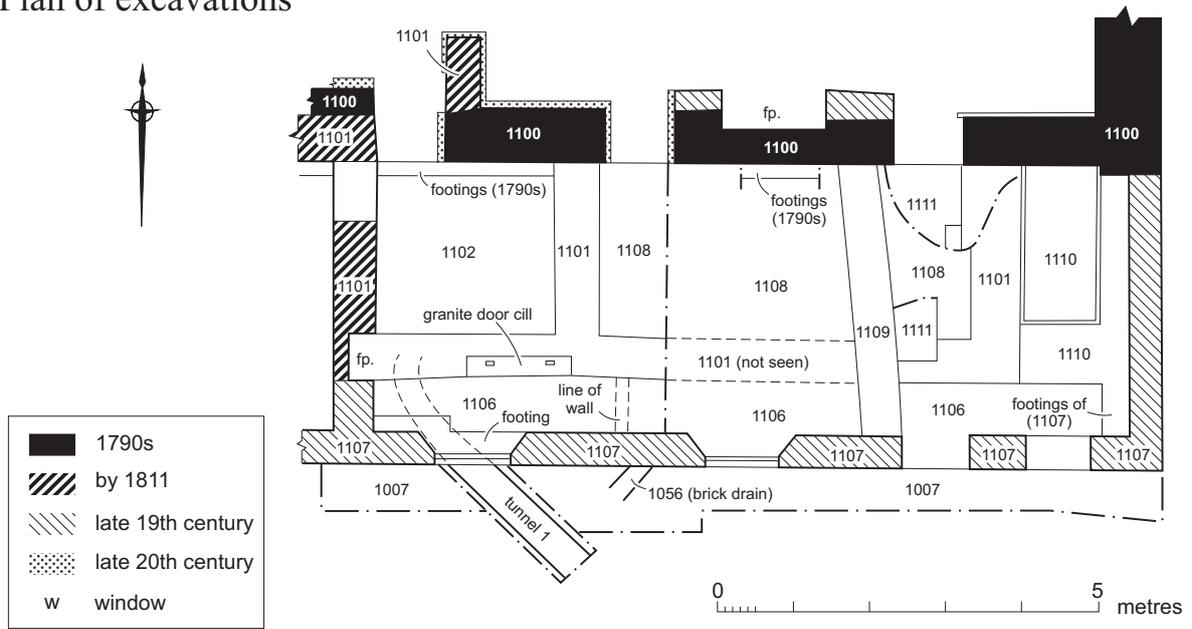
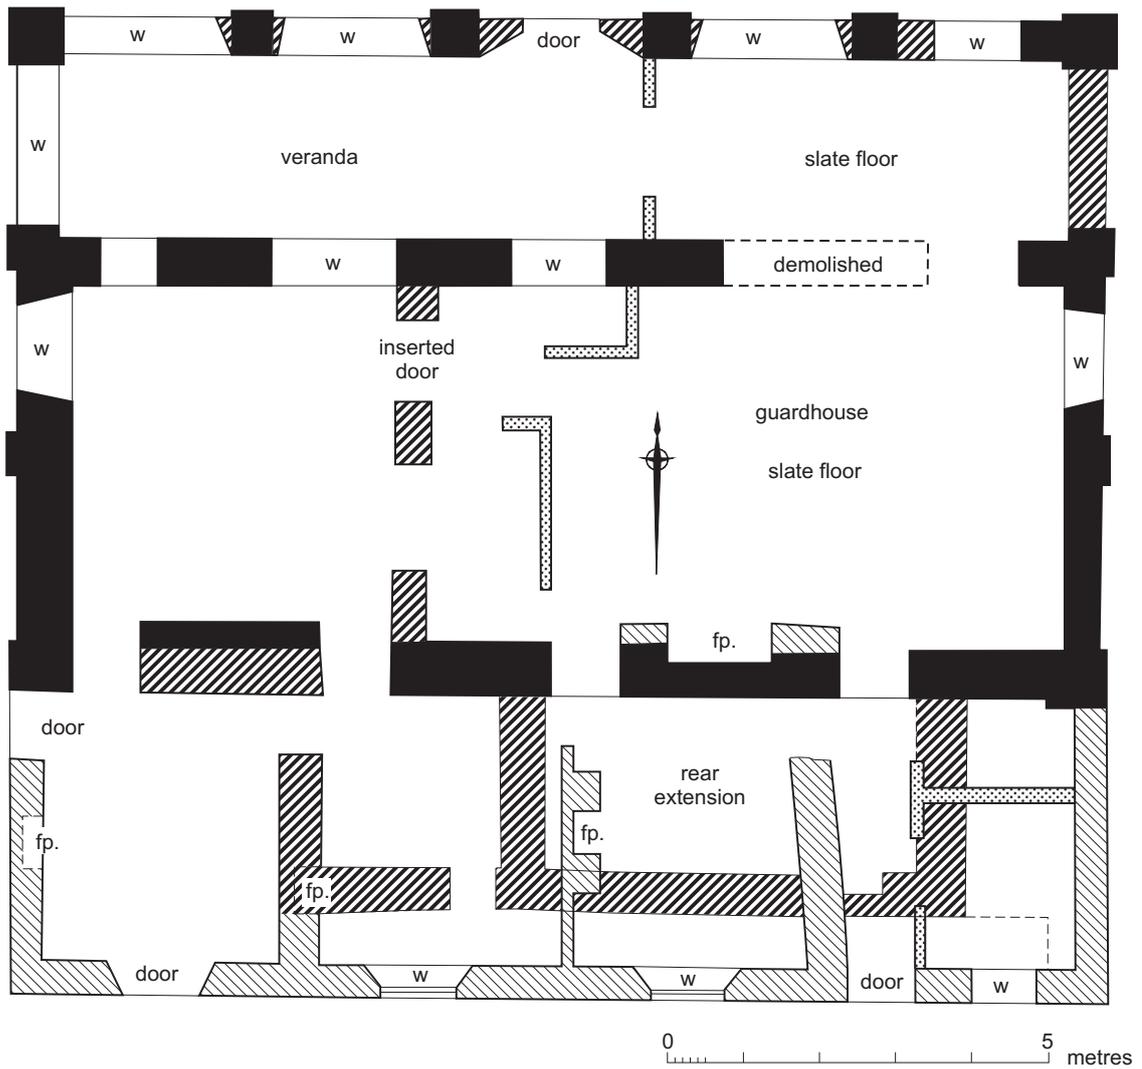
Fig. 10 Fort 3: the guardhouse.

## Plan of excavations

## Phased plan

Extensive works to the guardhouse were undertaken, including stripping of modern internal coverings and repairs to the ceiling and roof. Excavations were undertaken within the rear extensions of the building, and along the outside of the south elevation that was not excavated in February 2009 due to the presence of then live services. These works have provided new information on the development of the guardhouse, although the description provided by Pye and Slater in 1990 remains largely valid. The phased plan in Fig. 10 supersedes Pye's 1990 fig. 19.

The original guardhouse, constructed in 1798-1802, was a large rectangular structure with a veranda on its northern side (1100). Removal of modern concrete from within the veranda uncovered a well-preserved slate flagstone surface that has been left exposed for display in the new cafe. Internally, the building is currently divided into two rooms by a stone wall, previously thought to be original (Pye and Slater, 1990). This was however shown to be a later insertion, and dates to the early nineteenth century (the mortar being identical to that used in the extension constructed by 1811). No evidence for any original internal dividing walls was exposed (e.g. guard room, and mess room) although these may have been present in the form of partitions. Within the eastern third of the building a slate floor was exposed; elsewhere it had been removed and replaced with a concrete floor.

By 1811 the building had been extended to the rear, and the extension is depicted on the 1865 Ordnance Survey map. Though a combination of building recording and excavation, it can be shown that this extension comprised (at least) two rooms, and was smaller than previously thought. The building was 2.30m wide internally, some 1.30m narrower than the later alterations. Only the east wall survives above ground, the remainder surviving as footings (1101). The position of a door into the western room is defined by a granite threshold incorporating sockets for a wooden door frame. Remains of a limestone flag floor (1103) covered with a gravelly lime screed tainted with coal dust were exposed, possibly indicating this room was used for storage. The veranda at the front of the building was also probably infilled at this time.

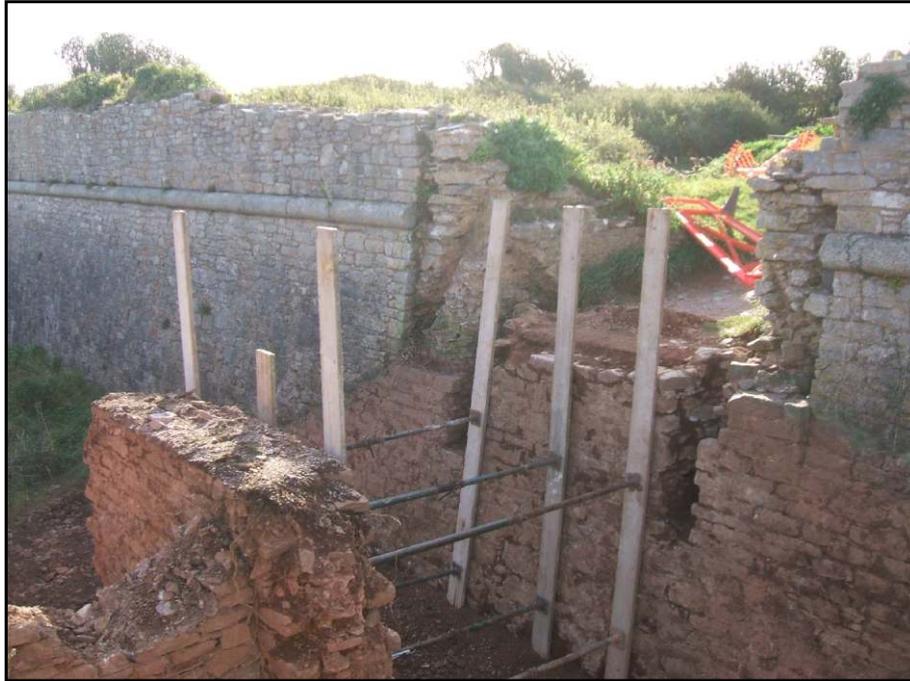
Pl. 1 Fort 1: entrance showing pier, and chases for timbers on the curtain wall, looking south-east.

It is clear from the structural features within the curtain wall and the presence of the pier that access over the ditch was in two parts – a fixed bridge between the pier and the counterscarp wall, and a bascule drawbridge between the curtain wall and the pier. Although the bascule bridge has been removed the curtain walls retain chases and sockets for fixed timberwork supporting the drawbridge. The principle timbers would have been two vertical posts set into open sockets at the front of the wall. At their bases these posts would have been fixed into a horizontal timber embedded within the front of the wall. Further horizontal timbers, also embedded into the wall but at right angles to the horizontal timber, would have been attached to the base of the posts. The vertical posts would also have been supported, on their outside and rear faces by high-level diagonal braces which terminated at the end of the horizontal timbers. There is no surviving evidence for any mechanism for raising the bridge, although a bascule bridge does not require the complicated winding gear needed on a drawbridge, and may simply have been raised by pulling on chains. A suggested drawing of the arrangement likely to have been employed at the entrance to Fort 1 is shown in Fig.5a.

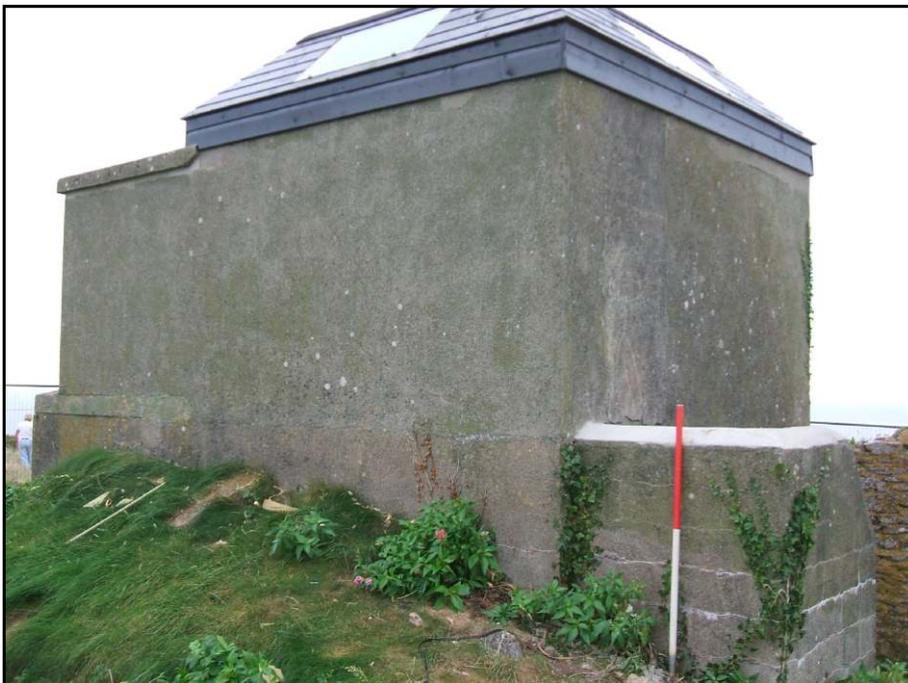
Pl. 4 Fort 3: The Royal Observers Corp post, looking south-east. 1m scale.

There is evidence to indicate that there are two phases to this building's construction, which may date to 1943/4 and the period 1950-55. The original structure was constructed against, and utilising, the southeast corner of the existing Napoleonic store building, using concrete blocks. Internally, the building was divided into a large west and a smaller east room, the former entered by a door in the west elevation, which was protected by an external blast wall. A small, internally-arched opening, with brick lining has been inserted into the stone masonry of the east elevation. This feature is probably part of the original ROC building, but may have been added at a later date. The east room has a concrete roof, displaying scars of the corrugated iron sheet shuttering used as a former on its underside. In the west room there are fixings in the north, east and west elevation for now-removed shelves and/or cupboards. Set into the concrete floor is a 2" diameter steel post, sawn-off at floor level that would have supported the surveying equipment.

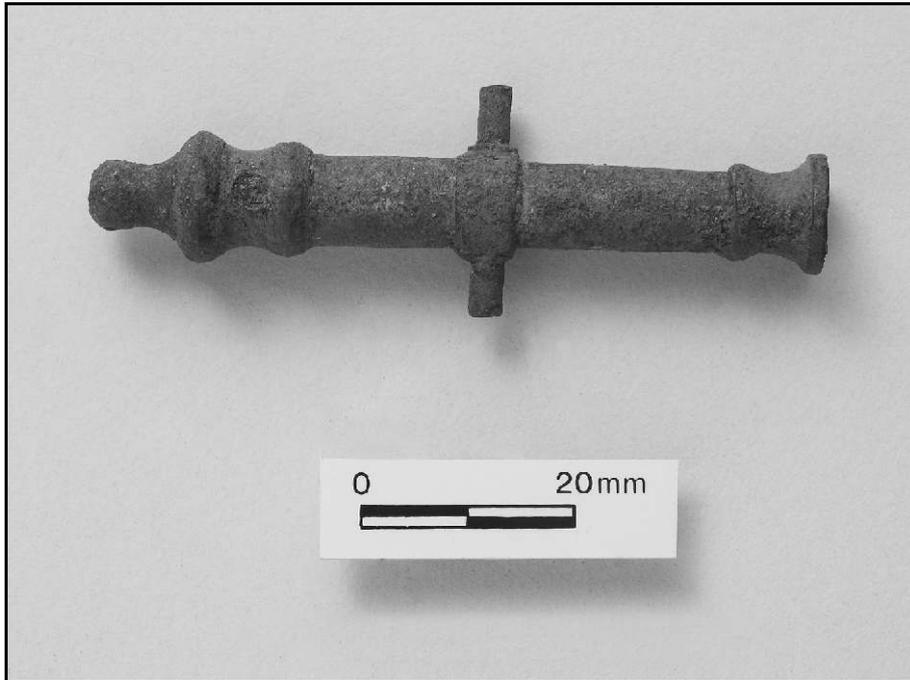
Pl. 5 The toy cannon. 20mm scale.

Of particular interest is small find 12, a child's toy cannon (Pl. 5). In part due to the numerous worldwide conflicts throughout the 19th century toy cannons were particularly popular with children. The example from Berry Head is made from brass and measures 69mm long, being at the smaller end of the scale for such toys (finds of cannons in England seem to be smaller than those shown in historic pictures of those manufactured in the USA). The cannon is missing its carriage, which was probably made from wood. The type of cannon represented by the toy has not been identified, but the slender profile of the barrel and its relatively wide reinforcing rings and muzzle moulding may reflect an earlier (i.e. Napoleonic) date. The toy was cast and was designed to be fired, with a hollow barrel and a touch hole or vent on the upper surface. This is the second toy cannon to be found at Berry Head – a fragment from another cannon, of a slightly different design, was recovered from a Napoleonic context by Brixham Museum in 2001 during excavations for a new service trench adjacent to the Artillery Store in Fort 3. This cannon had exploded when fired. Small find 12 is almost identical in shape and size to an example found at Churston in 1960 (information provided by P.L. Armitage).

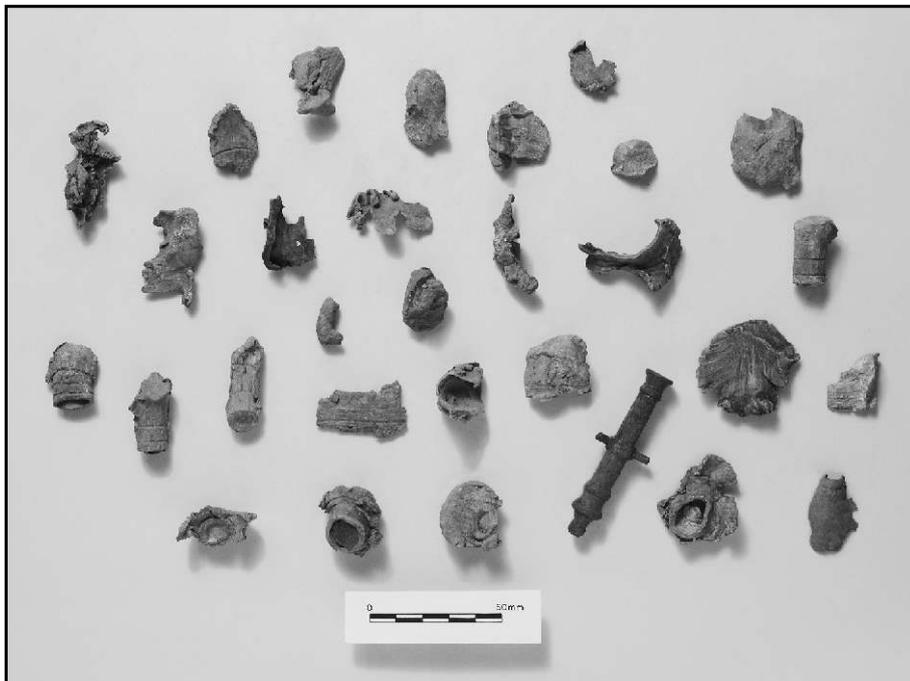
Pl. 6 The bullets and cannon. 50mm scale.

The military finds (Pl. 6), including ordnance, spans the period c. 1850-1945. Most of these finds were recovered from the guardhouse of Fort 1 and may have derived from the rifle range (c.1860s-1908) located outside this fort; some finds had clearly been collected and were found together in small groups. The ordnance includes rifle bullets and revolver cartridge cases that probably represent both military issue, and commercially-bought items (identified by the lack of official markings) used in a privately-owned Adams revolver. The use of an Adams revolver fits well the discovery during excavations by the Brixham Heritage
