**ARCHAEOLOGICAL RECORDING AT
BRIXHAM BATTERY 2009**

**Prepared for
The Brixham Battery Heritage Centre Group**

Exeter Archaeology

Report No. 09.115

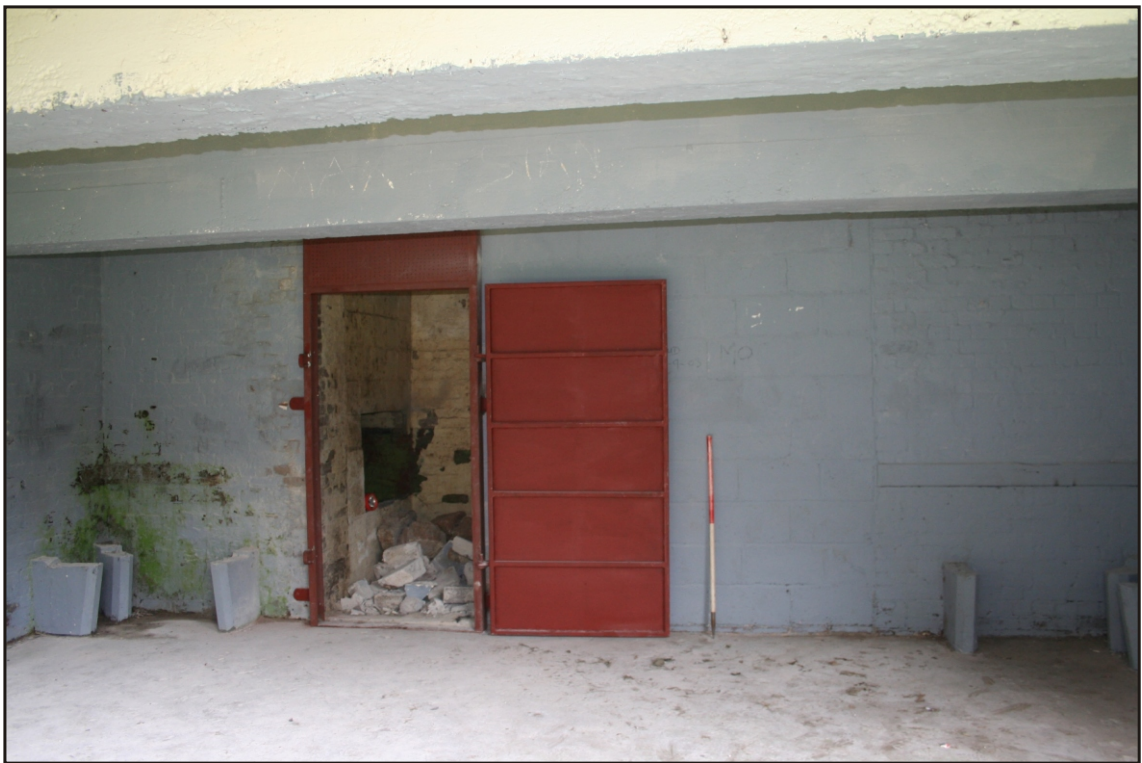
The No. 1 gun floor and corridor (Pl. 1)

The gun house, over the gun floor, is constructed of brick, whose east and west walls incorporate blocked recesses, possibly former storage lockers for ready ammunition. In the rear of the gun house is a tall, wide opening that gave access into a corridor. This opening was sealed in 1947 using concrete blocks, and has recently been partially unblocked with a new steel door added to provide entry to the corridor. The corridor is constructed of brick and is integral to the gun house. The corridor gives access to a southern tunnel and to the no. 1 gun crew war shelter. The entrances to these rooms were also sealed in 1947 using concrete blocks, and at the time of the survey this blocking had been partially removed.

Plate 1 The inside of the gun floor showing blocked rear opening, looking south-west. 1m scale.

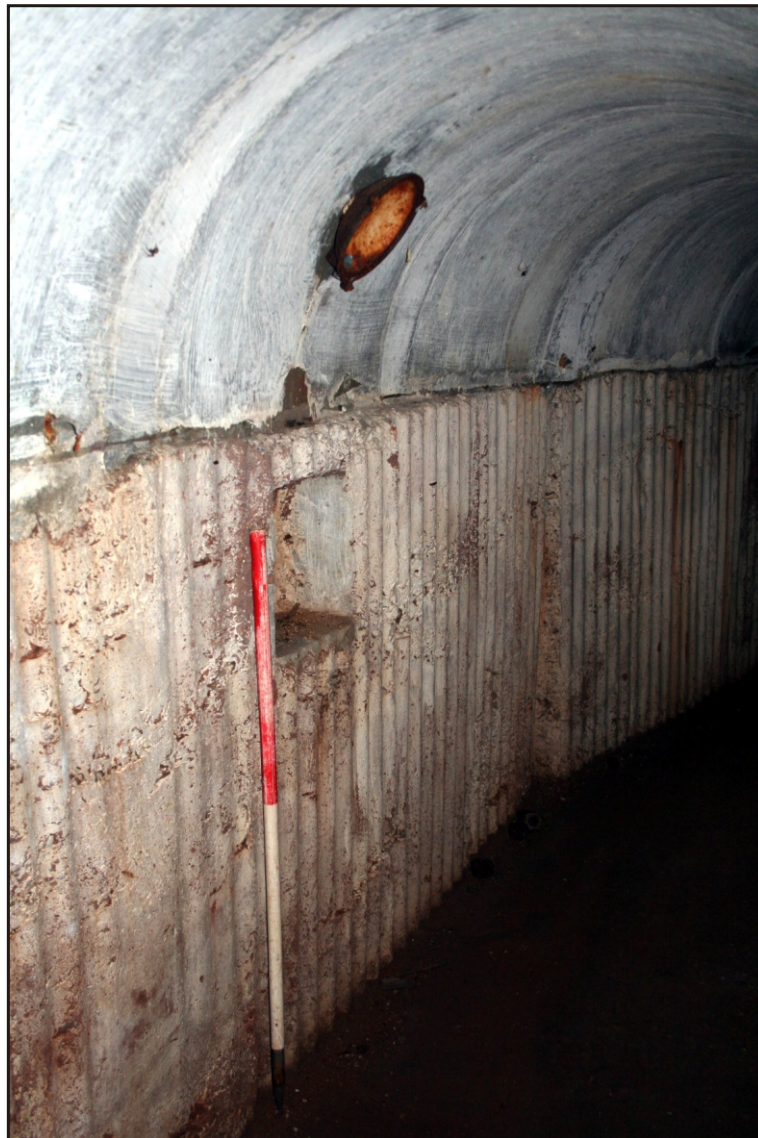
The south tunnel (Pl. 2)

The south tunnel is constructed of concrete with a smooth finish, but with small sections where impressions from corrugated iron shuttering is visible. The roof of the tunnel is formed from concrete with an arched profile. On its north elevation are clips for removed electric cabling, and fittings for two electric lights. Below these fittings are two recesses, probably for storage (possibly of extra light bulbs). The tunnel is aligned north-west to south-east, but

halfway along its source changes direction to a north to south origination (see inset plan on Fig. 2). At its south end the tunnel has been sealed, again with concrete blocks, and here the tunnel probably turns east and continues for a short distance where an exit is visible beside a path. At the south end of the tunnel are two low recesses set into the west elevation. These may have provided storage for ammunition, but are relatively small, so may have housed the cartridges containing the propellant, rather than the shells themselves.

Plate 2 Electric light fitting with void below in the south tunnel, looking south-east. 1m scale.

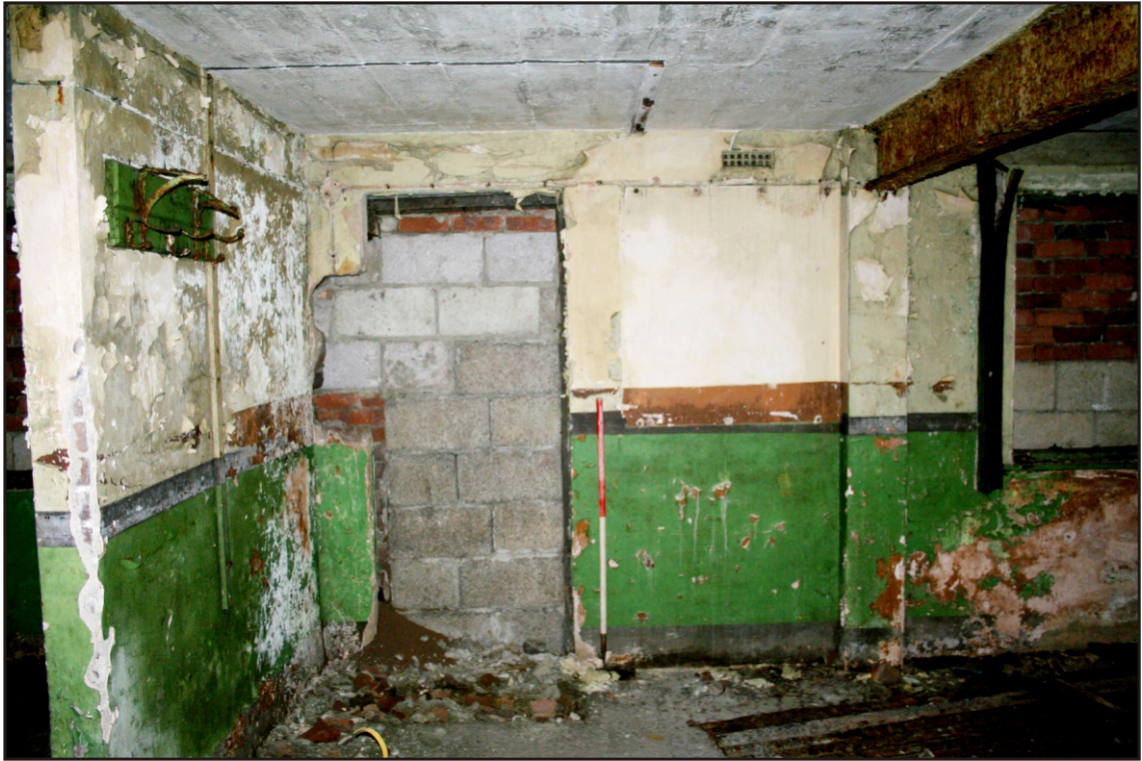
No. 1 crew war shelter (Pl. 3)

Both war shelters are constructed of brick. The present paint scheme of green and light yellow with a black stripe overlies a partial layer of brown paint, possibly an undercoat. Both rooms have high-level brick vents.

The no. 1 crew war shelter is entered from the corridor, and there is also an opening in its west elevation into the no. 2 crew war shelter. During the survey a door, now blocked, was discovered in the north (external) elevation. The shelter would have been lit by a window, also blocked, in the north elevation. Surviving fittings include scars of electric cabling and the fuse box, a stove base with asbestos sheet lining to the walls and a vent pipe in the ceiling above, a noticeboard or backing of a dartboard, coat hooks and scars of removed shelving.

Plate 3 No. 1 gun crew war shelter showing blocked external door, looking north-east. 1m scale.

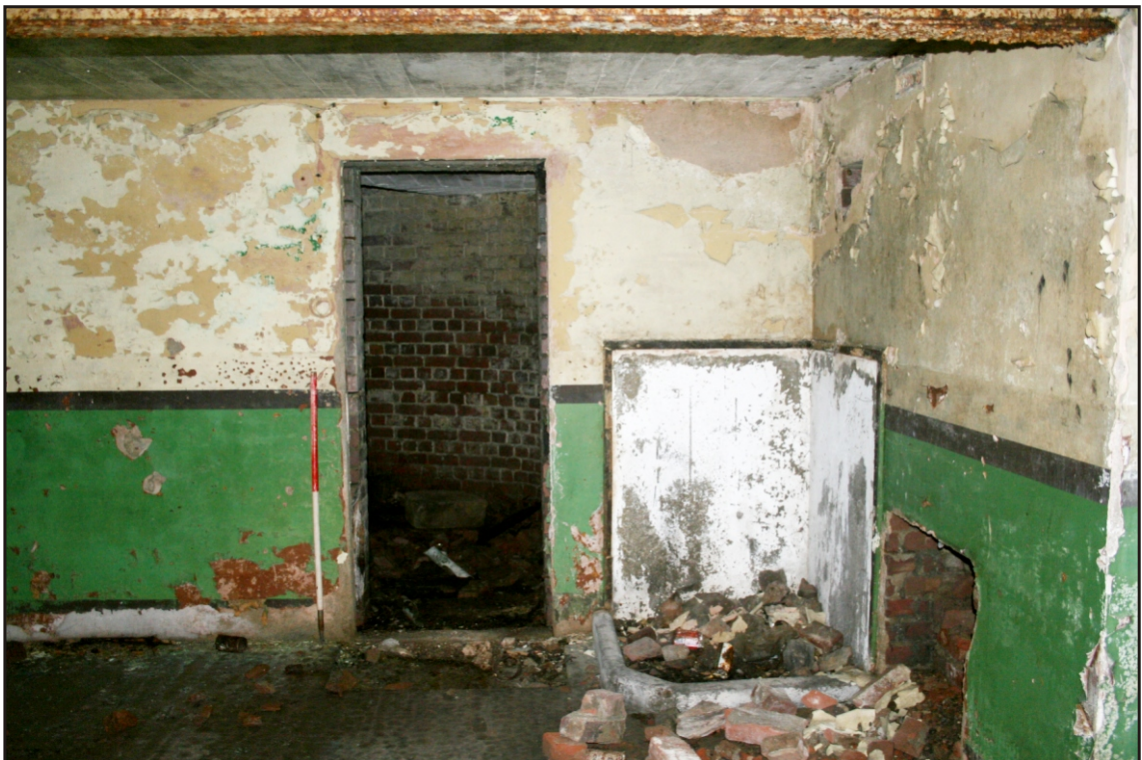
No. 2 crew war shelter (Pl. 4)

The shelter would have been entered via a brick-lined passage from the no. 1 gun floor, which is now blocked just outside its doorway. There was, and still is, also access between the two war shelters. The shelter is L-shaped, which reflects the position of an exterior coal store. A chute provided access to this bunker from inside the shelter. The shelter would have been lit by a window, now blocked, in the north elevation. Surviving fittings include clips for electric cabling, two stove bases and coat hooks on the south and east elevations.

Plate 3 No. 2 gun crew war shelter showing door opening and stove base, looking south-east. 1m scale.
