STABLES AT HILLERSDON HOUSE, CULLOMPTON, DEVON

Results of historic building recording

Mid Devon District Council planning reference
21/00834/LBC

Document No: ACD2583/2/1

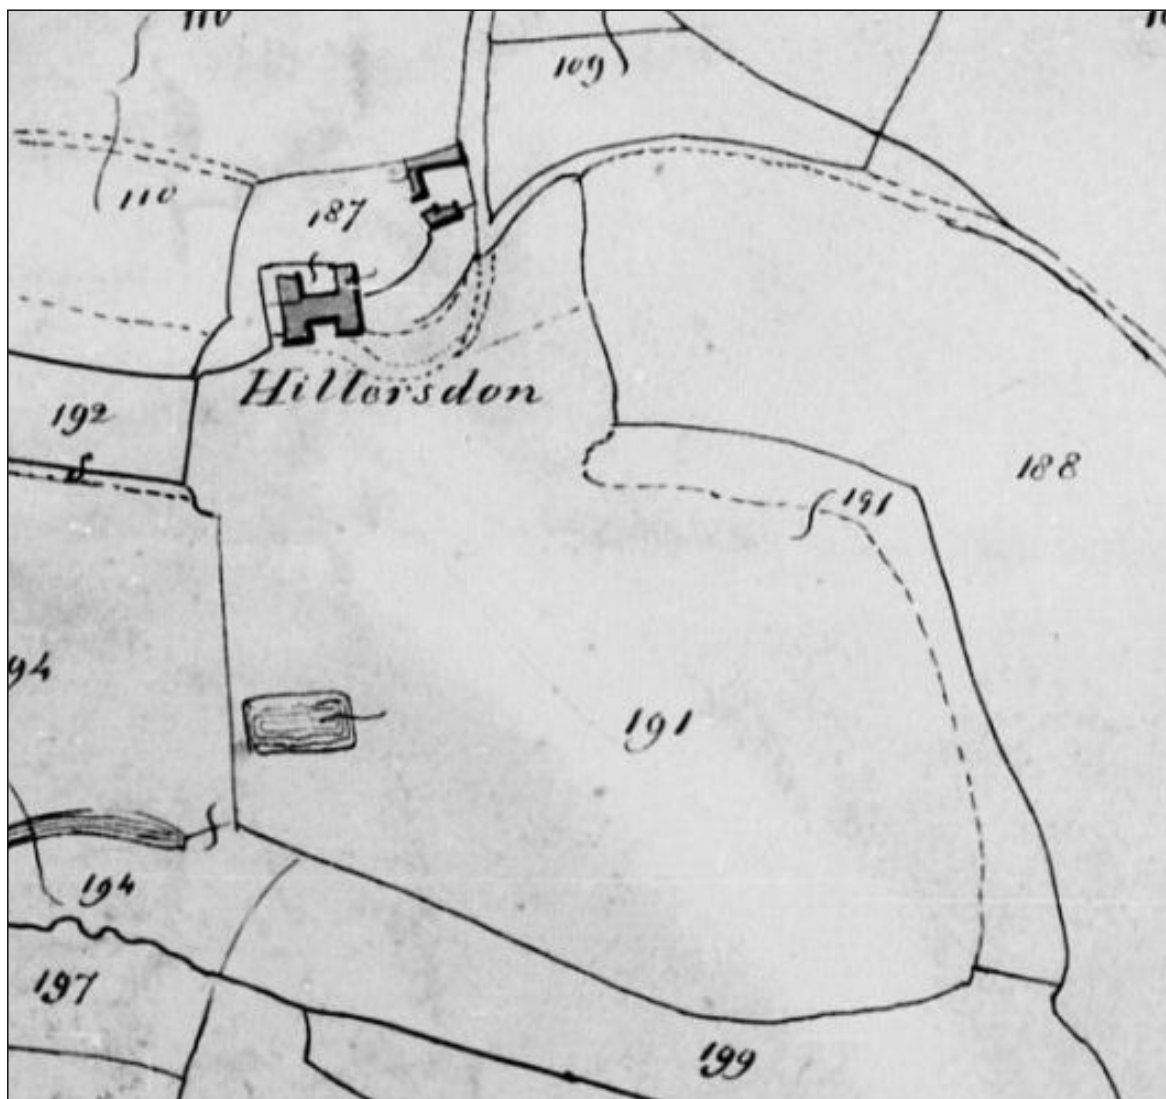
Fig. 2: Extract from the
Cullompton tithe map, 1842

- 2.3 The Cullompton tithe map of 1842 (Fig. 2) records the estate prior to William C. Grant's changes. The main house is shown to the northwest of the current house and has a H-shaped plan. There is a small rectangular structure in the location of the current stable block, and a larger L-shaped building to the north. They are all situated within plot 187. The accompanying apportionment of 1839 records that the plot was owned by Robert Baker and occupied by Daniel Roberts; it was described as 'Mansion House, Offices and Shrubbery'.

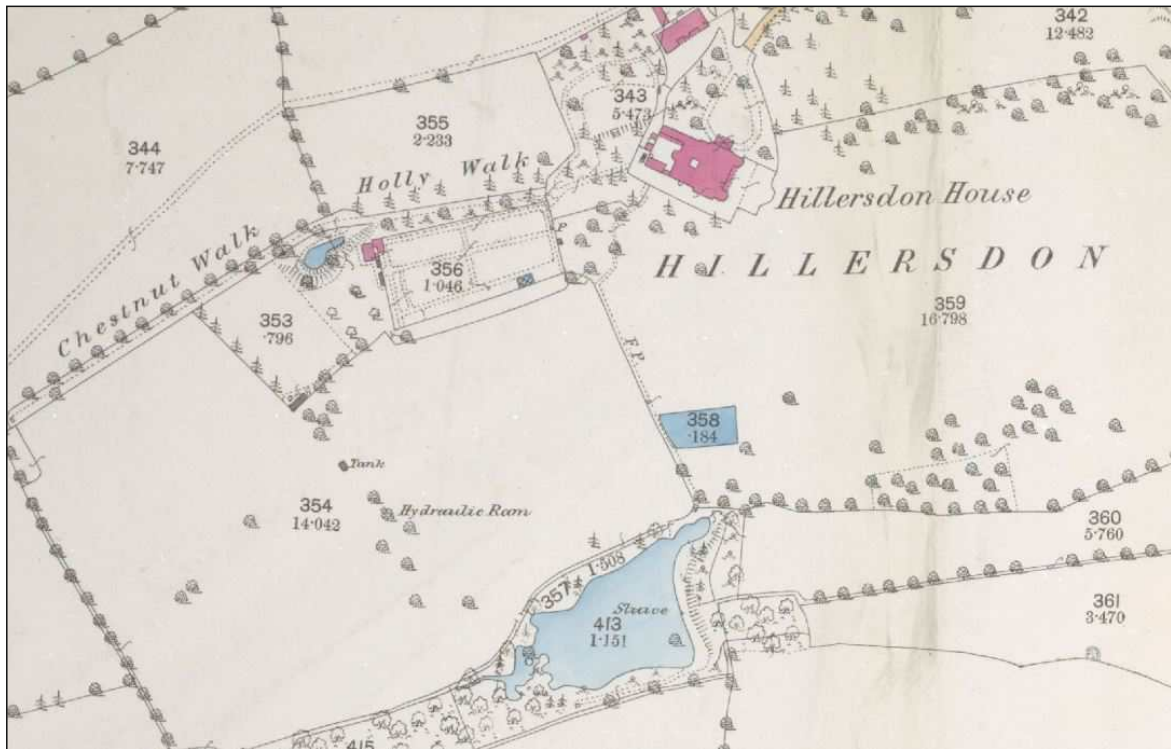
Fig. 3: Extract from the First Edition 25-inch Ordnance Survey map, 1889

- 2.4 The First Edition 25-inch Ordnance Survey map of 1889 (Fig. 3) records the new house and stable block, along with changes to the landscape of the estate. The stable block faces southeast overlooking the rear of the house and the surrounding grounds. The map records its C-shaped plan (with a central projection), and an open-fronted canopy between the two wings. The Second Edition 25-inch Ordnance Survey map of 1905 (not illustrated) depicts a small rear extension on the northwest side of the stable block.

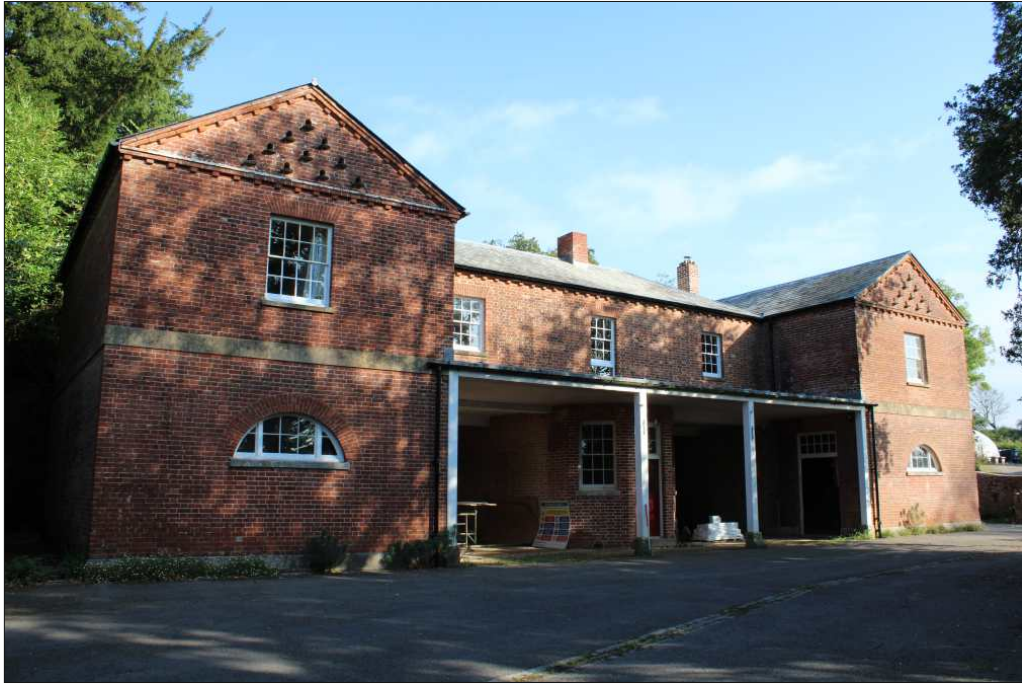
5.3 The main façade is to the southeast (Plate 1). The projecting bays have lunette windows fitted with fixed wooden casements on the ground floor. Above these, at first-floor level, is a rendered plat band; this continues around all the elevations. However, on the northwest elevation it is not rendered but of exposed brick. On the first floor are single eight-over-eight pane hornless sash windows. Above these, at eaves level, is a line of brick dentil detailing, which continues around all the other elevations of the building. There is further dentil detailing within the upper part of the gables along with groups of 10 pigeonholes, each with a slate perch, arranged in a triangular layout.

Plate 1: Southeast elevation, looking north (1m scale)

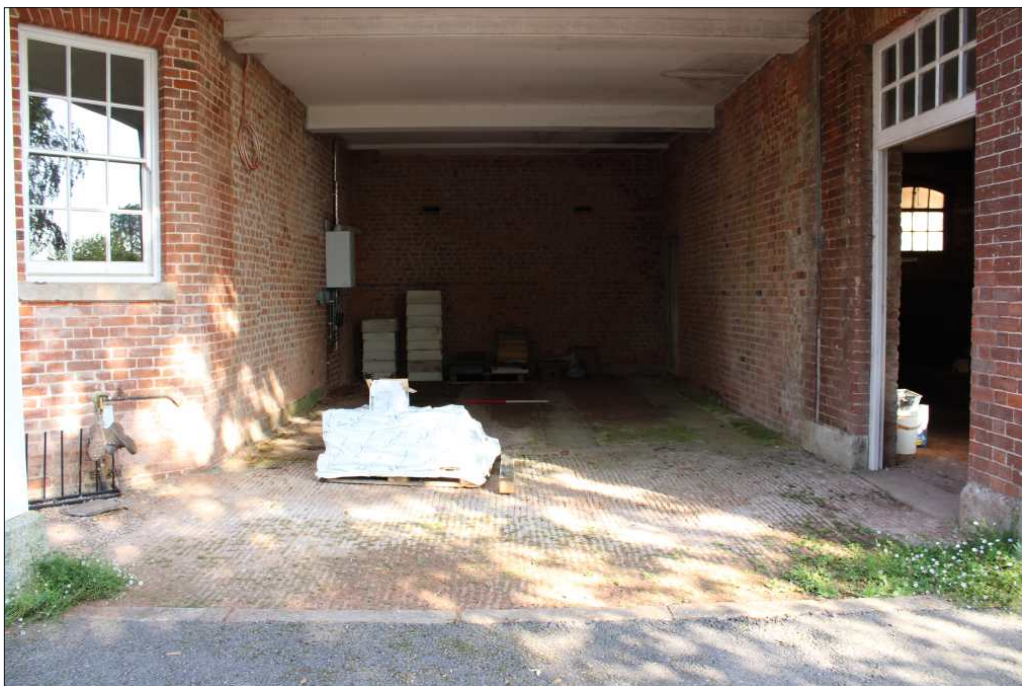
5.4 The ground-floor yard in front of the central section and between the side wings is covered with a flat roof. The front edge is supported on four timber posts on stone pads. The surface of this yard is laid with stone setts defined by stone kerbing along the front, and further blocks forming a threshold on the line of historic doors (Plate 2).

Plate 2: East garage, looking northwest (1m scale)

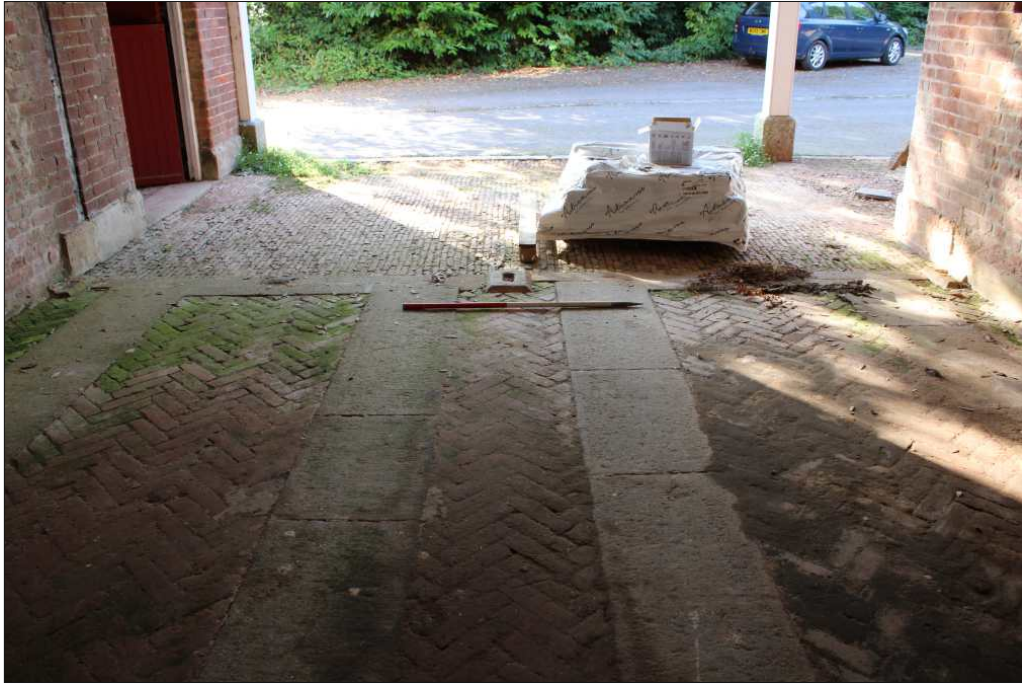
In the east garage they incorporate four small but taller blocks that contain sockets for the original (now removed) doors to the coach houses (and later garages). Iron fittings for catches on each pair of doors also survive (Plate 3). Within the garages there are four rows of flagstones for the wheels of pairs of carriages to run on, with brickwork set in a herringbone pattern in between.

Plate 3: Door fixtures surviving in the floor of the east garage, looking southeast (1m scale)

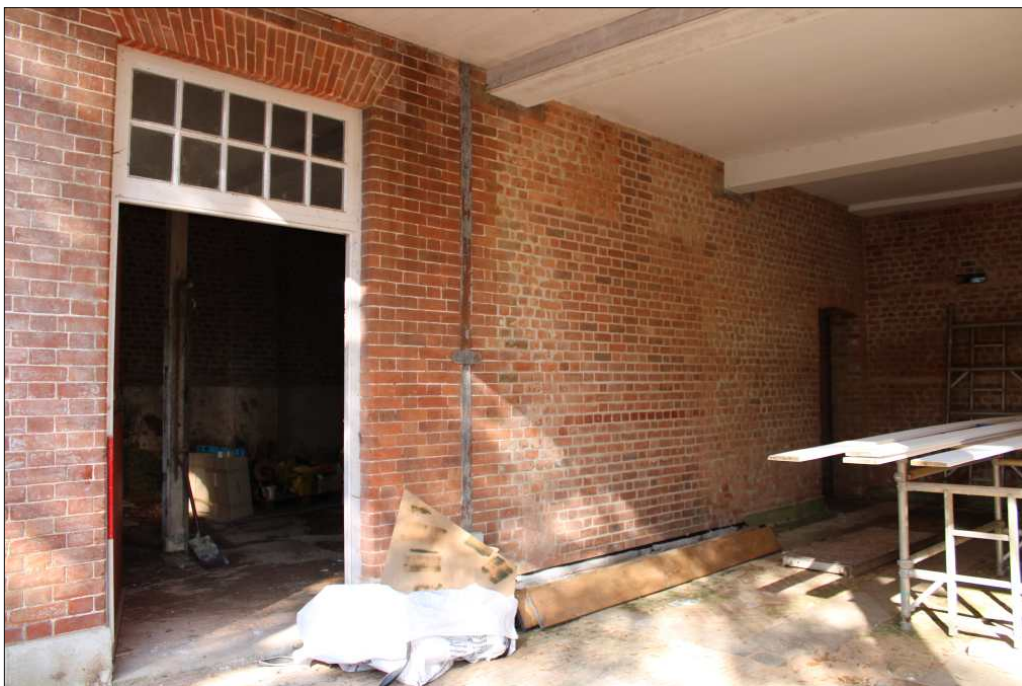
- 5.5** The walls within the garages are constructed of poorer quality brickwork than the external elevations, and feature larger mortar joints. The walls between the garages and stables incorporate large stable doors to the front (opening from the yard) with lights of 10 panes over. To the rear of these are downpipes integrated into the masonry. Within, and at the front of, the garages there are wide doorways which have been infilled with brick and beyond at the rear there are single doorways (Plate 4). The doorway in the east garage retains its original simple four-panel door (Plate 5). Between the garages is a three-sided central bay. This has a central doorway with light over and single six-over-six pane sash windows to either side. These are late 20th-century replacements dating from the conversion of the western first-floor area into residential use. In the rear section of the central bay there are former doorways into the adjacent garages that have been infilled with brick. On the first floor of the central section there are three six-over-six pane hornless sash windows, located over the two garages and within the central bay.

Plate 4: Wall between the west garage and stable, showing the arrangement of doorways (1m scale)

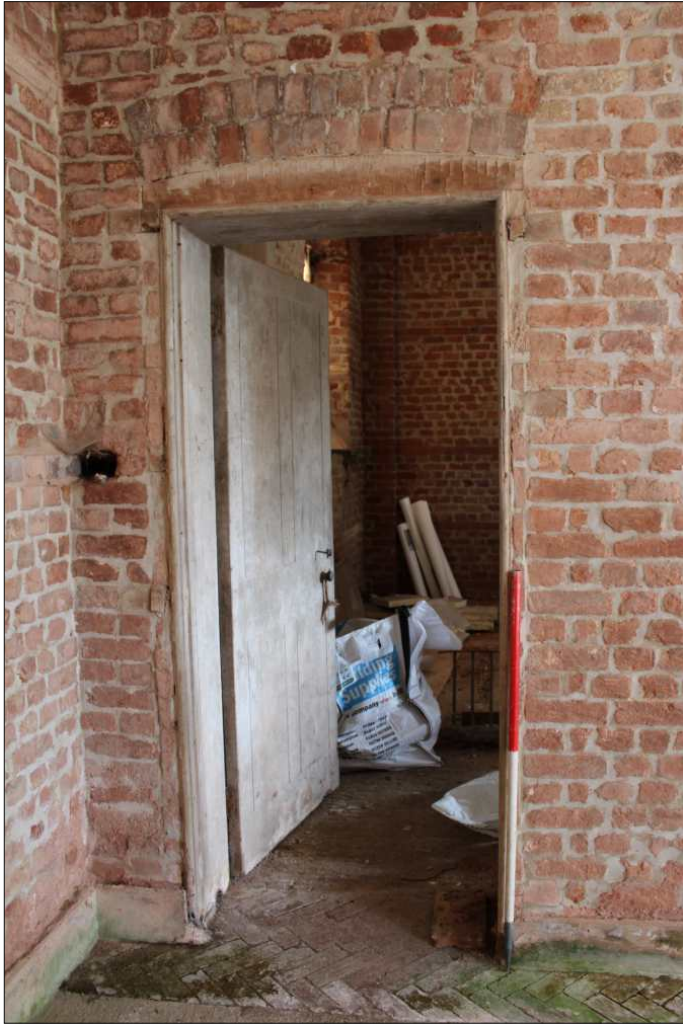
Plate 5: Original four-panel door in the east garage, looking north (1m scale)

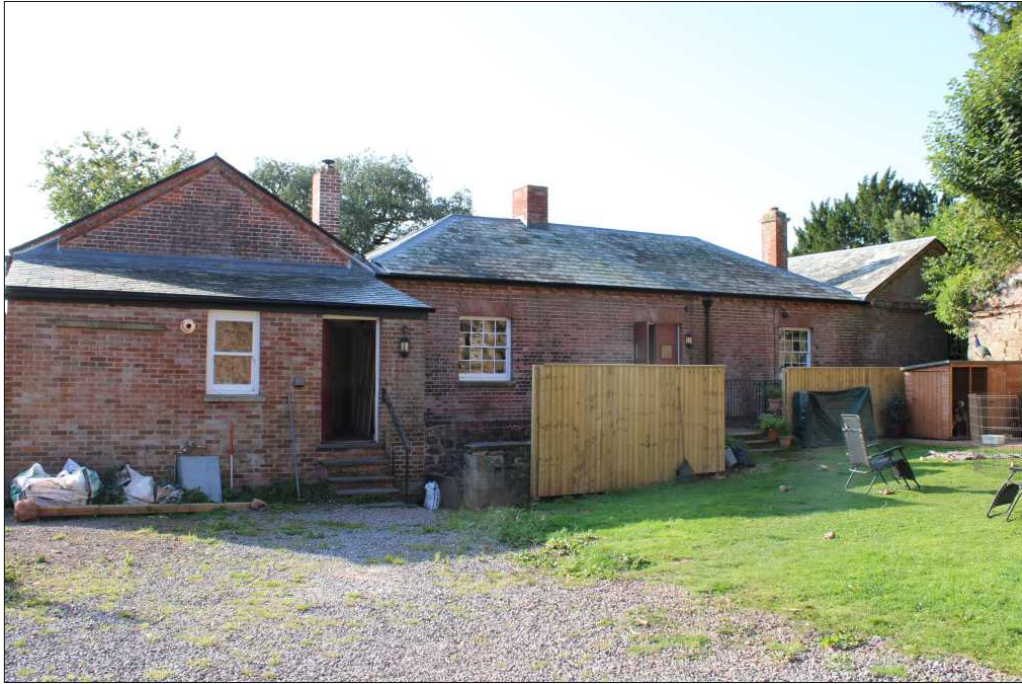
Plate 7: Northwest elevation, looking southeast (1m scale)

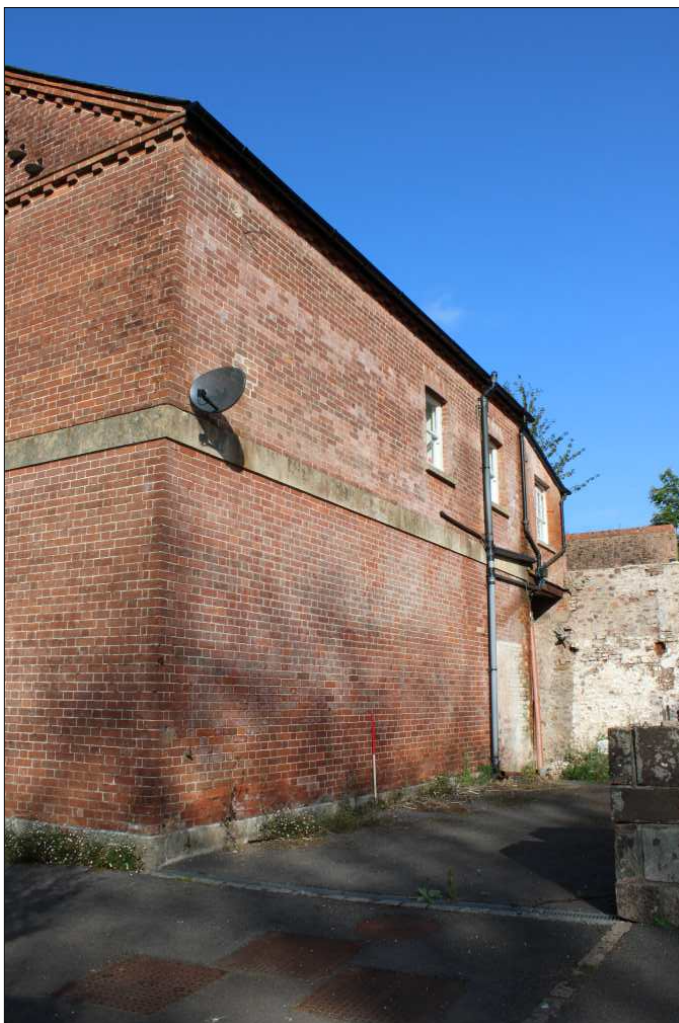
- 5.7** The northeast elevation formerly had an attached small lean to. This has been removed leaving a roof scar and paint on the wall (Plate 8). On the first floor, set toward the rear of the building, are two, one-over-one pane horned sash windows with a further eight-over-eight pane hornless sash window in the extension. There are no openings in the southwest elevation.

Plate 8: Northeast elevation, looking northwest (1m scale)

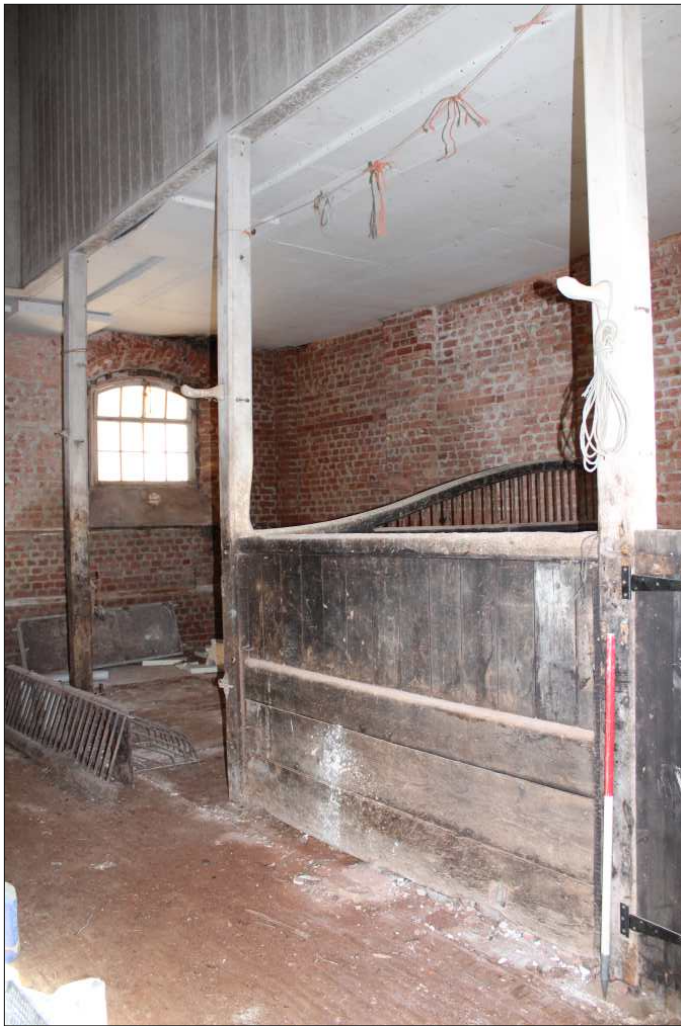
- 5.8** This wing has a stone sett surface, but within the area of the looseboxes it has been largely replaced with larger rectangular flagstones and bricks. There are drains within and along the front of the looseboxes. The walls are largely of exposed brick but there are small sections of wooden panelling surviving on the lower sections of the northwest, southwest and southeast walls. This was presumably originally present on all the walls. The double height lightwell along the southwest third of the wing has wooden tongue and groove panelling and the ceiling to the east of this, over the looseboxes, is of plasterboard (Plate 9). The first floor is supported on three timber posts that also form structural elements of the looseboxes. Originally there were two looseboxes, each capable of housing two horses. However, only the southeast loosebox survives and is constructed of wooden boards. It contains a refitted replacement plank and batten door (Plate 10). The length of partition between the two

Plate 9: East stable, looking north (1m scale)

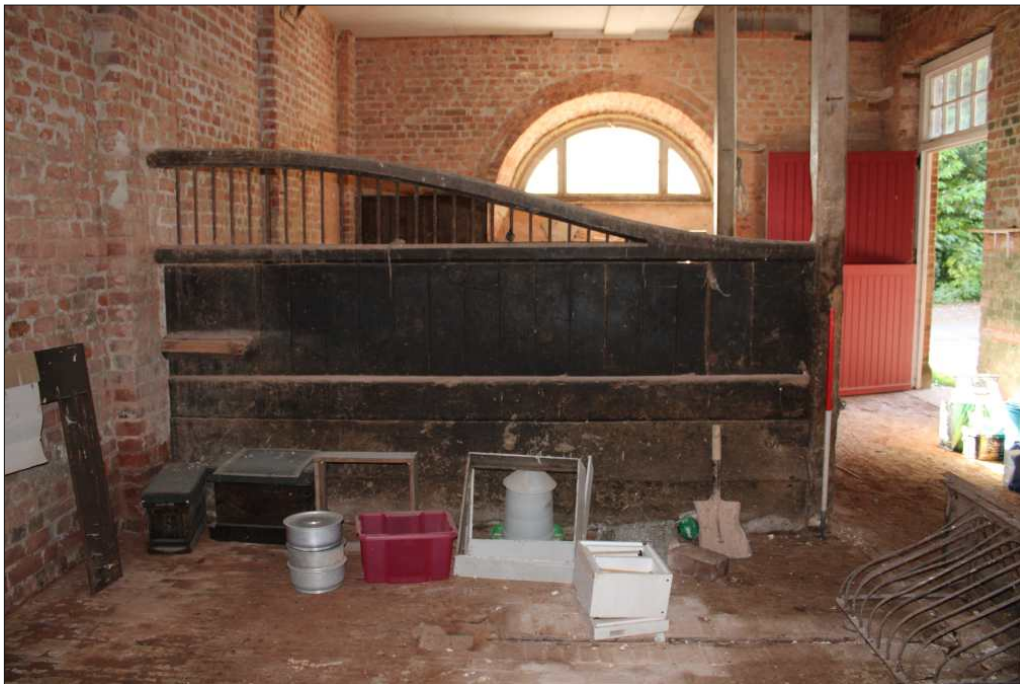
Plate 10: East stable, looking southeast (1m scale)

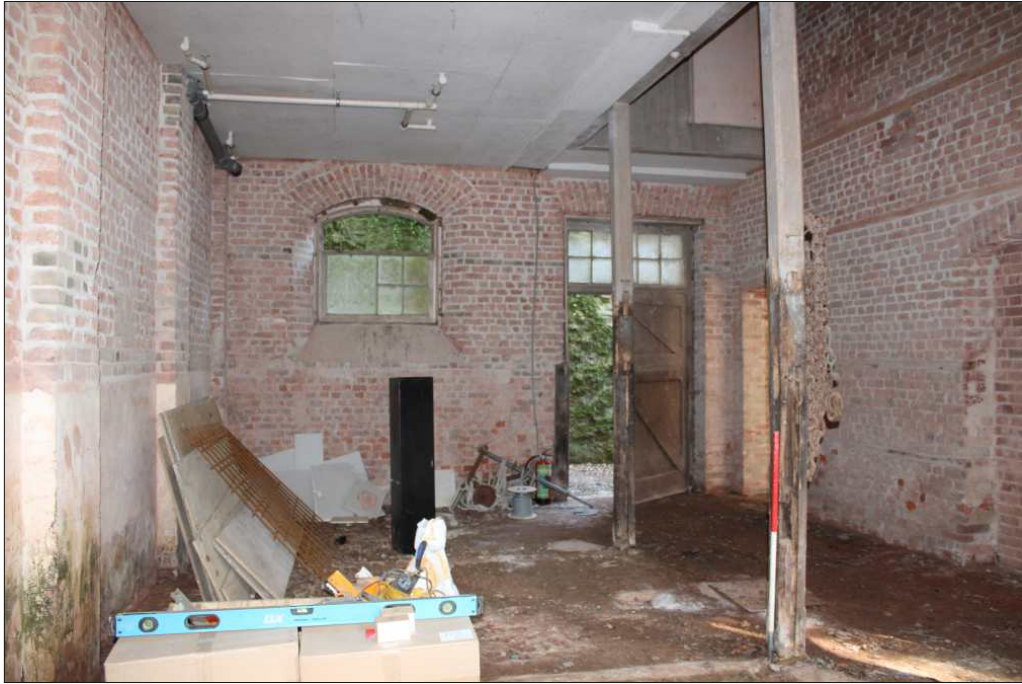
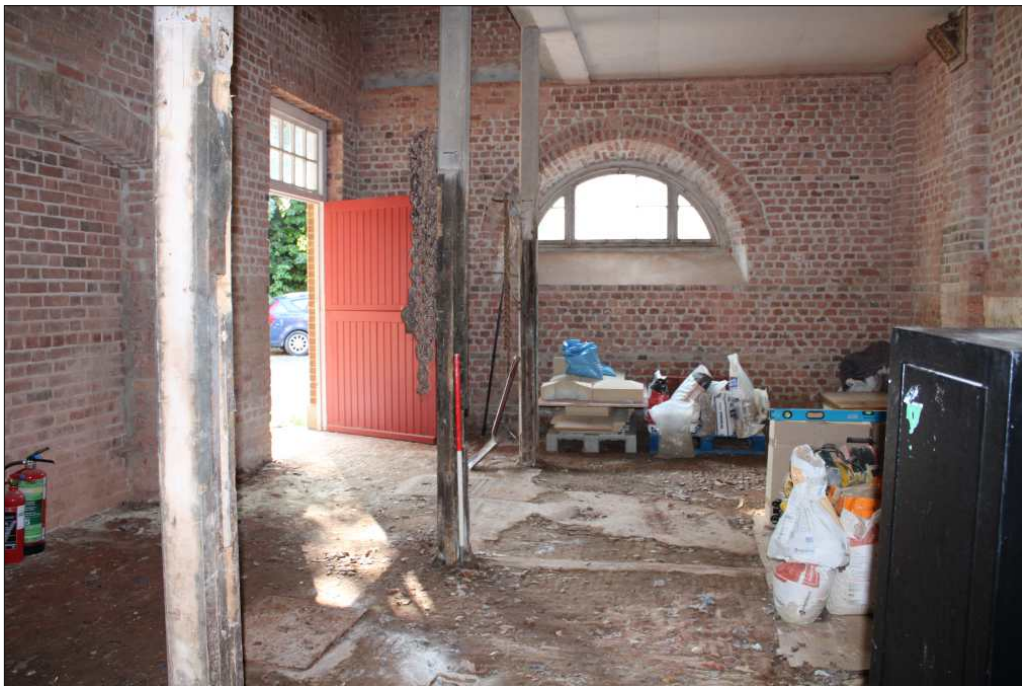
- 5.9 The floor, lightwell and ceiling are of the same form as the east stable described above (Plates 11-12), and there is also an iron fitting in one of the piers on the southwest wall. An area of cement patching on the floor is marked with the date '1951', but generally the original setts survive better than in the east stable, with good evidence for original and later drainage. The majority of the lower section of the southwest wall is rendered; no wooden panelling survives. No stable partitions remain, although sockets for rails supporting the panelling are visible on the vertical timber posts that hold up the ceiling.

Plate 11: West stable, looking northwest (1m scale)

Plate 12: West stable, looking southeast (1m scale)

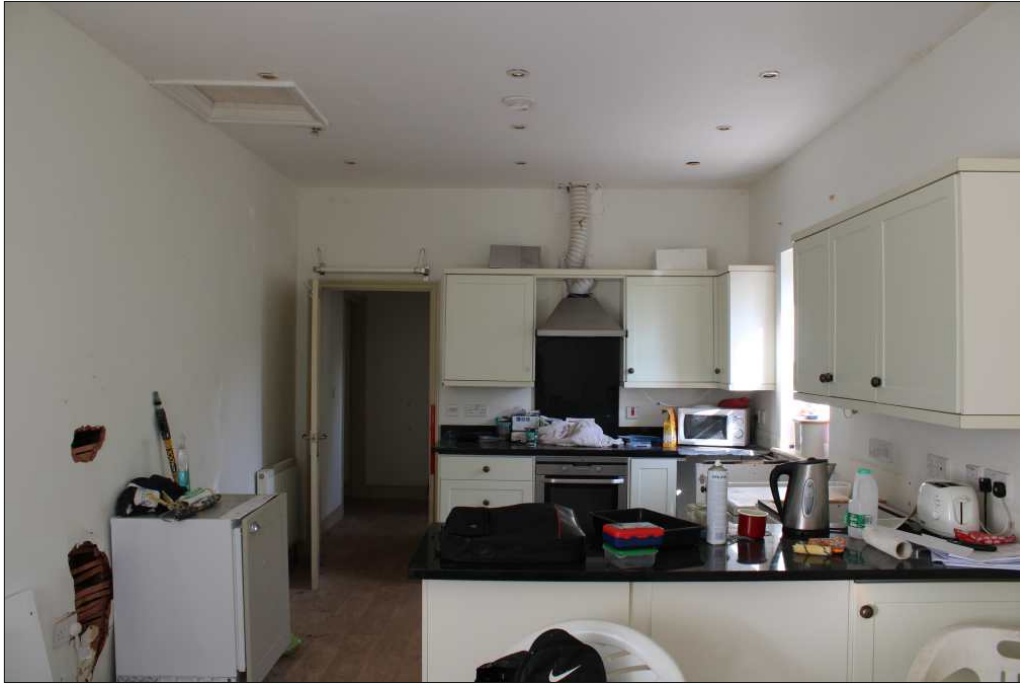
- 5.10 This has a modern finish throughout with modern flooring, plastered walls and ceilings. All the fittings are modern, including doors, their architraves, the bathroom and kitchen (Plate 13). The modern layout is set around the original lightwell, and incorporates the turn of the 20th century extension at the rear. The only early feature is an original wooden panelled door into the lightwell on its north side; this has an iron latch (Plate 14).

Plate 13: Kitchen on first floor, showing modern finishes and fittings, looking northwest (1m scale)

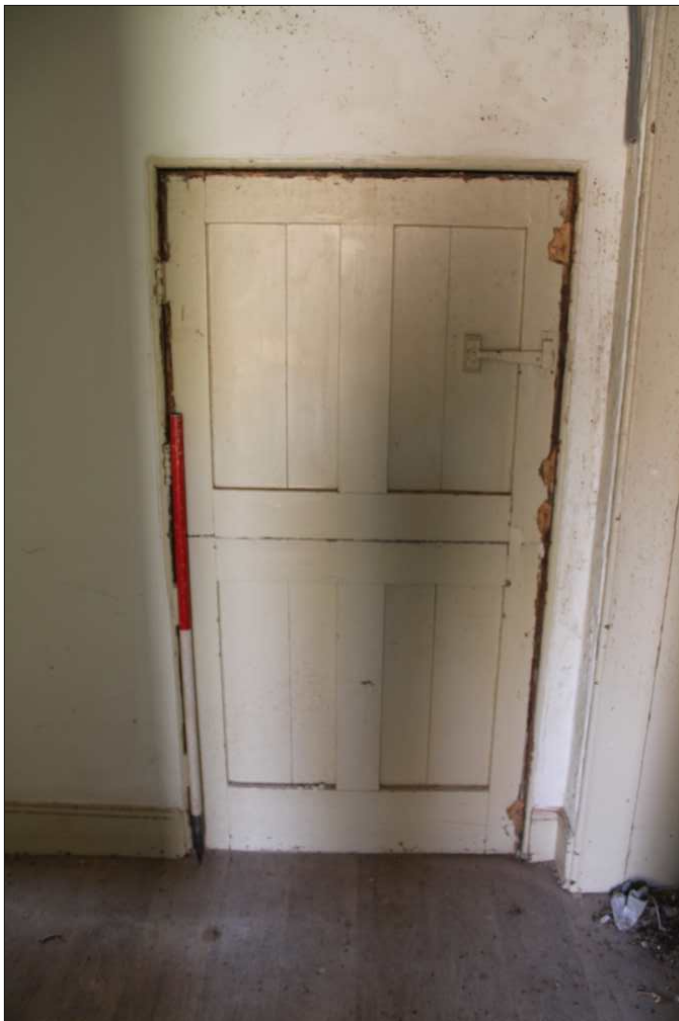
Plate 14: Original door into the lightwell on the first floor, looking southeast (1m scale)
