**Preliminary assessment of
industrial sites of
archaeological importance**

Preliminary assessment of industrial sites of archaeological importance in the Tamar Valley

December 1998

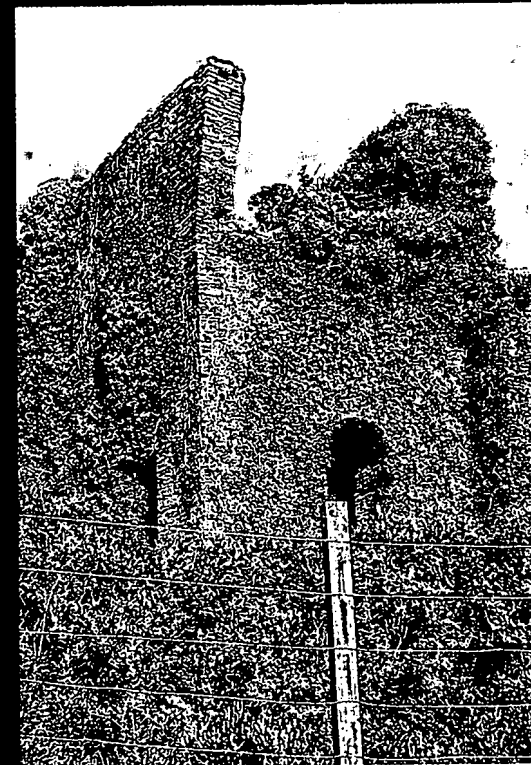
Deerpark Mine (Lucketts). Site No 15. Boiler house chimney stack.

Prince of Wales Mine (Harrowbarrow). Site No 30.

Spoil heap at Devon Great Consols.

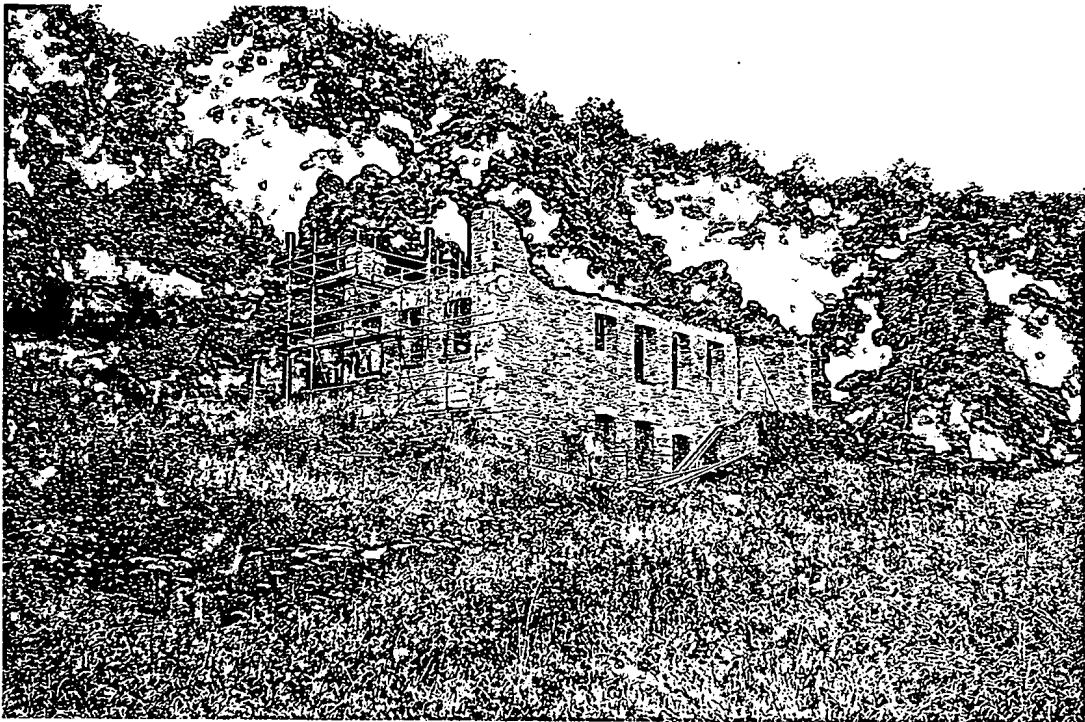
Consolidation works to Danescombe Valley paper mill (during a recent Land Reclamation Scheme jointly funded by the National Trust, Environmental Trust and English Partnerships). Site No 37.

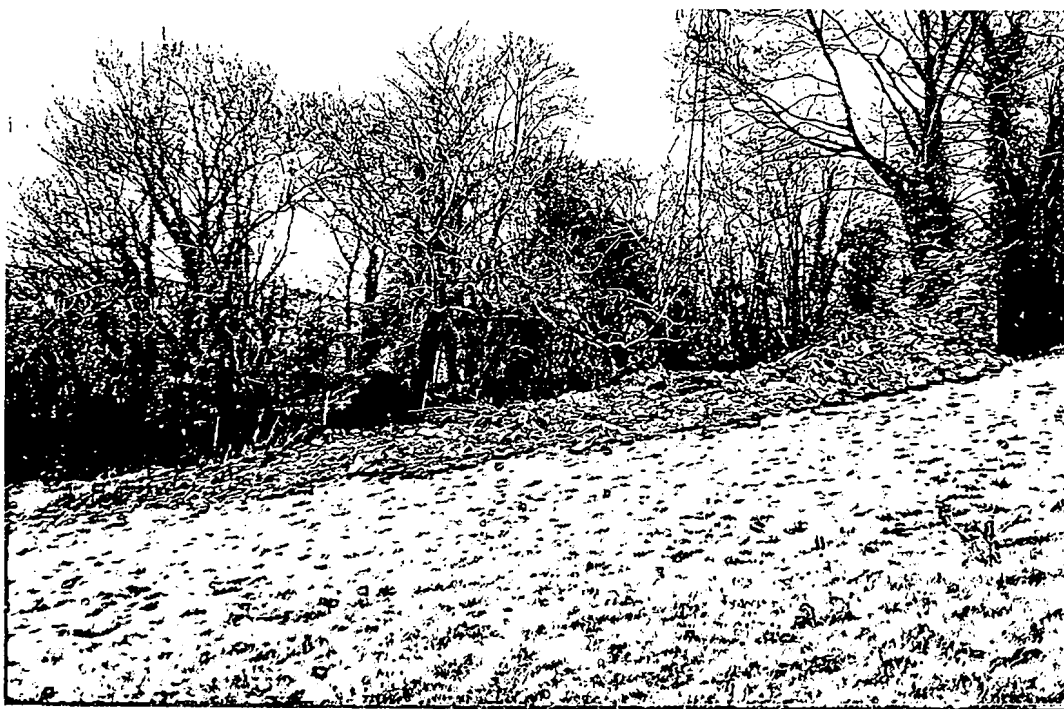
South Tamar Mine: the remnants of an engine house chimney, an exposed and weathered structure which has not been consolidated. Site No. 75

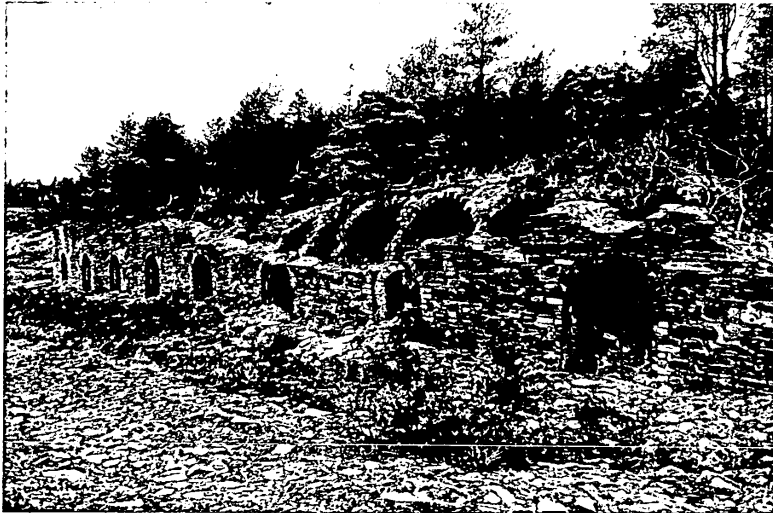
Devon Great Consols calciner labyrinths
