# ASHREIGNEY METHODIST CHAPEL

HISTORIC BUILDING RECORDING

SOUTH WEST ARCHAEOLOGY LTD. REPORT NO. 181102

Draft issued: 6<sup>th</sup> November 2018  
Finalised: 2018

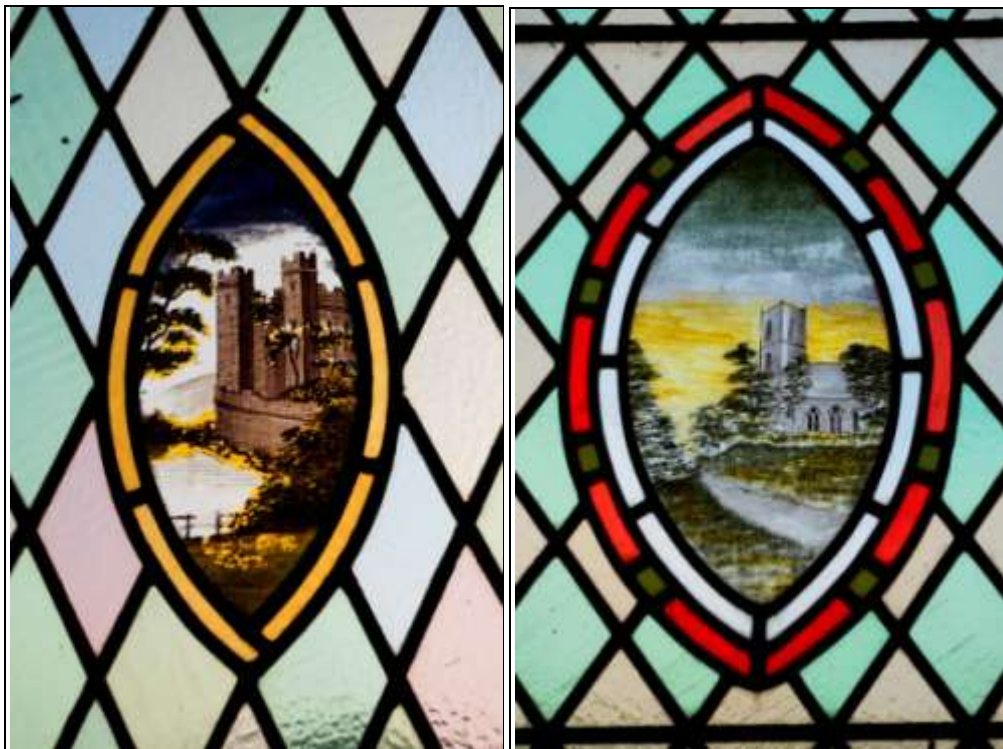
FIGURE 4: DETAILS OF TWO OF THE 'RURAL SCENES'; LEFT: INSET H - A CASTLE; RIGHT: INSET I - A CHURCH.

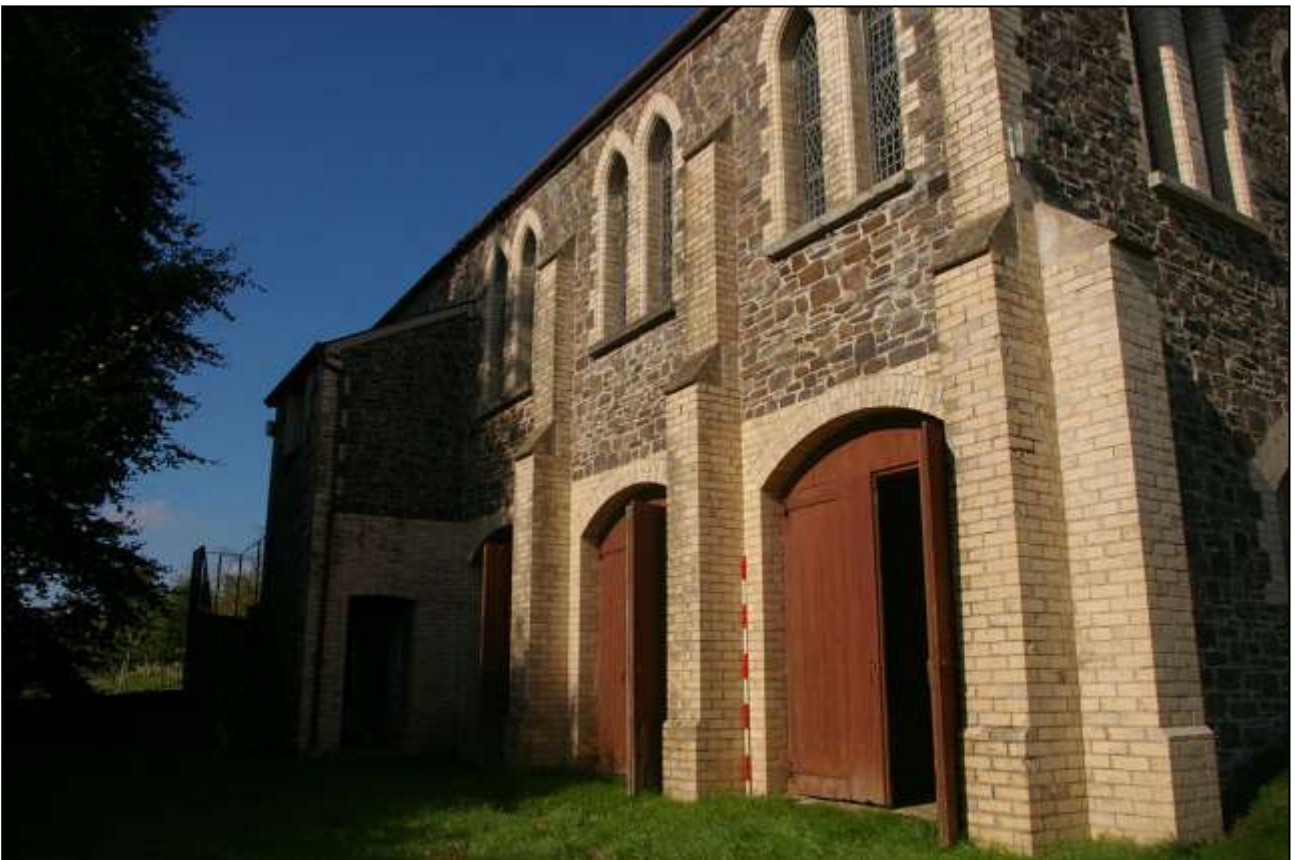
22. THE SOUTH ELEVATION OF THE CROSSWING, SHOWING SUBTLE DIFFERENCES IN BUILD, SUCH AS BRICK BUTTRESSES AND LOWER GROUND FLOOR; FROM THE SOUTH-EAST.

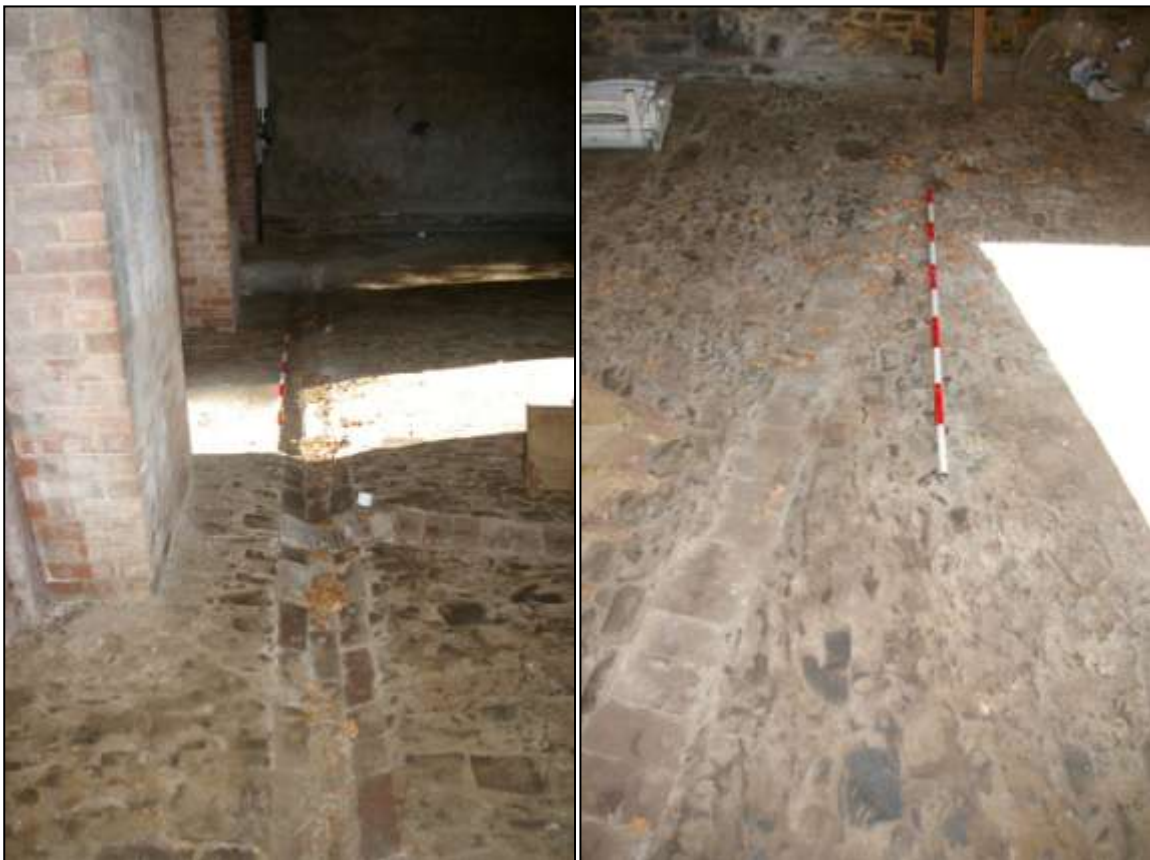
48. LEFT: THE BRICK DRAIN TO THE SOUTH SIDE OF THE COBBLED FLOOR IN THE CARRIAGE HOUSE, 2M SCALE; FROM THE EAST.

49. RIGHT: THE LATER CUT INTO THE FLOOR TO SERVE THE BOILER PIPES, 2M SCALE; FROM THE SOUTH.

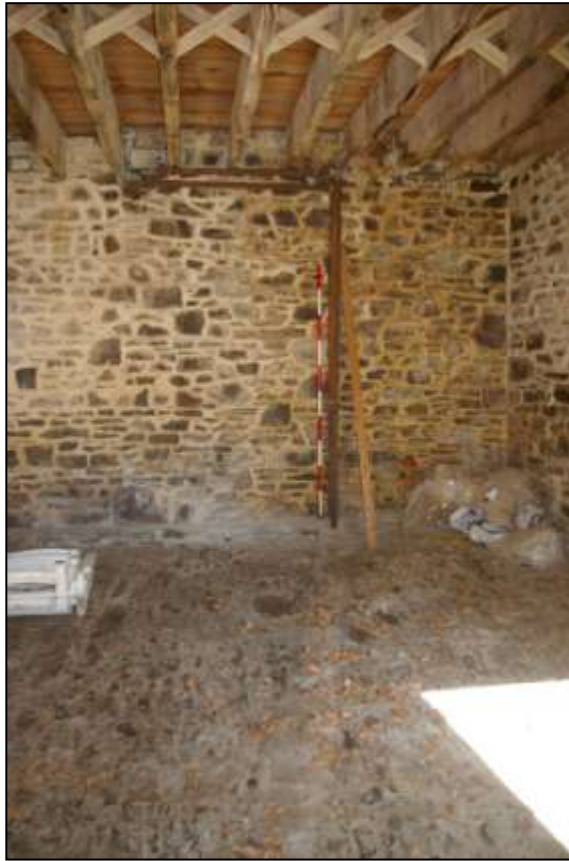
50. THE BOILER PIPES, WHERE THEY BREACH THE WALL OF THE CARRIAGE HOUSE, WITH 2M SCALE; FROM THE SOUTH.

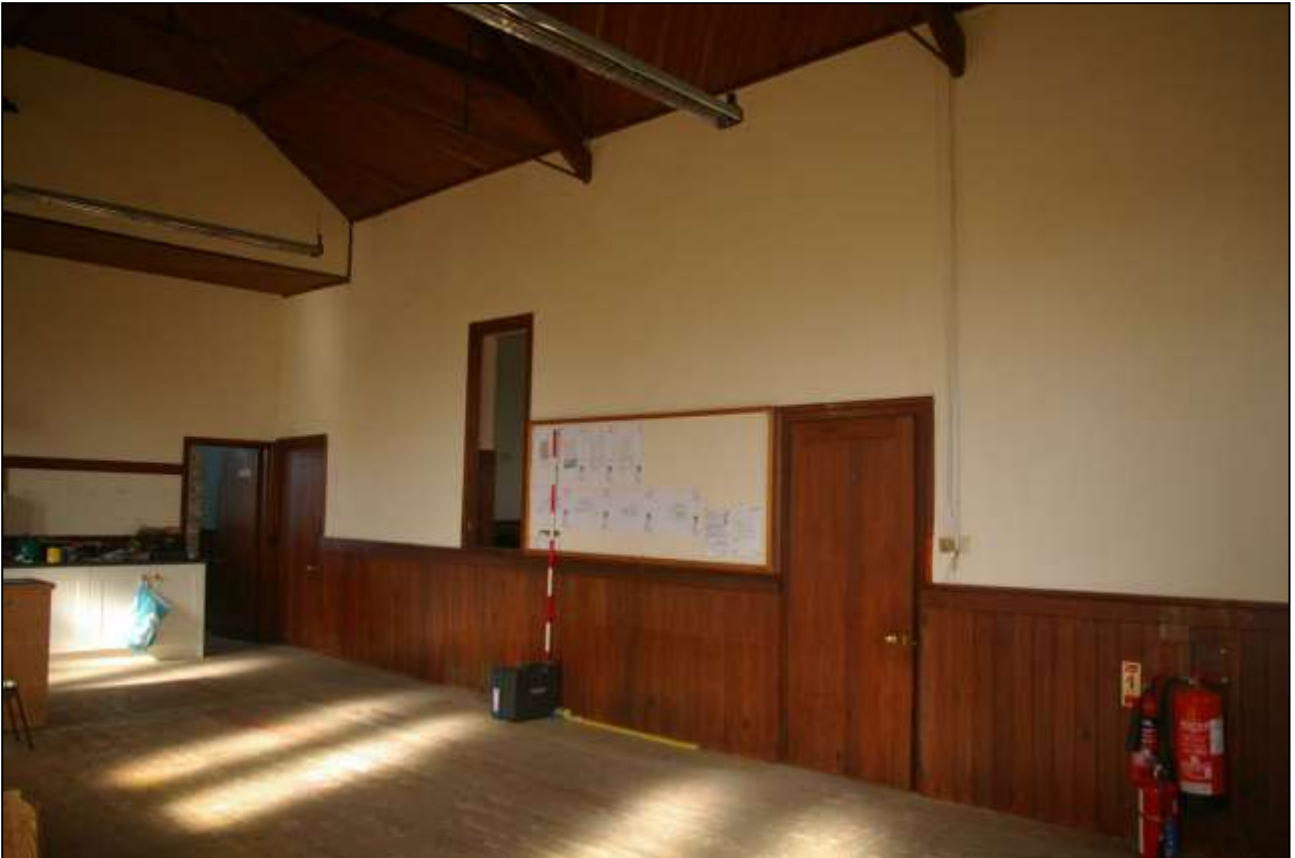
97. THE PARTY WALL BETWEEN COMMUNITY HALL AND CHAPEL, WITH 2M SCALE; FROM THE SOUTH-EAST.

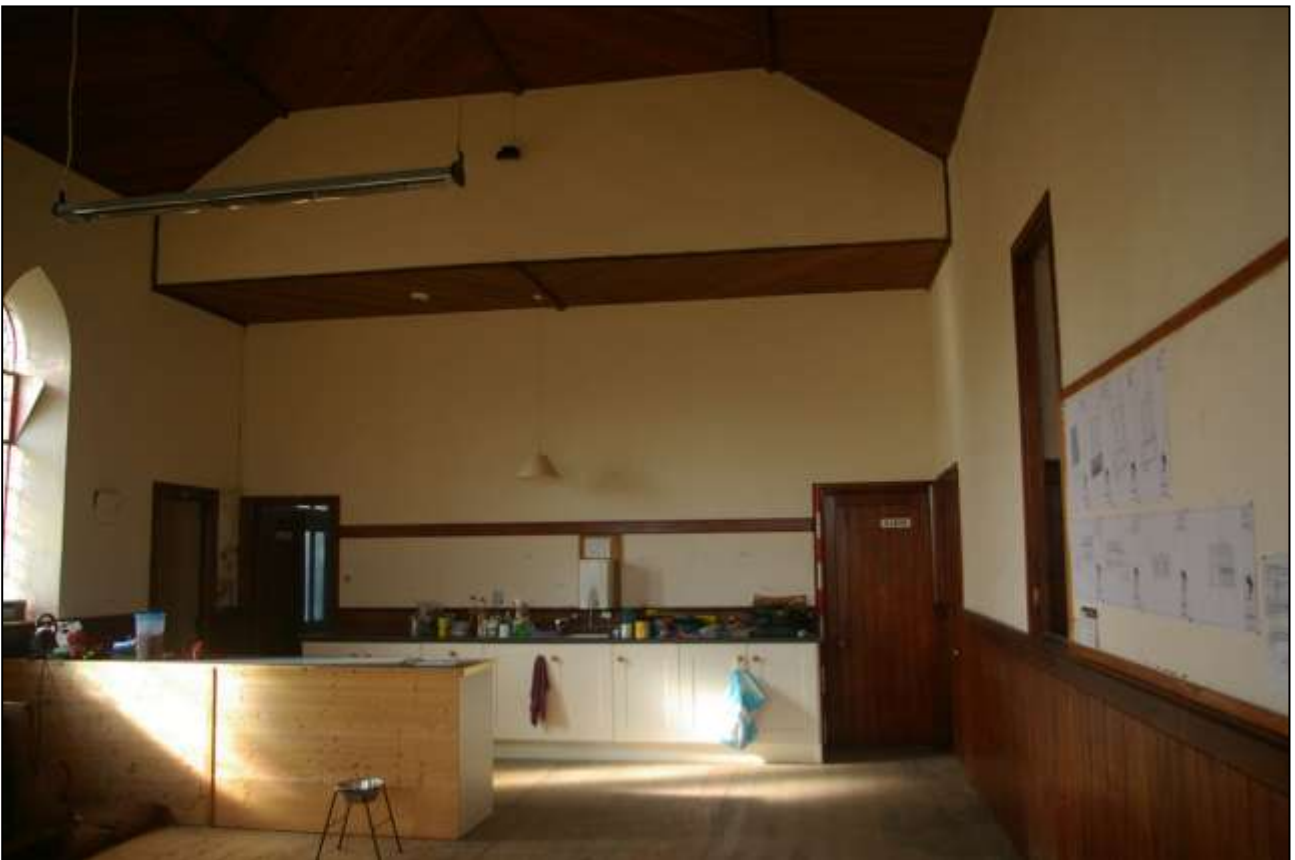
98. THE WEST WALL OF THE COMMUNITY HALL, WITH 2M SCALE; FROM THE EAST-NORTH-EAST.

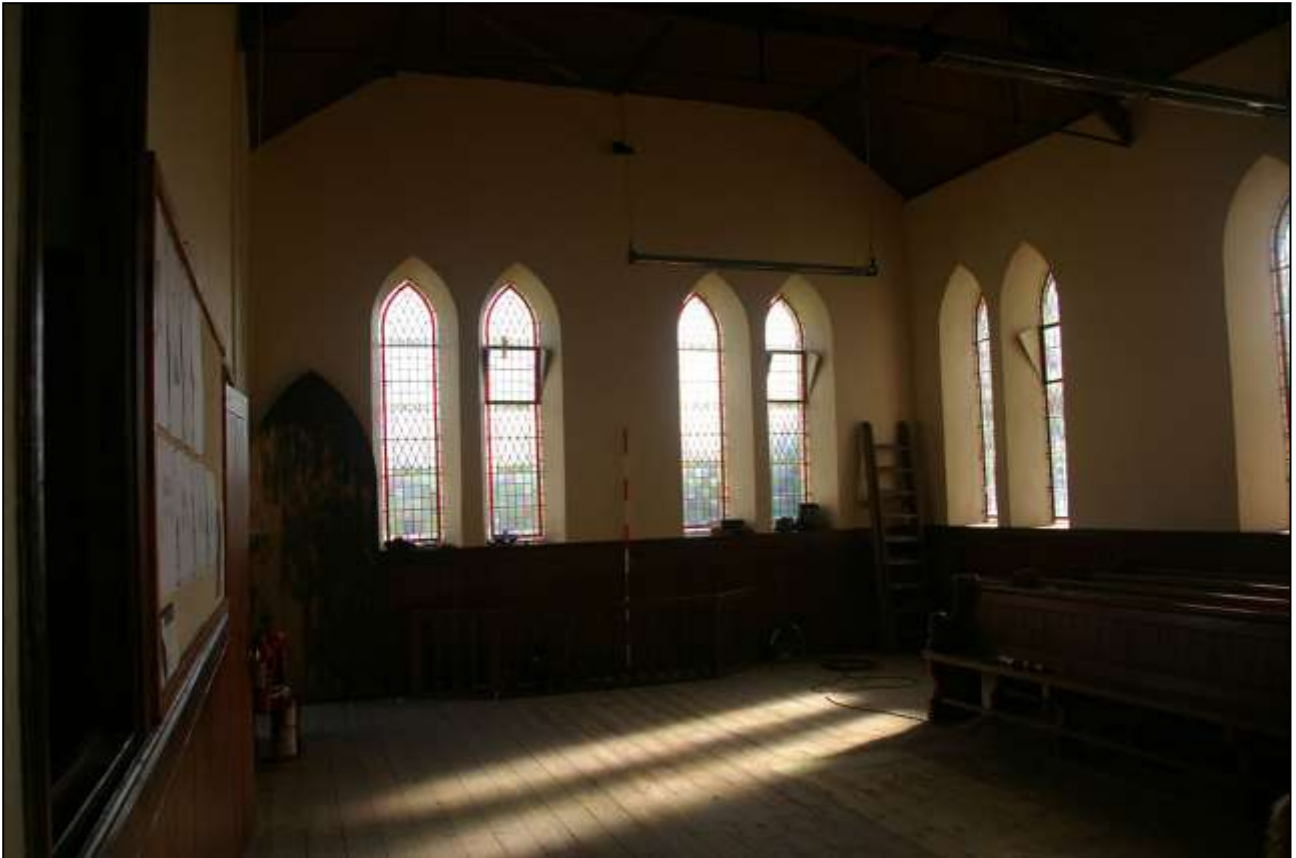
101. THE EAST WALL OF THE COMMUNITY HALL, WITH 2M SCALE; FROM THE WEST, NORTH-WEST.

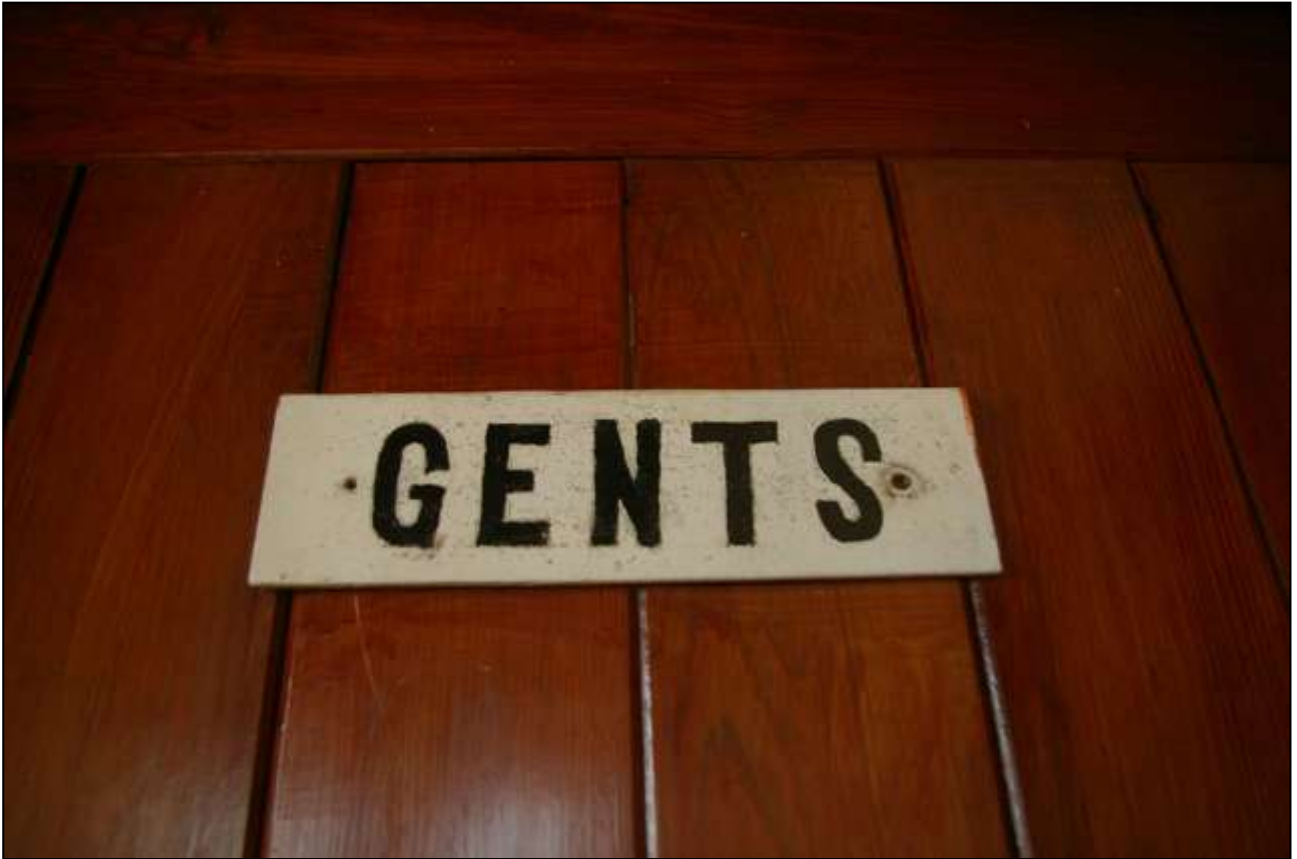
108. THE MID 20<sup>TH</sup> CENTURY HAND PAINTED TOILET SIGN; FROM THE EAST.

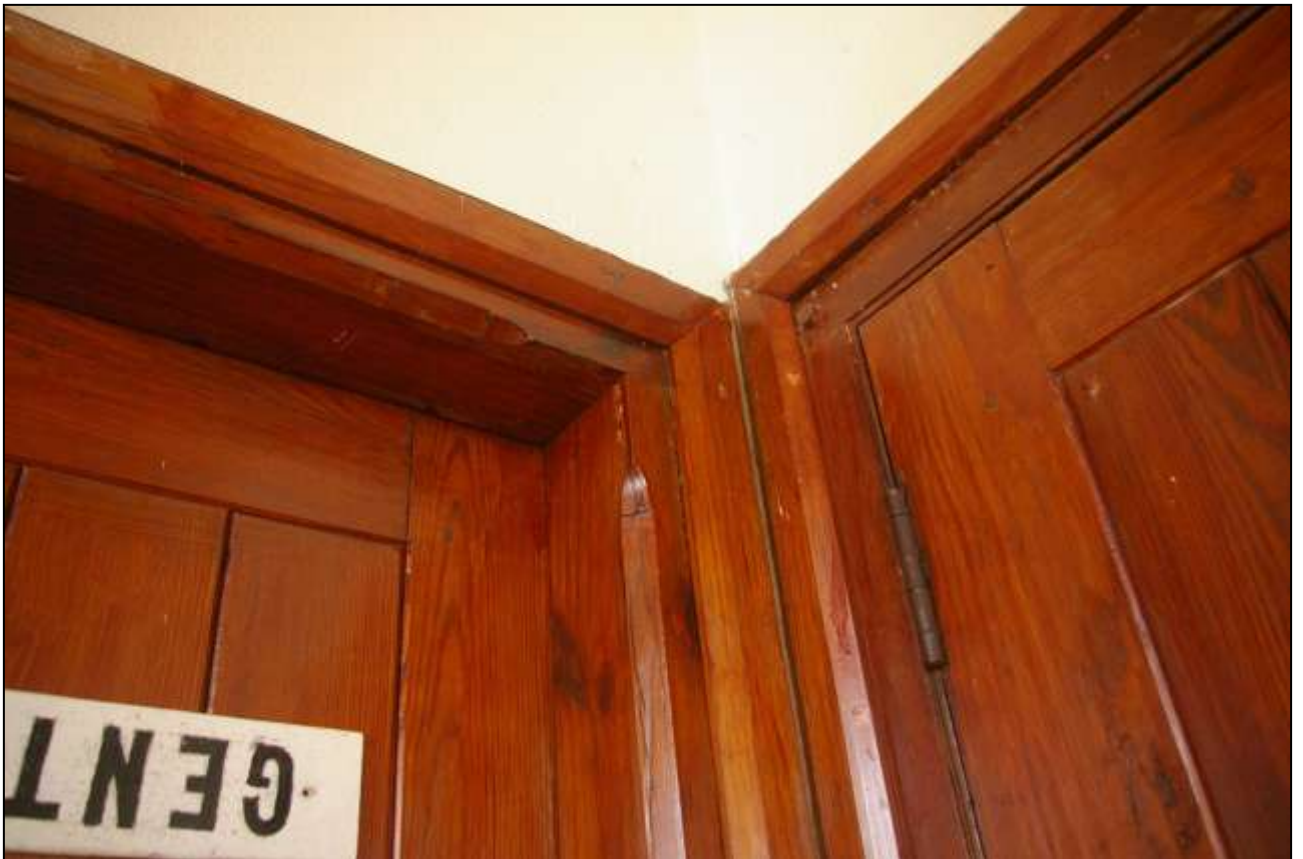
109. DETAILED VIEW OF THE DIFFERENT CHAMFERED OR BEADED DOORFRAMES IN THE BUILDING; FROM THE SOUTH-EAST.

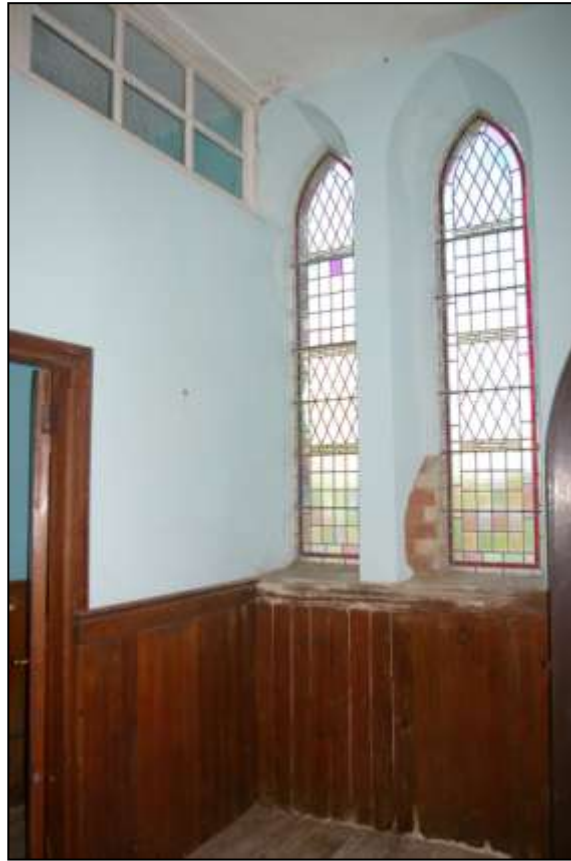
110. THE CURRENT WEST CLOAKROOM AND GENTS TOILETS, WITH INSERTED PARTITION; FROM THE EAST-NORTH-EAST.

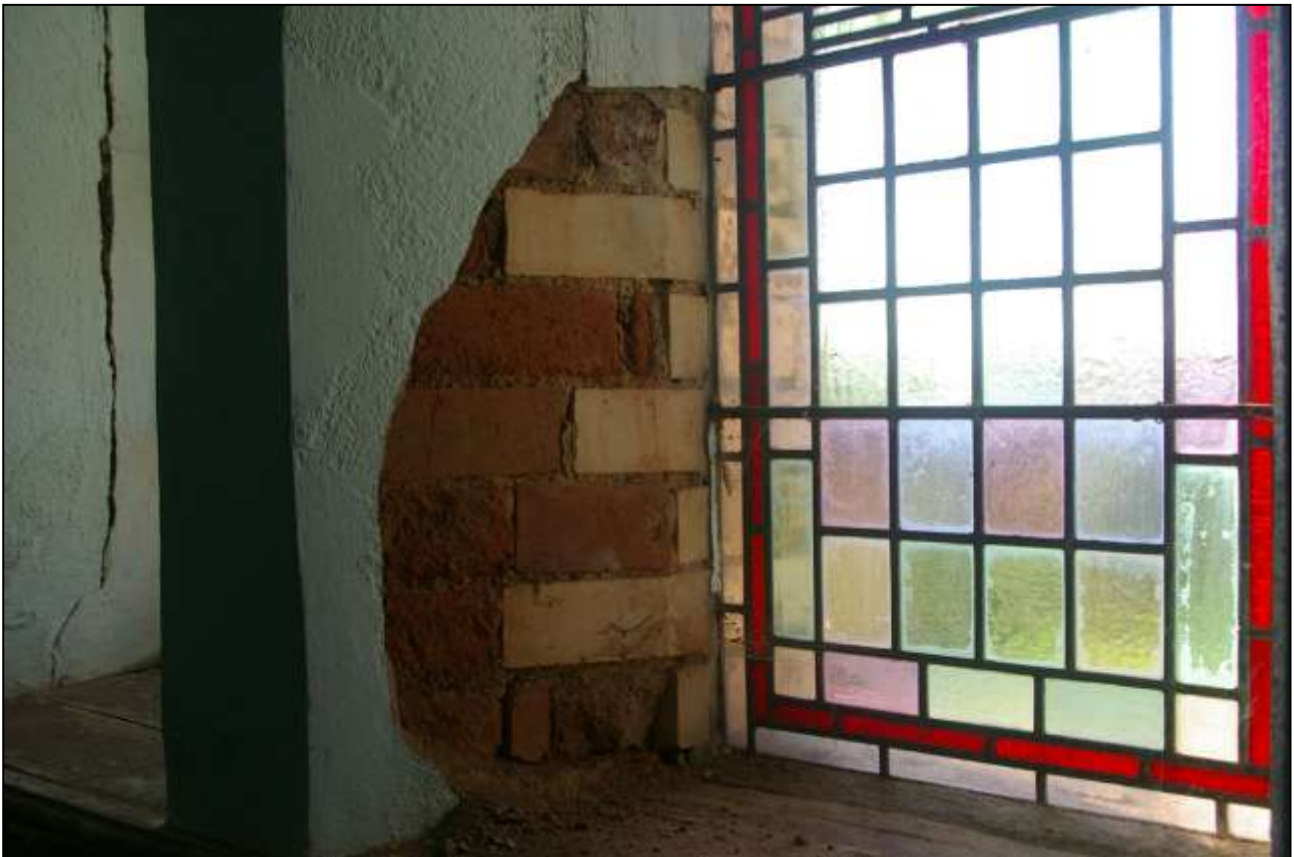
111. DETAIL OF REMOVED PLASTER AT WEST WINDOW, W18; SHOWING EXTERNAL CREAM CERAMIC BRICK, INTERNAL RED ENGINEERING BRICK; FROM THE EAST-NORTH-EAST.

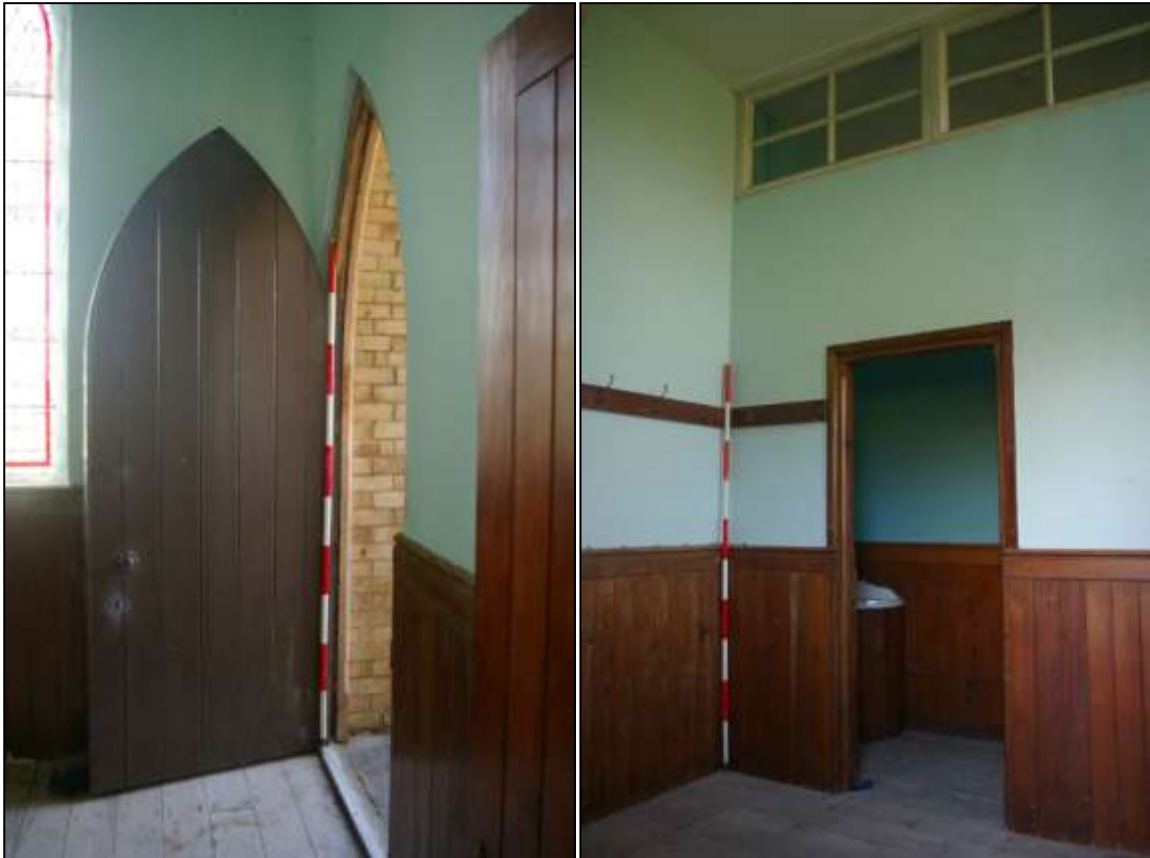
112. LEFT: D6, WITH 2M SCALE; FROM THE EAST.

113. RIGHT: THE INSERTED PARTITION, REUSING SOME RESET WINDOWS AND A DOOR, WITH 2M SCALE; FROM THE NORTH-WEST.
