**HIGHER PARK FARM**

**CREDITON**

DESK-BASED ASSESSMENT WITH HISTORIC BUILDING RECORDING

South West Archaeology Ltd. report no. 181115

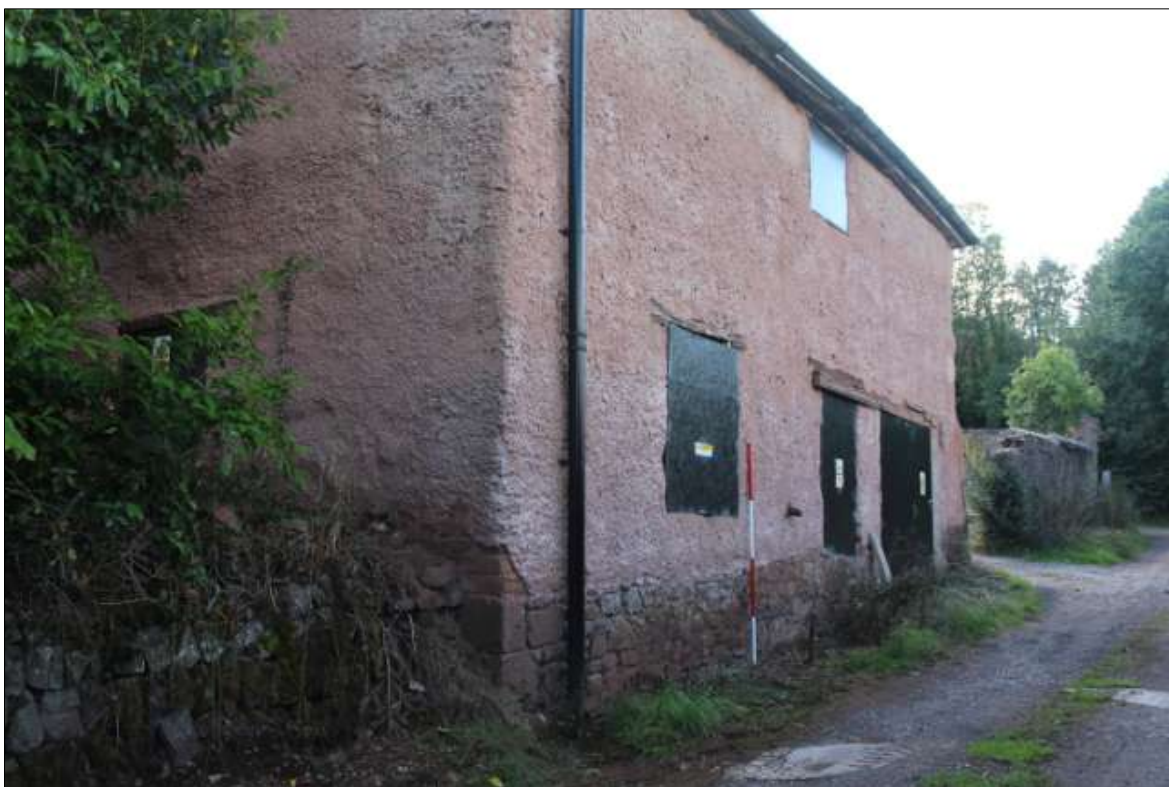
FIGURE 13: THE NORTH ELEVATION OF THE POUND HOUSE; VIEWED FROM THE NORTH-EAST (SCALE 2M).

The interior of the Pound House has been heavily altered, stripped of most historical features, and was full of clutter when inspected. The cob of the walls is visible, as are the various repairs. The wall separating the Pound House from the Shippon rises up into the roofspace and is of pale pinkish-red brick laid, for the most part, in a header bond. It is pierced by a single ground-floor doorway (D4) with timber lintel. The internal floor level appears to have been lowered and replaced with modern concrete, and steps up irregularly to the Shippon; however, the reveals to D2 respect this lower level so the height of the floor may be genuine, and the *yard* may have been raised. The western part is open to the roof, but there are sockets in the north and south walls for beams and/or joists. The eastern part has a first floor carried on two heavy, transverse beams with deep but narrow joists. The floor is of even-width floorboards. There is a hatch to the north-west side, and the remnants of other timber fittings that would once have belonged to a mechanism. To the front and enclosing the loft, facing onto the void, is a rail-and-plank boarded screen that is spiked to the beam below.

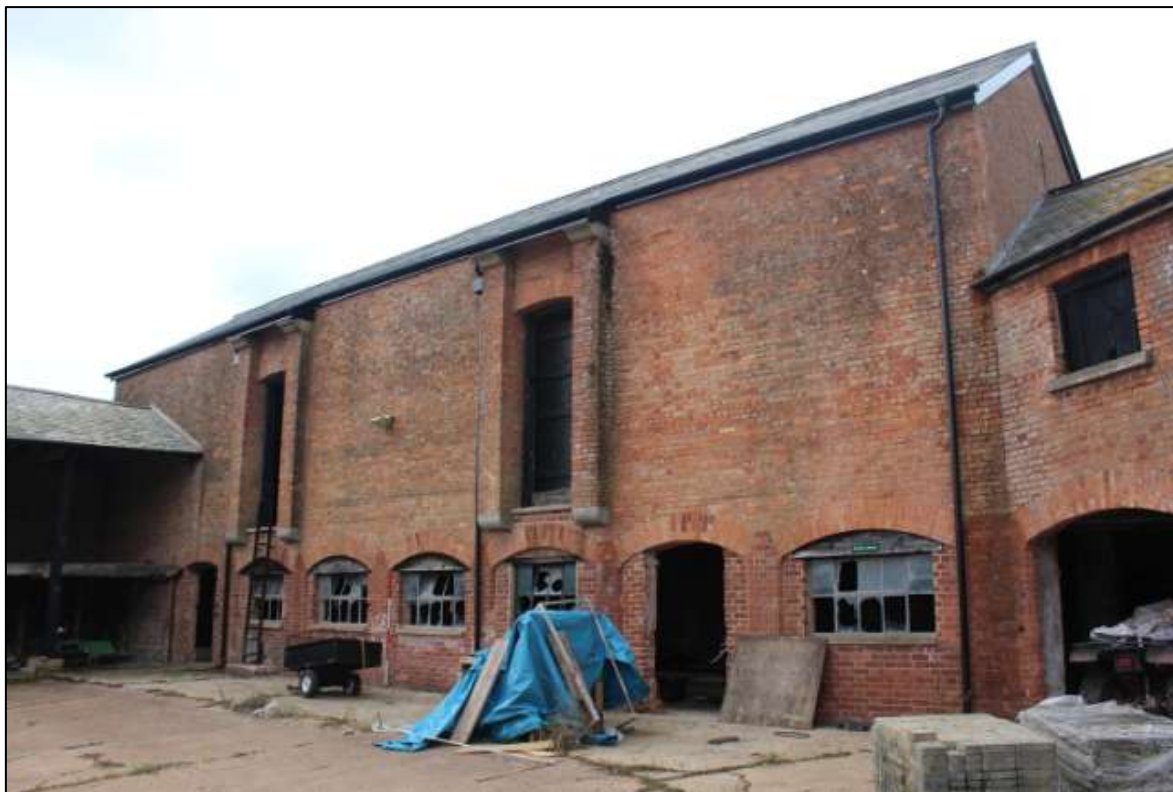
The east elevation faces onto the yard and is the most elaborate. As with B5, the bricks used at ground-floor level differ from those above: red brick below, pale orange above. At ground-floor level there are eight wide openings separated by narrow brick piers with chamfered corners. At the southern end of the elevation there is a regular door opening. The piers and springers are of red brick but the wide segmental arches above the openings are of pale orange brick, identical to that of the wall above. The southernmost openings (abutting B7) are blocked in concrete block. Two of the other openings are narrowed in brick to form doorways; wooden frames survive in

these openings. The other five openings have been part-blocked in brick and crittal-style windows installed. Three of these windows are of ten panes with three-pane hopper casements, one is of eight panes with a four-pane hopper casement, and one is of eight panes with a four-pane, central, horizontally-pivoted casement. The northernmost window has an ALFA LAVAL sign fixed to the lintel.

FIGURE 21: THE EAST ELEVATION OF THE B6 THE THRESHING BARN; VIEWED FROM THE NORTH-EAST (SCALE 2M).

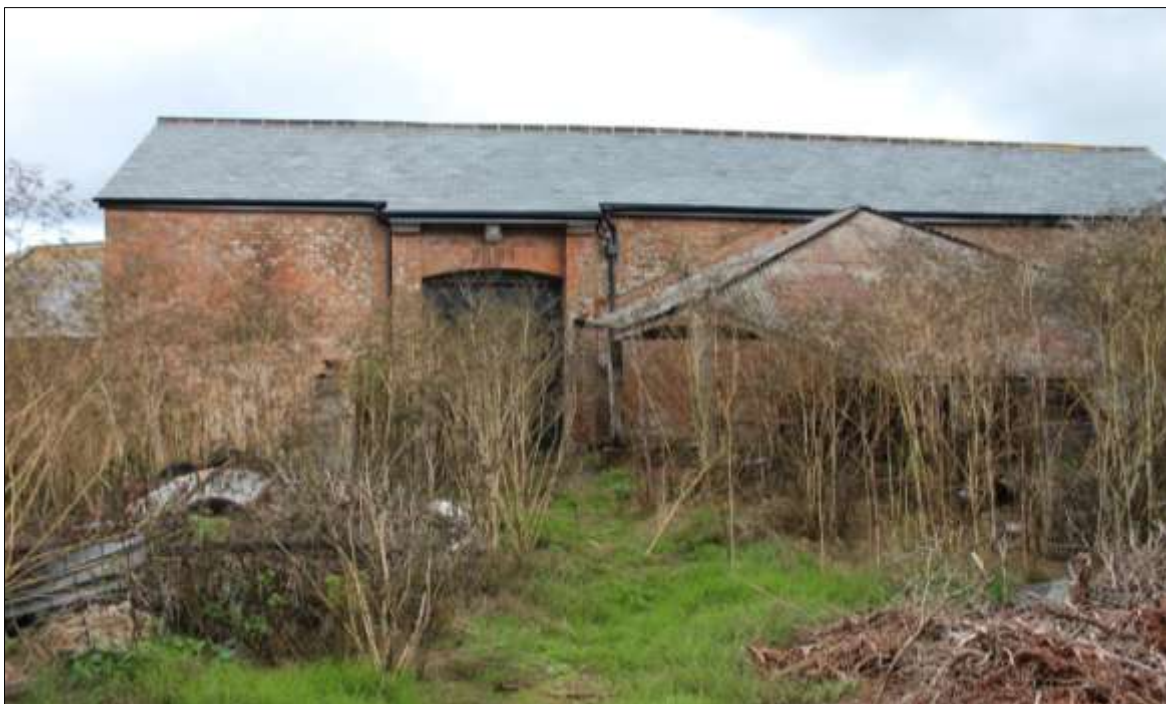
The west elevation is contiguous with B5, and is abutted by B8 and the surviving wall of B9. The main features are two, double-width, symmetrical doorways with porches and pentice roofs with granite corbels, as per the east elevation. These doorways feature segmental brick arches, with timber lintels to the interior. Both doorways retain their frames but are currently boarded to the exterior; on the interior, framed, braced and ledged doors survive to the south doorway. The cheeks of the south porch have been truncated by the roof of B8 and the pentice has been removed. The upper part of the south doorway has been blocked in brick, with an iron railway rail used as a lintel. Positioned centrally, between the two doorways, is a small blocked opening with a brick segmental arch at ground level; this was the original opening for a horse engine shaft. Just to the south is a small ragged forced opening for a horse engine shaft that corresponds with B8. Vents have been forced into this elevation.

FIGURE 22: THE WEST ELEVATION OF B6 THE THRESHING BARN; VIEWED FROM THE WEST.

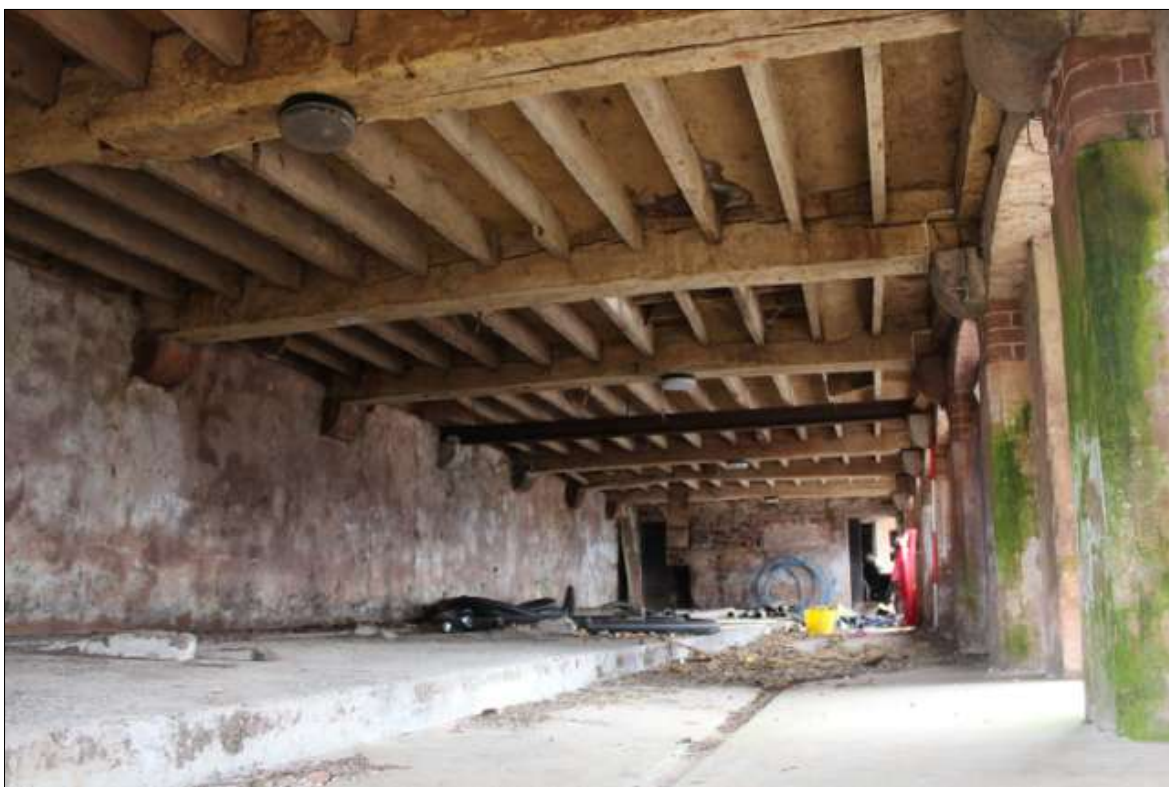
The interior comprises a single large room on each level. On the ground floor, the floors are concrete and the wall rendered up to c.1.5m above internal floor level. The interior is lit by the crittal-style windows in the blocked openings in the east elevation, and there are doors in the south, east and north walls. The concrete floor indicates the interior was used as a milking parlour, with a feed passage along the west wall, a drain along the east wall, with room for eight stalls for 16 cows. The walls of the stalls, feed troughs and passage wall have been removed. The floor above is carried on eight, heavy transverse beams, one replaced with an RSJ, sat on corbels that project from the east and west walls. The joists are deep but narrow, and beneath the opposing doors, at first-floor level, those joists support a second set of smaller joists. The floorboards are not visible from beneath, as chipboard has been affixed to the underside. The only other feature of note here was an *ex situ*, early 19<sup>th</sup> century, domestic, six-panel door from the Farmhouse. At first-floor level, the interior has lost all historic detail, save for the surviving doors and the roof structure, noted above. The floorboards were concealed beneath a layer of detritus, but had failed to the inside of the south doorway on the west side. The only other feature of note is the salt-glazed ceramic pipes that line the west wall, linking the ground-floor room to the forced vents in that wall.

FIGURE 23: THE INTERNAL GROUND-FLOOR OF B6 SHOWING THE HEAVY ROOF STRUCTURE; VIEWED FROM THE SOUTH (SCALE 2M).

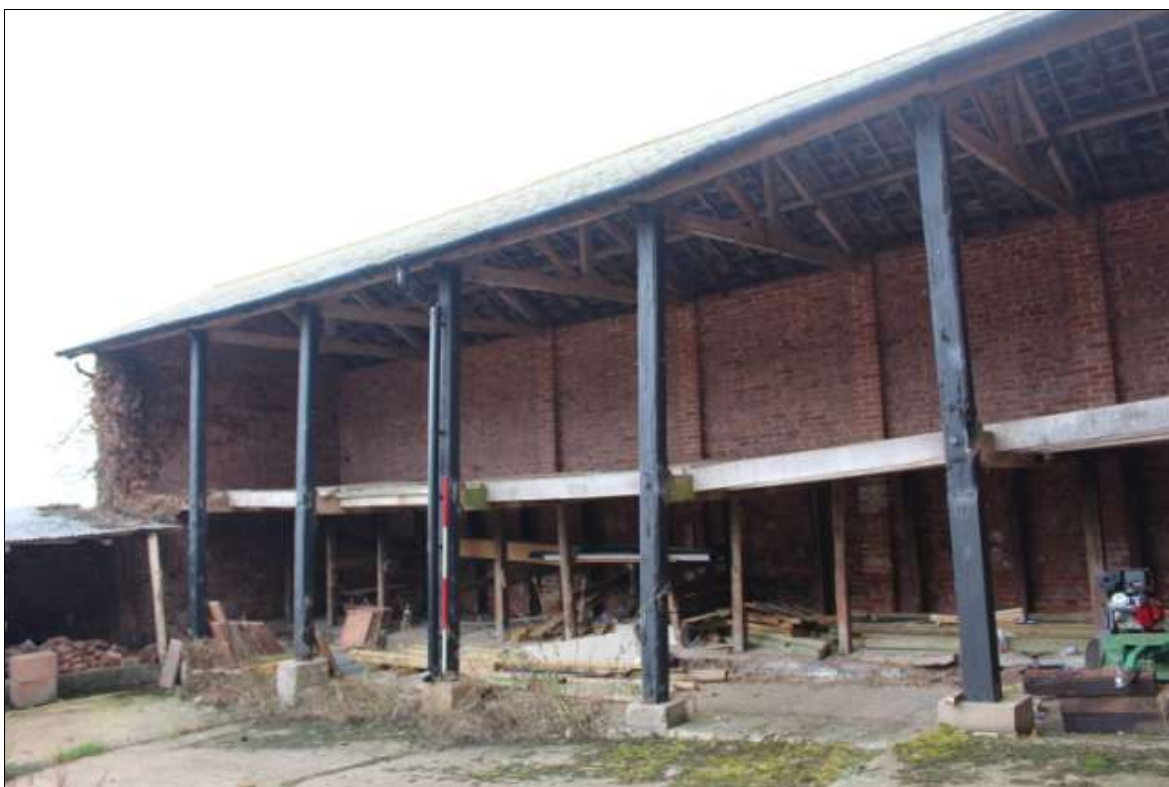
The Linhay is a six-bay, open-fronted, rectangular building of red brick on a plinth of blocky stone. The pitched roof of slate, recently renewed to the north pitch, is carried on five later 19<sup>th</sup> century bolted kingpost trusses. The brickwork is laid in a Flemish bond, and the south wall has integral brick piers to carry the trusses. The east and south walls are blank, and B7 abuts B6 to the west. The whole of the north elevation is open to the yard, with five tall oak posts carrying the first floor and the trusses. These posts are weathered, and the bases have failed; the roofline has dropped as a result. The base of the posts have been repaired/encased in concrete to stabilise this. There are sockets in the sides of the posts at first-floor height, which might indicate the front was originally partly closed in.

FIGURE 24: THE NORTH ELEVATION OF THE LINHAY; VIEWED FROM THE NORTH-WEST (SCALE 2M).

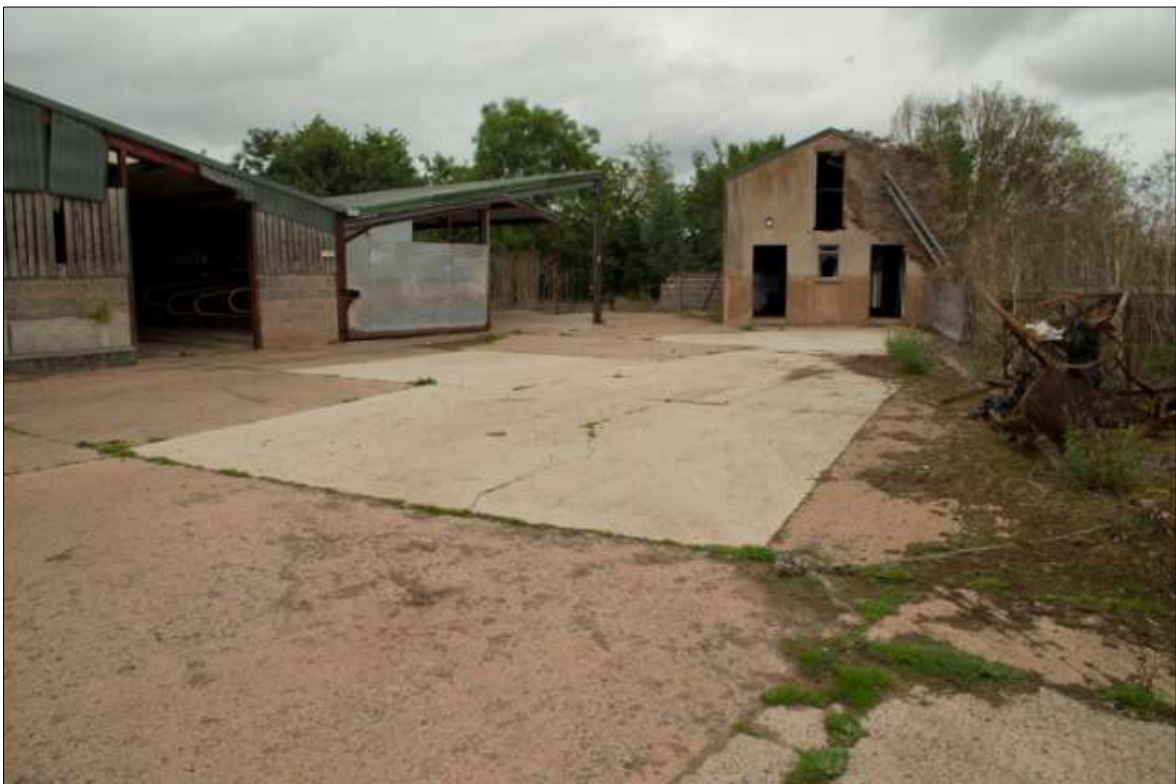
A large, late 20<sup>th</sup> century steel portal-framed shed, with concrete floors, concrete block walls with Yorkshire boarding above, with a roof of box-section, plastic-coated steel sheets. It contains two double-rows of cow cubicles with an area of loose housing beyond.

FIGURE 27: B11 THE MODERN COW CUBICLES (LEFT) AND B12 MILKING PARLOUR (RIGHT); VIEWED FROM THE SOUTH-WEST.

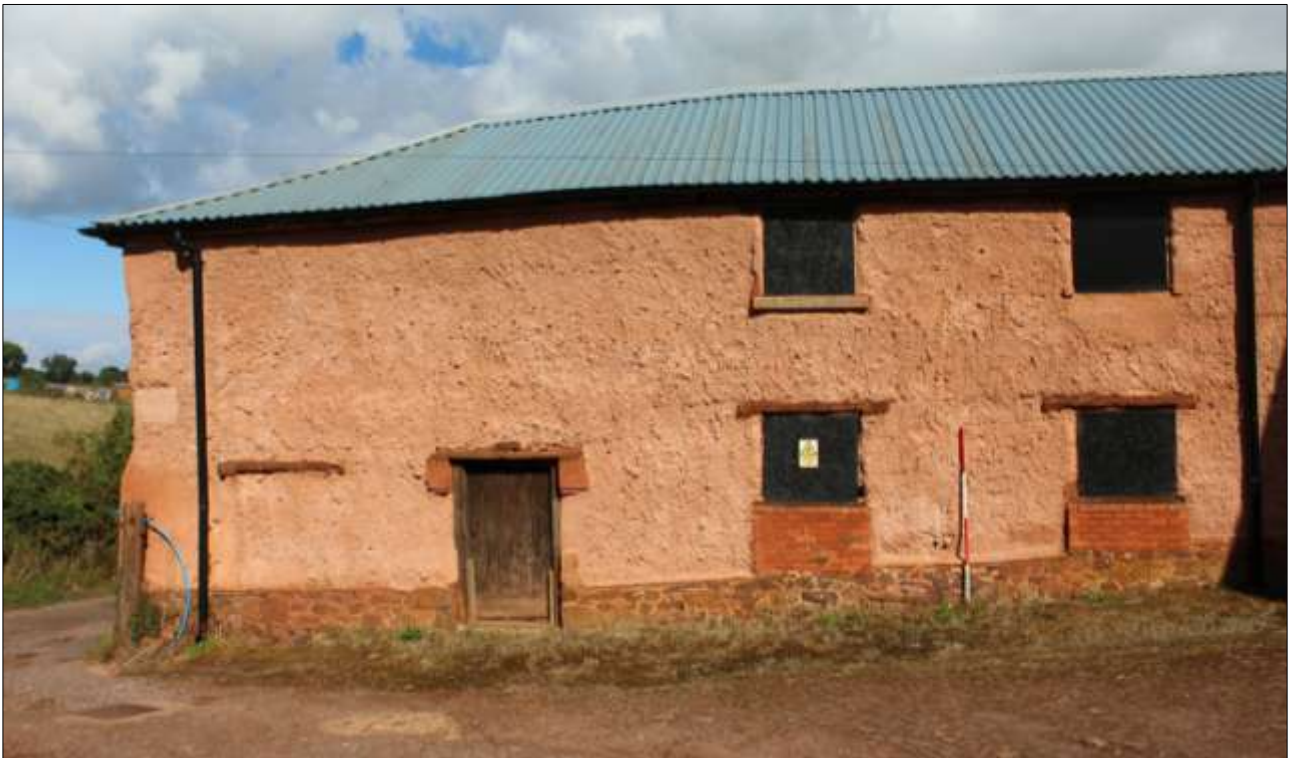
B1 EXTERIOR, THE WEST ELEVATION; VIEWED FROM THE WEST (SCALE 2M).

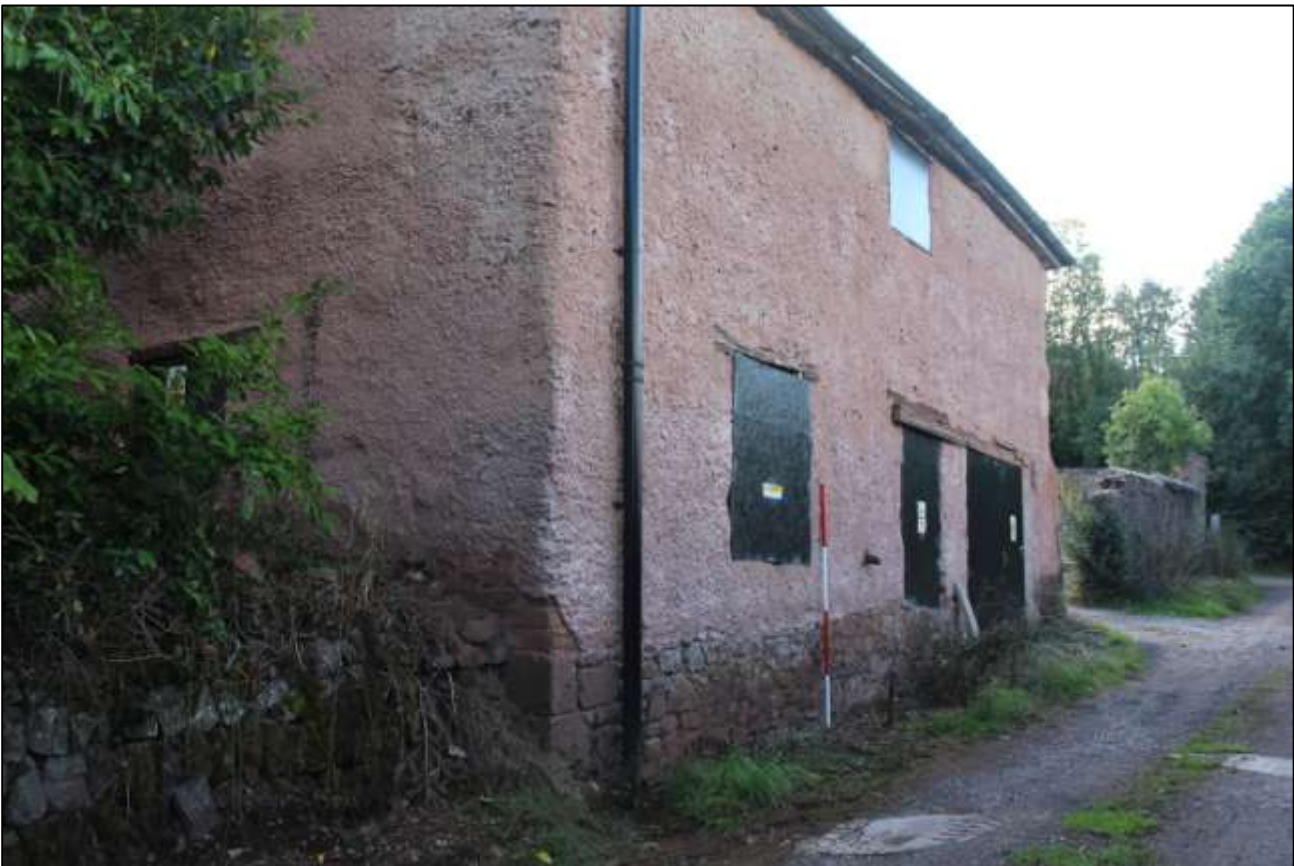
The two cob structures survive in reasonable condition. The roofs are reasonably sound and the walls in good order. The north-west corner and east gable wall of the Pound House have been repaired with varying degrees of sympathy and appear stable.

B1 EXTERIOR, THE NORTH AND EAST ELEVATIONS; VIEWED FROM THE NORTH-EAST (SCALE 2M).

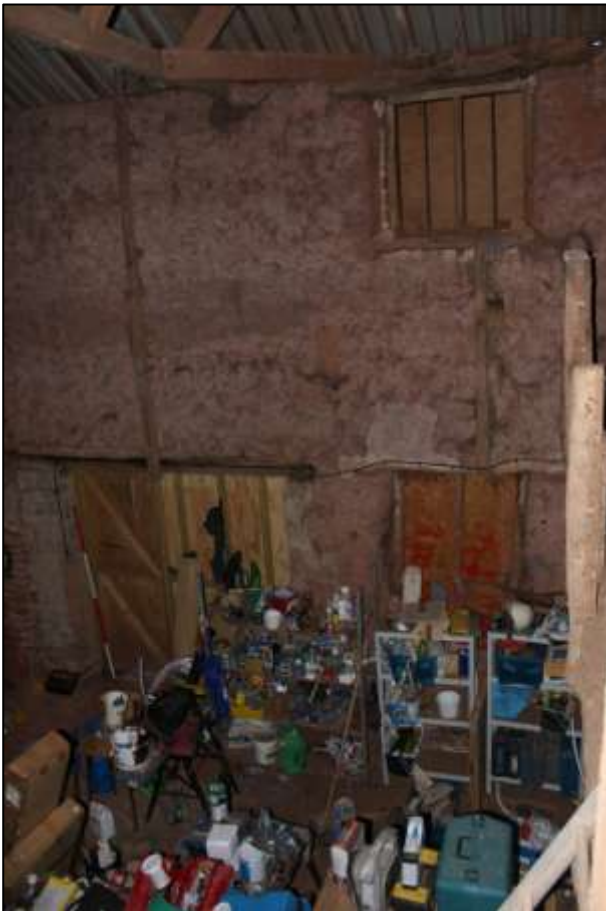
LEFT: B1 INTERIOR, NORTH WALL; VIEWED FROM THE SSE.

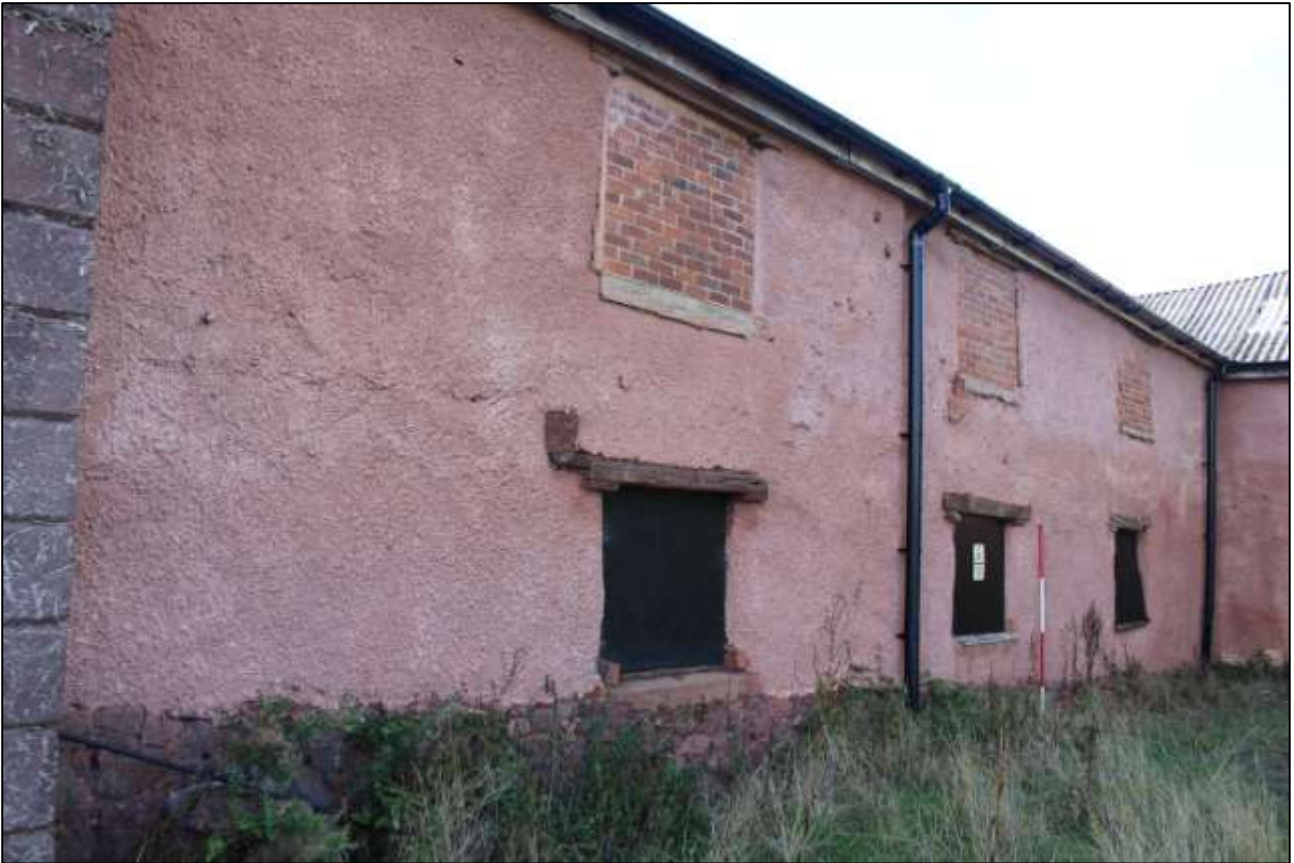
W3	GF window. Square window opening, boarded externally. Reused timber lintel on timber pads, timber sill. The wall below the sill has failed and been rebuilt in red brick. Surviving timber two-light frame, central mullion lost, sockets in the frame for iron bars. Two shutters on iron pintles and strap hinges with spearhead terminals, plain thin planks and ledging bars. One shutter is hung, the other is on the floor adjacent.
	W11	FF window. Square window opening, boarded externally. Timber lintel on timber pads. Slate sill. Surviving timber two-light frame, one iron bar to each light. Internal plank sill. Two shutters on iron pintles and strap hinges with spearhead terminals, a mix of plain thin planks and ledging bars, cobbled together.
	W12	FF window. Square window opening, boarded externally. Timber lintel on timber pads. Wall below the sill rebuilt in cob; projecting bricks to either side of opening. Crude modern frame of tanalised timber, sill rebuilt in cob block.

B2 EXTERIOR, WEST ELEVATION, SHOWING W2, W3, W12 AND W13; VIEWED FROM THE WEST (SCALE 2M).

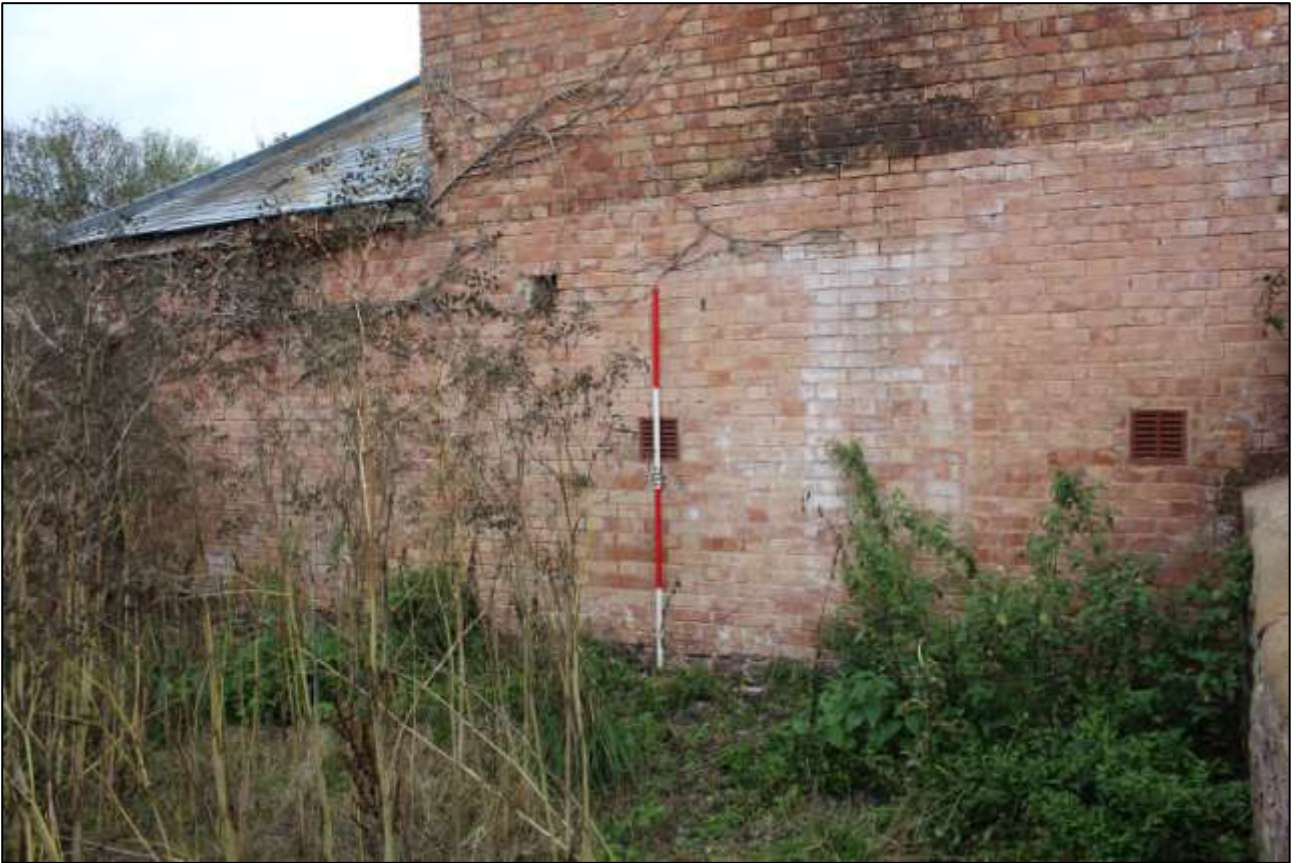
B9 'INTERIOR', THE WEST WALL OF B5 AND B6; VIEWED FROM THE WEST (SCALE 2M).

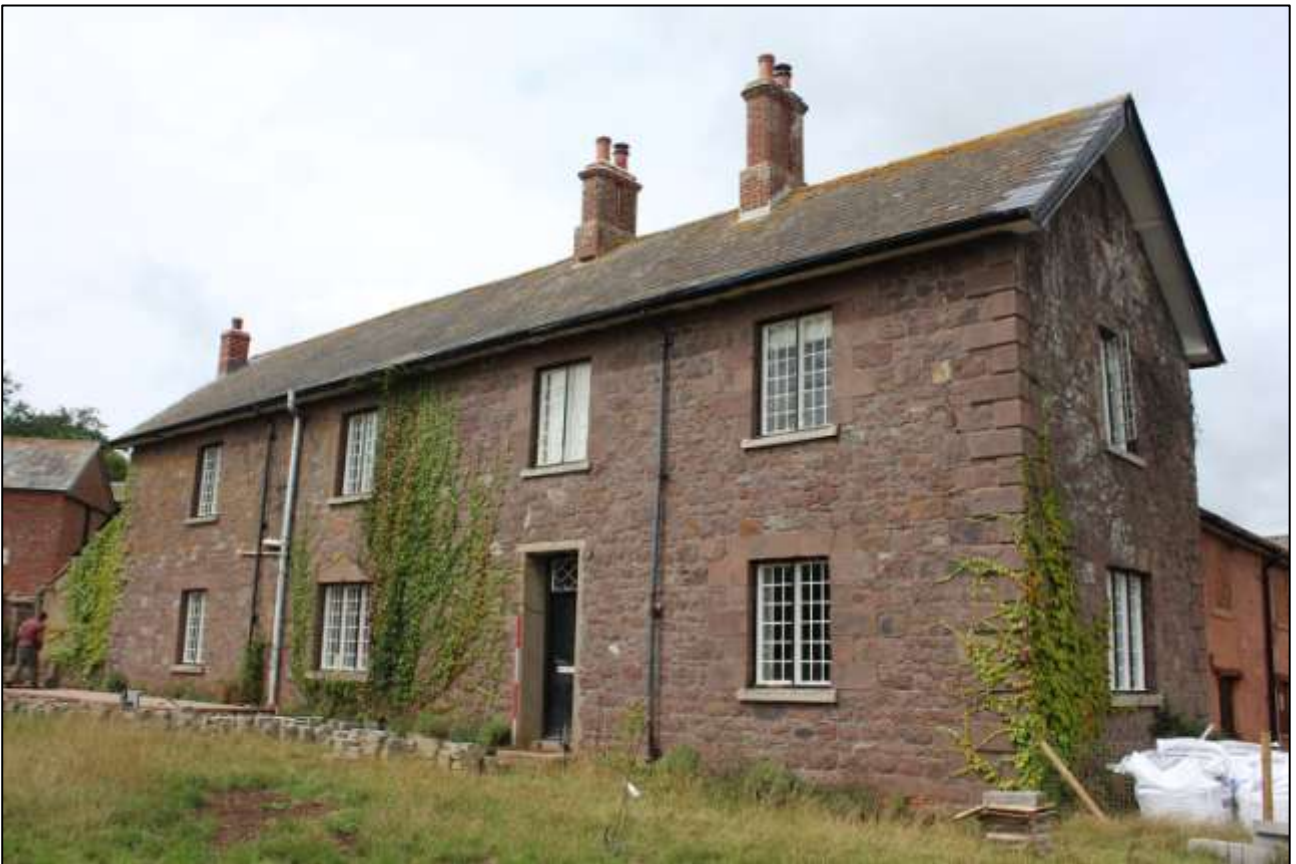
THE SOUTH ELEVATION OF THE FARMHOUSE; VIEWED FROM THE SOUTH-EAST (SCALE 2M).

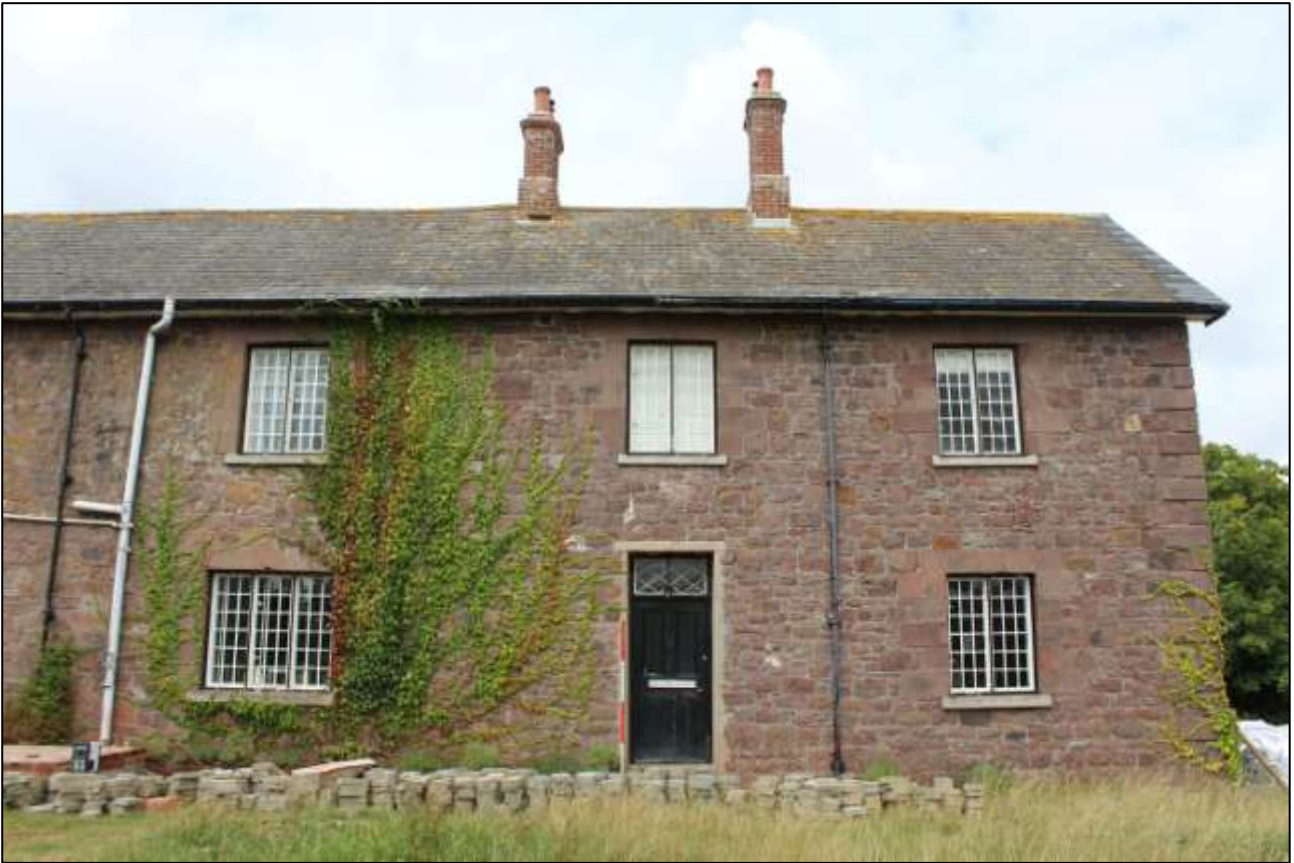
AS ABOVE, THE EASTERN (MORE RECENT) END OF THE FARMHOUSE; VIEWED FROM THE SOUTH (SCALE 2M).

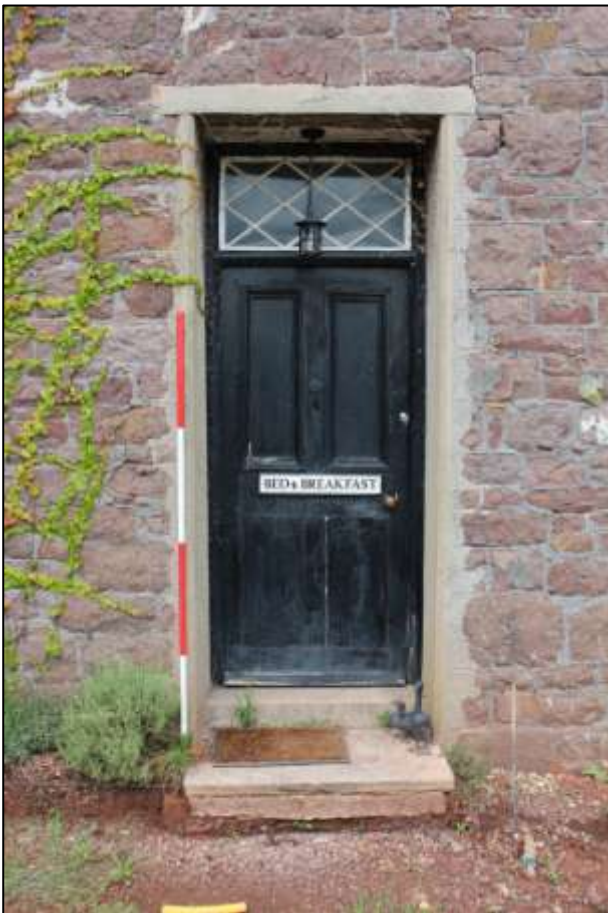
DETAIL OF THE FRONT DOOR OF THE FARMHOUSE; VIEWED FROM THE SOUTH (SCALE 2M).

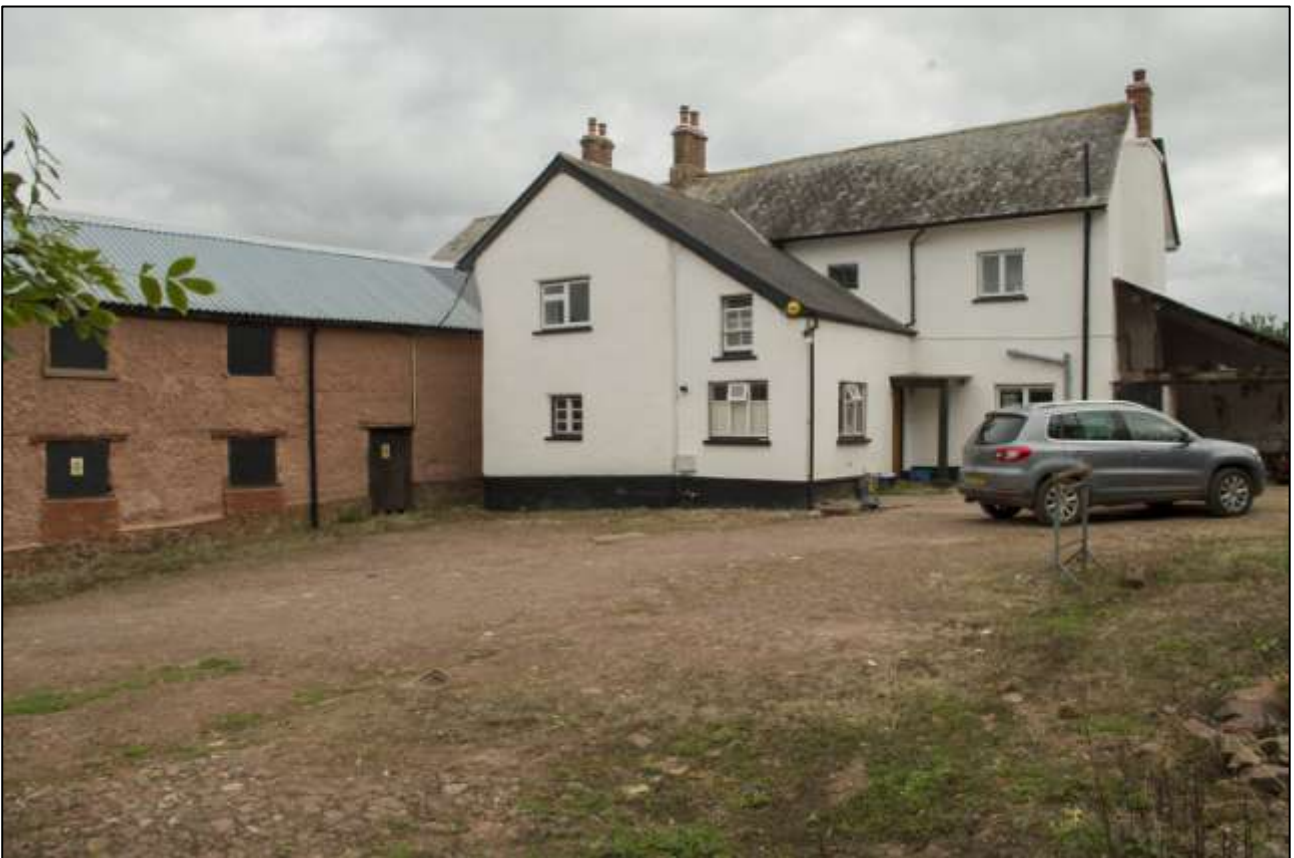
THE FARMHOUSE FROM THE REAR, WITH ITS 17<sup>TH</sup> CENTURY CROSSWING AND COBBLED YARD; VIEWED FROM THE NORTH.

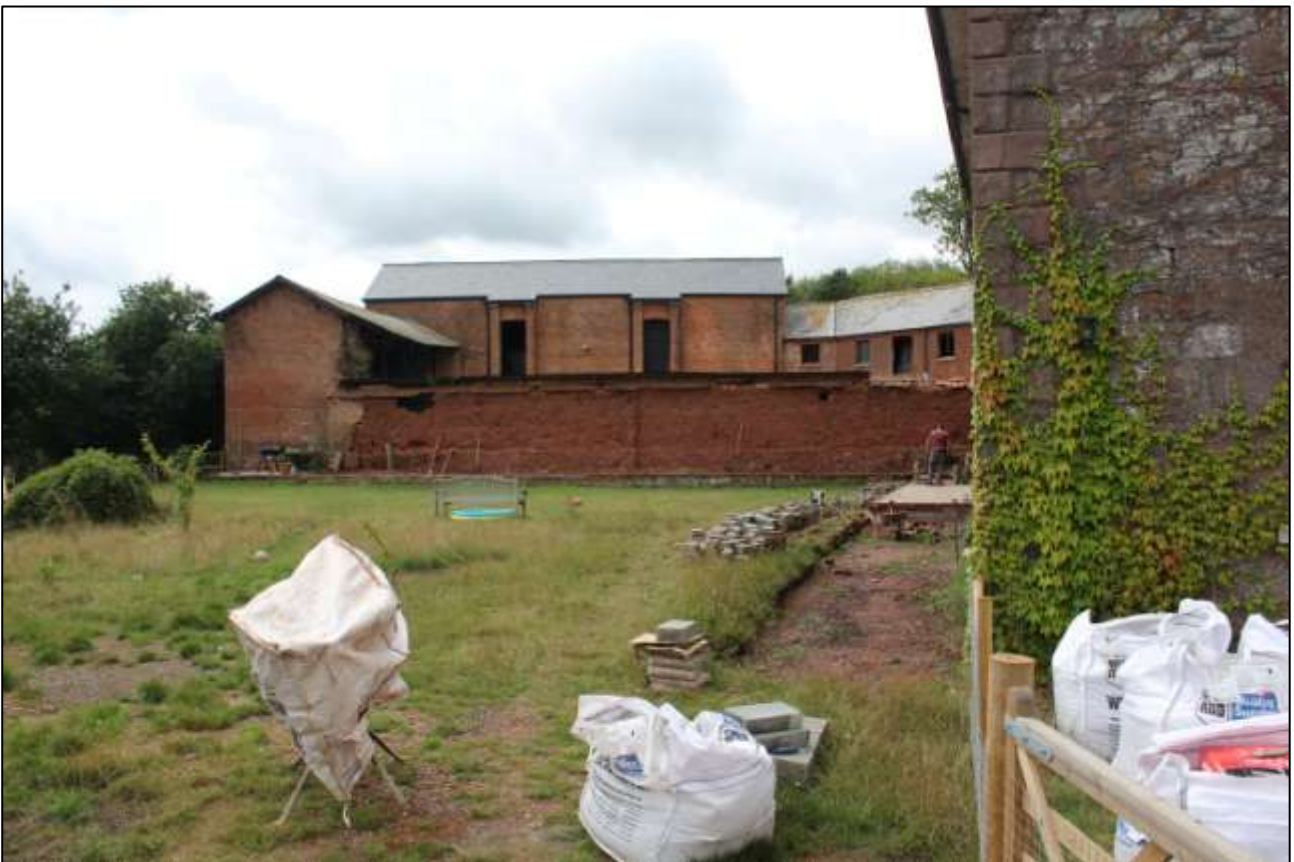
THE BRICK BARN (B6 TO CENTRE) AS VIEWED FROM THE GARDEN OF THE FARMHOUSE; VIEWED FROM THE EAST.

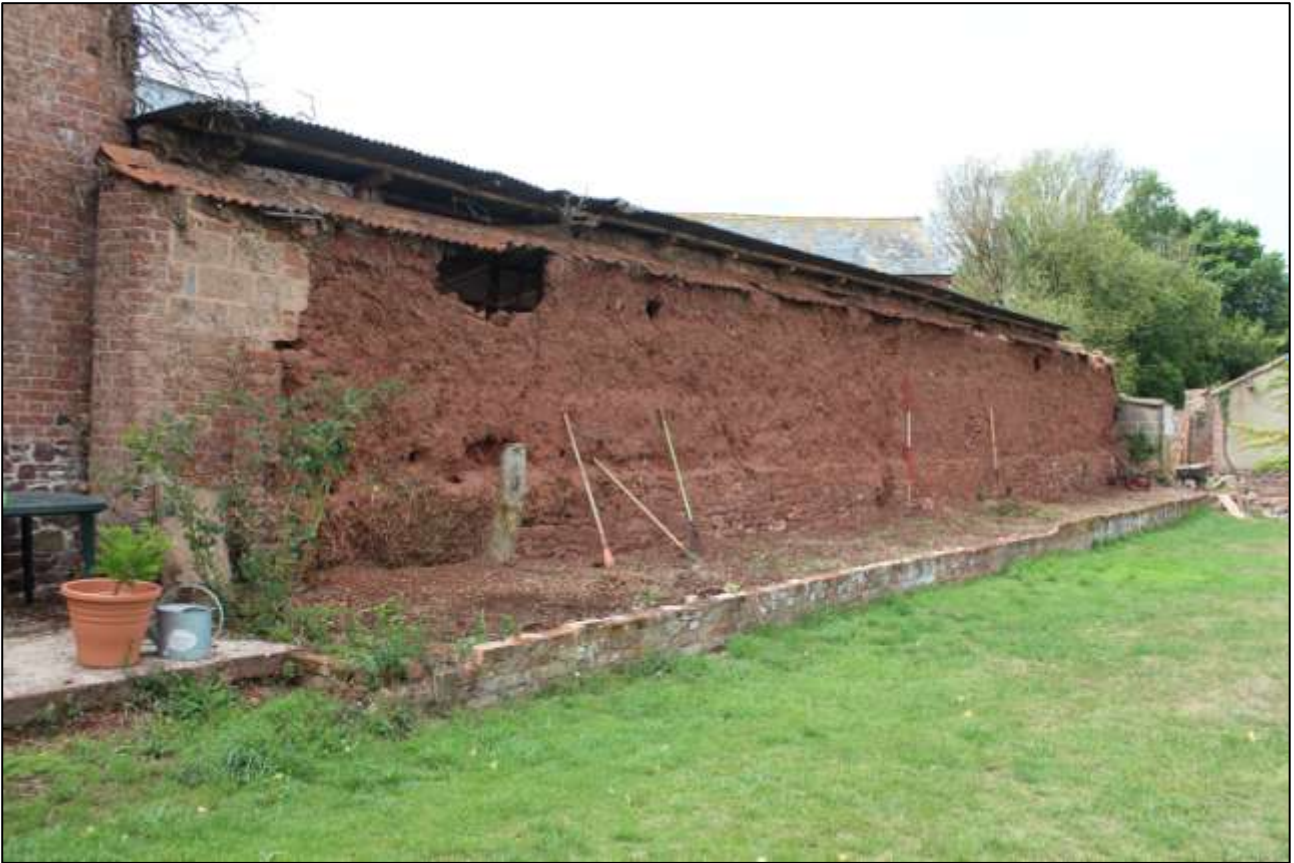
DETAIL OF THE COB GARDEN WALL; VIEWED FROM THE SOUTH-EAST (SCALE 2M).

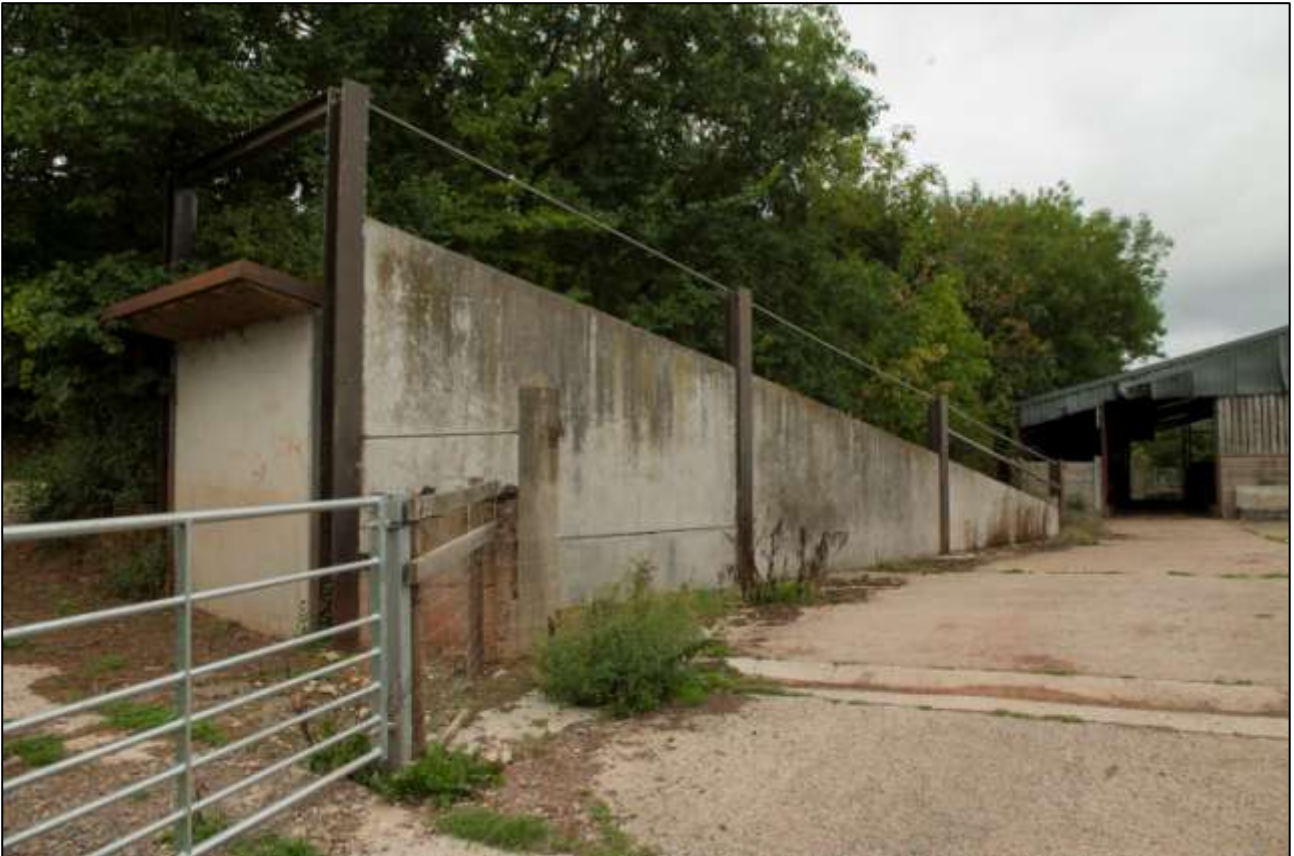
CONCRETE AND STEEL RAMP TO THE WEST OF THE MODERN FARM BUILDINGS; VIEWED FROM THE SOUTH-EAST.

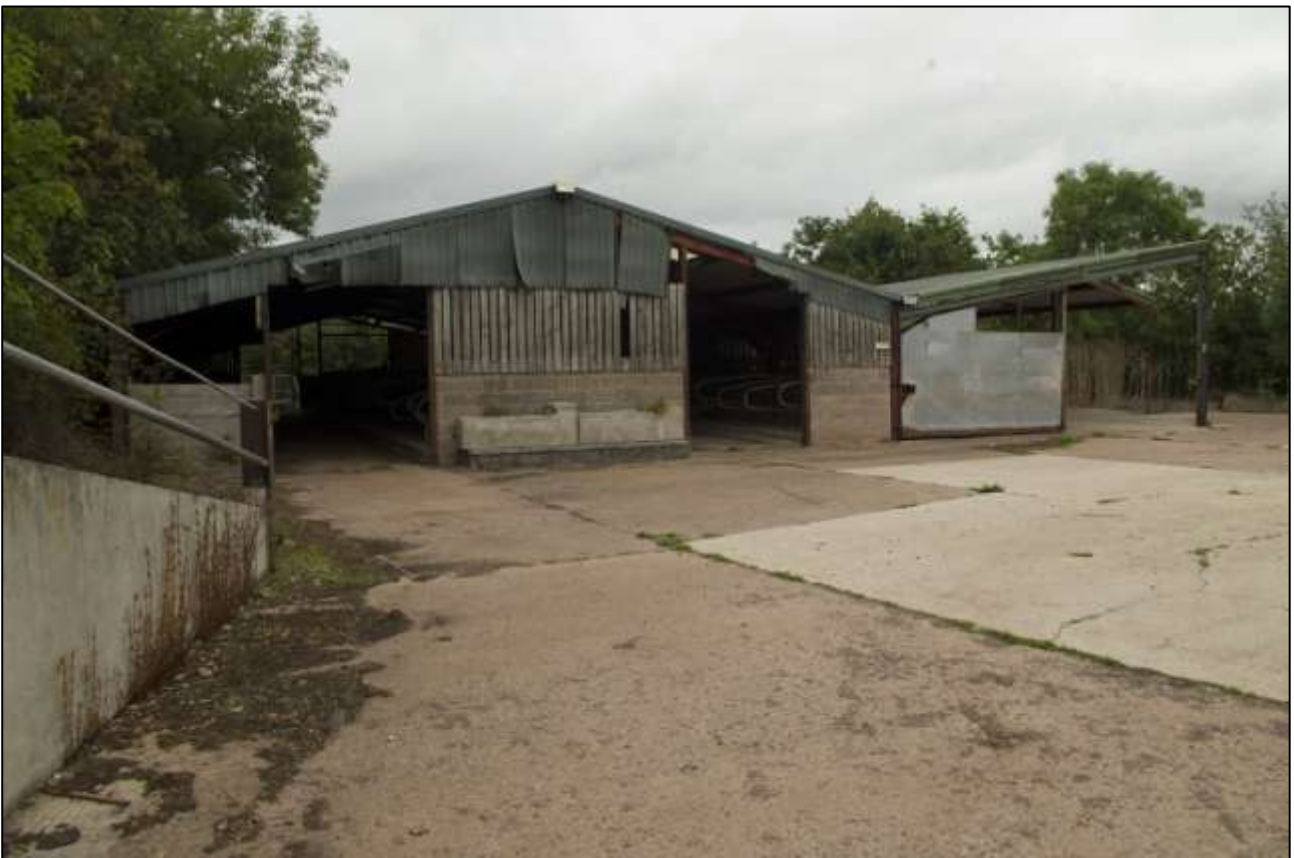
B11 EXTERIOR, THE MODERN COW CUBICLES; VIEWED FROM THE SOUTH.

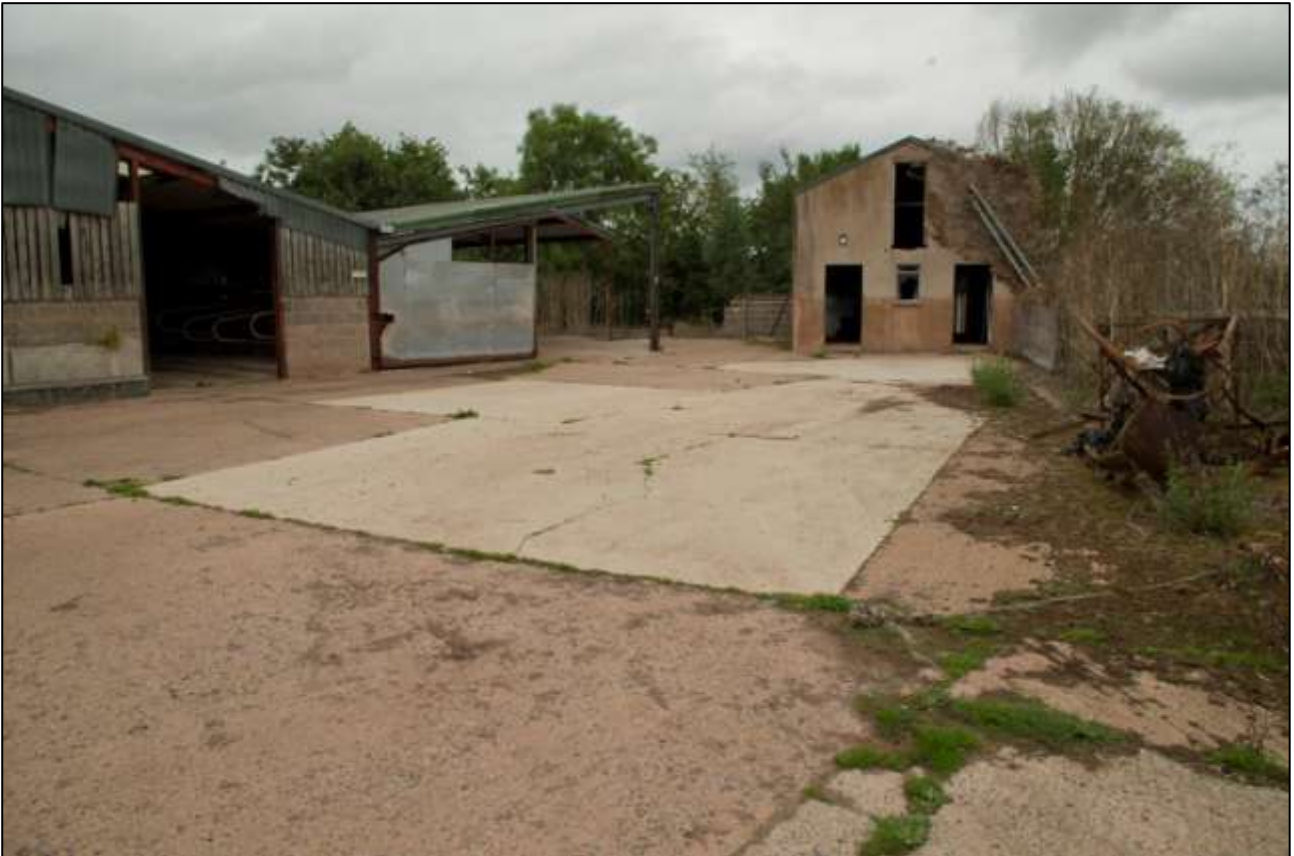
AS ABOVE, SHOWING B12; VIEWED FROM THE SOUTH-WEST.
