# MAYOR'S AVENUE TRAVIS PERKINS

Desk-Based Assessment & Historic Building Recording

South West Archaeology Ltd. report no. 181127

## Mayor's Avenue Travis Perkins, Dartmouth, South Hams, Devon Desk-Based Assessment & Historic Building Recording

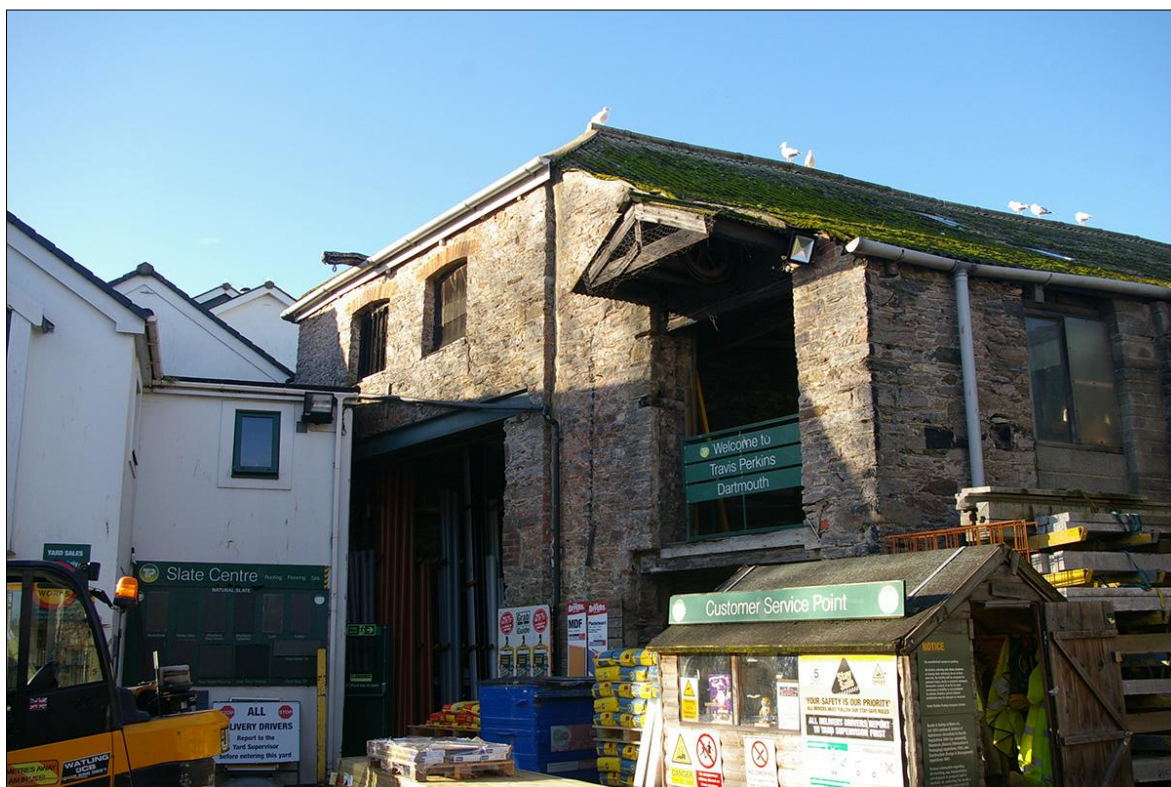
FIGURE 26: THE SOUTH ELEVATION OF B2 AND B3; VIEWED FROM THE SOUTH-EAST.

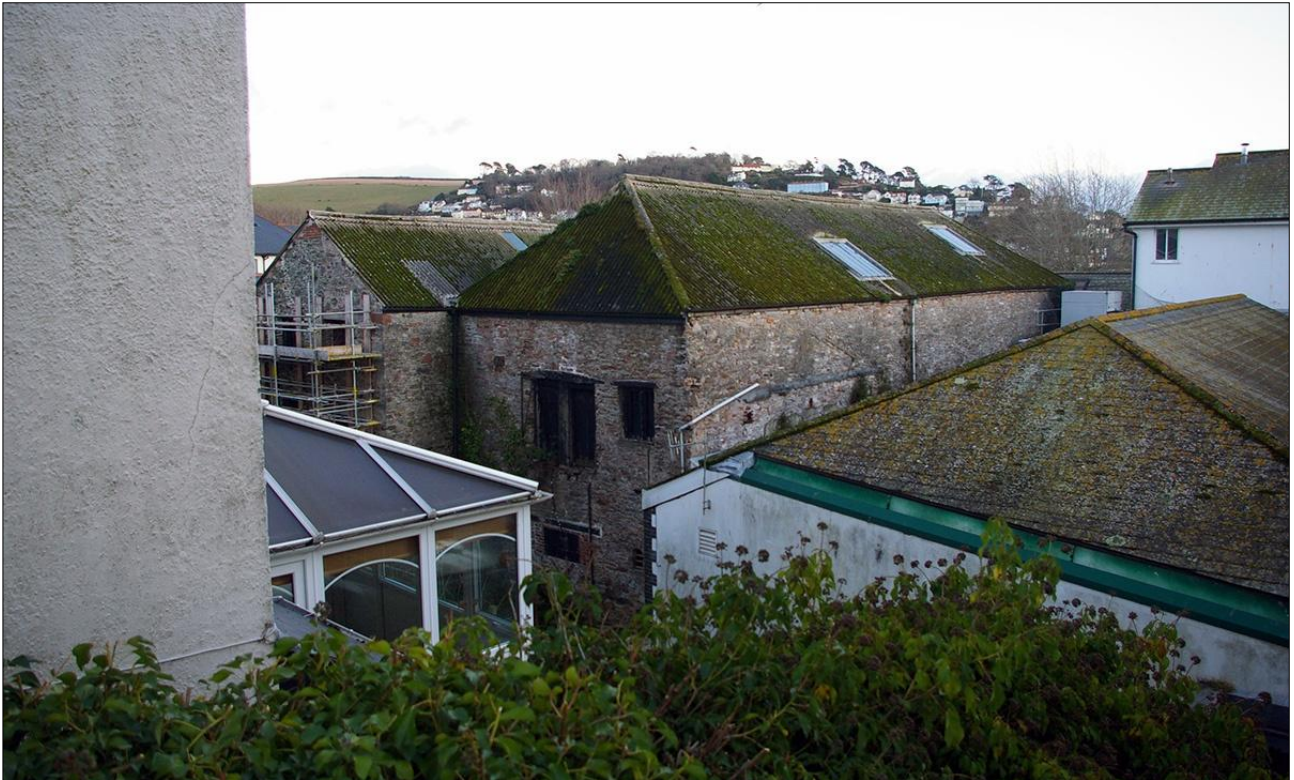
1. THE NORTH AND WEST WALLS OF BUILDING 1 (B1), VIEWED FROM THE NORTH-WEST.

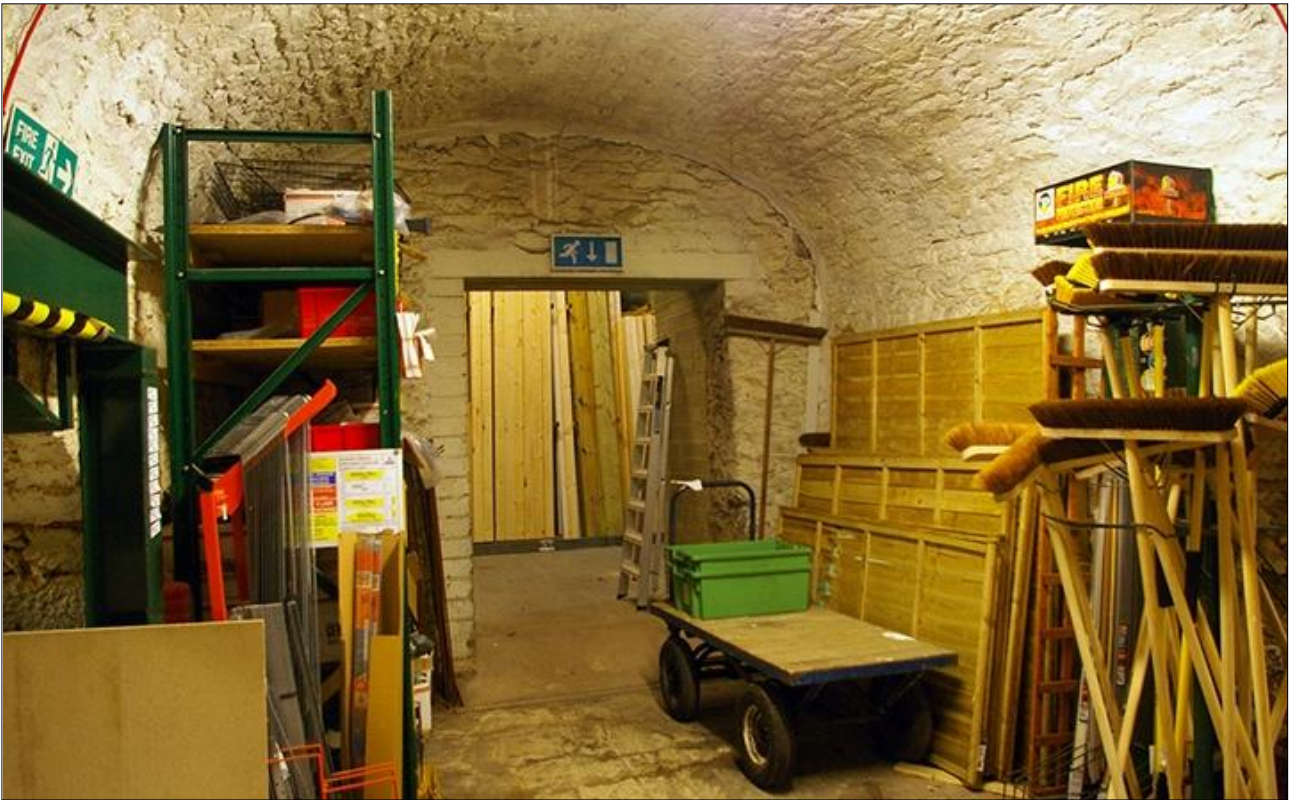
40. B1 GF, THE NORTHERN HALF OF V3 SHOWING FORCED DOORWAY D5; VIEWED FROM THE WEST.

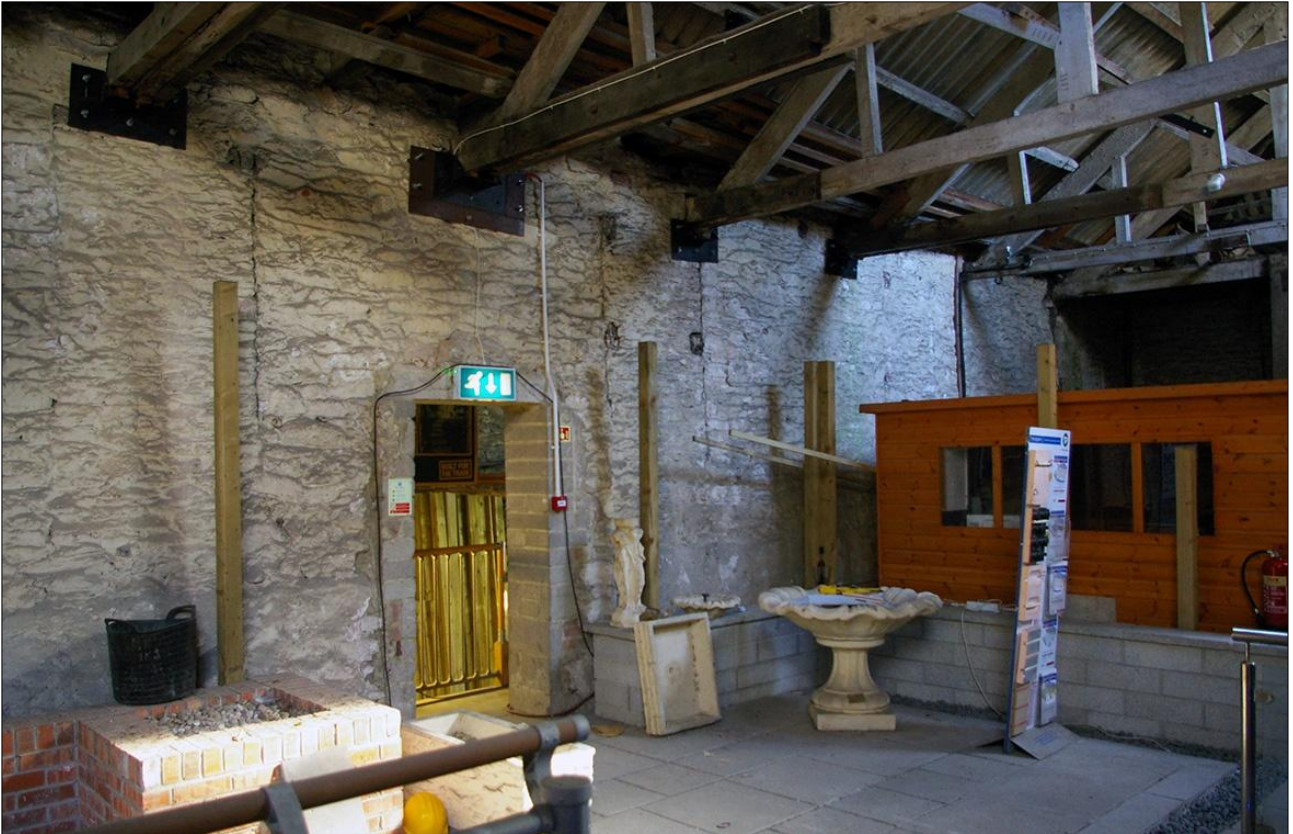
45. AS ABOVE, SHOWING THE STEEL REINFORCED TIE BEAMS ABOVE; VIEWED FROM THE NORTH-WEST.

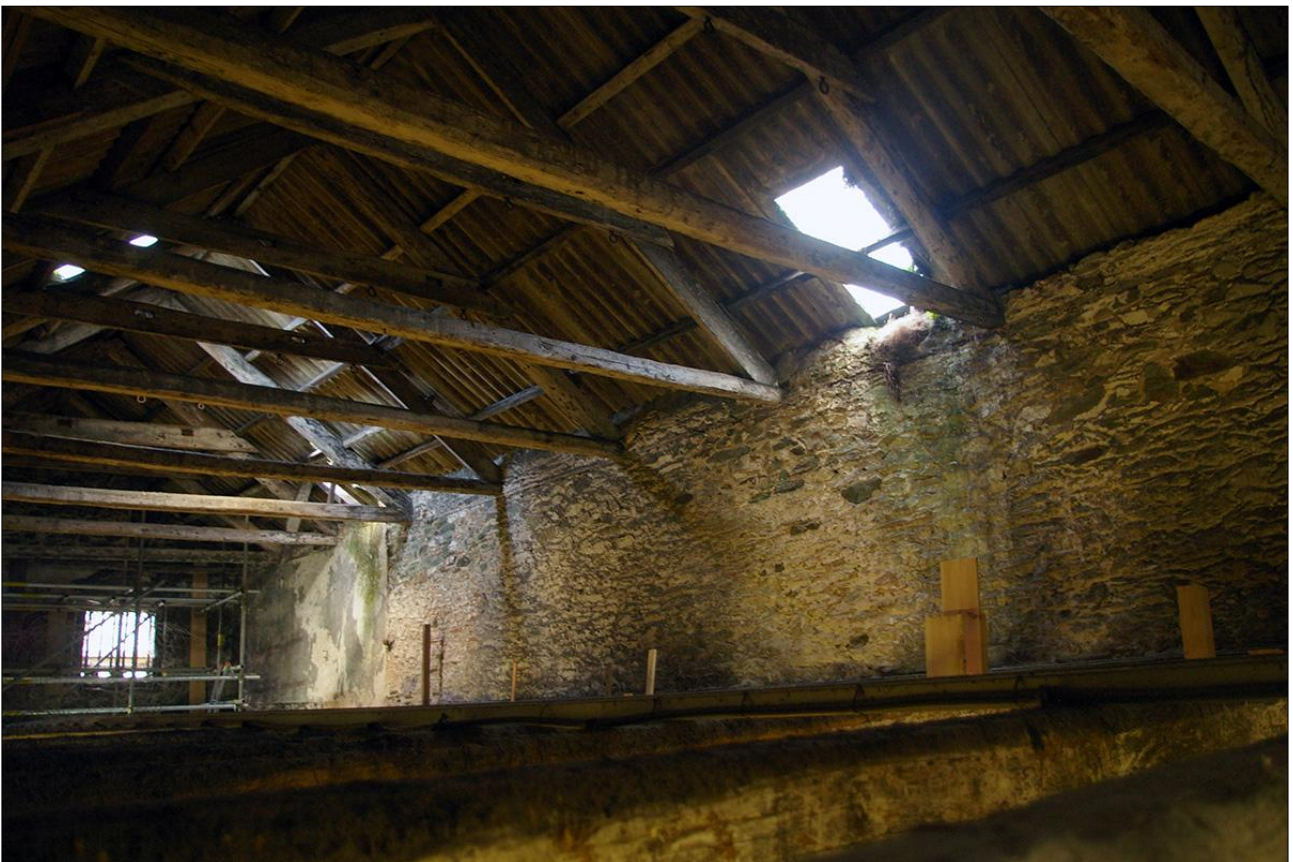
123. AS ABOVE.

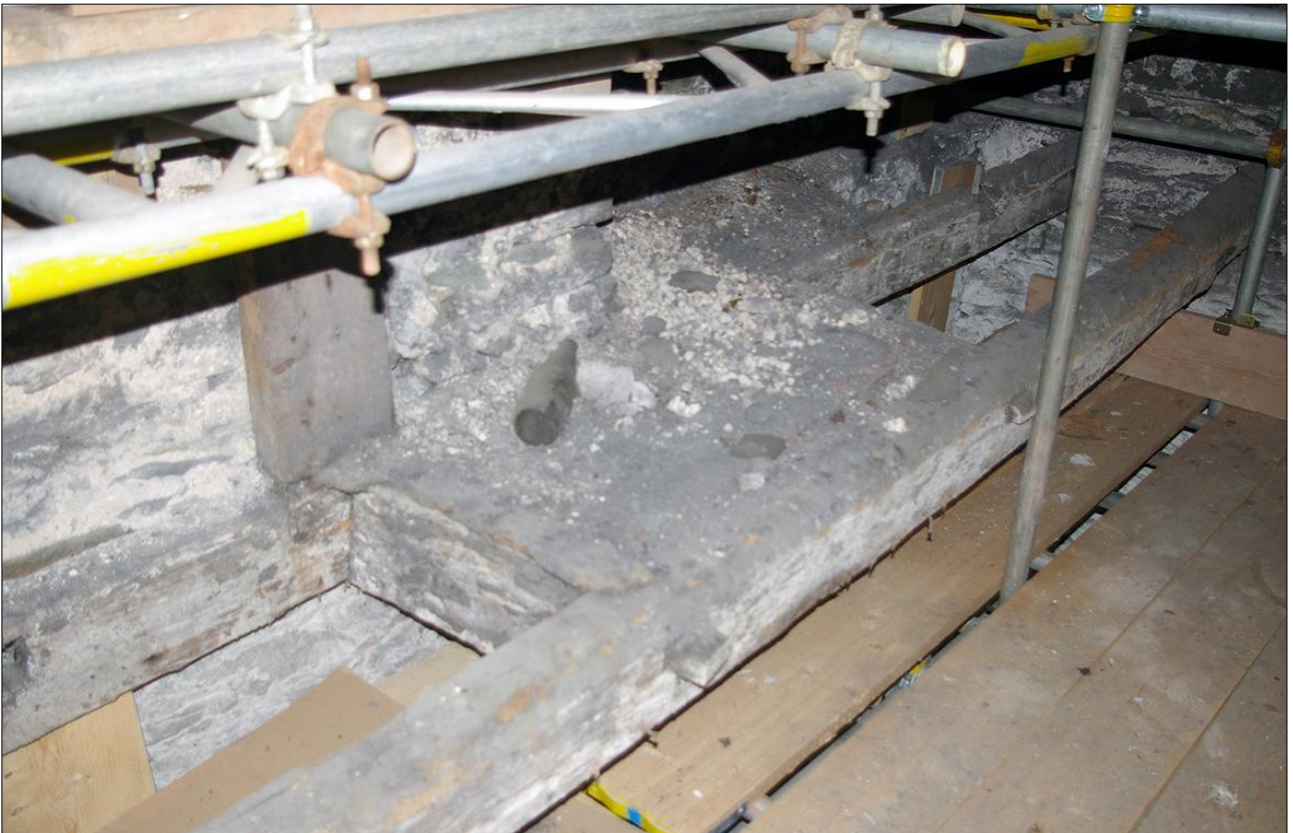
125. B2 SF INTERIOR, DETAIL OF THE BEAMS AT THE SOUTHERN END OF B2; VIEWED FROM THE WEST.

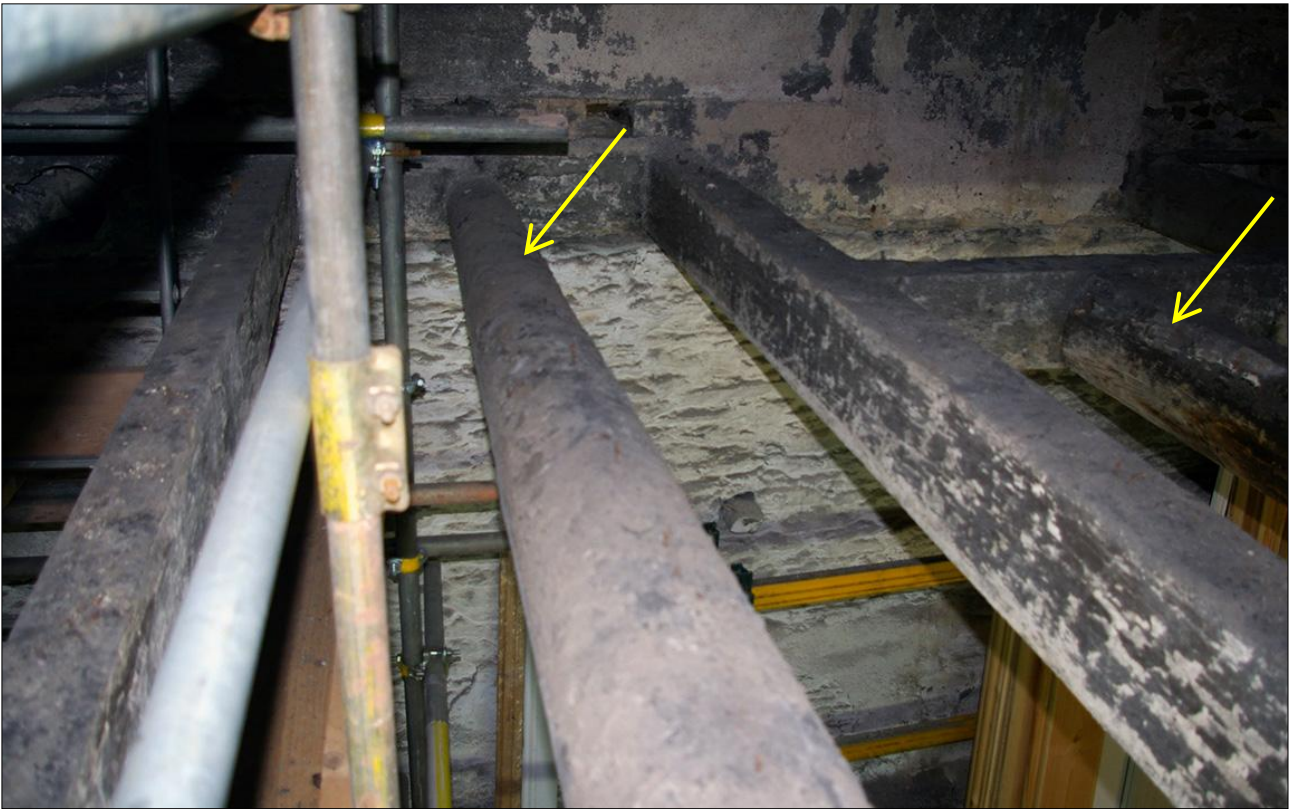
126. AS ABOVE, SHOWING THE REINFORCED BASE FOR FP3; VIEWED FROM THE WSW.

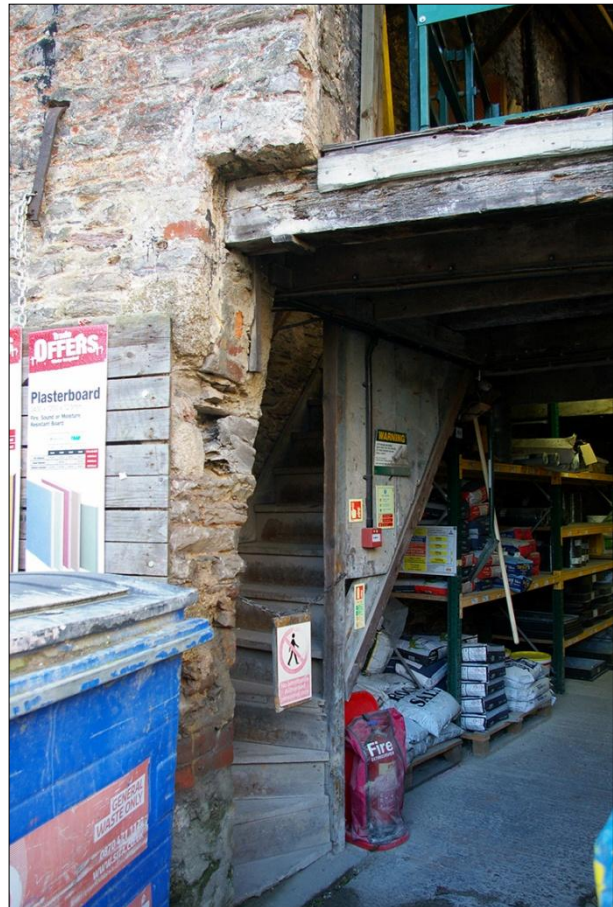
139. LEFT: THE SOUTH ELEVATION OF B3; VIEWED FROM THE SOUTH.

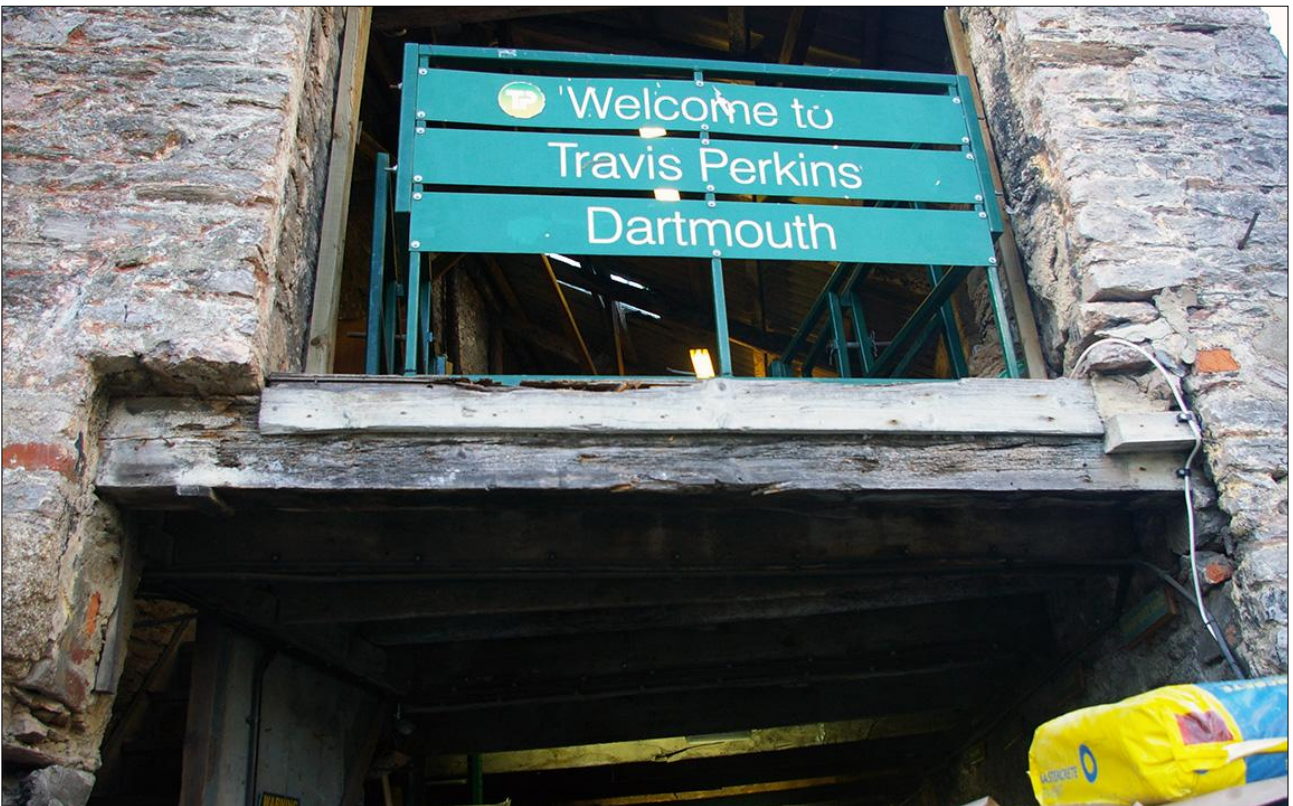
141. THE SOUTH ELEVATION OF B3, WITH FF LOADING DOOR D19 WITH PENTICE AND FLYWHEEL (S23) ABOVE; VIEWED FROM THE SOUTH.

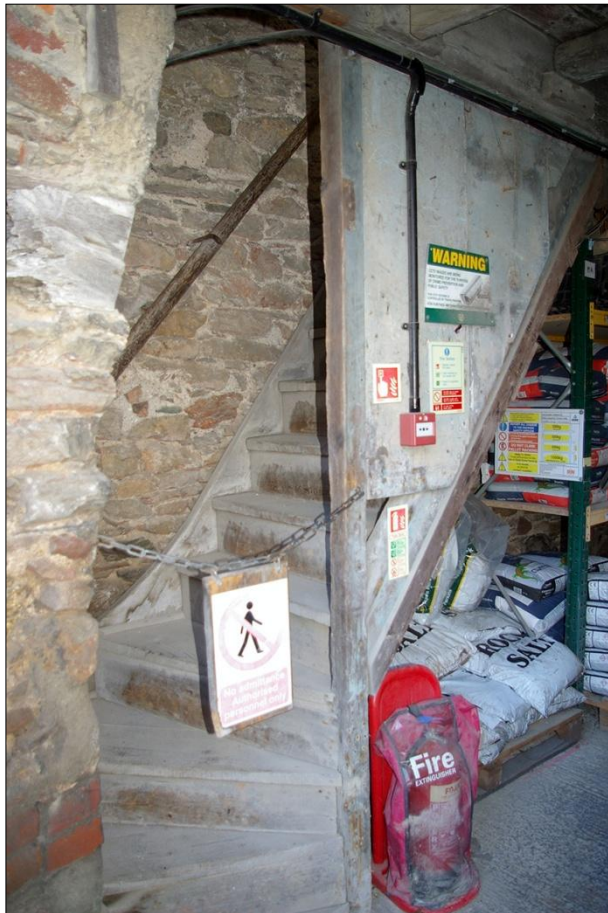
145. B3 GF INTERIOR, THE EAST WALL; VIEWED FROM THE SSW.

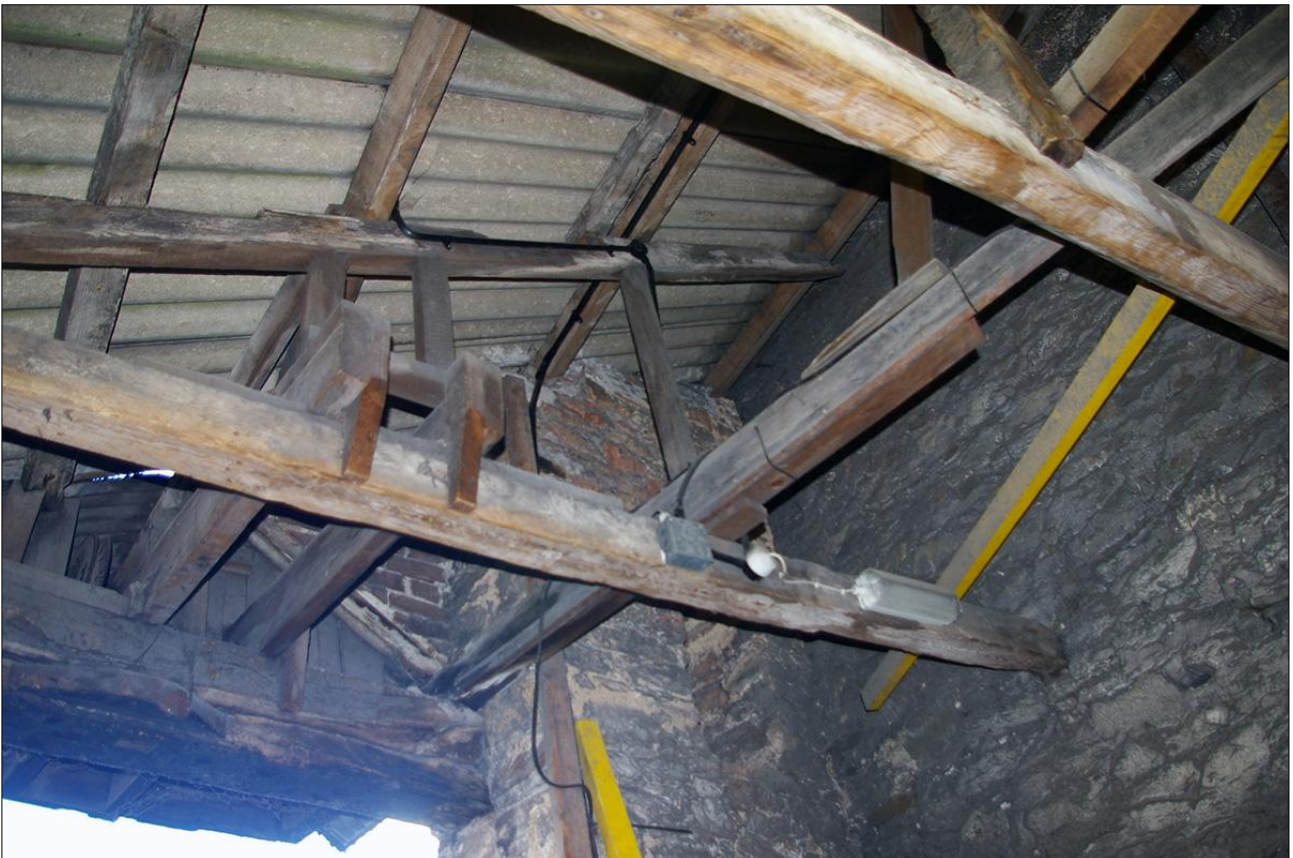
169. B3 FF INTERIOR, THE ROOF STRUCTURE OVER THE SOUTHERN END AND BEAMS FOR HOIST (S23); VIEWED FROM THE NNE.

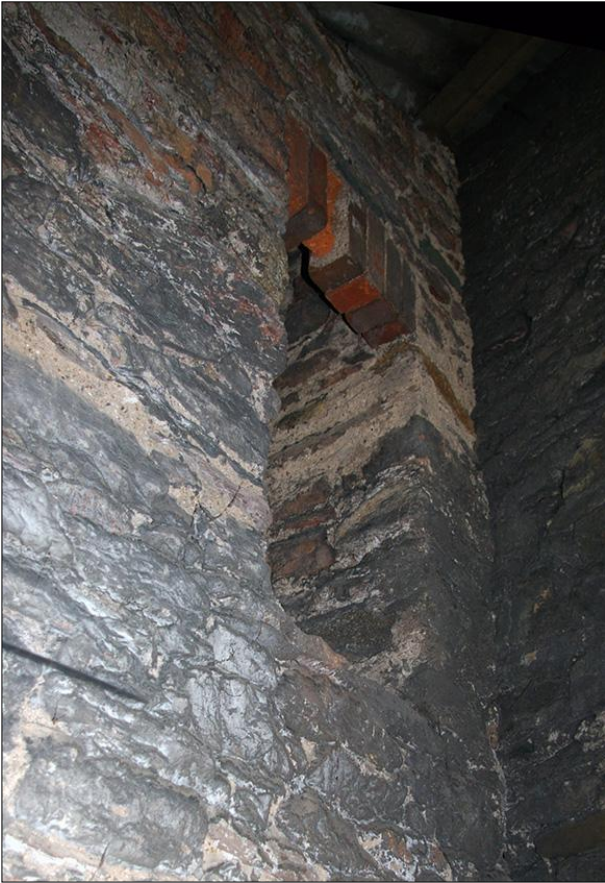
170. B3 SF INTERIOR, DETAIL OF FP4 ABOVE THE STAIRS; VIEWED FROM THE NORTH-EAST.

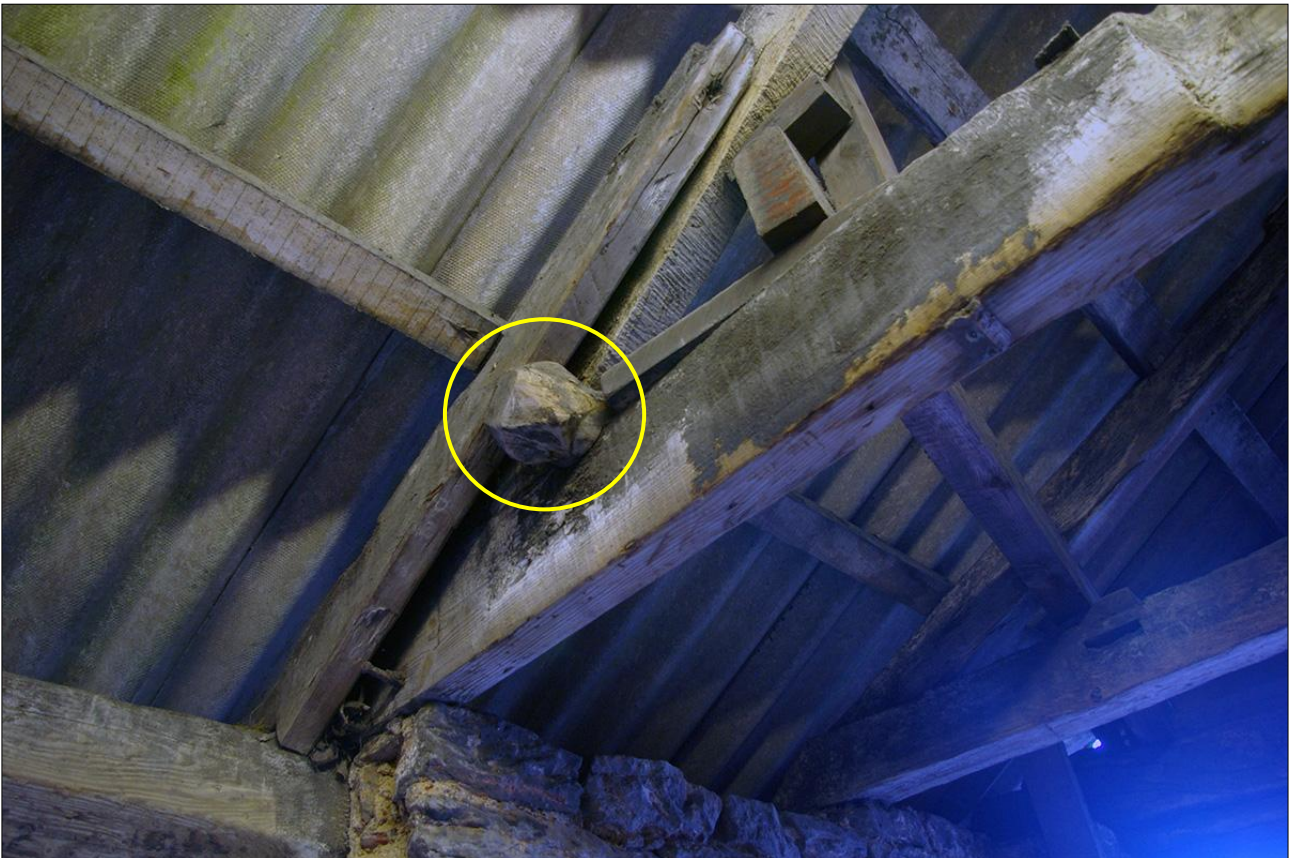
171. B3 ROOF STRUCTURE, SHOWING THE RE-USED SHAPED TIMBER (INDICATED) (S12); VIEWED FROM THE NNW.

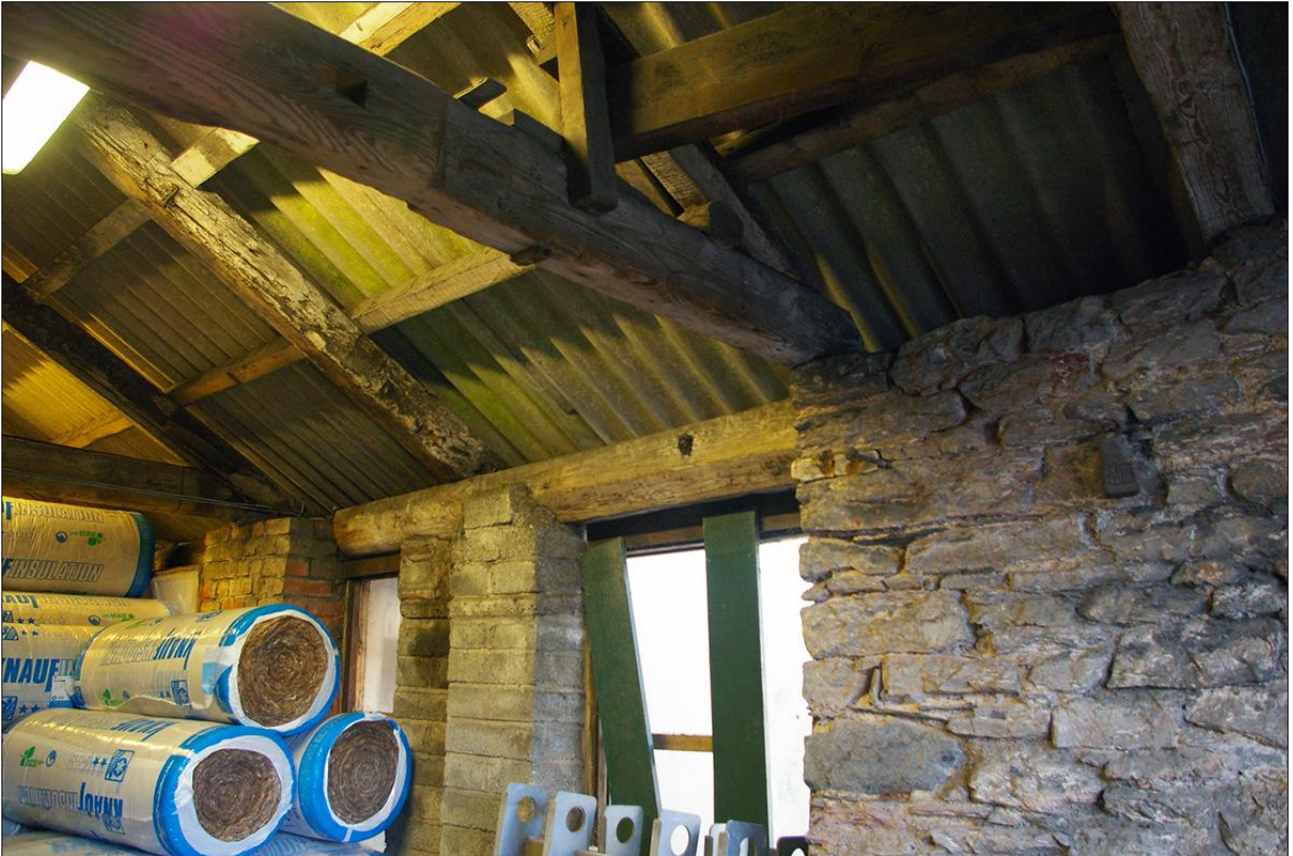
172. B3 FF INTERIOR, THE EAST WALL AND W14 AND W15 IN BO42; VIEWED FROM THE SOUTH-WEST.

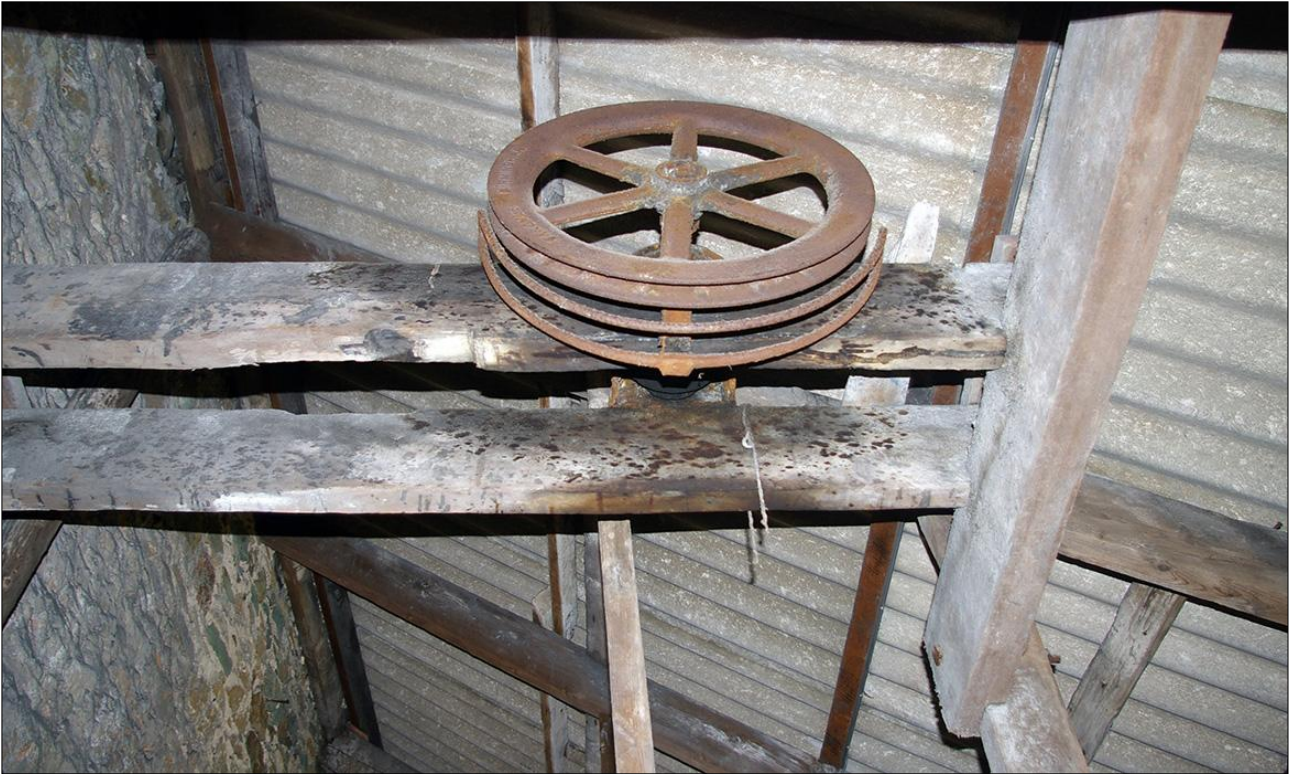
174. B3 FF INTERIOR, THE FLYWHEEL (S24) OVER HATCH S14; VIEWED FROM THE SOUTH.

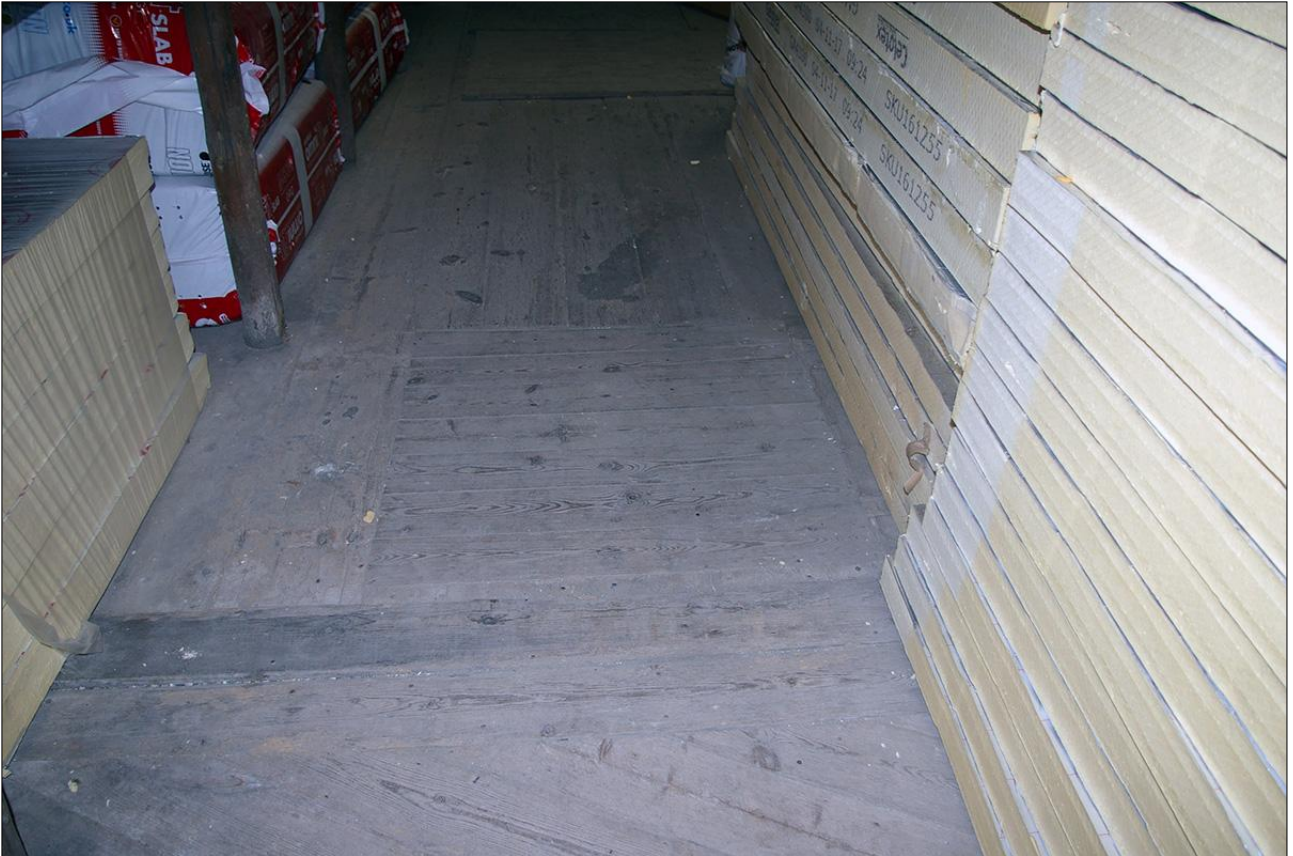
179. B3 FF INTERIOR, HISTORIC FLOORBOARDS (S13) AND HATCH (S14); VIEWED FROM THE NORTH.

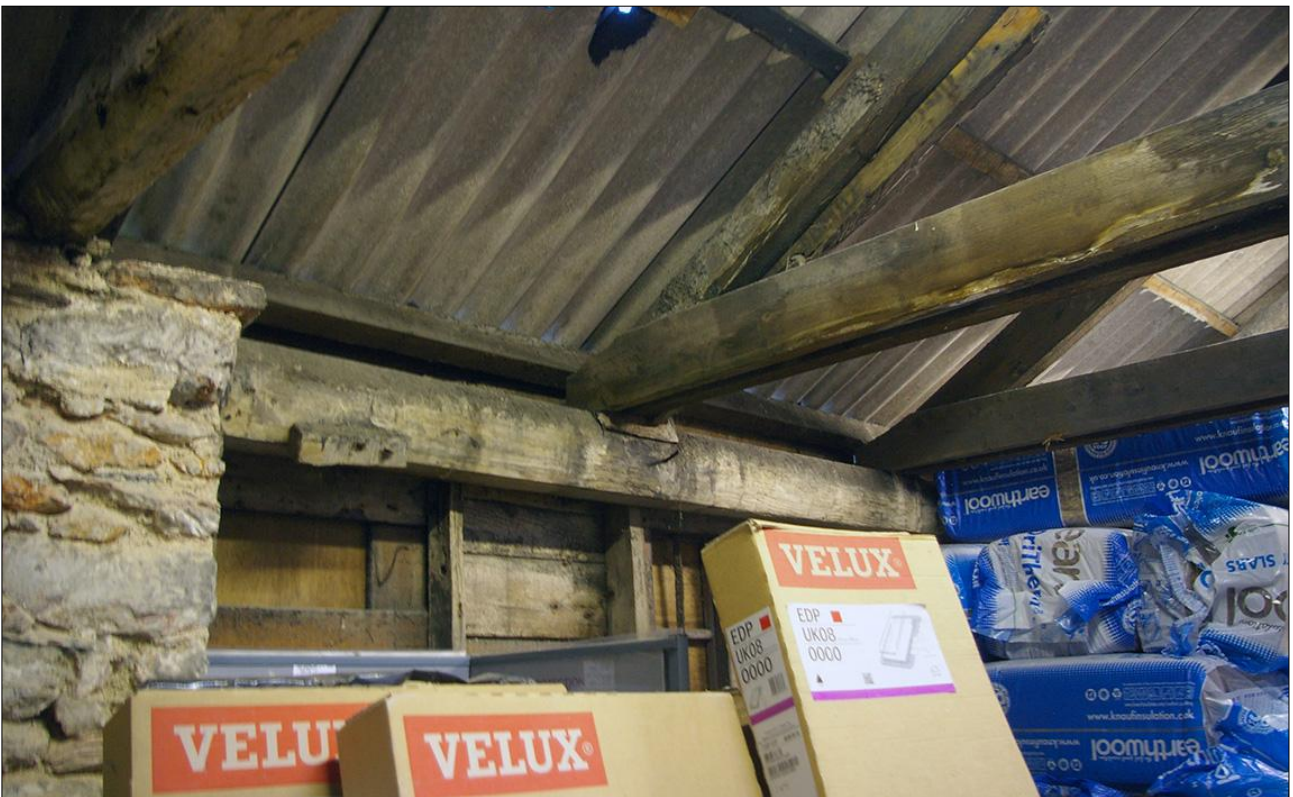
182. B3 FF INTERIOR, SHOWING ORIGINAL WOODEN FRAMEWORK TO BO17; VIEWED FROM THE WNW.

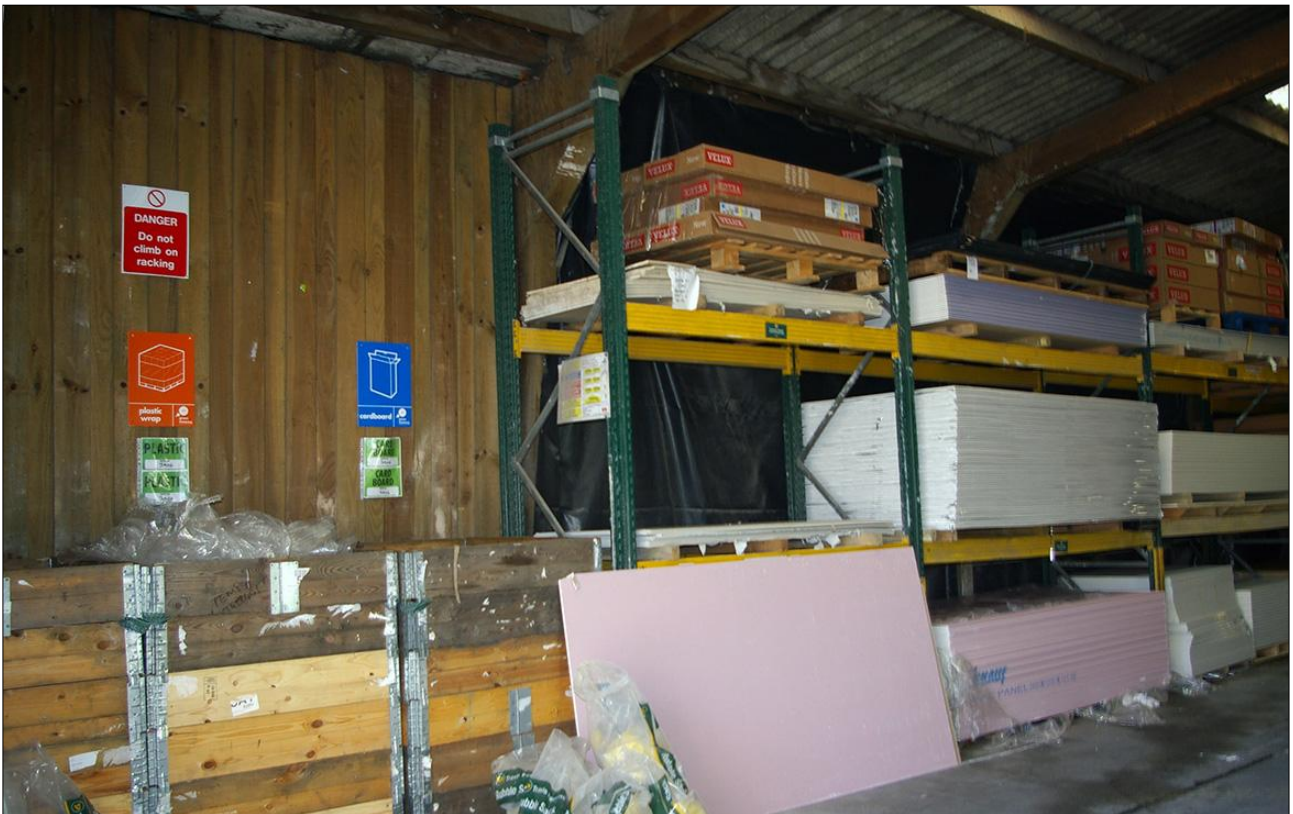
191. AS ABOVE, THE CONCEALED EAST WALL OF B3; VIEWED FROM THE SOUTH-EAST.

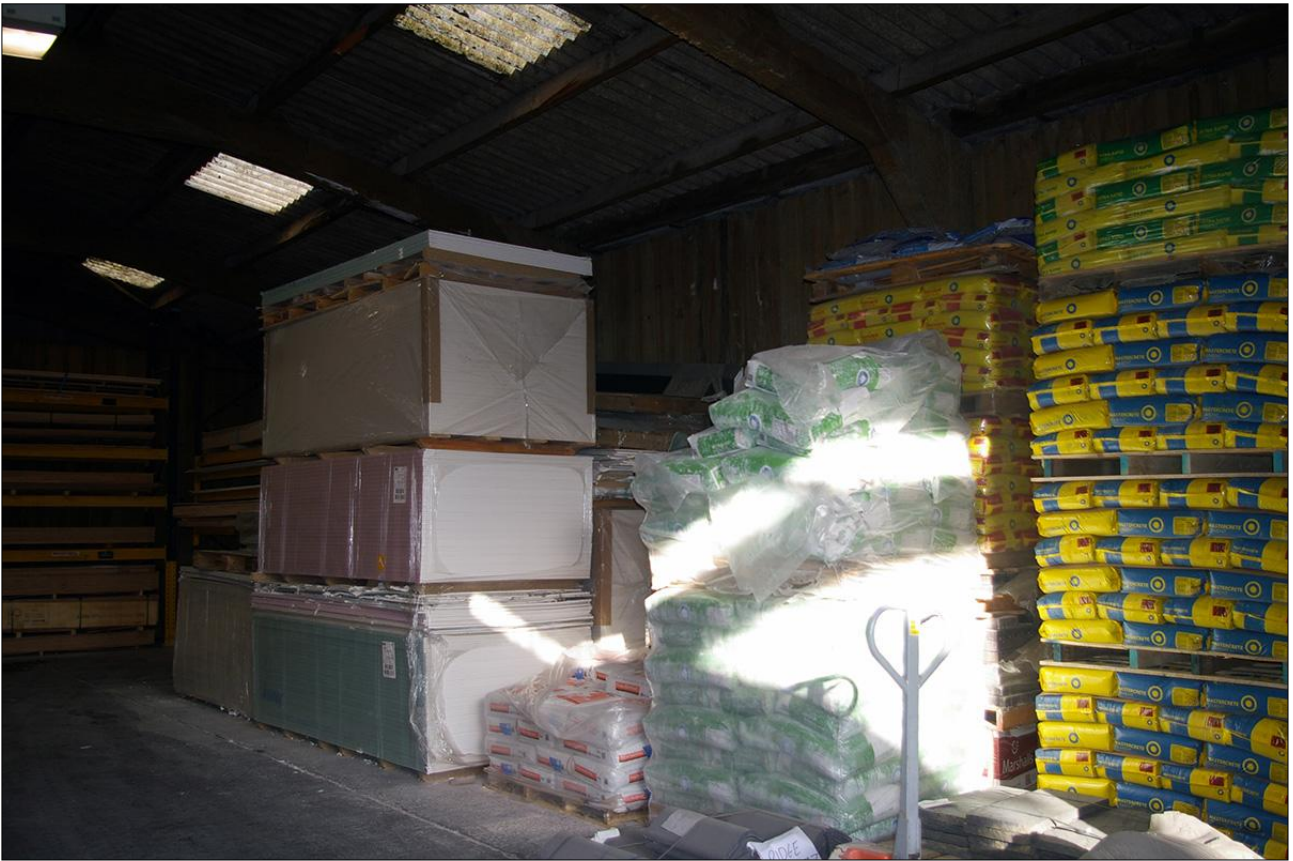
192. AS ABOVE, THE CONCEALED EAST WALL OF B4 (WALL OF THE ADJOINING PROPERTY); VIEWED FROM THE SOUTH-WEST.
