**THE BICKFORD CENTRE  
23 SOUTH STREET  
GREAT TORRINGTON  
DEVON**

HISTORIC BUILDING RECORDING

South West Archaeology Ltd. report no. 181114

By E. Wapshott & N. Boyd  
Report Version: **DRAFT01**  
14<sup>th</sup> November 2018

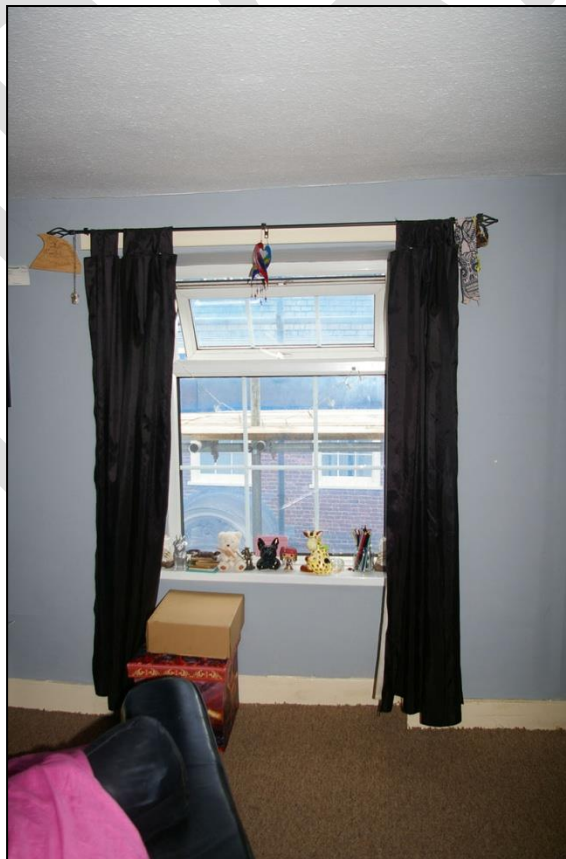
35. W13, 19<sup>TH</sup> CENTURY CASEMENT WITH GLASS FILLET ABOVE, INFILLING AN ORIGINALLY TALLER OPENING; FROM THE EAST.

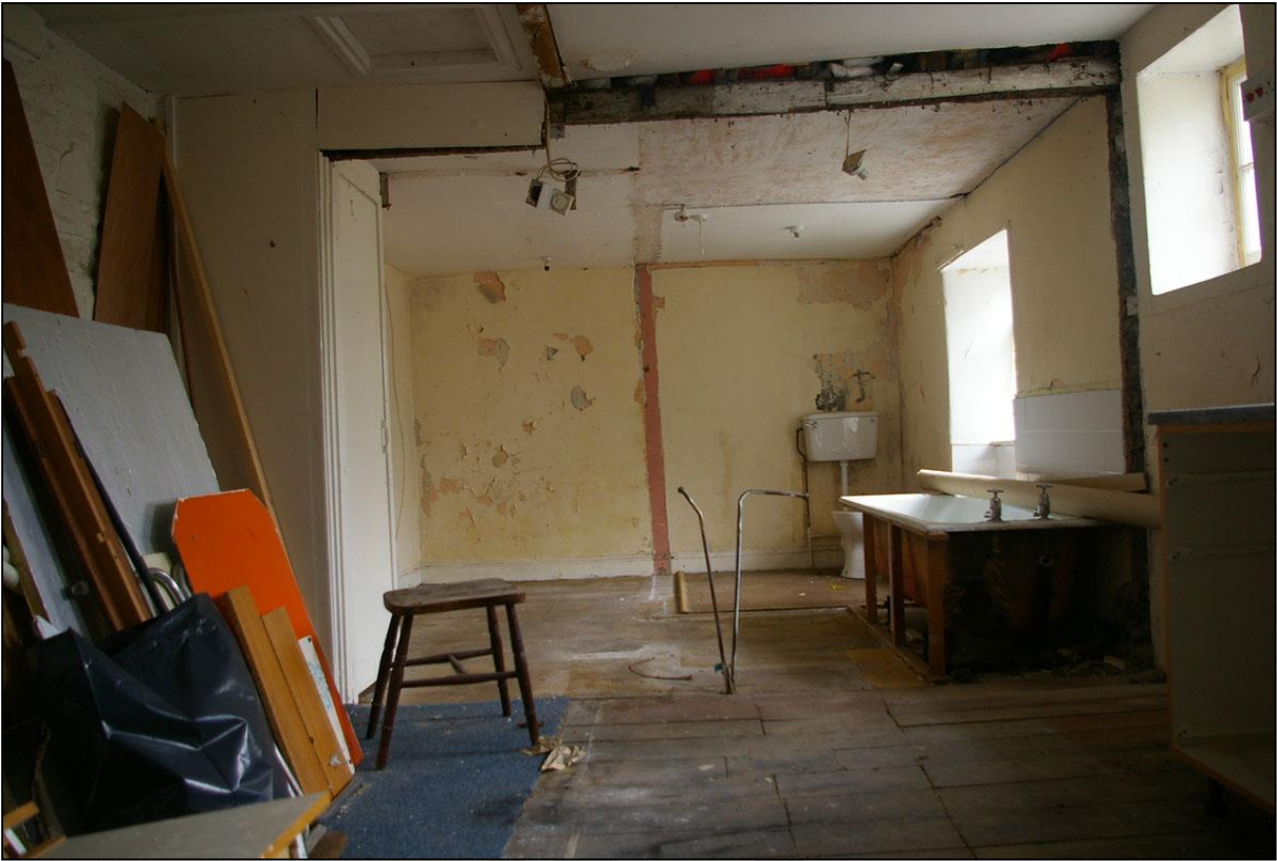
48. THE EAST WALL, ROOM 20, SHOWING W17, W18 AND W19; FROM THE SOUTH-WEST.

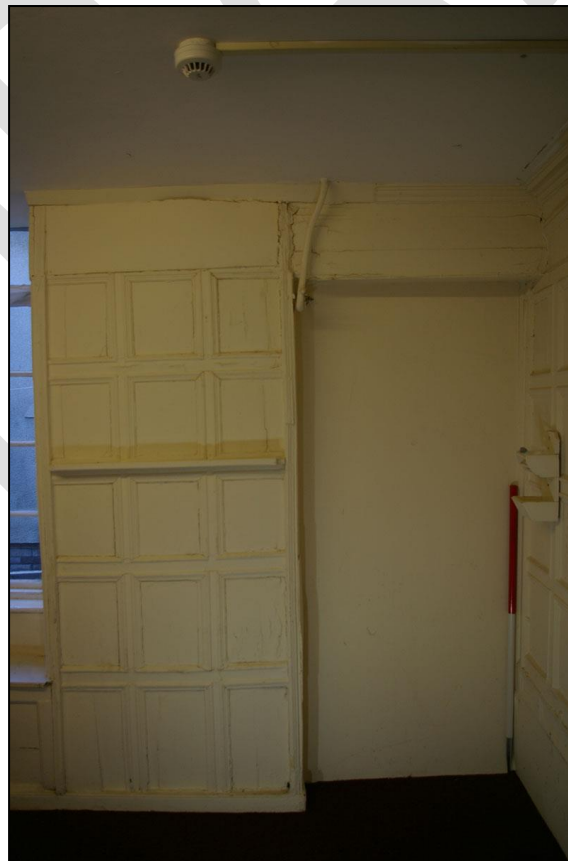
82. THE EAST WALL AT THE SOUTH END, WITH D7 AND 1M SCALE; FROM THE WEST.

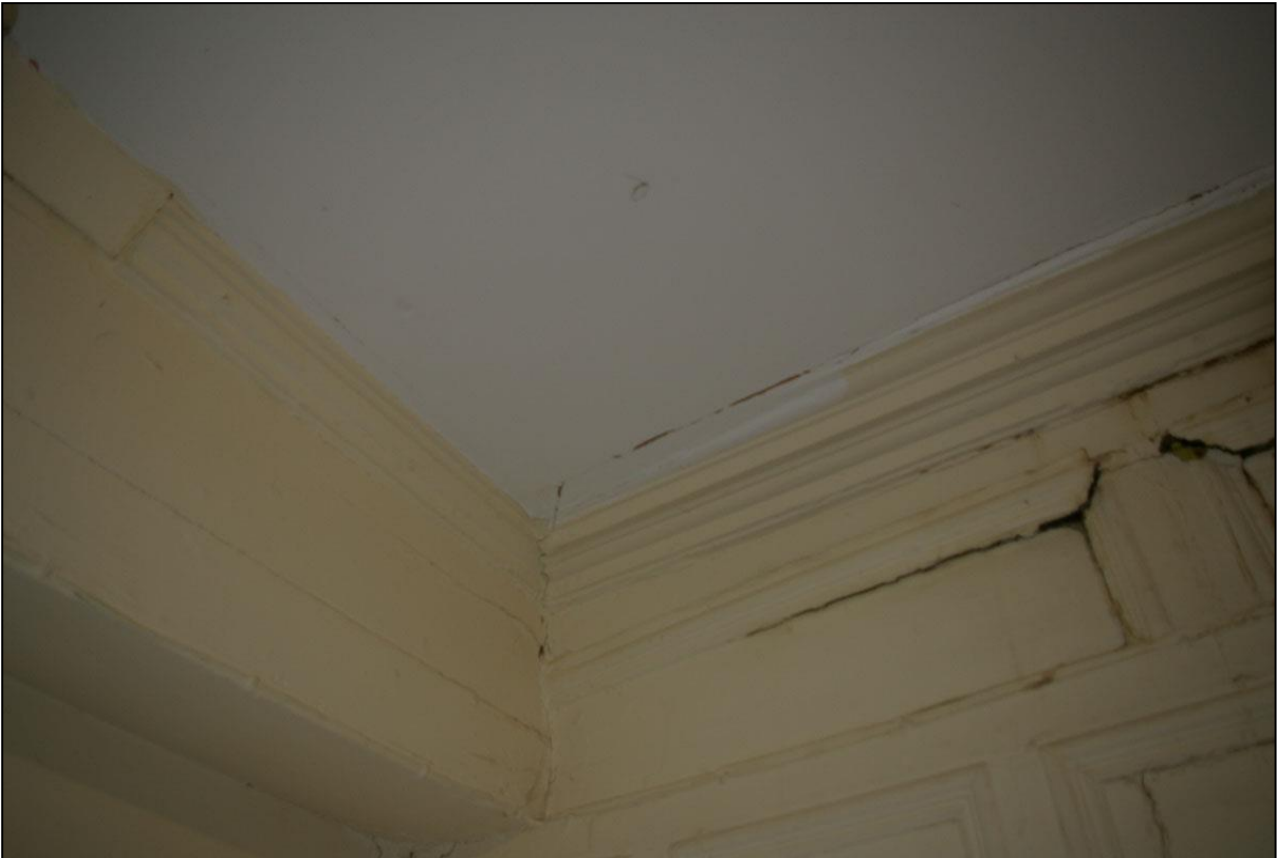
83. THE DIFFERENT WOODEN CORNICES MEETING IN THE SOUTH-EAST CORNER OF THE ROOM; FROM THE NORTH-WEST.

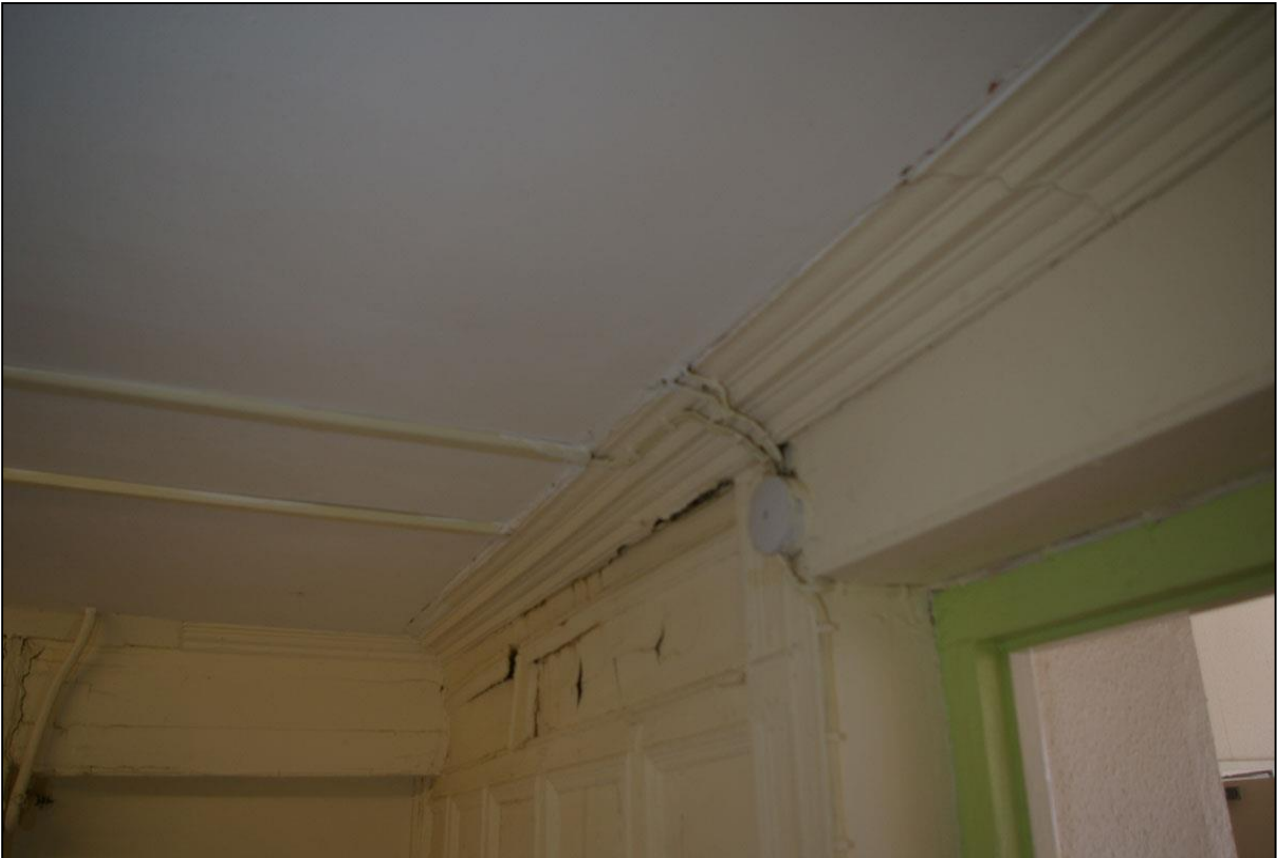
85. THE COMPLEX DEEP CORNICE OF OGEE, CAVETTO, OVULO AND BEADING, ALONG THE SOUTH WALL; FROM THE WEST-NORTH-WEST.

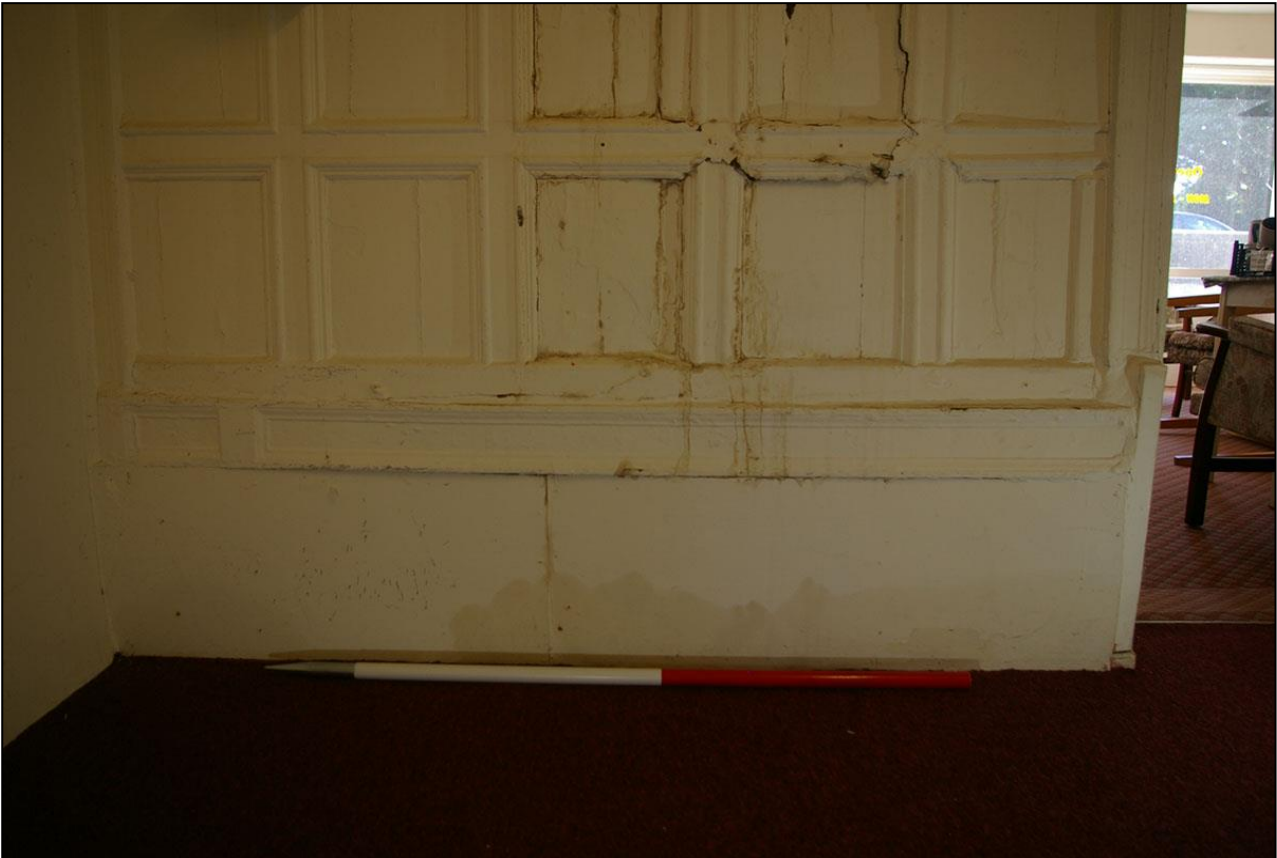
87. THE BASE OF THE SOUTH WALL, WITH 1M SCALE; FROM THE NORTH.

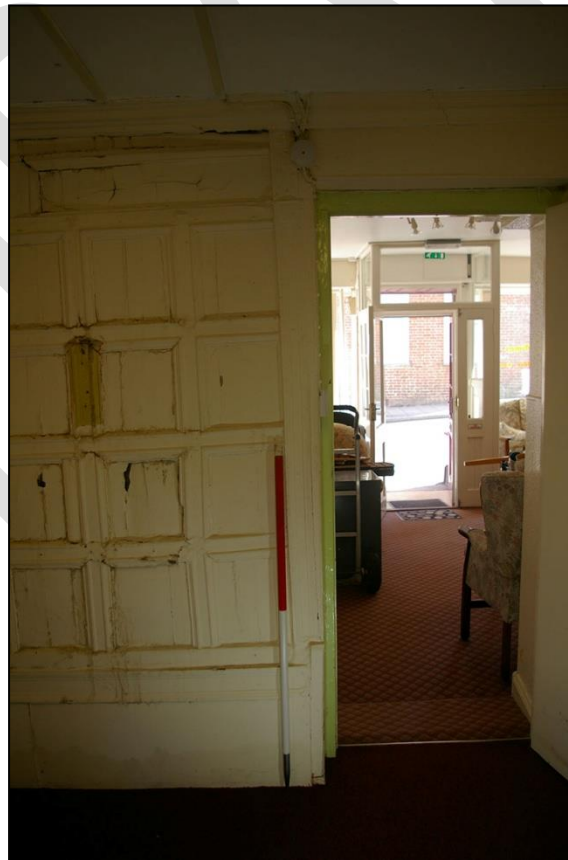
88. D24, FRAMED WITH THE TYPE 5 PILASTERS AND 1M SCALE; FROM THE NORTH

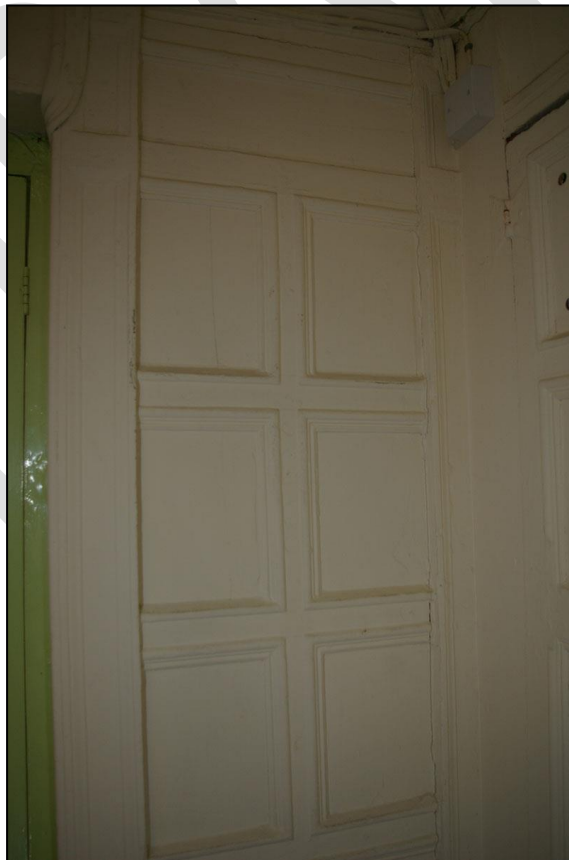
90. THE SOUTH-WEST CORNER, WITH PILASTERS AND TYPE 3 PANELLING; FROM THE NORTH-EAST

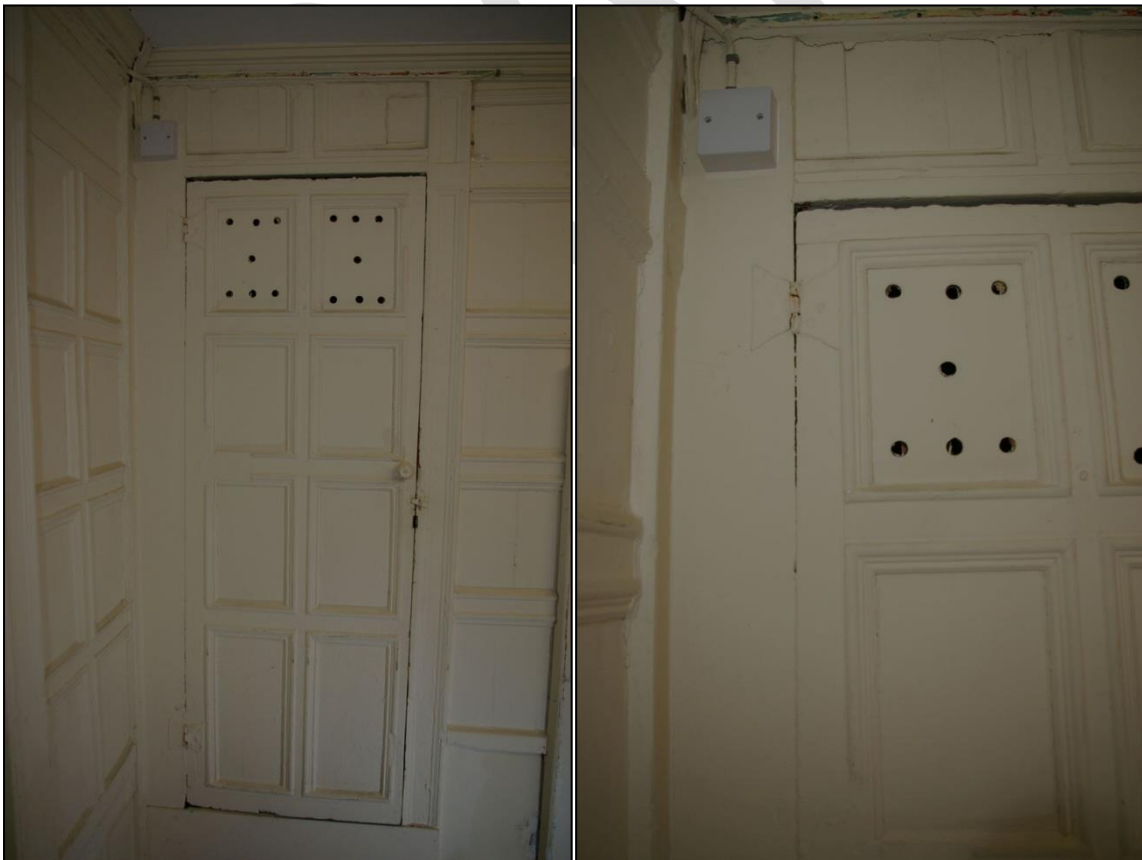
92. LEFT: THE FINE PANNELLED DOOR TO THE SOUTH OF THE WEST WALL; FROM THE EAST

93. RIGHT: THE BUTTERFLY HINGES TO THE CUPBOARD IN THE SOUTH-WEST CORNER OF ROOM 17; FROM THE EAST.

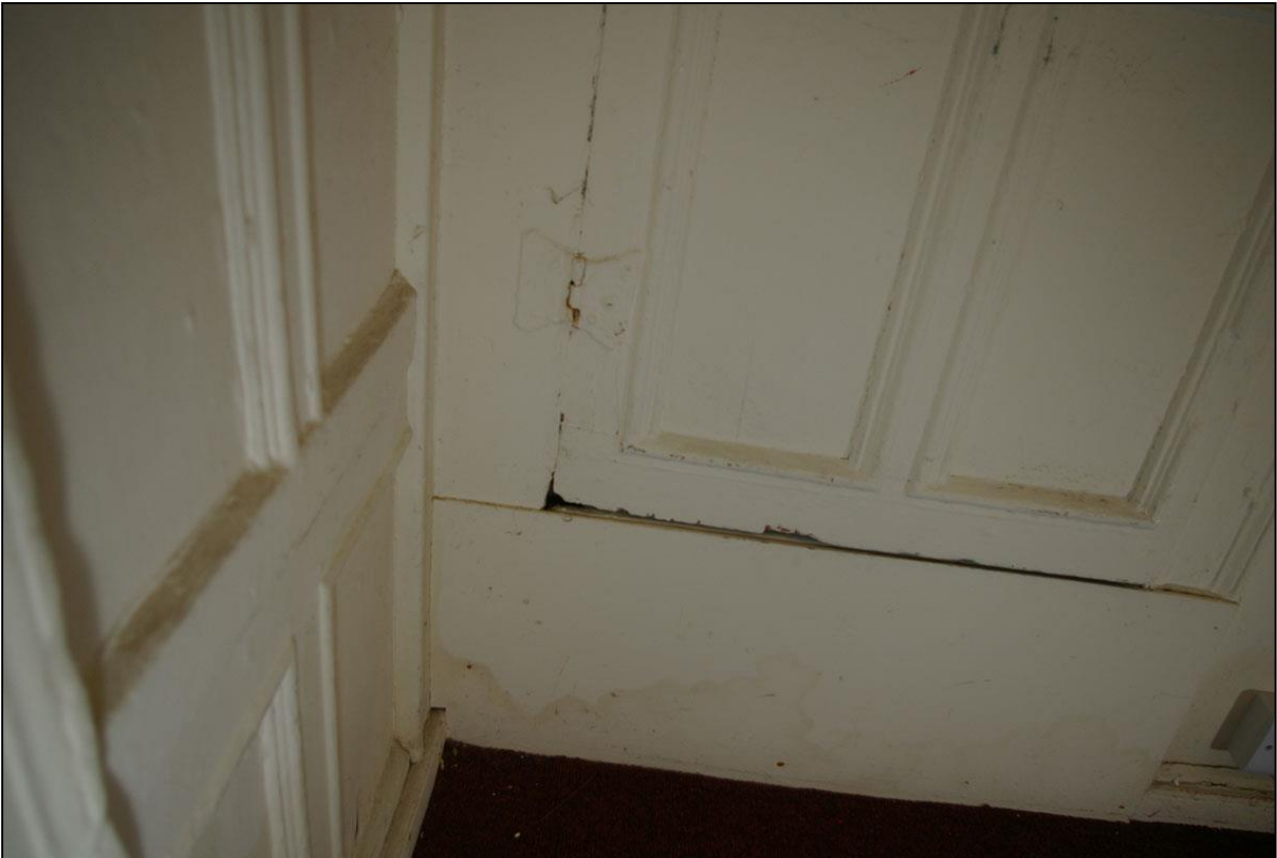
94. THE BUTTERFLY HINGES TO THE CUPBOARD IN THE SOUTH-WEST CORNER OF ROOM 17; FROM THE EAST.

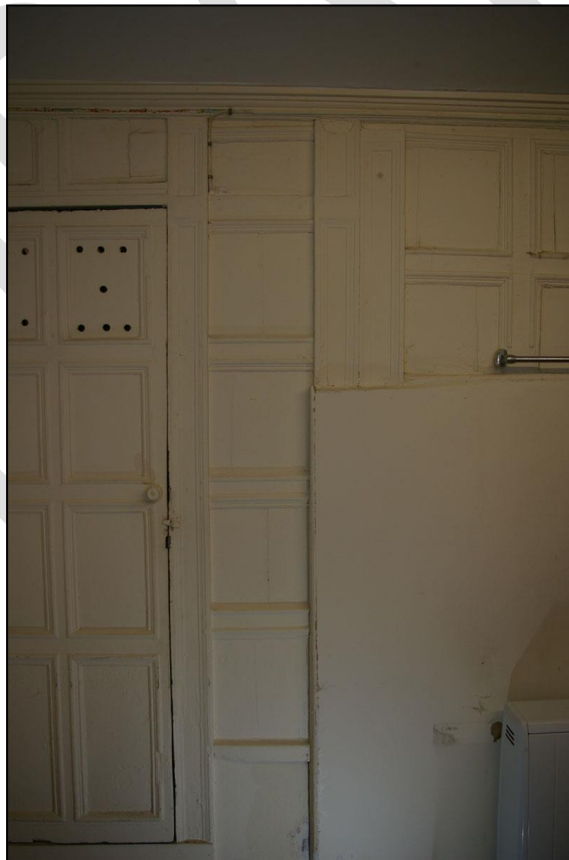
95. THE CUT AND RESET PANELLING AND PILASTERS TO THE SOUTH OF THE BLOCKED FIREPLACE; FROM THE EAST.
