79 HEAVITREE ROAD

RESULTS OF AN ARCHAEOLOGICAL EVALUATION AND RAPID BUILDING RECORDING

SOUTH WEST ARCHAEOLOGY LTD. REPORT NO. 181002

79 Heavitree Road, Exeter, Devon Results of an Archaeological Evaluation and Rapid Building Recording

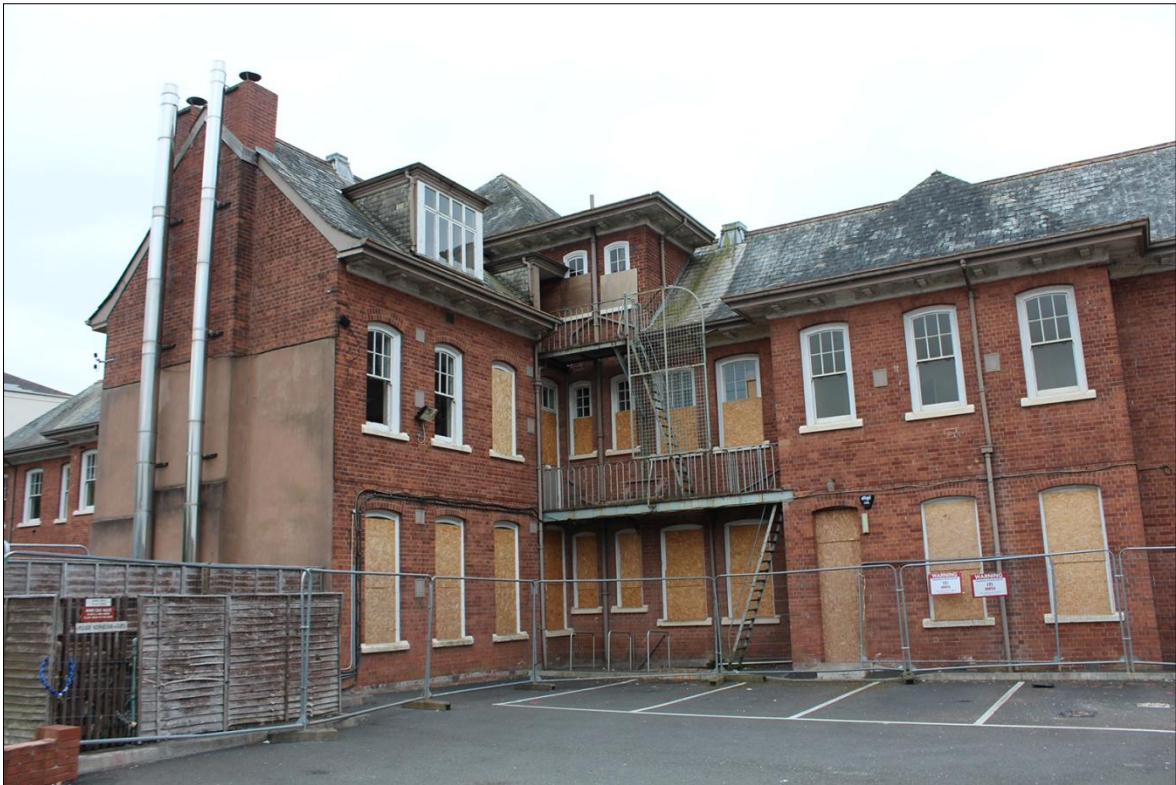
FIGURE 8: THE REAR (NORTH-EAST) ELEVATION OF THE BUILDING; VIEWED FROM THE NORTH.

The rear (north-east) elevation presents a more complex picture. The projecting central rear service wing has clearly been truncated, with cement render repairs contrasting to the brickwork. Historic mapping depicts a long narrow T-shaped projection here, of which the basement survives

(not accessible). As with the front elevation, the rear elevation is defined by shallow intermediate wings brought forward, though each of has a rear doorway with fanlights over. The elevation has the same nine-over-one arched horned sashes to ground floor and six-over-one horned sashes to first floor. However, the surround is simpler, with plain segmental brick arches and lacking the notched plinth below. The central block of the main range rises to a third storey with four-over-one pane horned sash windows; the projecting rear wing has four-light casements in flat-roofed projecting dormers to the second floor. To the rear west side, in the angle between the main range and the rear wing, is a small slate-hung structure that leads to a wrought-iron fire escape stair supported on iron girders.

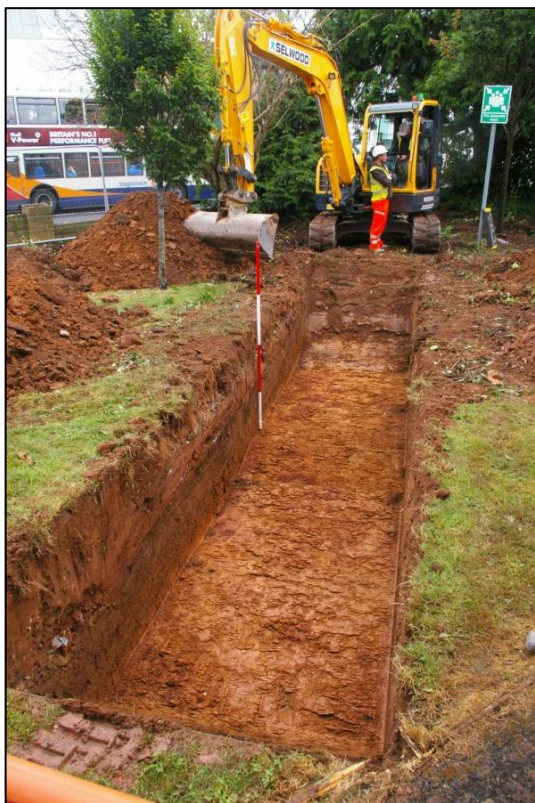
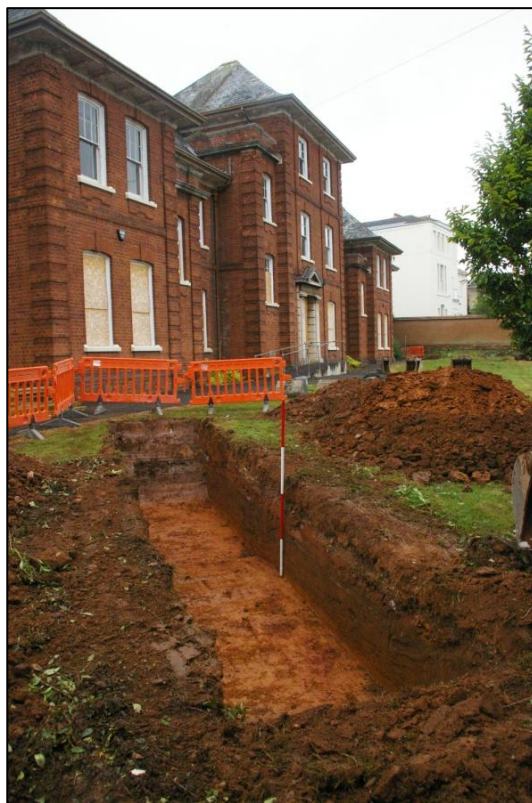
13. LEFT: TRENCH 01 POST-EXCAVATION; VIEWED FROM THE EAST (2M SCALE).

14. RIGHT: TRENCH 01 POST-EXCAVATION; VIEWED FROM THE WEST (2M SCALE).

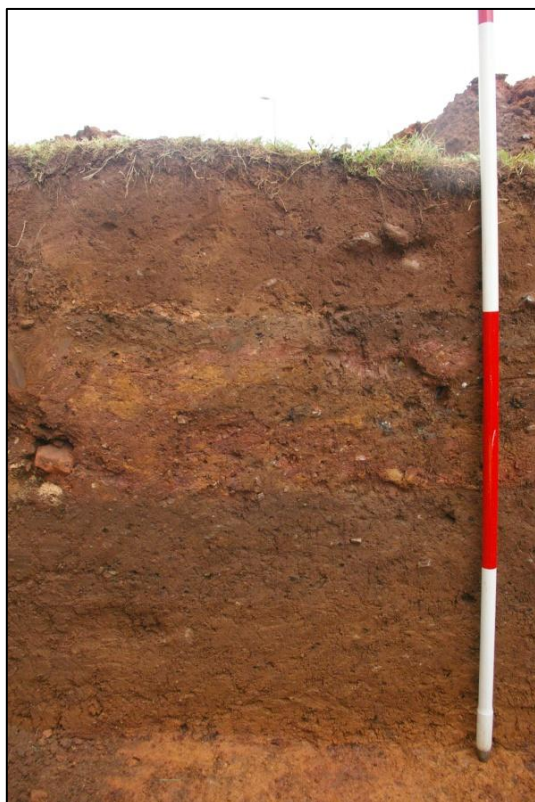
15. LEFT: TRENCH 01 DETAIL OF NORTH FACING REPRESENTATIVE SECTION; VIEWED FROM THE NORTH (PARTIAL 2M SCALE).

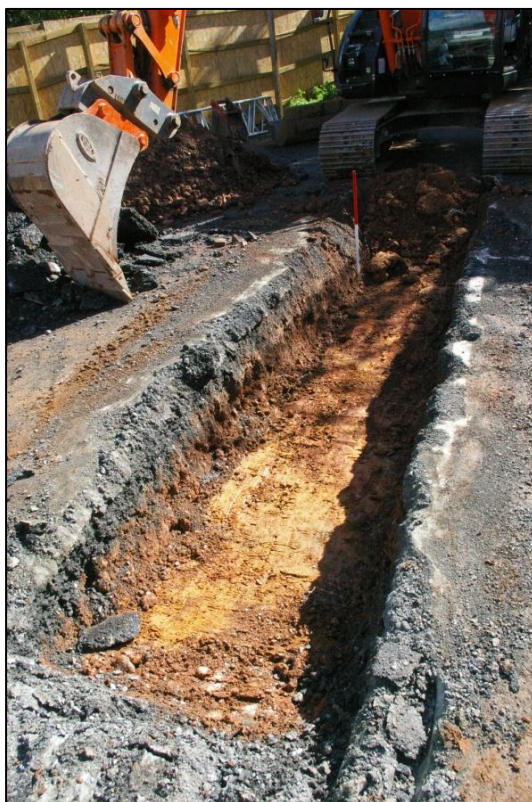
16. RIGHT: TRENCH 02 POST-EXCAVATION; VIEWED FROM THE NORTH-EAST (1M SCALE).

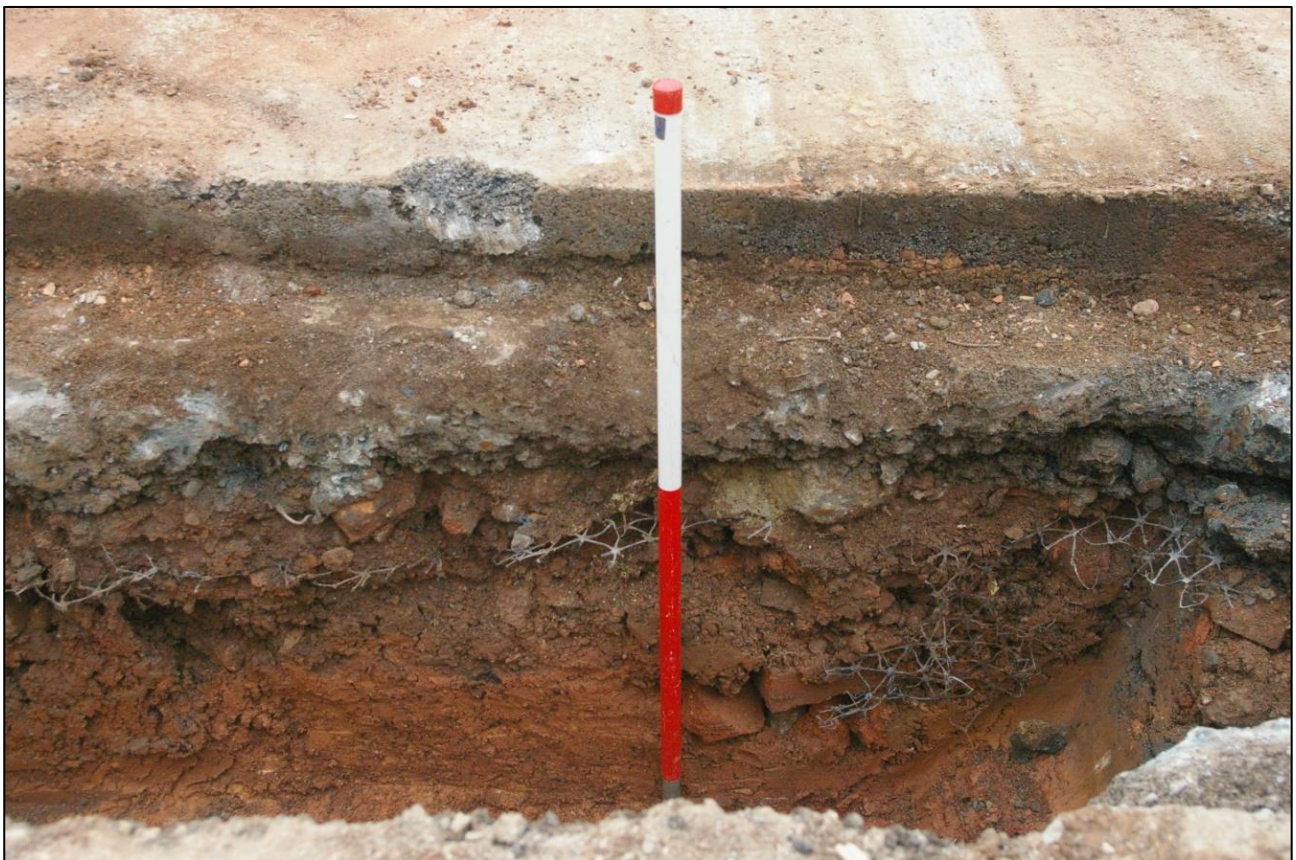
- 19. TRENCH 03 DETAIL OF NORTH-EAST FACING REPRESENTATIVE SECTION; VIEWED FROM THE NORTH-EAST (1M SCALE).

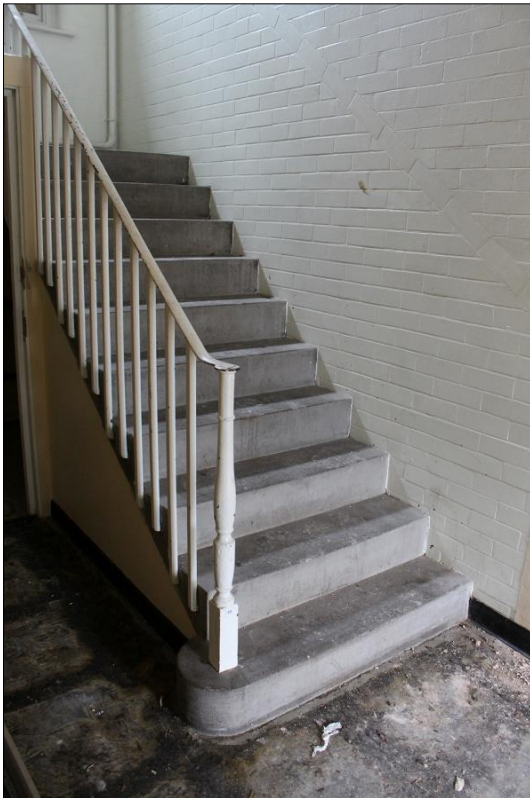
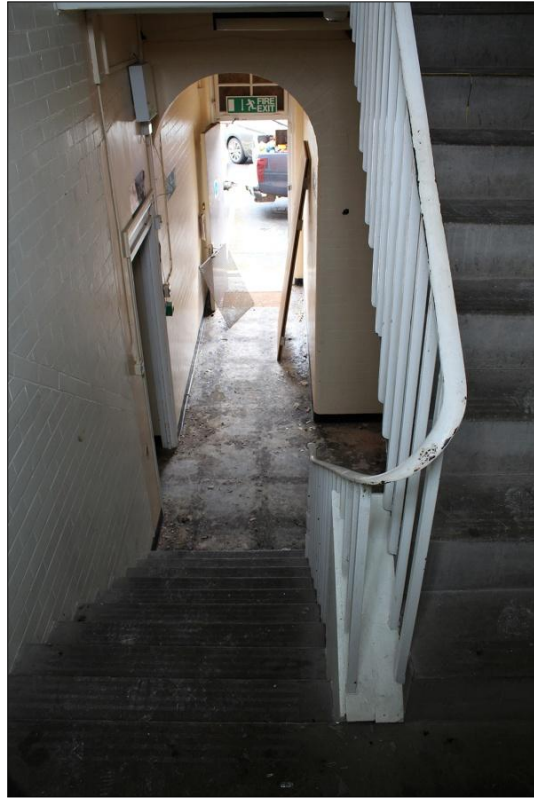
LEFT: 34. DETAIL OF STAIRWELL IN ROOM 32, EAST WING OF BUILDING; VIEWED FROM THE NORTH-EAST.

RIGHT: 35. VIEW DOWN STAIRWELL (ROOM 33) THROUGH ROOMS 32 AND 31 TO REAR EXIT, EAST WING; VIEWED FROM THE SOUTH-WEST.

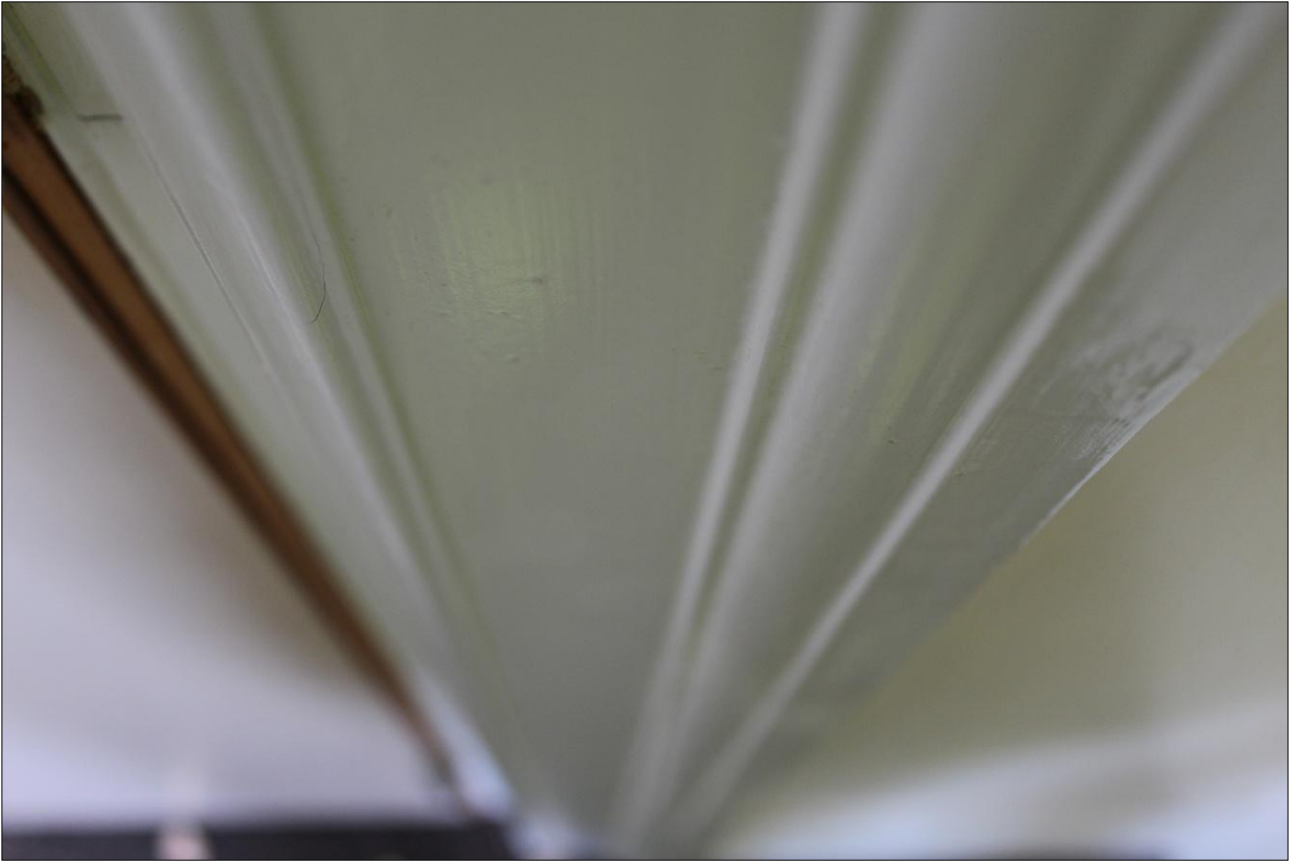
54. DETAIL OF THE MOULDINGS ON THE DOOR FRAME, NORTH-EAST WALL, ROOM F4; VIEWED FROM THE SOUTH-WEST.

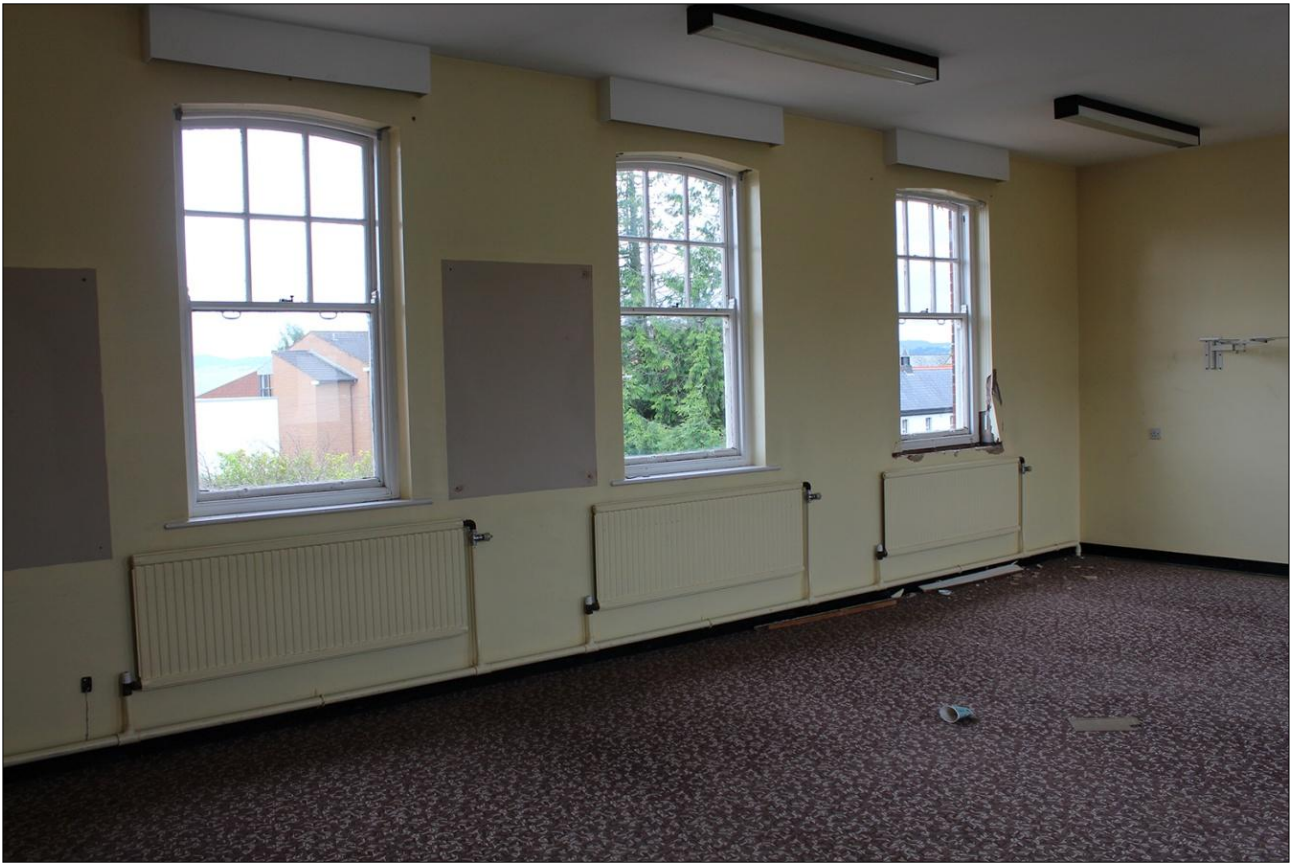
56. VIEW OF ROOM F1, WINDOW OPENINGS IN SOUTH-WEST WALL; VIEWED FROM THE EAST.

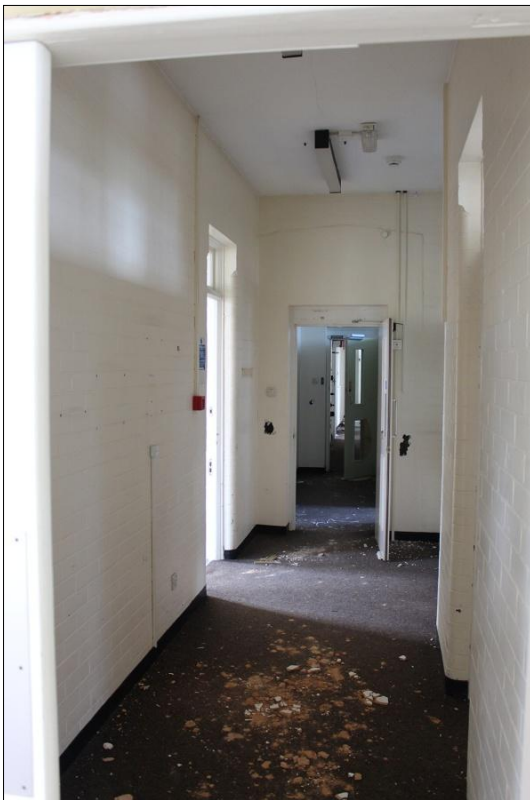
LEFT: 57. VIEW ALONG CORRIDOR ROOM F3; VIEWED FROM THE NORTH-WEST.

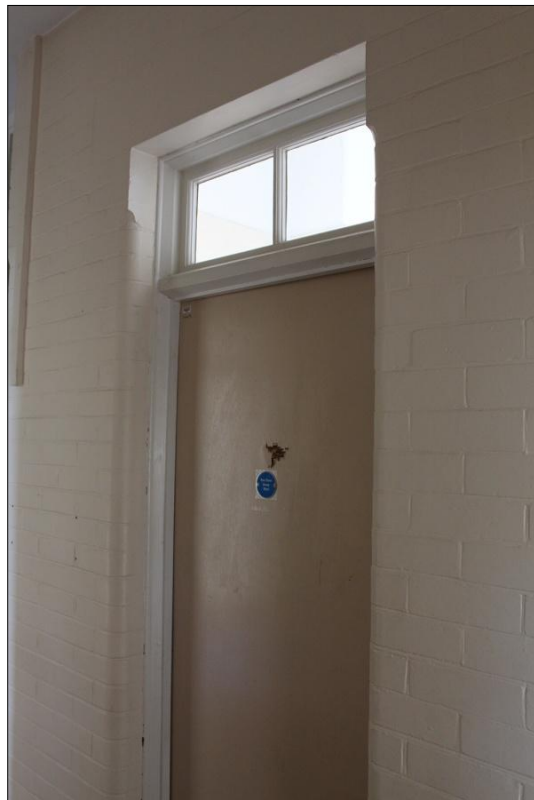
RIGHT: 58. DETAIL OF THE DOOR OPENING (TO ROOM F4) IN THE SOUTH-WEST INTERNAL WALL ROOM F3; VIEWED FROM THE NORTH-WEST.

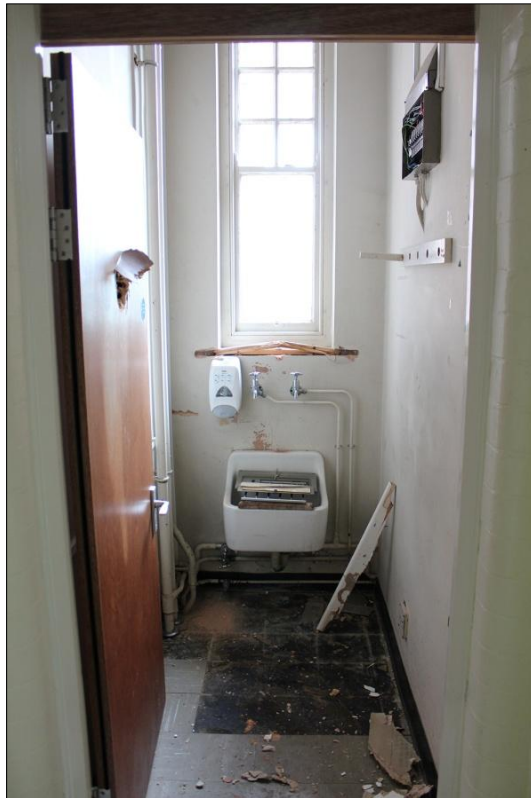
63. DETAIL OF F15 SHOWING INDICATING FORMER FUNCTION AS BATHROOM; VIEWED FROM THE SOUTH-WEST.

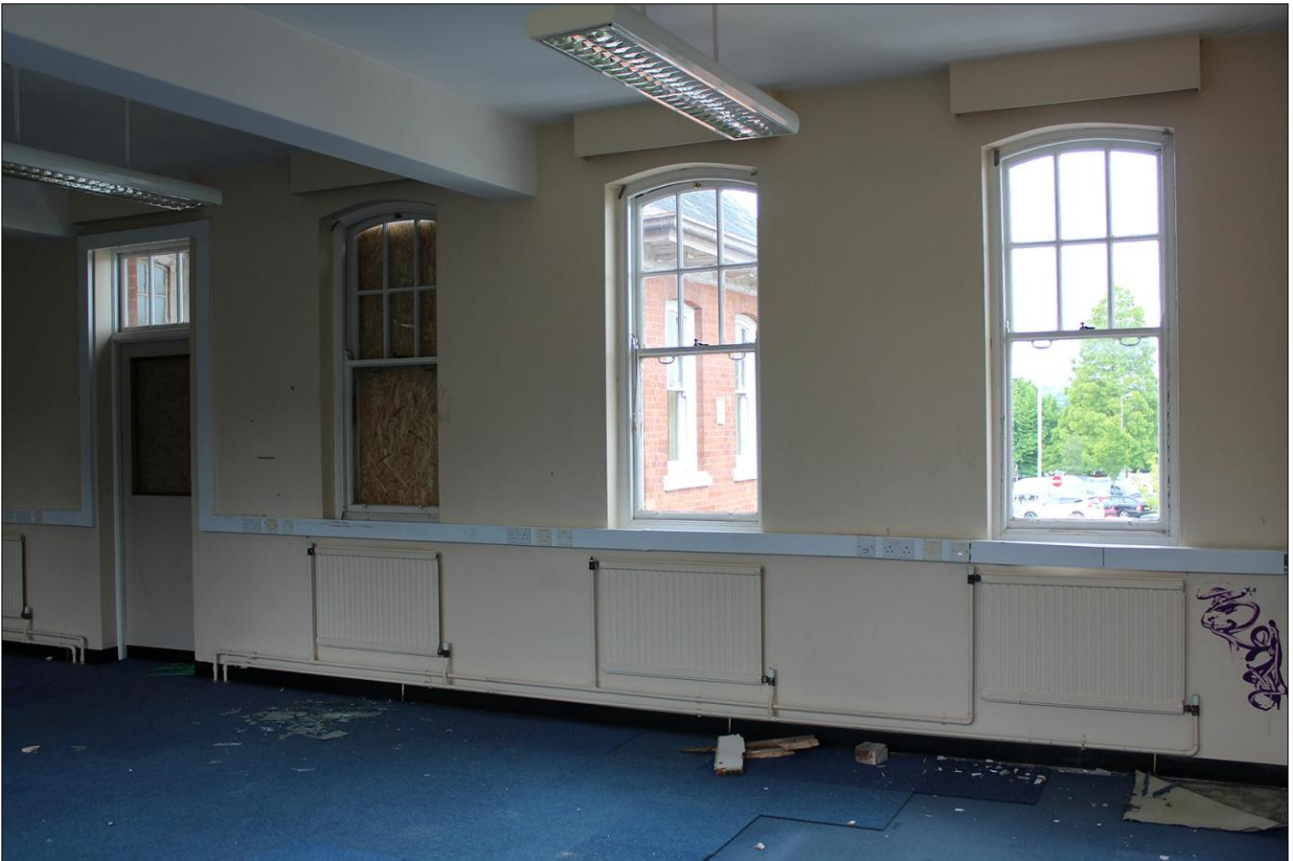
65. DETAIL OF ROOM F12 SHOWING WINDOW OPENINGS IN THE NORTH-EAST WALL; VIEWED FROM THE SOUTH-EAST.

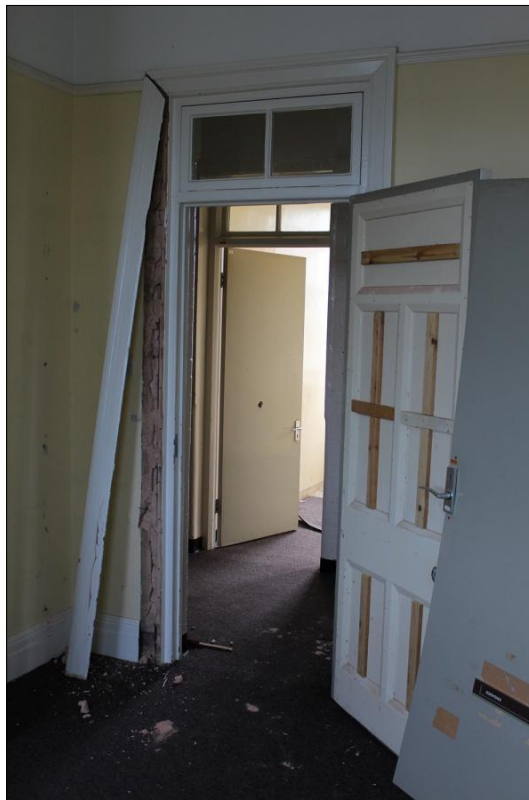
66. VIEW OF THE DOOR IN THE NORTH-EAST WALL OF ROOM F25, DEMONSTRATING IT TO BE A 1913 ORIGINAL; VIEWED FROM THE SOUTH-EAST.

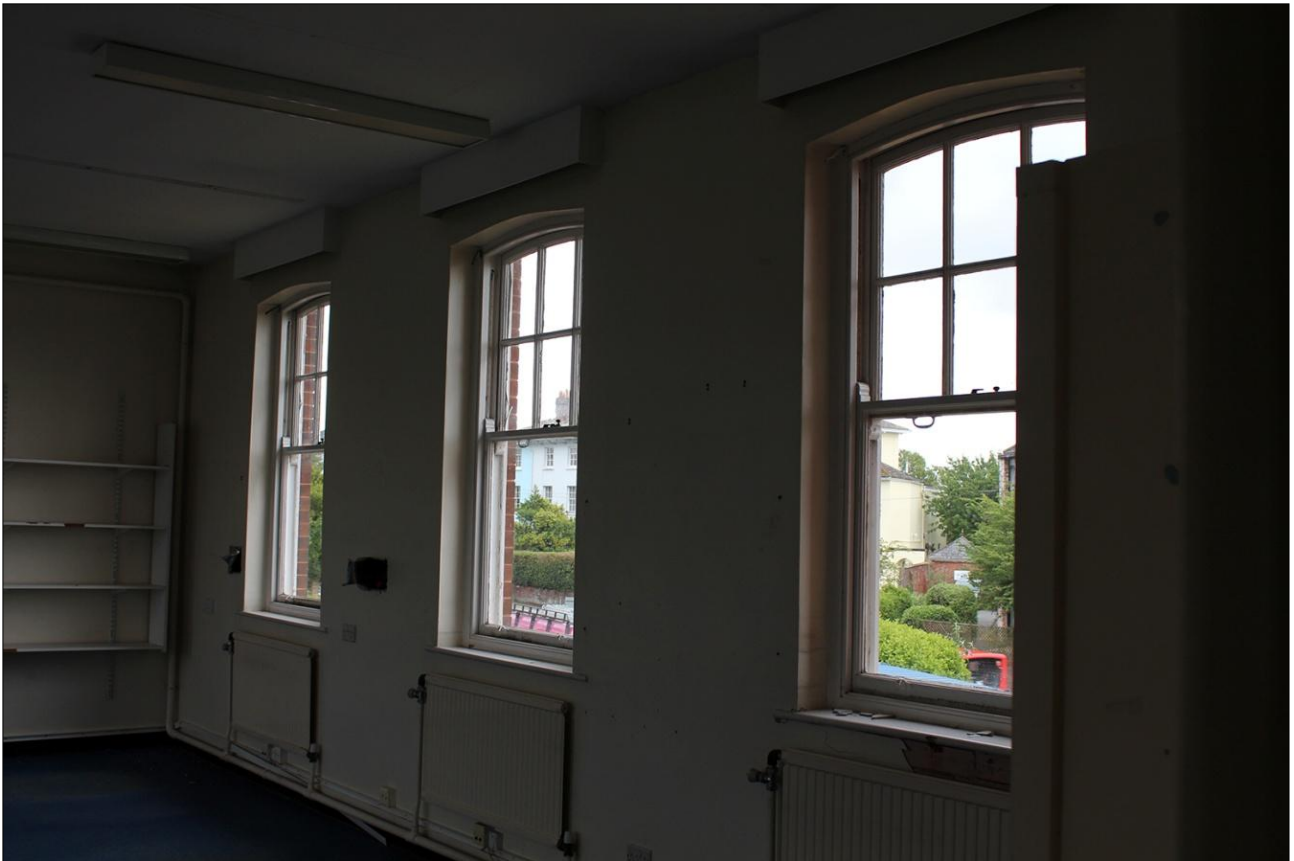
67. DETAIL OF WINDOW OPENINGS IN THE SOUTH-WEST WALL OF ROOM F26; VIEWED FROM THE NORTH-WEST.

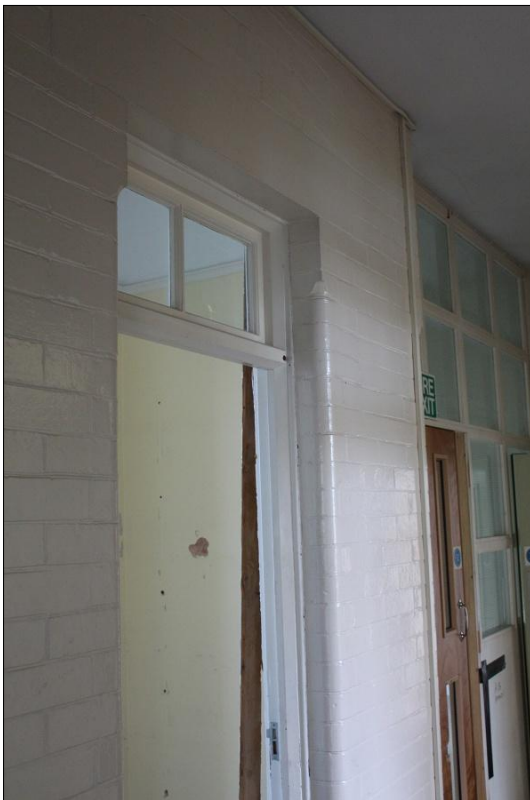
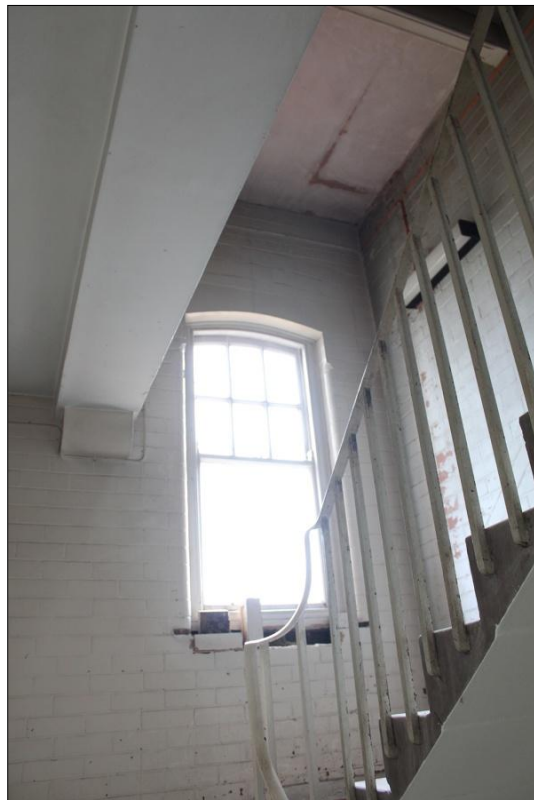
LEFT: 68. DETAIL OF DOOR OPENING IN SOUTH-WEST INTERNAL WALL CORRIDOR F24 (INTO F25); VIEWED FROM THE NORTH-EAST.
RIGHT: 69. DETAIL OF WINDOW OPENING IN SOUTH-WEST WALL OF FIRST FLOOR LANDING TO ROOM G17; VIEWED FROM THE NORTH-EAST.

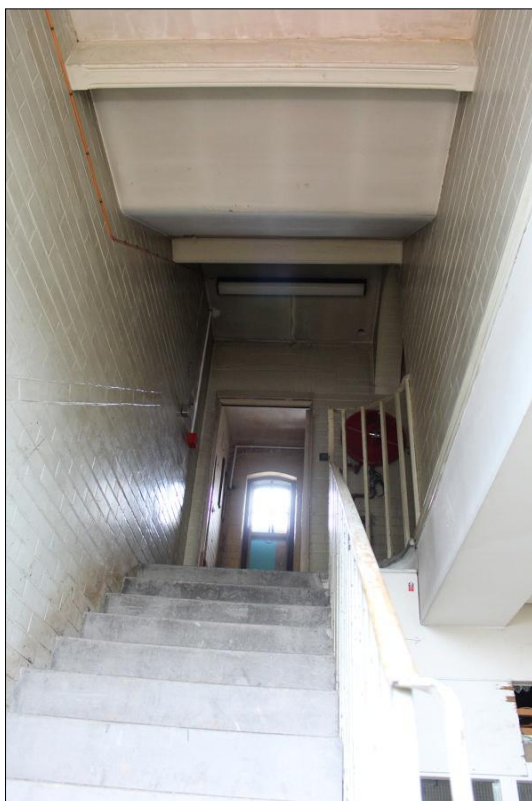
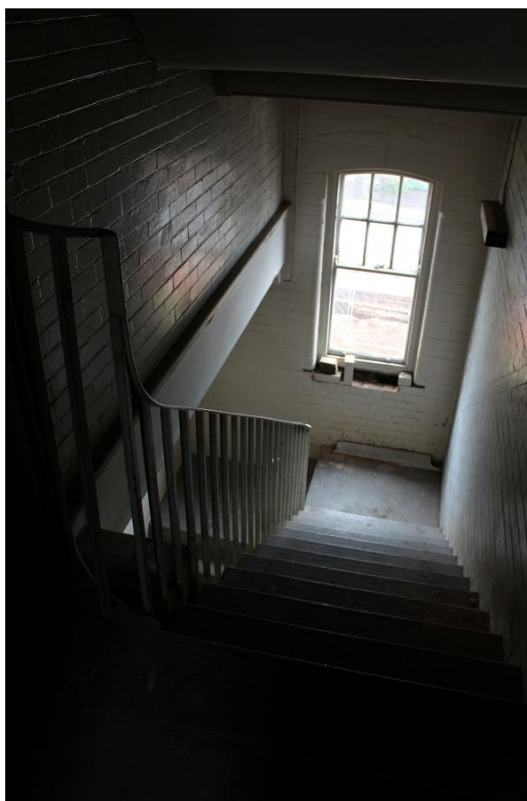
LEFT: 70. VIEW OF STAIRWELL G7 UP TO SECOND FLOOR LANDING; VIEWED FROM THE SOUTH-WEST.

RIGHT: 71. DETAIL OF WINDOW OPENING IN SOUTH-WEST INTERNAL WALL STAIRWELL G7 FROM SECOND FLOOR LANDING; VIEWED FROM THE NORTH-EAST.

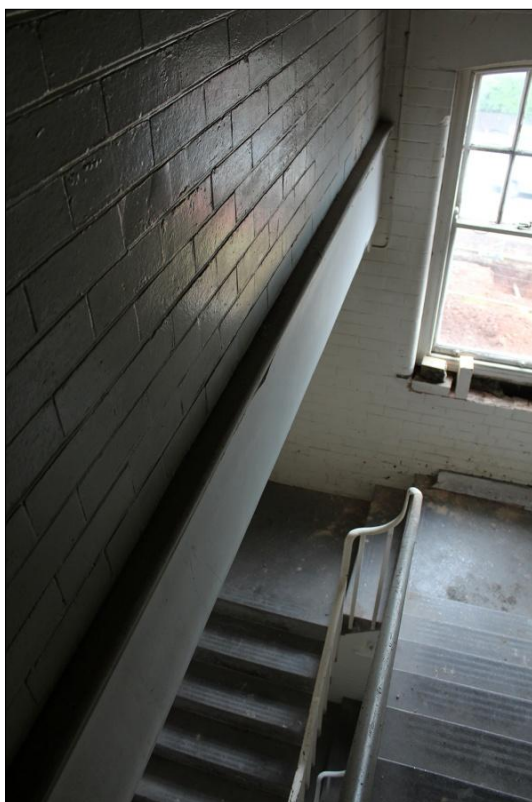
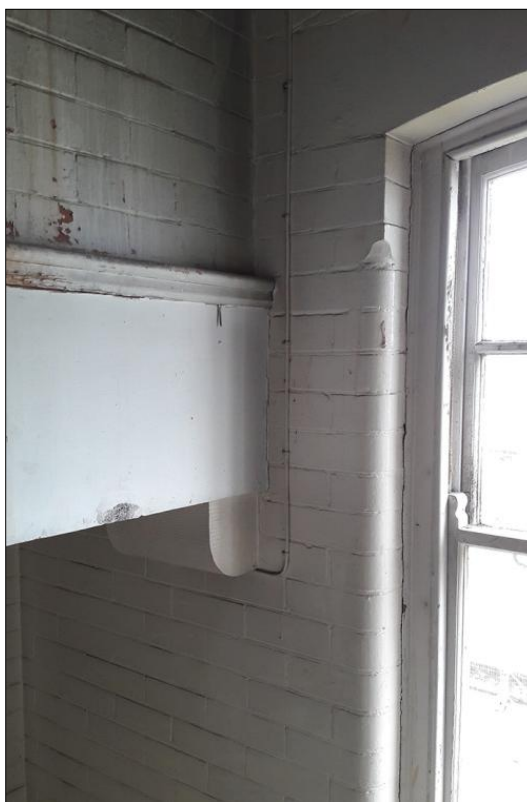
LEFT: 72. DETAIL OF STAIRWELL G7 FROM SECOND FLOOR LANDING; VIEWED FROM THE NORTH-EAST.

RIGHT: 73. DETAIL OF STAIRWELL G7 FROM SECOND FLOOR LANDING, SHOWING THE CORBEL SUPPORTING THE HEAVY BEAM; VIEWED FROM THE NORTH-EAST.

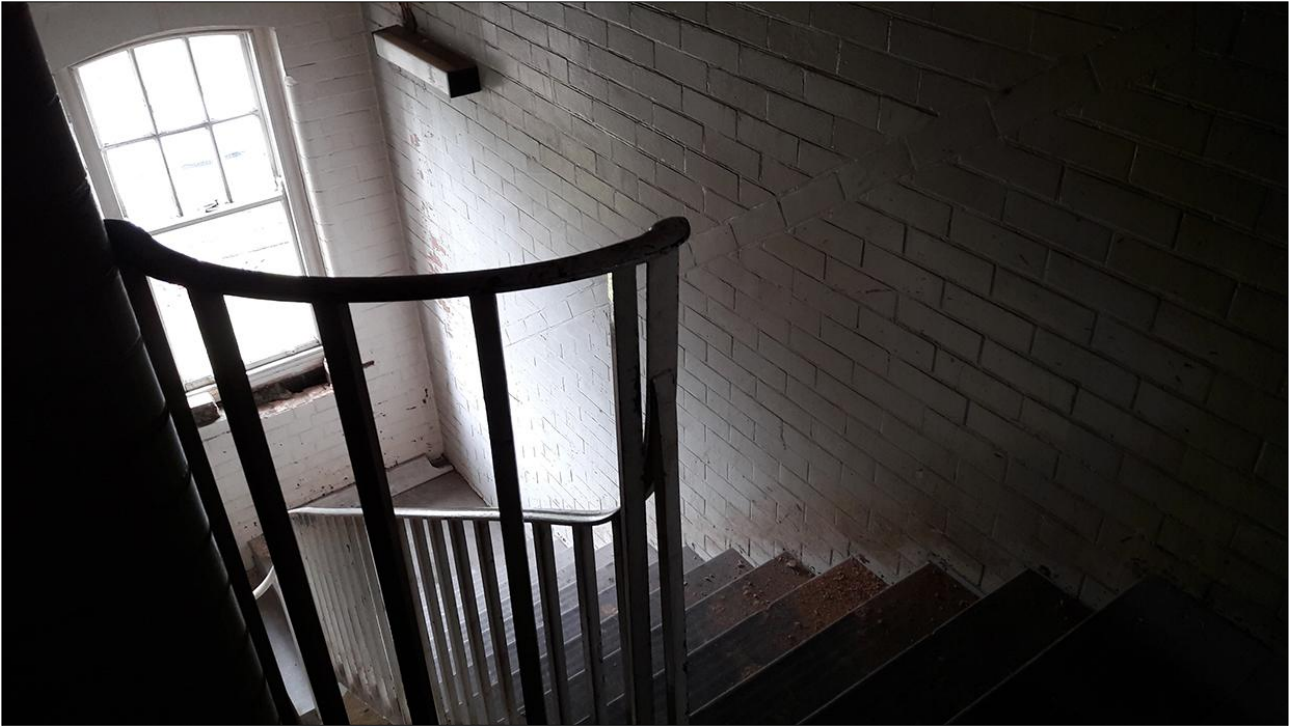
74. DETAIL OF STAIRWELL G7 FROM SECOND FLOOR LANDING; VIEWED FROM THE NORTH-EAST.

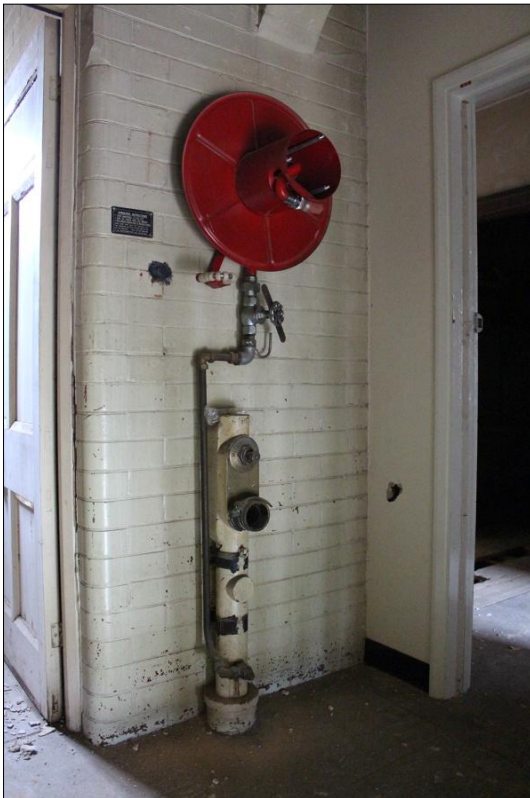
LEFT: 75. THE FIRE HYDRANT IN ROOM S3; VIEWED FROM THE WEST.

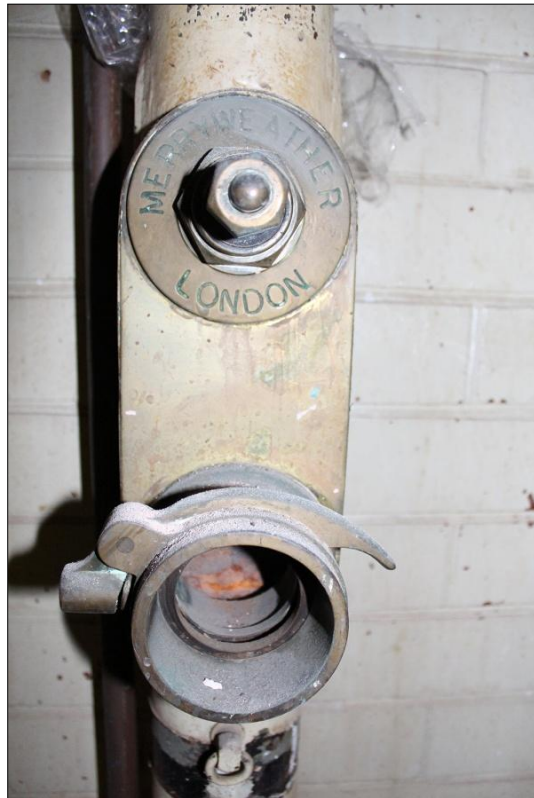
RIGHT: 76. DETAIL OF THE FIRST HYDRANT IN ROOM S3; VIEWED FROM THE WEST.

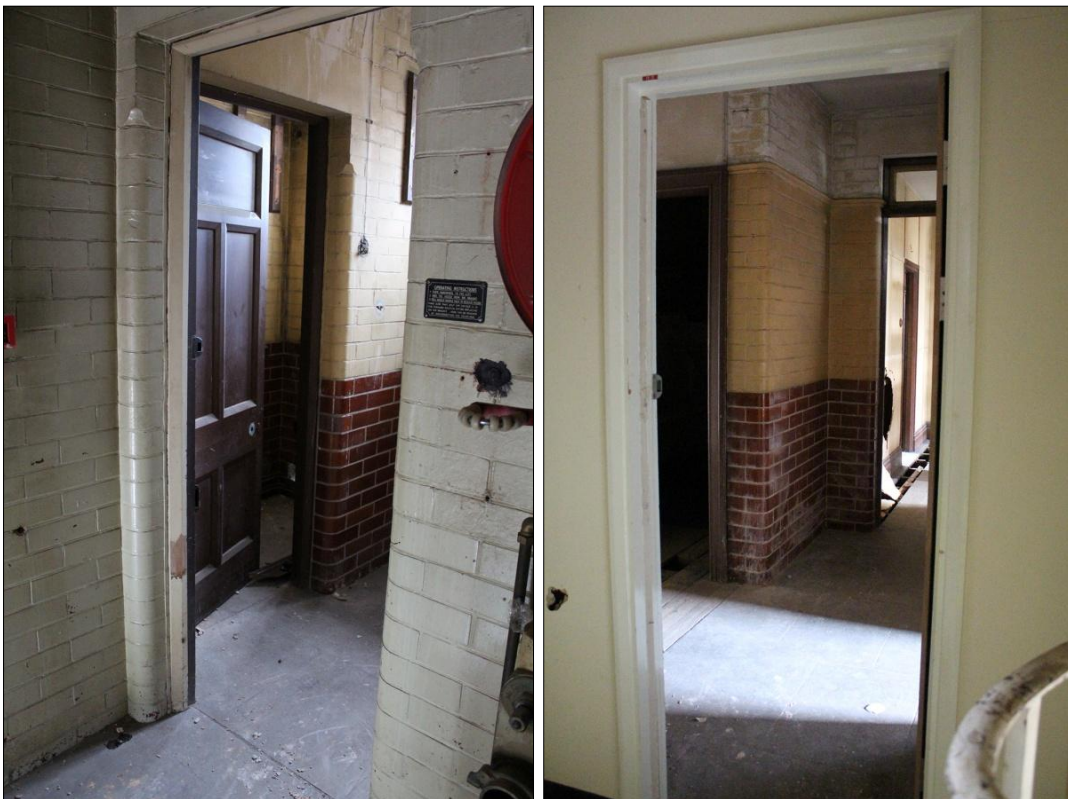
LEFT: 78. DETAIL OF DOOR OPENING IN NORTH-EAST WALL OF ROOM S3, LOOKING THROUGH INTO S2; VIEWED FROM THE SOUTH.

RIGHT: 79. DETAIL OF DOOR OPENING IN SOUTH-EAST WALL OF ROOM S3, LOOKING THROUGH INTO S5; VIEWED FROM THE NORTH-WEST.

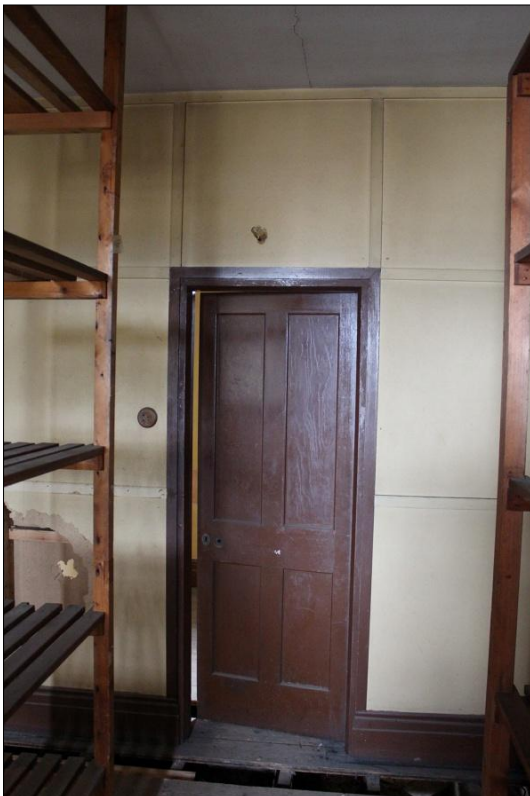
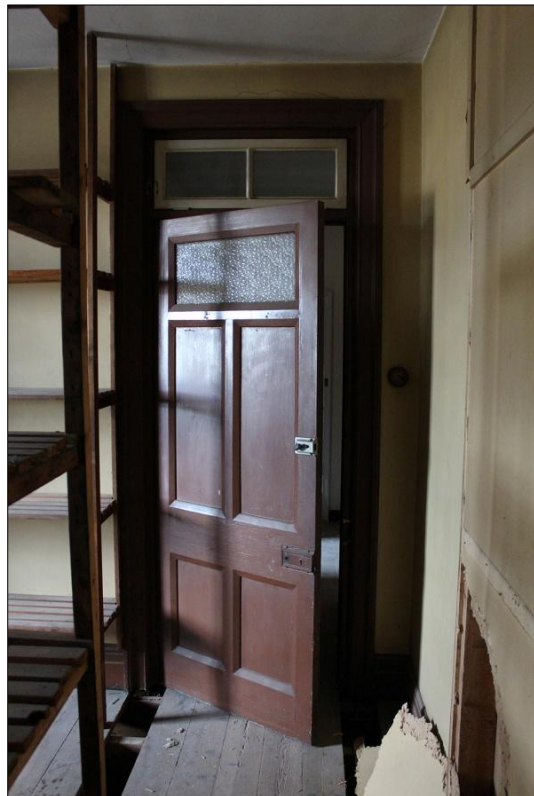
LEFT: 84. DETAIL OF THE DOOR OPENING IN THE NORTH-EAST WALL OF ROOM S12; VIEWED FROM THE SOUTH-WEST.
RIGHT: 85. DETAIL OF THE DOOR OPENING IN THE NORTH-WEST WALL OF ROOM S12; VIEWED FROM THE SOUTH-EAST.

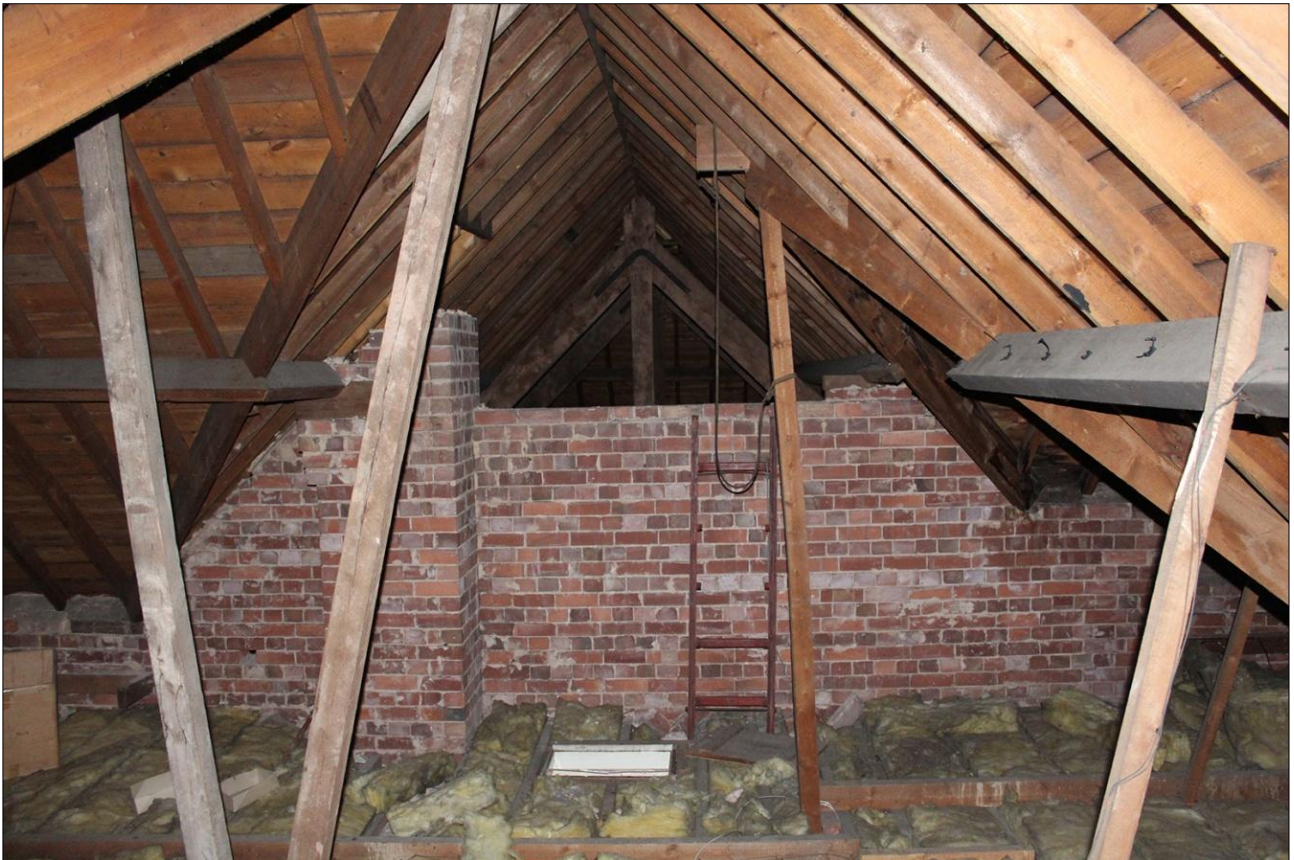
88. DETAIL OF THE ROOF STRUCTURE WITHIN ROOM S13 WITH DIVIDING BRICKWORK; VIEWED FROM THE NORTH-WEST.

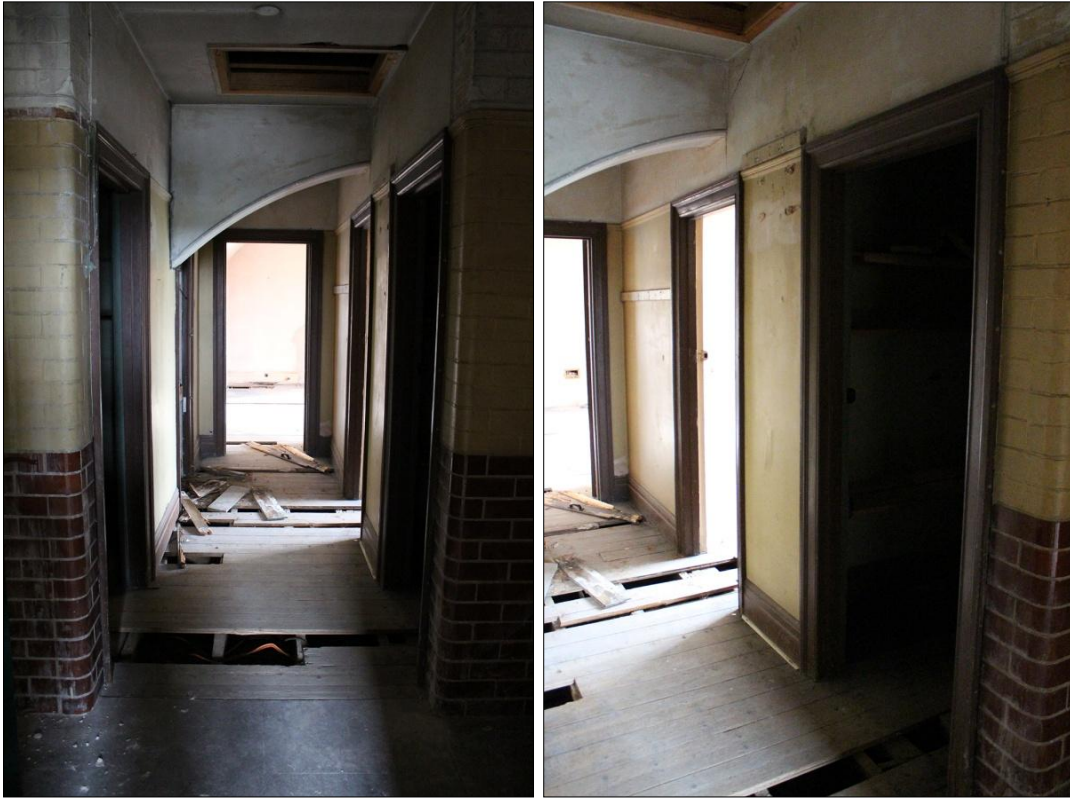
LEFT: 89. VIEW ALONG CORRIDOR S8; VIEWED FROM THE SOUTH-WEST.

RIGHT: 90. DETAIL OF DOOR OPENINGS IN THE SOUTH-EAST WALL OF CORRIDOR S8; VIEWED FROM THE WEST.

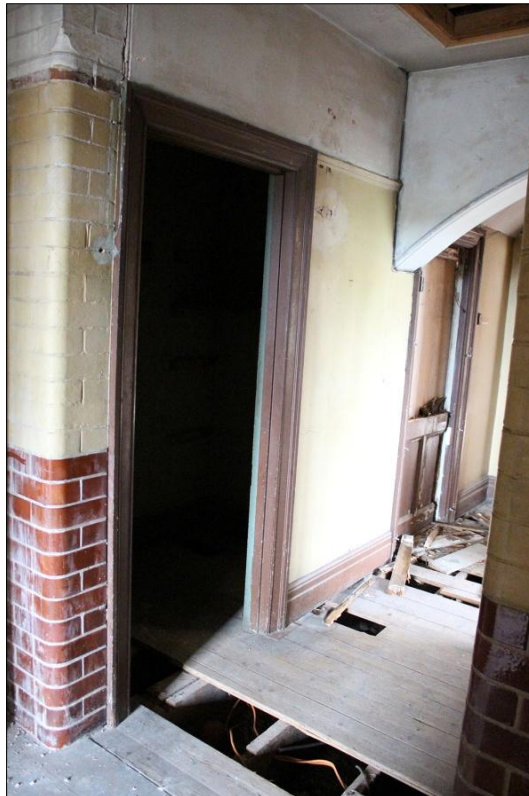
91. DETAIL OF THE DOOR OPENINGS IN THE NORTH-WEST WALL OF CORRIDOR S8; VIEWED FROM THE SOUTH-EAST.

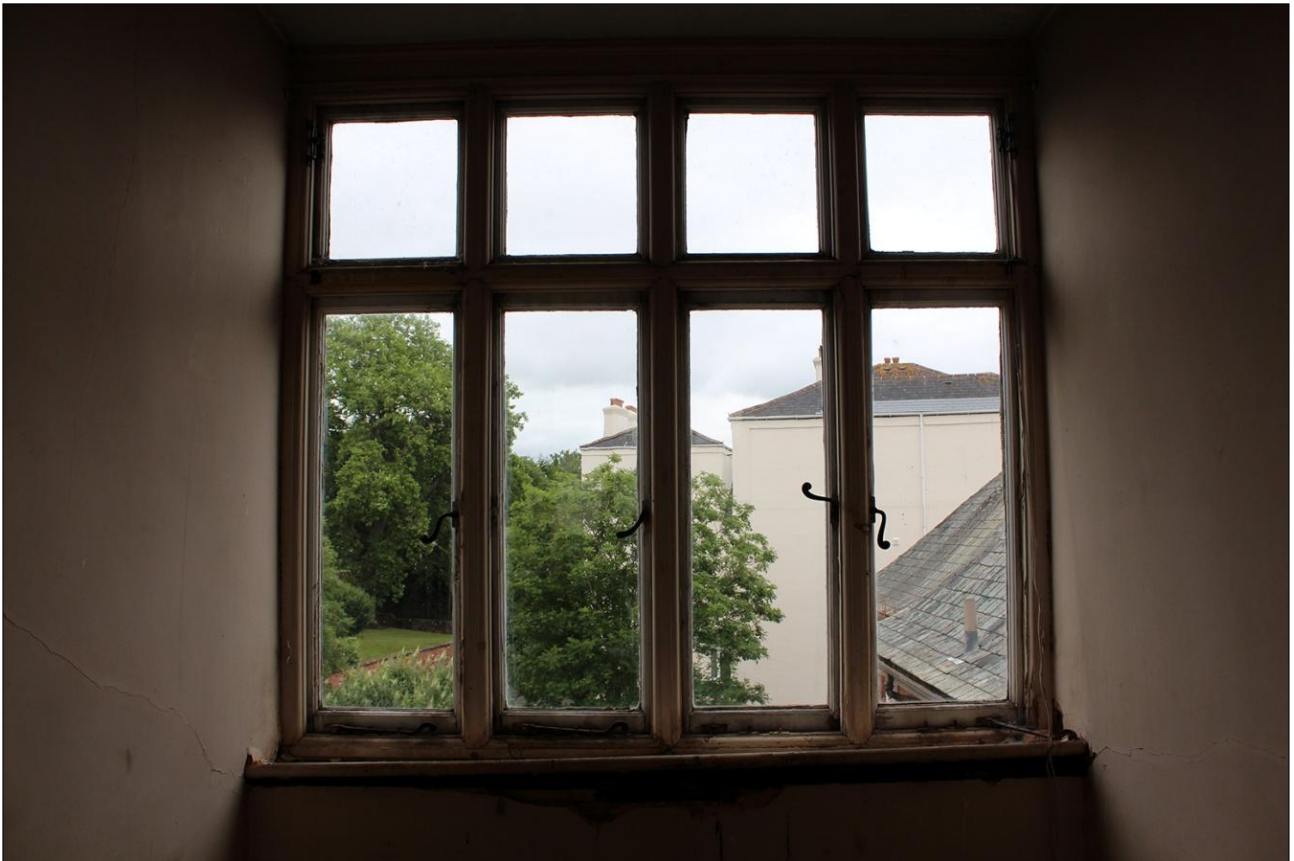
97. DETAIL OF THE WINDOW OPENING IN THE SOUTH-EAST WALL OF ROOM S7; VIEWED FROM THE NORTH-WEST.
