# ASHREIGNEY METHODIST CHAPEL

HISTORIC BUILDING RECORDING

SOUTH WEST ARCHAEOLOGY LTD. REPORT NO. 181102

Draft issued: 6<sup>th</sup> November 2018  
Finalised: 2018

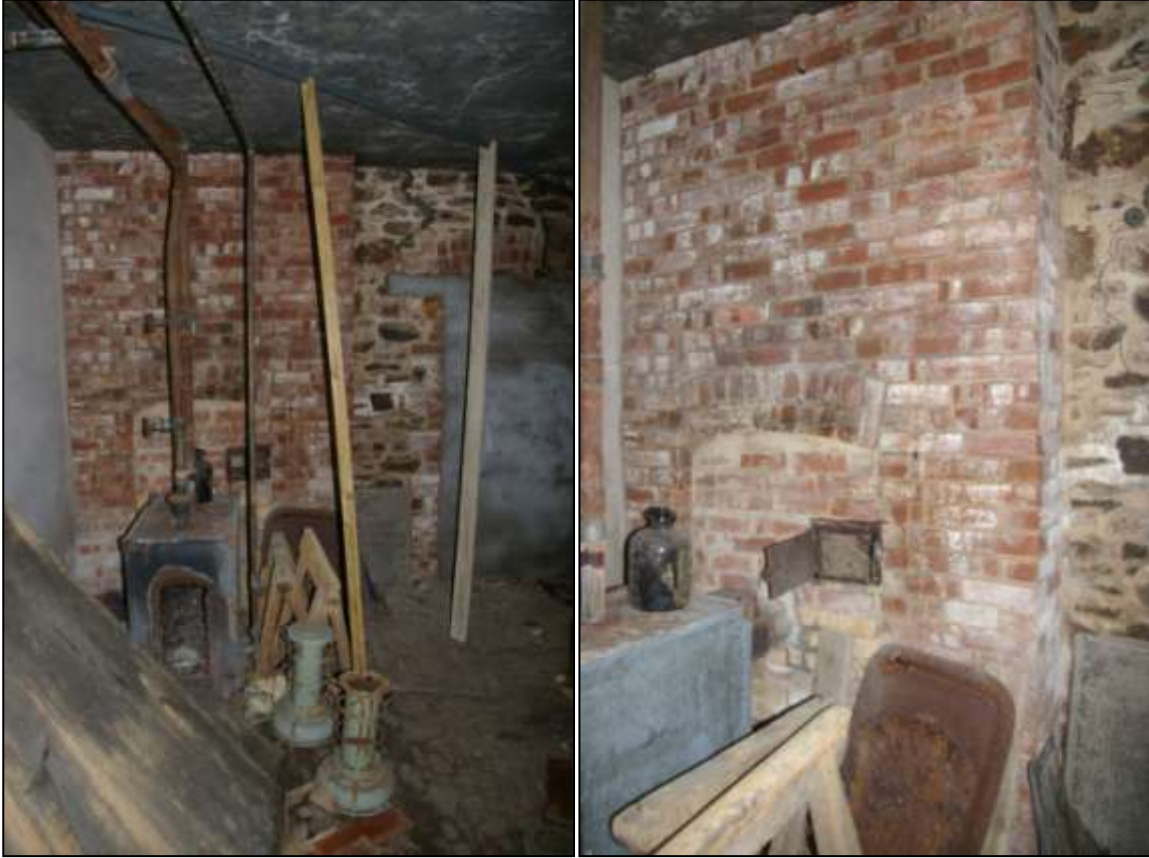
Openings Windows:	– 1	W22 - Fine arched tripartite window to the east wall, described with elevation.
Significant Details:		Britannia cast iron boiler and heavy duty pipes to the south-east corner, standing next to earlier brick flue for presumably wood heating?

29. LEFT: THE BOILER WITH ITS BRICK FLUE; FROM THE NORTH.

30. RIGHT: THE BRICK STACK, WITH BLOCKED FIREPLACE AND INSET IRON HATCH; FROM THE NORTH-WEST.

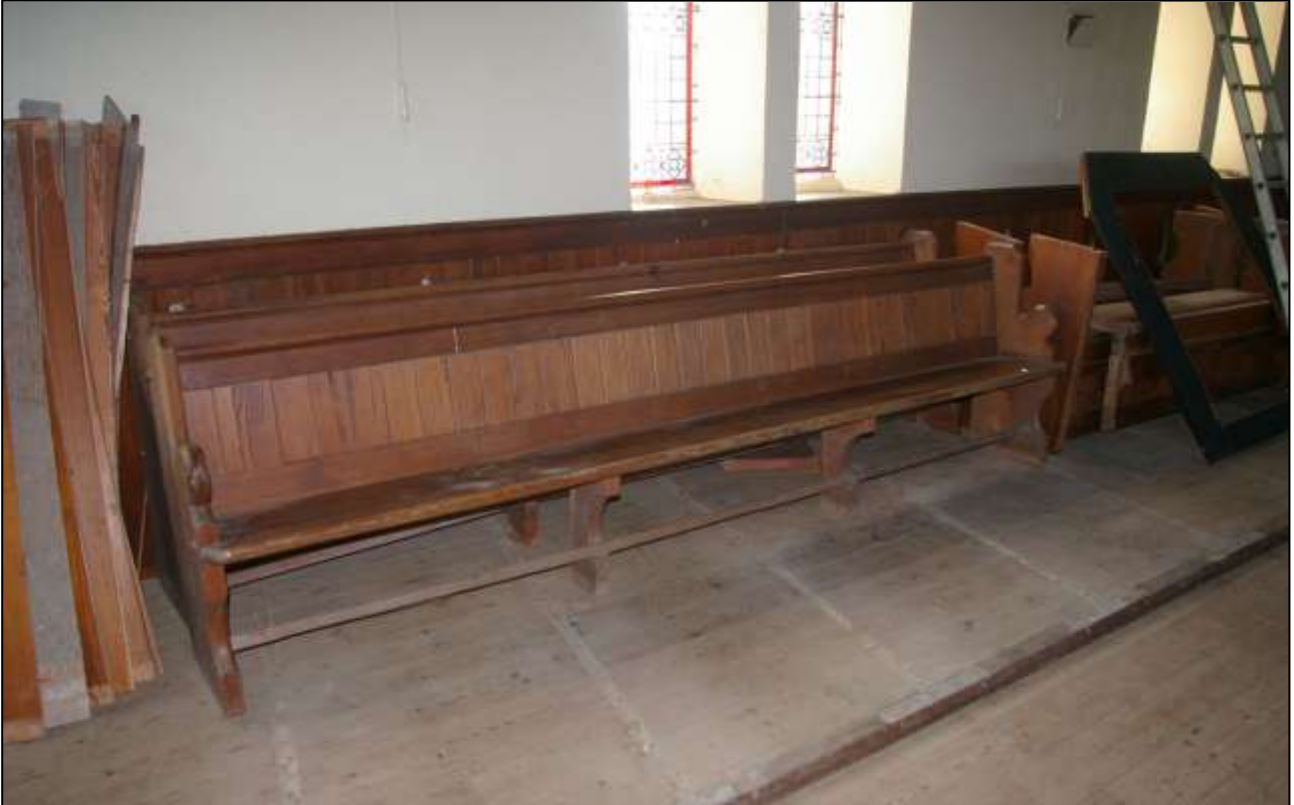
91. THE PITCH PINE FREESTANDING BENCHES FROM THE CENTRAL PART OF THE CHAPEL, NOW STORED TO THE SIDES; FROM THE NORTH-WEST.

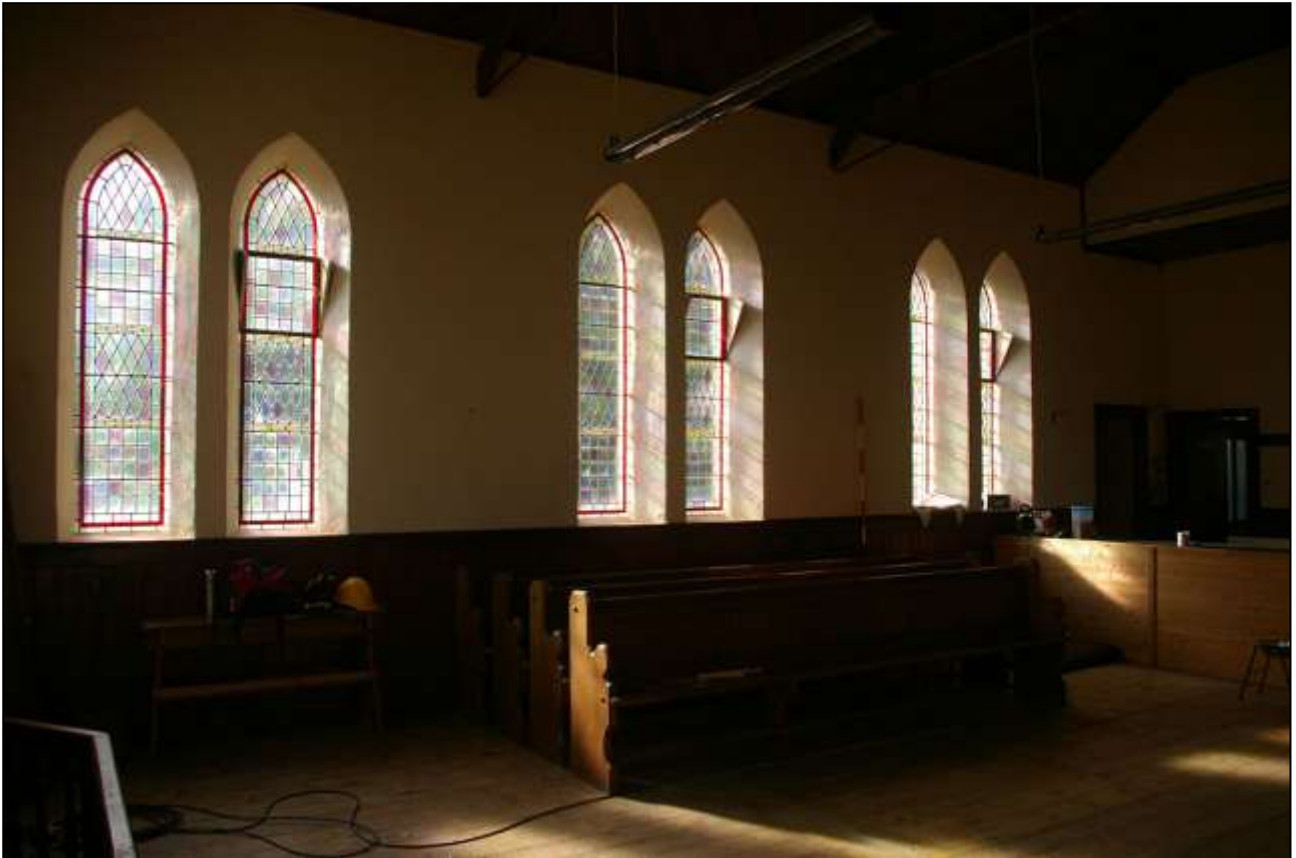
99. THE SOUTH WALL OF THE COMMUNITY HALL, WITH 2M SCALE; FROM THE NORTH-EAST.

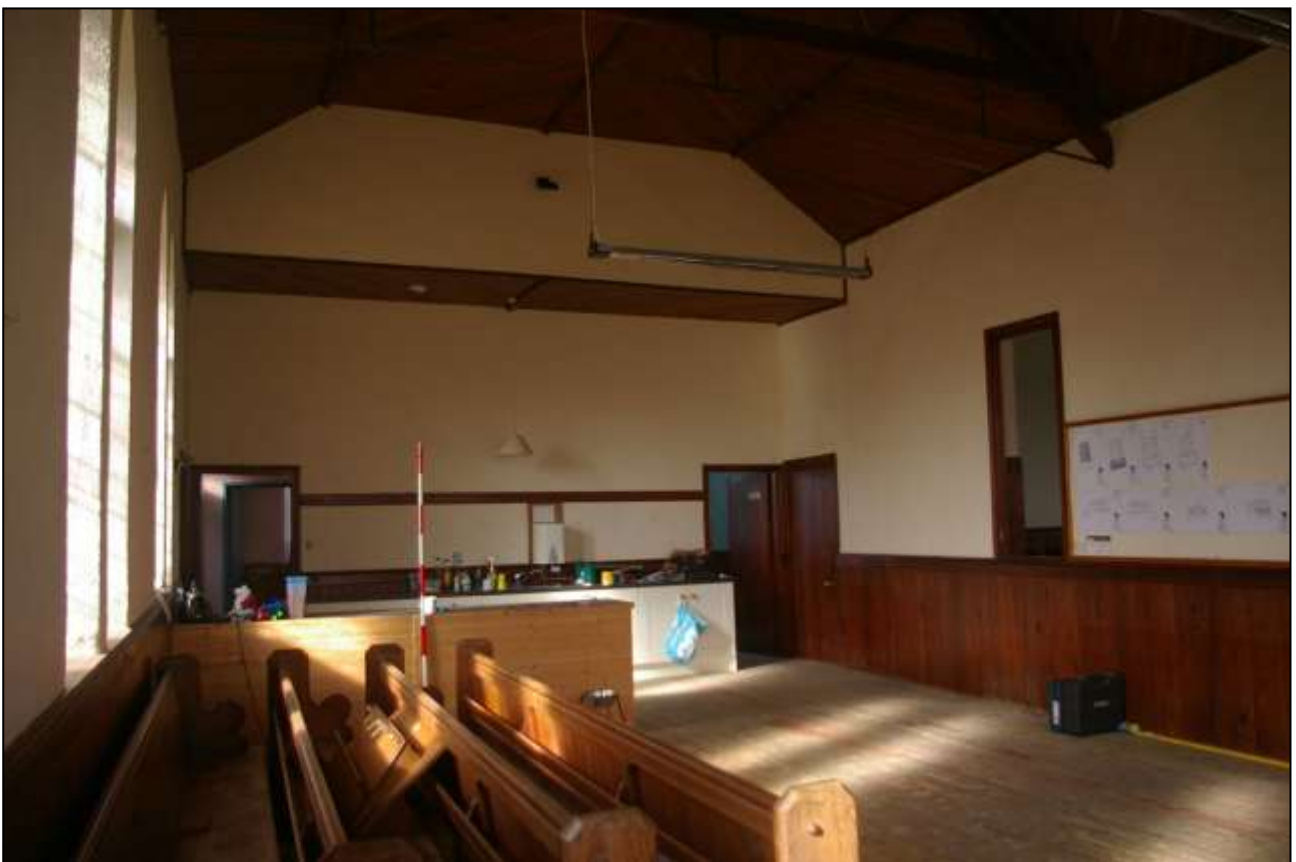
100. THE NORTH AND WEST WALL AND INSERTED MODERN KITCHEN FITMENTS, TWO ORIGINAL DOORS TO WEST TO OFFICE AND VESTRY; FROM THE SOUTH-EAST.

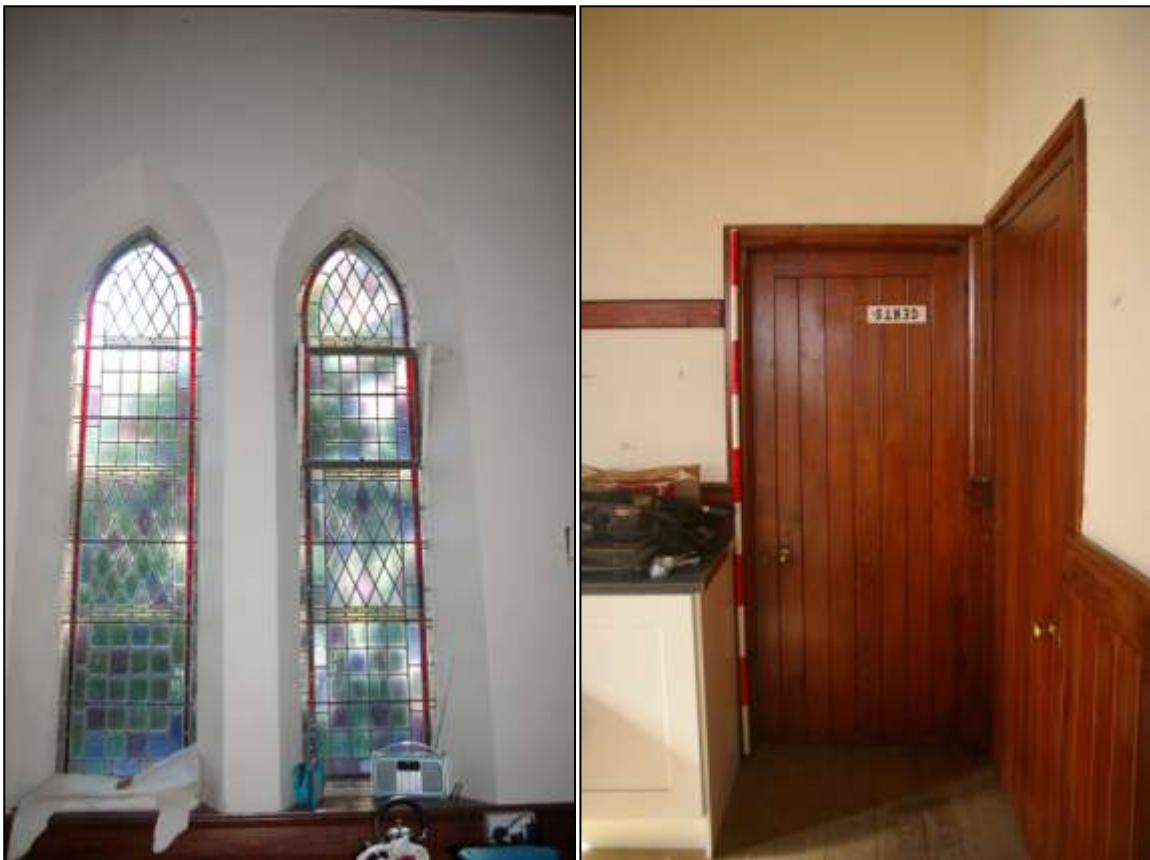
106. LEFT: WINDOW 16; FROM THE WEST.  
107. RIGHT: ONE OF THE ORIGINAL BOARDED AND FRAMED DOORS, LEADING TO THE THE GENTS TOILETS; FROM THE EAST.

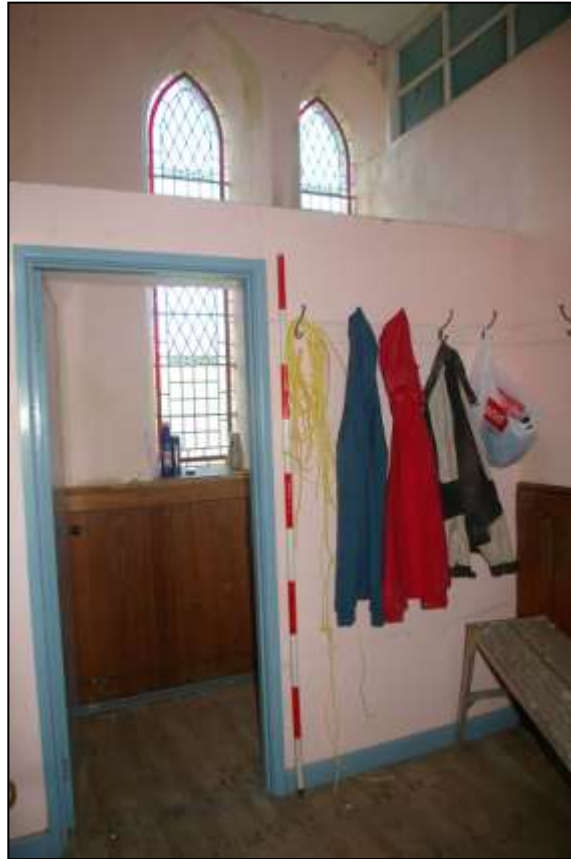
116. THE EVEN LATER PARTITION FORMING A LADIES TOILET CUBICLE; FROM THE SOUTH-EAST.

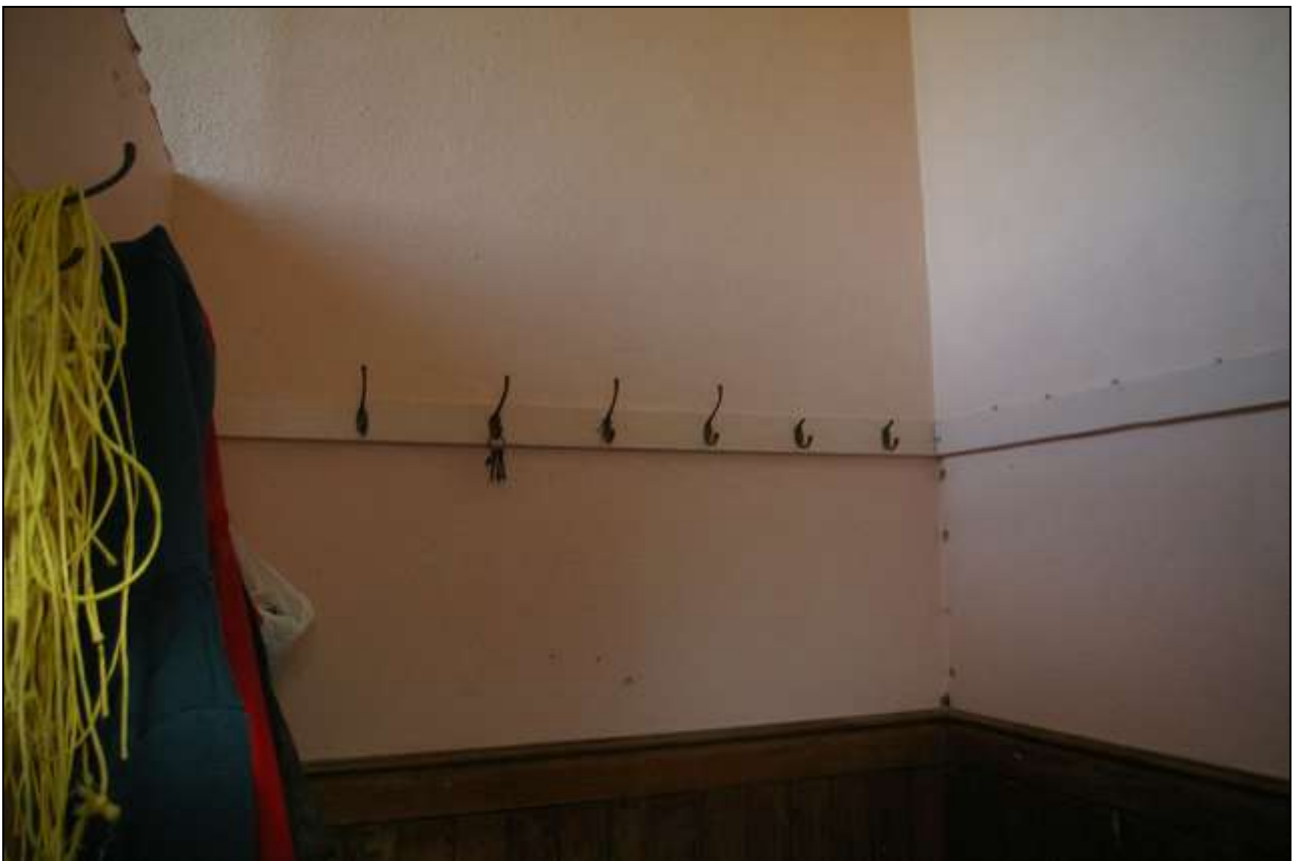
117. THE GOOD ROWS OF COAT HOOKS; FROM THE SOUTH-WEST.

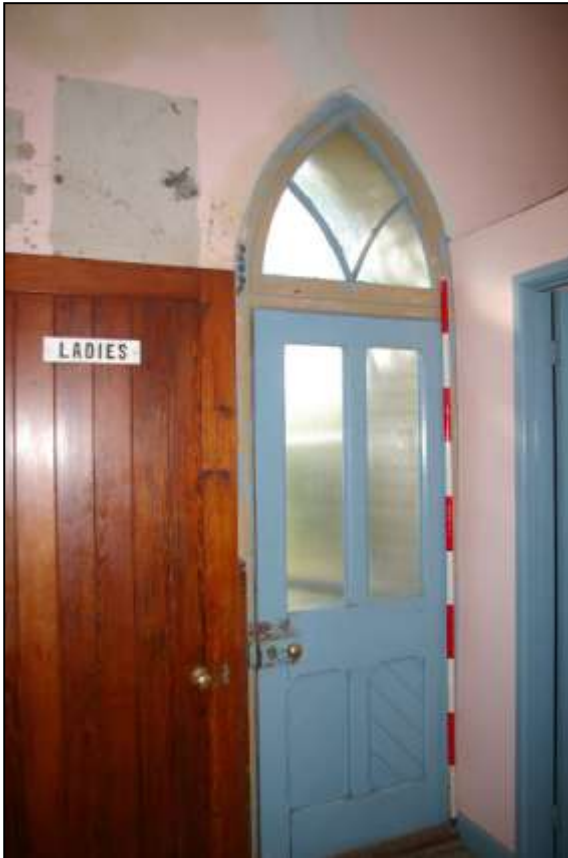
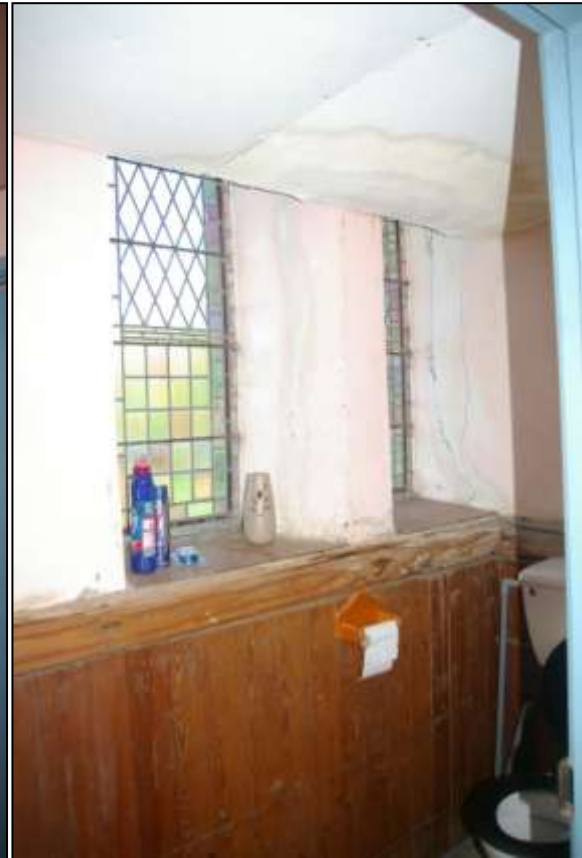
118. LEFT: D10, GOING TO THE REAR STAIRS; FROM THE NORTH-EAST.

119. RIGHT: VIEW OF THE LADIES CUBICLE SHOWING ORIGINAL WALL PANELLING UNDER WINDOW; FROM THE SOUTH-EAST.

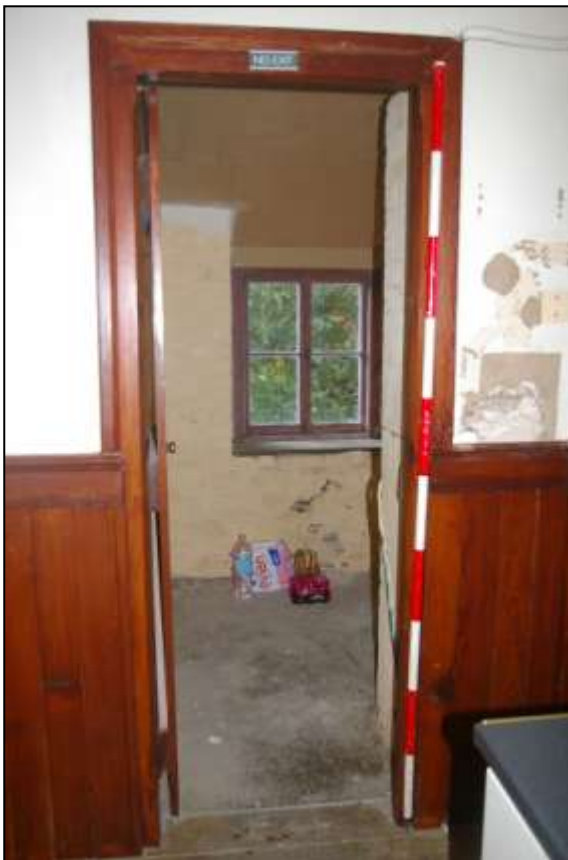
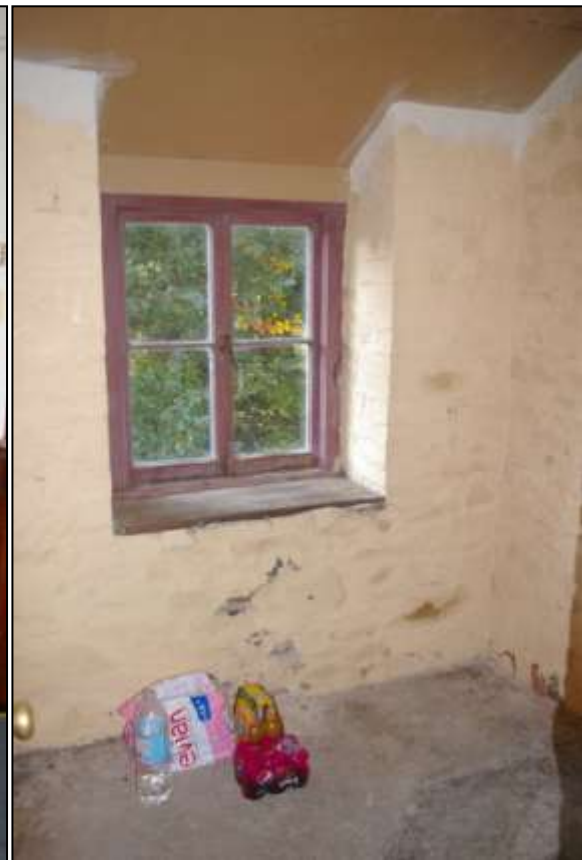
120. LEFT: VIEW INTO THE REAR PROJECTING SERVICE BLOCK, WITH 2M SCALE; FROM THE NORTH.

121. RIGHT: W17, IN THE REAR PROJECTING SERVICE BLOCK; FROM THE NORTH-NORTH-EAST.

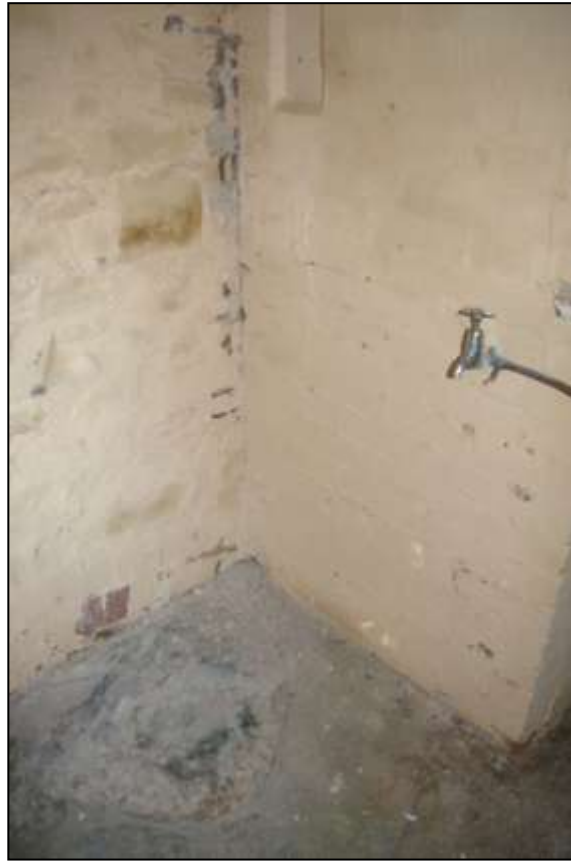
122. SCARRING ON THE FLOOR OF THE SERVICES BLOCK SHOWING REMOVED FITMENTS AND A TAP FOR RUNNING WATER; FROM THE SOUTH-EAST.
