**HIGHER PARK FARM**

**CREDITON**

DESK-BASED ASSESSMENT WITH HISTORIC BUILDING RECORDING

South West Archaeology Ltd. report no. 181115

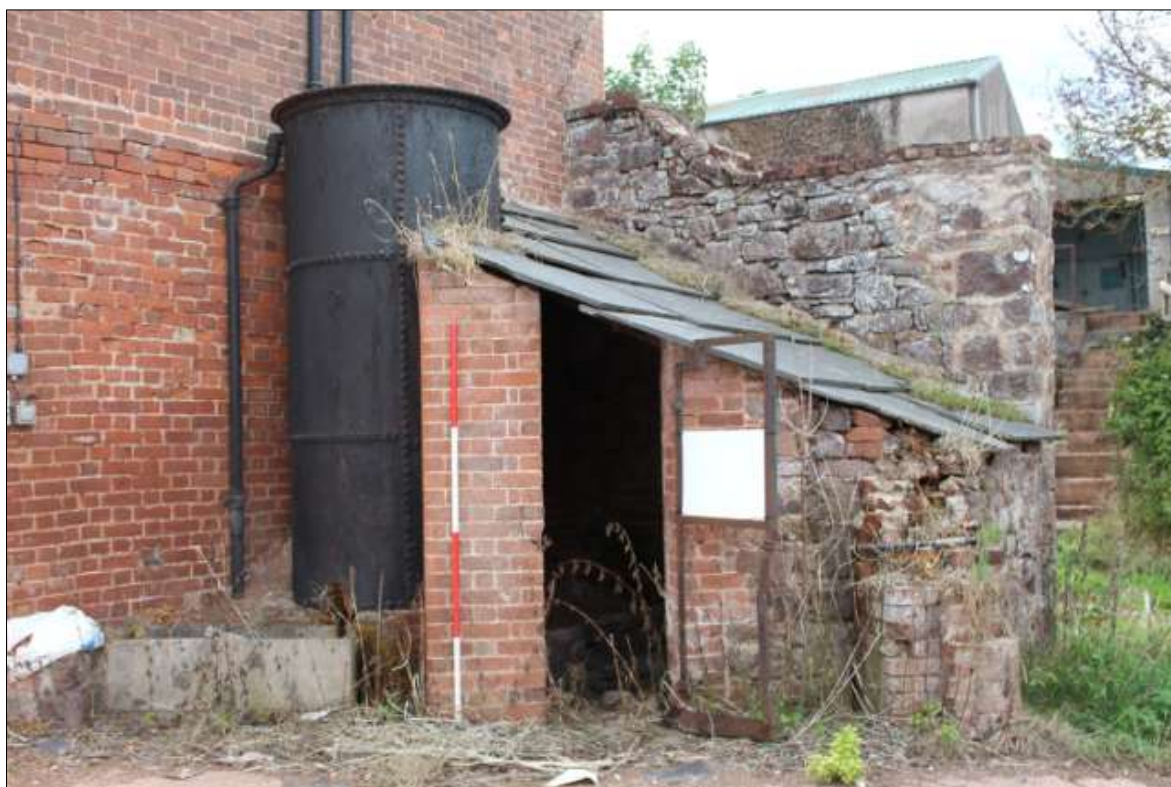
A small, single-storey lean-to structure built into the angle between the yard wall and B4. The north-west and north-east (yard) walls are of coursed stone rubble in a white lime mortar, with brick quoins to the doorway. The south-east wall comprises a heavy cylindrical iron water tank c.1.2m in diameter and c.2.5m high, partly encased in a block of mortared brickwork. To the north side is a small opening at ground-floor level, probably a stoke hole. The iron tank is comprised of heavy iron sheets, closely riveted, with a reinforced rim. The base sits on a brick plinth, and there is a tap at the base over a concrete water trough. A redundant set of guttering and downspouts fed water from the roof of B4 into the tank, and the tank has a separate overflow pipe. The lean-to roof is of very large slate slabs, probably flagstones but perhaps reused walling from a pigsty, carried on corroded iron beams; the floor is cobbled, with a later trough formed up against the west wall.

FIGURE 17: B3 WITH LARGE BOILER; VIEWED FROM THE SOUTH-EAST (SCALE 2M).

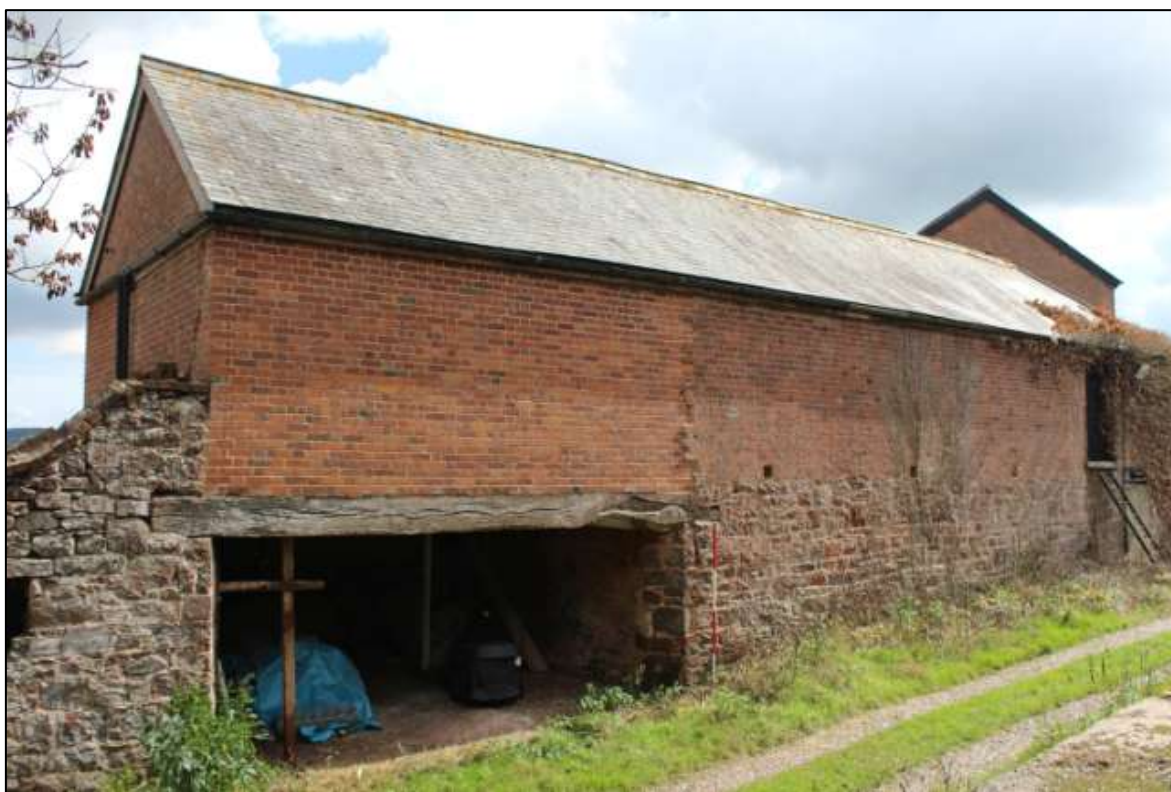
FIGURE 19: THE NORTH-WEST ELEVATION OF B4; VIEWED FROM THE NORTH (SCALE 2M).

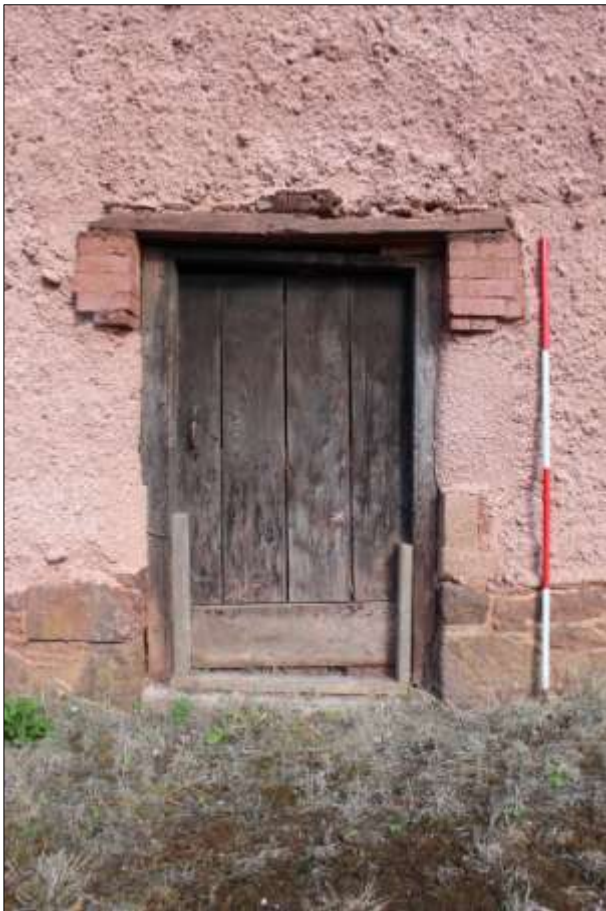
The west elevation of the Pound House is contiguous with the Shippon and features a single ground-floor door and blocked window. The door (D2) has a raised timber lintel with the sides patched in brick, but with good, roughly-dressed stone reveals lower down. It has a fine beaded doorframe and uneven-width beaded plank door with thumb latch. Just north of D2 is a blocked window (BO1), only the lintel of which is visible. The north elevation features one door and three windows. The ground-floor door (D3) was been widened to form a garage or cart entrance, with a long timber lintel and reveals rebuilt in concrete block; a board affixed to the exterior would suggest it once sported a sliding door, but it now features a modern plywood door. The two ground-floor windows (W4 and W5), and the first-floor window (W14) are boarded externally, but feature 19<sup>th</sup> century pegged two-light timber frames; W14 is also barred. The east elevation features a single window at ground- and first-floor level (W6 and W15). Both windows have lost their historic frames; the lower window (W6) is partly blocked in brick, and may have been a door. Part of the south elevation is abutted by the Shippon, but the external section features a single window at ground- and first-floor level (W7 and W16). Both are blocked, in brick and concrete block, and have lost their frames.

LEFT: B1 EXTERIOR, DETAIL OF D2; VIEWED FROM THE WEST (SCALE 2M).

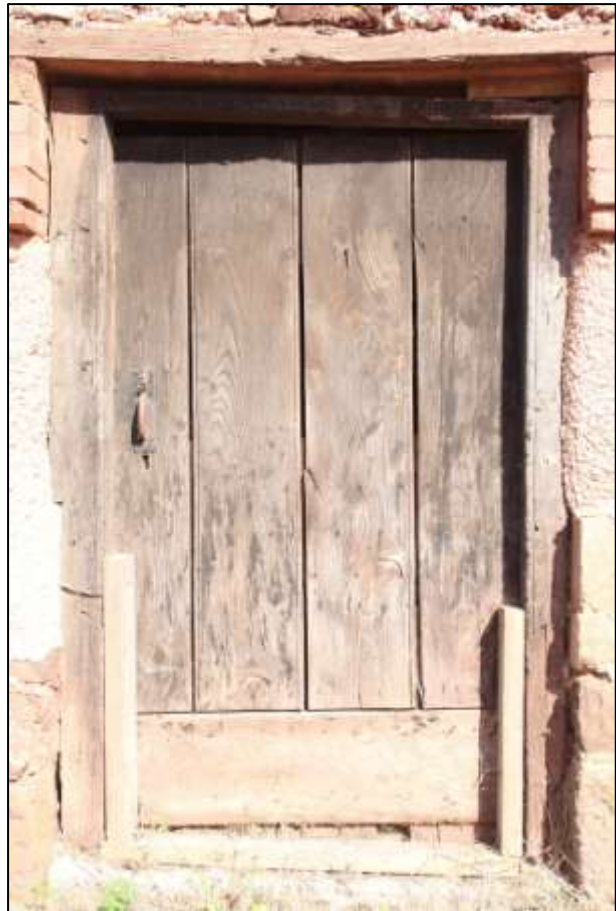
RIGHT: AS ABOVE, DETAIL OF THE DOOR.

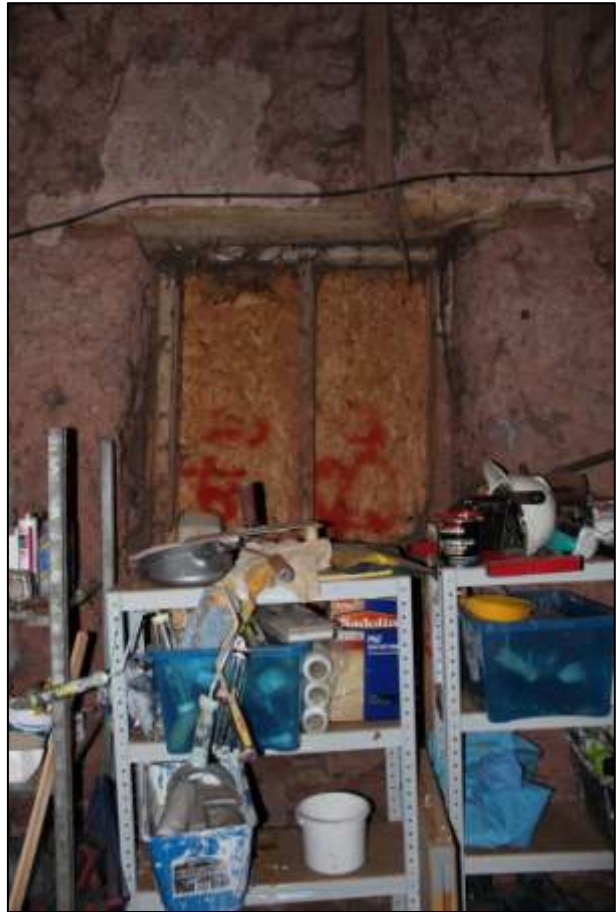
Openings: Windows	W4	GF window. Long deep central opening. Timber lintel on timber pads set higher in the wall than the openings to either side. Boarded externally. Surviving timber two-light frame, rebated for glazing.
	W5	GF window. Square window opening, reused timber lintel on timber pads, boarded externally. Surviving two-light timber frame, missing central mullion. One of the beams carrying the FF sits on the lintel of this opening.
	W14	FF window. Square window set up into eaves, plank lintel on timber pads at wallplate height. Boarded externally. Surviving timber two-light frame, pegged corners, a single iron bar to each light.
<b>B1 Elevation EAST</b>		<b>Description</b>
Fabric Detail:		The cob appears thicker and more irregular here. North-east corner repaired with cob blocks; the south-east corner is very irregular and battered, with rebuild in concrete block and brick to the interior face.

LEFT: B1 EXTERIOR, NORTH ELEVATION, DETAIL OF W5; VIEWED FROM THE NORTH (SCALE 2M).  
RIGHT: B1 GF INTERIOR, NORTH WALL, DETAIL OF W4; VIEWED FROM THE SOUTH.

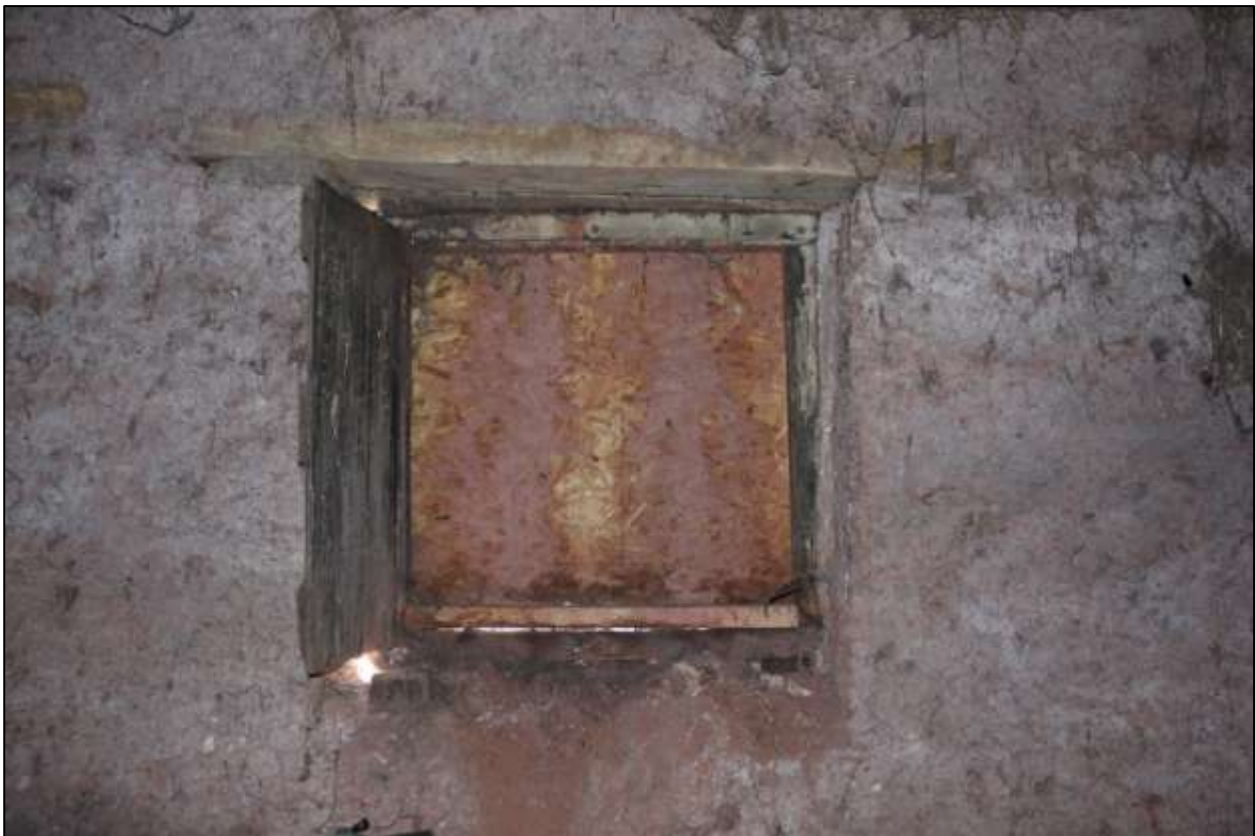
timber lintel on timber pads, timber sill. The wall below the sill has failed and been rebuilt in red brick. Surviving timber two-light frame, central mullion lost, sockets in the frame for iron bars. Two shutters on iron pintles and strap hinges with spearhead terminals, plain thin planks and ledging bars. One shutter is hung, the other is on the floor adjacent.
	W8	GF window in east wall. Slightly narrower than the others, boarded externally. Straight cob sides, heavy timber lintel on timber pads, timber plank sill. The lintel sits a little higher and is more weathered, the stonework below is more disturbed, possibly a blocked doorway. Surviving timber two-light frame, two iron bars to each light. One shutter on iron pintles and strap hinges with spearhead terminals, plain thin planks and ledging bars. Later C20 iron mesh.
	W9	GF window in east wall. Square window, boarded externally. Straight cob sides, reused timber lintel on timber pads, sloping C21 slate sill. Crude modern frame of tanalised timber.

B2 GF INTERIOR, WEST WALL, DETAIL OF W3; VIEWED FROM THE EAST.

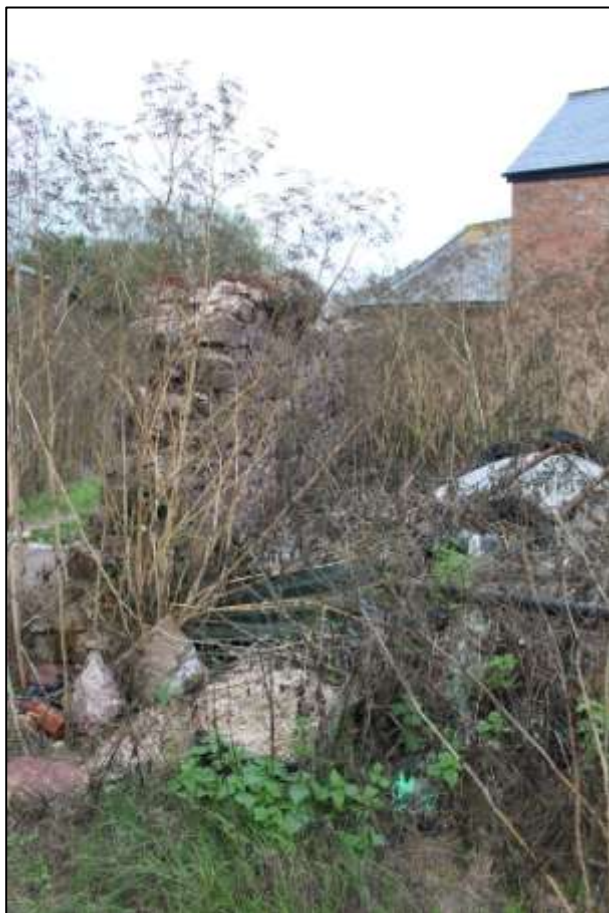
B9 EXTERIOR, VIEW OF THE UTILISED STONE YARD WALL; VIEWED FROM THE SOUTH-WEST.

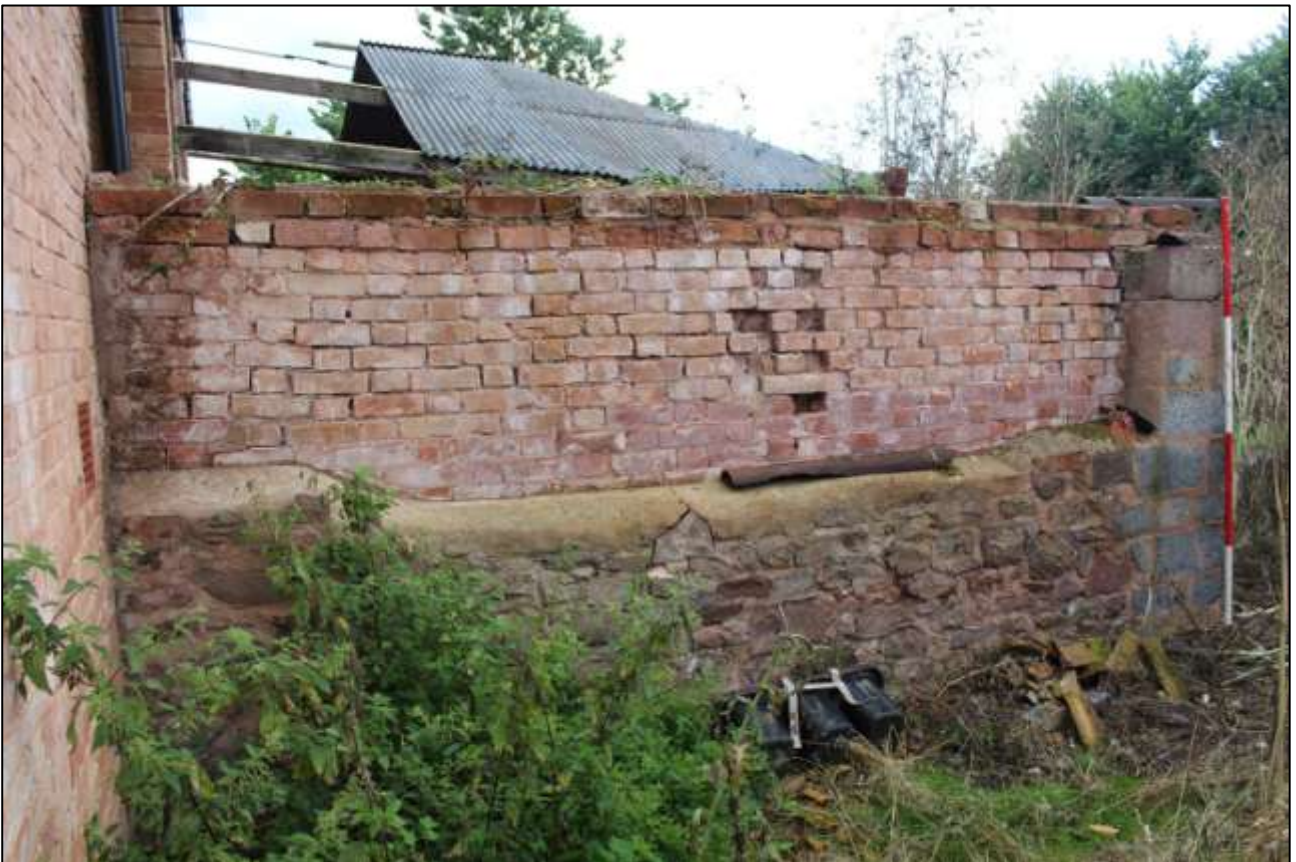
AS ABOVE; VIEWED FROM THE NORTH (SCALE 2M).

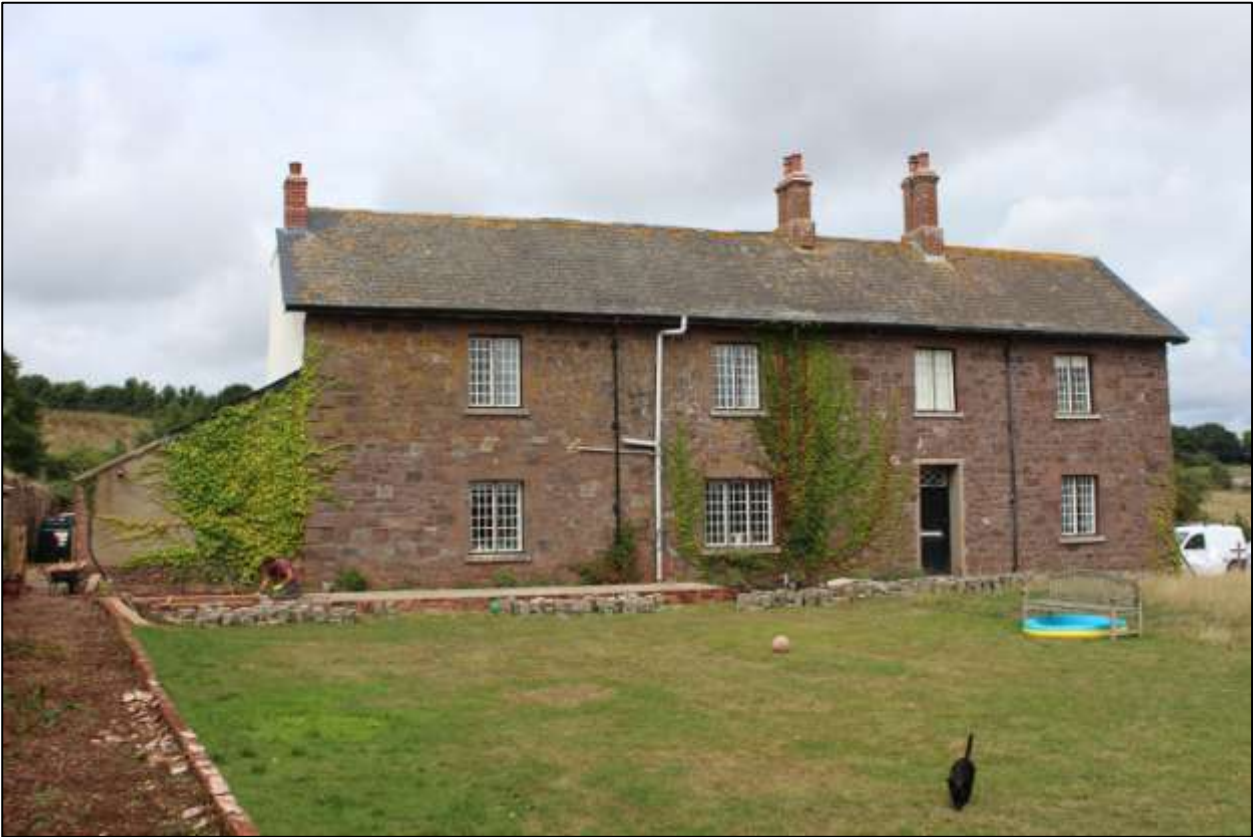
THE SOUTH ELEVATION OF THE FARMHOUSE; VIEWED FROM THE SSW.

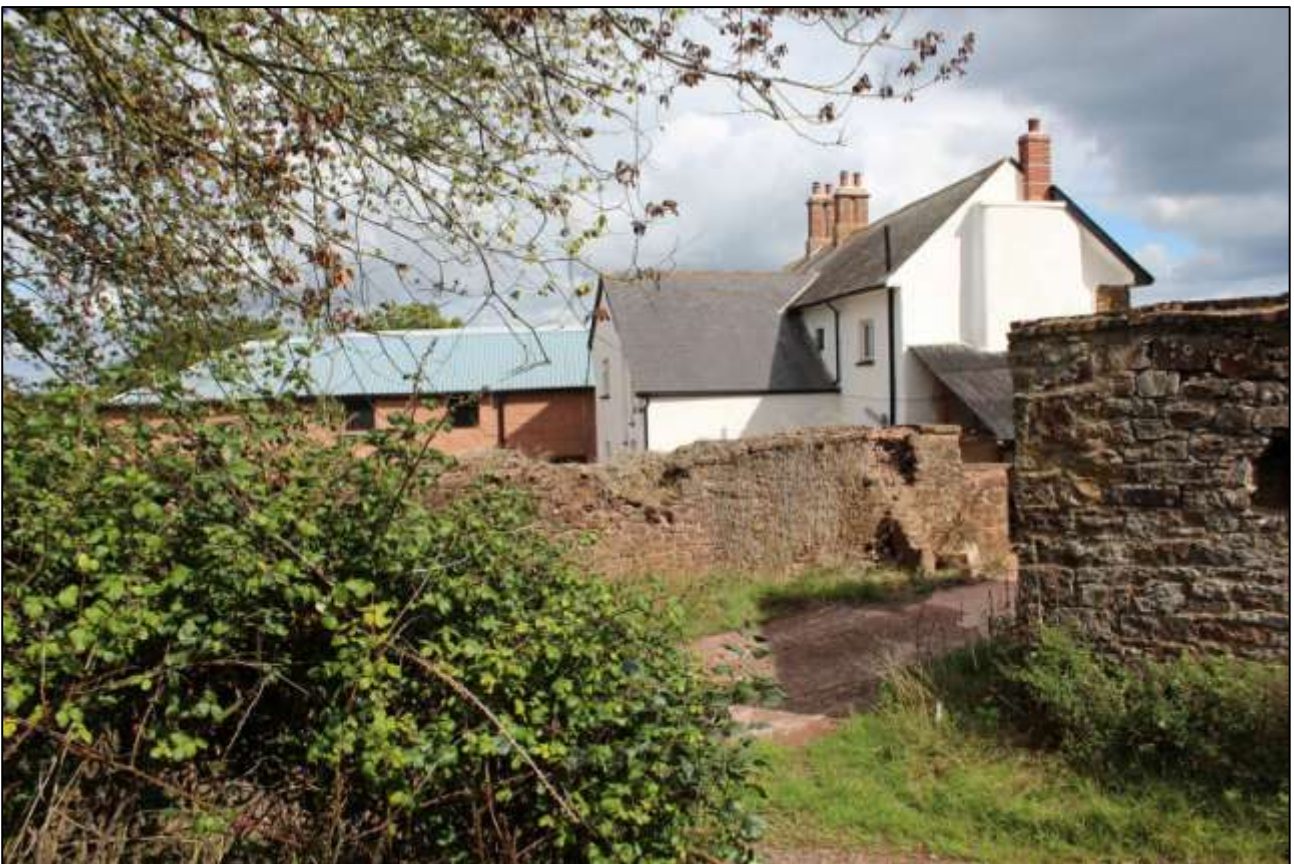
THE FARMHOUSE, VIEWED FROM OUTSIDE ITS YARD TO THE WEST.

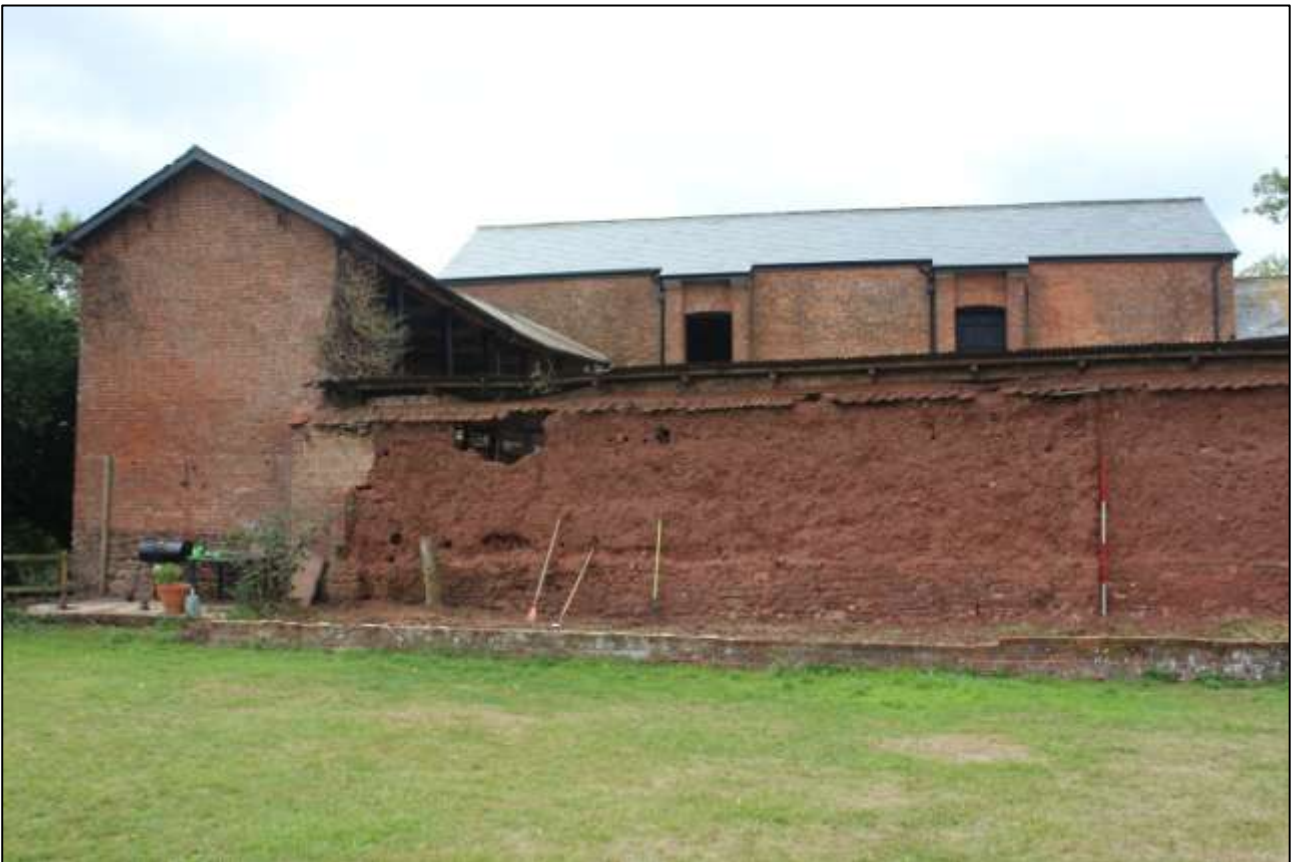
AS ABOVE; VIEWED FROM THE EAST (SCALE 2M).

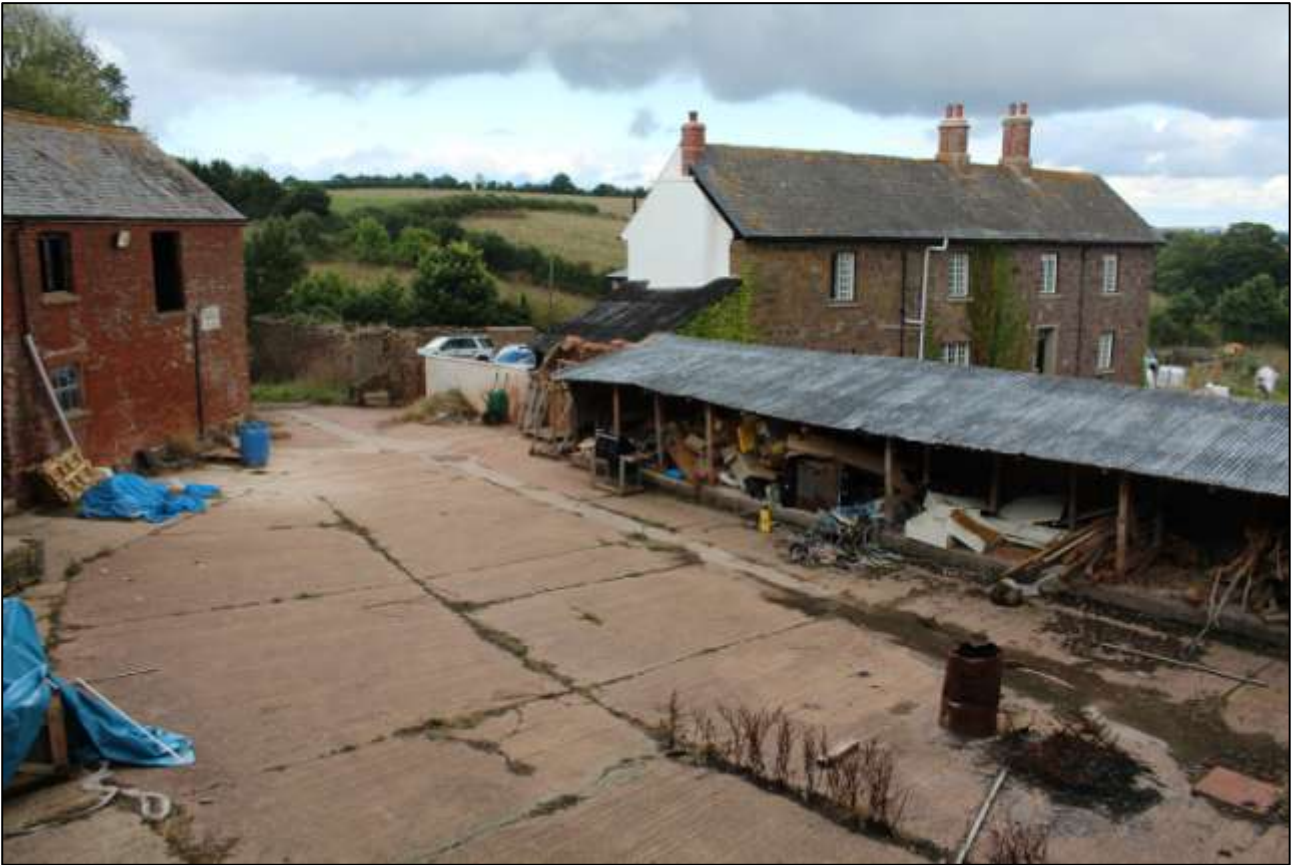
THE FARMHOUSE AS VIEWED FROM B6, WITH B10 IN THE FOREGROUND; VIEWED FROM THE SOUTH-WEST.

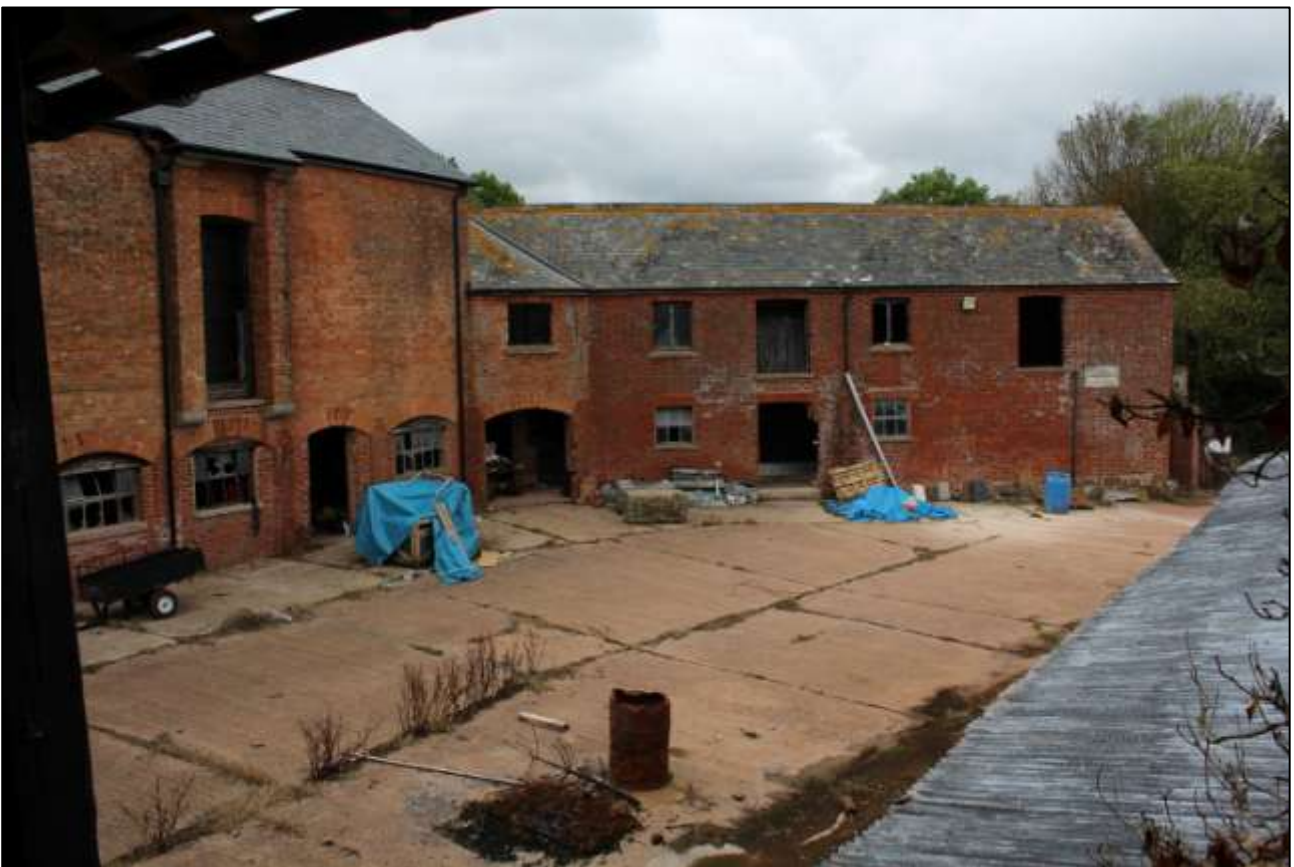
T4-B6 AS VIEWED FROM B7; VIEWED FROM THE SSE.

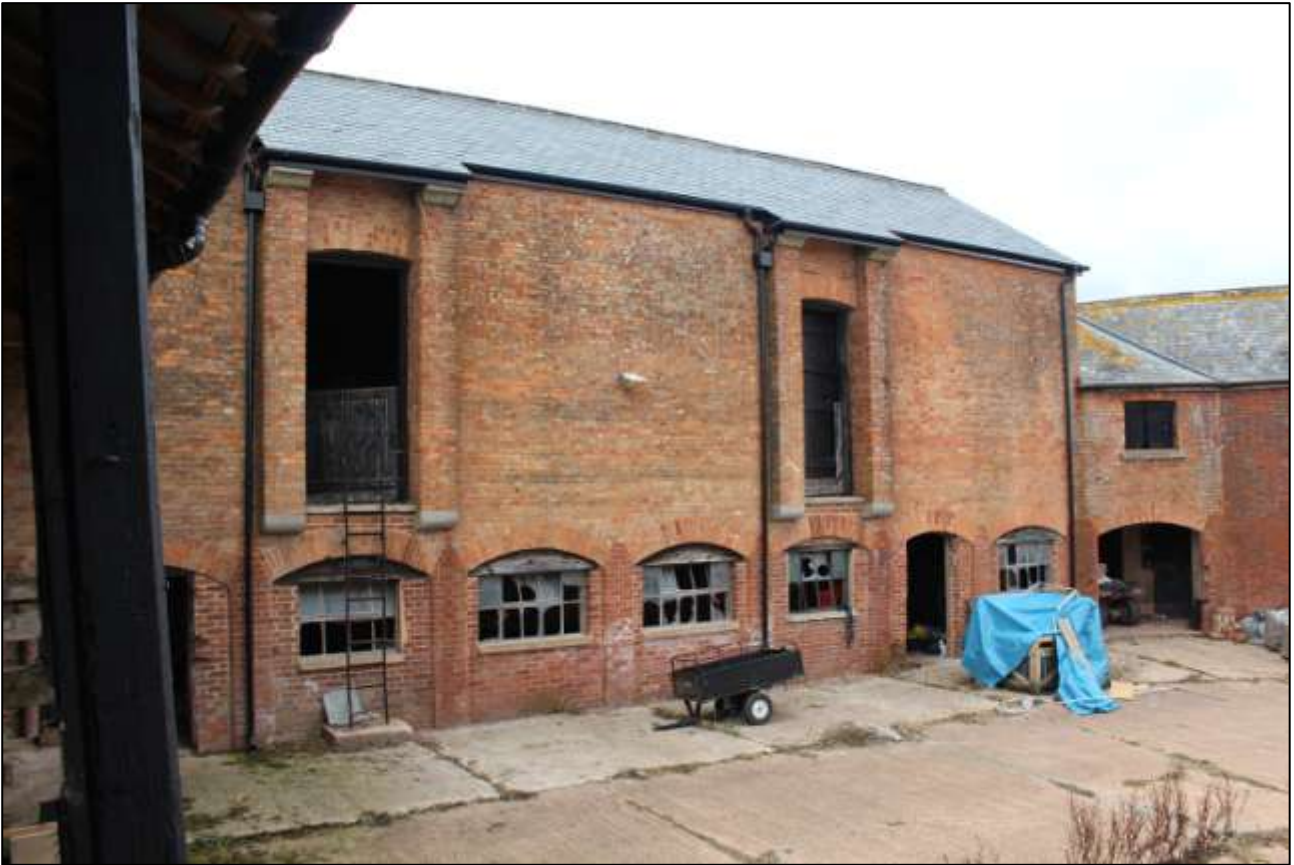
B6 AS VIEWED FROM B7; VIEWED FROM THE ESE.

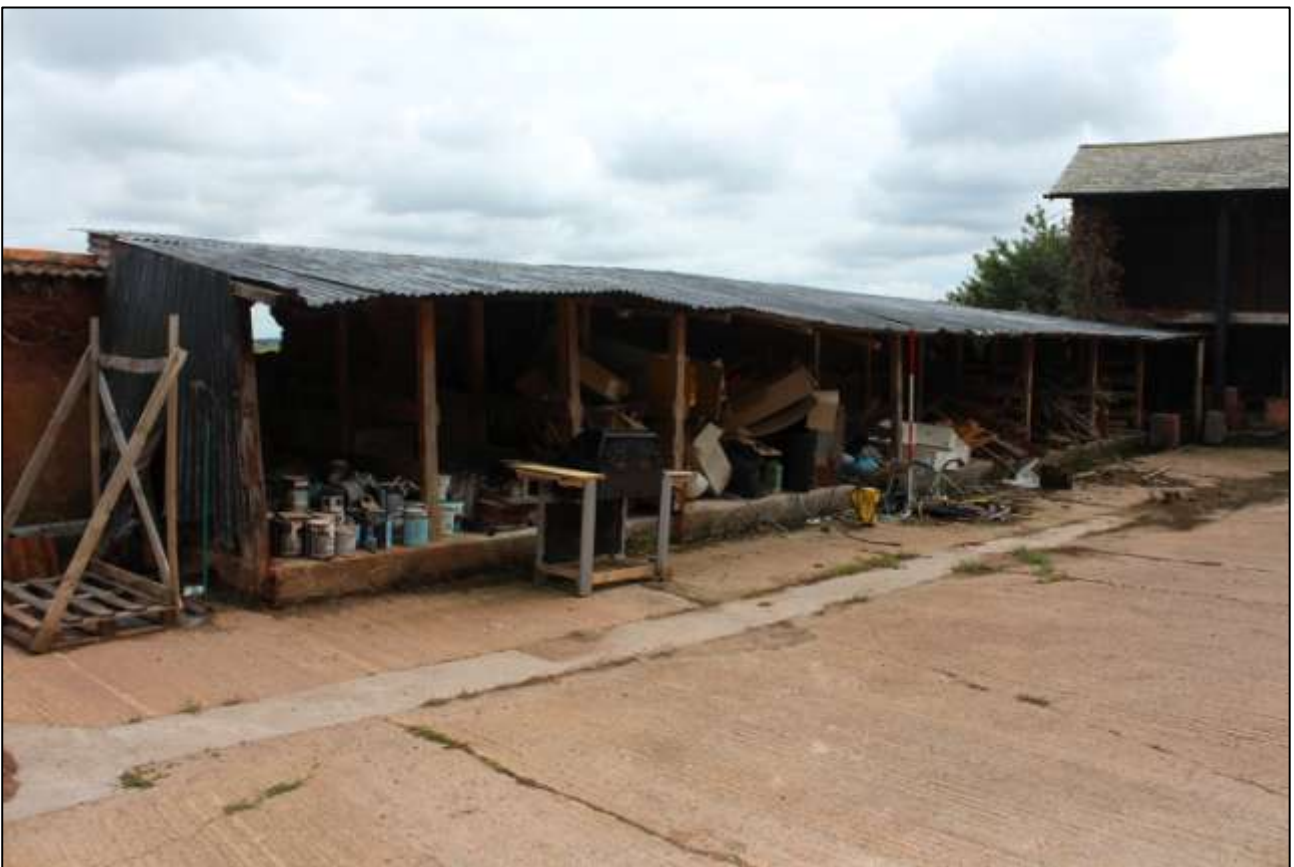
B10; VIEWED FROM THE NORTH-EAST (SCALE 2M).

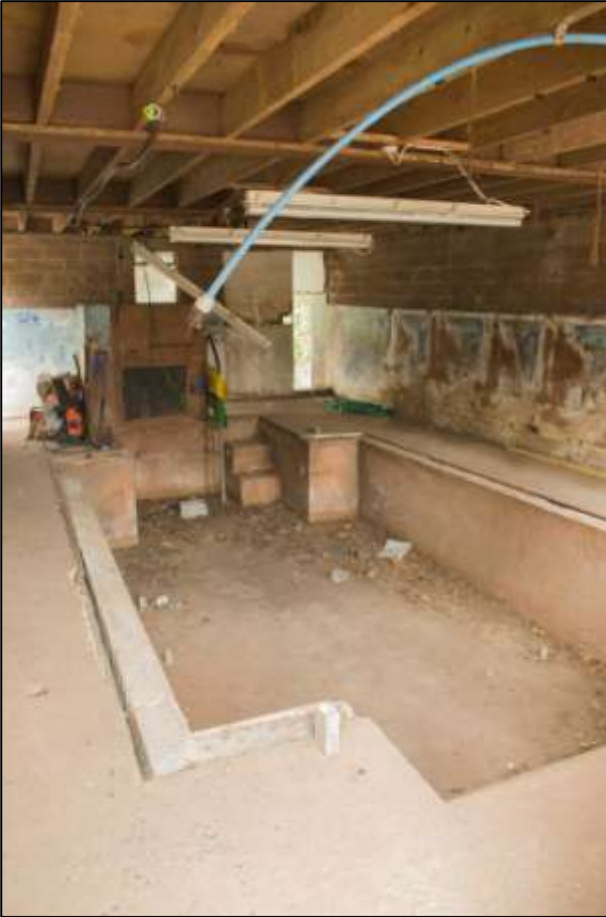
B12, THE INTERIOR OF THE MODERN MILKING PARLOUR; VIEWED FROM THE SOUTH-WEST.
