# MAYOR'S AVENUE TRAVIS PERKINS

Desk-Based Assessment & Historic Building Recording

South West Archaeology Ltd. report no. 181127

## Mayor's Avenue Travis Perkins, Dartmouth, South Hams, Devon Desk-Based Assessment & Historic Building Recording

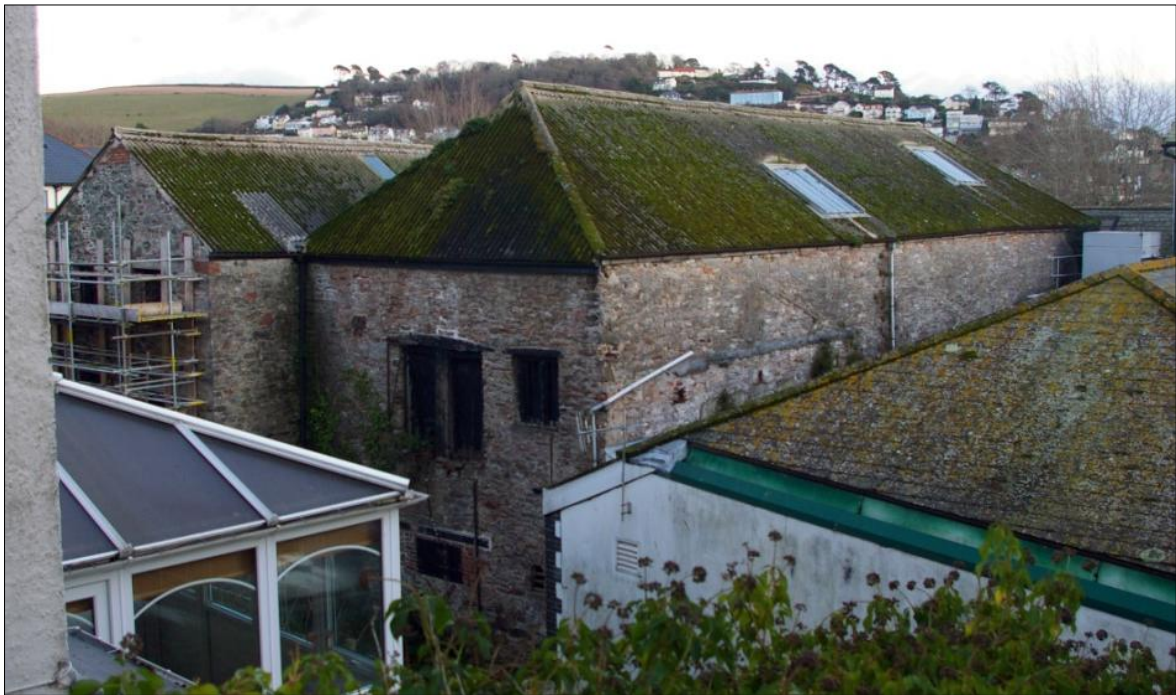
FIGURE 19: THE NORTH AND WEST WALLS OF B1, VIEWED FROM THE NORTH-WEST.

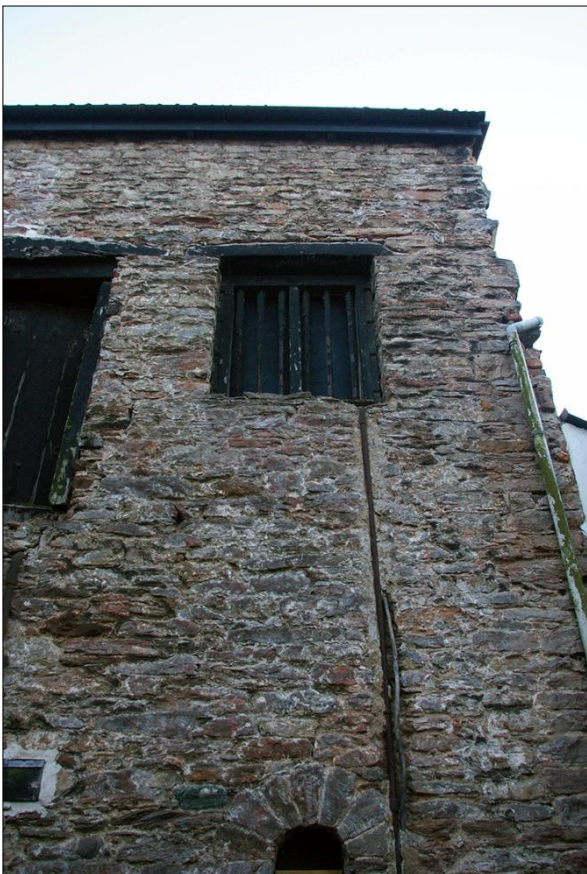
2. LEFT: THE NORTH WALL OF B1 SHOWING WINDOW 7 (W7); VIEWED FROM THE NORTH.

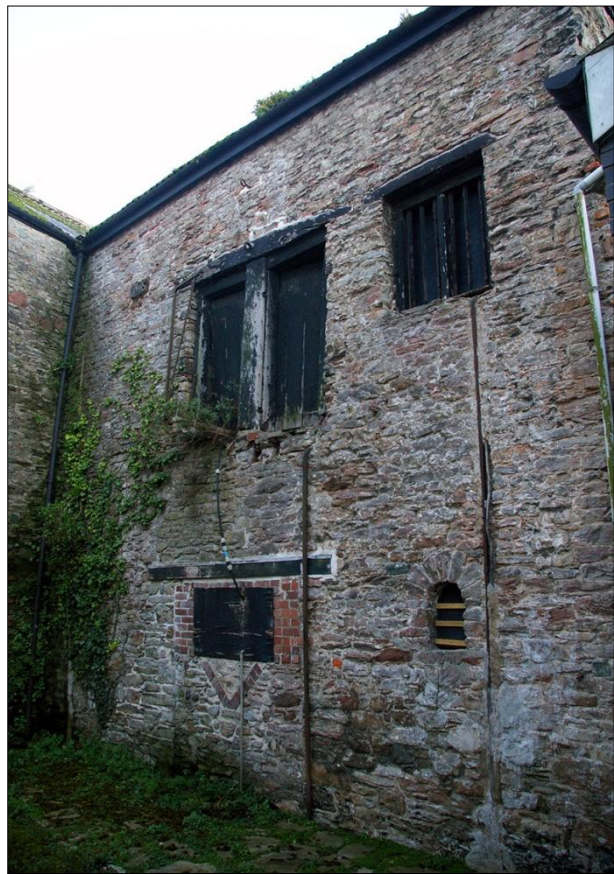
3. RIGHT: THE NORTH WALL OF B1, SHOWING THE VARIOUS GROUND-FLOOR (GF) AND FIRST-FLOOR (FF) OPENINGS; VIEWED FROM THE NORTH-WEST.

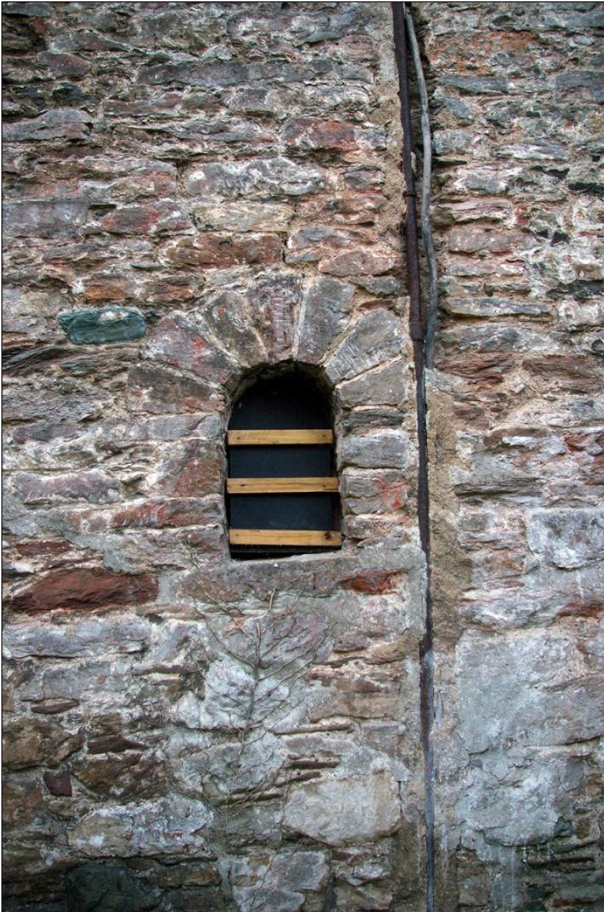
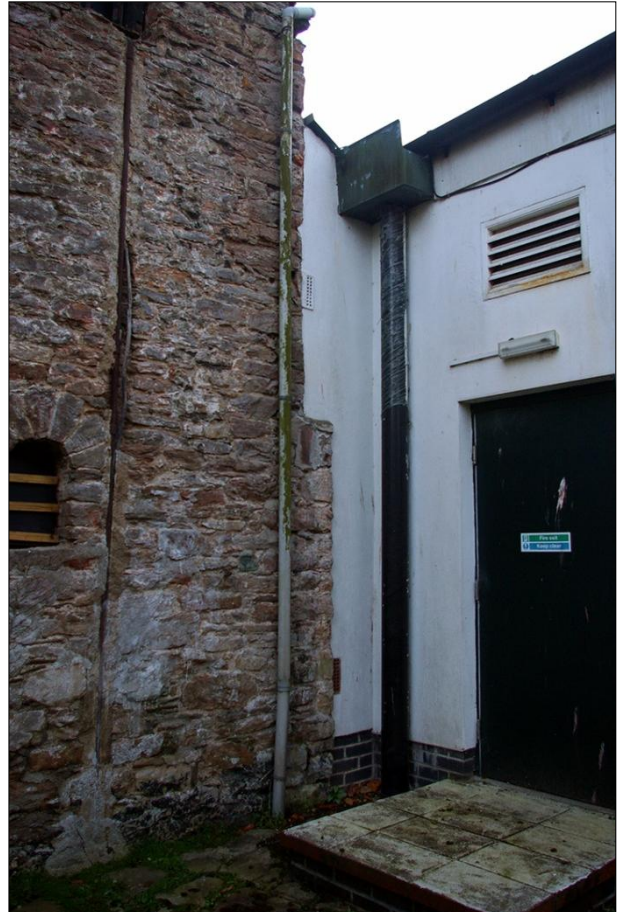
6. LEFT: THE NORTH WALL OF B1 SHOWING ORIGINAL GF WINDOW W7; VIEWED FROM THE NORTH.
7. RIGHT: AS ABOVE, SHOWING THE RELATIONSHIP WITH THE 1990S M&S BUILDING; VIEWED FROM THE NORTH-EAST.

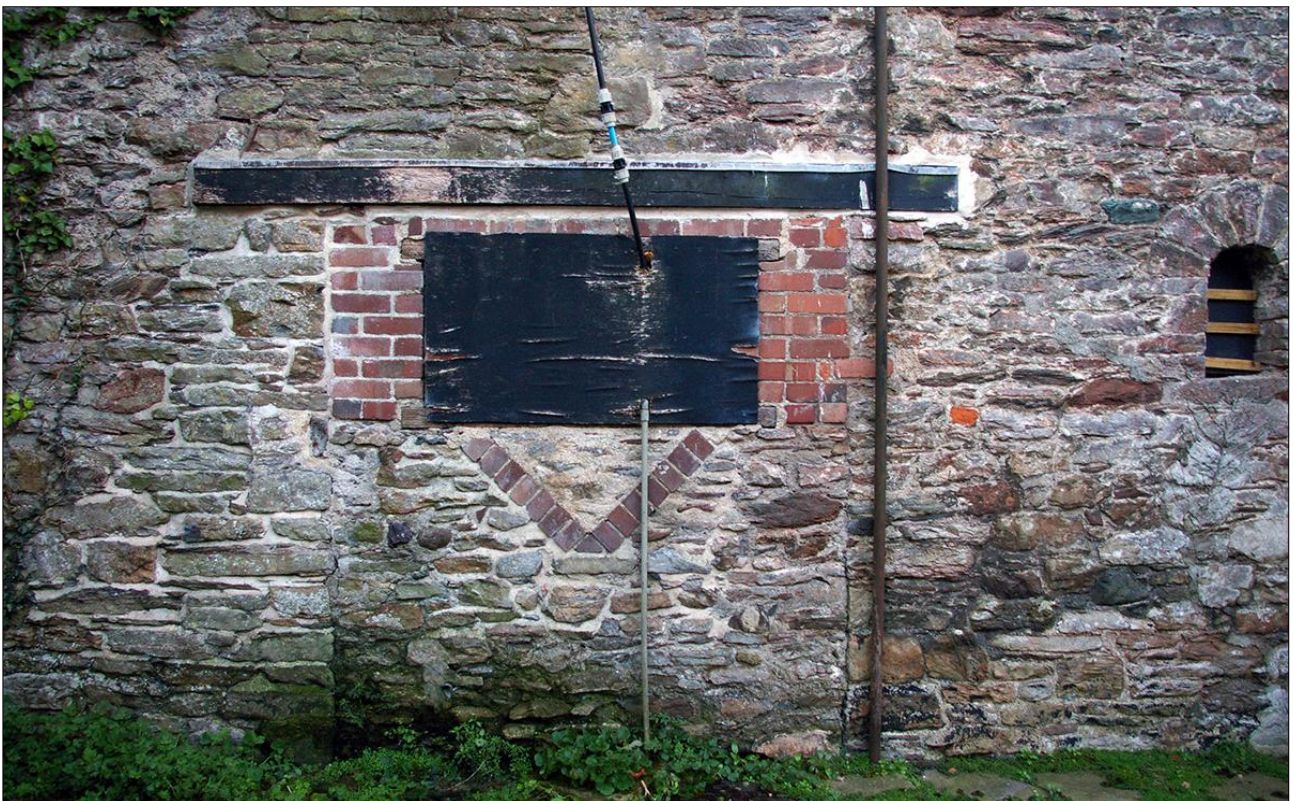
8. THE NORTH WALL OF B1, SHOWING THE GF BLOCKED OPENING 24 (BO24); VIEWED FROM THE NORTH.

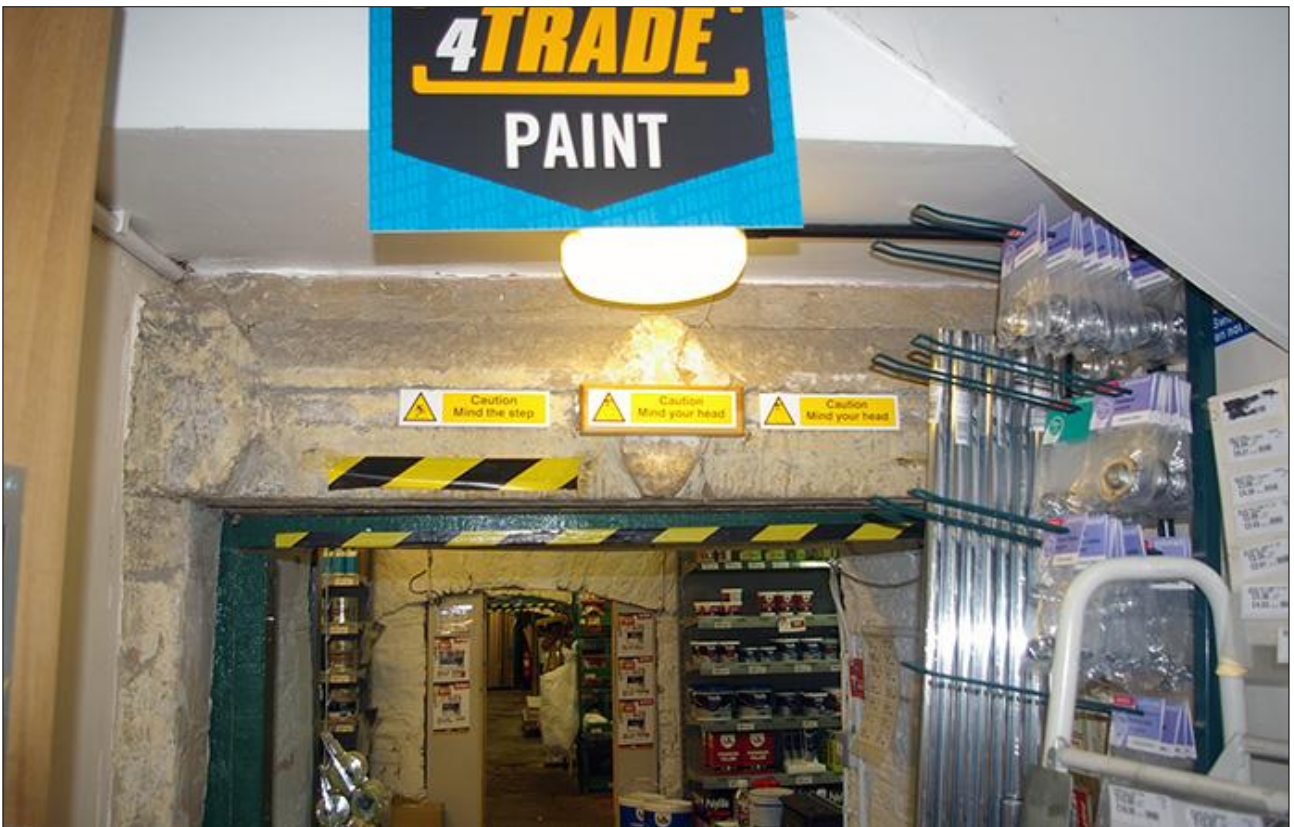
19. AS ABOVE, DETAIL OF THE RE-USED DRESSED STONE LINTEL; VIEWED FROM THE SOUTH.

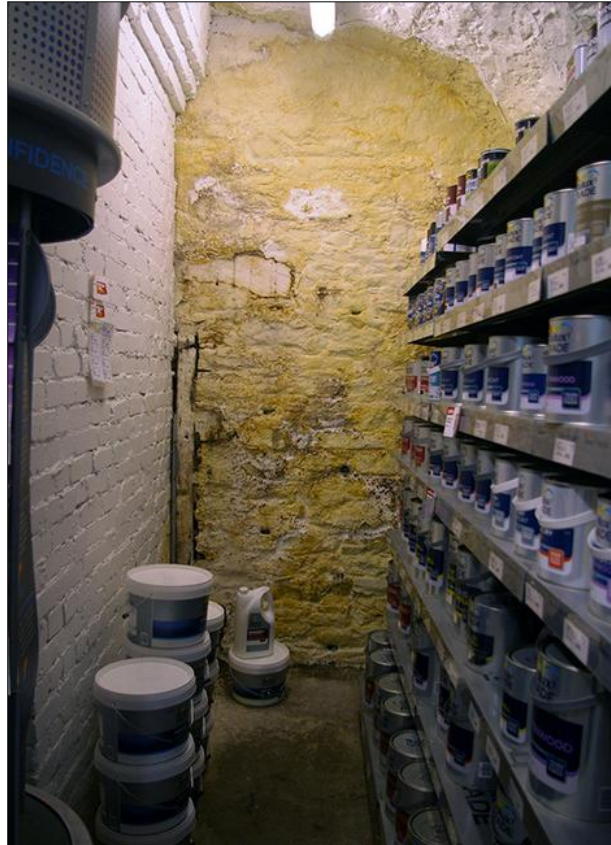
25. RIGHT: B1 GF, THE SOUTH END OF V1, SHOWING THE CONCEALED BLOCKED DOORWAY BO1; VIEWED FROM THE EAST.

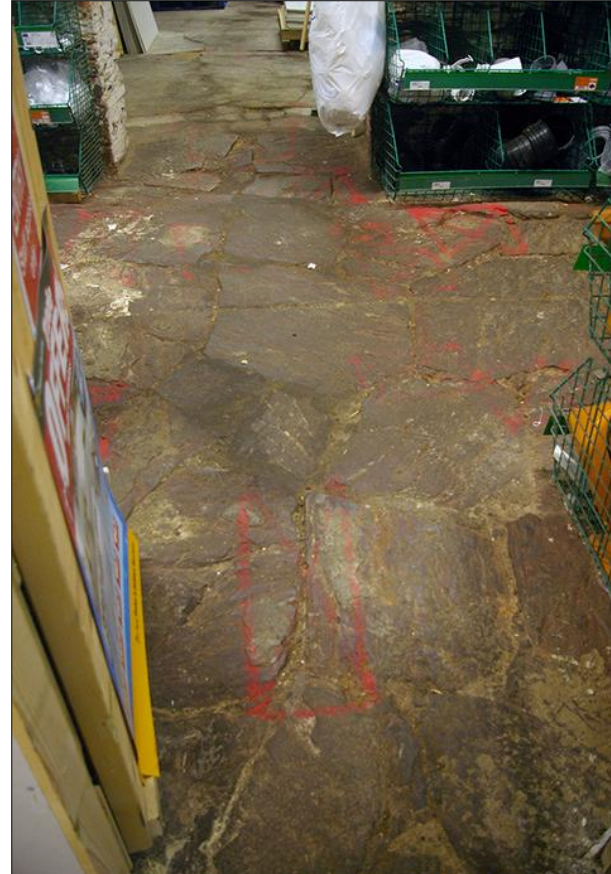
27. RIGHT: B1 GF, DETAIL OF THE STONE SLAB FLOOR IN V2; VIEWED FROM THE SOUTH.

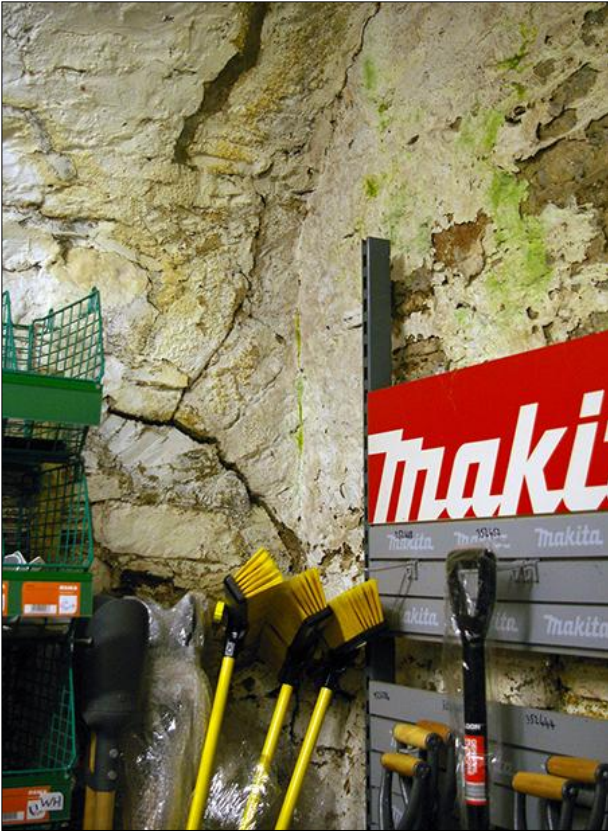
BO10	GF southern flanking arch to V1. Blocked in stone rubble.
	BO11	GF blocked doorway to B2, centre to vault. Straight timber lintel and blocked with loose mortared stone rubble.
	BO12	GF northern flanking arch to V3. Blocked in stone rubble.
	BO13	GF central arch to V3. Partly blocked in stone rubble with brick.
BO14	GF southern flanking arch to V3. Blocked in stone rubble.	
<b>VAULT 3</b>		
V3a		The southern part of the vault is enclosed by plasterboard with a modern door (D6).
Opening – Doors:	D3	GF doorway to V2, set within BO13. No frame or door.
	D4	GF central arch to V4. No frame, door or blocking. The arch has dropped and is braced with RSJs
	D5	GF forced doorway, repaired in concrete block with a concrete lintel. Probably an opening like BO7-BO8 but much enlarged.
	D6	GF modern door to V3a.
Opening – Windows:	W3	GF small window in apex of vault and above BO3; good stone voussoirs to its segmental arch, inset carved arched solid-stone window frame, timber lintel, and stone sill to interior; set with <i>ferramenta</i> (vertical bar with saddle bar). Same as W1-W2 and W4-W7.

- 31. LEFT: B1 GF, THE SOUTH END OF V2 SHOWING THE ARCH OF BO10; VIEWED FROM THE NNE.
- 32. RIGHT: B1 GF, THE SOUTH END OF V2 SHOWING THE WINDOW W2 WITH ITS SURVIVING *FERRAMENTA*; VIEWED FROM THE ENE.

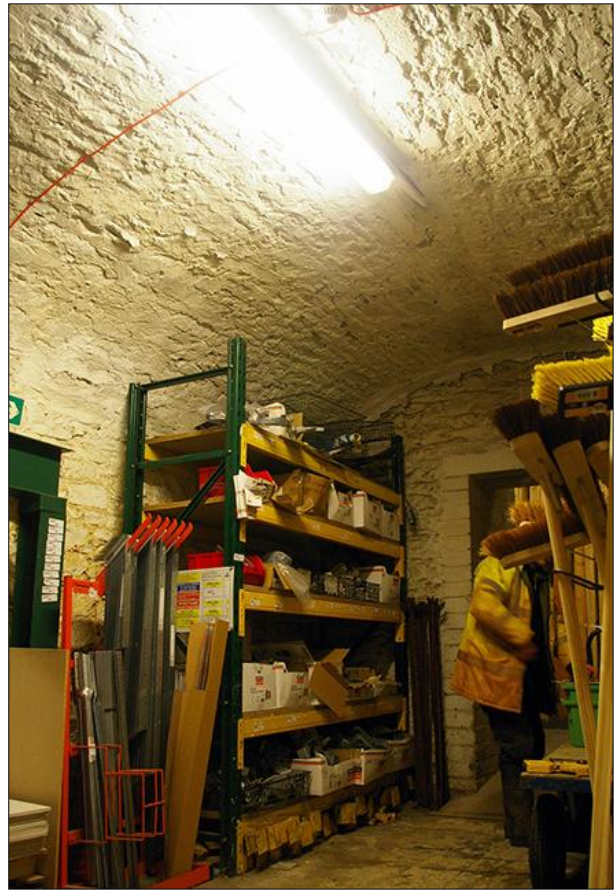
38. RIGHT: B1 GF, THE NORTHERN PART OF V3; VIEWED FROM THE WSW.

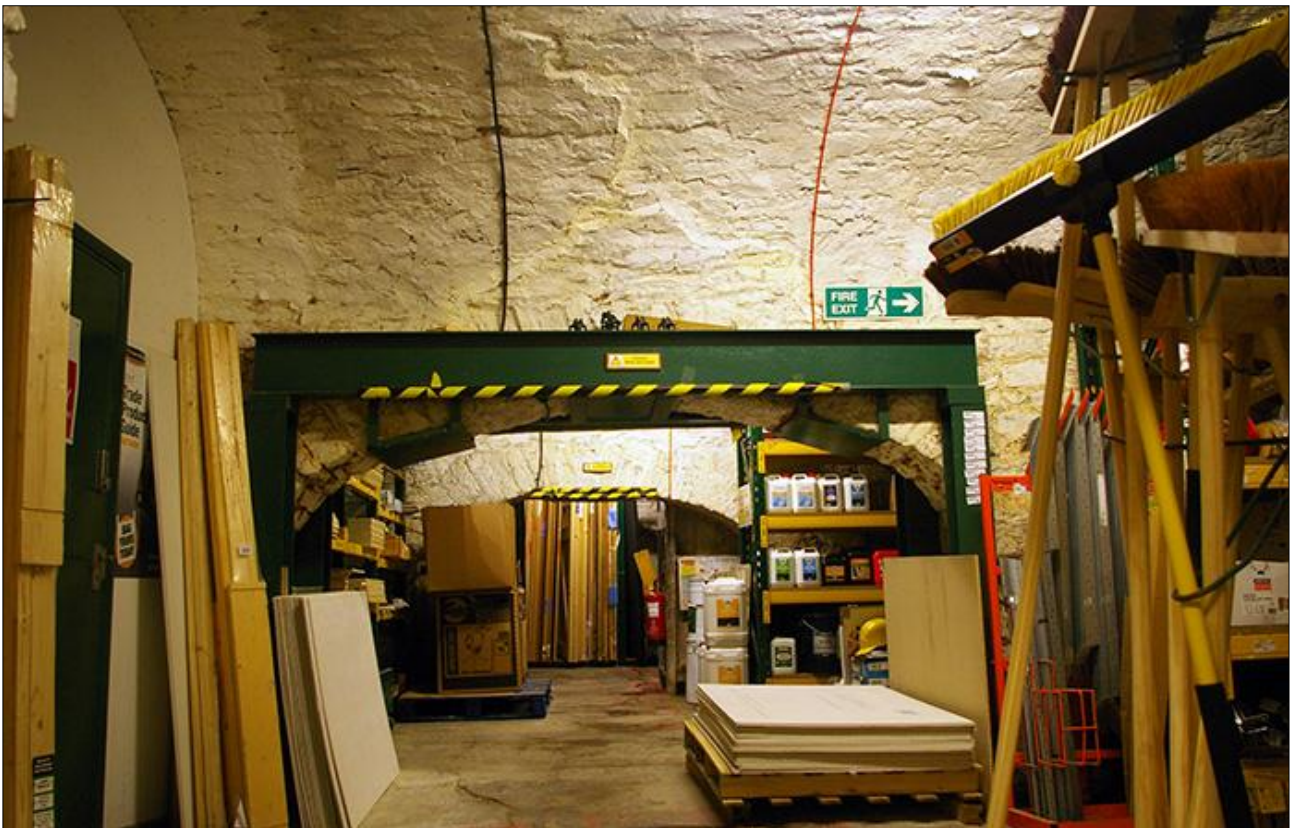
39. B1 GF, LOOKING THROUGH STEEL REINFORCED D4 FROM V3 INTO V4; VIEWED FROM THE SOUTH.

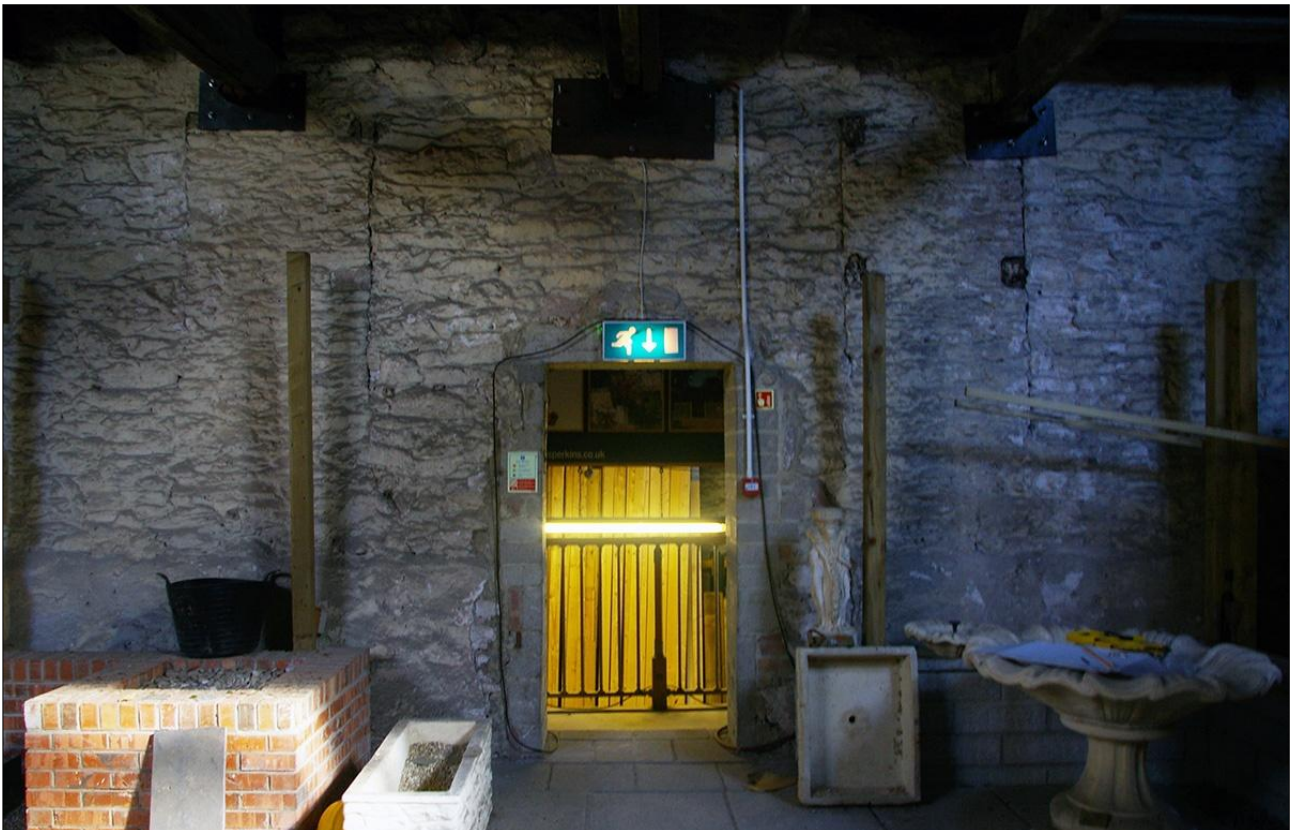
44. B1 FF ROOM 1 (R1), SHOWING FORCED DOORWAY D18 IN BO37; VIEWED FROM THE WEST.

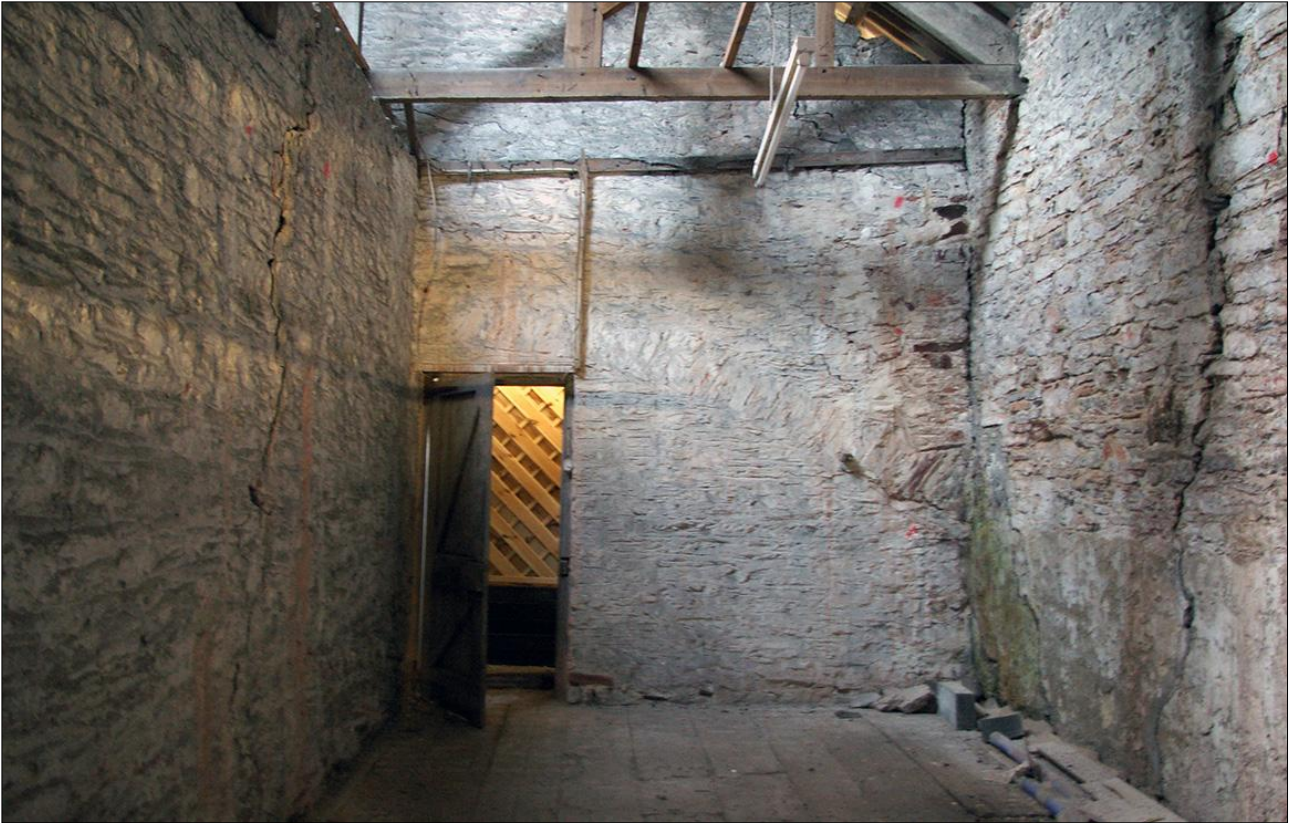
82. B1 FF R3, THE SOUTH END OF THE ROOM SHOWING D20; VIEWED FROM THE NORTH.

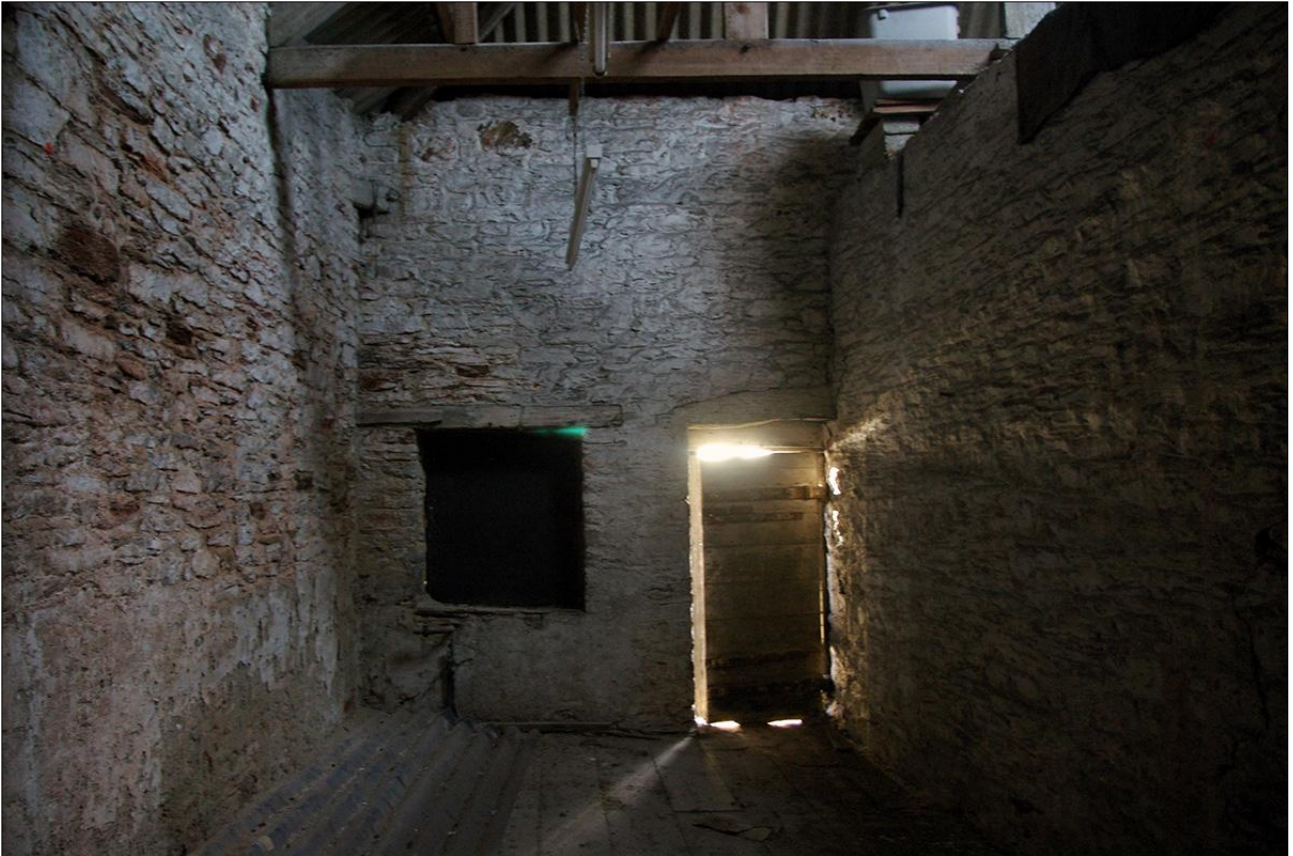
84. B1 FF R3, THE NORTH END OF R3 WITH W11 AND D21; VIEWED FROM THE SOUTH.

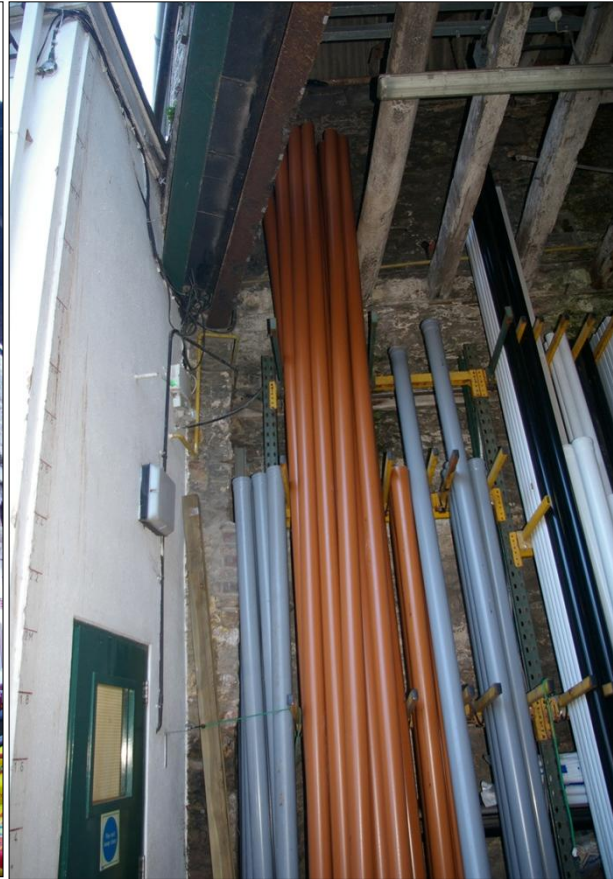
Openings – Doors:	D5	GF forced doorway to B1, repaired in concrete block with a concrete lintel. Probably an opening like BO7-BO8 but much enlarged.
	D12	GF and FF tall wide modern forced opening in the south wall, heavy RSJ lintel, with reveals patched with cement and brick.
Openings – windows:	W12	FF square window opening. Forced or widened, with west reveal rebuilt in brick. Thin timber lintel, pegged frame with central mullion, pintles for shutters, set with thin modern iron bars.
	W13	FF square window opening. Forced or widened, cutting the blocked fireplace FP2. Plains chunky pegged frame with central mullion. Diamond-set iron security bars, pintles for shutters. Thick black paint. Similar to W11 and W21.
	W18	SF square window opening in south wall, paired with W19. Brick segmental arch. The window has a heavy plain frame with pegged joints, six wooden diamond-set security bars, painted black. Covered with modern mesh to prevent pigeons.

95. LEFT: THE REBUILT EAST JAMB OF D12; VIEWED FROM THE SOUTH-WEST.

96. RIGHT: THE REBUILT WEST JAMB OF D12; VIEWED FROM THE EAST.

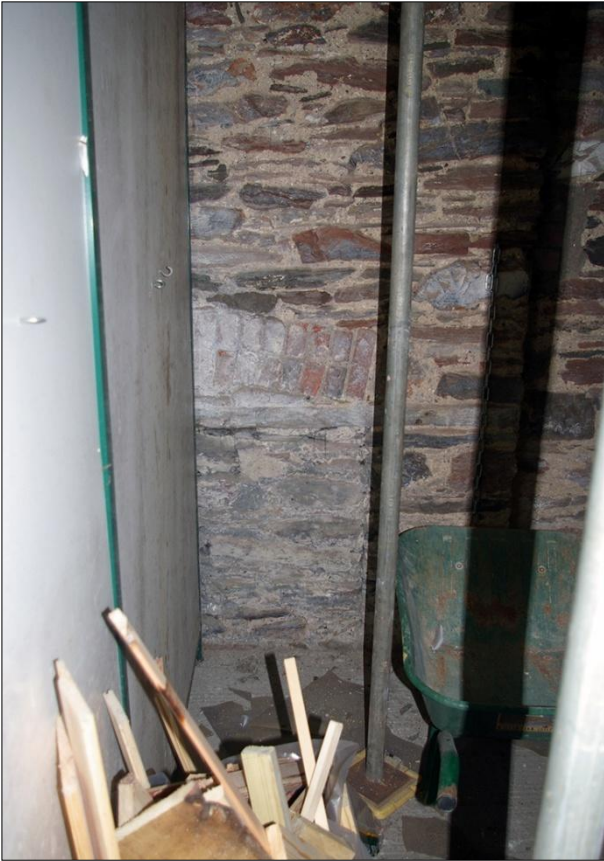
111. AS ABOVE, DETAIL OF FP1; VIEWED FROM THE SOUTH.

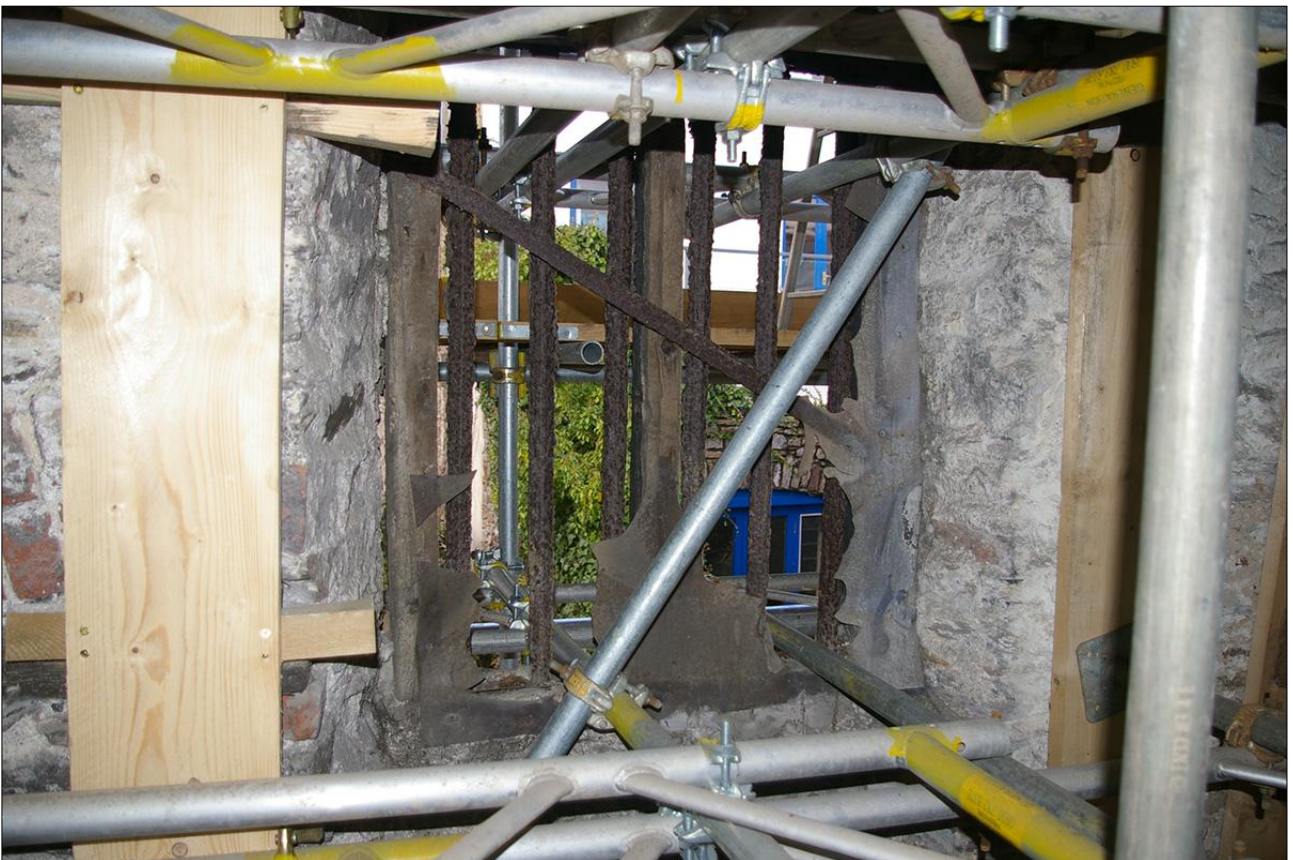
114. B2 FF INTERIOR, NORTH WALL, SHOWING W13; VIEWED FROM THE SOUTH.

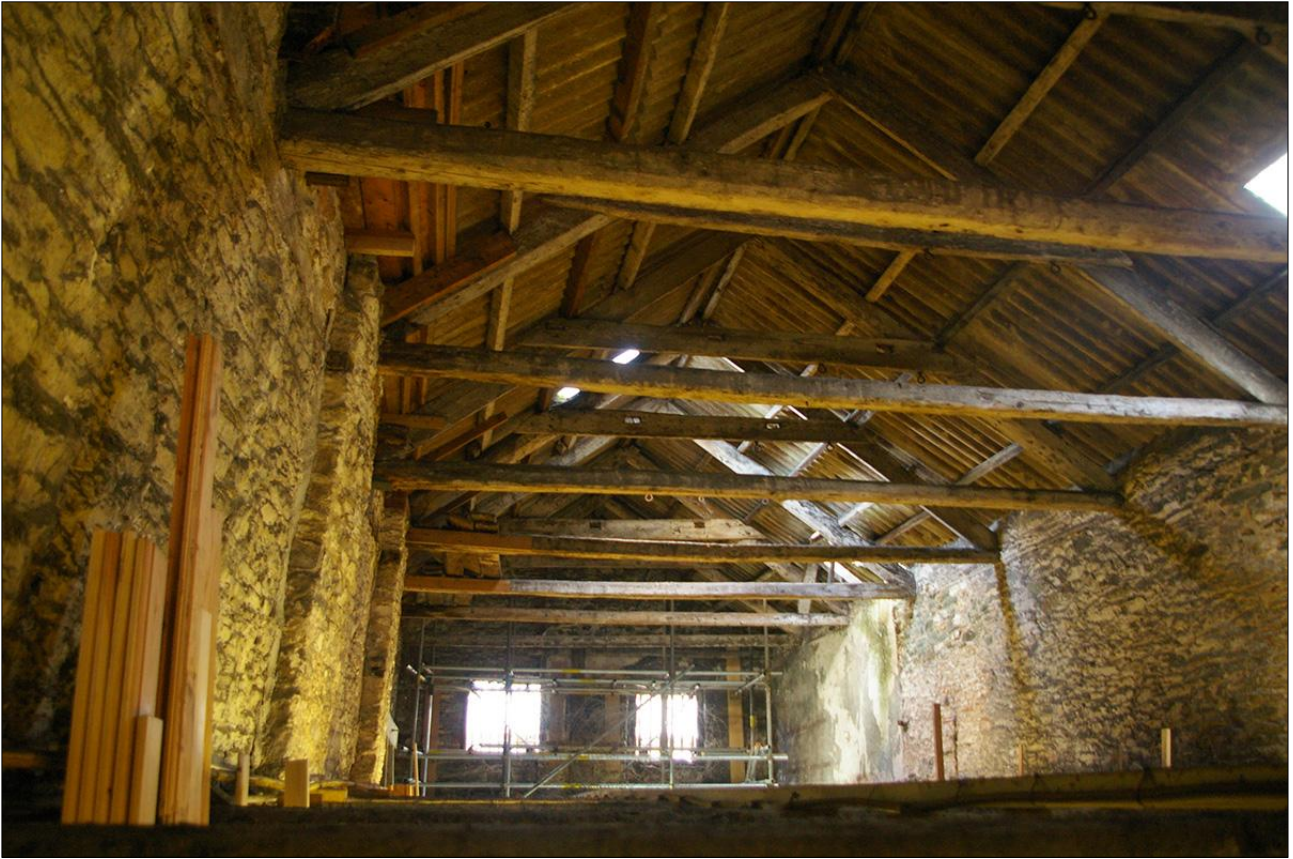
122. B2 SF INTERIOR; THE ROOF STRUCTURE OVER THE NORTHERN END OF B2, W20 AND W21; VIEWED FROM THE SSW.

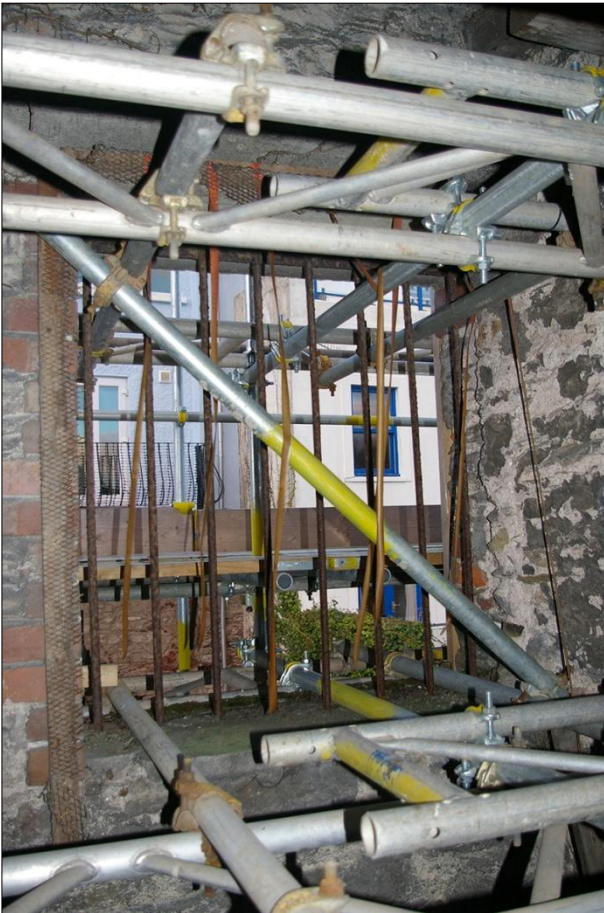
127. B2 SF INTERIOR, SHOWING THE BEAMS AND RE-USED SHIPS TIMBERS S22 (INDICATED); VIEWED FROM THE WEST.

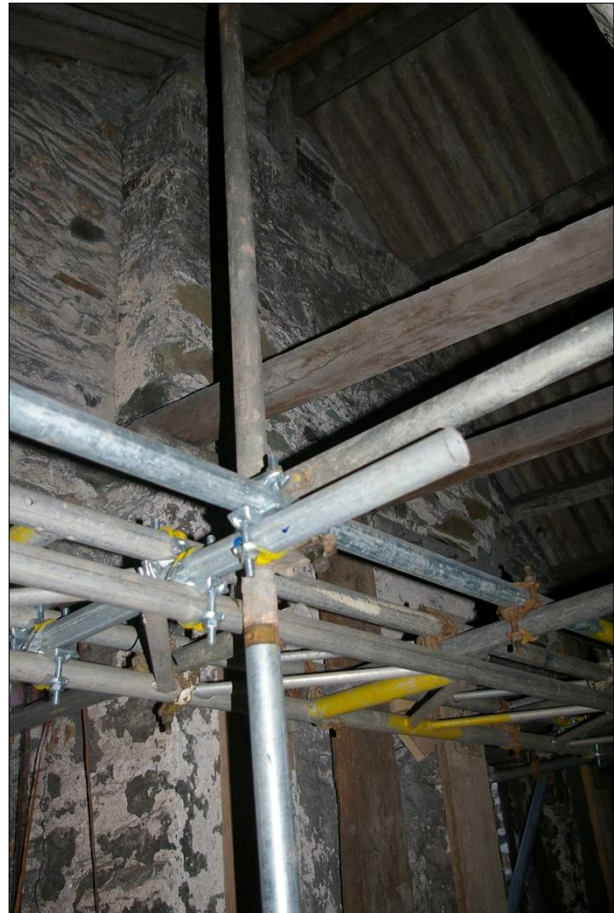
128. LEFT: B2 SF INTERIOR, NORTH WALL, SHOWING W20; VIEWED FROM THE SOUTH.

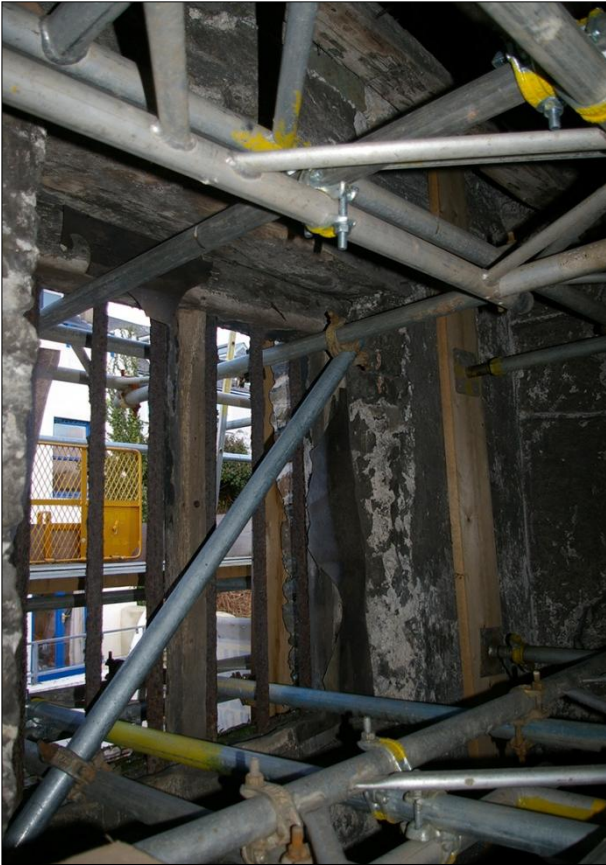
129. RIGHT: B2 SF INTERIOR, NORTH WALL, DETAIL OF THE STACK; VIEWED FROM THE SOUTH-WEST.

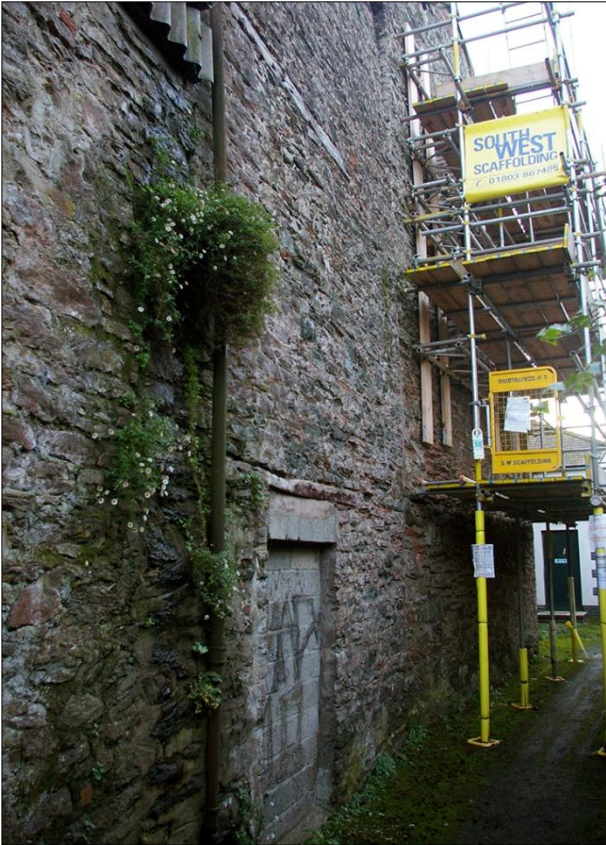
134. LEFT: THE NORTH WALL OF B3, SHOWING GF BO34 AND FF BO46; VIEWED FROM THE EAST.

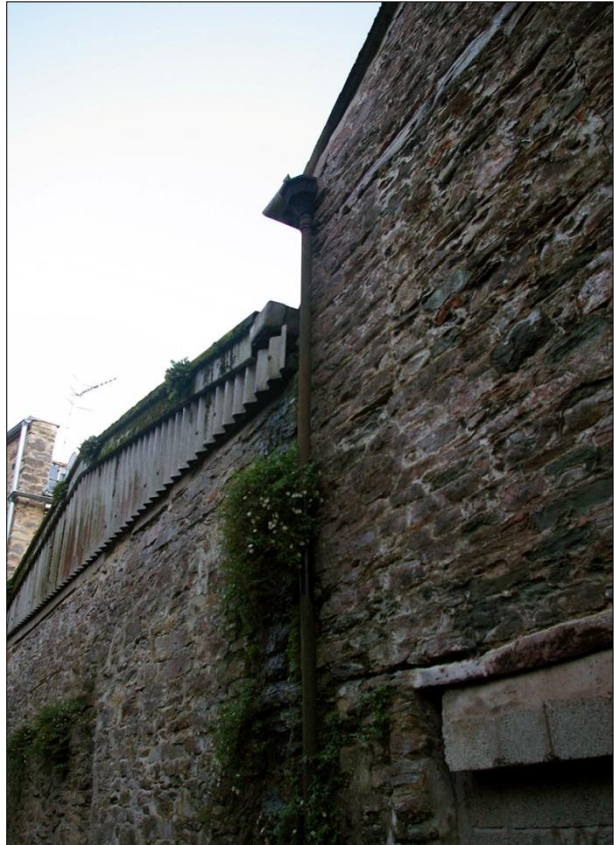
<b>B3 Exterior</b>		
<b>B3 Elevation NORTH</b>		<b>Description</b>
Fabric:		Reduced on the east side, patched with brick and hard cement mortars at the eaves. Repair to the north-east corner, infilling a damaged pier at the end of the open-fronted east elevation?
Blocked Openings:	BO34	GF blocked doorway with thin timber lintel to exterior, another possible yoked lintel to the interior. Blocked in concrete block. Poor quoins suggested this is forced.
	BO46	FF blocked loading door with timber exterior lintel. Shaped lintel to interior, used upside down; this may be a reused yoked lintel, or a reused structural timber (shaped upper section with clear sockets). Blocked with stone rubble.
Relationships:		Abuts B2; abutted by B4.
<b>B3 Elevation WEST</b>		<b>Description</b>
Relationships:		Built up against the east elevation of B2 (described above).
<b>B3 Elevation SOUTH</b>		<b>Description</b>
Fabric Description:		The south-west corner has been altered to incorporate a stack; brick and cement repairs.

135. RIGHT: THE NORTH WALL OF B3 AND THE YARD WALL OF B4; VIEWED FROM THE WEST.

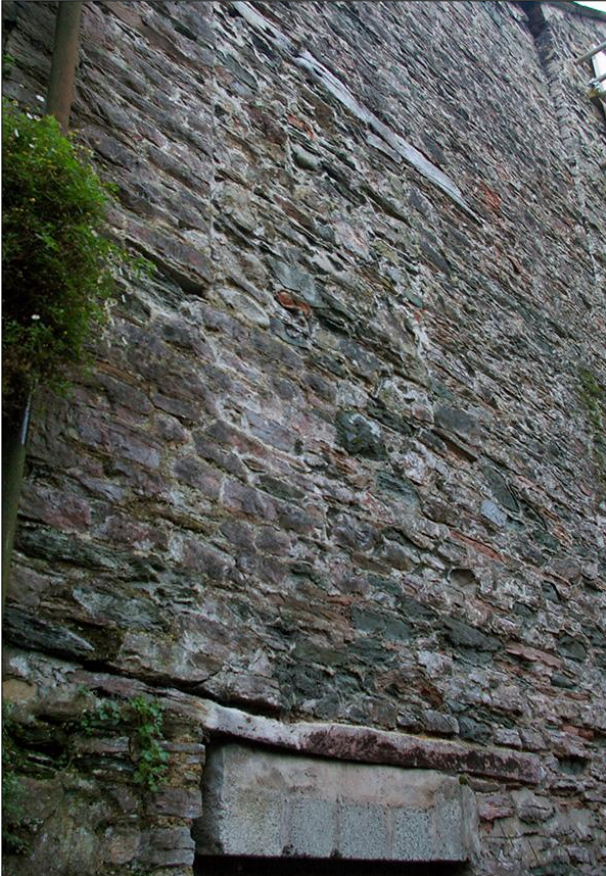
136. THE NORTH WALL OF B3 SHOWING FF BO46; VIEWED FROM THE NORTH-EAST.

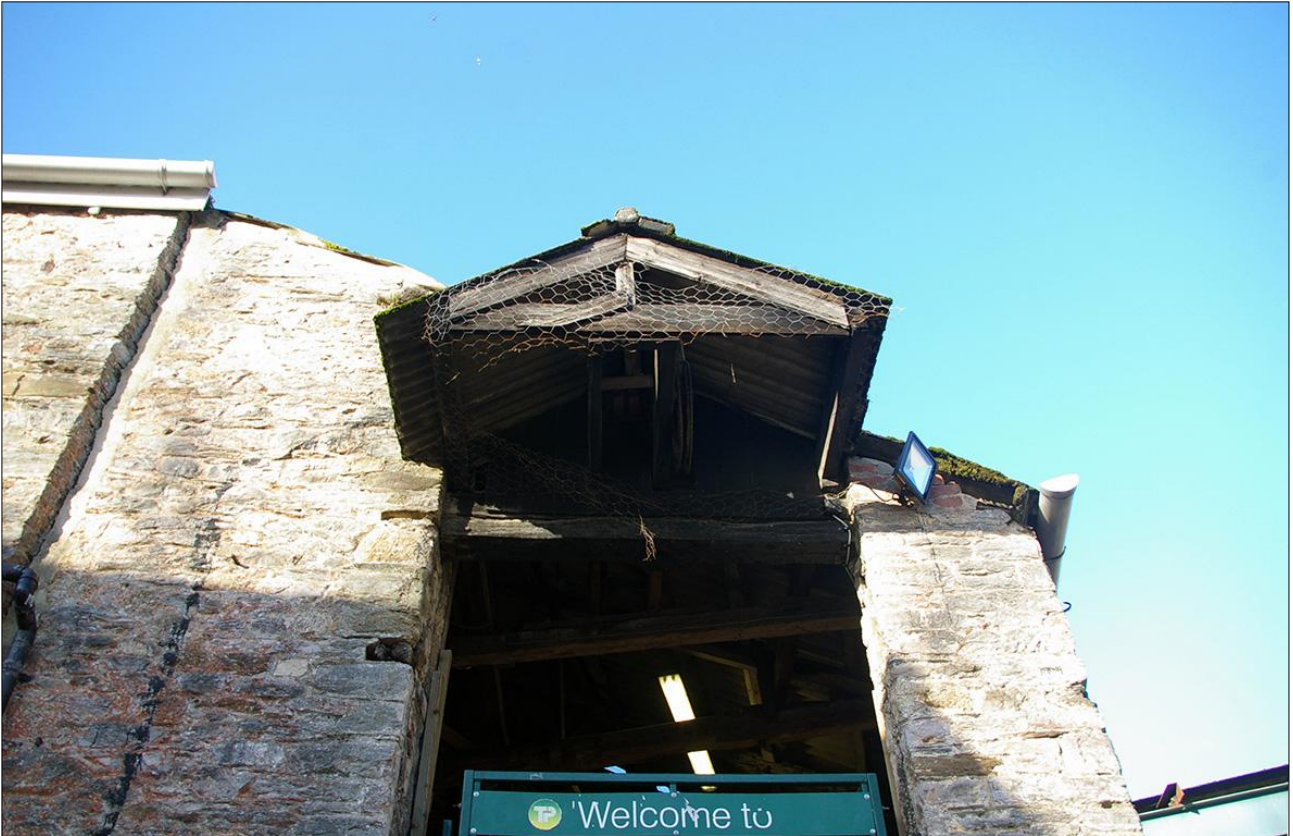
140. RIGHT: THE SOUTH ELEVATION OF B3 SHOWING THE WIDENED DOORWAY D13 WITH STAIRS (S3) BEHIND; VIEWED FROM THE SSE.

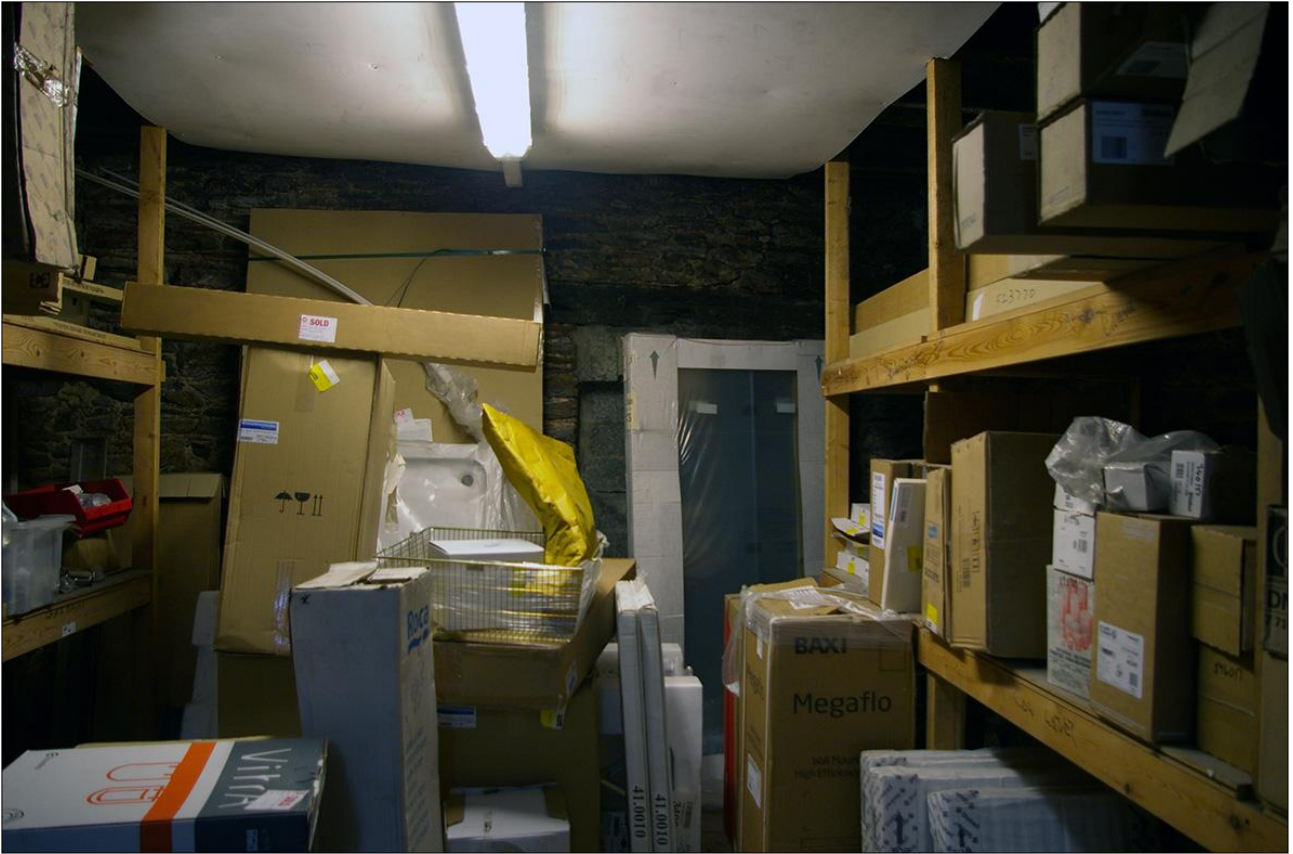
161. B3 GF INTERIOR, THE NORTH WALL WITH BO34; VIEWED FROM THE SOUTH.

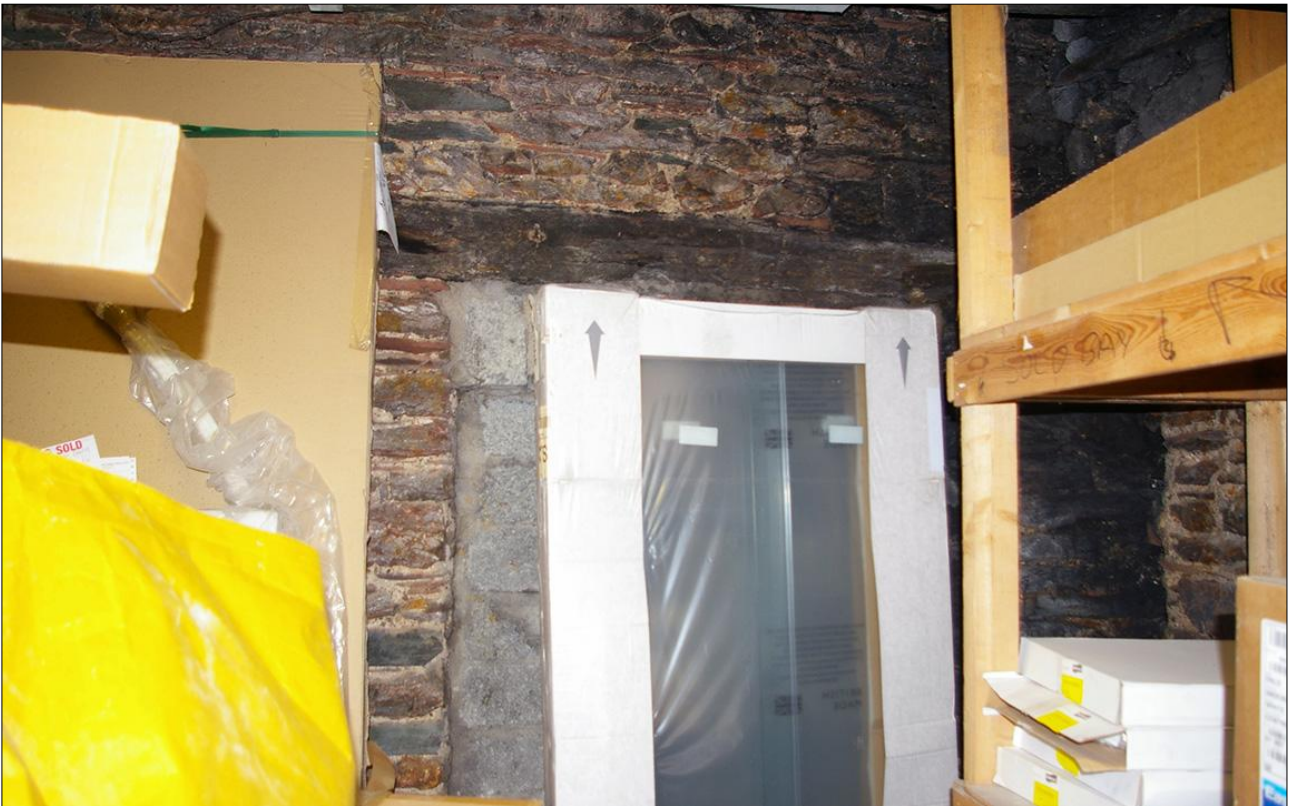
162. AS ABOVE, DETAIL OF BO34.
