# MAYOR'S AVENUE TRAVIS PERKINS

Desk-Based Assessment & Historic Building Recording

South West Archaeology Ltd. report no. 181127

## Mayor's Avenue Travis Perkins, Dartmouth, South Hams, Devon Desk-Based Assessment & Historic Building Recording

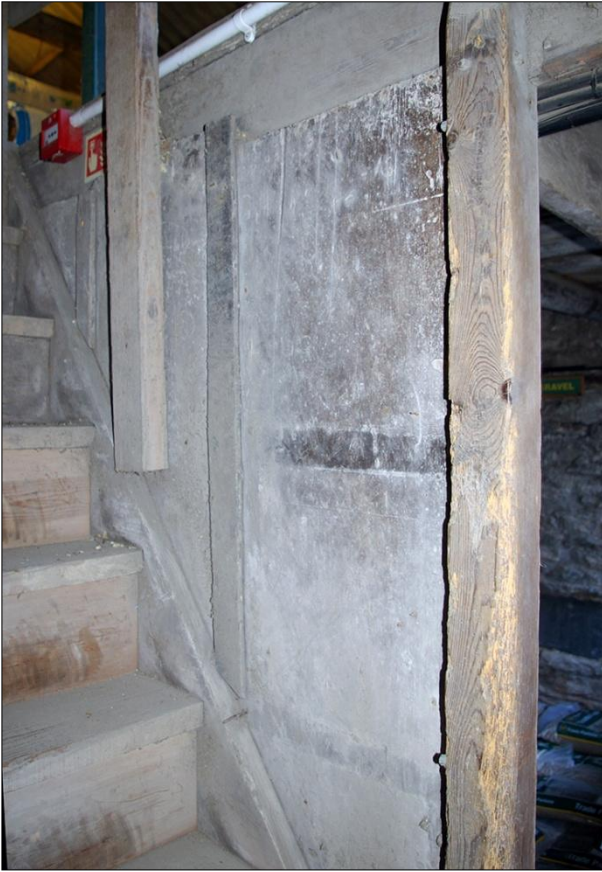
167. LEFT: B3 FF INTERIOR, THE SIDE OF THE STAIR S3; VIEWED FROM THE SOUTH-WEST.

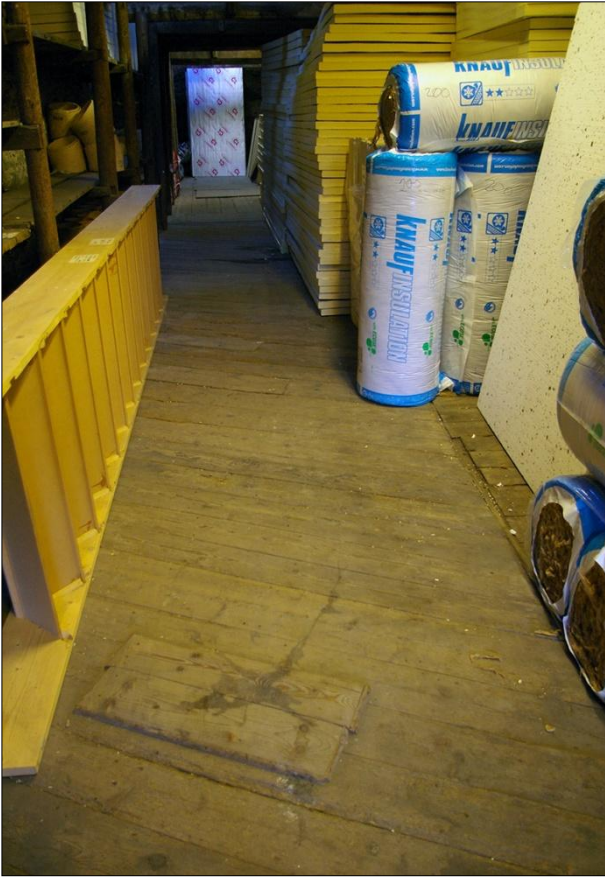
176. LEFT: B3 FF INTERIOR, HISTORIC FLOORBOARDS (S13); VIEWED FROM THE SOUTH.

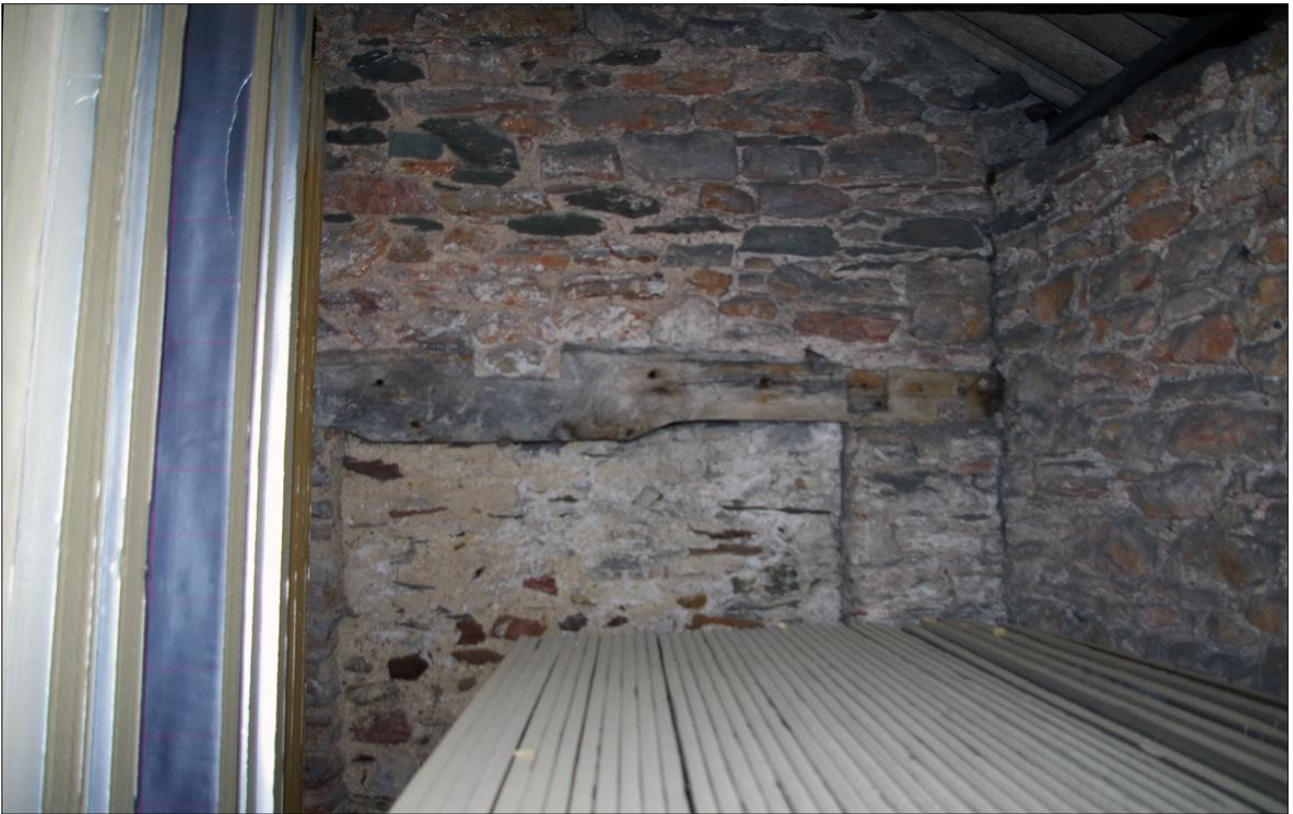
185. B3 FF INTERIOR, THE NORTH WALL SHOWING BO46 WITH UPSIDE-DOWN YOKED LINTEL; VIEWED FROM THE SOUTH.
