**THE BICKFORD CENTRE  
23 SOUTH STREET  
GREAT TORRINGTON  
DEVON**

HISTORIC BUILDING RECORDING

South West Archaeology Ltd. report no. 181114

By E. Wapshott & N. Boyd  
Report Version: **DRAFT01**  
14<sup>th</sup> November 2018

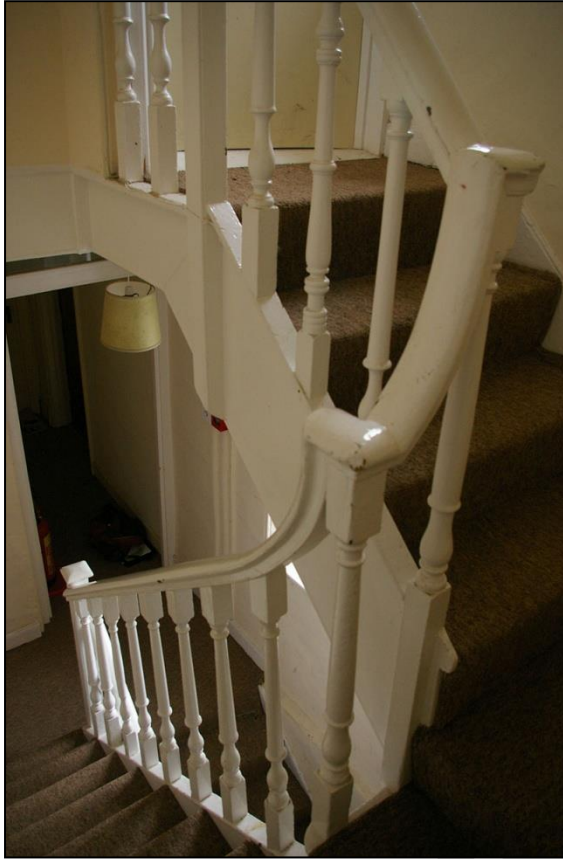
27. LEFT: THE THIRD FLIGHT OF STAIRS, SHOWING THE MOULDED HANDRAIL AND TURNED BALUSTERS; FROM THE SOUTH-WEST.  
28. RIGHT: R11 AND THE DOOR TO THE LONG-DROP TOILET WHICH PROJECTS OFF THE BACK OF THE BUILDING. THE DOOR IS A SIX PANEL WITH DEEPLY REEDED FRAME; FROM THE SOUTH.

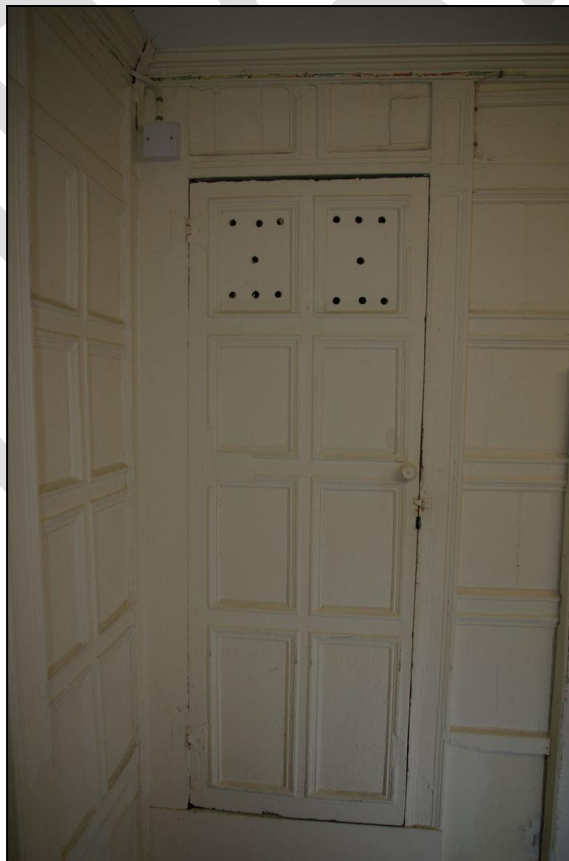
39. THE 18<sup>TH</sup> OR EARLY 19<sup>TH</sup> CENTURY BEADED, FLAT PANELLED CUPBOARD DOORS TO THE NORTH OF THE STACK IN R17; FROM THE EAST.

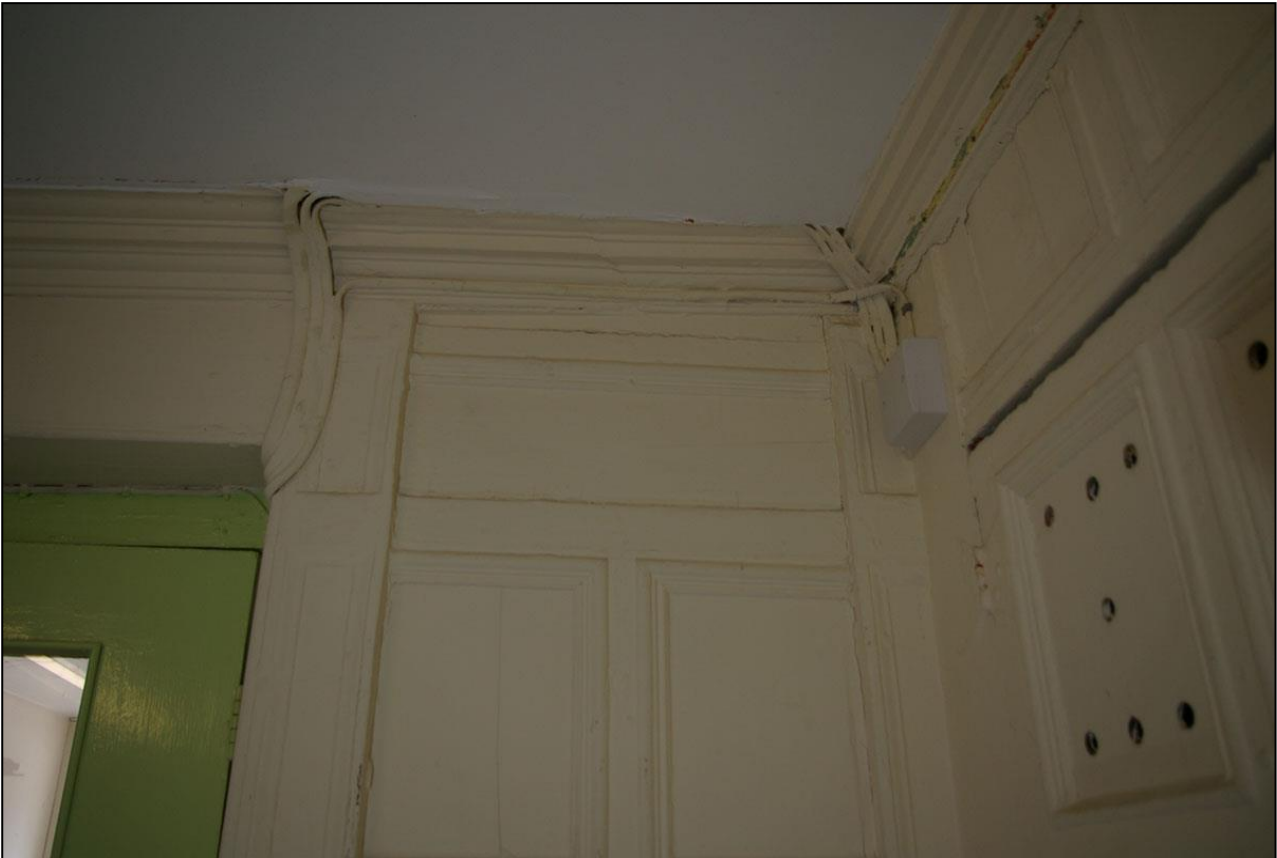
89. THE DIFFERENT CORNICES IN THE SOUTH-WEST CORNER; FROM THE NORTH-EAST.

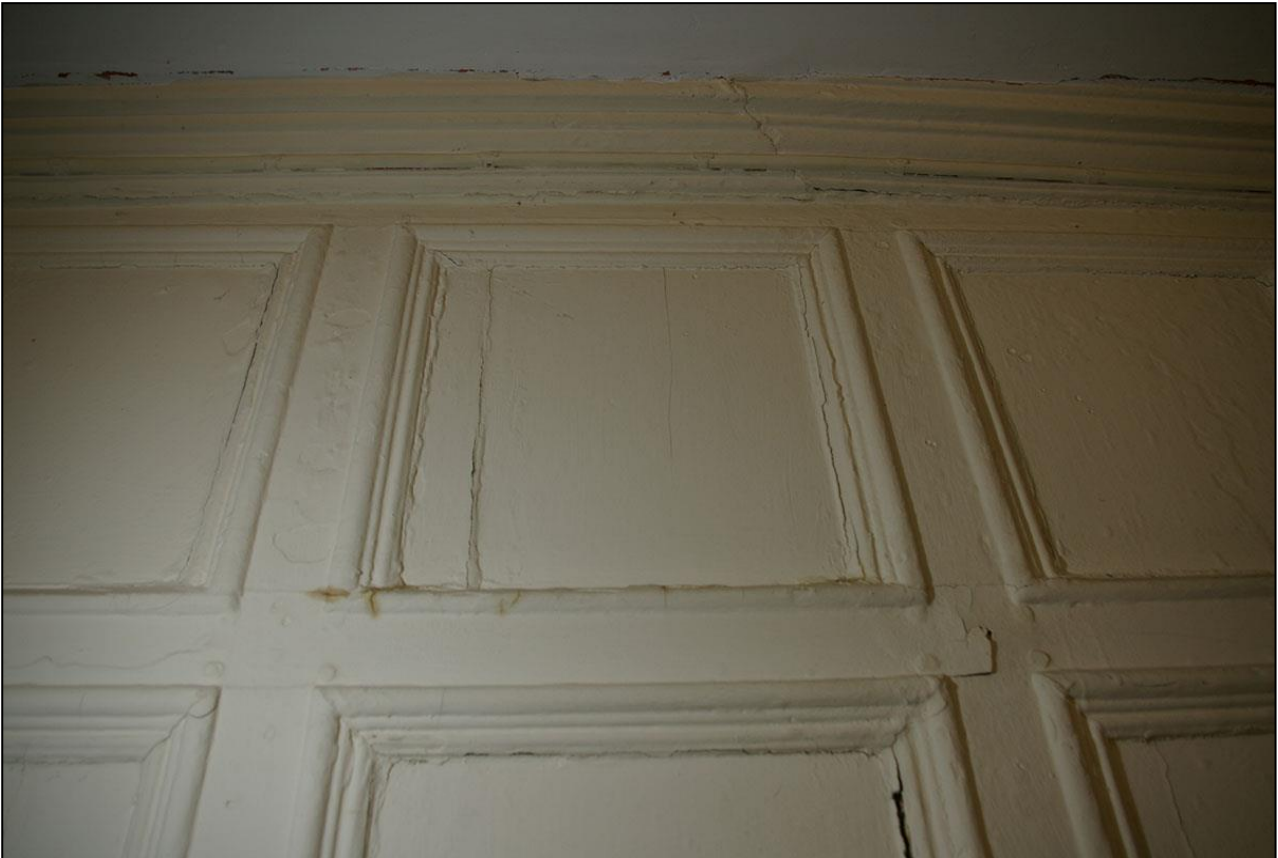
96. DETAIL OF THE TYPE 3 BOLECTION MOULDING; FROM THE EAST.

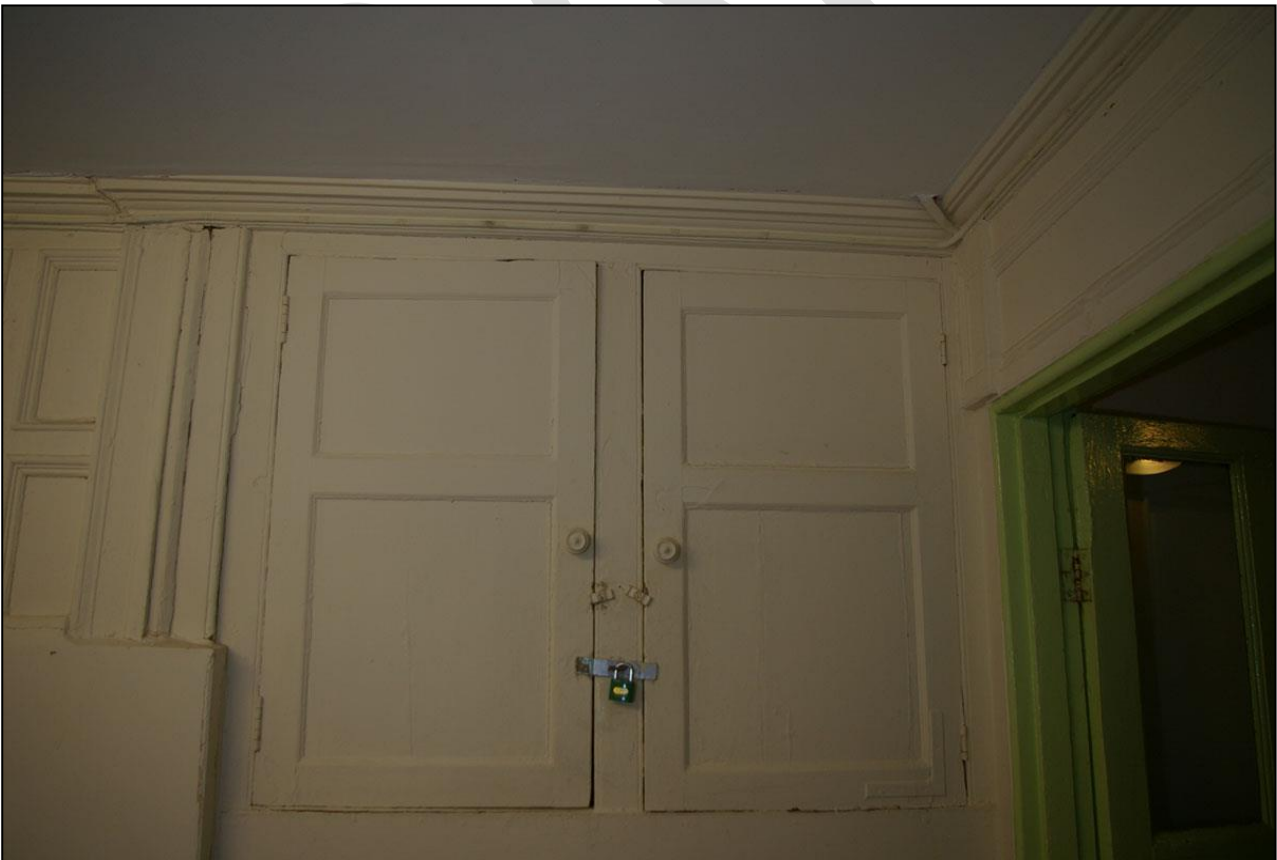
99. THE EARLY 19<sup>TH</sup> CENTURY CUPBOARD, TYPE 9 BEADED DOORS; FROM THE EAST.
